St Bride's Church and churchyard

Kirkton of Cushnie, Leochel-Cushnie, Aberdeenshire

Historic Building Survey and Assessment

AA 2089

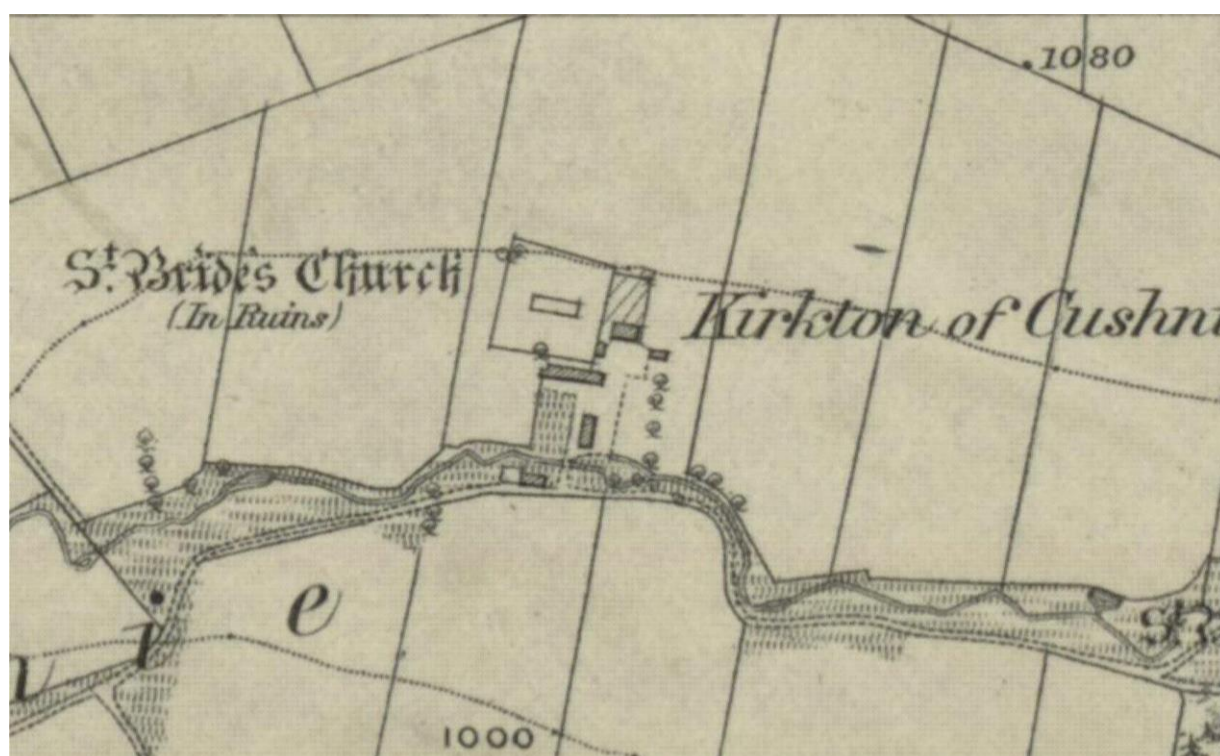
Figure 3 Ordnance Survey : First Edition, 6": mile, Aberdeenshire sheet LXXI, surveyed 1867, published 1869 (NLS)

Early Ordnance Survey maps, such as those of the First Edition of 1867, *figures 3 and 4*, show little useful detail of the church other than its outline which, shown as an unfilled rectangle, indicate the structure to have been roofless by that stage.

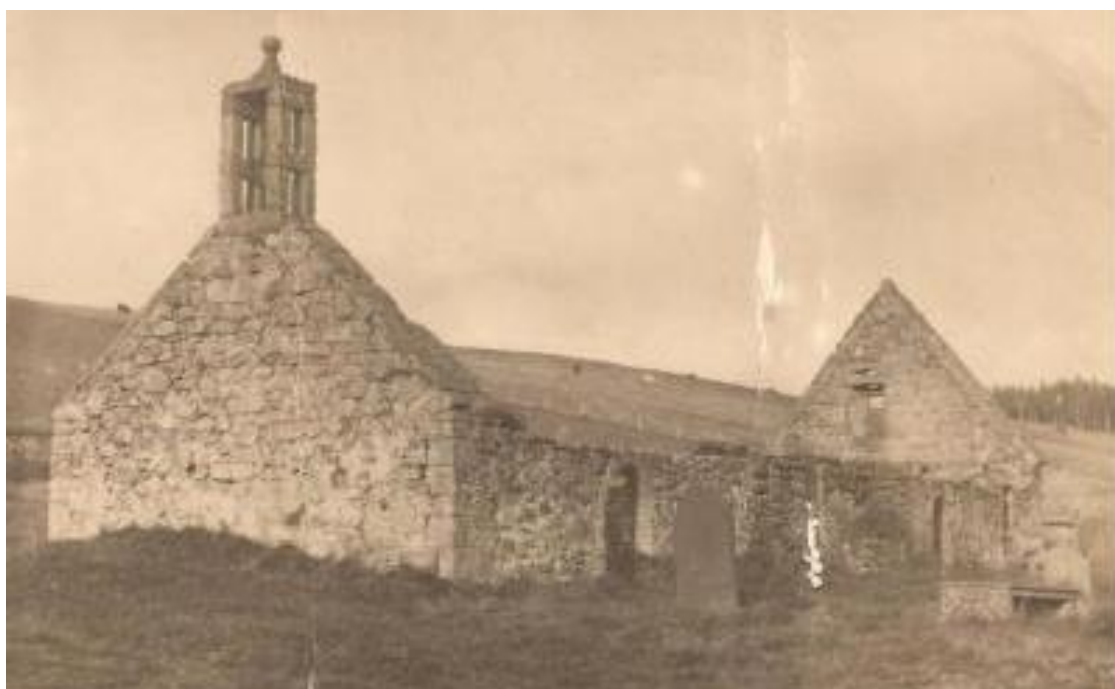
Plate 1 St Bride's Church, photograph taken from the SW, about 1906 (with permission, <http://www.cushnie-tough.co.uk/cushniechurchhistory.html>)

A surviving photograph of St Bride's, of c.1906, shows the masonry fabric of the structure to have survived entire up to that date, *plate 1*. This gives an excellent impression of the simplicity and architectural severity of the structure. Fortunately this illustrates in some detail the exterior side of the now-lost west gable wall, with fine bird-cage bell-cote at its apex. It also shows the positions of openings in the south wall – an entrance further west and at the east end what appear to be a possible second entrance and a narrow window (writing in the 1870s Andrew Jervise described two arched entrances - see below); part of the window is still extant. Just visible in the central part of the south wall (partly obscured by the white scratch) is the stone memorial panel set in to the wall face, also still existing.

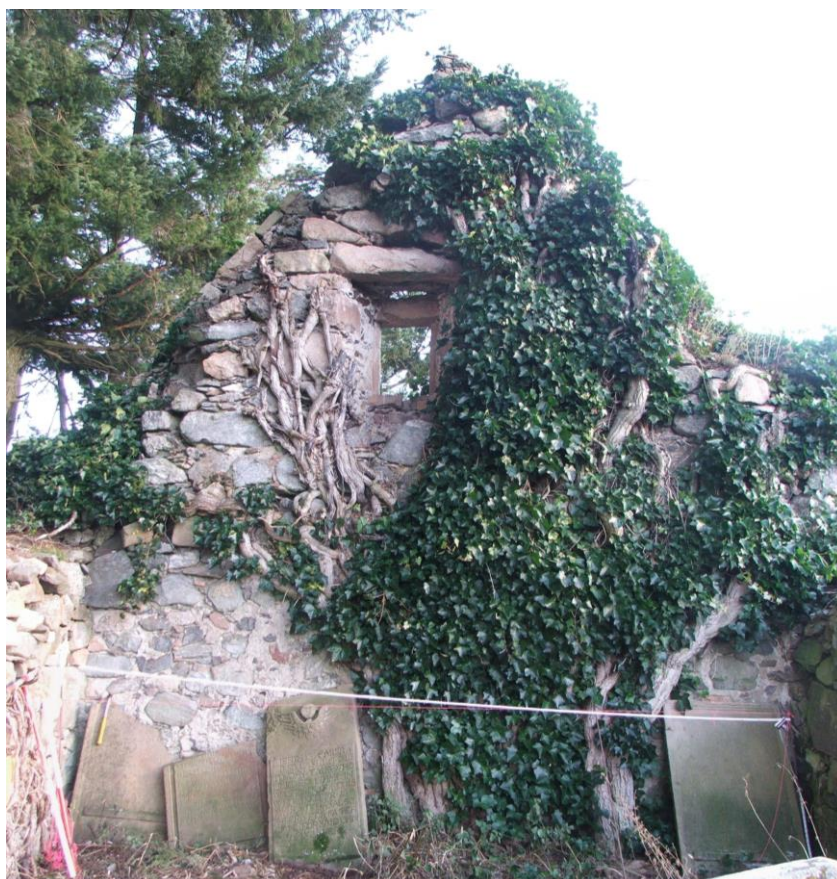
Plate 2 Ivy covering the interior of the east gable

Prior to commencement of the present project the church ruin had been subject to some clearance, removal of saplings and cutting back of ivy upon the upstanding walls. However much of the east gable in particular was still obscured by firmly attached mature ivy. A number of large tree stumps exist within the structure were located close to or upon the wall lines and probably contributed to their collapse; at the time of survey these were re-sprouting with new growth.

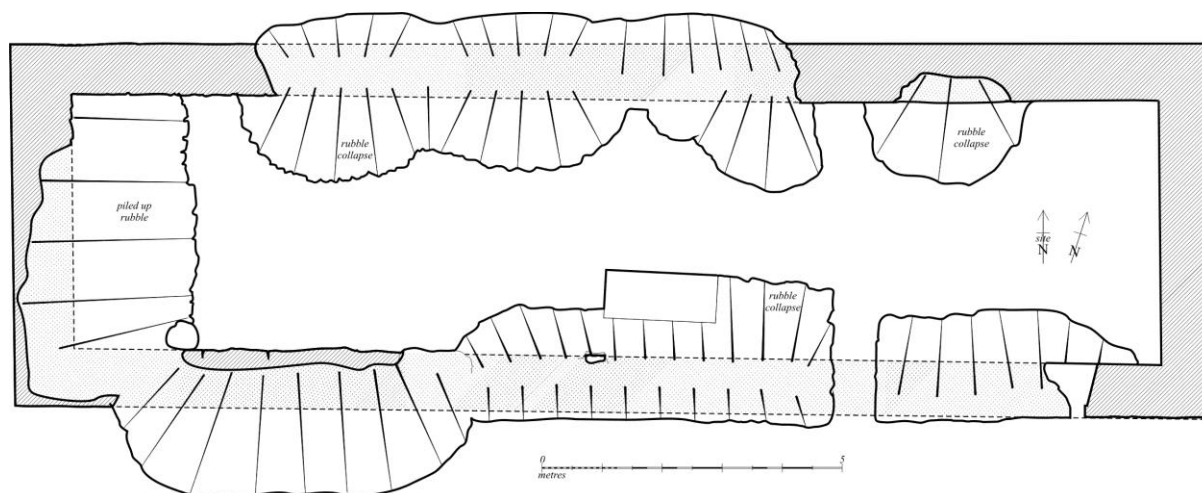
Figure 5 Plan of the church ruin

As the survey plan of the structure, *figure 5*, illustrates the church to have been of the simplest rectangular form, measuring some 19.75m lengthways (east-west) by 6.15m – 6.25m in width, over walls generally 0.90m in thickness. The plan displayed little irregularity or structural variation to indicate that it comprised more than one basic phase of development.

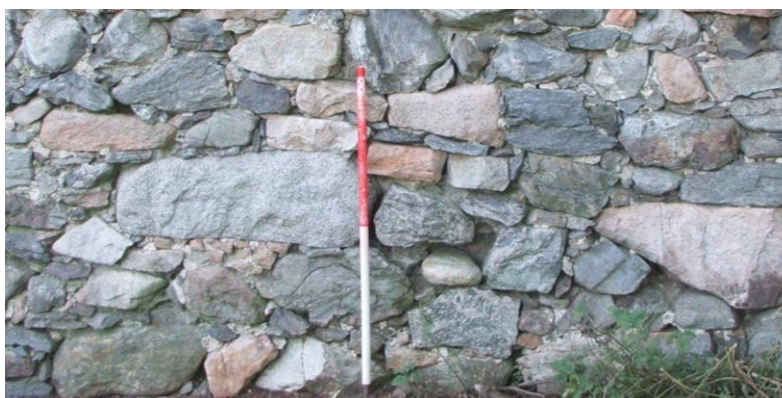
Plate 3 A typical area of masonry construction (east gable) displaying stone types present

The general masonry fabric of the building was built from the varied stone types typical of the vernacular architecture of the area, these for the most part field gatherings rather than quarried stone. Stones included pale pink granite, sometimes partly dressed, and blocks of whin and schist – some angular, some evidently simply cobbles (some possibly gneiss). Pinnings, employed relatively lightly, tended to be of smaller chips and pieces of whin and schist. Rubblework construction displayed little evidence of coursing. Where dressings remained these were either of a pale fine-grained sandstone, or of pale pink granite. The former were clearly imported.

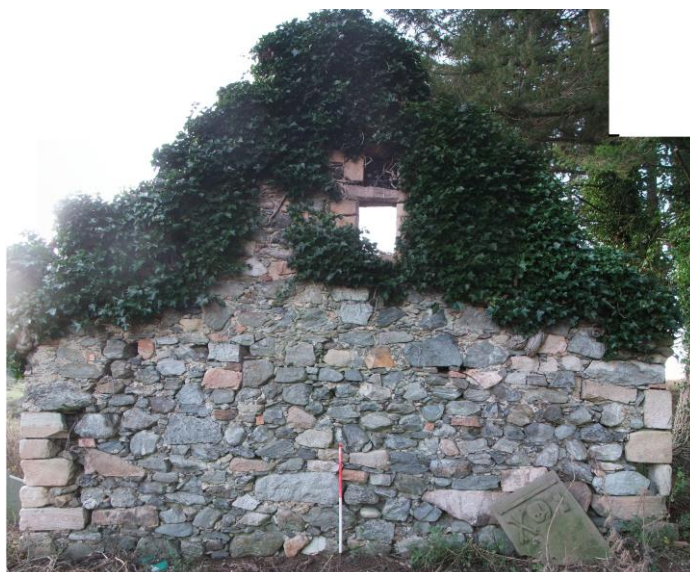
Plate 4 ivy covering the exterior of the east gable

The most substantial surviving part of the structure is the east gable which in spite of the concealing ivy growth appears to stand complete to its apex. On the visible masonry of the exterior the upper parts appear to be of a different build, bedded with a mortar that is generally much better preserved than elsewhere. While the ivy covering will have certainly afforded some protection, the difference in mortar character relates to phase. The more eroded lower wall areas are of a different build that corresponds to the sandstone quoining to the NE and SE that still remains, these of well-cut regular blocks of a pale fine-grained stone. The more durable upper mortared masonry relates to a clear horizontal construction break about 2.0m above ground and corresponds to upper quoining that is formed of rubble stone. Why the sandstone quoins were not reused in the upper rebuild is unknown, perhaps the structure had been derelict and part-robbed before the rebuilding occurred.

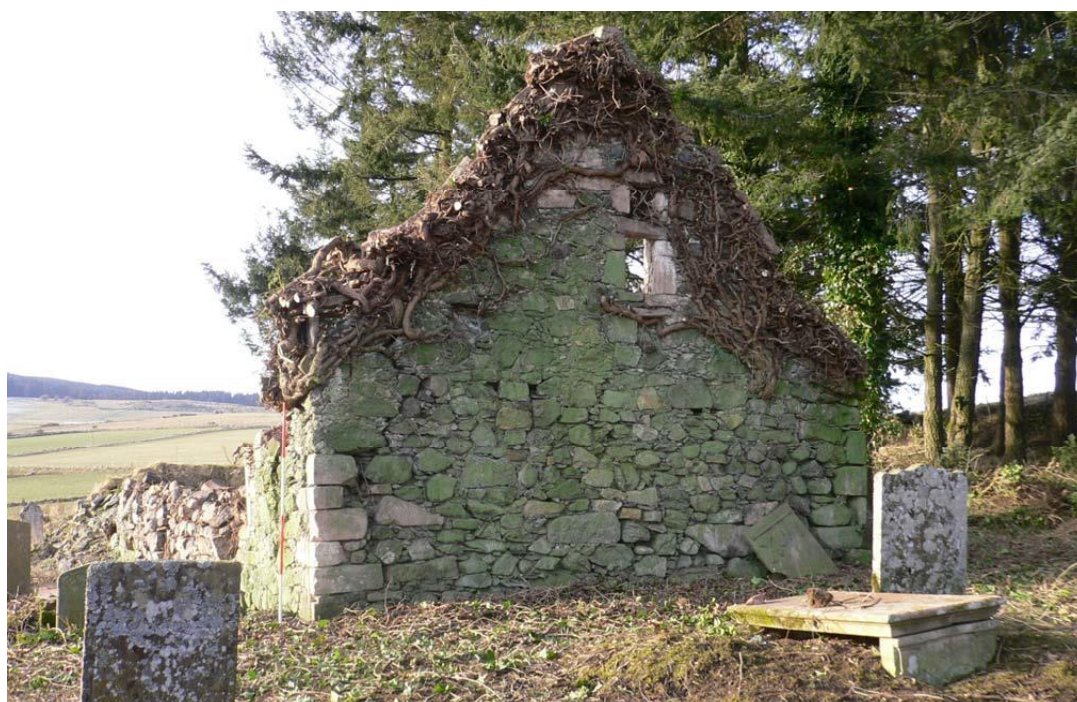
Plate 5 The exterior of the gable following partial clearance (Historic Scotland)

The principal feature of the rebuilt gable head is a solitary window, this at high level and slightly off-set to the south of centre. Internally the opening is broadly splayed (*plate 6*); externally its pale pink granite dressings are detailed with a simple chamfer. Immediately above the window lintel there is a recess defined by granite dressings with squared arises; this feature may have contained an armorial or dedication / date-stone (*plates 4 and 5*).

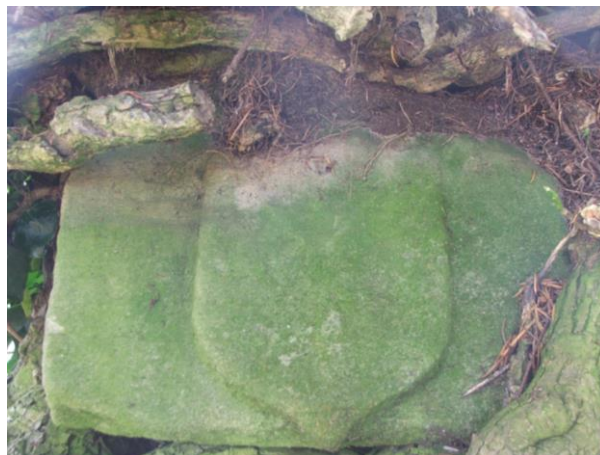
Plate 7 Carved skew-put at the NE corner

Of note at the NE corner is a sandstone skew-put that preserves a shield motif, *plate 7*. Unfortunately the surface was too worn to make out any decoration or inscription. Apart from this skew-put the wall heads were obscured on the exterior, they were mostly obscured on the interior as well with only a few copes visible on the north pitch, these of cut granite and angular blocks of field stone, *plate 6*.

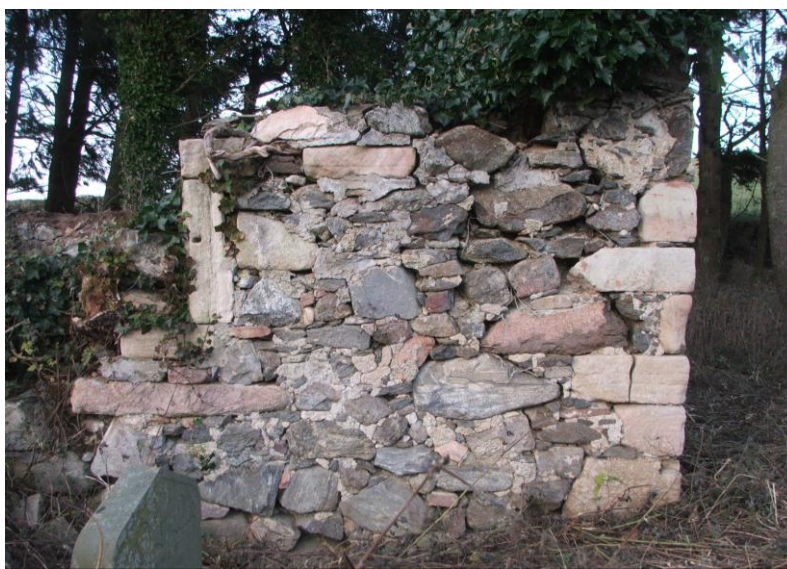
Plate 10 Remains of inserted window on at east end of south elevation and SE corner quoins

The south wall of the church is now much reduced, particularly to the west where its remains are mostly buried beneath rubble collapse. Few original features were noted apart from the sandstone quoining of the corners. Close to the east end survive the remains of a window, this is a clear insertion along with an associated area of masonry that employs a mortar that is distinct from the surrounding. Parts of a sill stone and the lower east jamb of the window survive, the lower stone of which is elongated and vertically set. The jamb stones display a rough chamfer now much eroded. On the interior the splay to the east survives but is partly obscured by a grave slab cemented against it.

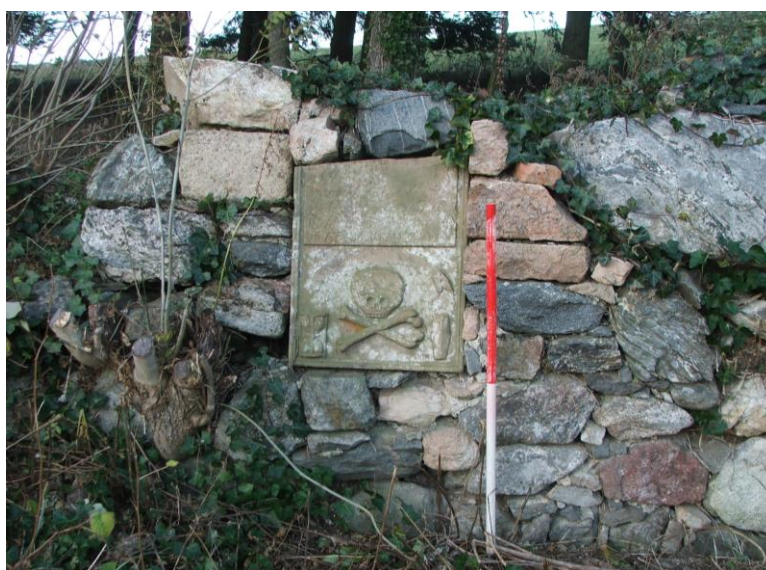
Plate 11 Memorial slab set in to the exterior south wall of the church

In the central part of the south wall a memorial slab (stone 47) had been set into the masonry of the wall face, *plate 11*. Whether this in-filled a former window opening or whether the surrounding secondary lime bonded masonry is associated with the insertion remained unclear; the wall top at this point is buried beneath rubble collapse and thus inaccessible. Some of the surrounding squared blocks appear to be early in character, but these may be re-set in their present positions.

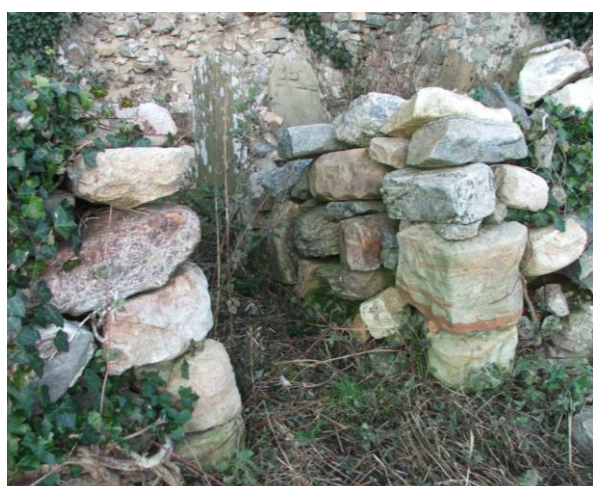
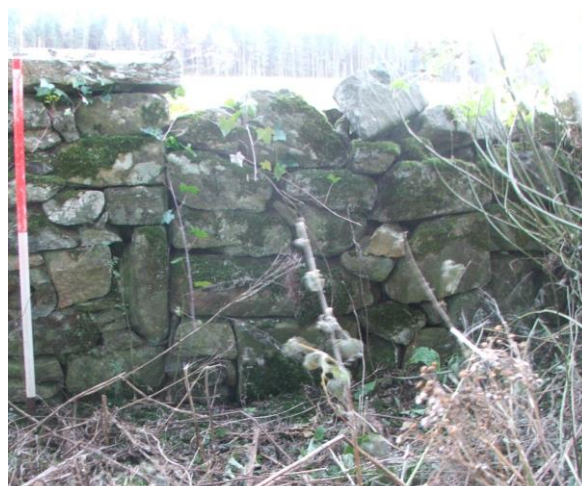
Plate 12 South wall - dry-stone masonry of existing entrance into structure towards the east end

An existing 'entrance' off-set to the east in the south wall is the now only opening into the structure, *plate 12*. However in its present form it is clear that this is not an original feature or even a well-built insertion, rather it had been largely formed of dry-stone construction in recent times along with much of the surrounding walling. Some sandstone blocks used in the jambs of the opening are likely to have been reused from elsewhere in the building, or even from a former entrance at about this point, though no cut faces were noted that bear diagnostic detail.

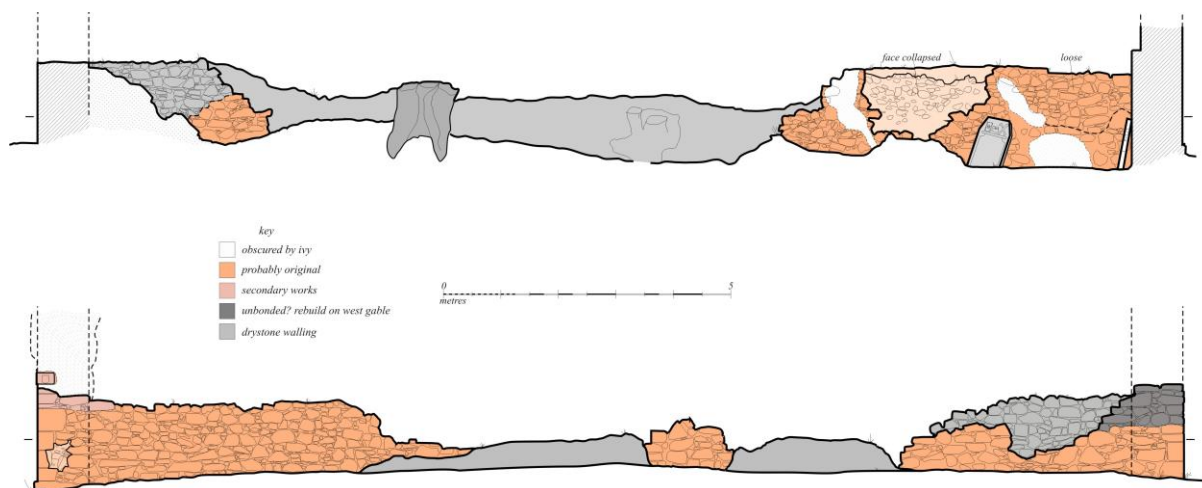
Figure 9 North elevation interior and exterior with suggested phasing (orange – extent of original fabric)

Towards the east gable the masonry of the north wall is better preserved, rising to upto 1.75m. Though featureless this section may be mostly original work. On the interior side of this eastern section a large area of facing has recently fallen, and the facings close to the east gable are also in poor condition, this possibly in part a secondary repair.

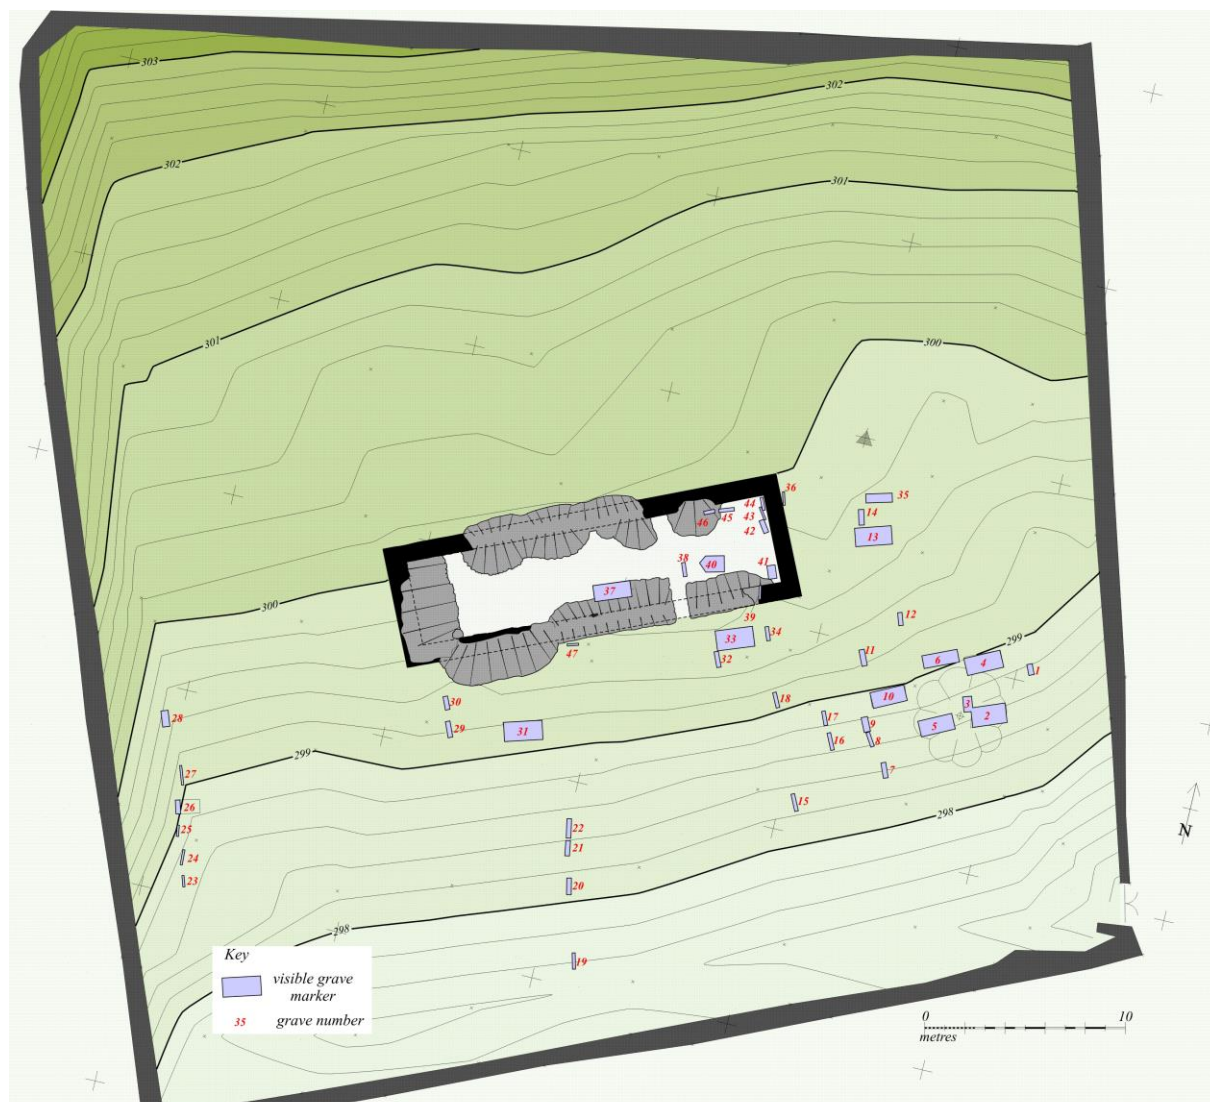
Figure 10 Graveyard survey plan

The churchyard comprises a roughly rectangular enclosure (actually 50.0m – 53.5m east/west by 45.5m - 57.0m north/south) defined on all sides by dry-stone walls, these now much over-grown. The churchyard has an elevated south-facing prospect over the Cushnie Burn and across Cushnie Glen. The ground within the enclosing walls rises steadily from south to north from 297.0m above estimated

OD to the SE (at the entrance) to 303m at the NW corner. The ground levels up along the southern extent of the enclosure, the walling bounding that side in effect functioning as a half-dyke retaining feature. Some terracing-in is apparent along the northern and western perimeter.

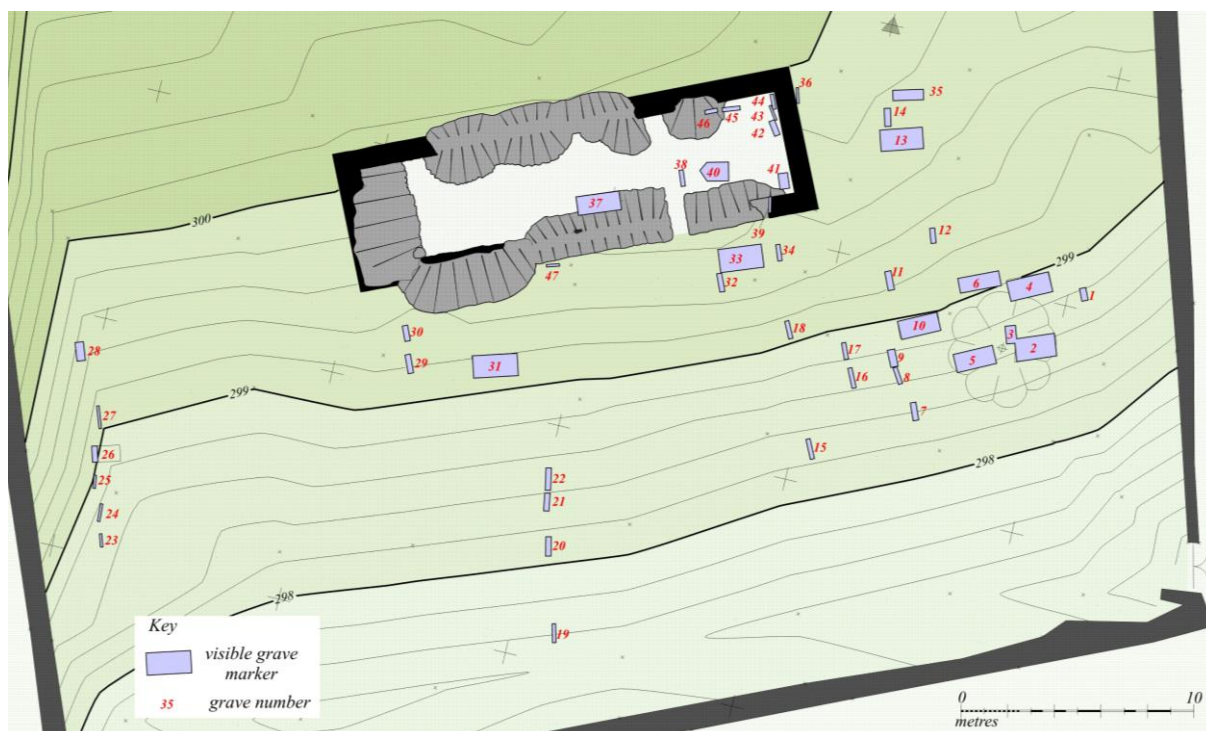
Figure 11 Excerpt of graveyard survey showing locations of individual monuments

A total of 45 graveyard monuments were recorded at St Bride's during the present survey exercise. These were individually numbered and catalogued in the form of a gazetteer (*Appendix A*), and plotted upon the graveyard survey plan (*figure 11*). The more precise positions of some individual monuments were recorded where they lay up against the walls of the church ruin (Nos. 36, 41-45) or, in the case of monument 47, built in to its fabric.

No monuments were located beyond the north side of the church. The main concentrations lay to the SE, the south and the SW, with further groups within the church interior and beyond its east end. There was some internal organisation of graves apparent, with the SW and south groups in regular alignment, indicating the establishment of formal lairs (burial plots). There was some indication of a similar arrangement of lairs in the southwestern group, with up to six rows apparent.

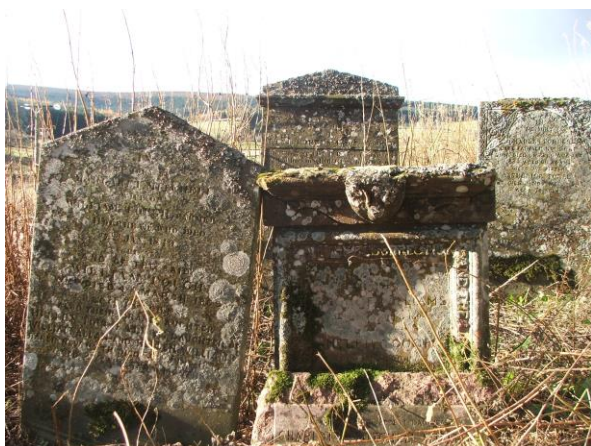
Plate 15 Stones 8, 9, 16 and 17

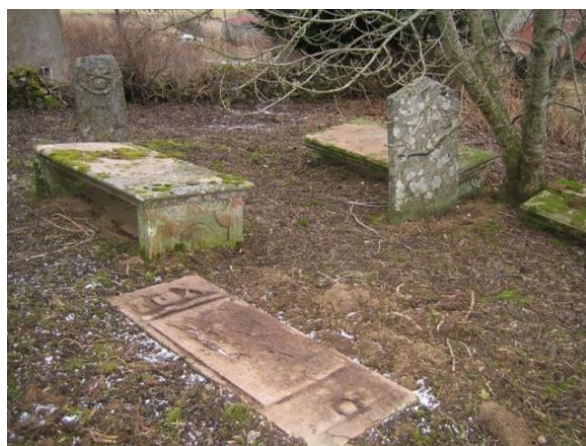
Plate 16 Stones 1 - 4 and 6 looking SE (photo ©Copyright 2013, SCHR Ltd.)

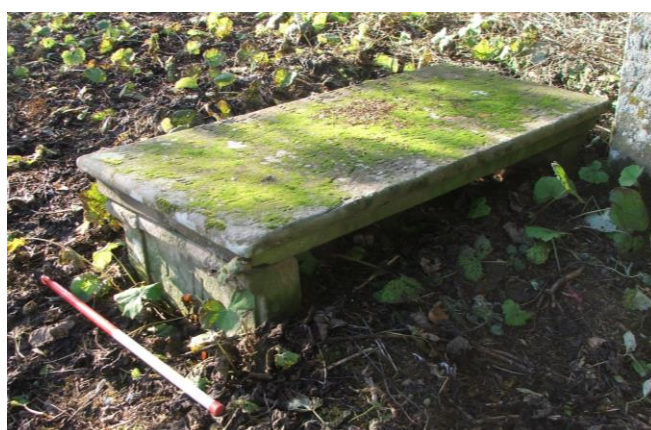
Plate 18 Stone 13 (Ross, 1811)

<p>13</p>	<p>Table tomb with foot panels. <i>"Under this...is the...John Ross..."</i> Flat top with beaded edge, foot panels with Doric columns carved in relief. E foot contains the inscription <i>"1811"</i> Top obscured by weathering and moss. Likely commemorates 4 or more individuals.</p> <p>Approx. 2.0m length, 0.70m width, 0.40m height.</p> <p>Shows signs of granular erosion and level 1 surface loss. Heavy moss and lichen growth.</p>

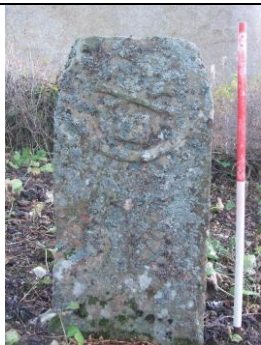
1	<p>Headstone. Heavily weathered, illegible. Erected upside-down, likely displaced. Unclear if orientation is of significance. Tapered base. Displays in relief an arched ribbon above mortality symbols of a skull facing left, over crossed bones.</p> <p>Approx. 1.0m height, 0.50m width</p> <p>Shows granular erosion, level 1 surface loss and level 2 differential weathering. Heavy lichen growth.</p>

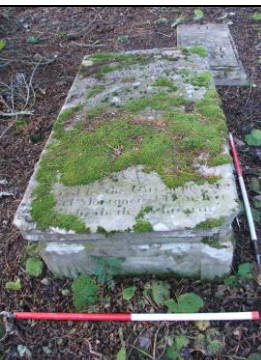
4	<p>Table tomb with foot panels. "...Tawse [?]..." (and spouse). Top nearly illegible, obscured and weathered. Flat top with damage to corners and cyma recta moulding. Foot panels engraved in low relief. Greek style columns with fan or shell decoration. W foot cracked and engraved "IT IM". E foot engraved "182[?]"</p> <p>Approx. 0.40m height, 1.5m length, 0.80m width</p> <p>Shows granular erosion, level 1 surface loss and level 1 differential weathering. Heavy moss and lichen growth.</p>

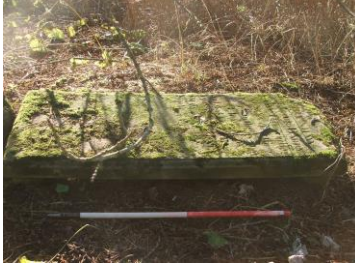
<p>5</p>	<p>Table tomb with inset foot panels. "...Shaw..." Top nearly illegible, weathered. Flat top with beaded edge and moderate damage to corners esp. SW. Foot panels undecorated.</p> <p>Approx. 0.35m height, 1.6m length, 0.80m width.</p> <p>Shows granular erosion, level 1 surface loss and level 1 differential weathering. Moderate moss and lichen growth.</p>

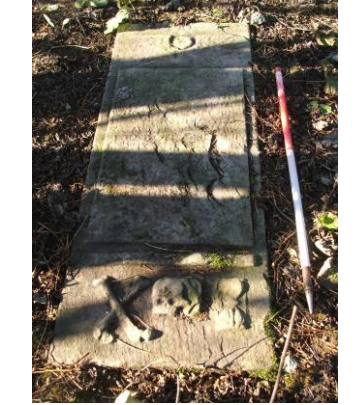
<p>6</p>	<p>Ledge stone. "AW 1740" incised top left. Top shows winged cherub carved in relief, middle contains raised placard with heavily weathered illegible inscription, base shows relief carvings of ribbon over mortality symbols of crossed bones (L), skull facing left (C), hourglass (R).</p> <p>Approx. 1.6m length, 0.60m width.</p> <p>Shows granular and planar erosion, level 2 surface loss, level 2 differential weathering, level 2 delamination. Some moss and lichen growth.</p>

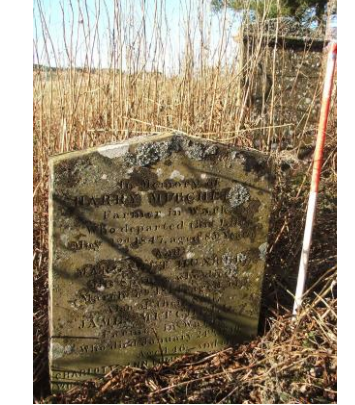
<p>7</p>	<p>Headstone with triangular top. "In Memory of Harry Mitchell, Farmer in Wark, who departed this life May 22d 1847, aged 85 years and Margaret Hunter, his spouse, who died March 7th 1814 aged 54, also of their son, James Mitchell, Farmer in Wark, who died January 24th, 1849, aged 46; and of Charlotte Ann Lumsden... who died..."</p> <p>Different font used for Charlotte Ann Lumsden, added at a later date</p> <p>Approx. 0.80 height, 0.70m width.</p> <p>Minimal weathering, some lichen growth.</p>

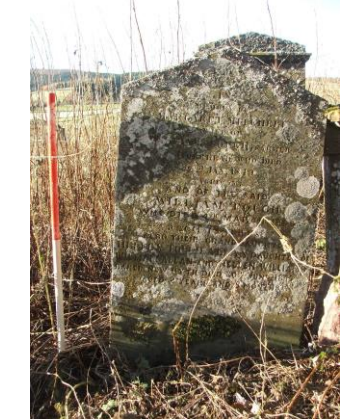
<p>8</p>	<p>Headstone with triangular top. "In Memory of Margaret Mitchell wife of William Tough, farmer, Holehead, who died 27th Jan, 1849, aged 55. And of the said William Tough who died 4th March 1869, aged 78 years, also their granddaughter Hellen Tough Allan daughter of William Allan and Hellen Williams barer New Byth, died 30th June 1877 aged 2 years and 8 months".</p> <p>Appears that William Tough was added at a later date, and Hellen Tough Allan added later still.</p> <p>Approx. 1.25m height, 0.60m width.</p> <p>Minimal weathering, some moss, considerable lichen growth.</p>

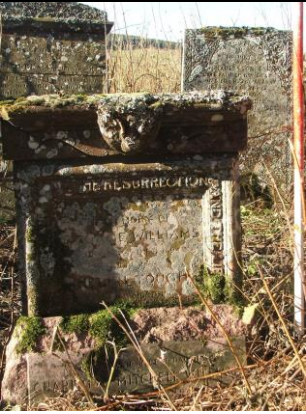
<p>9</p>	<p>Headstone. "Erected in memory of George Williams, born 1814-died 1894 and Helen Tough born 1819- died 1889" Erected in 3 pieces. Natural 'unworked' stone look to base with smooth plaque reading "also...their eldest daughter Charlotte Mitchell Williams...died 1907". Square central section with raised border and lettering in relief "and the life, I am the resurrection, and the life" carved around the edges, top section is plinth with cyma reversa moulding and shield with carved relief.</p> <p>Approx. 1.0m height, 0.60-0.75m width.</p> <p>Minimal weathering, some damage to plinth, heavy moss and lichen growth.</p>

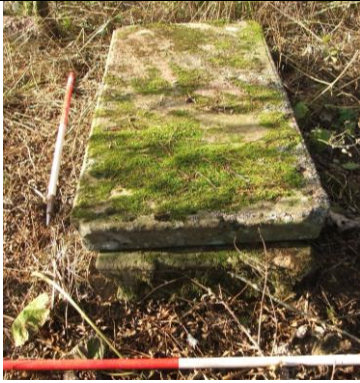
<p>10</p>	<p>Table tomb with foot panels. Flat top with coved edges, damaged corners. Decorative legs and feet carved in relief on foot panels. Heavily weathered, illegible.</p> <p>Approx. 1.8m length, 0.80m width, 0.40m height.</p> <p>Shows signs of granular erosion, level 1 surface loss and level 1 differential weathering.</p>

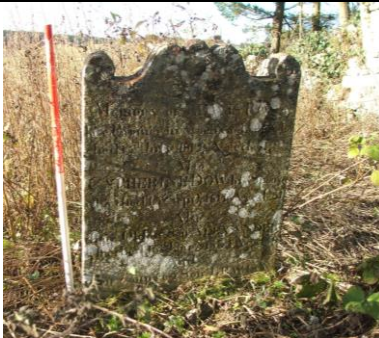
<p>11</p>	<p>Headstone. "In memory of Lewis Ross...farmer in Gorb...who died 13th July 1812, aged 51, also Catherine Dow his spouse who died 15th Sept 1814 aged 51, also their oldest son Alexander who died 16th Jan...1951 aged...and their youngest son Lewis..." Subsquare with stylised top. Possible winged cherub with flowers at corners.</p> <p>Approx. 1.0m height, 0.85m width.</p> <p>Signs of surface loss along top faces, heavy lichen growth.</p>

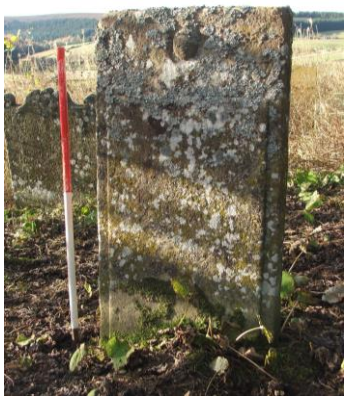
<p>12</p>	<p>Headstone. Illegible. Winged cherub at top, raised plaque in central section, inscription weathered. May be an erected ledger stone similar to #6.</p> <p>Approx. 1.2m height, 0.6m width.</p> <p>Shows signs of granular erosion, level 2 surface loss, level 2 differential weathering.</p>

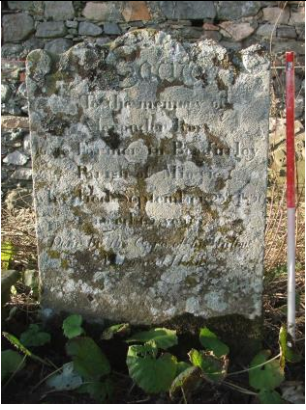
<p>14</p>	<p>Headstone. <i>"Sacred to the memory of Alexander Ross, late farmer in Bogfurloy, Parish of Migavie who died September 25 1837, aged 63 years, Done by the care of his widow Margaret Hosie"</i> Rectangular shape with stylised top.</p> <p>Approx. 1.0m height, 0.70m width</p> <p>Moderate weathering with some surface loss along top. Thick lichen growth.</p>

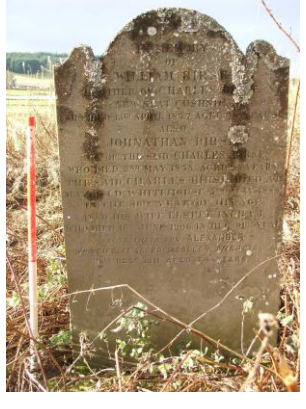
<p>15</p>	<p>Headstone. <i>"In memory of William Birse brother of Charles Birse New Slat Cushnie, who died 13th April 1877, aged 78 years. Also Jonathan Birse, son of the said Charles Birse, who died 2nd May 1875, aged 25 years. The said Charles Birse, died at Mayfield Whitehouse, 5th May 1888 in the 80th year of his age. Also his wife Elspet Ingram who died 11th June 1906 in her 91st year, also their son Alexander who died at Sedro-Woolley, Amercia, 18th Dec 1911 aged 74 years"</i> Rectangular stone with semicircular central feature.</p> <p>Approx. 1.4m height, 0.90m width</p> <p>Minimal weathering, some lichen growth.</p>

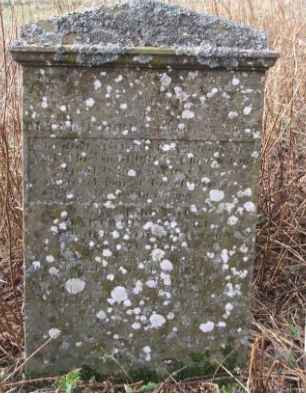
<p>16</p>	<p>Headstone. <i>"In memory of Peter Forbes, farmer, Newbraes, who died 21st Feb 1848 aged 66 years and of his son George who died 9th April 1826 aged 10 years and of four of his children who died in infancy. Also of his wife Margaret Clark, who died 15th April 1864 aged 76 years. Also their granddaughter Eliza Forbes wife of Samuel Tawse, farmer, Mains of...Migavie, died 19th September 1882 aged 82 years, also the above Samuel Tawse who died at Culou...h cottage 19th March 1913 in his 79th year"</i> Triangular top with cyma reversa moulded band. Recessed panel in top 2/3rds.</p> <p>Approx 1.4m height, 1.0m width.</p> <p>Some granular erosion and surface loss, Heavy lichen growth.</p>

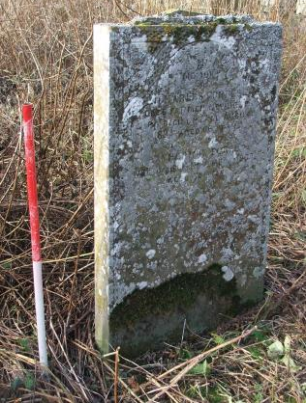
<p>17</p>	<p>Headstone. "Erected in memory of Charles Forbes late farmer, Newbraes, who died on 22nd August 1884 aged 66 years, also his sister Catherine Forbes who died 1st November 190th Aged 78 years" Incised stylised arch with diamond pattern around edges and flower roundels in corners. Top is missing, may be associated with #45.</p> <p>Approx. 1.2m height, 0.80m width.</p> <p>Shows heavy lichen growth and minimal surface loss.</p>

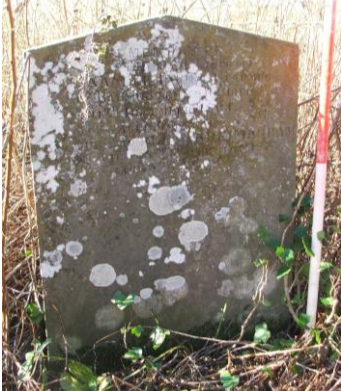
<p>18</p>	<p>Headstone with triangular top. "In memory of...wife of Alexander Ingram, farmer...died 11th December 1863 aged 70 years, also the said Alexander Ingram who died 23rd September 1875 aged 91 years"</p> <p>Approx. 0.80m height, 0.60m width</p> <p>Minimal weathering, moderate lichen growth.</p>

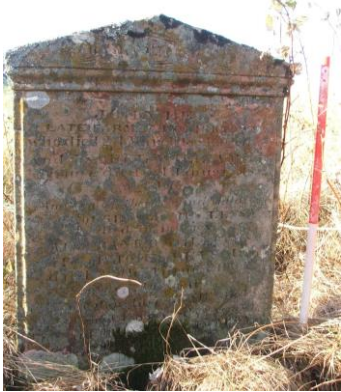
<p>19</p>	<p>Headstone with triangular top. "In Memory of" engraved in pediment. Cyma recta style 'architrave', raised panel with inscription "John Leys, late farmer in Kirkton who died 2nd March 1834 aged 77, and Isabel William his spouse, died...January 1857 aged 75, and...of their grandchildren George James Leys died in infancy also Janet William wife of John Ley...died 25th August 1861 aged..."</p> <p>Approx. 1.2m height, 0.90m width</p> <p>Shows some differential weathering and obscuring of script. Moss and lichen growth.</p>

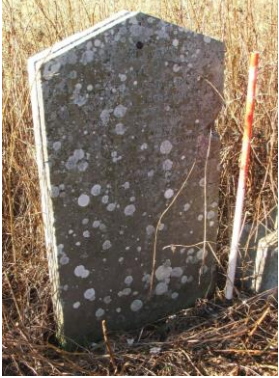
<p>21</p>	<p>Headstone with triangular top. <i>"In memory of George Williams, late farmer in Miltown of Cushnie died 4th Nov 1862 aged 80 years, and of Helen Duckison his wife who died 15th June...aged 86 years also their son Harry Williams, farmer in Braeside, died 15th...1881 aged 38 years"</i></p> <p>Approx. 1.1m height, 0.60m width.</p> <p>Some surface loss, delamination level 2 with fracture along right edge. Bolts in top and right to arrest delamination. Fracture along right edge. Some lichen growth.</p>

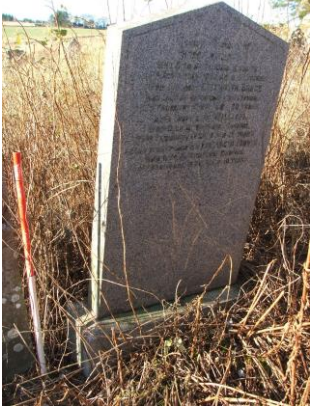
<p>22</p>	<p>Headstone with triangular top set in rectangular base. <i>"Erected in memory of Harry Williams who died at...Cushnie 13th September 1881 aged...years, also...Elizabeth Bruce who died at Woodend...12th February 1923 aged 80 years, also their son William who died in...February...aged 18 years also their daughter Elizabeth Forbes who died in...Cushnie 26th February...aged 10 years"</i> Granite with blackened shallow lettering and incised line around stone edge.</p> <p>Approx. 1.5m height, 0.80-1.0m width</p> <p>Little to no weathering, faint lettering.</p>

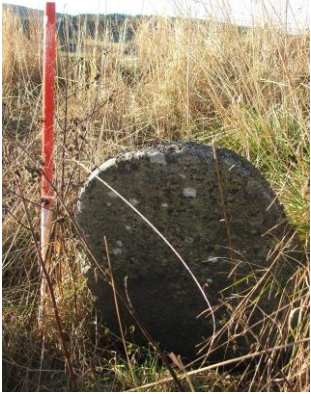
<p>23</p>	<p>Headstone with rounded top. Thinly engraved with "WR" over "IW" No other engravings or information is present. Stone rests on a considerable angle.</p> <p>Approx. 0.70m height, 0.60m width</p> <p>Little weathering, considerable lichen growth.</p>

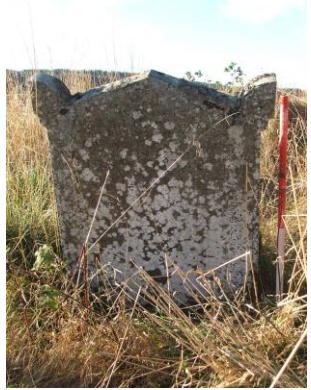
<p>24</p>	<p>Headstone with triangular top and projecting corners with raised floral decoration. <i>"The memory of William Riddle late farmer in Bennachilly, who died 12th April 1855 aged...also Euphemia Baird his...died 9th February...aged 78"</i> Has raised central panel inset from edges, sits at slight angle</p> <p>Approx. 1.1m height, 0.7m width</p> <p>Minimal weathering, considerable lichen growth.</p>

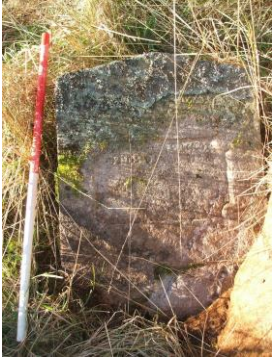
<p>25</p>	<p>Headstone with triangular top. Illegible. Carved inset rectangular panel in central section with concave edges. On its back, no longer standing.</p> <p>Approx 0.70m height, 0.55m width</p> <p>Displays granular erosion, level 1 surface loss and level 1 differential weathering. Some moss and lichen growth.</p>

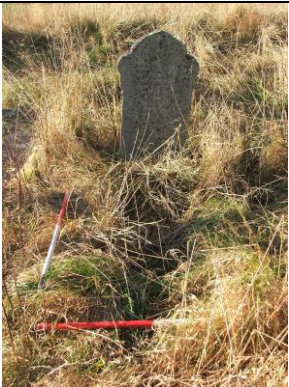
<p>26</p>	<p>Headstone with protruding rounded corners and rounded triangular top. Projecting edges at base of stone, set on rectangular platform. Illegible.</p> <p>Approx. 1.1m height, 0.50-0.60m width</p> <p>Displays level 1 differential weathering and slight surface loss Also incorporates plain kerb, turf covered.</p> <p>Approx. 1.3m length x 1.0m width, kerb stones 0.20m width.</p>

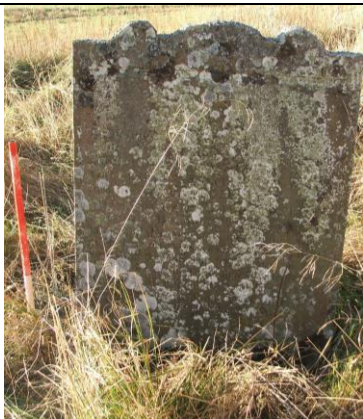
<p>27</p>	<p>Headstone with squared top and three raised rounded central portions on top surface. <i>"Erected in memory of Alexander Riddel of...Glenkinchie...wife Hellen Smith...1862 aged 95 years, and of their son Alexander who died in infancy aged 18 months, also of his...died December 12th..."</i> Many other names present but are illegible. Incised band surrounding engraved panel in centre of stone.</p> <p>Approx. 1.4m height, 1.1m width.</p> <p>Displays some surface loss and considerable lichen growth.</p>

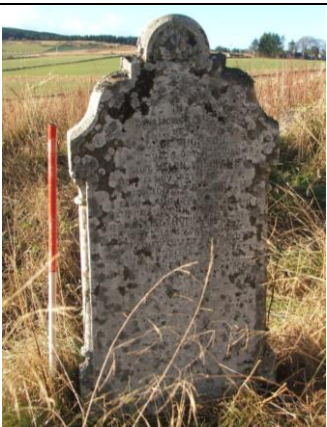
<p>28</p>	<p>Headstone with cyma reversa style top edges and semi-circular central section. <i>"In memory of George Thomson, Bogsowie, died 7 Oct. 1871 aged 62 his wife Helen Williams died 13 Nov 1887 aged 76 their daughter Elizabeth...Aug 1870 aged 38 their grandchildren Peter son of...Thomson, Bogsowie, died 10th...1870 aged 18 months Helen died 28th Feb 1902 aged 42 Bathia Riddel beloved wife of Peter Thomson, Bogsowie, Cushnie died 13th April 1915 aged 89 years and...Peter Thomson who died 12th...1918..."</i> Columns carved in relief down sides. Incised stylised arch with diamond pattern around edges, floral decoration in top central semi-circle.</p> <p>Approx. 1.5m height 0.8m width</p> <p>Displays some surface loss and considerable lichen growth.</p>

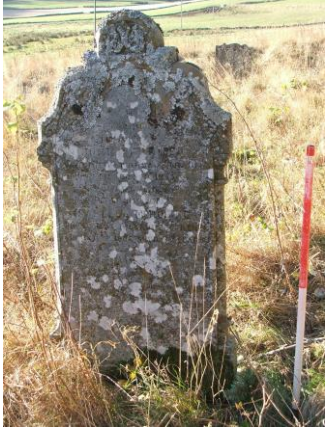
<p>29</p>	<p>Headstone with cyma reversa style top edges and semi-circular central section. <i>"In loving memory of John Ferries who died at Broadstrain...Oct. 10th 1895 aged 80 years, also his wife Isabella McRobbie who died...1908..."</i> Columns carved in relief down sides. Incised stylised arch with diamond pattern around edges, floral decoration in top central semi-circle. Same type as #28.</p> <p>Approx. 1.5m height 0.8m width</p> <p>Displays some surface loss and considerable lichen growth.</p>

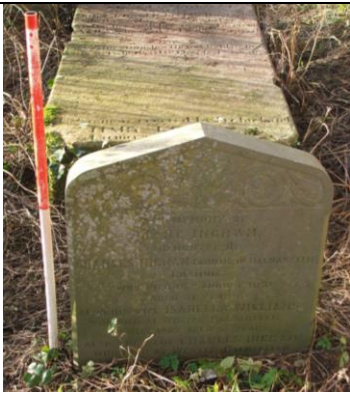
<p>33</p>	<p>Table tomb with foot panels. <i>"In memory of Janet Middleton who died...March 1825 aged 75, on her left...who died...also under this stone lies..."</i> Damage to table-top edges and missing portion of corner. Base of top engraved <i>"...stone is erected by her husband Harry Forbes, farmer in..."</i> Foot panels engraved with Greek Doric style columns in low relief with fan or shell decoration in interior corners. Initials engraved within incised oval in centre of panel. Cyma recta style moulding around top edges. Same style as grave #31. –Approx. 0.40m height, 0.70m width, 2.0m length.</p> <p>-Shows some differential weathering and surface loss, some moss and vine growth.</p>

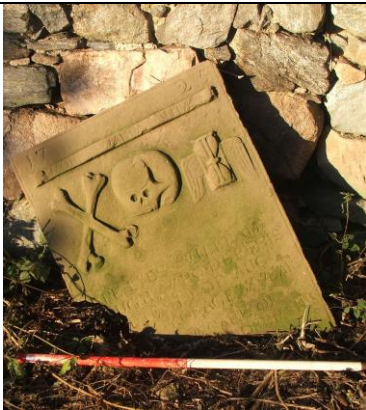
<p>36</p>	<p>Headstone with squared top. Horizontal fracture, missing base. Displaced, resting against E wall of Kirk exterior. Crack radiating NE from break, chipping on edges. <i>"1725"</i> engraved over horizontal ribbon with latin <i>"Mors Jamua Vitae"</i> Beneath ribbon, mortality symbols carved in mid-relief: (L) crossed bones (C) skull facing left (R) winged hourglass. Broken along inscription <i>"...ere lyes William...g a who dept this...e the 15 of Aug...of age 77 years...the care of...dhum his"</i> all in raised panel inset from edge.</p> <p>0.93m height surviving, 0.73m width, 0.09m thickness tapering to 0.08m.</p> <p>Level 1 surface loss, level 2 diff weathering.</p>

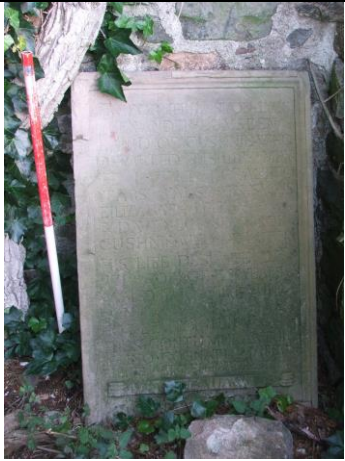
<p>41</p>	<p>Headstone with squared top. Displaced, resting against E interior wall of Kirk. Raised framed border 0.05m wide around exterior edge. "<i>Befor this ston lyes Alexander Lumsden Laird of Cushnie who departed this life May the 1 1714 of age 70 years & also his spous Elizabeth Leith & David Lumsden of Cushnie who departed this life Desr the 23 1718 & of age 38 years & also Lodovick Lumsden Hoc Lector Tumulo Tres Contumulantum in Uno Cognati Matei Fibius Ato El Pater</i>" Horizontal ribbon carved in relief beneath, containing "<i>Mors Janua Vitae</i>" over likely (L) crossed bones (C) skull. Base of slab remains buried. Sections of frame missing from left side.</p> <p>Surviving height 1.10m, 0.71m width, 0.11m thickness.</p> <p>Displays granular erosion, level 1 surface loss, level 2 differential weathering, level 2 delamination</p>

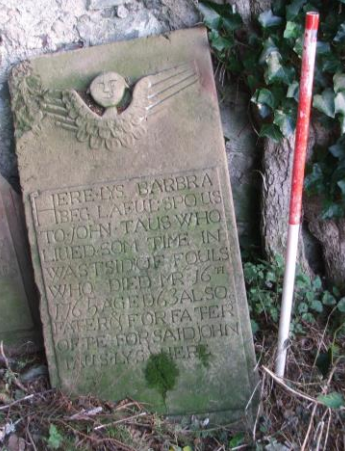
<p>42</p>	<p>Likely ledger stone. Displaced, resting vertically against E interior wall of Kirk. Winged cherub carved in relief within top section. Raised panel in middle section with dedication "<i>Here lyes Barbra Beg, Laful spous to John Taus who liuedsom time in Wastsid of Foulis who died MRx 16th 1765 aged 63 also father & forfathers of the forsaid John Taus lyes here</i>" Large crack radiating N from base. Below right, top portion of hourglass carved in relief survives. Heavy chipping to NW corner as well as chipping along western edge. Full extent of slab not visible, remains buried. Inscription remains clear.</p> <p>1.17m height above ground, 0.58m width, 0.15-0.08m thickness.</p> <p>Displays granular erosion, level 1 surface loss and level 1 differential weathering. Cherub displays some delamination. Some moss growth.</p>

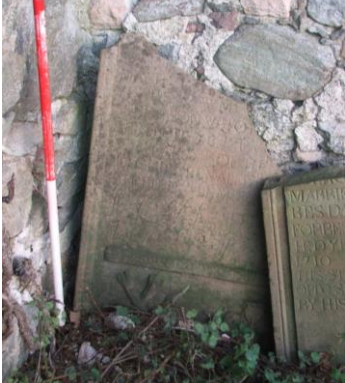
<p>43</p>	<p>Headstone. Displaced, resting vertically against E interior wall of Kirk. "<i>rie who was married to Agnes Forbes daughter to George Forbes of Skallitur, he dyed April the 20 1710. This stone was erected opposite to his grave by his eldest son James</i>" Dedication within raised panel, framed by raised edge with incision along perimeter of slab. Horizontal ribbon below "<i>...Christin</i>" Base of slab remains buried. Horizontal break above through dedication.</p> <p>Approx. 0.70m surviving height above ground, 0.50m width.</p> <p>Shows signs of slight differential weathering and surface loss.</p>

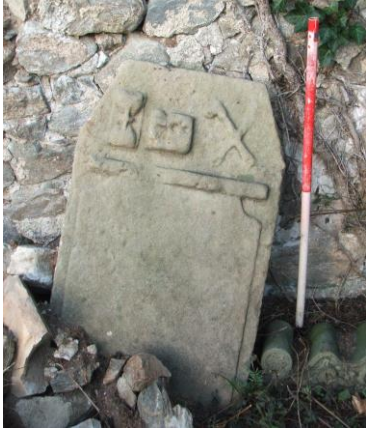
<p>46</p>	<p>Headstone. Heavily weathered, illegible. Resting upside-down against N wall of Kirk, displaced. Tapered base. Displays in relief the mortality symbols of (L) crossed bones (C) skull facing left (R) hourglass. Raised panel over mantle. No inscription remains. Top remains buried.</p> <p>Approx. 1.0m height above ground, 0.50m width</p> <p>Shows granular erosion, level 1 surface loss and level 2 differential weathering.</p>

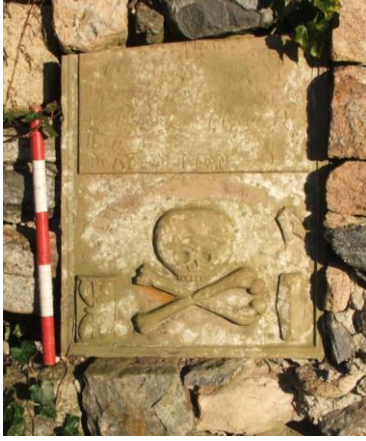
<p>47</p>	<p>Headstone. Displaced, set into exterior of S wall of Kirk. "...tear...wel liked...of Immanuel...Meek...this life...May M.Kean 1696" Inscription displays differential weathering and is nearly illegible. Horizontal fracture through dedication, only base of stone survives. Slab framed by raised edge with incision. Dedication inscribed within raised panel over ribbon (now mostly missing). At base are four symbols of mortality: (L) hourglass (C) skull facing forward atop crossed bones (R) coffin all carved in relief. Potentially the oldest surviving stone.</p> <p>Surviving height 0.64m, width 0.51m, section 0.09m.</p> <p>Displays granular erosion, level 1 surface loss, level 2 differential weathering, level 1 delamination. Some lichen growth.</p>
