St Bride's Church and churchyard

Kirkton of Cushnie, Leochel-Cushnie, Aberdeenshire

Historic Building Survey and Assessment

AA 2089

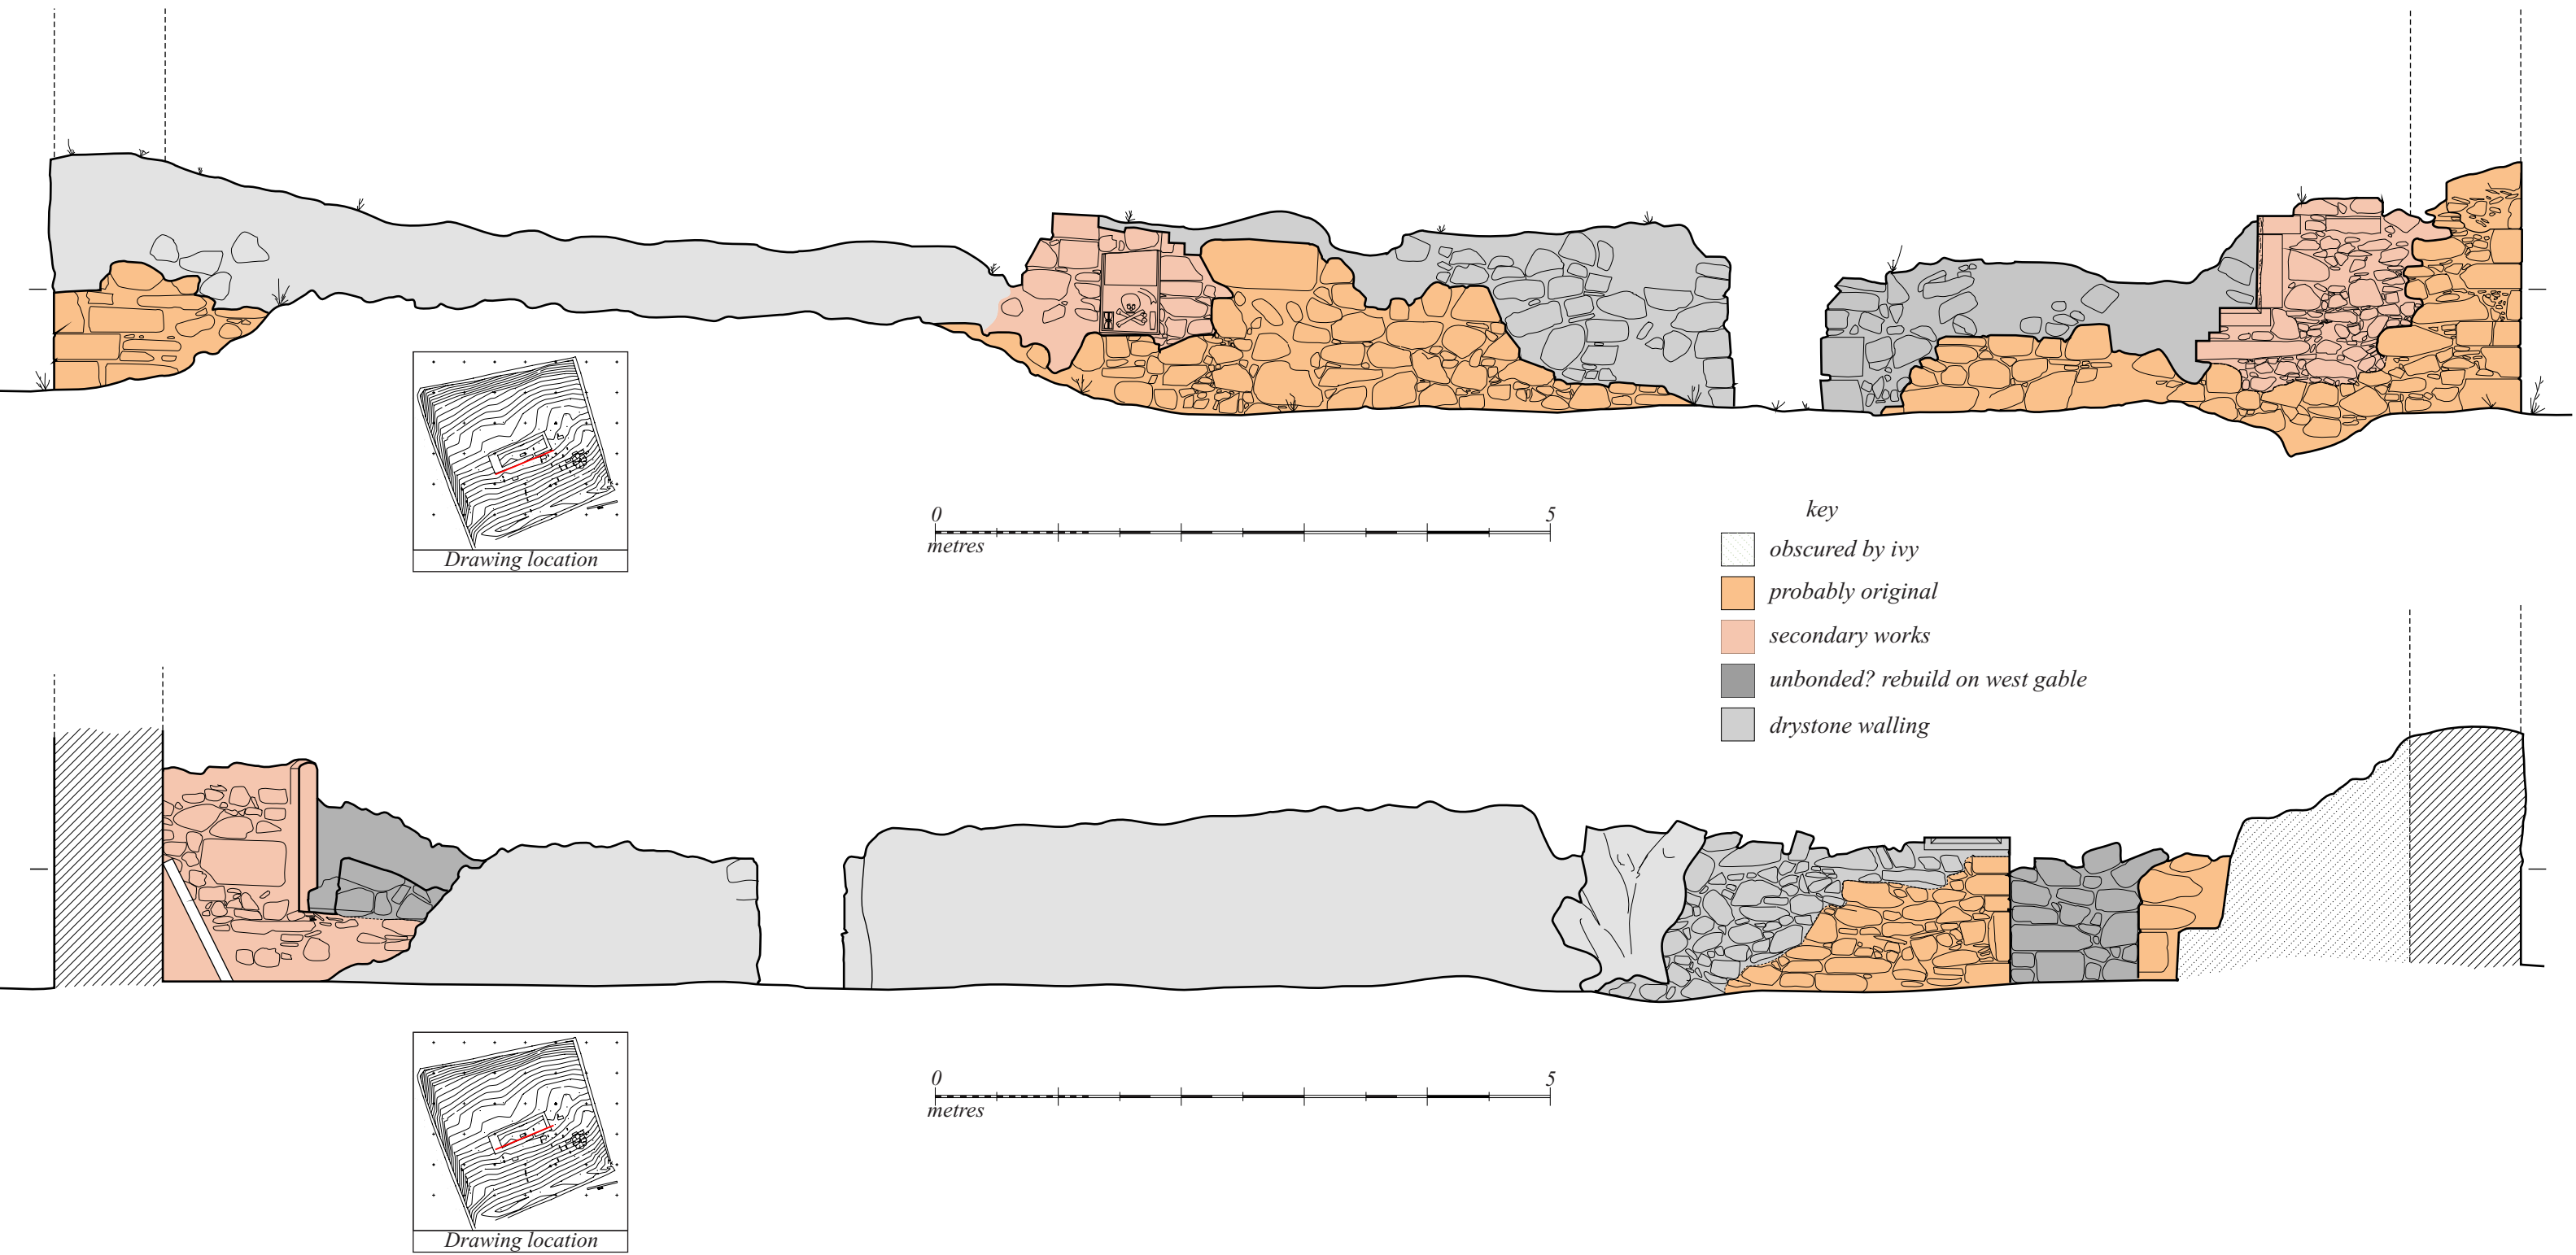
South Interior and exterior elevations of StBrides Church

The south wall of the church is now much reduced, particularly to the west where its remains are mostly buried beneath rubble collapse. Few original features were noted apart from the sandstone quoining of the corners. Close to the east end survive the remains of a window, this is a clear insertion along with an associated area of masonry that employs a mortar that is distinct from the surrounding. Parts of a sill stone and the lower east jamb of the window survive, the lower stone of which is elongated and vertically set. The jamb stones display a rough chamfer now much eroded. On the interior the splay to the east survives but is partly obscured by a grave slab cemented against it.

An existing 'entrance' off-set to the east in the south wall is the now only opening into the structure, *plate 12*. However in its present form it is clear that this is not an original feature or even a well-built insertion, rather it had been largely formed of dry-stone construction in recent times along with much of the surrounding walling. Some sandstone blocks used in the jambs of the opening are likely to have been reused from elsewhere in the building, or even from a former entrance at about this point, though no cut faces were noted that bear diagnostic detail.
