Biggar Museum

Archaeological Watching Brief: January – May 2014

Data Structure Report

Job No. 1896.00

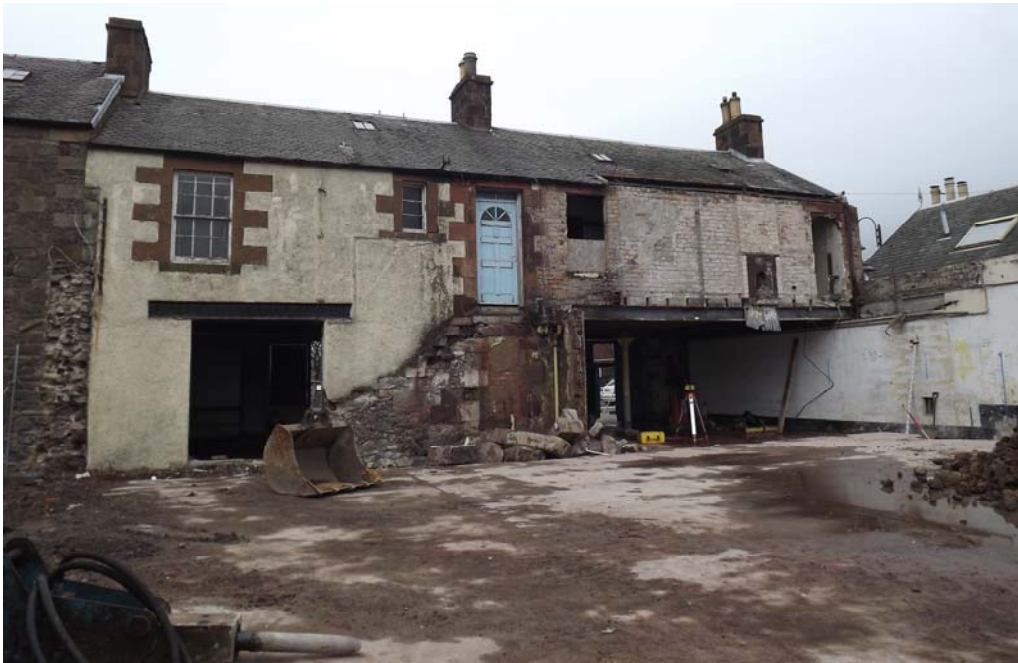
*Plate 1 Pre-excavation view of the development area to the rear of the existing High Street properties
(Addyman Archaeology Photograph 045)*

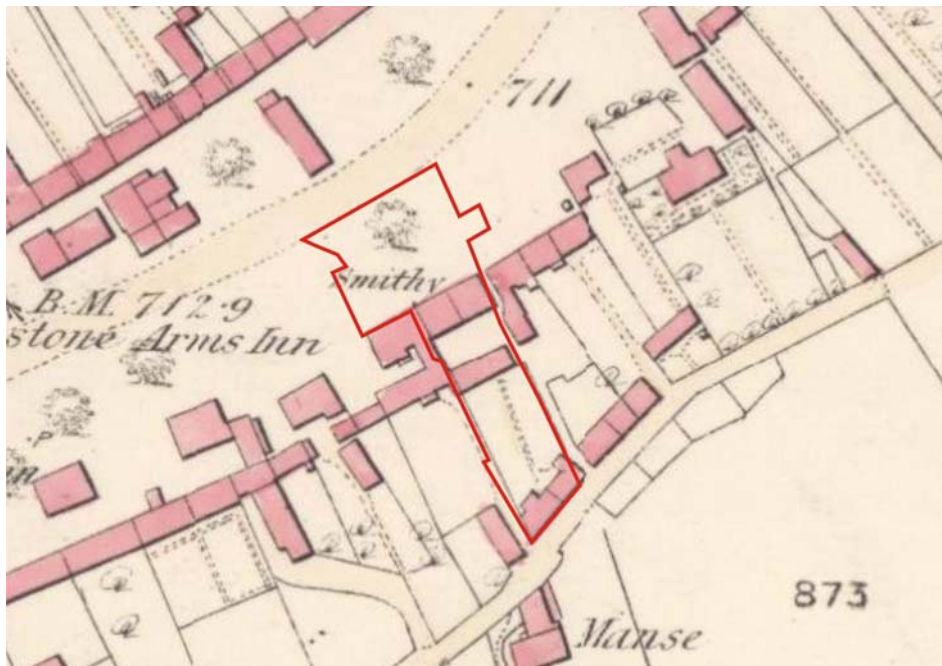
The Ordnance Survey begin coverage of the Biggar area with production of the 25 inch to 1 mile Lanark Sheet XXXIV.10 (Biggar) in 1864 (*Figure 3*). This area was surveyed in 1858 and shows two separate structures facing onto the High Street. These are clearly labelled as 'Smithy'. In the area comprising the burgage plot behind the High Street buildings, a larger rectangular structure stretches across the width of the site boundary. The backlands to the south contain what appears to be a pathway running roughly N-S towards two connected smaller structures facing what would become South Back Road.

Figure 3 The developemnt area at 156 High Street (indicated in red) shown on the OS 25inch, 1st edition map, surveyed in 1858 and published in 1864. NLS

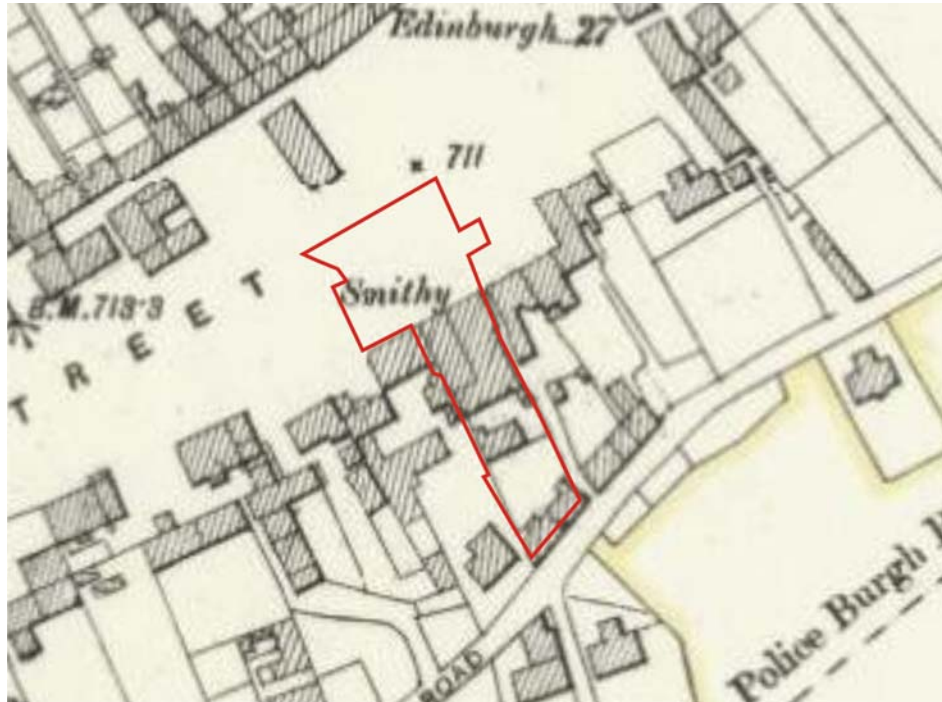
By the production of the 2nd edition OS Map in 1896/97 (*Figure 4*), the High Street properties have extended southwards, with the eastern of the two joining onto the long building to the rear visible in the first edition. These extensions essentially now cover the entire area of what was previously an enclosed backyard. A further structure has been constructed beyond these to the south, against the western perimeter of the burgage plot. The two buildings fronting South Back Road remain seemingly unaltered.

Figure 4 Ordnance Survey first edition revision, surveyed 1896. Scale: 25 inches to one mile. NLS

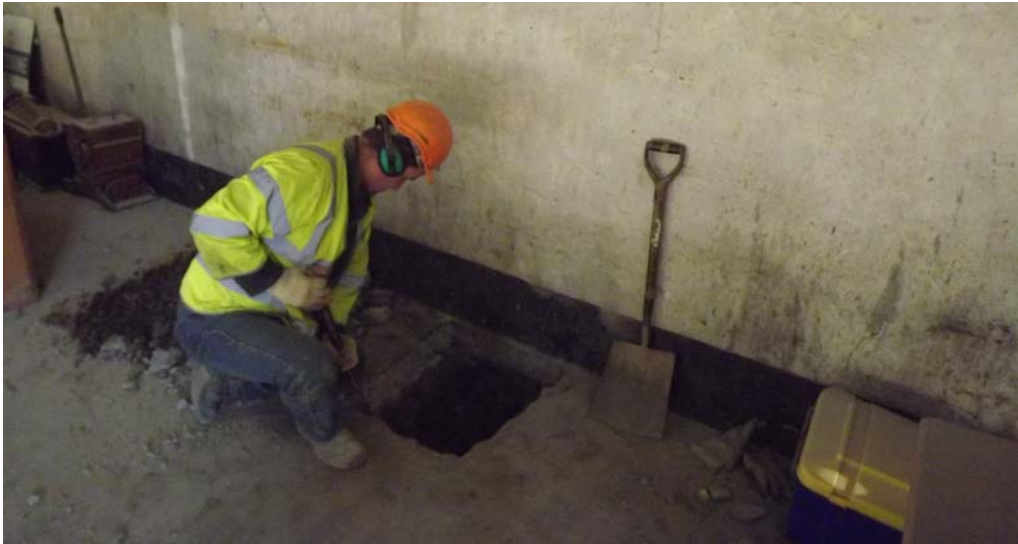
Plate 2 Working shot showing Trial Pit 1 being opened (Addyman Archaeology Photograph 006)

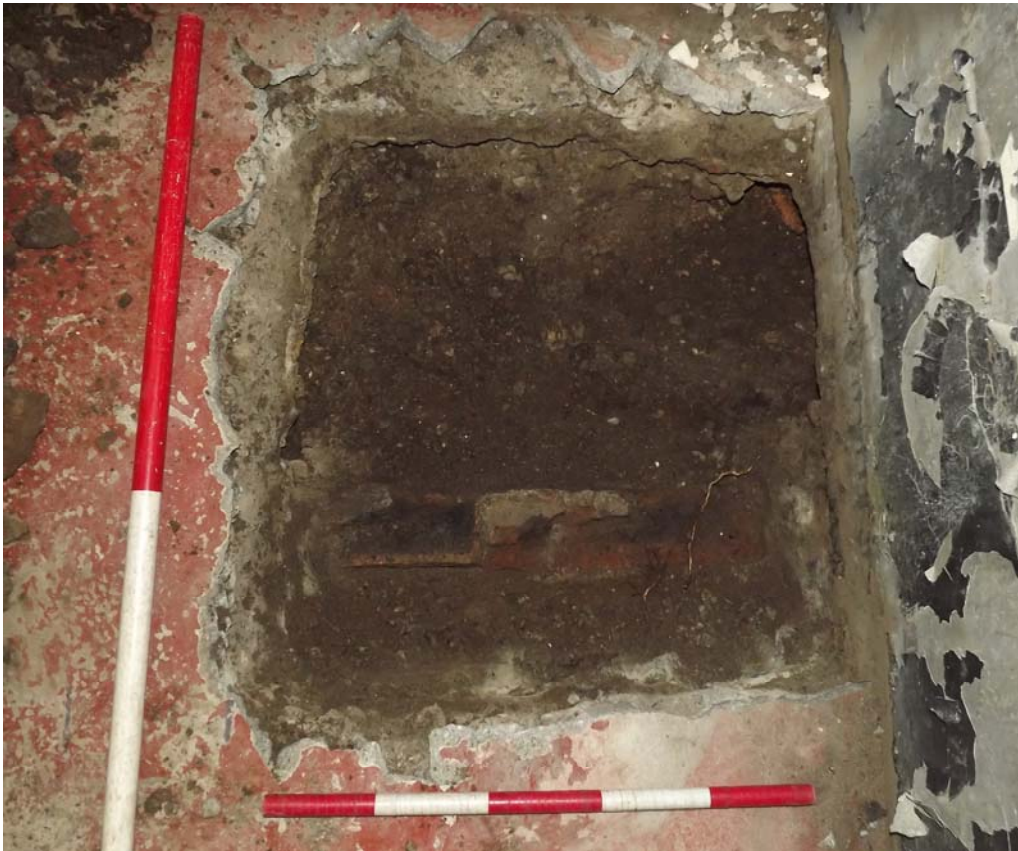
Set within (403) was what appears to be an alignment of bricks that ran west-east (*Plate 3*). Within a trench measuring 0.65m by 0.60m with a depth of 0.32m, any conclusions must be tentative at best, but it was felt this may be the remains of stalls partitioning for horses within the smithy.

Plate 3 Post-excavation view of Trial Pit 4 showing the brick alignment (404) (Addyman Archaeology Photograph 020)

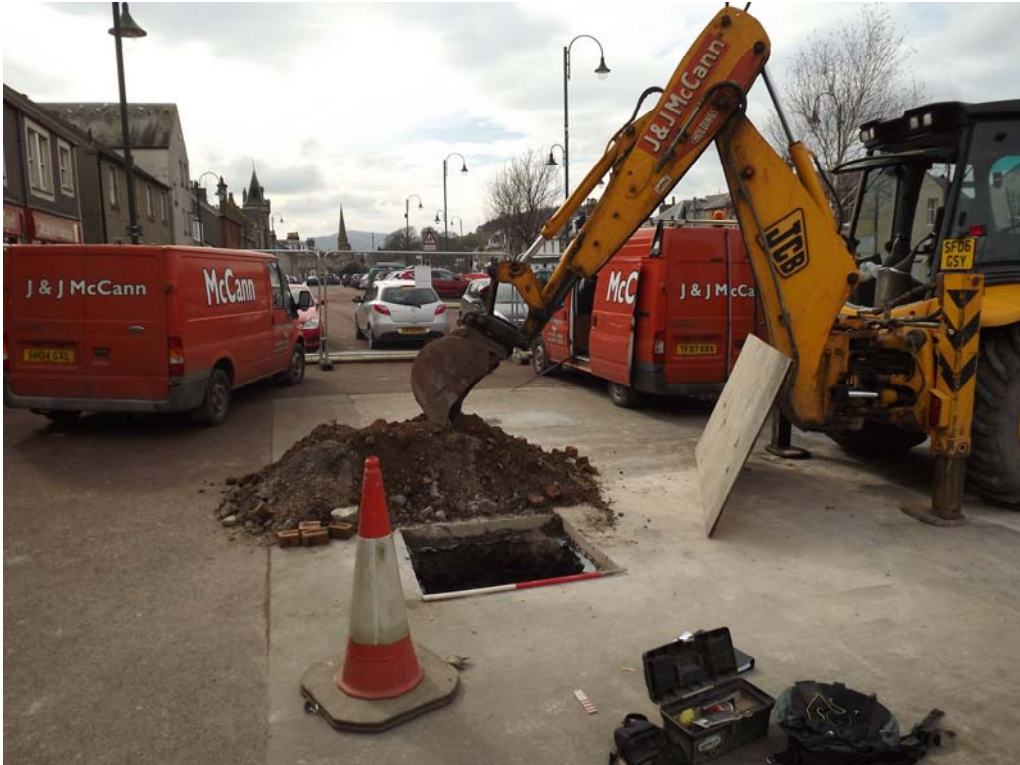
A further Trial Pit was opened on Biggar High Street, to the north of the development adjacent to the area once occupied by the concourse of the petrol station. Recorded as Trial Pit 5 (TP5), this measured 1.14m W-E by c.1.07m N-S, and had a final depth of c.1.35m.

Plate 4 Location of Trial Pit 5 looking west along Biggar High Street (Addyman Archaeology Photograph 032)

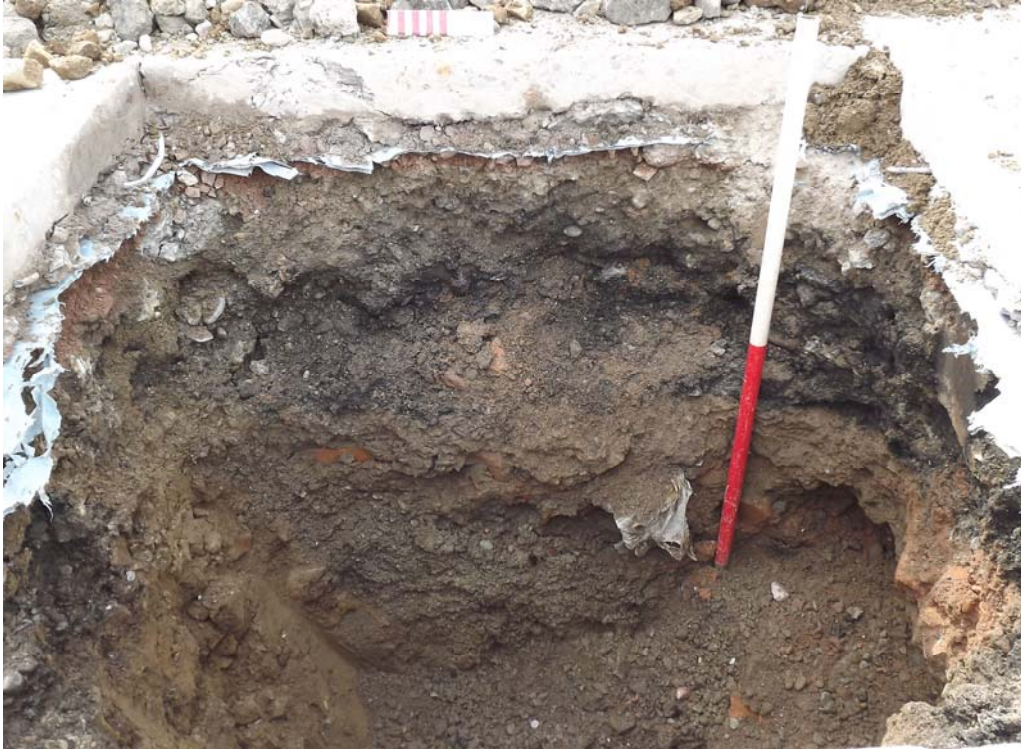
The concrete surface (505) was cut, broken by pneumatic drill and then removed to reveal a deposit 0.20m deep of mixed made ground abundant in small to medium angular stones – (502). A clear deposit of thickly compact black silt and grit (503) underlay this, possibly an earlier 20th century ground surface.

However, beneath (503), (504) comprised a deep deposit of moderately compact clay silt, abundant in fragments of 20th century brick. This also contained 1970s crisp packets, and some voids indicative of a period of non-consolidated backfilling.

The final deposit below (504) was (505), a much cleaner, firmer deposit of mid brown silty clay. The final depth of this was unrealised.

Although natural subsoil was not reached in TP5, it seems that significant landscaping work had been completed here in the 20th century, perhaps associated with the installation and operation of the petrol station on the site.

Plate 5 West facing section of Trial Pit 5 (Addyman Archaeology Photograph 025)

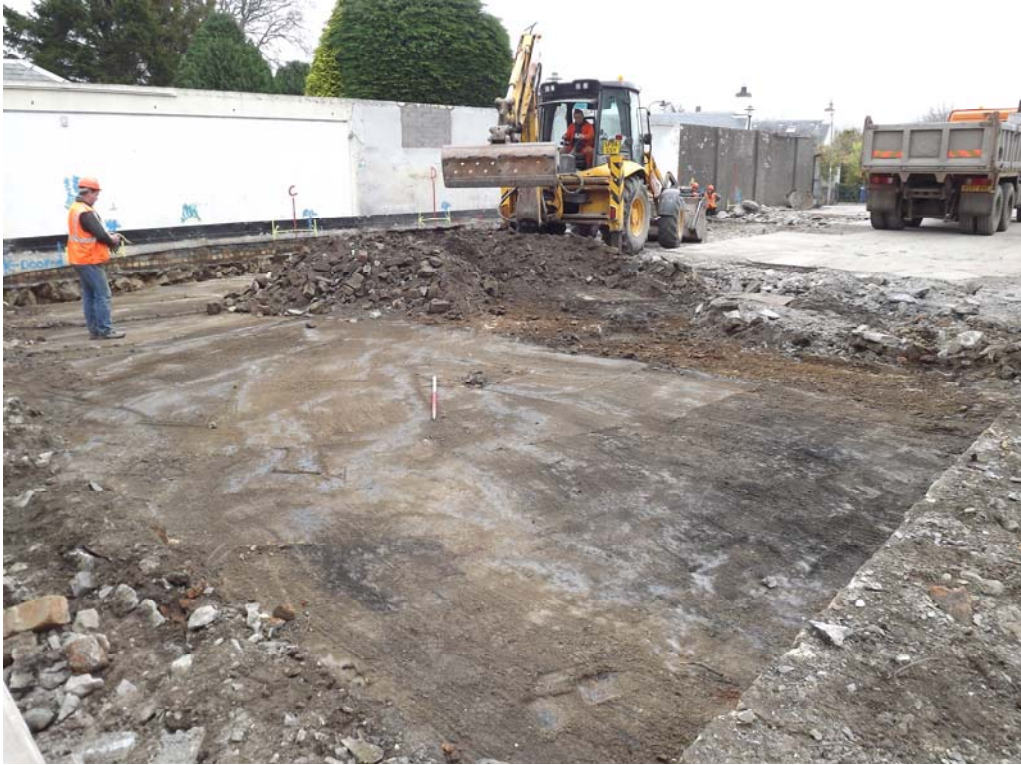
Below (003), a tarmac surface (004) was revealed (*Plate 6*). This surface stretched across much of the development area and directly overlay the undisturbed bedrock.

Plate 6 Tarmac surface (004) being revealed across the development area. Note the orange bedrock (005) visible to the right hand side of the JCB. (004) directly overlay (005) (Addyman Archaeology Photograph 063)

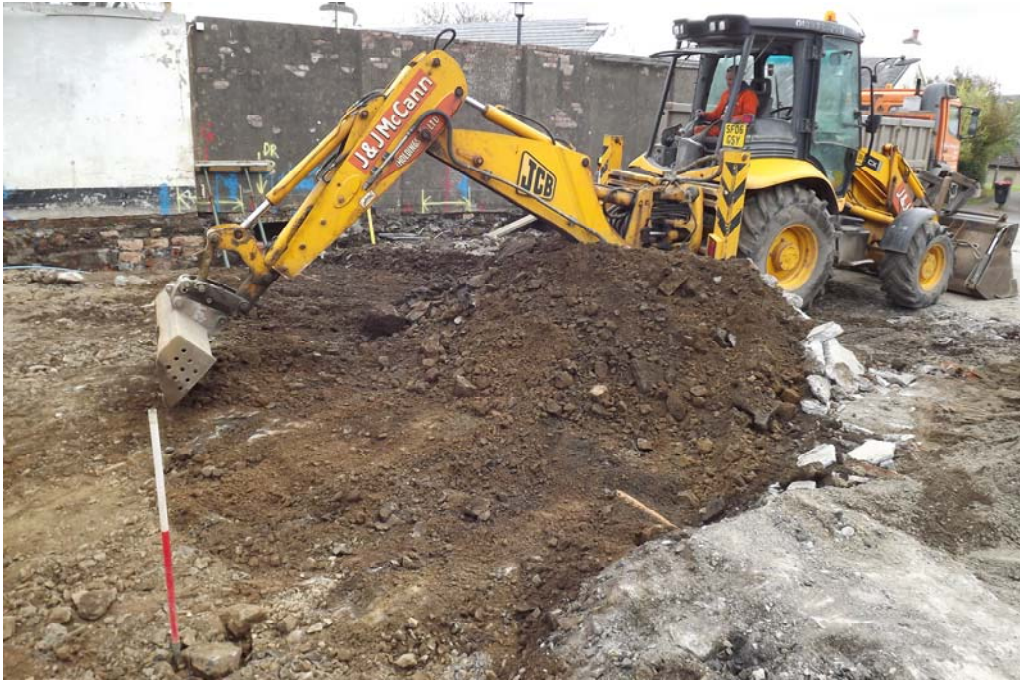
As excavation continued southwards, although the tarmac surface (004) did not extend across the whole site, the made ground (003) did, with the natural bedrock (005) visible across almost the entire development area (*Plate 7*).

Plate 7 Working shot looking south east and showing the JCB revealing the bedrock (005) across the site (Addyman Archaeology Photograph 101)

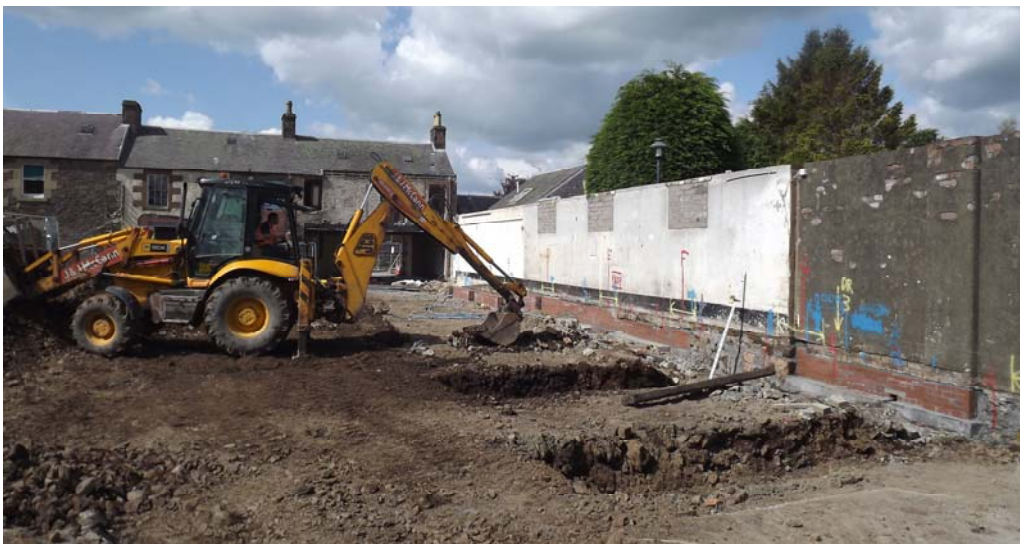
Plate 8 Digging the foundation trenches (Addyman Archaeology Photograph 121)

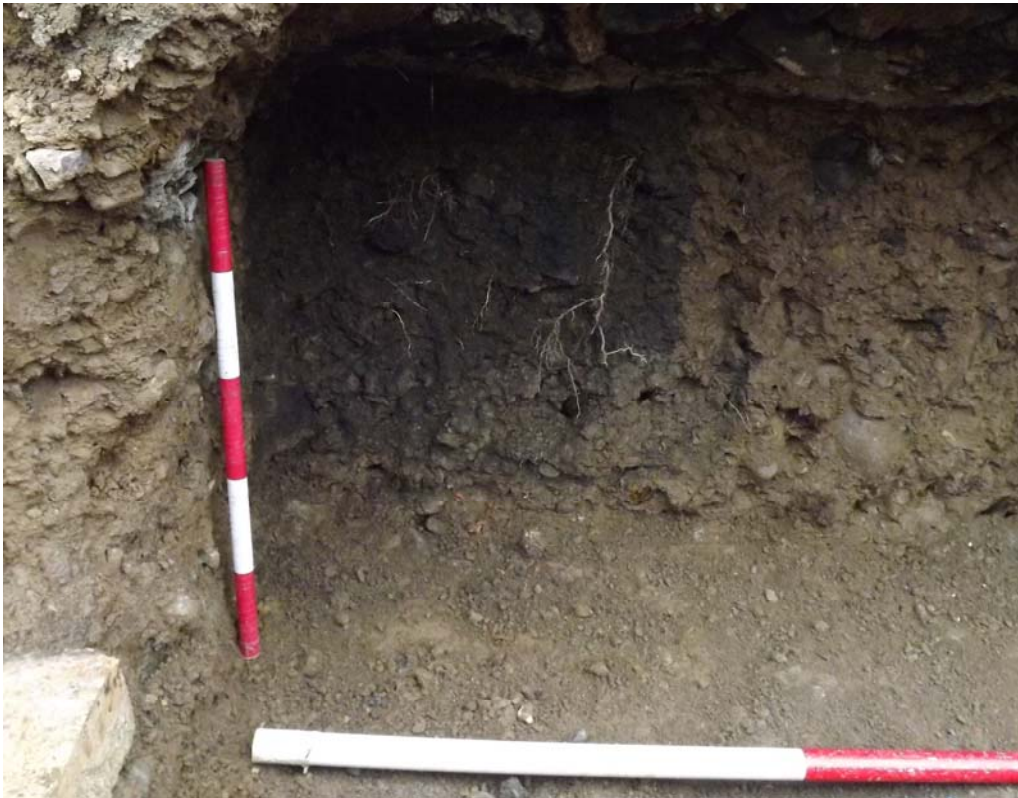
One of these ‘blocks’ revealed what appeared to be a pit at the limit of excavation, essentially lying below Smiddy’s Close (*Plate 9* and *Plate 10*). This was recorded in section, and seen to measure 0.64m N-S by >0.20m W-E with a depth of 0.62m. The cut [010] had very sharp, near vertical sides, specifically to the north and west, with a less steep south side, gradually lessening towards a roughly pointed base. Lying under Smiddy Lane, the eastern side was not recorded. The fill (009) comprised moderately compact black brown and mid brown silty sand with occasional flecks of charcoal and small rounded stones.

Plate 9 West facing section showing (009/010] (Addyman Archaeology Photograph 058)

(009) had the look of re-deposited topsoil, and did not have the feel of a medieval pit. Although no further features like this were recorded during the underpinning, water and drainage services were revealed beneath Smiddy Lane a short distance to the south. It is felt likely that the 'pit' (009/010] is actually related to the excavations associated with the services which run along Smiddy's Close.

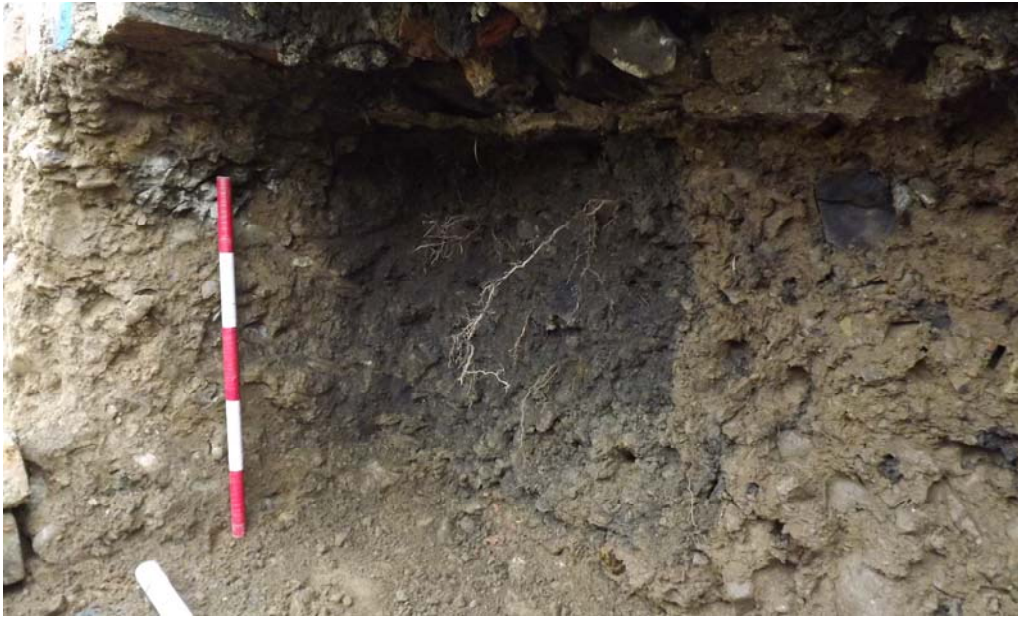
Plate 10 Oblique view of (009/010] looking NE (Addyman Archaeology Photograph 059)
