# The Law School, Old College Quadrangle

## *Archaeological Watching Brief*

Archaeological Watching Brief: August 2014

Data Structure Report

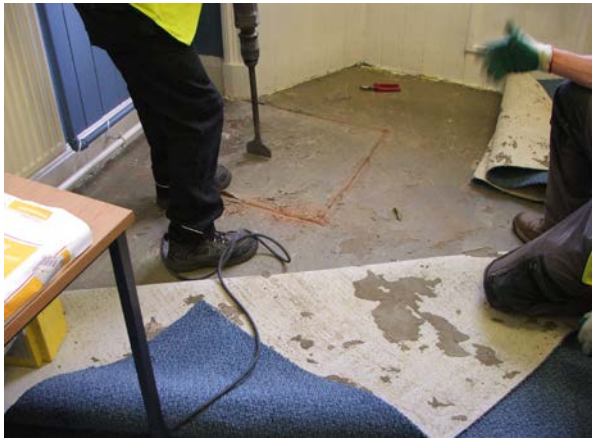
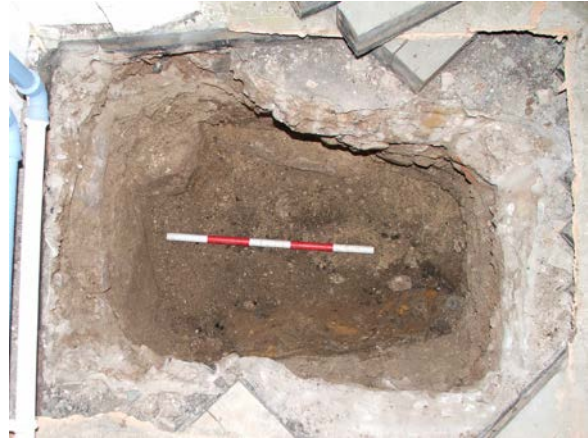
*Plates 1 and 2 Trench 1 carpet lifted trench being opened up and at LOE*

The carpeting was pulled back exposing a plywood levelling, this was cut through to the outline of the trench. Below this was a historic wooden herringbone patterned parquet floor, within the confines of the trench this was lifted and the timber kept for reinstatement. The parquet floor was constructed from lengths of pine approximately 2 inch square bedded into tar on top of a concrete base.

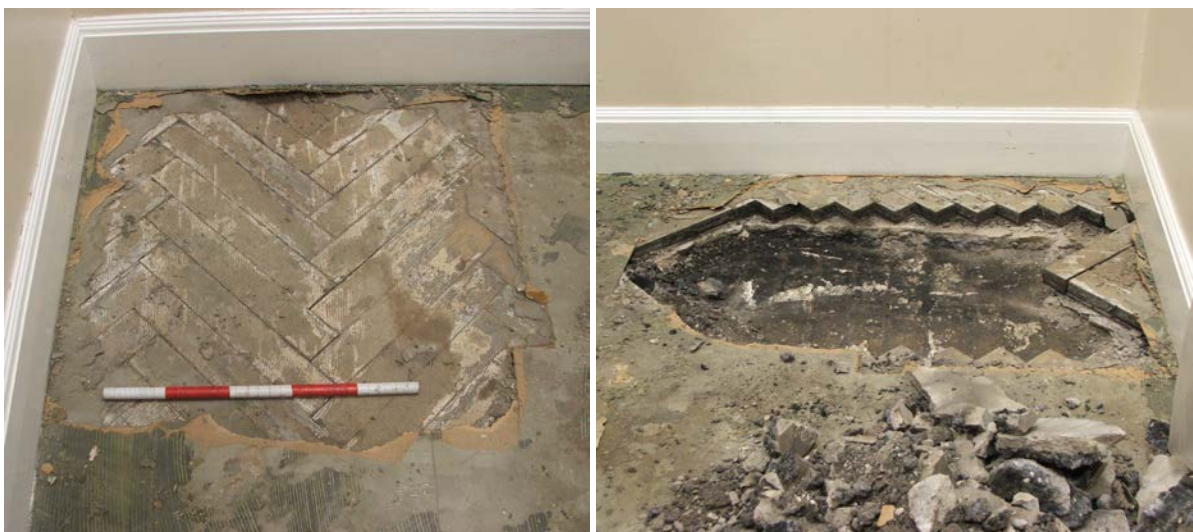
Plates 3 and 4 Parquet flooring exposed and following removal of floor to expose 202 brick floor

Following the breakout of the concrete 201 this proved to be quite shallow and was poured over a neat well-formed brick floor 202, this existed within the trench stopping at the west section and abutting the wall 206, but continuing beyond the east section either within a former door/recess in the masonry or more likely to the hidden former Wall face. The modern linings seem to heavily overlie the former floor and the parquet floor timbers along the wall foot are clearly built over and trapped beneath the modern linings and it seems likely the bricks beneath are similarly trapped.

These heavy bricks were 10.5cm x 23cm x 8cm of white fireclay and with a plain frog on one face. No manufacturer's marks were noted on any of the ones seen. They were lain on edge to form a neat floor and were bonded with a soft brownish lime mortar.

Directly beneath the 202 bricks was a second level of neatly lain bricks either an earlier floor or more likely a base for the 202. These 203 bricks were of similar dimensions and form but were of a red common brick type in contrast to the white of the upper layer. These are likely to be of the same phase.

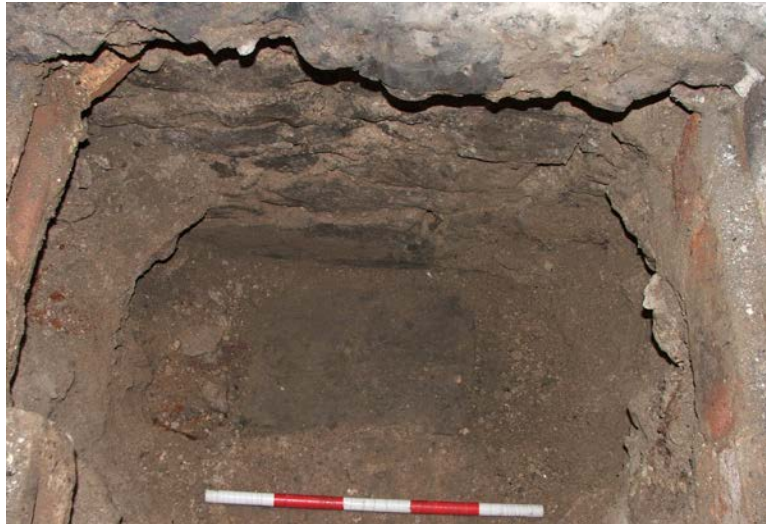
The masonry wall 206 to the west was constructed from smaller rubble stone in a lime mortar with a well formed face where seen. when initially exposed this was thought to be the eastern wall of the building to the north of Hamilton House, the slabs 207 at the base of the wall was suggestive of a courtyard potentially "Printing House Yard" to the exterior of that building with the foundations of the current structure 205 simply built up from this level. But following the excavation of trench 4 it may be that is more likely to represent large sleeper walls associated to the OCQ building rather than an earlier structure.

*Plate 5 Trench 2 looking west, wall 206 and slabs 207 at base*

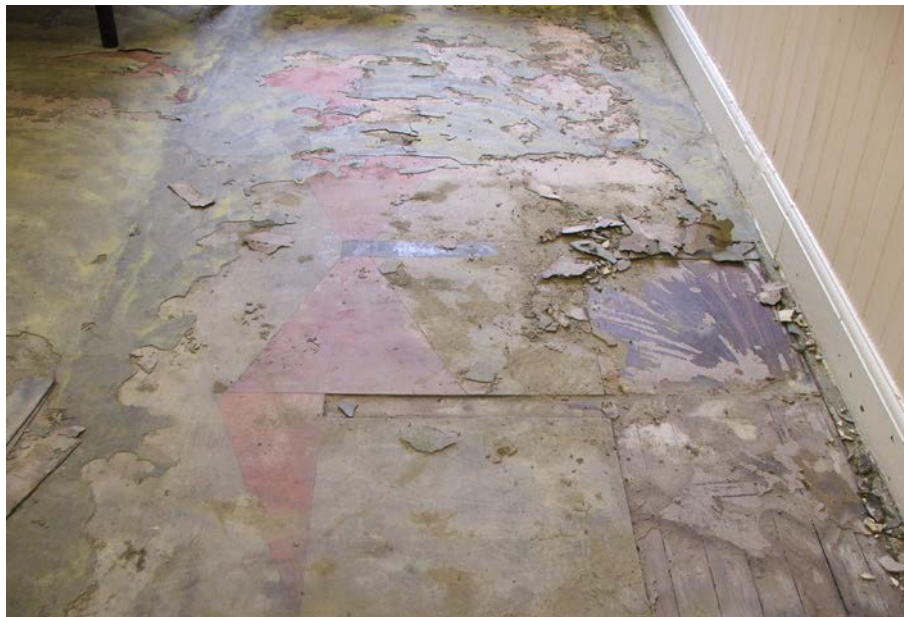
Trench 3 was excavated against the east wall and as well as to investigate underlying deposits this was intended to locate a service trench known to run through this area. Lifting of the carpet exposed a former lino floor formed from blocks of coloured lino lain to form a geometric pattern

*Plate 6 trench 3 patterned lino beneath the carpet*

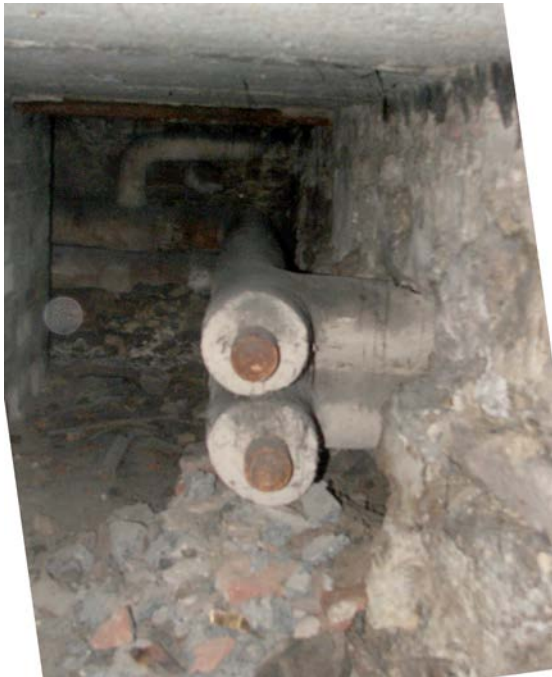
Within the duct 2 insulated pipes ran, these came from the room to the east through the wall to the north of the trench and ran to the north before turning to the west at the north façade. To the south the duct runs empty to the south wall face. Following the discovery of this duct excavation was stopped and the hole readied for reinstatement. No archaeology apart from the duct and the foundations of the main structure was seen.

*Plate 7 Trench 3, pipes within service duct looking north.*

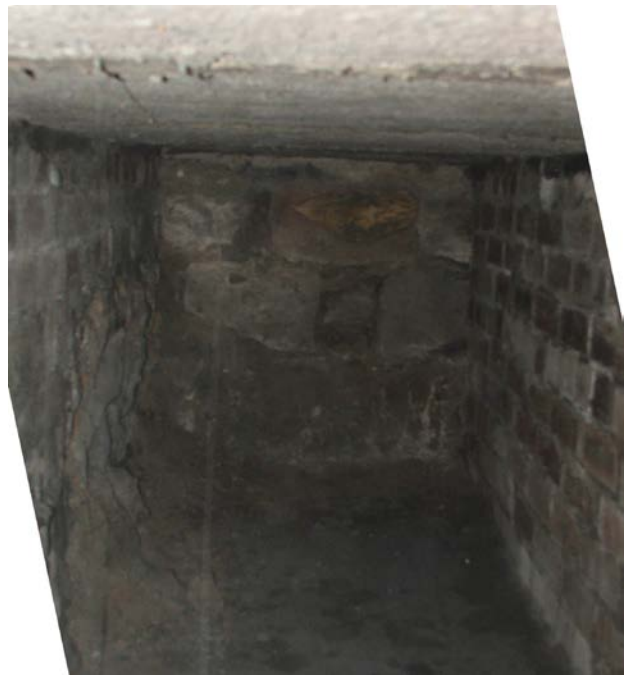
This void below proved to be a 0.90m square service duct with a concrete slab capping .the east wall of the duct was the rough foundation of the east wall, this stepped out a little and the capping appeared to sit upon the step . The west appeared to be of cemented brick. The base of the duct looked solid and was probably concrete.

*Plate 8 Trench 3, service duct looking south*

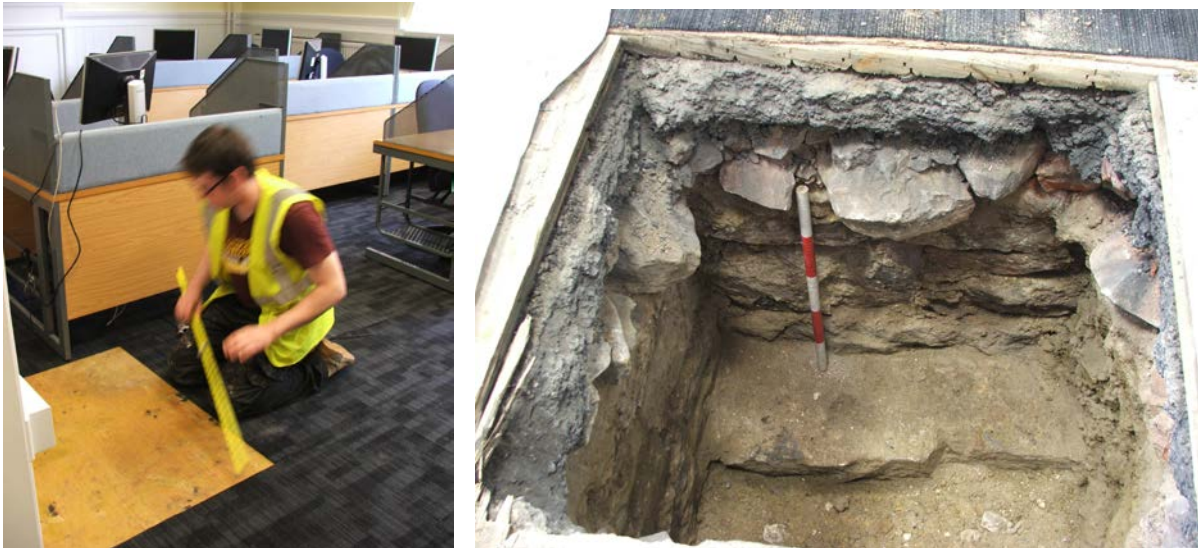
Plate 9 trench 4 Opening up and plate 10 trench 4 at LOE looking east to 406

Following the lifting of the carpet and underlying plywood a timber floor was exposed. This was of similar dimensions to the flooring in trench 3 and was also tongue and groove jointed. This as before sat upon a concrete base although no evidence for tar bedding was seen and the concrete beneath 402 was very easy to break up and very cinder rich.

The masonry walls exposed were of lime bonded rubblestone with a good formed face, the eastern wall 406 was associated with a wide stepped foundation at the LOE, the northern wall 407 did not appear to have a stepped foundation, and at least none was exposed within the trench.

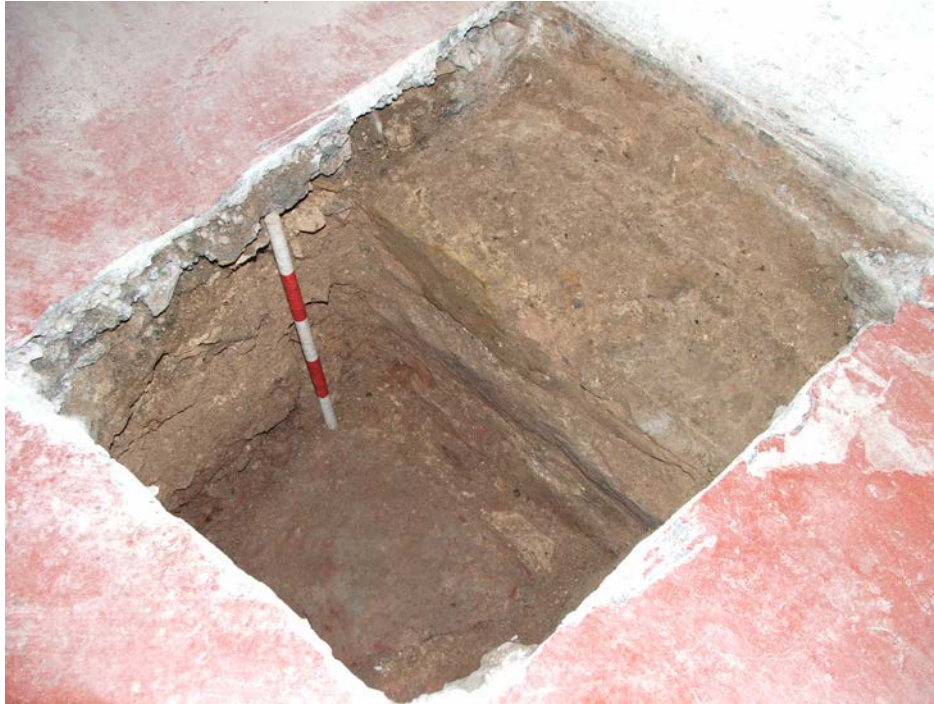
The room generally was floored with a red painted concrete floor, numerous boilers and the machinery of ventilating the college sat upon the floor, within the trench the concrete 501 broke up much easier than expected, this was relatively thin and not very solid for a plant room. Removal of this exposed a deep deposit of loose crushed lime mortar and rubble 502. Following removal of this 502. The stepped foundation 503 of the main gable wall was exposed and at the LOE a further horizontal masonry 504 was noted possibly related to the building

*Plate 11 trench 5 at LOE foundation exposed*
