St. Mark's Episcopal Church

Archaeological Survey and Excavation

Archaeological Survey and Excavation: October / November 2014

Data Structure Report

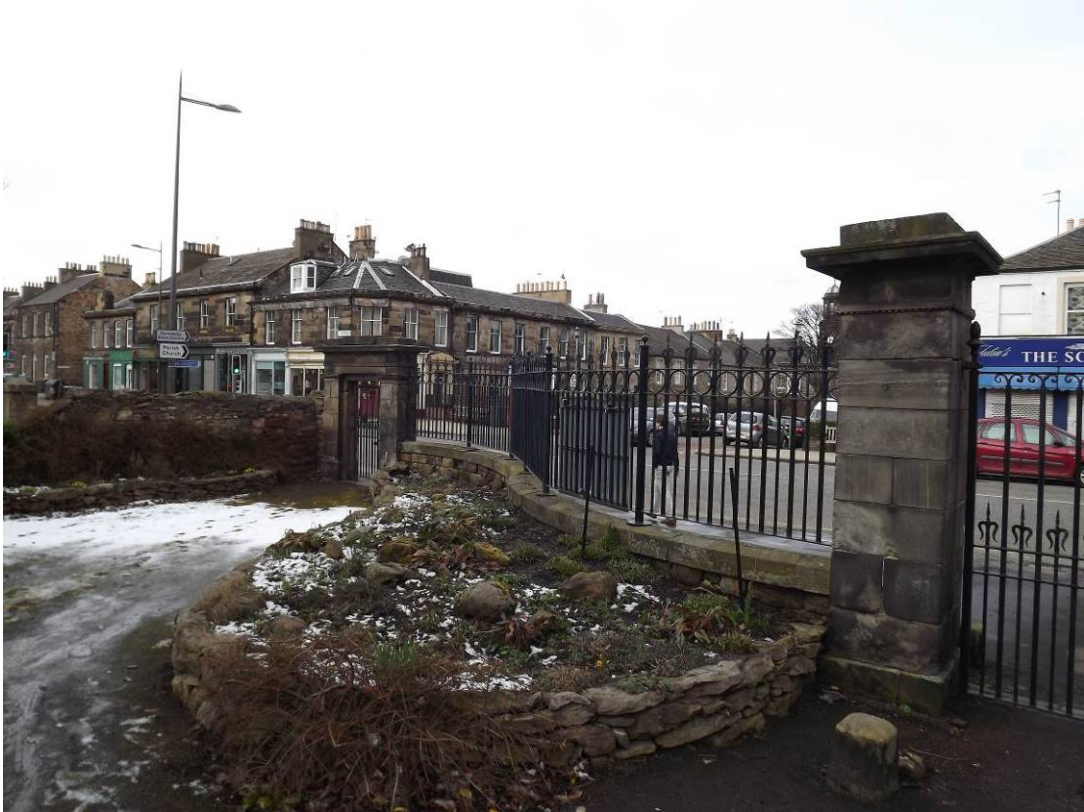
Plate 1 Northwest section of northern boundary wall showing gate and gatepiers (photo 331)

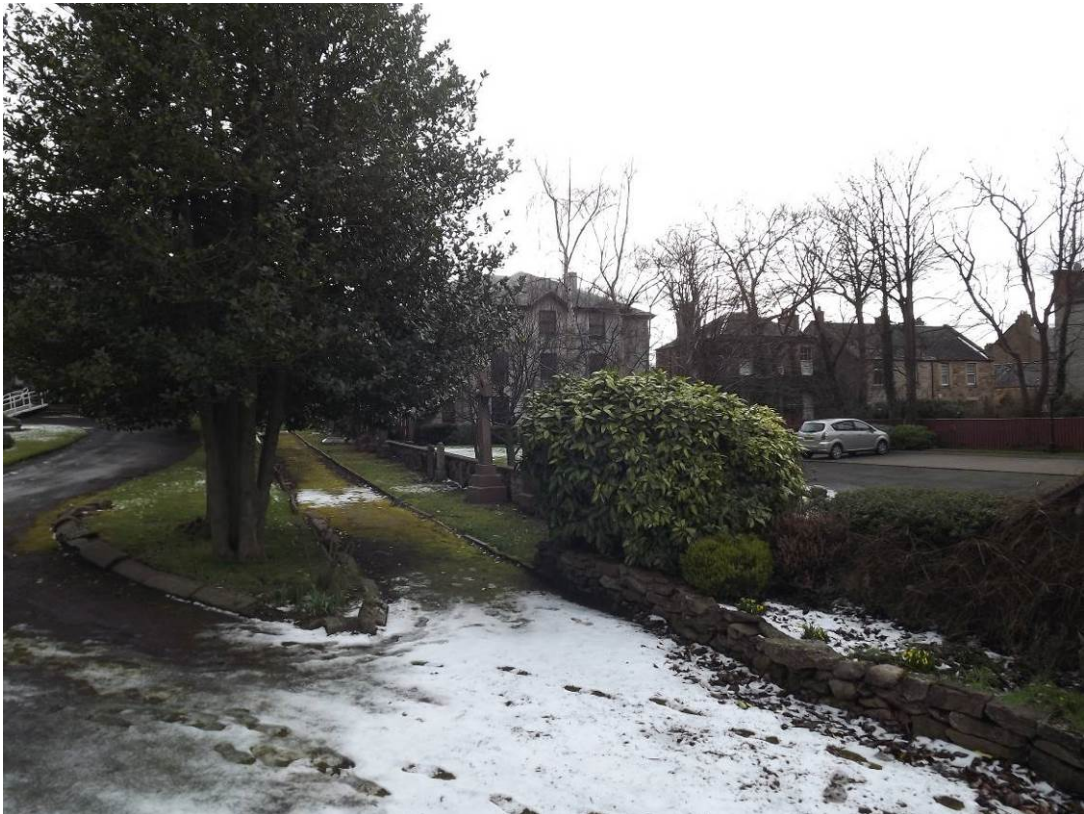
Plate 2 Northern end of western boundary wall from northwest gate (photo 336)

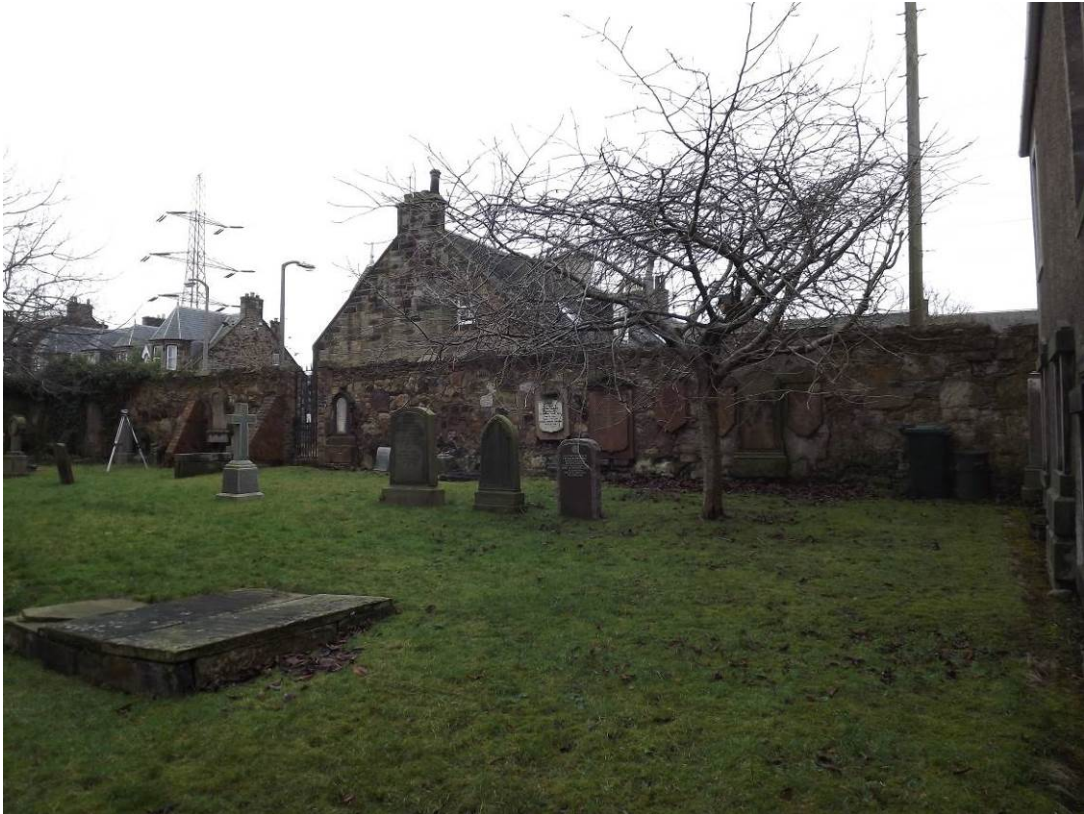
Plate 3 Western end of southern boundary wall with entrance (photo 128)

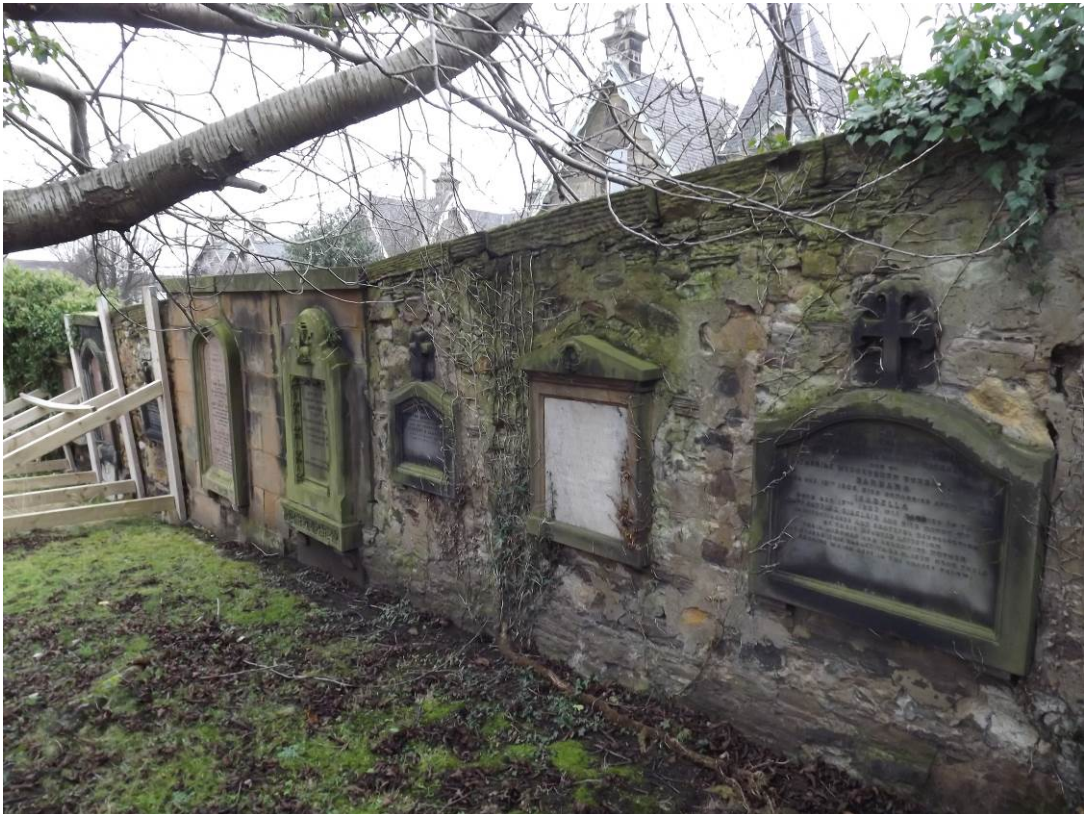
Plate 4 Southern end of eastern boundary wall section to be dismantled (photo 141)

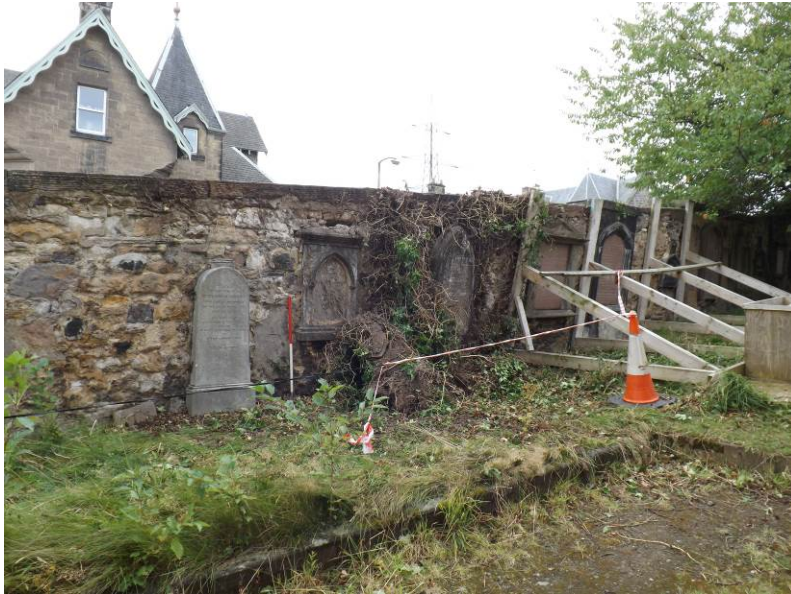
Plate 5 Collapsing wall section to be dismantled (photo 001)

The shallow depth of the foundations, the weight of the grave monuments, and the thin, un-tapered wall no doubt were the causes of its advanced state of collapse.

The wall was hand-demolished stone by stone by the contractor to ground level, with each grave monument carefully dismantled and removed. The gravestones were secured, carefully lifted, and stored on timber pallets away from the ongoing works. The grave markers were all successfully removed undamaged, and are stored and remain in excellent condition.

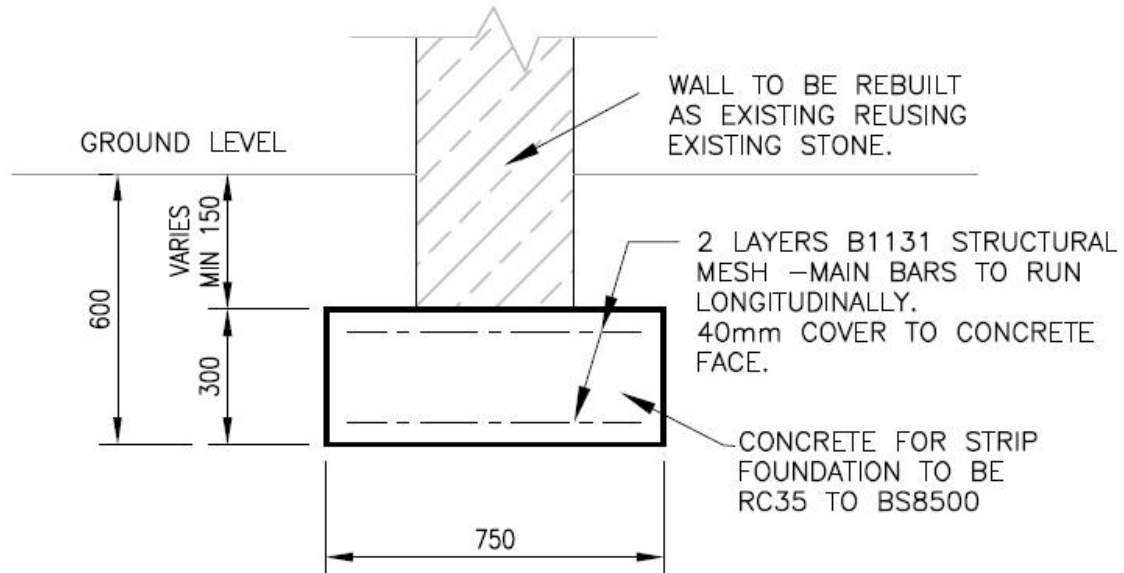
**SECTION THROUGH NEW
FOUNDATION**
1:20

Once the foundations stones had been removed, the trench was then cleaned of loose soil prior to its excavation to a required depth. Specifications for the new wall foundation called for a trench measuring 0.60m in depth by 0.75m in width (*Figure 5*), with an overall length of 7.67m. The excavation was completed in shallow spits, so that any archaeological features or burials could be properly recorded.

Figure 5 Section through the proposed new wall foundation. Note measurements are in mm. Courtesy of Wren & Bell

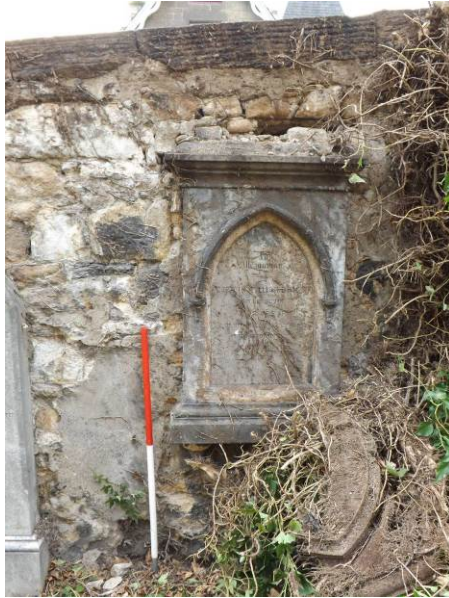
Plate 6 Grave monument #34.1 (photo 003)

Grave 34.1 is associated with the Briggs burial plot, and is located at the northern extent of the foundation trench (roughly 0.40m in width of which has been revealed). A mortared brick kerb [022], within cut [020] and abutted by fill (021), can be seen in the south facing section, and likely delineates the southern boundary of the Briggs burial plot (Plate 7). Topsoil in this area was recorded to a depth of 0.20m. The grave cut [020] and the light to mid orange sandy clay grave fill (021) are cut to the south by the later grave cut [017] associated with grave #34.2. There was heavy root disturbance throughout the grave fill, though no human charnel material was noted to be present. It is likely that the inhumation within grave #34.1 is located at a much lower depth than the 0.60m trench depth required.

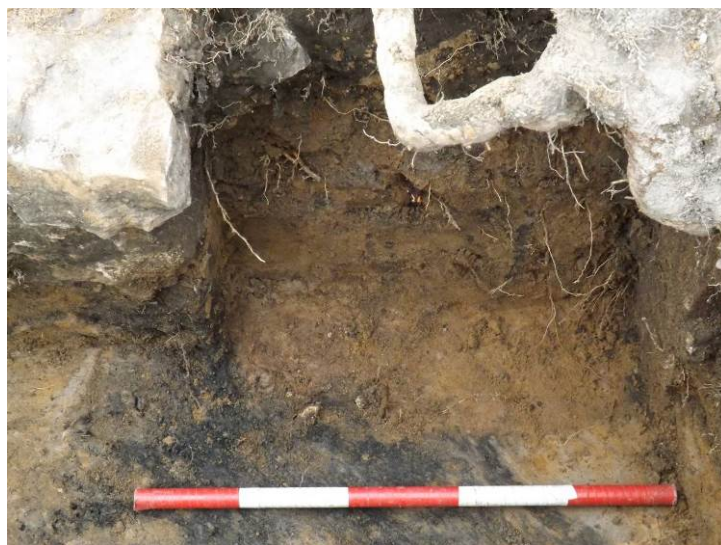
Plate 7 Grave #34.1 post-ex, east facing section (photo 080)

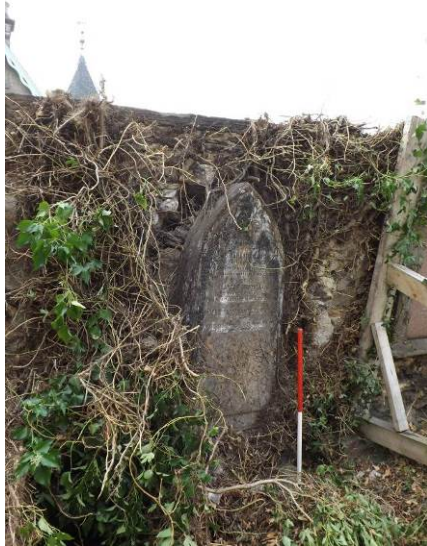
Plate 8 Grave monument #34.2 (photo 008)

Grave 34.2 is located immediately to the south of grave 34.1, and was obscured by ivy in the initial cemetery survey. The removal of the ivy revealed a fairly large grave monument dedicated to the Lang family (*Plate 8*).

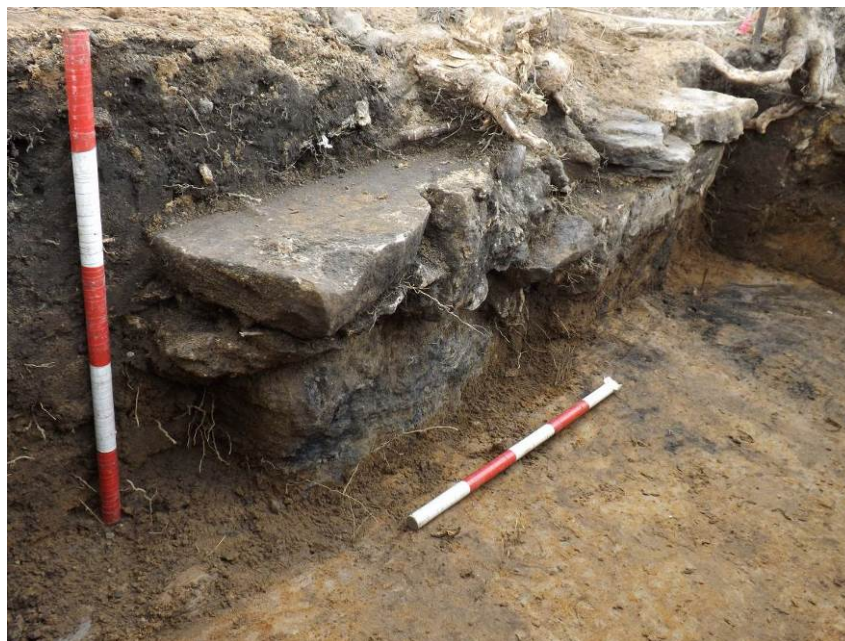
Excavations showed that the grave cut for #34.2 [017] cut the grave cut [020] and fill (021) of grave #34.1, indicating that the latest interment within #34.2 post-dates grave #34.1. The grave cut [017] abuts the mortared brick kerb [014] to the south, and is filled by the dark brown clay-rich primary grave fill (018), which underlies the large, mortared stone deposit (019). Overall, the grave plot measures roughly 1.5m in width. It is unclear if the stone filling the grave cut are limited to the eastern extent of the burial plot, or if they fill the full length and depth of the grave. This was the only grave plot excavated which showed a stone fill of this nature (*Plate 9*).

Plate 9 Grave #34.2 post-ex, east facing section (photo 101)

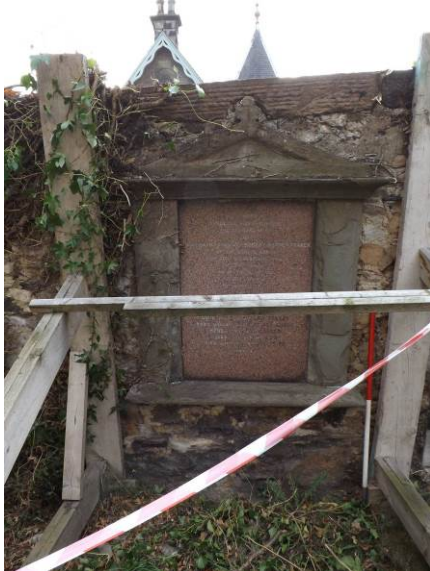
Plate 10 Grave monument #35 (photo 021)

Graves 35.1 (northern) and 35.2 (southern) were listed together as grave #35 during the initial churchyard survey, and are both associated with the Fraser monument. Upon excavation, two distinct grave cuts were revealed within the single grave plot, prompting a renumbering to 35.1 and 35.2.

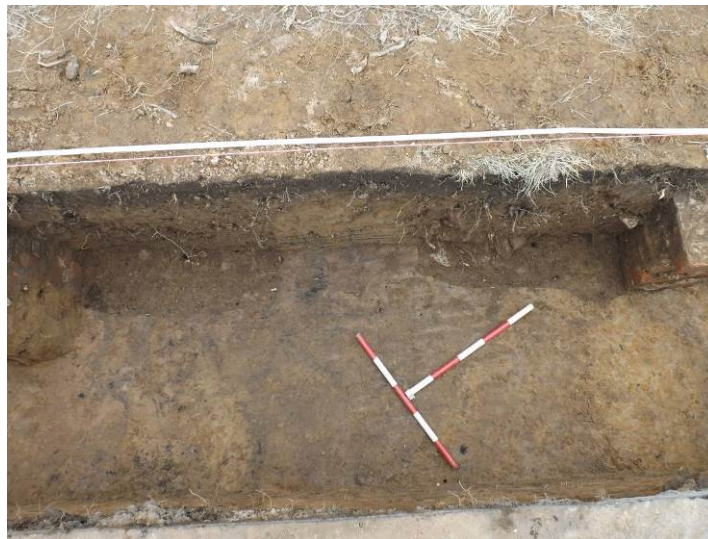
As mentioned above, excavations within grave #35 showed two distinct burial cuts within the same burial plot: #35.1 to the north, and 35.2 to the south. The northern burial is identified by grave cut [014], which has near vertical sides and cuts into natural; it contains the mid brown clay-rich sandy grave fill (015) and mortared brick kerb (016). The southern burial is identified by grave cut [012], which also has near vertical sides and cuts into natural; it contains the grave fill (013) similar to (015) only slightly lighter. Both grave cuts individually measure 0.75m in width, and both grave fills contain frequent small stone inclusions. Cut [012] contains the mortared brick kerb [011] to the south. The associated grave monument lists the inhumations of a mother and father with their four children, though it is unclear how those six burials may be divided between the two plots.

Plate 11 Graves #35.2 and 35.1 post-ex, east facing section and trench base (photo 108)

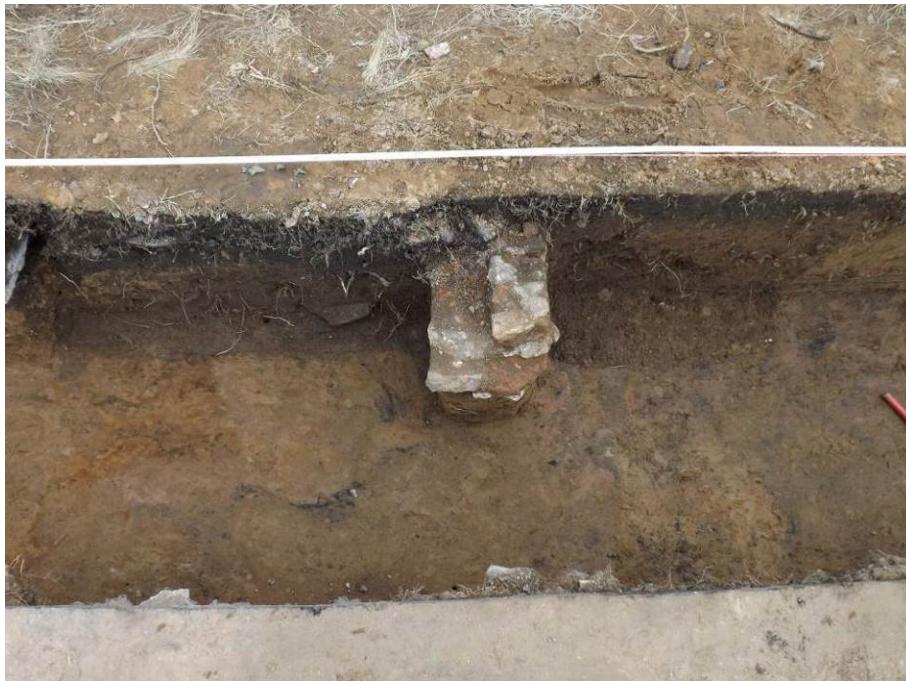
Grave 36 is located immediately south of grave 35.2, and is associated with the memorial of seven members of the Baldwin family. The plot is not thought to contain all seven family members, but is likely to contain a minimum of four. The burial is identified by grave cut [009] which is abutted by brick kerbs [011] to the north, and [008] to the south, and is filled by grave fill (010)- a dark to medium brown clayrich soil with redeposits of topsoil and sandy natural, and frequent angular stone and rare brick fragment inclusions. Topsoil in this area reaches a depth of 0.30m. Overall, the width of the grave plot measures roughly 0.75m. Heavy root disturbance was noted within this grave plot, and as was the case in all other excavated grave sections, no human charnel material was encountered.

Plate 13 Graves #36 post-ex (left of kerb), east facing section and trench base (photo 109)

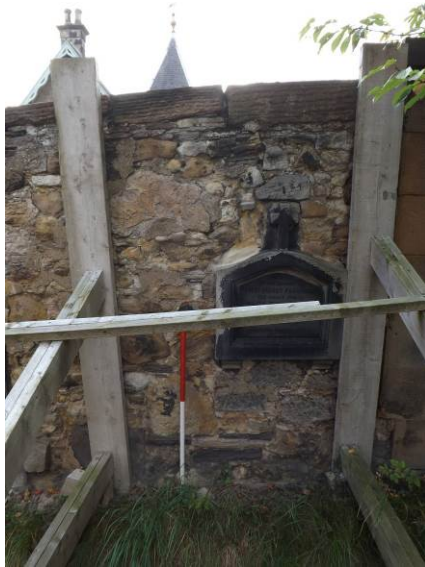
Plate 14 Grave monument #37 (photo 028)

A section of Grave #37 was partially excavated during the October works. The entire 2.0m in length east facing section was later fully revealed when the trench was extended on the 26th of November 2014. It was decided that in order to compensate for and mitigate the lean of the upstanding wall south of the foundation trench, a pier would be built- providing the extra strength and support required. In order to accommodate the pier, the trench was extended by 0.65m southwards, abutting the dressed ashlar facing stones.

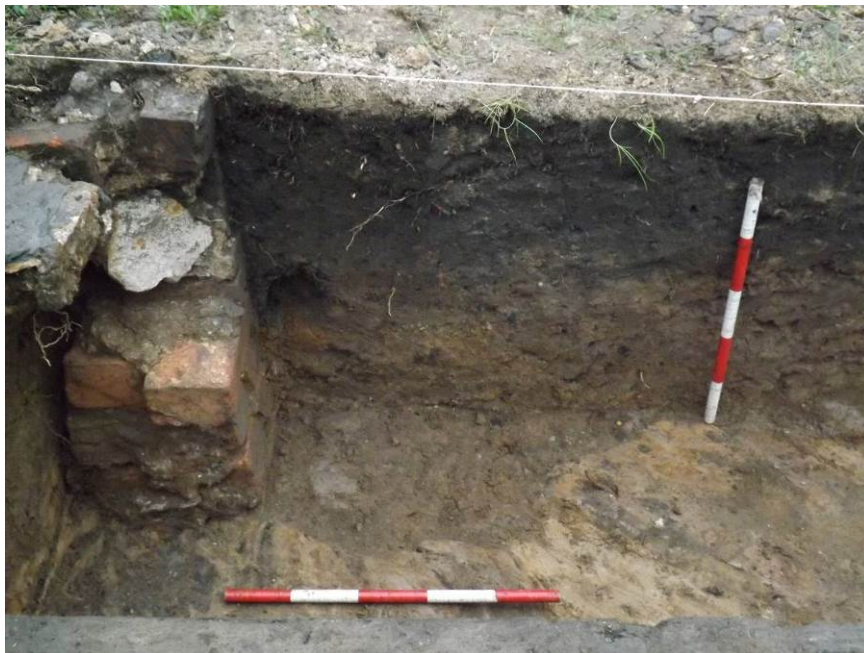
The burial is identified by grave cut [006] which contains brick kerbs [008] to the north, and [023] to the south, and is filled by grave fill (007): a medium brown clayrich sandy soil. Topsoil in this area reaches a depth of 0.30m. The grave cut seems largely confined to the southern edge of the grave plot (Plate 15), possibly related to the grave's association with an infant burial. It may be that the child was interred at the edge of the plot rather than the centre.

Plate 15 Graves #37 post-ex (S corner), east facing section and trench base (photo 127)

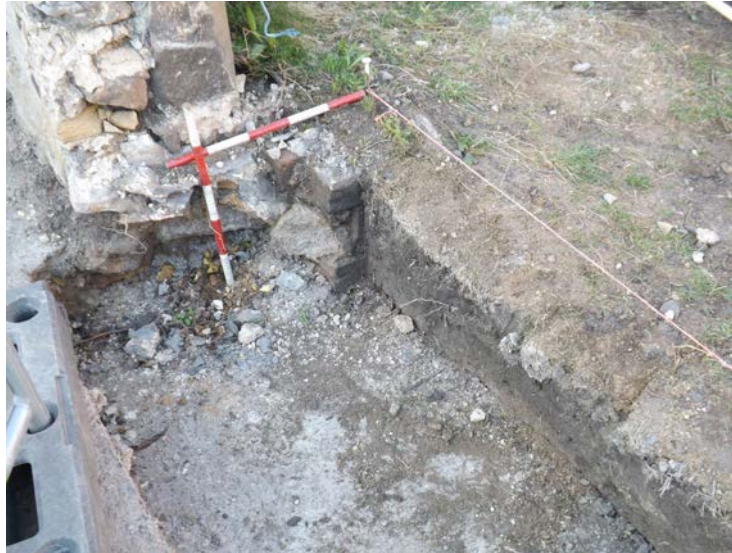
Plate 16 Trench extension pre-ex looking southwest (photo 359)

The foundation trench excavated in October 2014 (see *Plate 15*) had now been filled with concrete (*plate 16*), with the current excavations scheduled to take place alongside to the west. Excavations revealed more of the brick grave plot kerb {023}, showing it to extend below the maximum 0.60m depth. Grave cut 37 was further excavated, utilising 100% sieving through a 5mm mesh. No human remains or grave goods were encountered/ disturbed through this exercise.

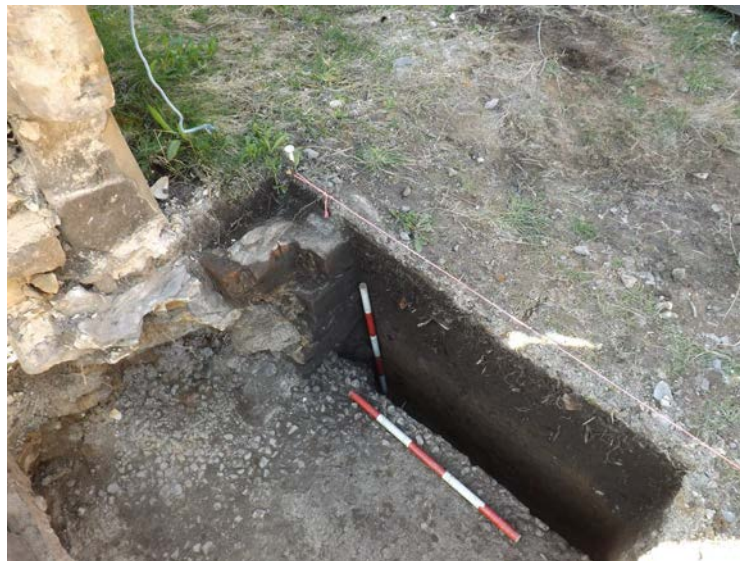
A small extension at the south extent of the wall foundation trench was excavated on the 8th of April 2015, under clear, sunny, and warm conditions. The trench extension was required in order to accommodate the construction of the wall support pier, necessitating the excavation of an area westwards into the cemetery; this extension measured 0.15m east-west, 1.0m north-south, to an overall depth of 0.60m as per the engineering specifications.

Plate 17 Trench extension post-ex (photo 366)

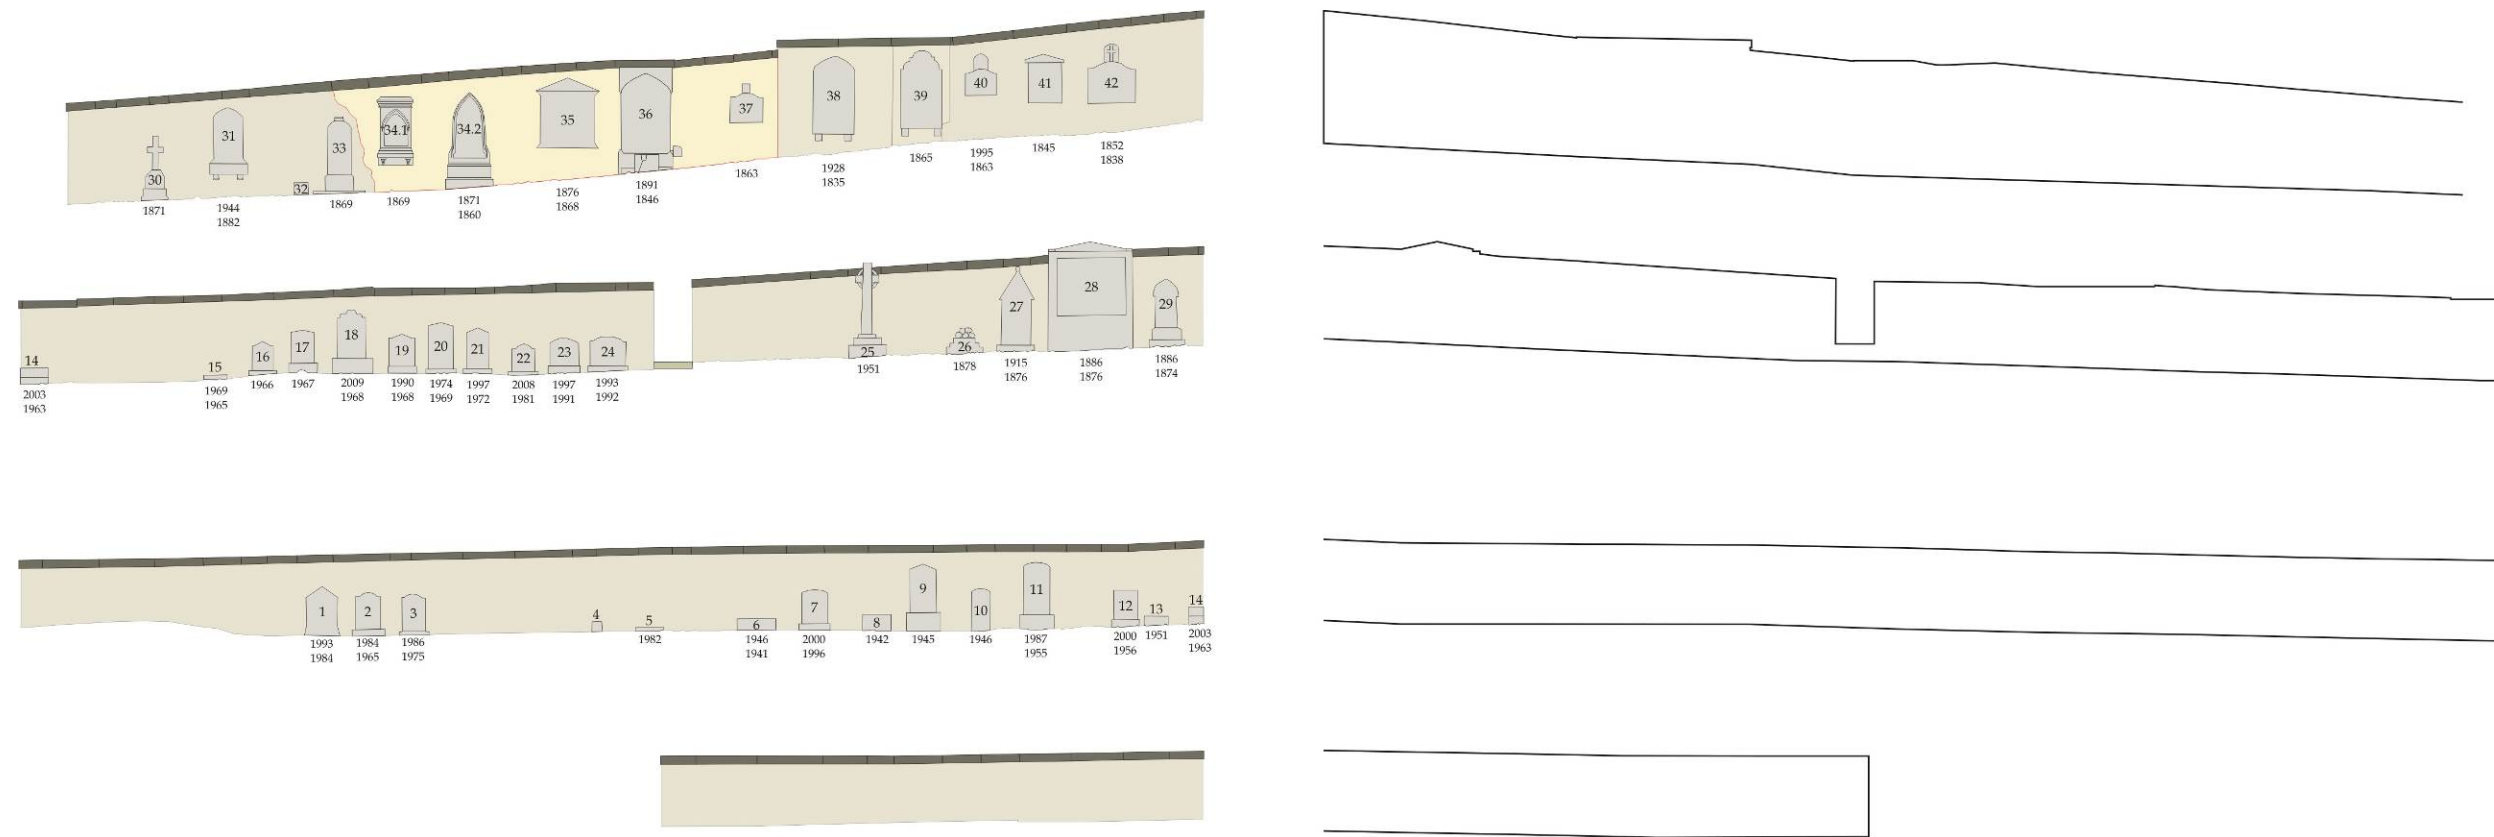
Figure 1 Continuous elevation of E wall, internal (left) and external (right) reproduced at 1:100

5m
Area of east wall dismantled

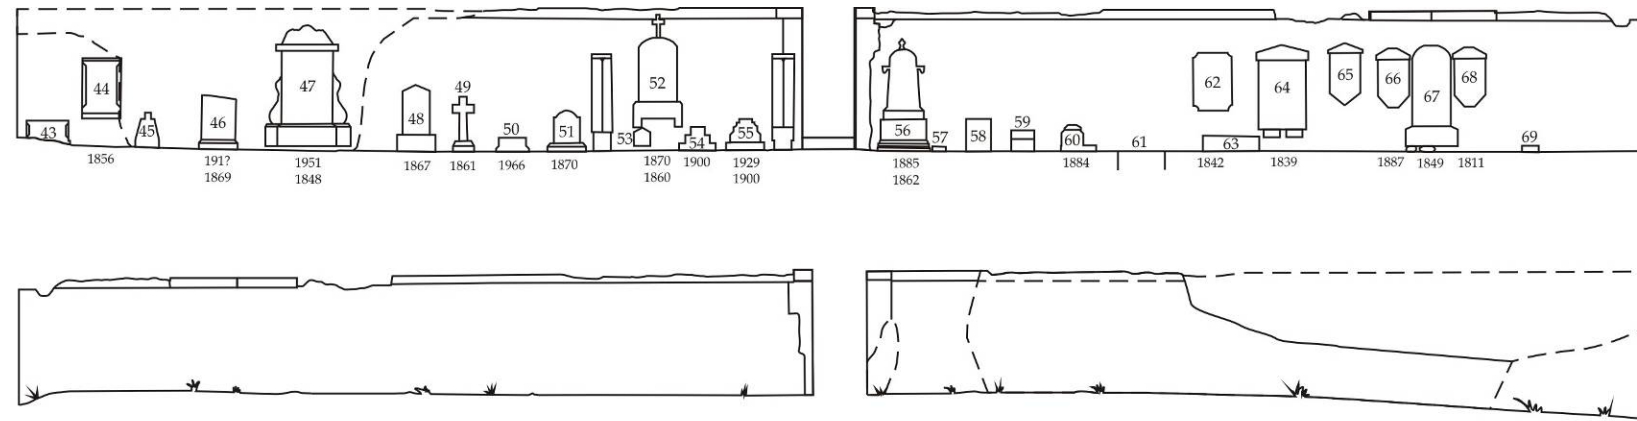
Figure 3 Continuous elevation of S wall, internal (top) and external (bottom) reproduced at 1:100

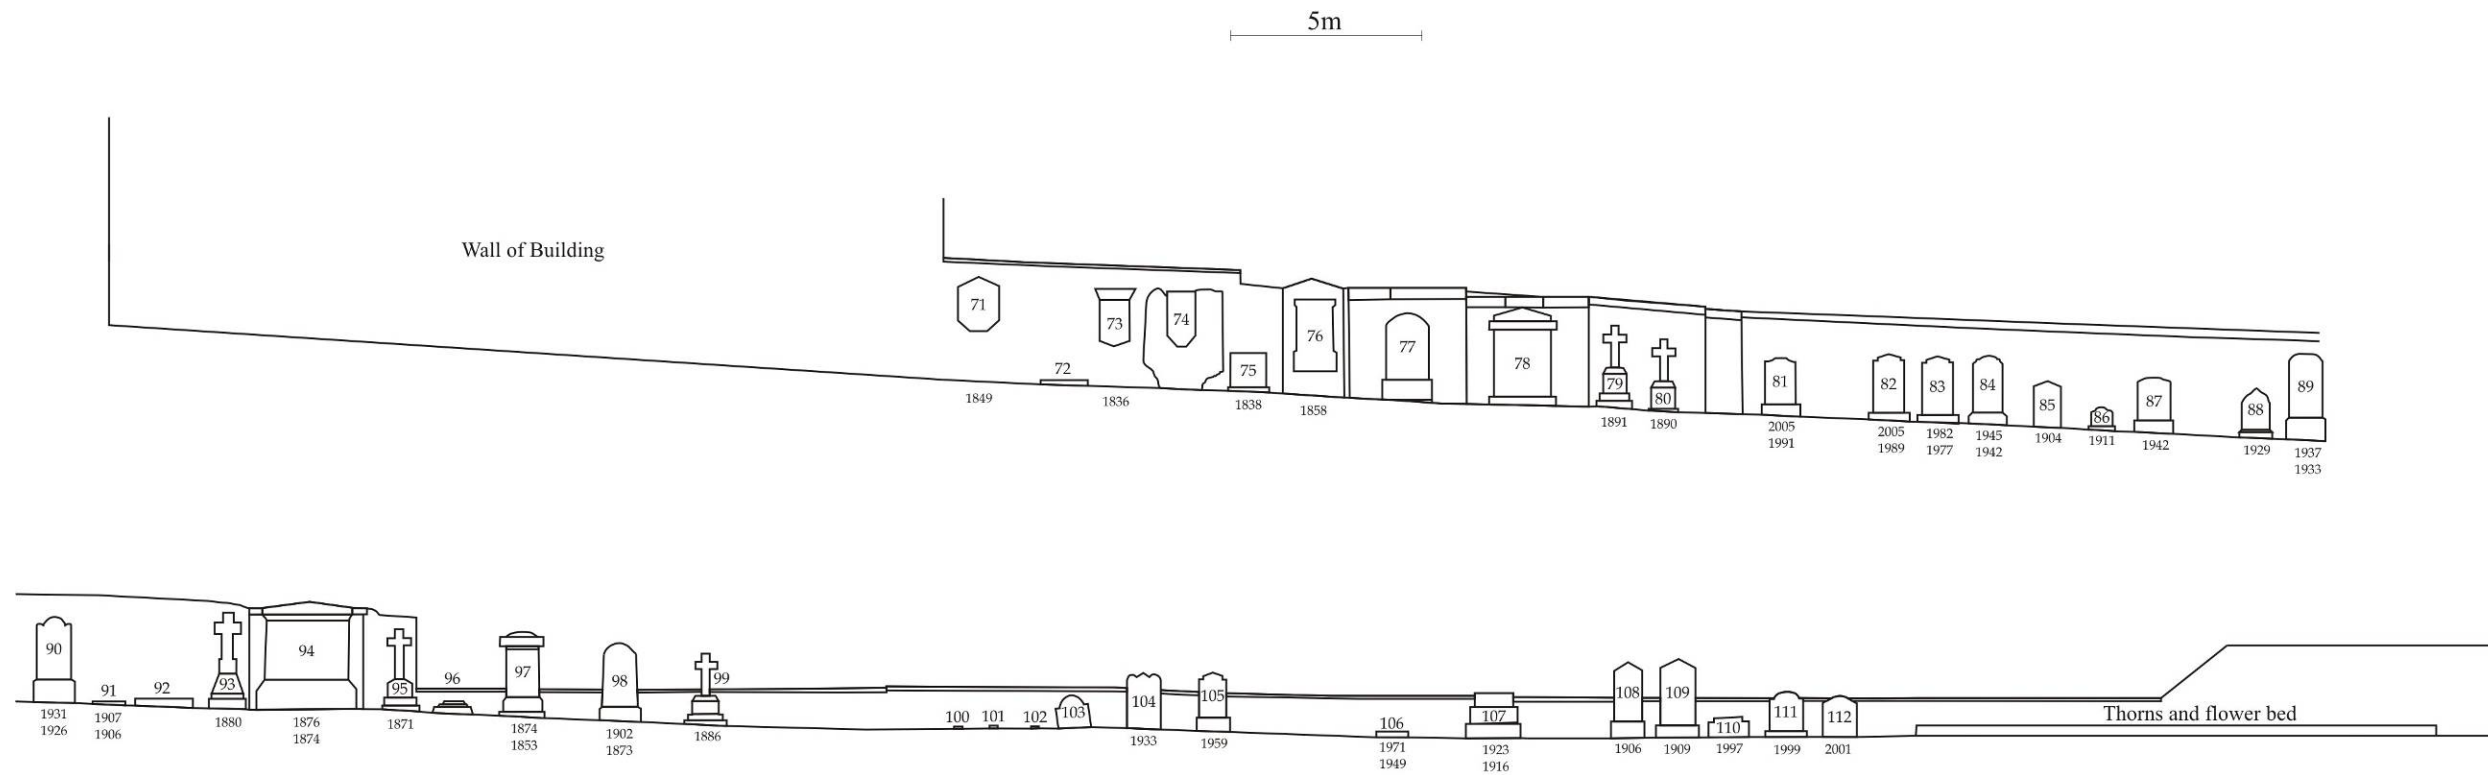
Figure 4 Continuous elevation of E wall, internal reproduced at 1:100
