Buccleuch Place and Meadow Lane

Archaeological Evaluation and Building Recording

The University of Edinburgh

December 2015

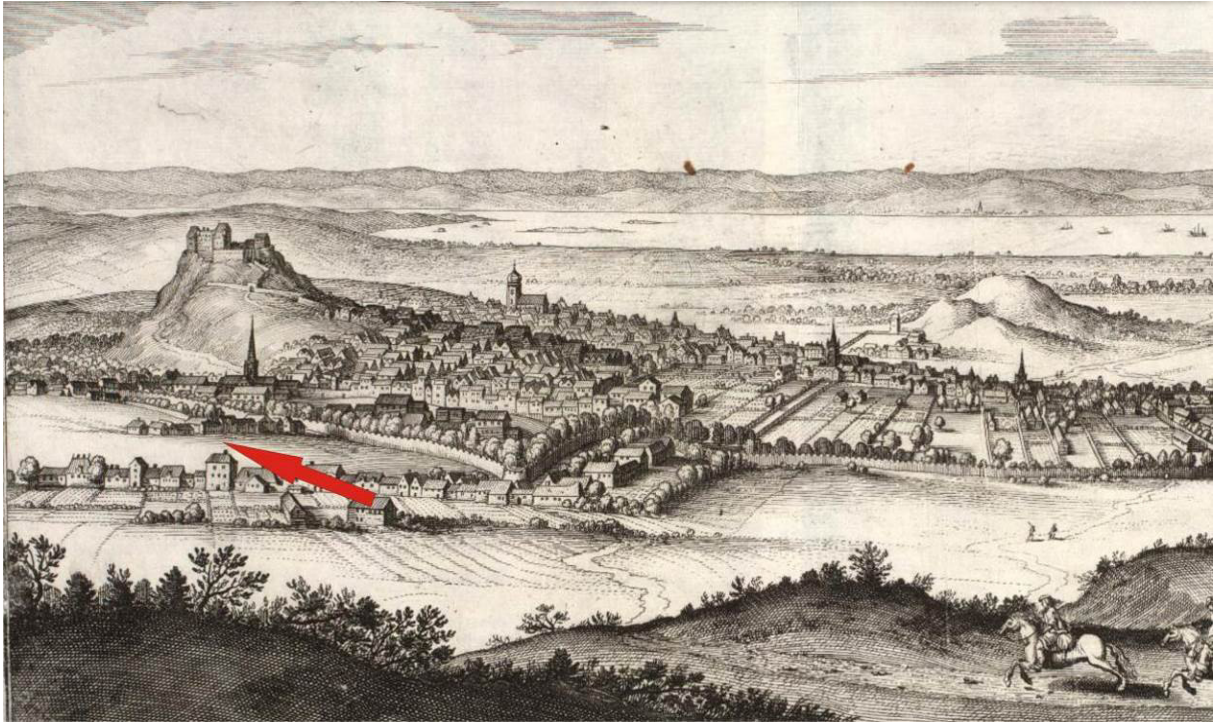
Figure 2 Extract from 'Edynburgum' by an unknown author. 1649. NLS

The depiction 'Edynburgum' by an unknown author, published 1649 (**Figure 2**), does not appear as if it was intended to be an overly accurate representation of the city scape, though it likely shows, more or less, the overall appearance and feel of Edinburgh in the mid 17th century.

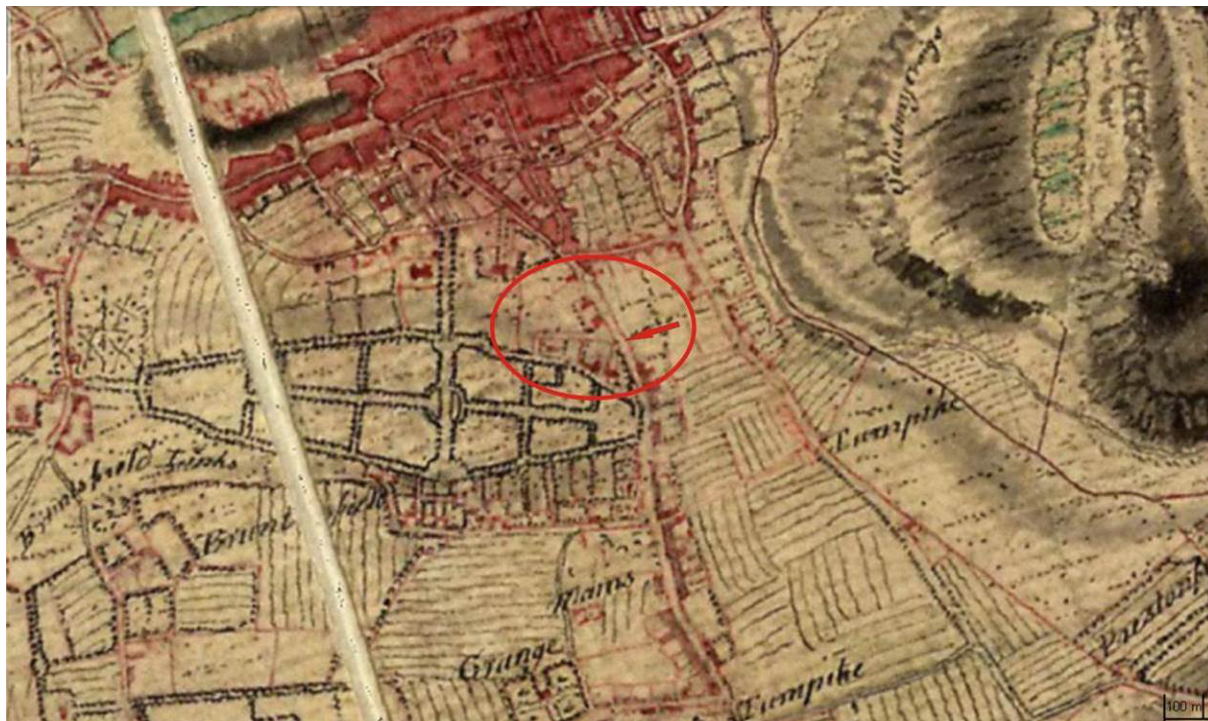
Figure 3 Extract from 'Military Survey of Scotland. Lowland Scotland' by William Roy 1747-55, with site area encircled in red. © The British Library Board. All Rights Reserved (Roy Military Survey of Scotland)

This section of Roy's lowland map (**Figure 3**) highlights the area south of the city walls, with the approximate location of the proposed development area encircled in red; surveyed from 1747 to 1755, it depicts the South Side just prior to the laying-out of George Square in 1766. The map shows the meadows in its correct location, laid out with the walk surrounding it and a network of drains through the centre. Middle Meadow Walk is also shown extending north past the Royal Infirmary to the line of the Telfer wall and the ornamental gardens surrounding George Heriot's. To the east of Heriot's, Bristo Port and Potterow meet at a point becoming Chapel Street and Buccleuch Street as it extends southwards. Further east, the Pleasance meets with what is likely Richmond Place becoming St. Leonards Street and a route out of town.

Along Chapel and Buccleuch Street, at the northeast edge of the Meadows, Archer's hall and Borough Loch are shown, along with the square plot of Hope Park Square and Hope House to the west. The road immediately to the north of Archer's Hall, orientated east-west and turning southwards at its western extent, most likely represents Buccleuch Place. The Chapel of Ease can be seen along Chapel Street to the north of it.

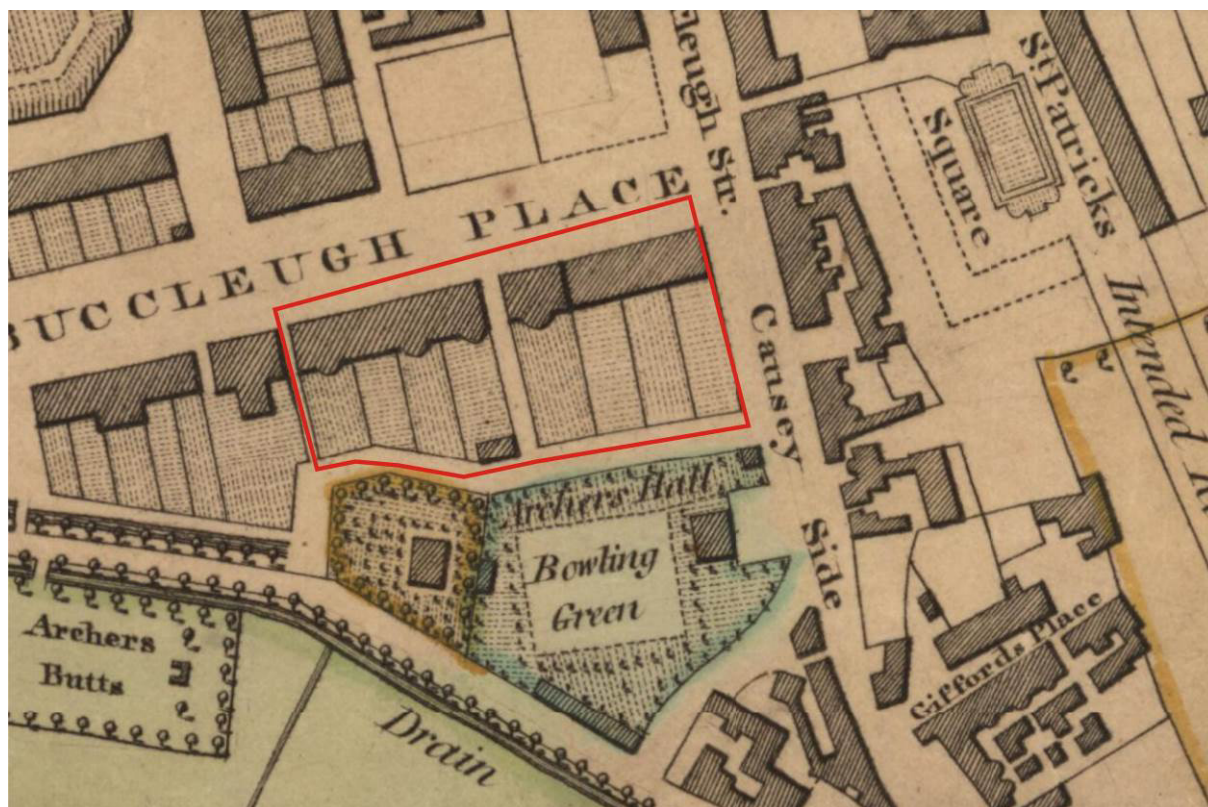
Figure 4 'Old and New Town of Edinburgh and Leith with the proposed docks' by John Ainslie 1804. NLS

John Ainslie's map 'Old and New Town of Edinburgh with the proposed docks' of 1804 (**Figure 4**), shows the completed structures along Buccleuch Place, and the north-south orientated Buccleuch Place Lane bisecting the site. The lands behind each block of houses (the west and east halves of the site) have been divided at this point into four linear garden plots on each side. A small coach house has been built at the southeast corner of the garden plot belonging to number 7, with access to it gained from Meadow Lane.

The earliest depiction of the coach house on the north-west corner of Meadow lane and Buccleuch Place lane can be found on Ainslie's 1804 map 'Old and New Town of Edinburgh with the proposed docks' (see **Figure 4**). Ainslie's map shows the structure situated in the south-east corner of the linear garden plot to the rear of #7 Buccleuch Place, and identifies this as the first structure to have been built to the rear of the tenements fronting Buccleuch Place, predating the adjacent coach house east of Buccleuch Place Lane. Shown fully built by 1804, it is possible that the construction of the coach house dates to the late 18th century, coinciding with the construction of the tenements along Buccleuch Place in the 1780's and 1790's.

The coach house at No.9 Meadow Lane does not appear on Ainslie's 1804 map 'Old and New Town of Edinburgh...' (**Figure 4**), but is depicted on 'Kirkwood's Plan of the City of Edinburgh' by James Kirkwood and Sons, produced 17 years later. These maps would indicate that this coach house dates from the early 19th century, with construction taking place sometime between 1804 and 1821. Like Nos. 10 and 11 to the west, the south elevation appears to have been replaced, while skylights have also been inserted in the slate roof. Inside, the single open space has lately been divided into two bays by a cement block partition (**Plate 26, Plate 27**).

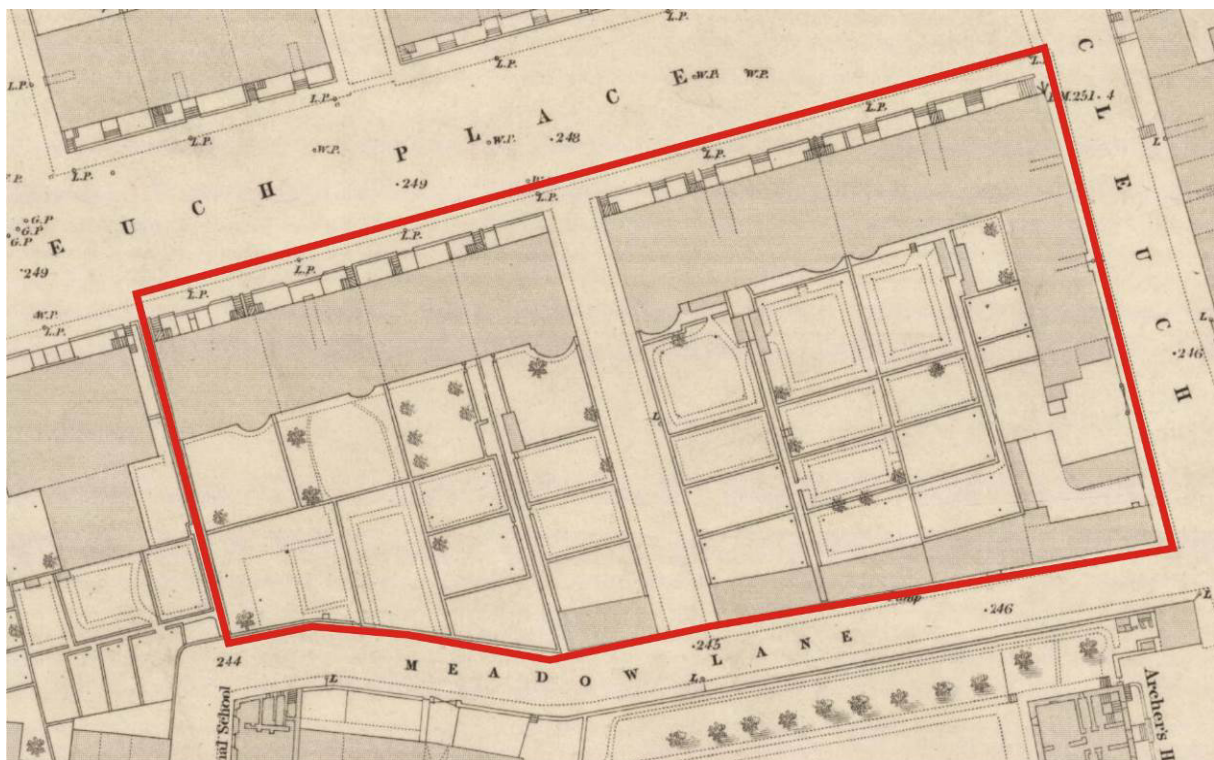
Figure 5 Ordnance Survey, 1st edition. 25 inch to 1 mile. 'Edinburgh' Sheet 40. Surveyed 1852. NLS

Beginning with the block to the west of Buccleuch Place Lane (**Figure 5**), the biggest development appears to be the reorganising of the back gardens and the placement of garden walls. A number of paths within the gardens can be seen, with two long linear passages connecting the houses at the front to the individual garden plots at the rear. There is a small outbuilding shown within the garden plot to the rear of #7, possibly representing a garden shed or out-building.

The block to the east of Buccleuch Place Lane has undergone the most visible changes, with additional garden walls, structures, and out-buildings having been constructed. As was seen in the western block, the four, long and linear gardens have been divided into much smaller garden plots, possibly reflecting a repurposing of the associated housing from single family dwellings into multi-family tenements. Numerous out-buildings are shown within the gardens, as well as an elaborate network of paths connecting the individual plots to the buildings to the north. The biggest changes have occurred in the southeast corner of the site where a number of coach houses and workshops have appeared, along their associated yards and sheds.

The structure at No.7 Meadow Lane is first shown on the Ordnance Survey 2nd edition, surveyed in 1905 (**Figure 6**). Prior to this, the land was occupied by a coach house as depicted on the OS 1st edition of 1852 (**Figure 5**), and 'Kirkwood's plan of the City of Edinburgh' of 1821. The structure dates to the late 19th, early 20th century, with a later extension to the rear, expanding the building northward. The primary function of the building is as a warehouse, with a later internal addition adding a storey in the south-west corner.

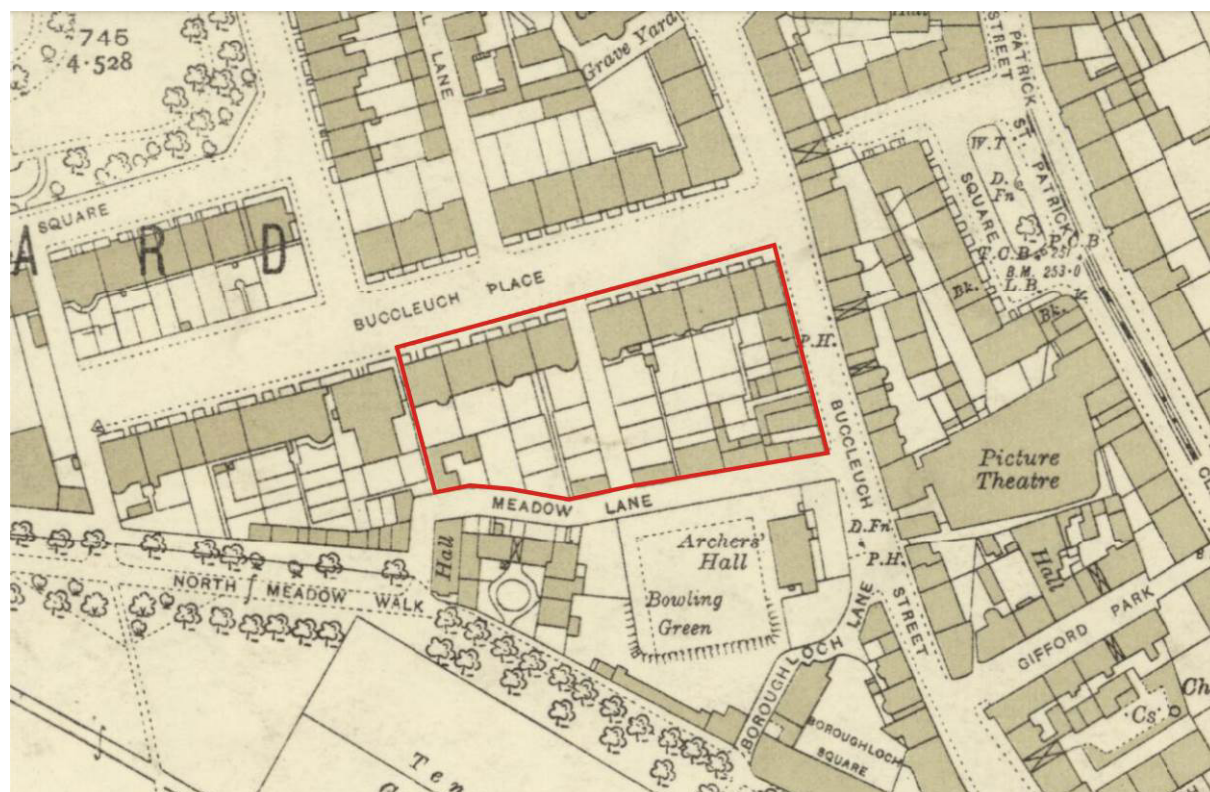
Figure 6 Ordnance Survey, 2nd edition revision. 25 inch to 1 mile. 'Edinburghshire' Sheet 003.12. Revised 1932.
NLS

From the 20th century onwards, the biggest change to the western half of the site is the appearance of a U-shaped structure in what was the southwest garden plot (**Figure 6**), which likely represents a workshop and yard. In the eastern half of the site, the cluster of structures to the southeast has continued to evolve, with some smaller structures consolidating into larger ones. Of note, the coach house behind #4 Buccleuch Place has been expanded northwards, now taking over a portion of the garden plot next to it. The southeast corner has continued to evolve, with the courtyard in front of what was an L-shaped structure now having been built-upon.

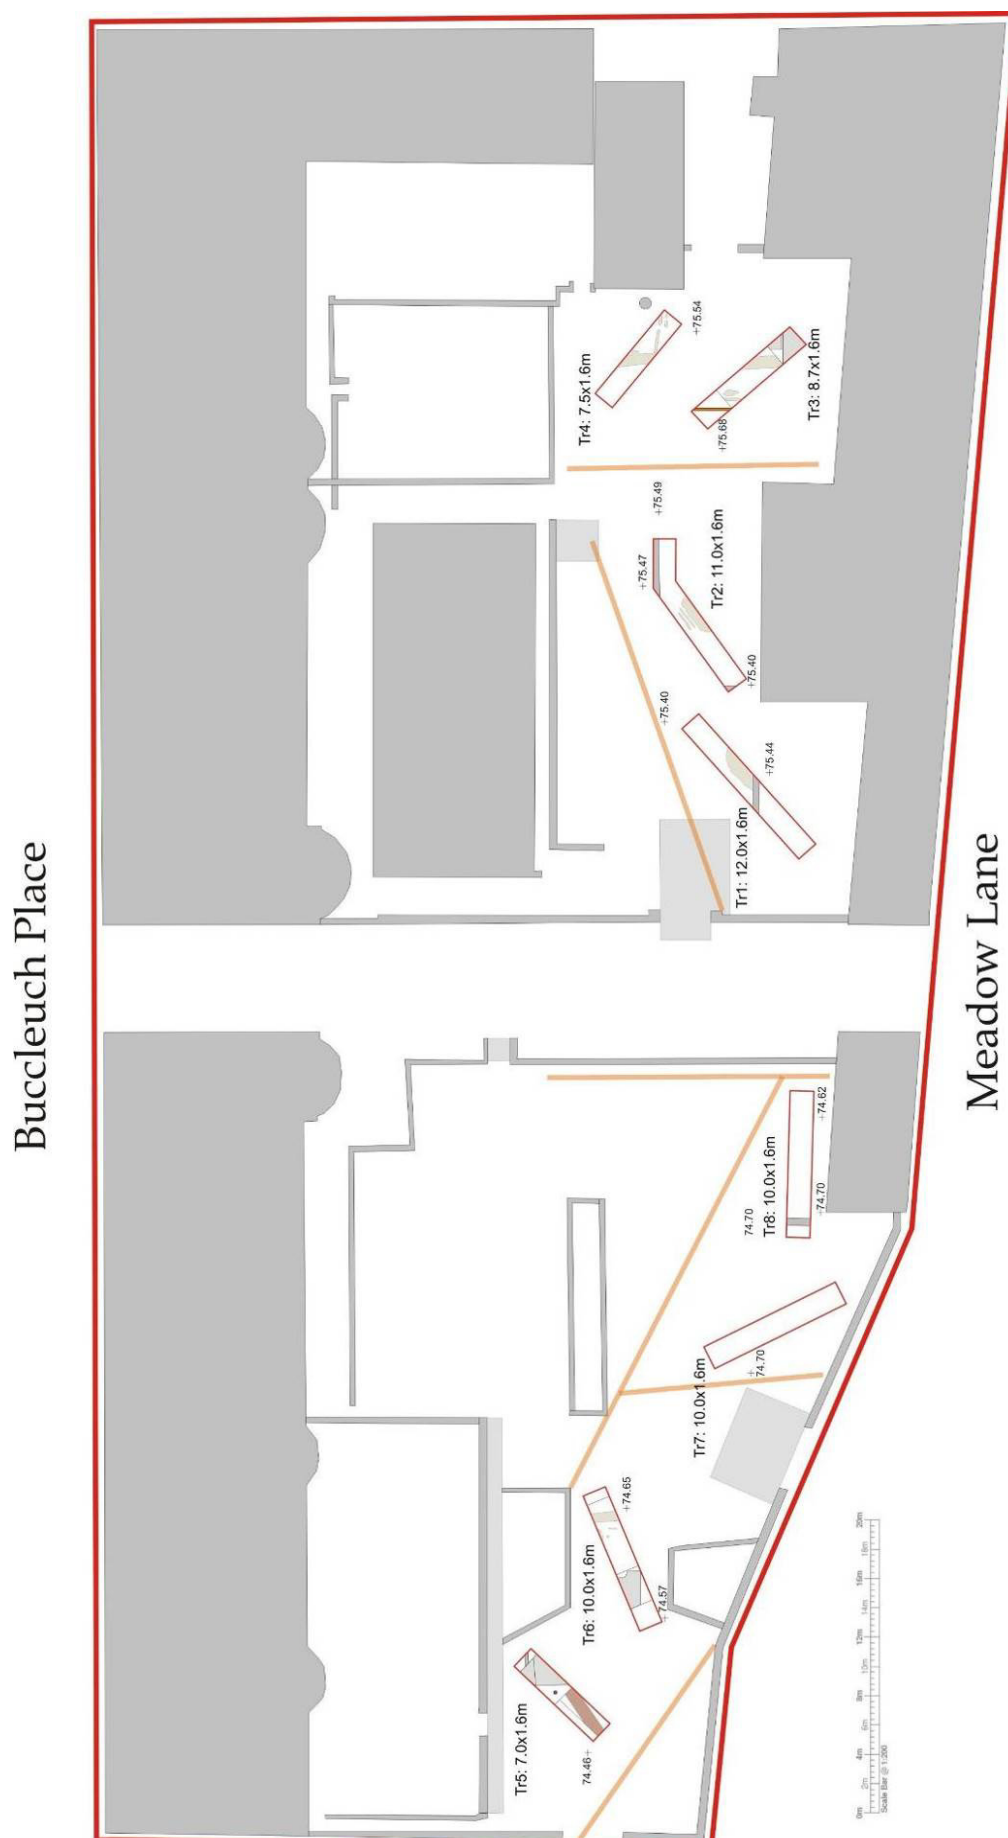
Figure 7 Trench locations as excavated

Trench locations can be seen above in **Error! Reference source not found.** Trenches are outlined in red, with existing buildings and walls indicated in grey. Yellow indicates the possible courses of below ground services located during pre-excavation scanning exercises, the locations of which greatly influenced trench placement and overall trench length. Trenches 1 through 4 were located in the eastern half of the site, while trenches 5 through 8 were located in the western half of the site.

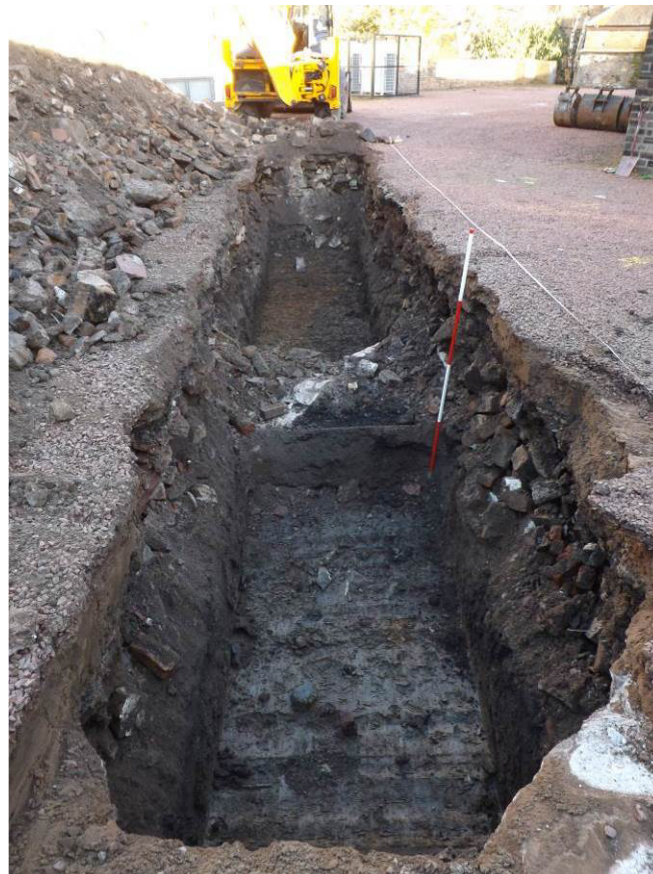
Plate 1 Trench 1 Post-ex, facing north-east (photo 021)

Trench 1 was excavated in the morning of Monday the 19th of January 2015, under clear and sunny, but cold conditions, with a layer of frost permeating the upper deposits. With an overall excavated depth of 2.0m below the surface of the modern car park, and with loose and unstable sections, Trench 1 was deemed too unsafe to enter.

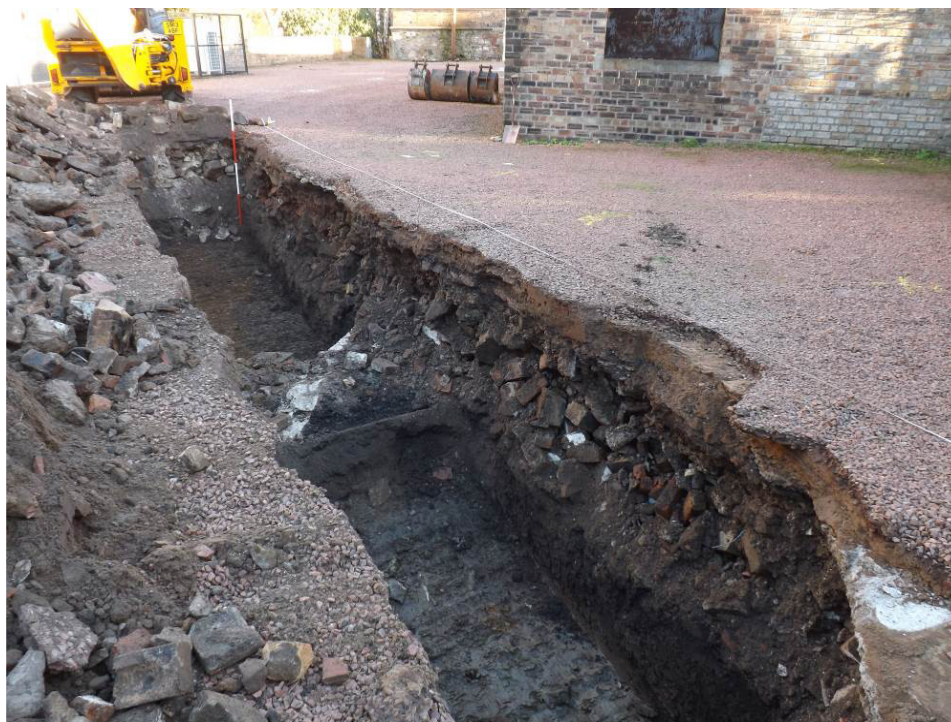
Plate 2 Trench 1 post-ex, showing E-W garden wall (photo 004)

Near to the excavated trench's centre, an east-west orientated stone and mortar built Victorian garden wall [104] was revealed that conforms to the location of the garden walls depicted on the OS 1st edition map of 1852. Underlying wall [104], and continuing to the northeast and southeast, was subcircular area of mid grey-brown soils with frequent charcoal flecks (105). The trench was excavated down on to the natural boulder clay (106), at an overall depth of 1.6-1.7m (OD+73.80 to +73.70) at the north-east end, sloping down to 2.0m (OD+73.40) in depth to the south-west.

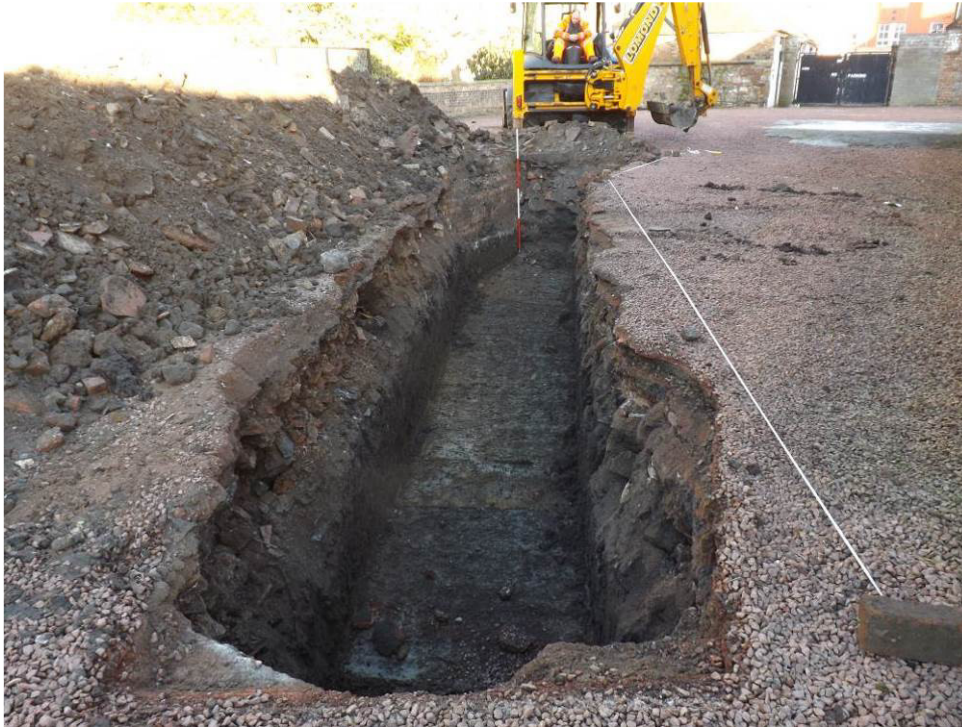
Plate 3 Trench 2 post-ex, facing north-east (photo 038)

Like Trench 1 to the west, the modern gravel car park surface layer (201) (OD+75.40 to +75.49), overlay a rubble demolition levelling deposit (202), made up of brick and structural sandstone in a loose sandy matrix with frequent voids, reaching an overall depth of 0.90m. Beneath the levelling deposit, a rich-dark Victorian garden soil (203) survived to a depth of 1.8-2.0m to the level of the natural clay (OD+73.60 to +73.40). From the garden soils (203) came a find of an 1890 Queen Victoria Halfpenny SF001.

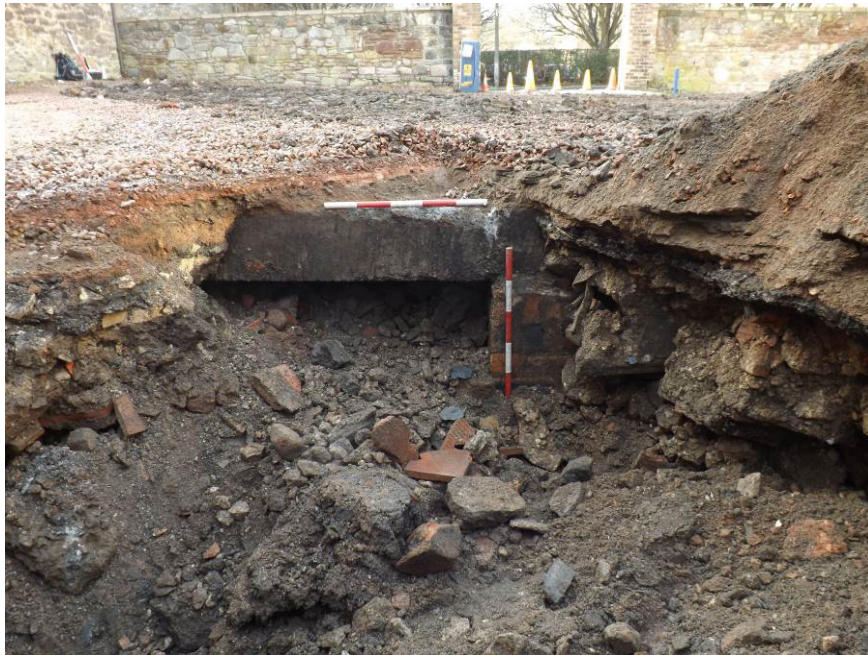
At the westernmost end of the trench in the northeast facing section, a north-south orientated possible garden wall was uncovered [204]. Wall [204] (**Plate 4**) exists as a brick-built section capped with a stone lintel spanning a gap or opening to the south. This section of wall corresponds with the Victorian garden walls shown on the OS 1st edition map.

Plate 4 Trench 2, Wall [204] mid-ex (photo 026)

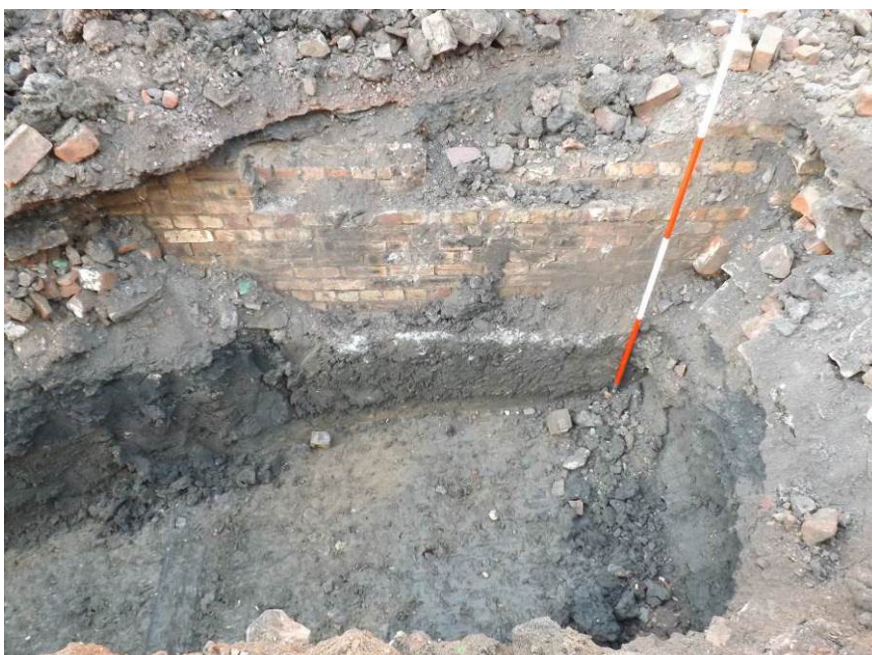
Plate 5 Trench 2, Wall [206] post-ex (photo 041)

At the north-east end of the trench, an east-west brick-built garden wall with concrete foundations [206] was encountered, surviving to a height of 11 courses and a foundation thickness of 0.40m for an overall height of approximately 1.10m (*Plate 5*). Wall [206] continues to the west and east, and was abutted by the garden soils (203) to the south. Near the centre of the trench, cutting into the natural clay subsoil, an area of earlier, possibly late medieval soils was noted, with likely ploughmarks orientated north-east/south-west and with an approximate length of 3.5m. These soils (205) were a similar mid grey-brown with frequent charcoal flecks as was seen in Trench 1.

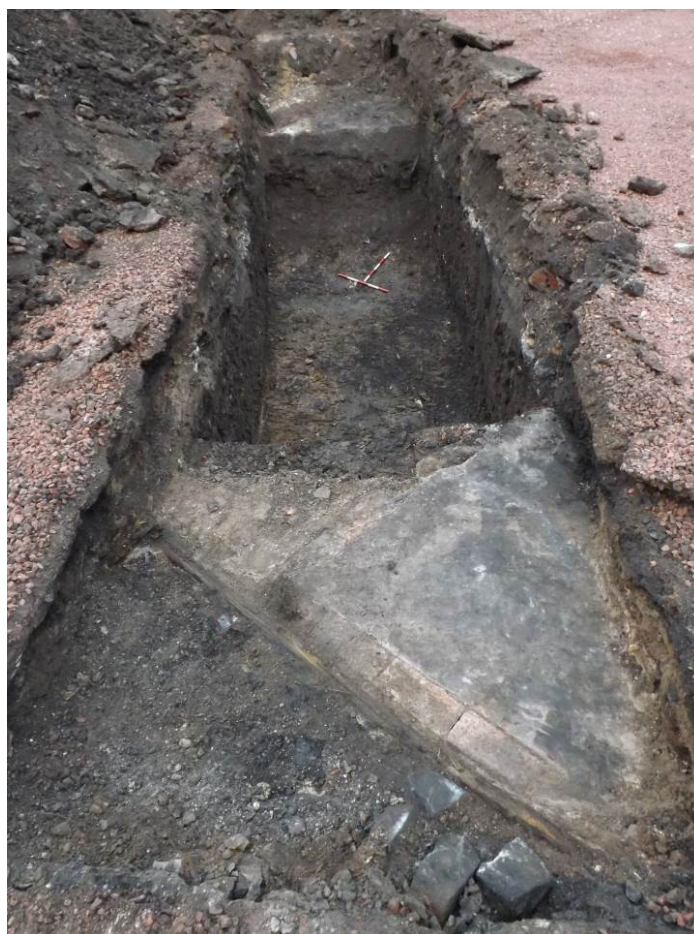
Plate 6 Trench 3 post-ex, facing north-west (photo 054)

The later courtyard features [302] were seen to directly overlie an upper horizon of mid-dark brown humic clay (303), interpreted as Victorian garden soil with frequent stone and some broken brick inclusions. Below the Victorian soils, a lower horizon of dark brown humic clay with instances of oyster shell (304) was noted, reaching a maximum depth of 1.5m (OD+74.18) below the surface of the modern car park. It is thought that this deposit may relate to the earlier Georgian garden soils that predate the Victorian garden plot subdivisions.

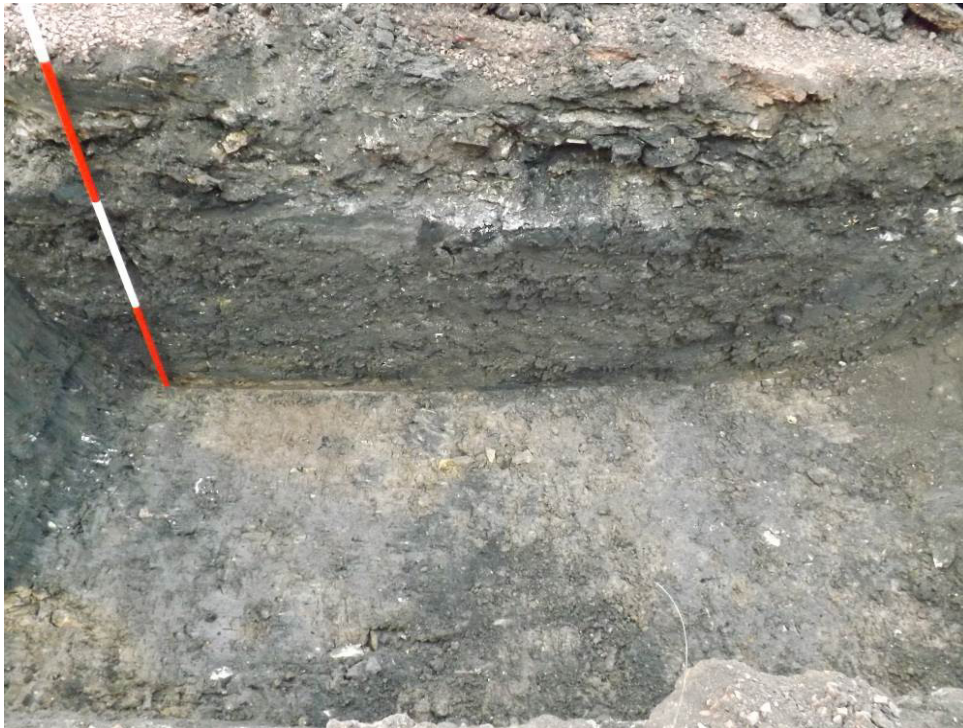
Plate 7 Trench 3 post-ex, north-east facing section (photo 063)

Possible late Medieval ploughsoils (305) could be seen underlying the Georgian garden soils (304), and cutting into the orange-brown natural clay (306) (**Plate 7**). A north-south orientated linear feature [307] diagonally cuts across the southeast end of the trench base, while possible ploughmarks can be seen immediately to the northwest. These ploughsoils (305) contained frequent small finds including: faunal remains, shell, glass, ceramic, and clay pipe fragments (SF002-009).

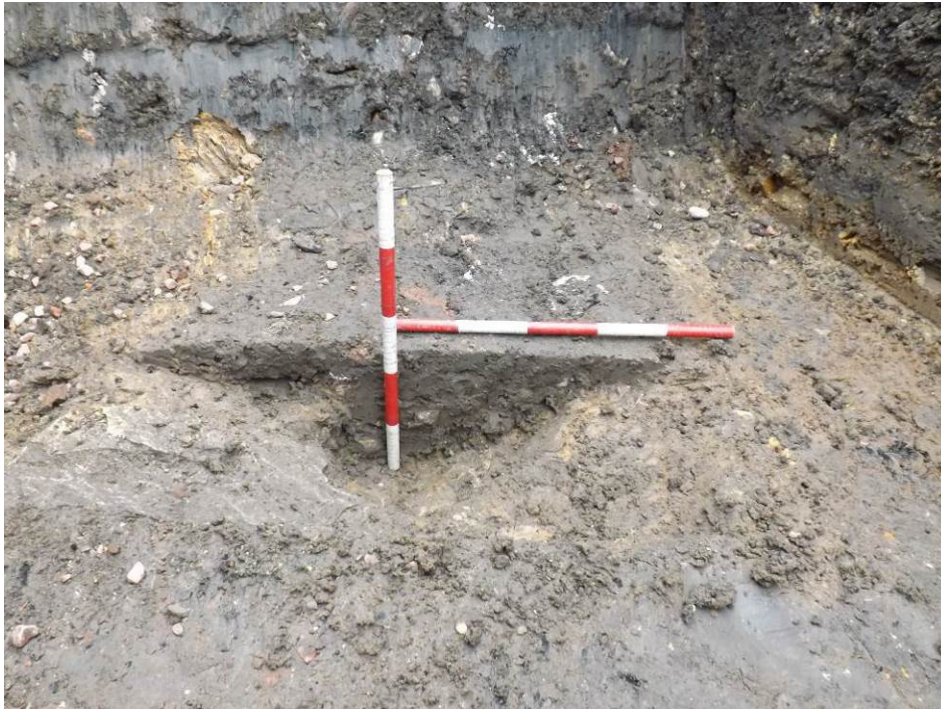
Plate 8 Trench 3, Feature [307] post-ex, north facing section (photo 074)

Linear feature [307] (**Plate 8**) was orientated north-south, and continued beyond the limits of the excavation both to the north and south. Feature [307] cuts into the natural clay subsoil, and measures approximately 0.70m in width, with an excavated depth of 0.30m (OD+73.88). The cut shows sloping sides at a near 45-degree angle, with a rounded base. Within the excavated sondage, the eastern edge of the cut was defined by a large piece of sandstone within the natural. It is possible the feature [307] may represent a cultivation furrow or a drainage channel.

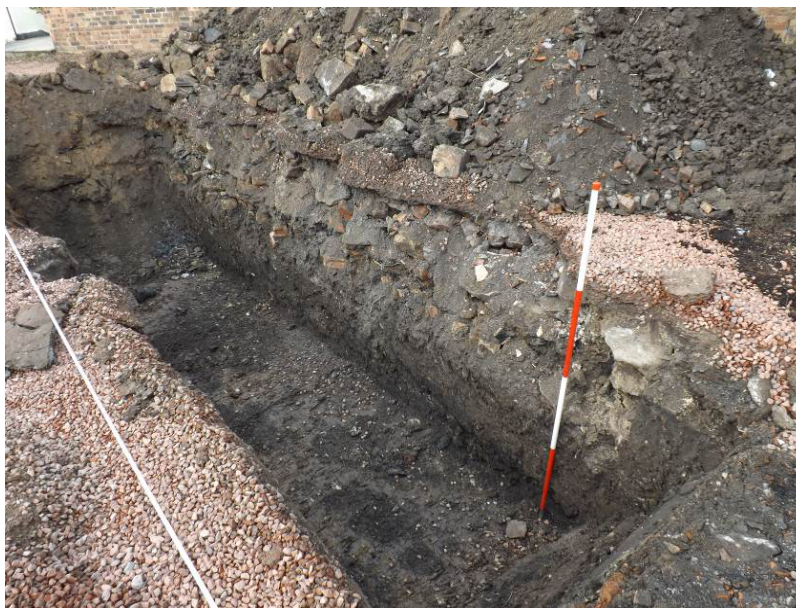
After the removal of the gravel car park surface layer (401) ($OD+75.54$), a demolition rubble deposit was revealed (402), acting as a levelling deposit for the car park above. This levelling deposit was made up of large, loose stone, brick and sandstone blocks, some of which were dressed architectural stones. Seen in the south-west facing section at the south-eastern end of the trench, the stub of a mortared stone east-west crosswall [403] was noted, abutted by likely Victorian garden soils (405) to the south. Also underlying the demolition rubble deposit, a brick surface [404] abutted the garden wall [403] to the north (*Plate 10*).

Underlying and abutting the east-west crosswall and brick surface layer seen in the south-west facing section, a mid-brown/grey garden soil deposit (405) was seen to a depth of approximately 1.3m below the level of the modern car park surface. This deposit is thought to be Victorian in date and shows evidence of middening. Beneath the garden soil (405), a much darker mid-brown/black clay-rich garden soil (406) was noted across the entirety of the trench, reaching an overall depth of approximately 1.6m below ground level ($OD+73.94$ to the north-west, $+73.84$ to the south-east). This thin deposit overlying natural is thought to date to the Georgian period or earlier, based on the finds assemblage that was recovered from within.

Plate 10 Trench 4 post-ex, south-west facing section (photo 091)

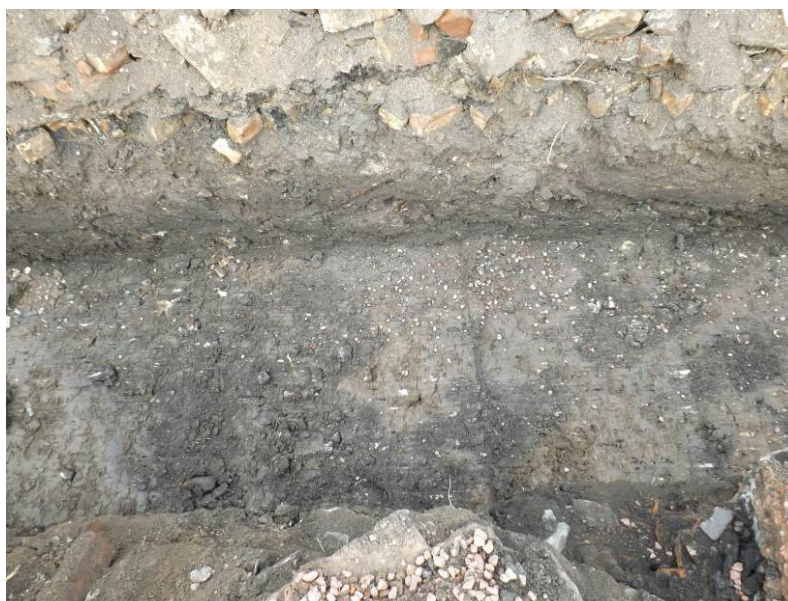
Underlying the garden soils (406) and cutting into the natural clay subsoils, a series of likely ploughmarks [407] could be seen across the majority of the trench base (**Plate 11**), orientated roughly north-west/south-east. Towards the north-west end of the trench, a linear feature orientated north-south, and approximately 0.70m in width was noted. This feature aligns with feature [307] in Trench 3, and is thought to be a continuation of the same furrow or channel. As mentioned above, due to the depth of the trench and the unstable sections, these features could not be evaluated further.

Plate 11 Trench 4 post-ex, showing features [407] (photo 094)

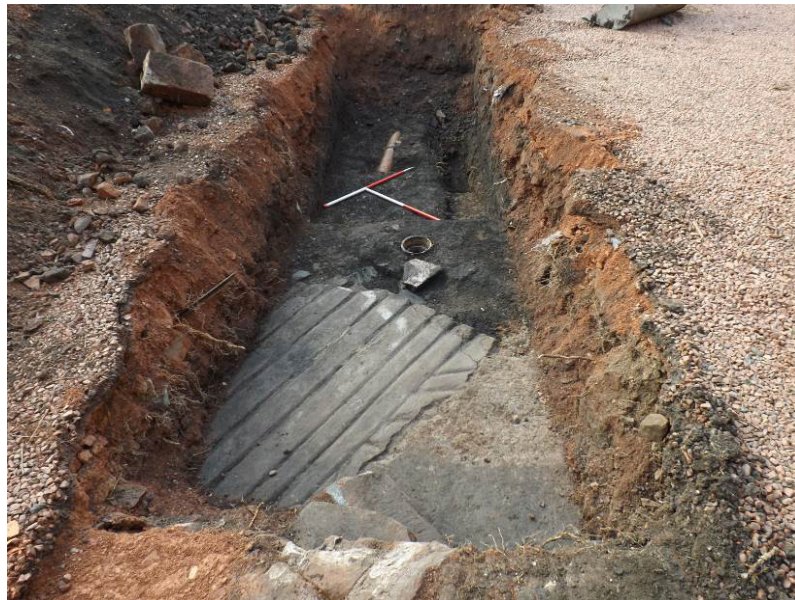
Plate 12 Trench 5 post-ex, facing south-west (photo 117)

Following the removal of the gravel modern car park surface layer (501) (OD+74.46), a loose orange blaze and rubble deposit (502) reaching a depth of approximately 0.70m was revealed, which acted as a levelling deposit for the gravel parking area above; this orange blaze would appear as a levelling deposit in all trenches excavated within the western half of the site. At the north-east end of the trench, and directly underlying the gravel (502), a roughly east-west aligned, mortared stone wall [503] was uncovered. Wall [503] (**Plate 12 foreground**) measured roughly 0.40m in width and 0.60m in height, and did not appear to continue westwards into the southeast facing section.

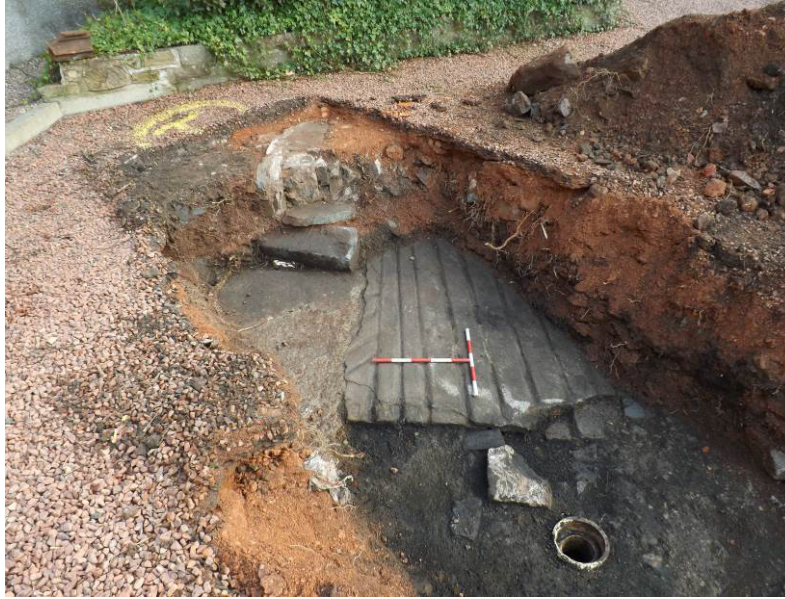
Underlying the E-W crosswall was a rough concrete surface [504] (OD+73.84) that was abutted by a line of red brick [506] to the east and west, and by a smooth concrete surface [505] to the south incised with a linear pattern likely intended to aid drainage or to provide traction (**Plate 13**). The smooth, incised concrete surface [505] showed areas of hard-packed, worn-in soils across its surface, likely deposited through footfall indicating that this surface possibly acted as a walkway.

Plate 13 Trench 5, facing east, showing concrete surfaces (photo 123)

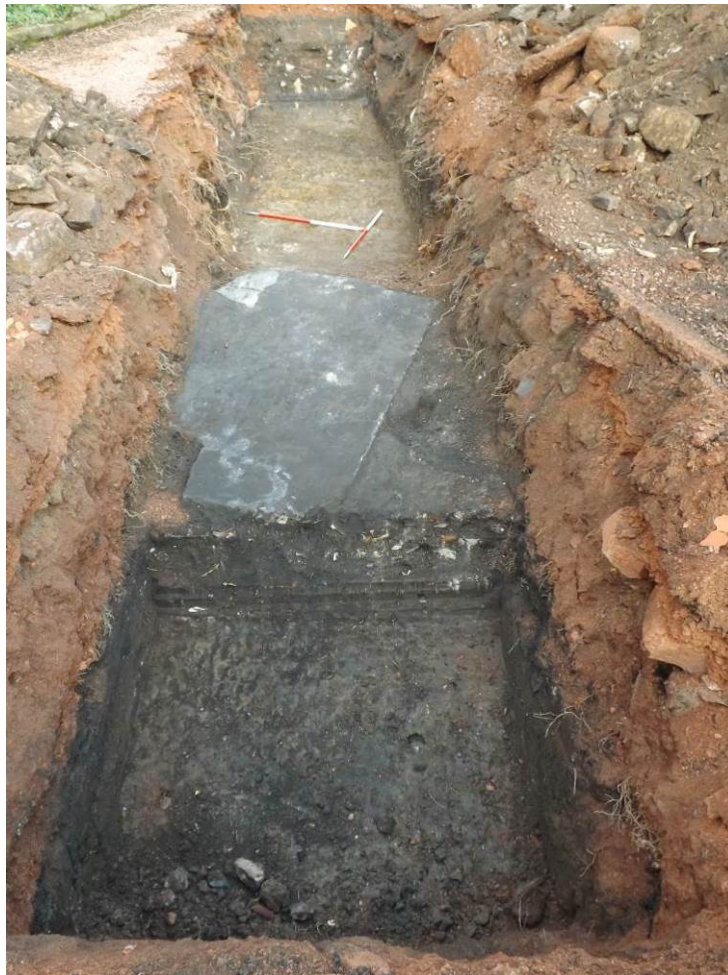
Plate 14 Trench 6 post-ex, north-east facing (photo 135)

Once the modern car park gravel surface layer (601) (*OD*+74.57 south-west to +74.92 north-east) was removed, it was shown to overlie the same loose orange blaze levelling deposit (602) that had been seen previously in Trench 5. This loose blaze deposit reached a maximum depth of 0.60m below the car park surface, and was present trench-wide. Within the north-east end of the trench, underlying the orange blaze, a 0.50m deep deposit of Victorian / Georgian garden soils of mid-dark brown humic clay of moderate compaction (603) overlay the natural subsoil at a maximum depth of 1.10m (*OD*+73.55 to +73.47).

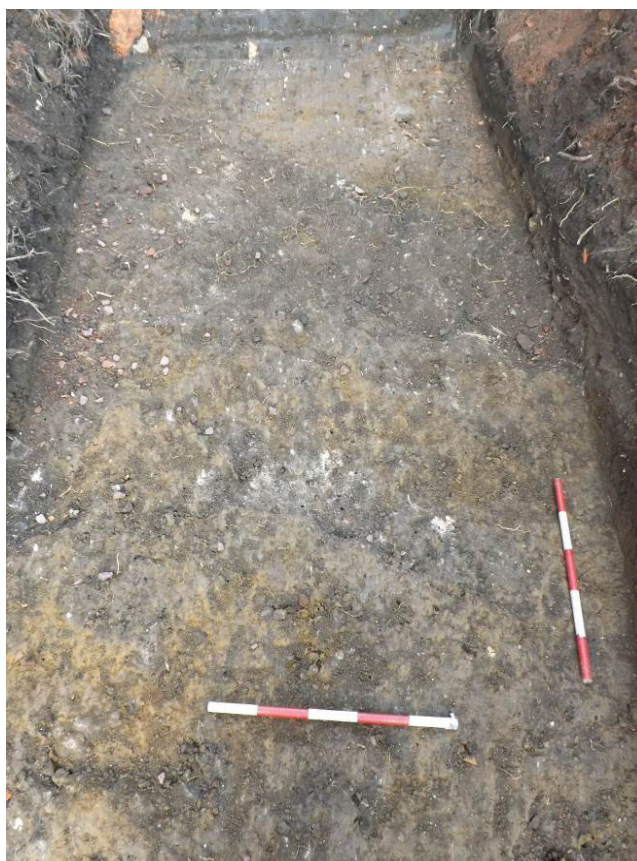
Plate 15 Trench 6, pre-ex of features [610, 613, 615, 617], north-east end (photo 145)

Excavations in the north-east end of Trench 6 revealed a grouping of earlier features cut into the firm and dry clay subsoil (**Plate 15**). The group consisted of a long linear feature orientated north-south at the north-eastern end of the trench, flanked by fairly ephemeral possible ploughmarks to the west, and a trio of smaller subcircular and rectangular features along the south-eastern facing section of the trench.

The long, linear feature [610], was aligned north-south, and continued beyond the limit of excavation in both directions. Centred on NT 26015 72795, the feature had a uniform width of 0.65m, and a depth of 0.20m (OD+73.42). Linear feature [610] cut into natural, and had vertical sides with a flat base. Two distinct fills were noted within the cut: the bottom fill (612) was a loose dry white sand with a depth of less than 0.10m, while the top fill consisted of firmly packed angular stone less than 0.20m in size within a dark sandy soil matrix. The nature of the fill within [610] indicates that the feature is unlikely to be intended for drainage or horticulture. It remains a possibility that this feature may be a foundation trench for an earlier, previously unknown structure.

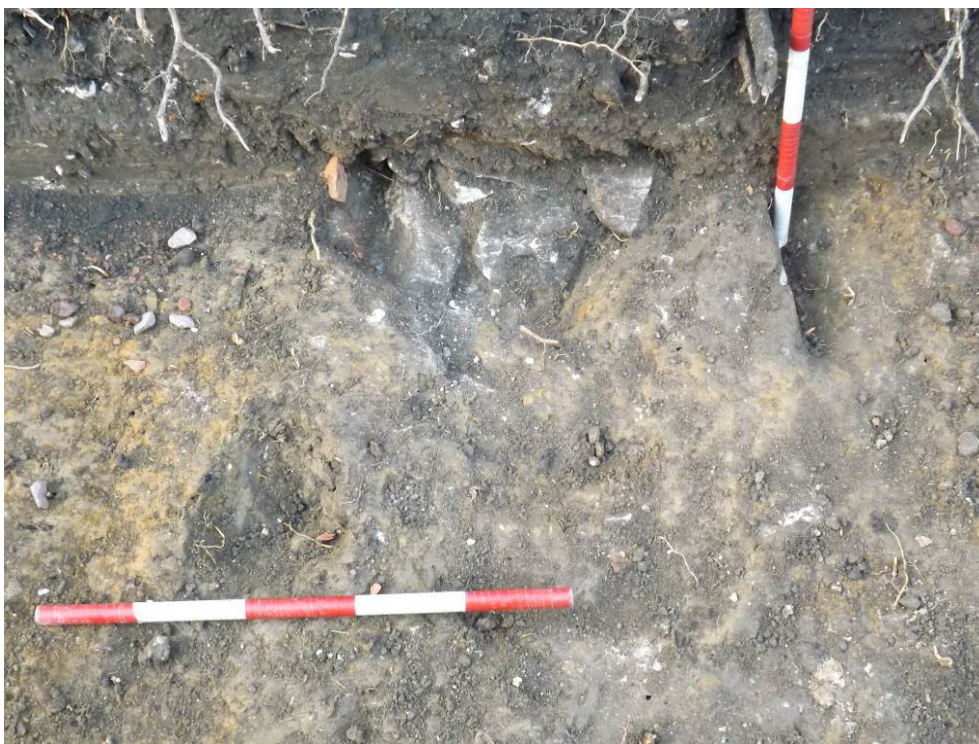
Immediately adjacent to feature [613] to the west, and protruding from the trench section was a square/subrectangular feature [615] cut into the natural subsoil. This feature was only partially located within the excavation area, and as a result could not be investigated fully. Centred on NT 26015 72791, feature [615] had an approximate length of 0.30m along its side (**Plate 16**, upper centre). The feature was tightly packed with small-medium angular stone less than 0.20m in length, with a medium firm light brown sandy clay matrix. As the feature could not be bottomed, it remains unclear as to its function, however, its proximity to the other features suggests a possible association.

Plate 16 Trench 6, post-ex of features [613, 615, 617], facing north-west (photo 154)

Located to the south-west of feature [615], subcircular feature [617] was a small, single fill pit with an overall diameter of 0.15m and a total depth of 0.07m cutting into natural. Centred on NT 26014 72793, the pit contained a single fill of compact, mid brown clayrich soil with frequent charcoal flecks. A single find of a faunal leg bone fragment was recorded (SF015). Feature [617] is likely the surviving base of a truncated pit predating the earliest garden deposits in Trench 6.

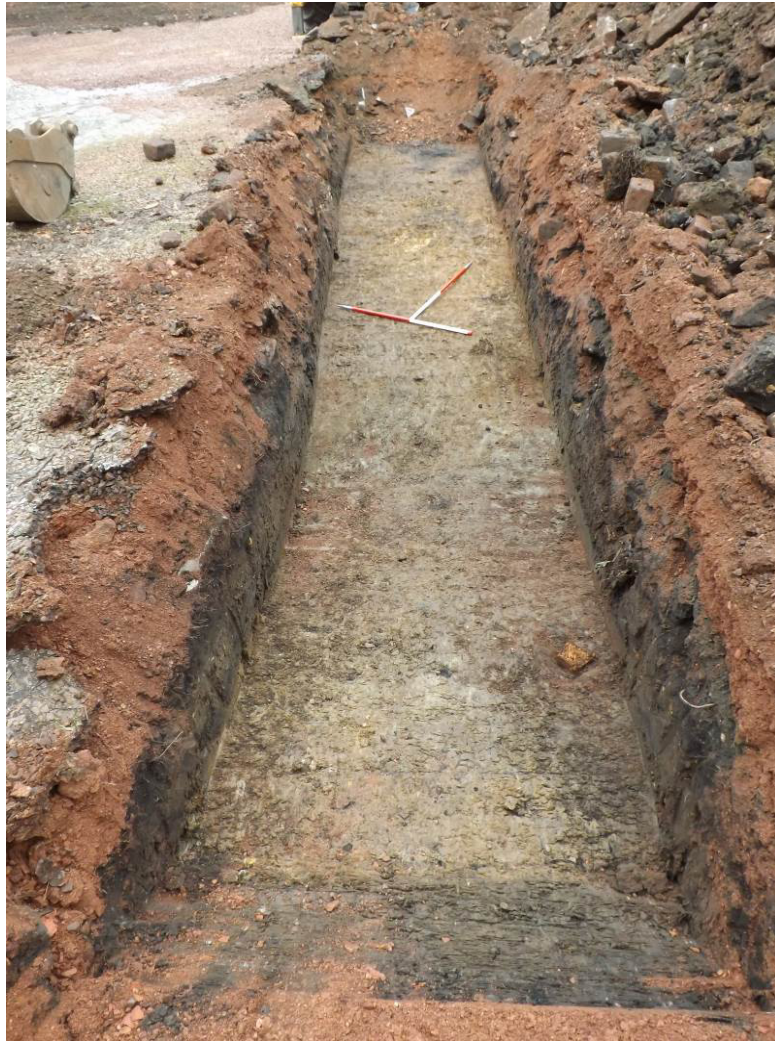
Plate 17 Trench 7 post-ex, north-west facing (photo 155)

The natural clay subsoil was encountered at the north-west end of the trench at depth of 0.95m (OD+73.75) below the car park surface, and was found to slope towards the south-east, where it became a blueish-grey silty clay encountered at a depth of 1.2m (OD+73.50) below the modern surface (**Plate 17**).

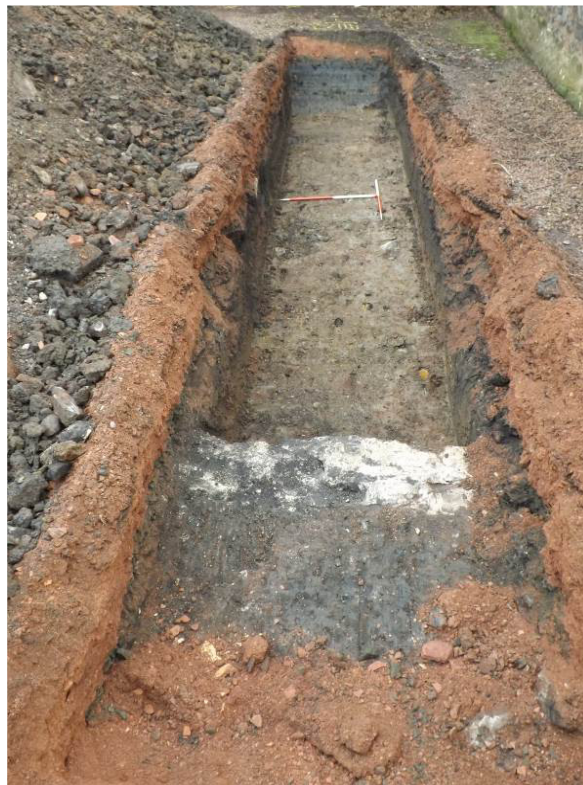
Plate 19 Trench 8 post-ex, east facing (photo 177)

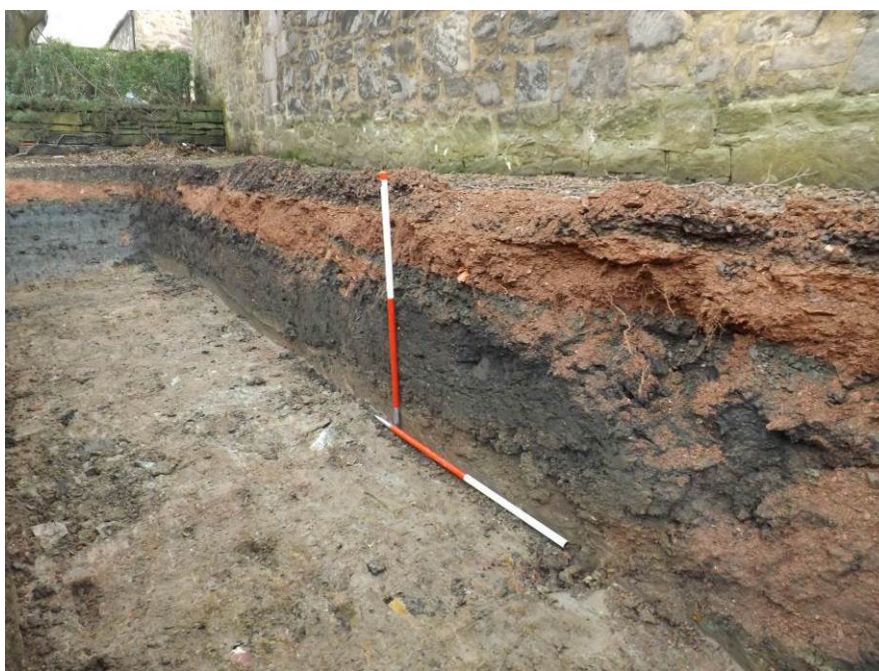
Underlying the modern gravel car park surface (801) (*OD+74.70 west end, +74.62 east end*) was a levelling deposit of loose orange blaze (802) of approximately 0.30m in thickness, bedded by a silty gravel deposit (804) less than 0.10m thick. At a depth of 0.40m below the car park surface, an artefact-rich, midden-like deposit of dark brown humic soil (805) was uncovered, appearing trench-wide to a thickness of 0.10m. Directly underlying (805), was a lower horizon of garden soil consisting of a 0.50m thick deposit of mid-brown silty clay containing frequent flecks of charcoal and instances of burnt bone. Finds from (806) included tin-glazed ceramic, clay pipe, shell, glass, and bone. The natural clay subsoil was encountered at a depth of 1.0m below the surface of the car park (*OD+73.70 west end, +73.62 east end*), and was noted to slope downwards towards the north.

Plate 20 Trench 8 post-ex, north facing section (photo 182)
