Buccleuch Place and Meadow Lane

Archaeological Evaluation and Building Recording

The University of Edinburgh

December 2015

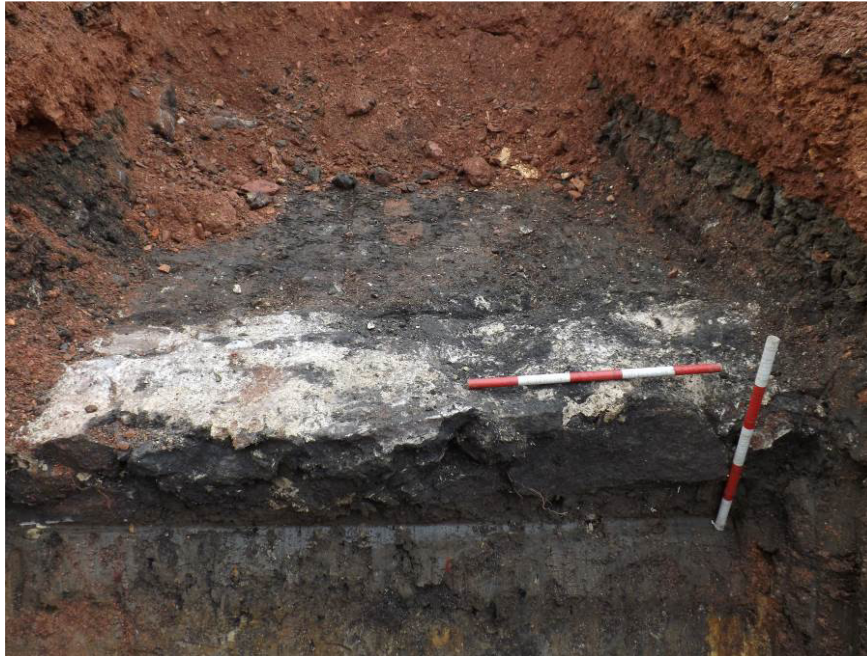
In the western end of the trench, the base of a north-south orientated mortared stone wall was uncovered. The wall had previously been removed, leaving only the base standing to a height of 0.25m, and a thickness of approximately 0.50m. The wall base (808) overlies the lower garden soil horizon (806), is abutted by (806) to the east, and by the upper garden soil horizon (805) to the west. This wall base represents the surviving portion of the western wall of the pathway running along the western end of the coach house, leading from Meadow Lane to the south up to the rear of the houses fronting on to Buccleuch Place to the north.

Plate 21 Trench 8, Wall [808], east facing elevation (photo 184)

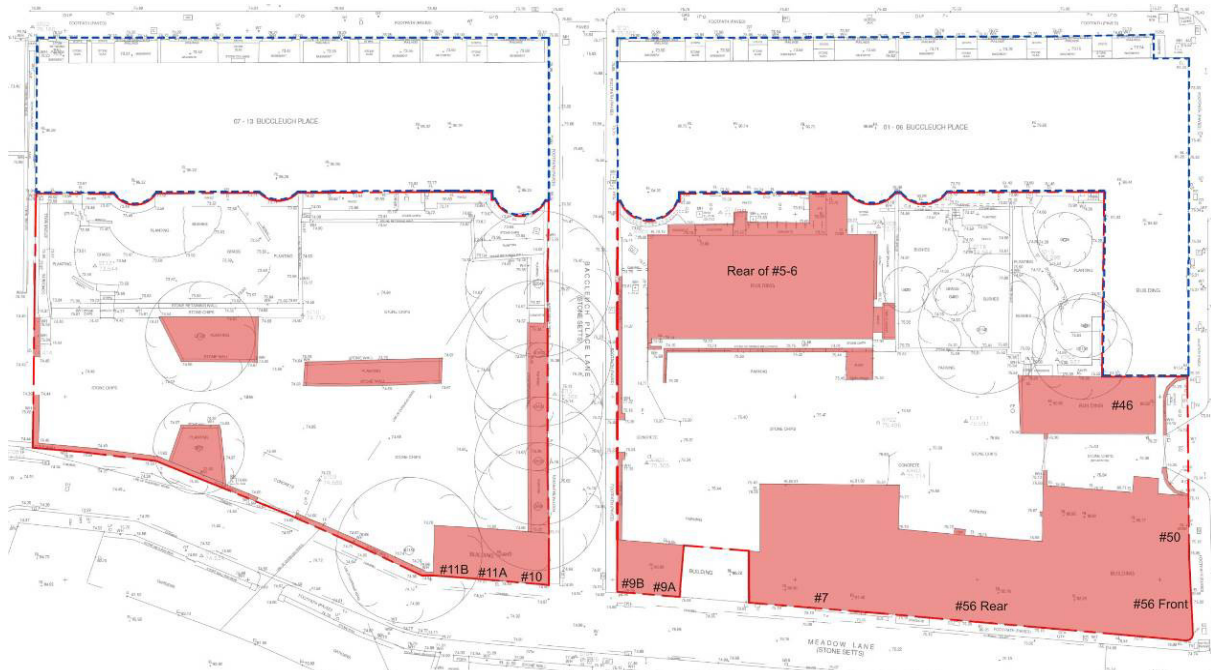
As required by the proposed development scheme, a number of structures and historic walls along Meadow Lane and at the corner of Buccleuch Street and Meadow Lane are scheduled for demolition. The demolition of these structures has necessitated the implementation of a program of building recording that involves a full photographic record and measured hand drawn record of significant features within the affected area. A depiction of the affected structures is illustrated in **Figure 8** below.

Figure 8 Buildings and features scheduled for demolition (in red). (Addyman Archaeology after Turley)

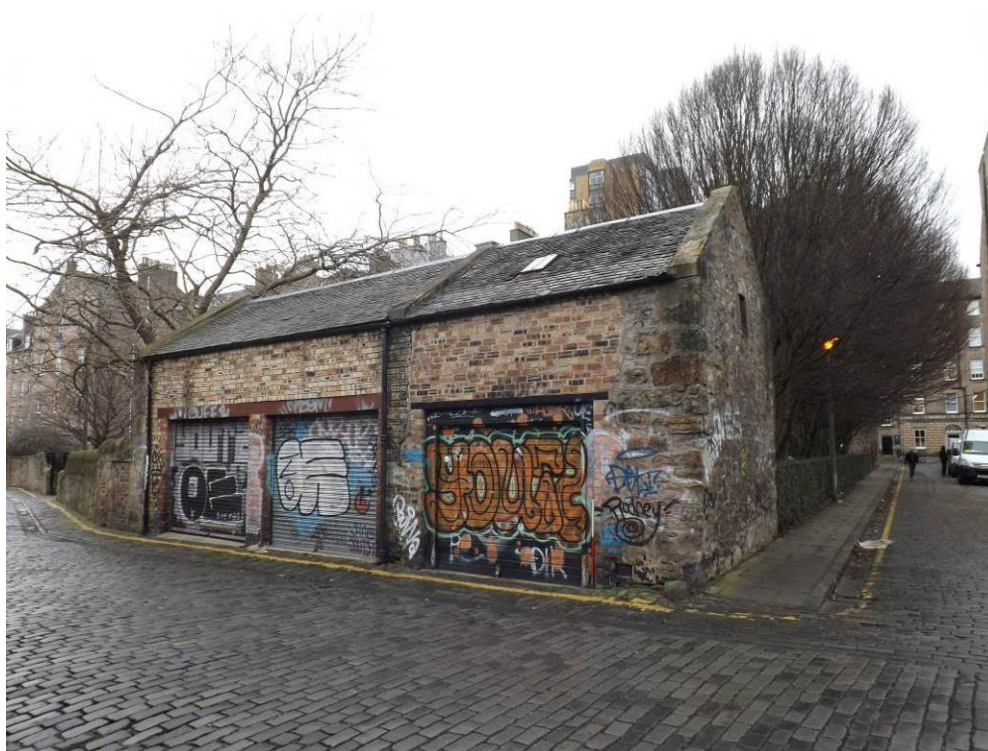
Plate 22 Western coach house, Nos.10-11B Meadow Lane, front (photo 524)

The earliest depiction of the coach house on the north-west corner of Meadow lane and Buccleuch Place lane can be found on Ainslie's 1804 map 'Old and New Town of Edinburgh with the proposed docks' (see **Figure 4**). Ainslie's map shows the structure situated in the south-east corner of the linear garden plot to the rear of #7 Buccleuch Place, and identifies this as the first structure to have been built to the rear of the tenements fronting Buccleuch Place, predating the adjacent coach house east of Buccleuch Place Lane. Shown fully built by 1804, it is possible that the construction of the coach house dates to the late 18th century, coinciding with the construction of the tenements along Buccleuch Place in the 1780's and 1790's.

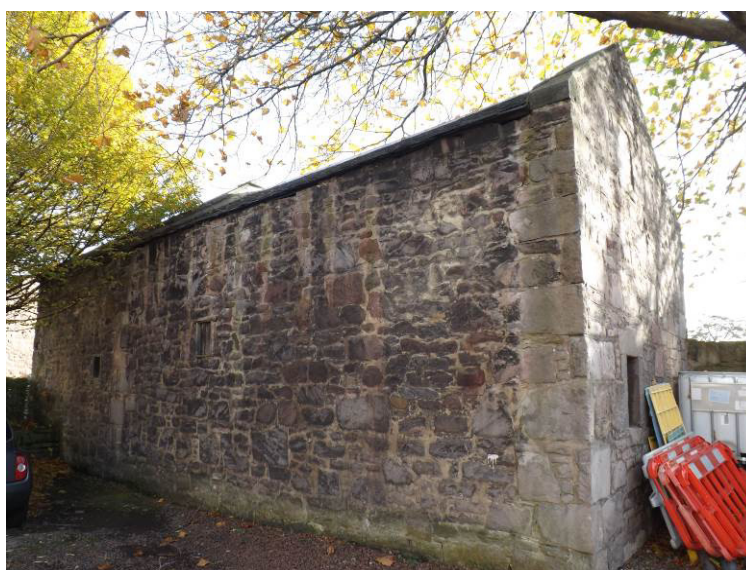
Plate 23 Western coach house, Nos.10-11B Meadow Lane, rear (Addyman Archaeology)

The majority of the coach house fabric (Nos.11A, 11B) is of a single phase, with the eastern portion (No.10) having been built slightly later, perhaps though within the same building programme. The eastern portion of the coach house (No.10) has been added onto the complete structure of Nos.11A, and 11B, using the exterior of the eastern facing gable as an interior face. The south facing elevation has been altered drastically, with most of the original stone frontage having been removed and replaced with brick and steel in the mid to late 19th century (see **Figure 9** below).

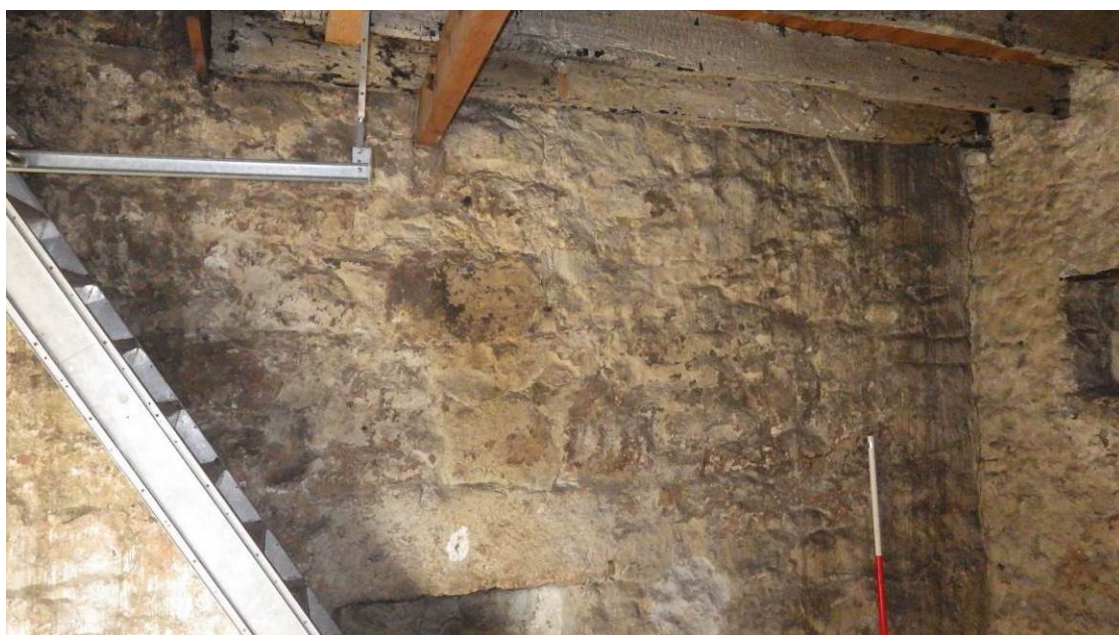
The interior of No.10 Meadow Lane shows minimal alterations, with many of the original coach house features still visible. The hearth and flue within the west wall have been inserted into the east gable of No.11A, most likely during the initial construction phase. The north wall window has been blocked, with two small vents inserted likely sometime during the 20th century. The upper storey contains a possibly original roof structure, with replaced floors over charred joists indicating a sizeable fire having occurred within (**Plate 24**).

Plate 24 Meadow Lane #10, interior, east facing elevation (Photo 945)

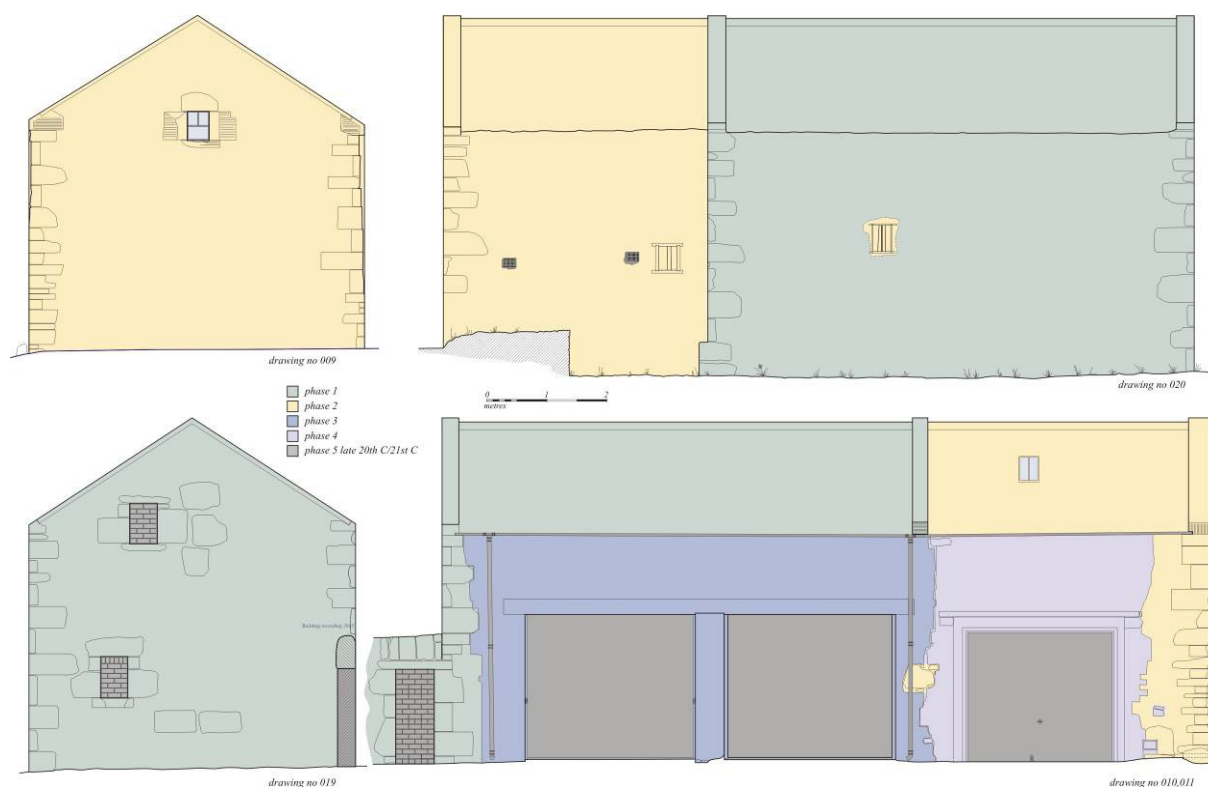
Figure 9 External elevations of coach house at Nos.10-11B Meadow Lane

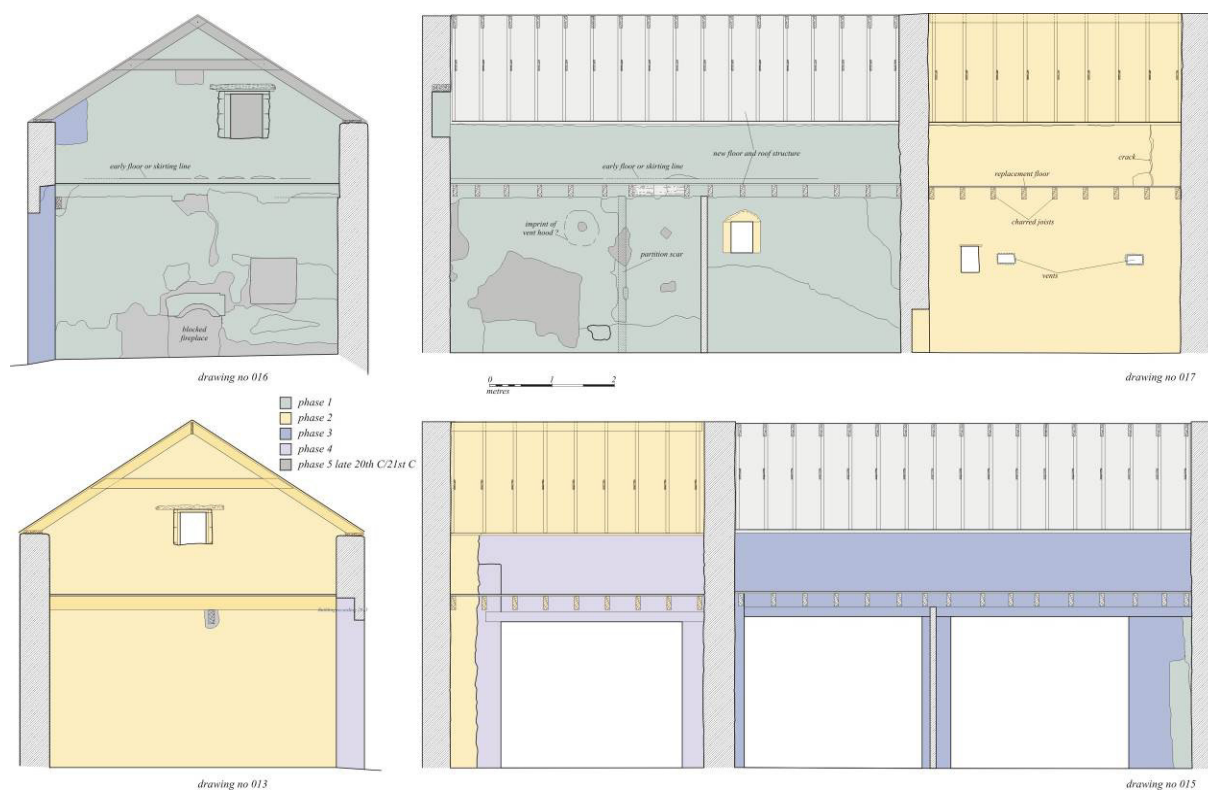
Figure 10 Internal elevations of coach house at Nos. 10-11B Meadow Lane

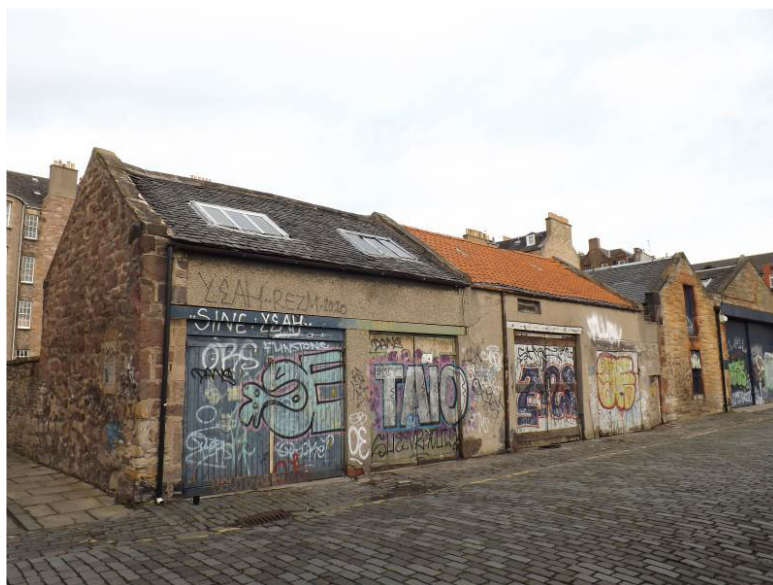
Plate 25 Meadow Lane Nos.9A,9B (Addyman Archaeology)

Numbers 9A and 9B Meadow Lane make up the western half of the coach house on the north-east corner of Buccleuch Place Lane and Meadow Lane. The eastern half of the coach house (red tile roof in *Plate 25* above) lies outwith the site boundary, and is not scheduled for demolition.

The coach house at No.9 Meadow Lane does not appear on Ainslie's 1804 map 'Old and New Town of Edinburgh...' (**Figure 4**), but is depicted on 'Kirkwood's Plan of the City of Edinburgh' by James Kirkwood and Sons, produced 17 years later. These maps would indicate that this coach house dates from the early 19th century, with construction taking place sometime between 1804 and 1821. Like Nos. 10 and 11 to the west, the south elevation appears to have been replaced, while skylights have also been inserted in the slate roof. Inside, the single open space has lately been divided into two bays by a cement block partition (**Plate 26, Plate 27**).

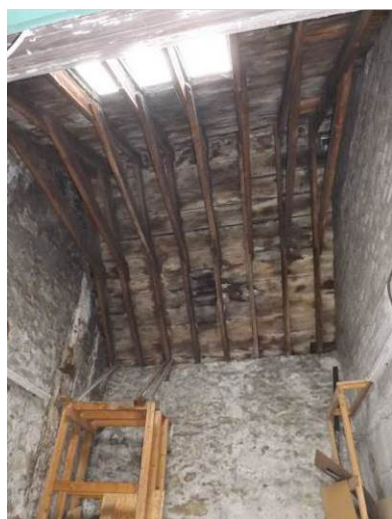
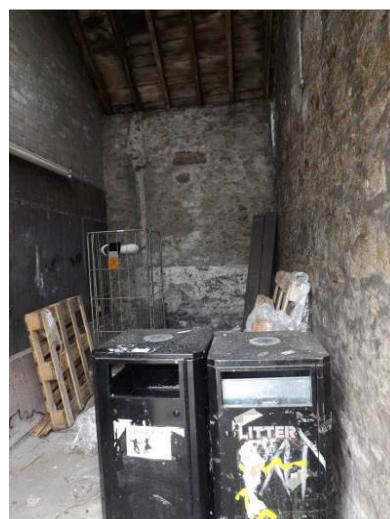
Plate 26 Meadow Lane No.9B, interior (Photo 792)

Plate 27 Meadow Lane No.9A, interior (Photo 805)

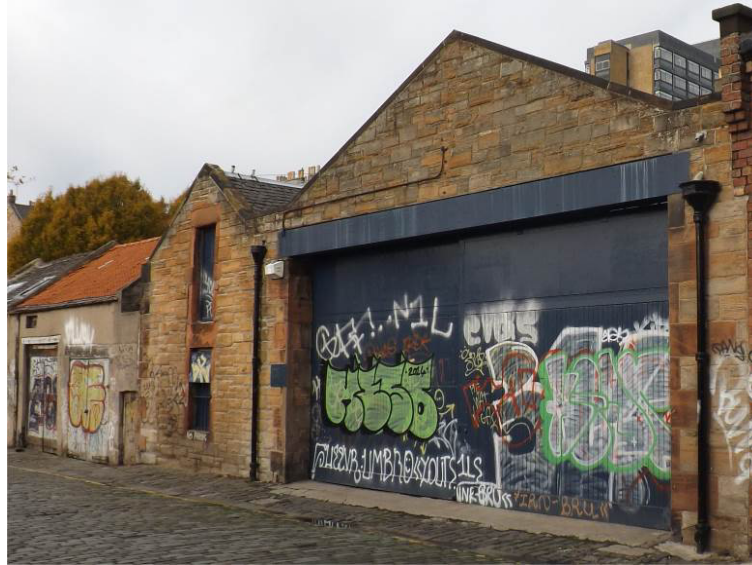
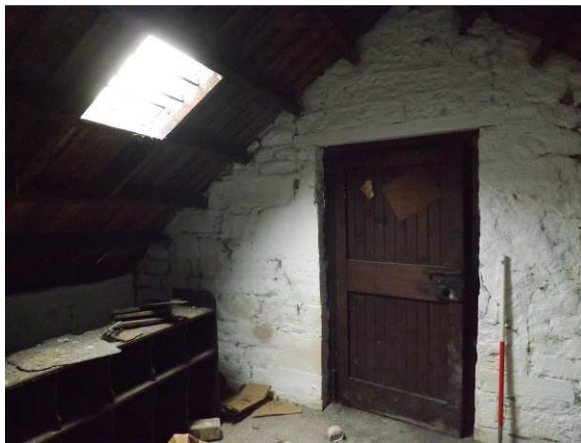
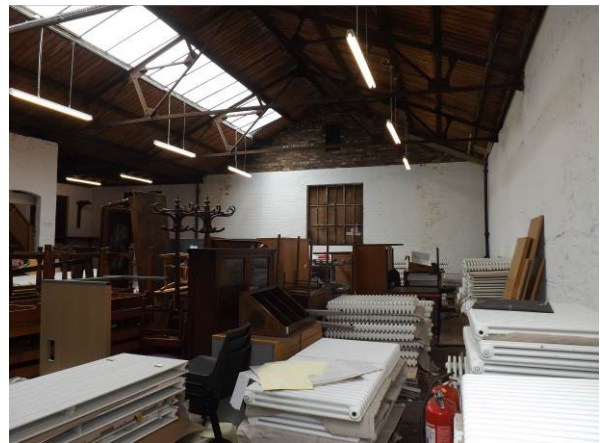
Plate 28 No.7 Meadow Lane (Addyman Archaeology)

The structure at No.7 Meadow Lane is first shown on the Ordnance Survey 2nd edition, surveyed in 1905 (**Figure 6**). Prior to this, the land was occupied by a coach house as depicted on the OS 1st edition of 1852 (**Figure 5**), and 'Kirkwood's plan of the City of Edinburgh' of 1821. The structure dates to the late 19th, early 20th century, with a later extension to the rear, expanding the building northward. The primary function of the building is as a warehouse, with a later internal addition adding a storey in the south-west corner.

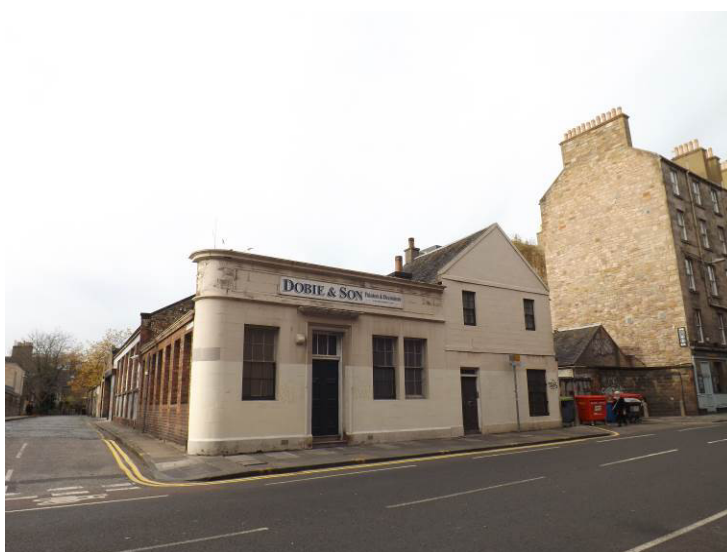
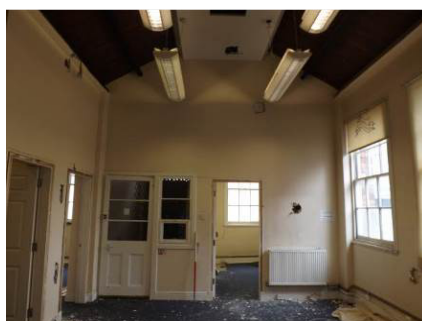
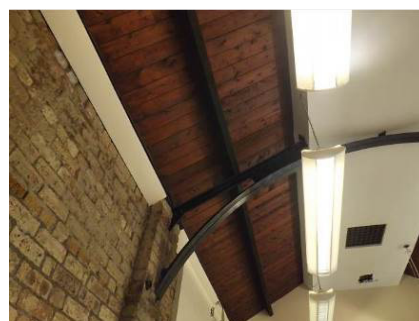
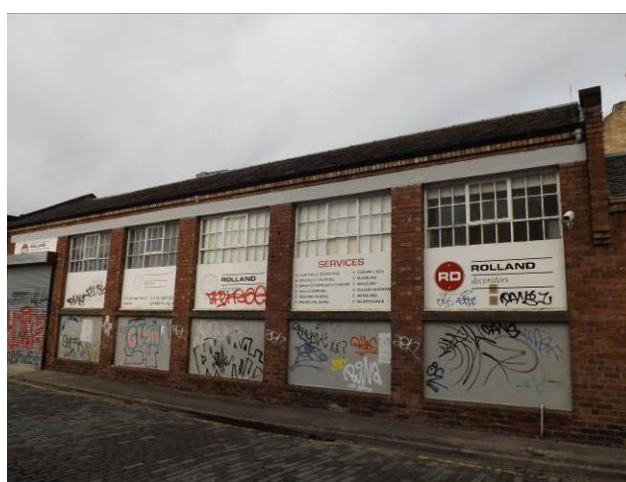
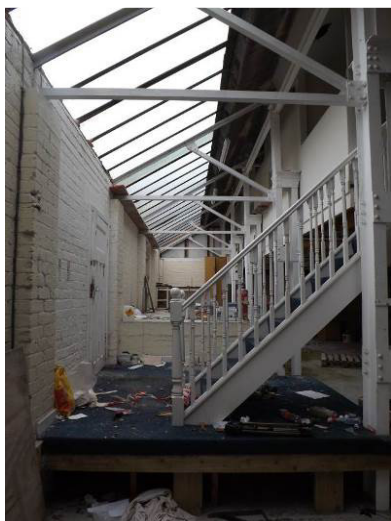
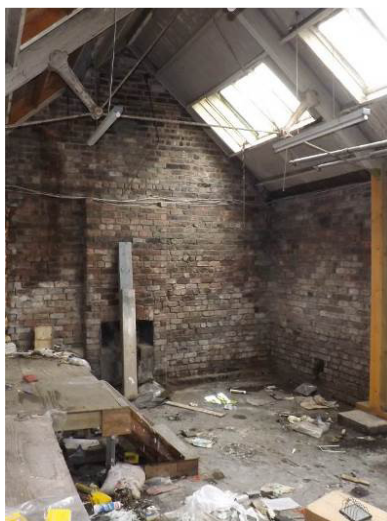
The structures at No.56 Buccleuch Street, Front (**Plate 31**, **Plate 32**, **Plate 33**), No.56 Buccleuch Street, Rear (**Plate 34**, **Plate 35**, **Plate 36**), No.50 Buccleuch Street (**Plate 37**, **Plate 38**, **Plate 39**), and at No.46 Buccleuch Street (**Plate 40**, **Plate 41**, **Plate 42**), have all existed in one form or another since the late 19th/ early 20th century, undergoing frequent alterations in the pre-war and interwar years, before settling in their current state near to or shortly after 1946. The structures have seen use in a variety of functions including: as warehouses, workshops, businesses, and classrooms. Many original fixtures remain, including: roof structures (**Plate 42**), hearths (**Plate 36**), and wallpaper (**Plate 39**), with more likely to be revealed once the 20th/21st century interiors have been stripped.

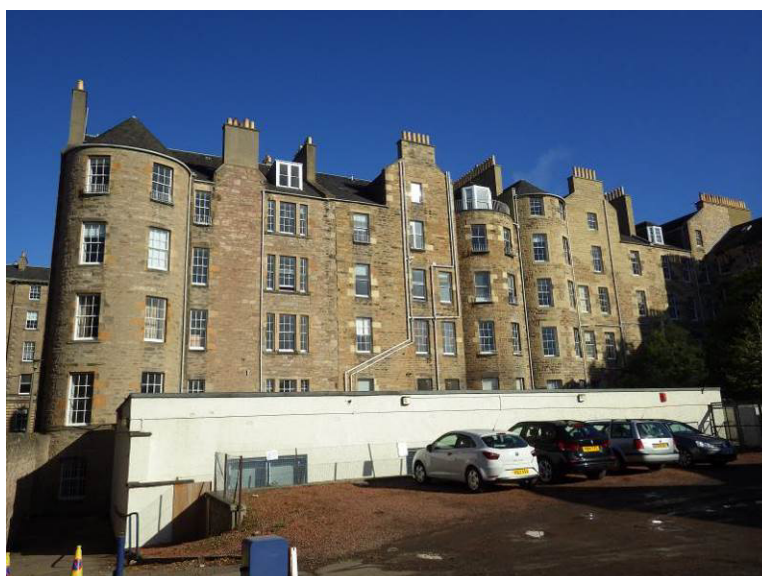
Plate 43 Building to the rear of No.5-6 Buccleuch Place, foreground (Photo 859)

The structure to the rear of No.5-6 Buccleuch Street is a single story, purpose-built University annex, dating to the latter half of the 20th, or early 21st century.
