Gladstone's Land, 483 Lawnmarket

Edinburgh

Historic building survey and analytical assessment

The National Trust for Scotland

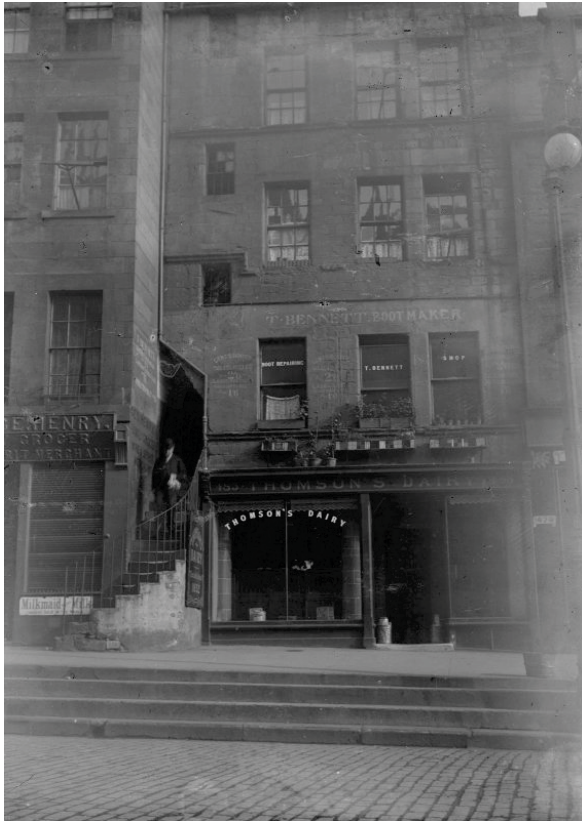
*Figure 6 Photograph of the front elevation c.1900, showing the dairy as Thomson's and T. Bennet Bootmaker on the first floor.
Canmore_image_SC01130811 digitised from ED6998*

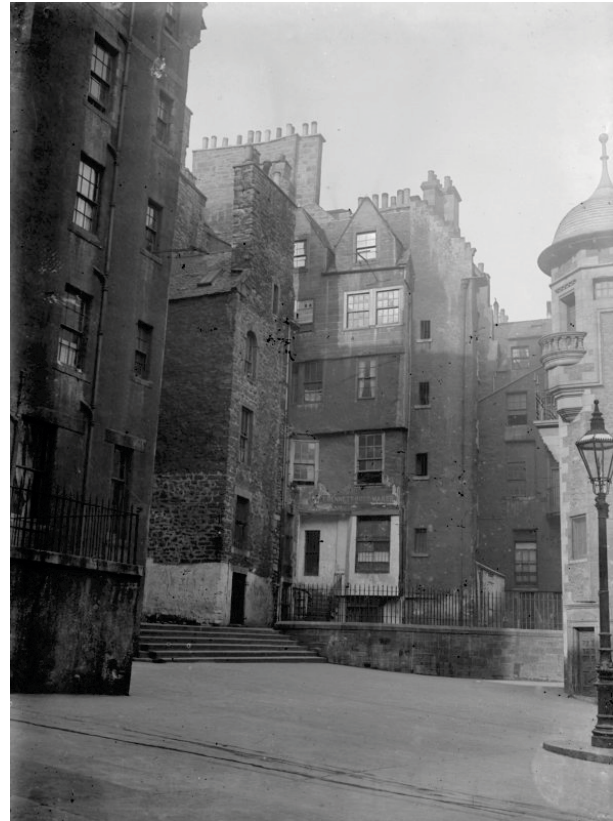
*Figure 7 Photograph of the rear elevation c.1900, looking west, showing another sign for T. Bennet Bootmaker above the white-washed area on the first floor. By this date the rear range
Canmore_image_SC01130812 digitised from ED6999*

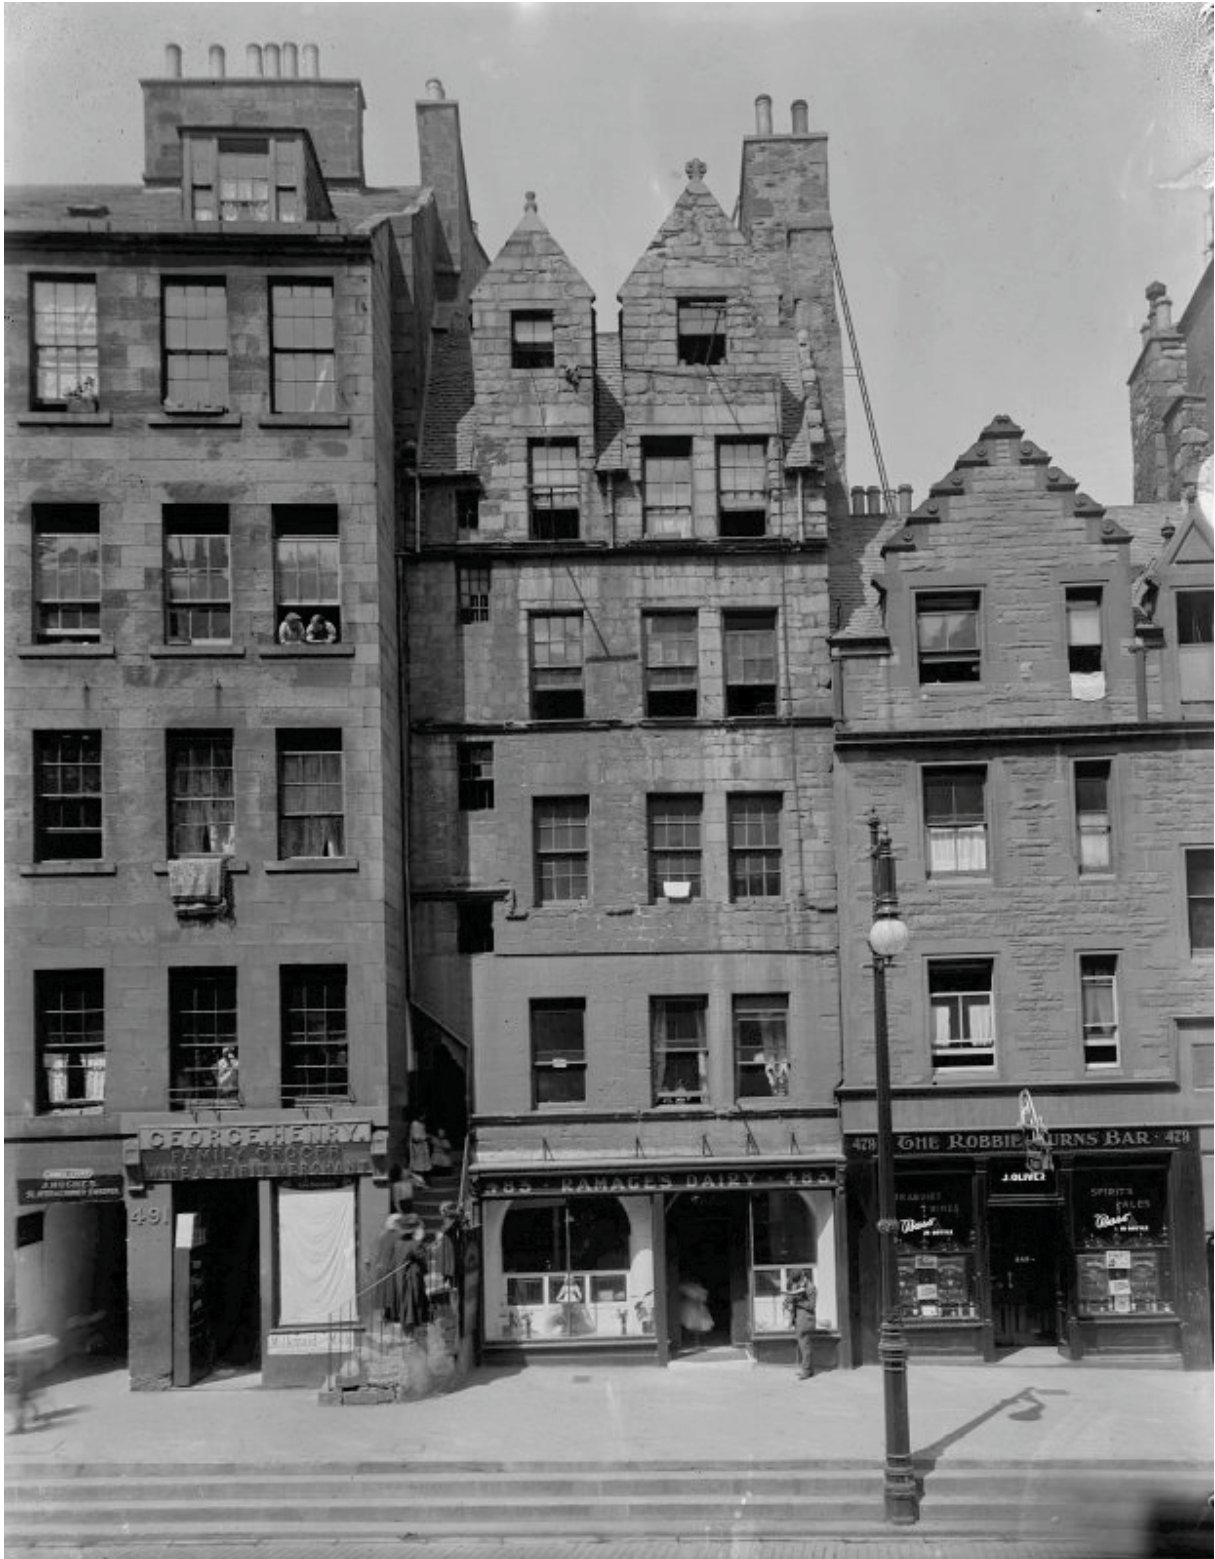
Figure 9 Photograph of the front elevation c.1910, showing that the roof ridge had been taken off. Ramages Dairy are shown on the ground floor. Canmore_image_SC01122221 digitised from ED6909

There are no further petitions before the 1936 application for the National Trust for Scotland. However, it is clear from several photos c.1900 that the E-W ridge on the front range of the building parallel to the street had been removed (Figure 9). The thackstane is visible on the W chimney and gives an idea of the ridge height, but the ridge is not visible between the dormers. Additionally, there is a ladder from the E chimney which must be secured to a flat roof. If it is assumed that the 1881 elevation is correct (see Figure 3), then the ridge was taken off between the 1880s and the 1910s.

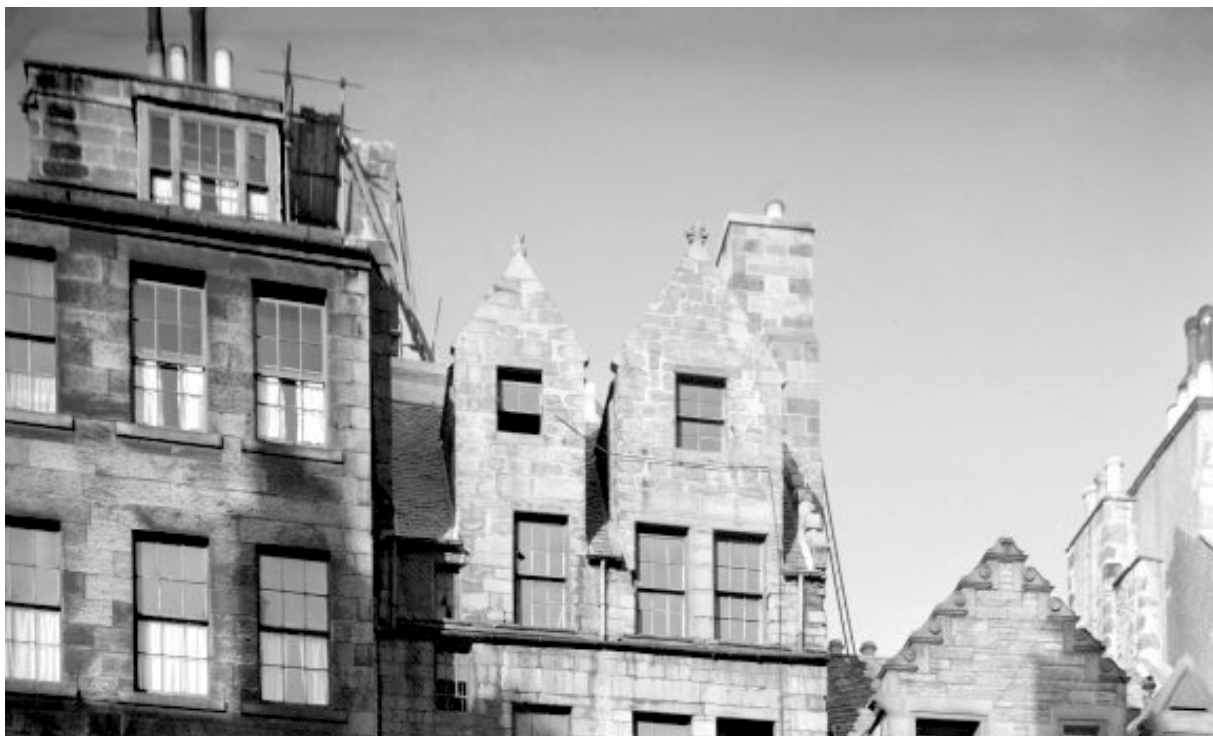
Figure 15 Detail of c.1935 photograph showing works to roof and common chimney (scaffolding platform to the left). The chimney E on the right, seems to have been completed. A hording seems to have been raised on the W end of the flat roof perhaps as edge-protection for works. Canmore_image_SC01164086 digitised from ED247

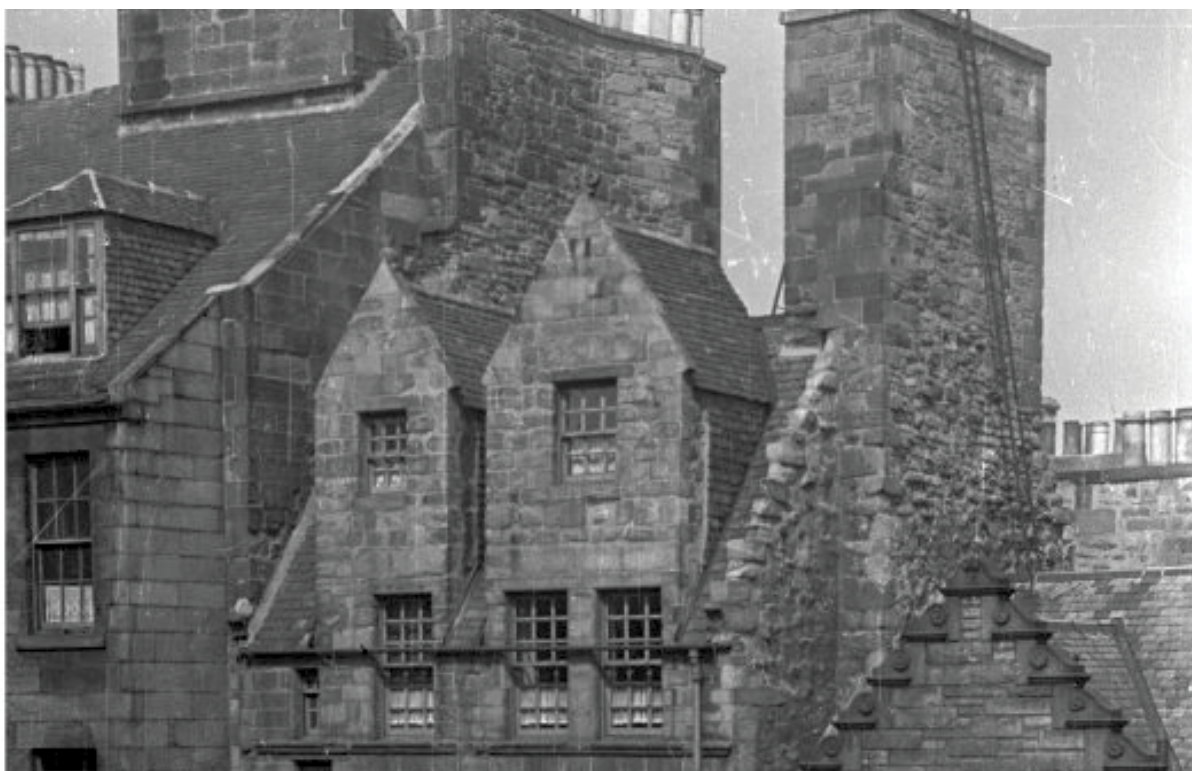
Figure 16 Detail of c.1940 photo showing the completed chimney works. The E crow-steps are in poor condition and must have been replaced subsequently. Canmore_image_SC00426588

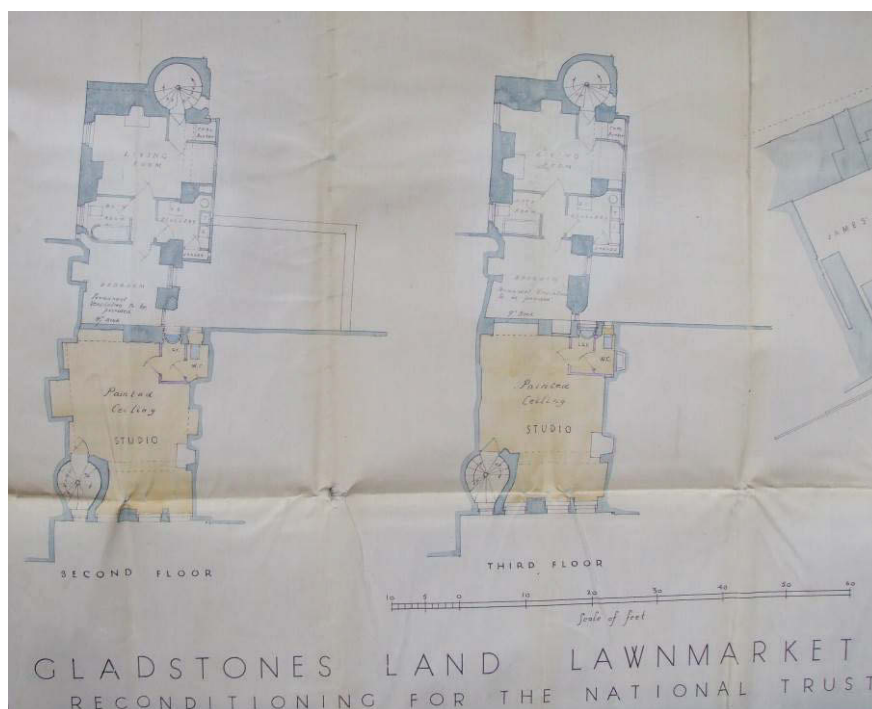
Figure 19 Plans showing plans for second and third floor, scheme warranted 3rd June 1938. It seems that the WCs on these floors were not installed. City of Edinburgh plan store

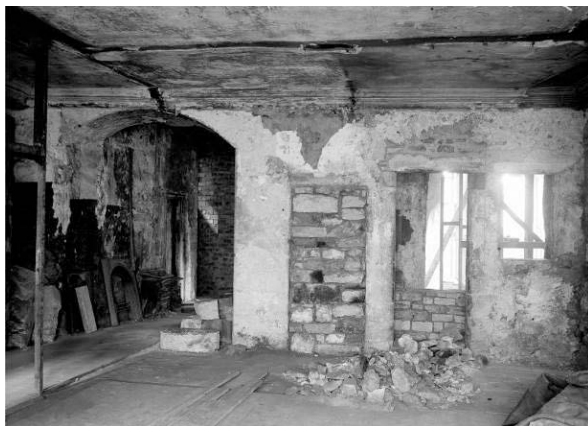
Figure 22 1938 photograph of second floor, looking N. This was taken early in the works, before the floors were lifted and the existing plaster ceiling removed, to reveal the painted timbers above. Compare to Figure 23. canmore_image_SC01164116 digitised from ED249

There are a large number of photographs dated by the RCAHMS to 1938, generally showing the interiors stripped back to structural stone and timber (Figure 22 to Figure 25). A large number of the original prints are pasted onto the pages of a brown bound folder in Historic Scotland's Conservation Centre files (XHCC_O_1272_SP (SCC/SC/42)). The NTS does not seem to have any of these images, and the largest number of photos is with the RCAHMS.

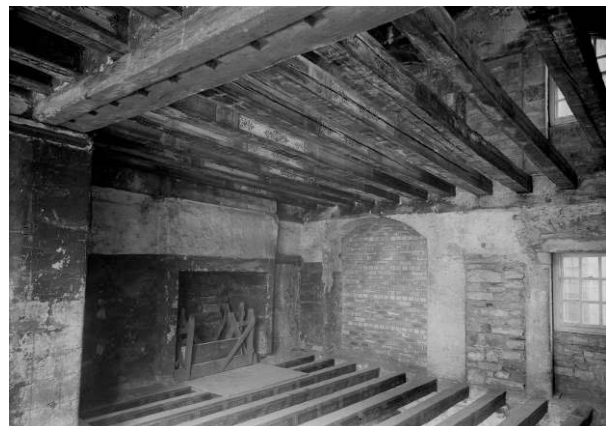
Figure 23 1938 photograph of second floor, looking NW. Both the first and third floor rooms are visible between the floor joists. Compare to Figure 22. canmore_image_SC01114335 digitised from A52477

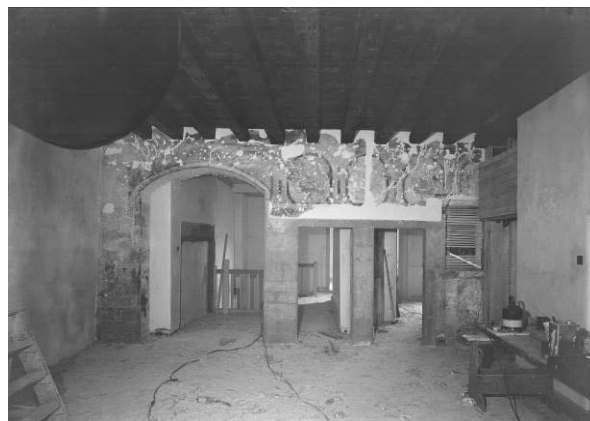
Figure 25 1938 photograph of first floor looking N. This must have been taken at an advanced stage of the works, as the ceiling has returned and the walls are plastered. The balustrade of the inserted staircase can be seen on the left. canmore_image_SC01114324 digitised from A52468

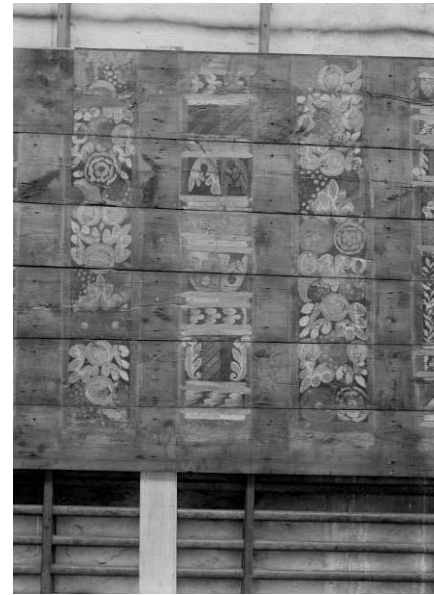
Figure 27 Undated photograph c.1941 of painted boards of ceiling on second floor (the southern part next to the windows) after cleaning but before waxing. canmore_image_SC01114323 digitised from A52467

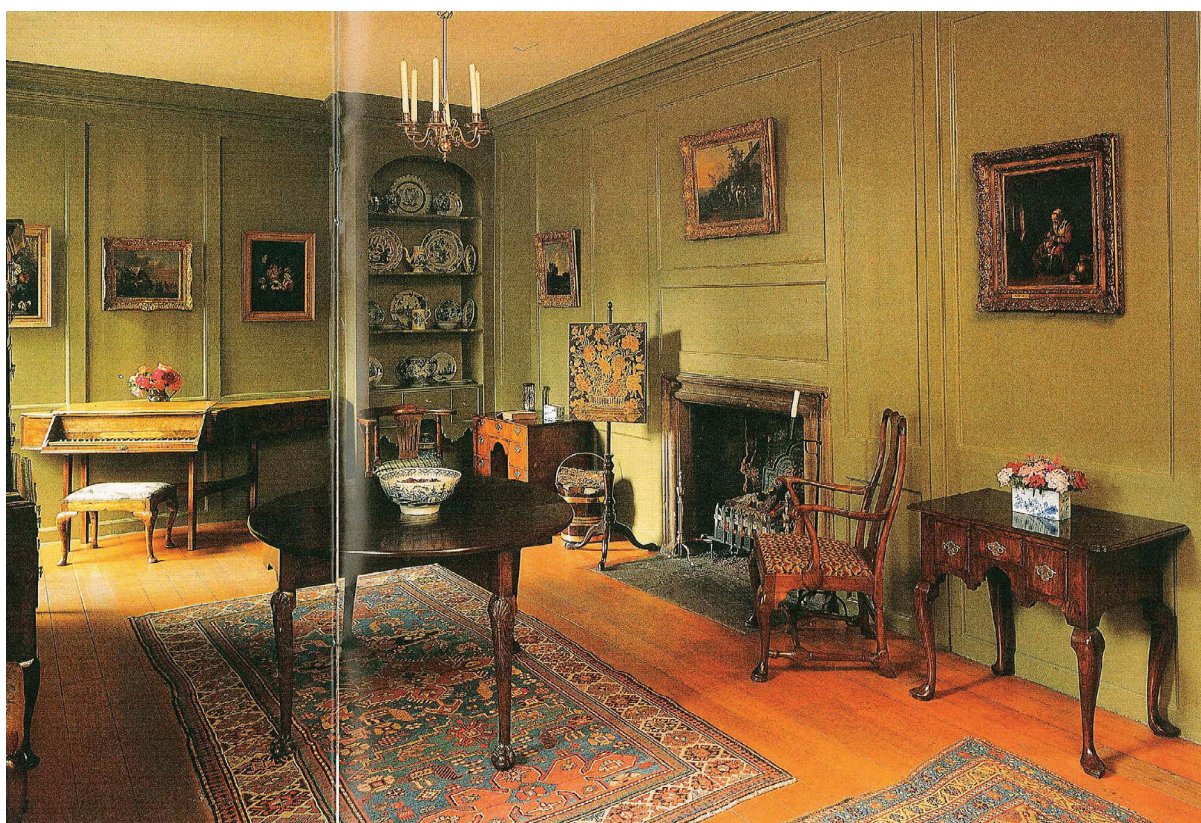
Figure 34 Photo of panelled room looking SE, c.2000. From Hartley 2000, pp.18-19

Various interiors and the exterior of the building was repaired and re-painted. It is clear that the cement harling and timber outshot on the rear elevations dates from this period. Internally, the paneled room was repainted from its existing white (Figure 34). According to the Hartley guidebook, there were fourteen layers of paint on the walls, and the present green was 'one of the earlier colours' (2000, p.18). It goes on

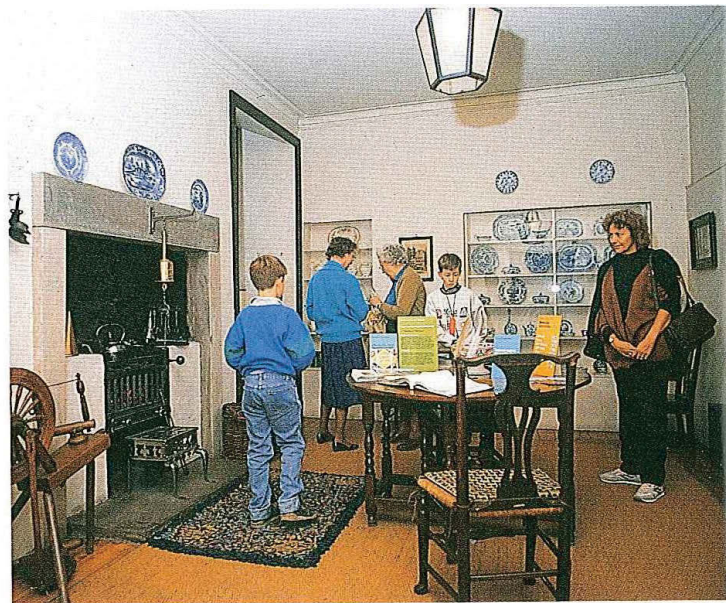
Figure 42 Photo of ground floor room (shop/bar parlour) with the purchased fire grate, c.2000. From Hartley 2000, p.20

There is correspondence and annotations on drawings in the NTS archives between Hartley and the project architect, Bob Heath, discussing details of many of the recreated elements (Figure 39 and Figure 40). In particular, drawings by Heath show two schemes for the grate in the former bar parlour on the ground floor of the E wing. According to Hartley, this grate was purchased (Figure 42).

After the photos in the Hartley 2000 guidebook (see Figure 42), the former bar parlour was changed in appearance to give the character of a 1950s bar. It was repainted in drab colours to resemble tobacco-stained paint work and dressed with furniture and props.

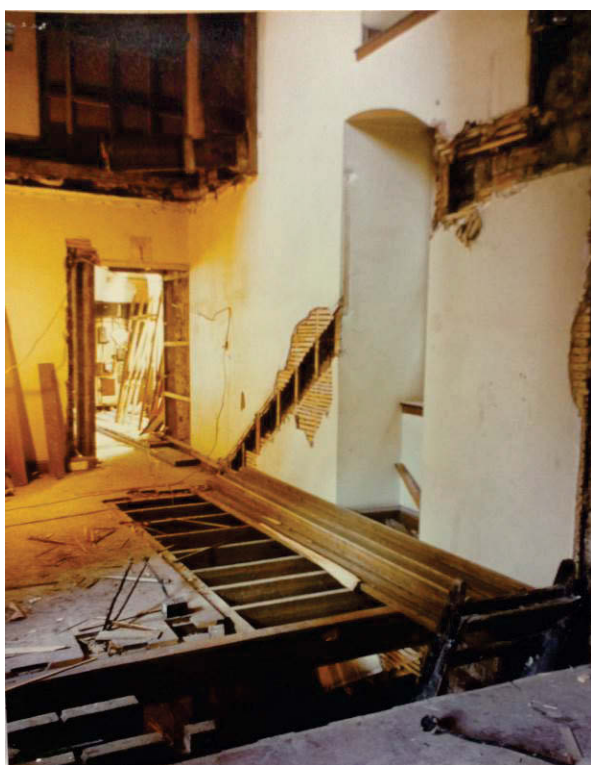
Figure 43 Photo of c.1979, looking SW on ground floor (Addyman plan number room 14), showing the W wall after the late 1930s stair was removed. NTS archives P/01/053

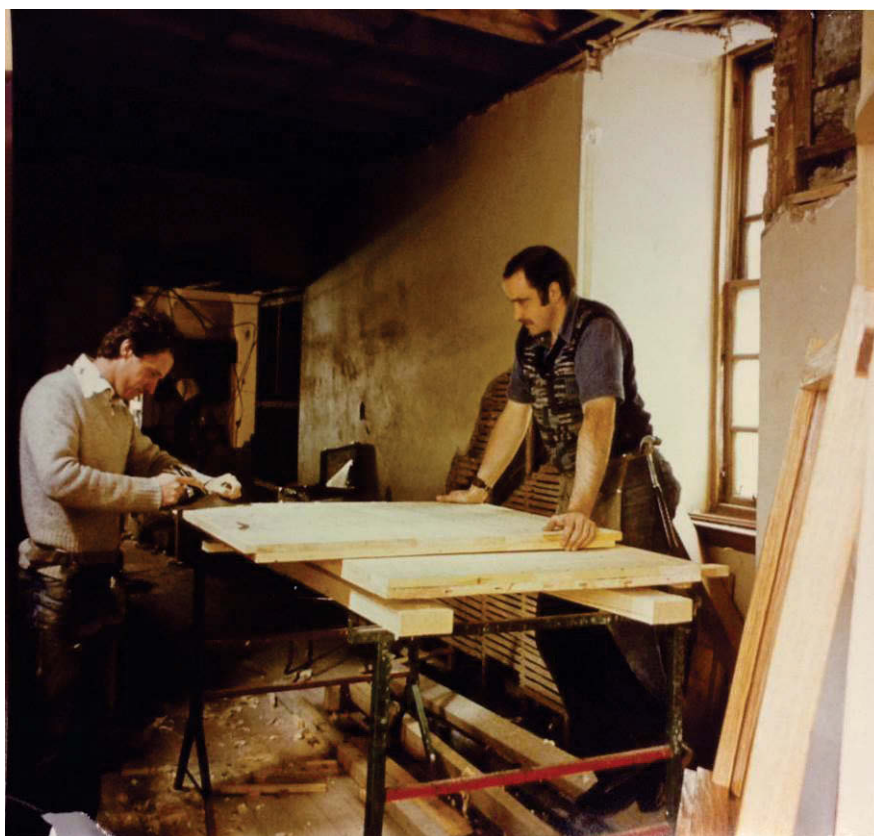
Figure 45 Photo of c.1979, looking SW on ground floor (Addyman plan number room 14), subsequent to Figure 43. It shows the W wall after first floor was replaced. NTS archives P/01/053

Figure 45 Photo of c.1979, looking SW on ground floor (Addyman plan number room 14), subsequent to Figure 43. It shows the W wall after first floor was replaced. NTS archives P/01/053

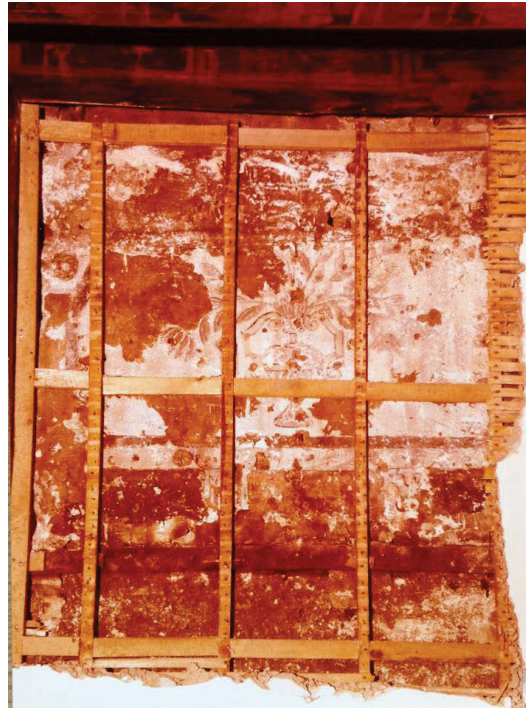
Figure 46 Photo of September 1979, of E wall on first floor showing the frieze uncovered behind the 1930s lath and plaster. HS Conservation Centre Y573-2

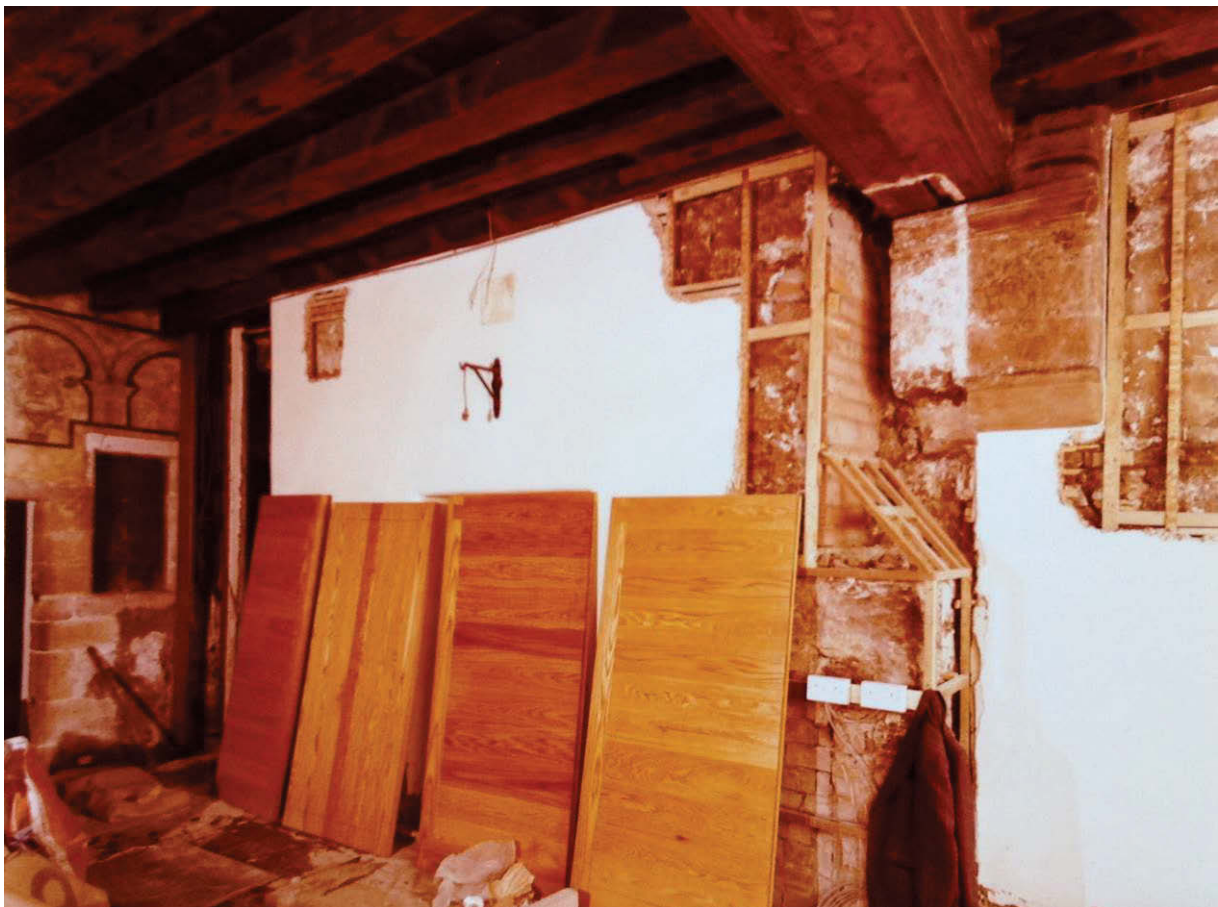
Figure 47 Photo of September 1979, of E wall on first floor showing the chimneybreast being discovered. The area of wall in Figure 46 can be seen top right. There is a test area for the frieze opened up on the upper left of the chimneybreast. HS Conservation Centre Y571-7

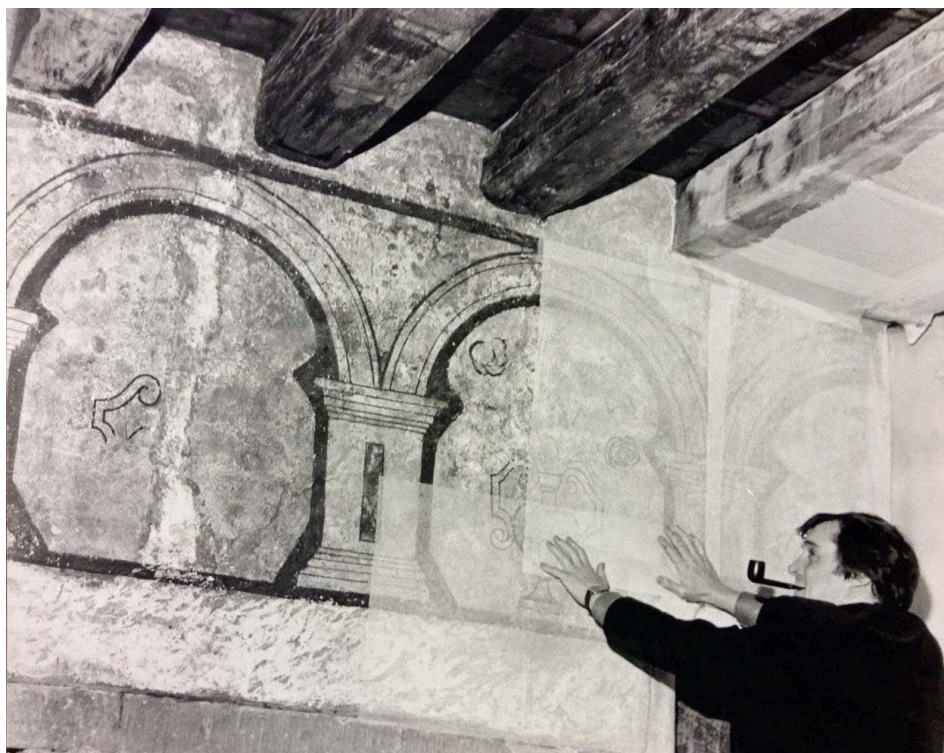
Figure 48 Photo showing frieze on N wall of first-floor front room, E end. Rab Snowden himself is shown at work during restoration in 1980. NTS archives P/01/053

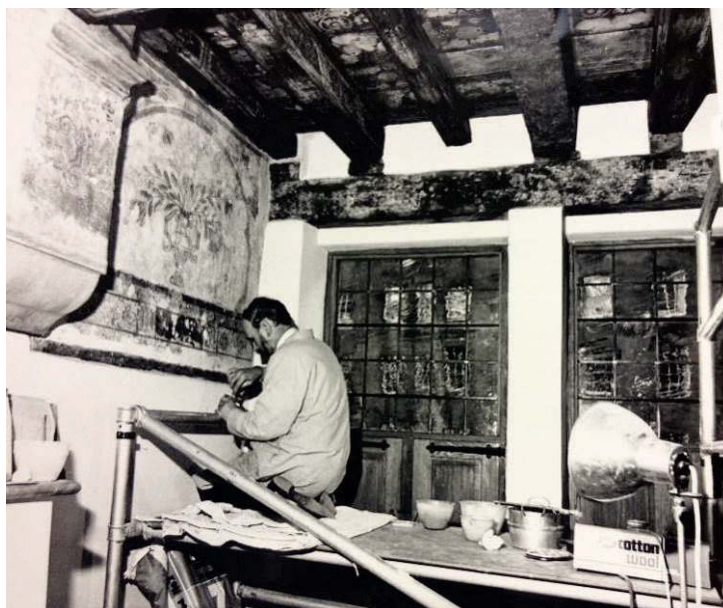
Figure 50 Photo showing frieze on E wall of first-floor front room, looking S. NTS archives P/01/053

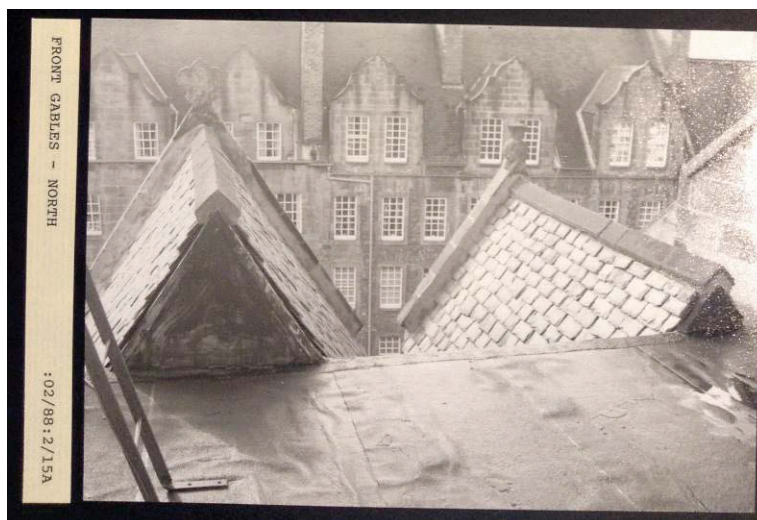
Figure 52 Photo looking S, showing the flat area of roof. From the 1988 Quinquennial inspection report, Heath Architect & Stone Consultant. RCAHMS MS 503/14

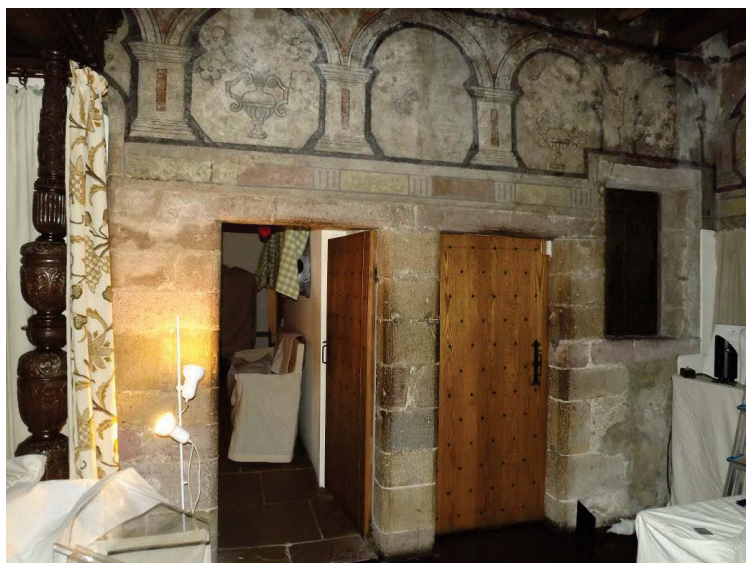
Plate 2. Relict openings of the frontage of the early range as seen at first floor level, looking north; the broad arched opening to the oriel is behind the bed to the left

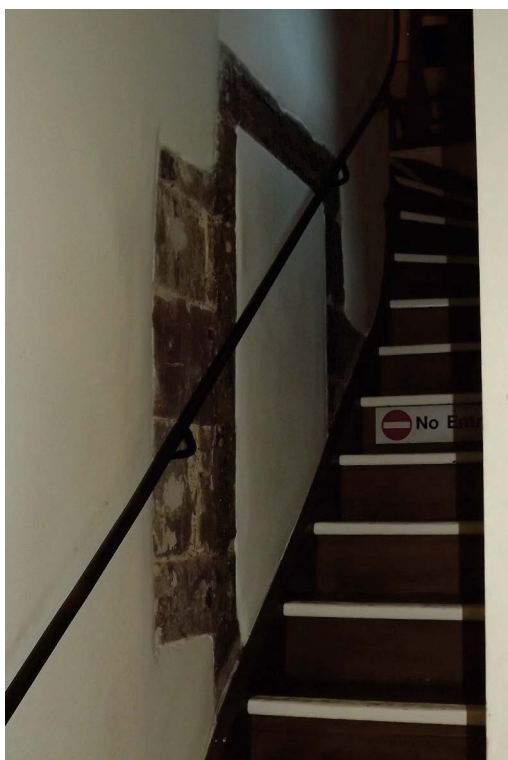
Plate 5 former window in the east wall of the rear range at ground floor level,

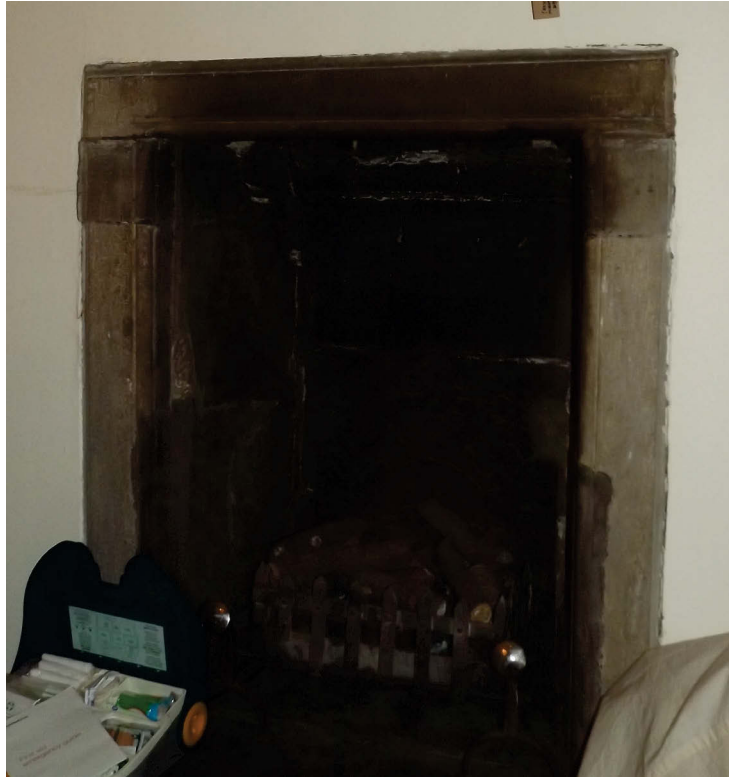
Plate 6 First floor room, west wall – early fireplace

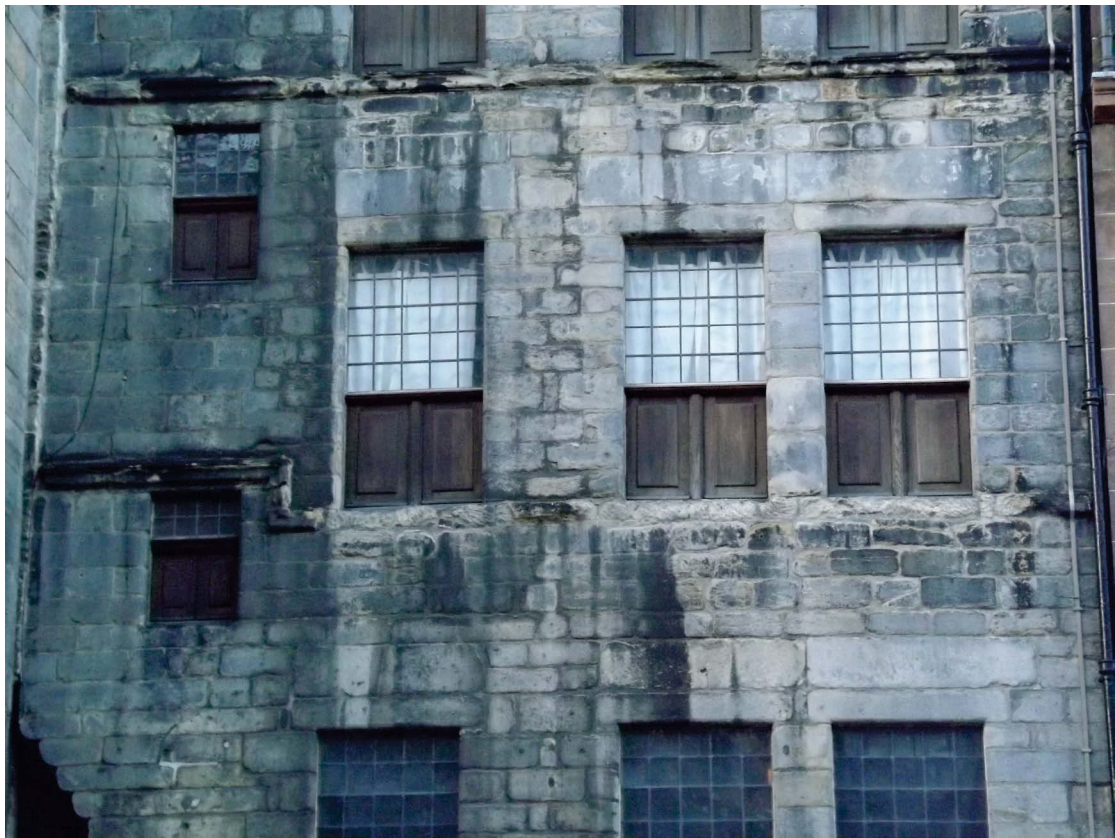
Plate 9. The first and second floor levels of the street facade

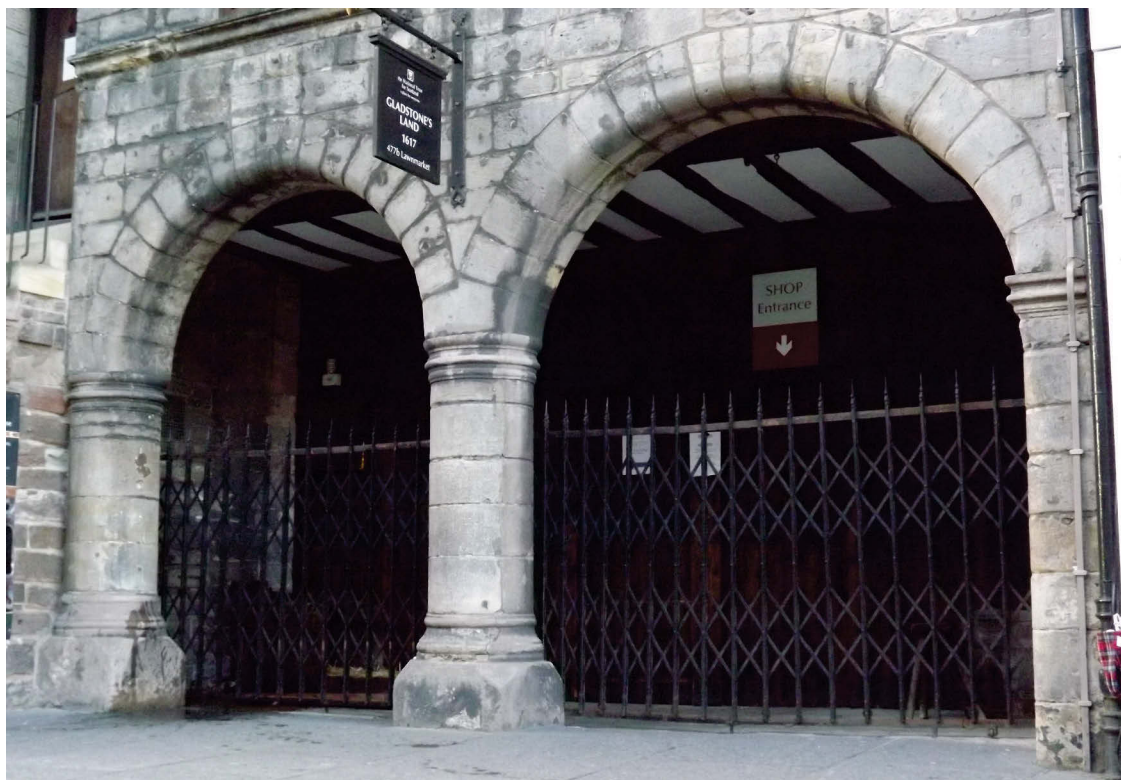
Plate 10. The ground floor arcade

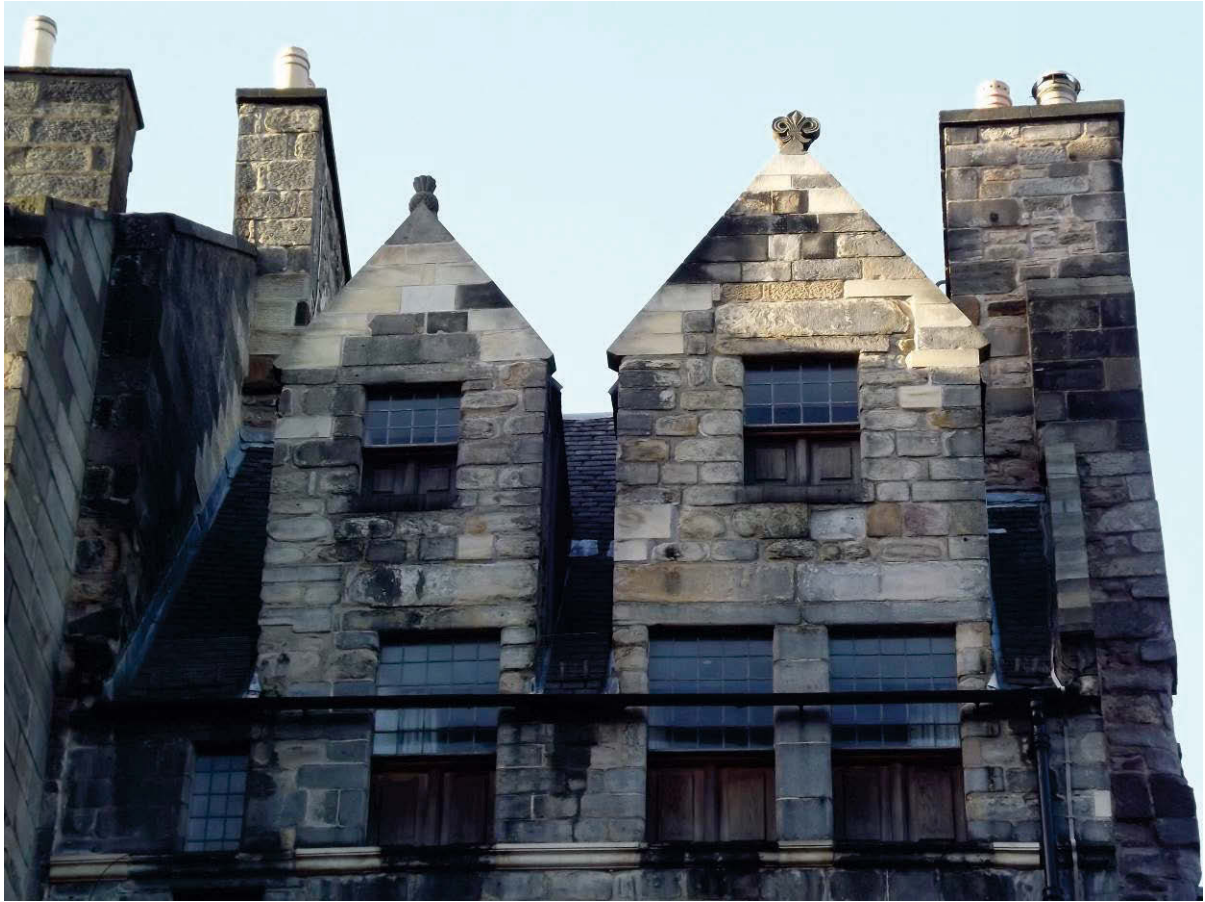
Plate 11. The upper part of the street frontage

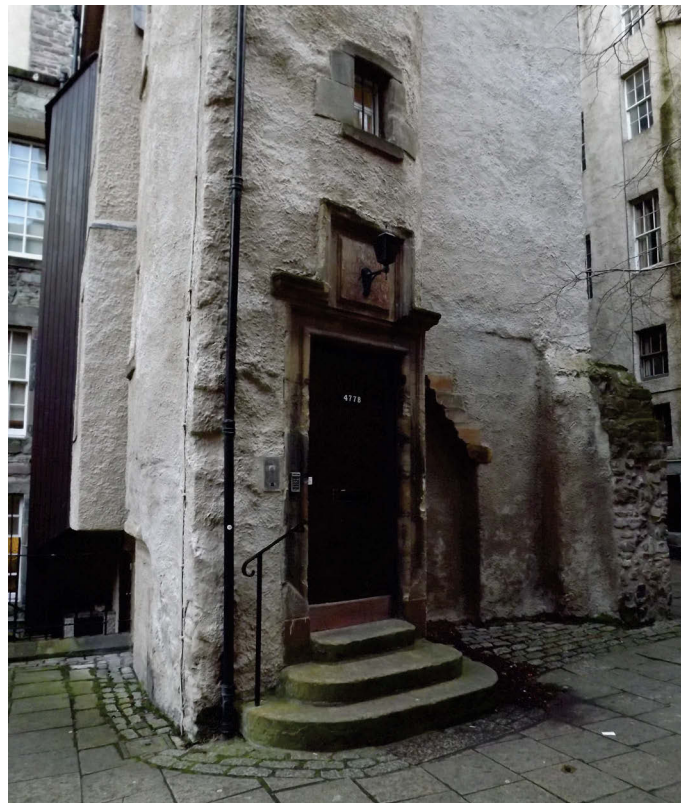
Plate 12. The inserted entrance of c.1900 to the NE stair

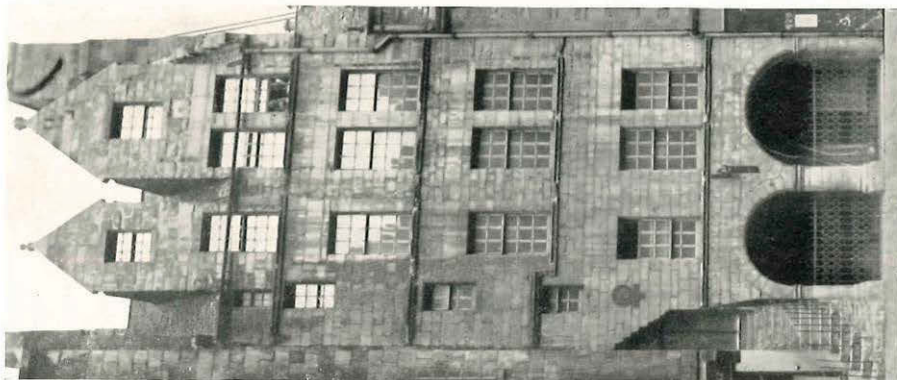
FIG. 209.—Gladstone's Land (No. 14).

(Fig. 209), standing on the N. side of the street and extending at the back into James' Court, takes its name from Thomas Gladstones,* burgess and guild-brother of Edinburgh, who became its proprietor in 1631.¹ In 1934 it was acquired by the National

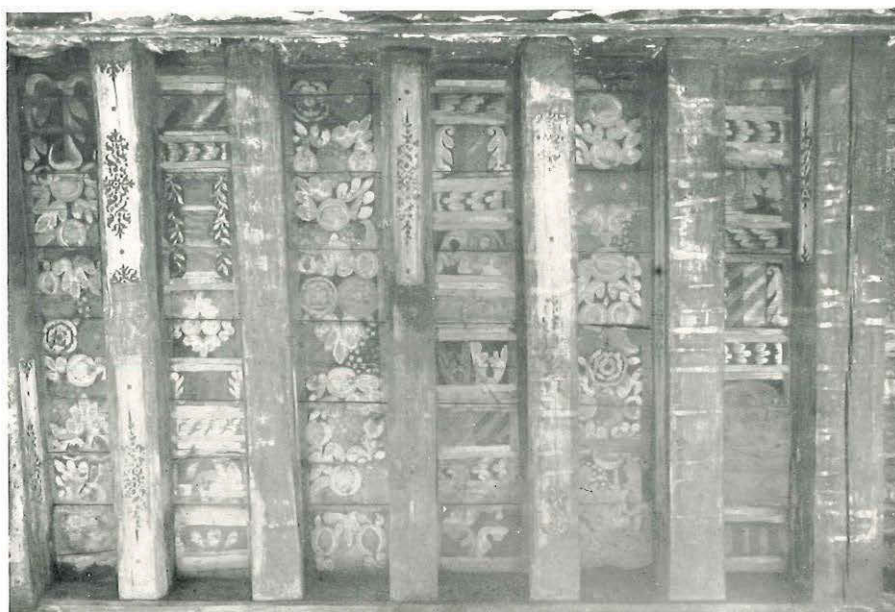
FIG. 214.—Painted ceiling.
