# Hownam Mains Steading

*Kelso, The Scottish Borders*

Historic Building Record

*for* The Roxburghe Estate

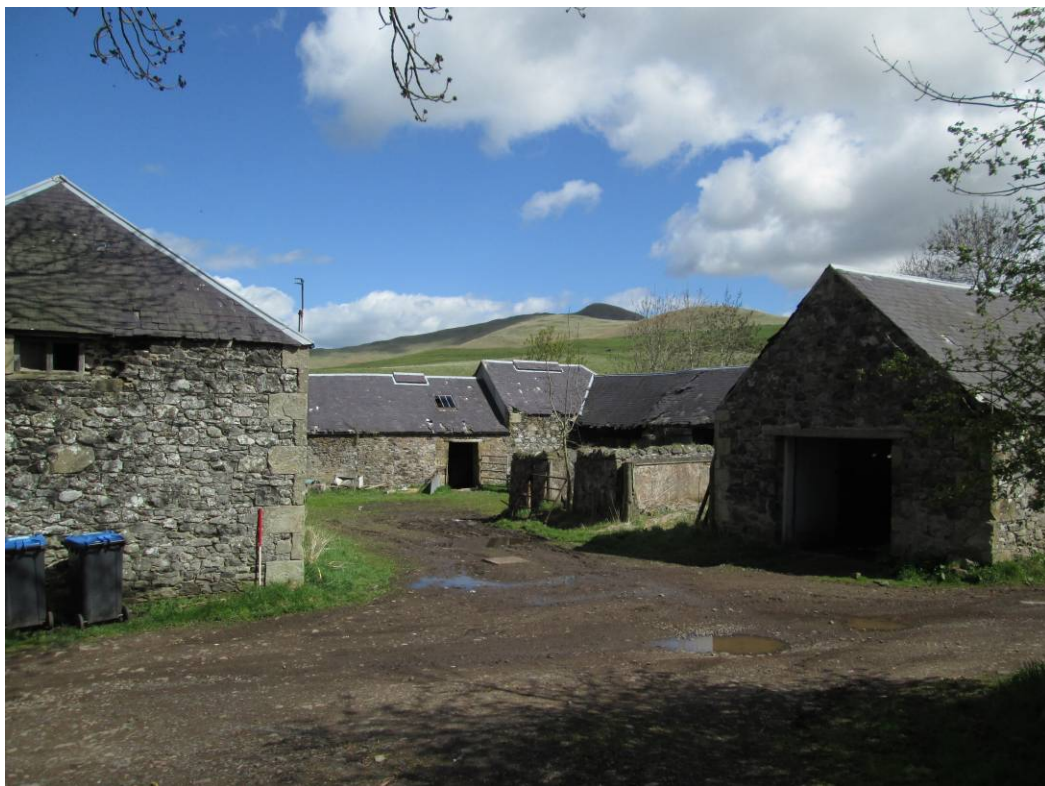
*General view of the Steading looking north east*

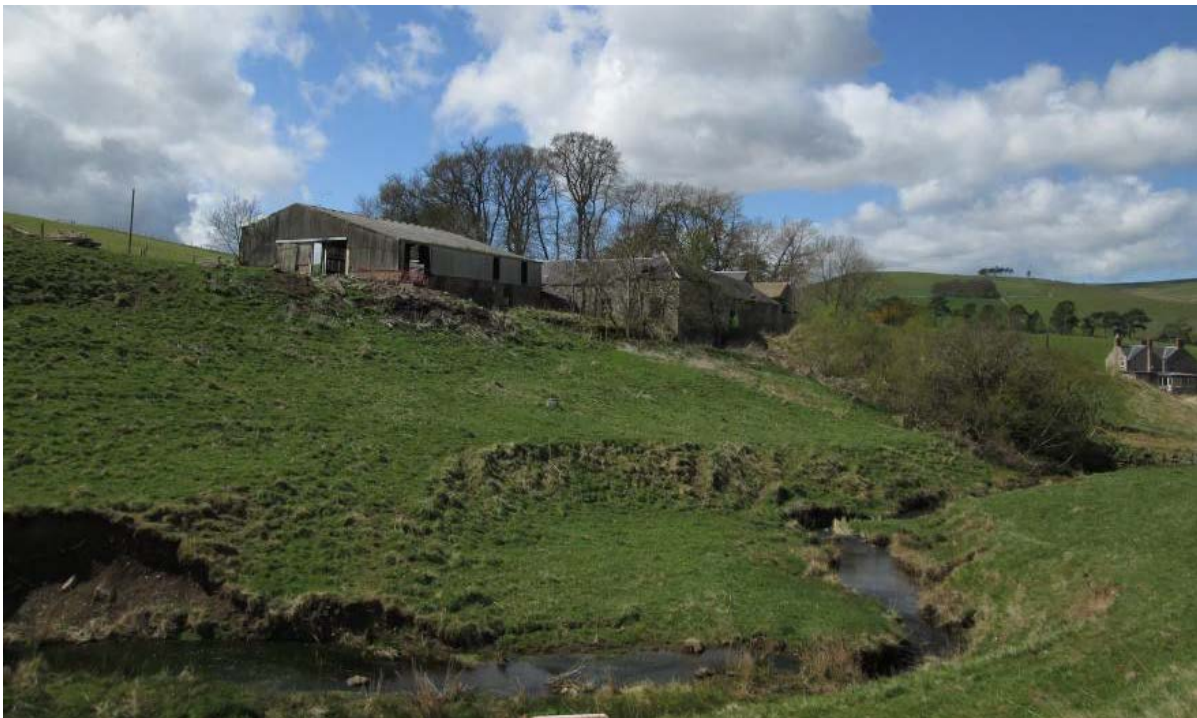
*Plate 1 The Steading looking South West (088)*

The buildings which form the Steading complex are roofed and in moderately good repair. They are still in use for the housing of sheep and cattle and storing of hay.

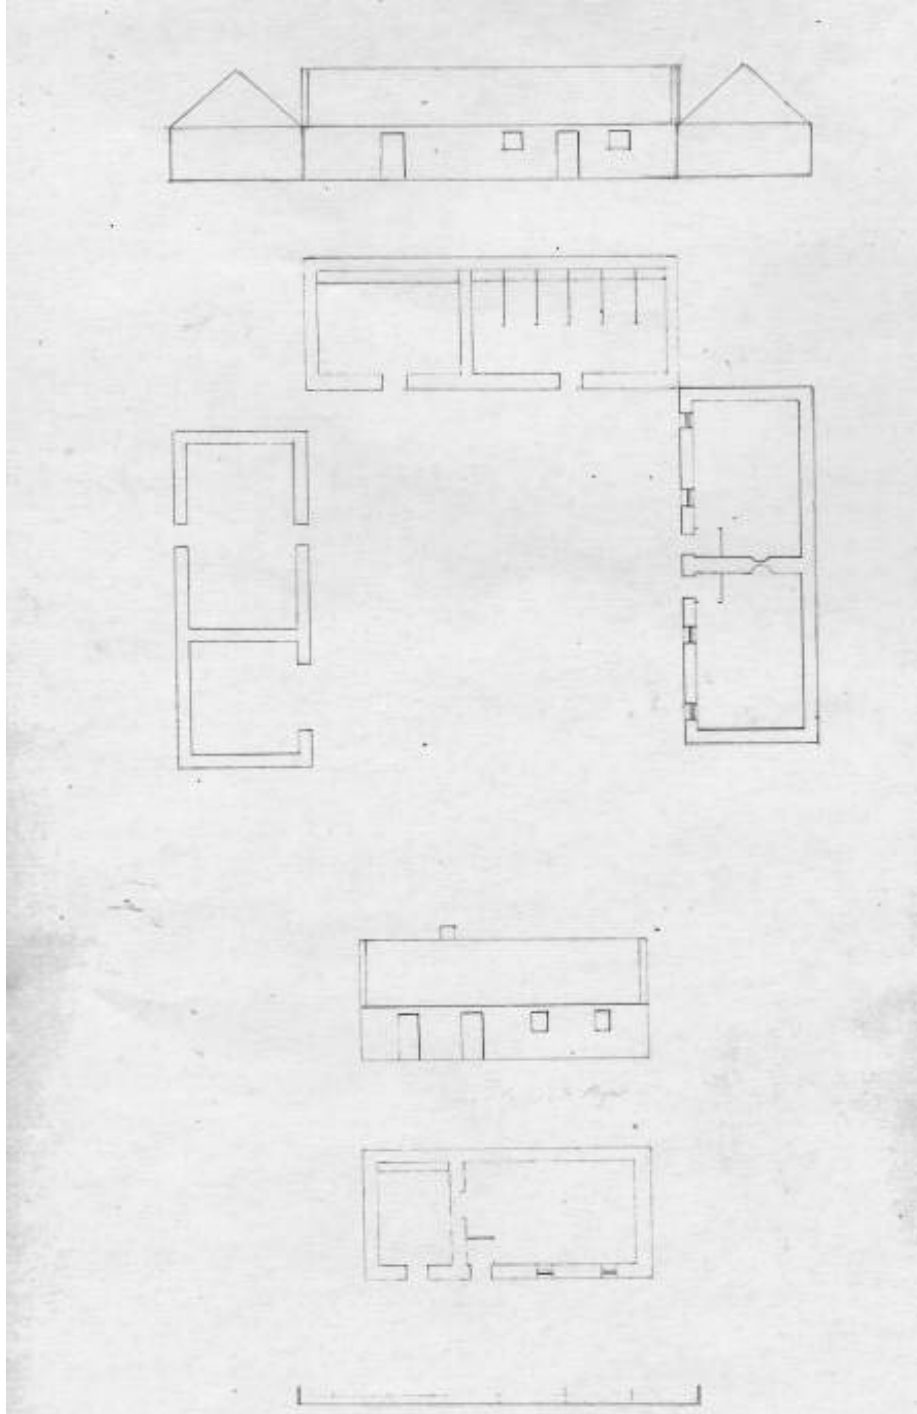
*Figure 2 1826 Elevation and plan of Steadings and herd's house*  
©RCAHMS [DP50612]. Licensor [www.rcahms.gov.uk](http://www.rcahms.gov.uk)

numbers 159587 and 159584 respectively). The collection held by the Royal Commission includes one item relating to Hownam Mains. Item D 50612P is a photograph of a drawing showing elevations and plans of the steading and Herdsman's house dating to 1826 (*figure 2*). The layout of the Steading depicted on this plan differs from all other later representation and from what is surviving today. It may be that the plan was never executed as depicted, or that additions and alterations were made very soon afterwards. In particular we know that the south range was added by the time of the First Edition Ordnance Survey of 1859. The elevations from 1826 also show the west, east and north ranges as single storey with no dormers.

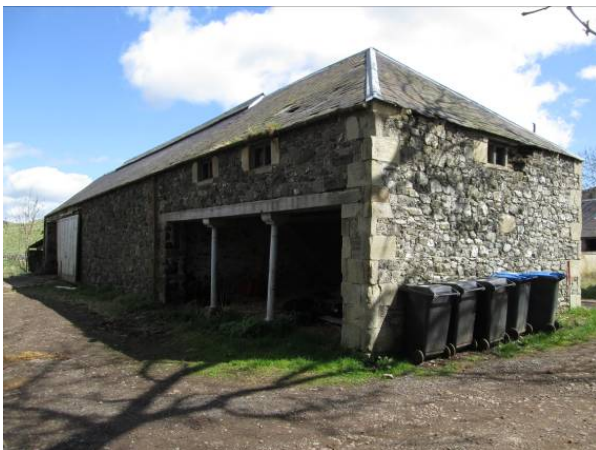
*Plate 2 Area A cartshed looking north east (084)*

Area A is located at the southern end of the west range and is the only part of the Steading to retain an upper floor. The ground floor space is open on the west side. Here the masonry of the upper floor is supported upon a timber lintel which spans the entire length of the compartment, and is in turn supported on two simple cast iron columns sat on stone plinths (*plate 2*). The internal walls have been whitewashed. Its original use was in likelihood as a cart-shed; it is currently used for storing hay and animal feed

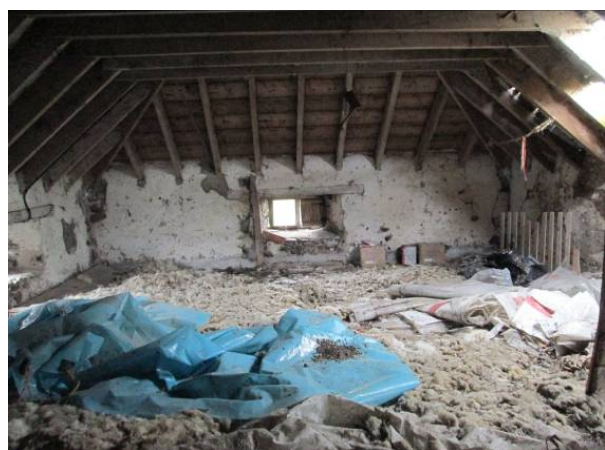
*Plate 3 Area A loft looking south (175)*

The upper floor or loft area is accessed from the courtyard (034) via a timber staircase which survives in good condition. The floor is of timber whose joisting was built off the wall heads and supported by means of a single rough timber post beneath. There are four small low windows sat directly below the roof eaves, one at the south end of the east side (035), one in the centre of the south gable (036) and two on the west side (037), (038). The windows are not glazed suggesting they were for ventilation. They have timber shutters internally and wire mesh on the exterior. The sills, lintels and jambs are of dressed sandstone. On the interior the walls have been roughly plastered and whitewashed. The roof timbers are all exposed. The loft is currently used for storage and or drying of fleece (*plate 3*). The lack of glazing in the windows would suggest that it was intended for drying and storage (a hay-loft?).

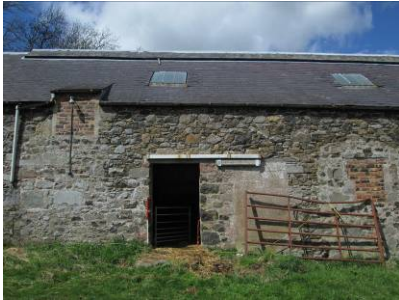
Plate 4 Area B East elevation (075)

At ground floor level there are three blocked windows (027), (028), (031) and a partially blocked entrance (029) on the east elevation fronting on to the courtyard. There is also a blocked dormer at the south end of the same elevation, which would have lit the loft area (061). The south wall of area B has a large recess at the east end, with a timber lintel above it (032) (plate 5). The proportions would be right for an entrance that has been partially blocked leaving a recess, presumably when the western range was extended to the south. It was not possible to view the blocking is visible from the other side because of the timber stair in that area. There is also no evidence to indicate that shelves had been present, either in the form of fixings or gaps in the whitewash. A second smaller, square blocked opening (062) is visible at the west end of this elevation. It also has a timber lintel and a solid stone sill. There is no evidence of it on the other side of the wall, but the wall is heavily smeared with lime mortar.

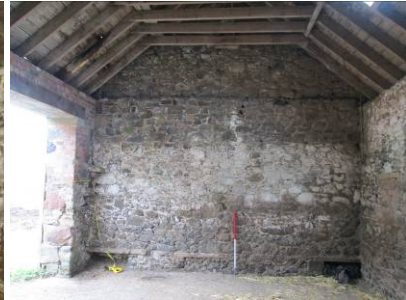
Access is by an entrance leading from the courtyard at its south end (030) (*plate 4*) and via a large opening (033) to the west at the north end. This appears to have been slapped through or at least raised in height; it has brick rebuilding of the upper jambs and a steel beam over. There is evidence of a loft (059) at the south end that had extended up to an internal stone partition wall which has been demolished. There are rectangular joist sockets in the west and east walls showing where joists ran supporting a timber floor. On the west wall ceramic pipes have been inserted through the wall to increase ventilation. This must have been done after the loft floor was removed as the pipes re-use some of the joist sockets.

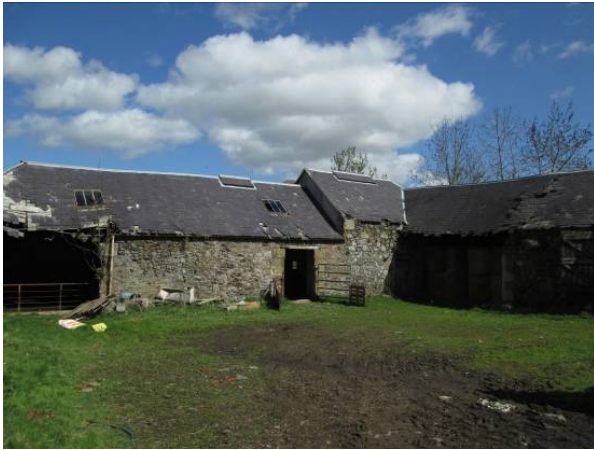
Plate 7 Courtyard elevation North Range (094)

The North range is currently one large rectangular open space, the eastern end which was originally a separate building - discussed below in section iii.b (plate 7). The remainder of the north range was originally subdivided into two roughly even spaces, each with an opening on to the courtyard. This can be seen on the plan of 1826 and a scar in the masonry was recorded on site. Where the internal wall was tied into the north wall is now patched with brick. The western room (Barn 2) was approximately 0.15 m wider N-S (5.35m) than Barn 1 at 5.20 m N-S perhaps indicating that the masonry represents 2 phases. Visible breaks can be seen in the construction on the north and south external masonry strengthening this theory.

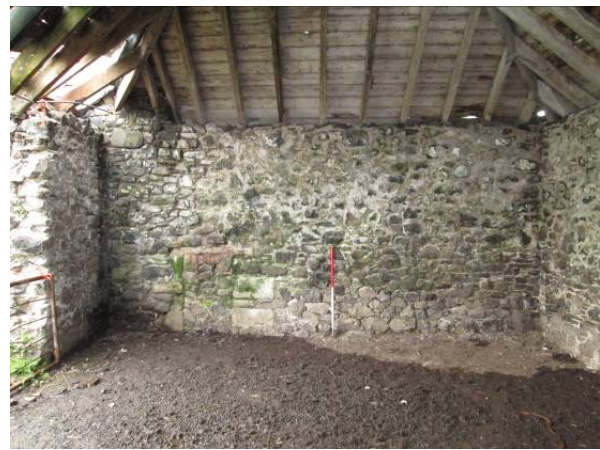
Plate 8 West interior wall (095)

The opening into the courtyard at the west end of *Barn 2* (018) is wide and extends up to the eaves. The lintel over this opening is missing and the western jamb stones have recently collapsed/been robbed causing the roof above to partially collapse. Alternate jamb stones on the eastern side are also missing. Those that remain are large squared yellowish grey sandstone. A doorway (019) with large rubble jamb stones and a timber lintel would have led out to the area to the west (plate 8). It is currently blocked (020) by rubble infill. The floor level within the room has been raised, this part-obscuring the entrance.

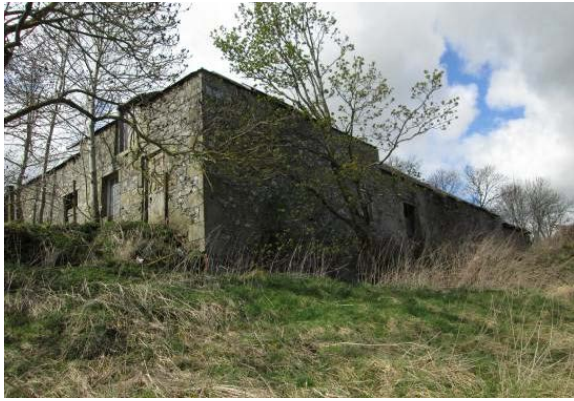
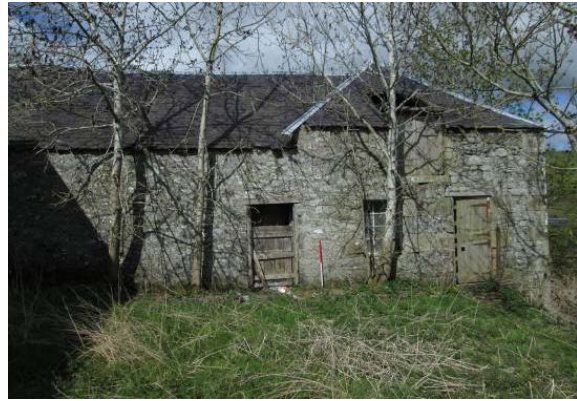
The eastern most end of the north range was added later, according to map evidence sometime between 1859 and 1896 (plate 9 and plate 10). The construction of this building blocked the earlier track leaving the Steading compound from its north-east corner. It stands several courses of masonry higher than the other buildings and internally shows evidence of an upper floor (008). The ground to the north drops away steeply to the east which allows the mill a further two floors beneath the ground level of the courtyard. Although the exterior masonry work (001) is almost identical, on both the north and south elevations, to the stonework in the rest of the Steading, there are construction breaks visible in both the north and south elevations. On the south elevation it is fairly clear where the mill house has been fitted in with a rough vertical break approximately on the line of the western gable of the mill house, to the north there is no clear break in the masonry on this line and it is possible that the whole of the north elevation of barn 1 was rebuilt at the same time as the mill house.

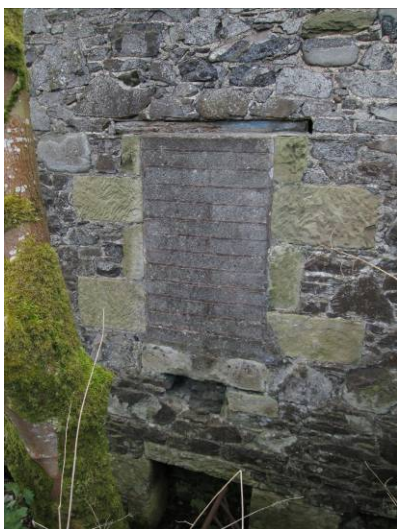
Plate 13 Blocked Door 054 (015)

Beneath the sill of the top opening is a small rectangular aperture (plate 13), thought to have housed the shaft to the mill wheel (063). The openings may have been doorways or windows to allow access to the wheel for maintenance purposes. The location of this in relation to the retaining walls (053) of the wheel pit (plate 14 and 15) would mean the mill wheel could not have exceeded 4m in diameter. The total depth of the wheel pit is not visible due to soil build up and vegetation, including a substantial tree.

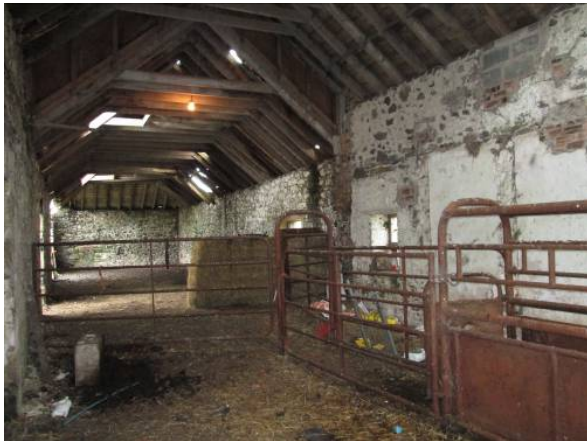
*Plate 16 Mill interior looking West (114)*

The interior of the mill has been infilled to ground floor level and the first floor removed, leaving a single space (*plate 16*). The level of the first floor is visible on all three remaining walls (*plate 17*), in the form of joist sockets (008) and a fillet of mortar (011) indicating the height of the first floor skirting.

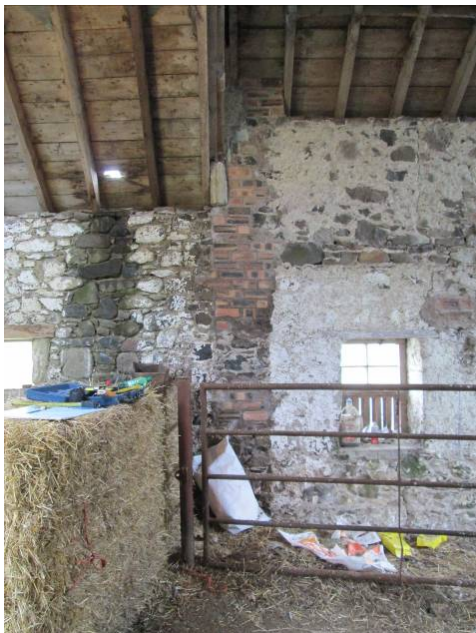
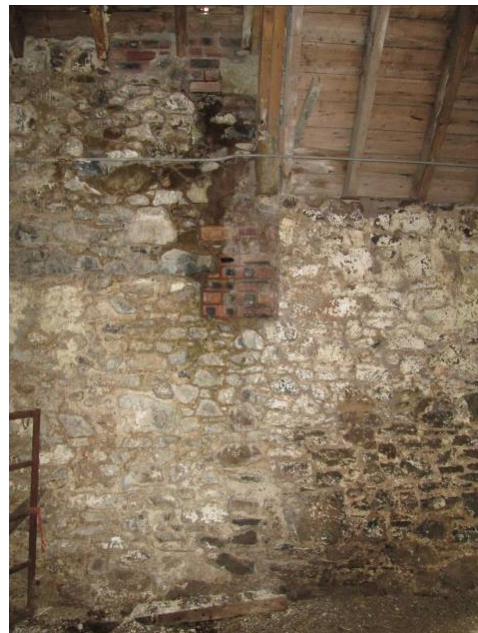
The mill has plastered (009) walls up to first floor height, above which the bare stone has been whitewashed (*plates 18 and 19*). The plaster stops in a vertical line on both the north and south elevations; this suggests that there was a timber partition (013) separating off a narrow room at the west end, lit by the window (005). It was not possible to determine with certainty that this partition or indeed the plaster related to the original function of the building; however self-evidently the partition was in place when the plaster was applied.

The upper narrow opening noted on the north elevation (006) can also be seen on the interior, where it has been blocked by cemented brickwork. The other blocked openings are all beneath the current concrete floor and are not accessible at present. It is hoped that when the lower floors of the mill are emptied there will be surviving evidence of the workings of the mill.

It is recommended that a programme of selective monitoring and recording be undertaken during the stripping out of the buildings. It is possible that the clearing and stripping of the courtyard may reveal evidence of the original surface together with the footings of the enclosure walls depicted on the First and Second Edition Ordnance Survey. If uncovered they should be cleaned, photographed and planned.

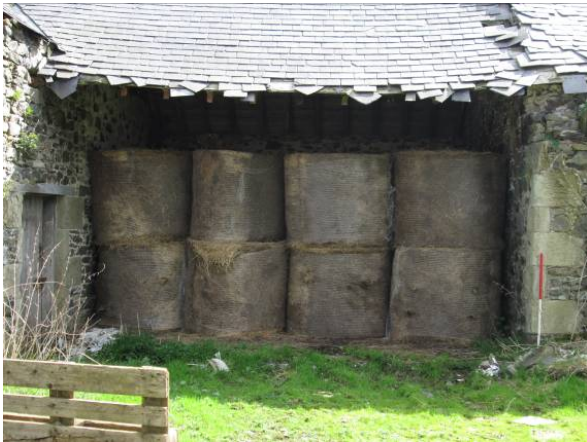
*Plate 20 Area D looking East (063)*

At the south end of the east range is a cart-shed or hay store. It is open on its west side to the courtyard and can be accessed from the east through a doorway (051). At the time of survey it was full of hay bales and therefore inaccessible. There was originally a timber lintel supporting the roof along the courtyard edge, the socket which held it is visible in the south wall of the mill above the door. Both the lintel and the central supporting pillar have been removed, presumably to allow access with a farm loader for storing the large round bales. As a result the roof has slumped.

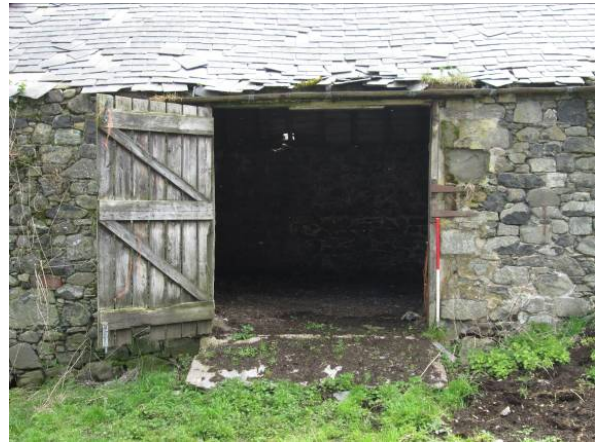
*Plate 21 Area E looking East (060)*

It is entered at present by a steep concrete slope (*plate 21*) leading up to a pair of large timber doors (050). The interior is featureless with exception of a large stone trough in the south west corner a small stone built box or trough in the south west corner. The walls have been whitewashed, though it has largely been removed up to animal shoulder height. It is not possible to see any floor surface due to the build up straw and manure.

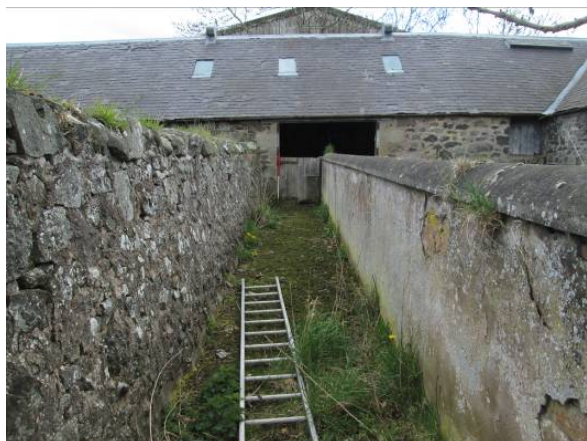
Plate 22 Approach to Area F showing 039,041(052)

This area is also for housing livestock but it is more complex on the interior and exterior. It has one opening divided into two separate entrances (047), (048) on the courtyard side. The north side of the entrance (048) is approached via a narrow alley between two walls (*plate 22*). The northern wall is built of rubble field stone (039) and is shown on both early Ordnance Survey maps. The southern wall is brick built (041) with cement render and a rounded cope. Both walls abut a perpendicular rubble wall with a break in it to allow access. The plans show that this wall originally continued the length of the courtyard forming the west wall of the enclosures.

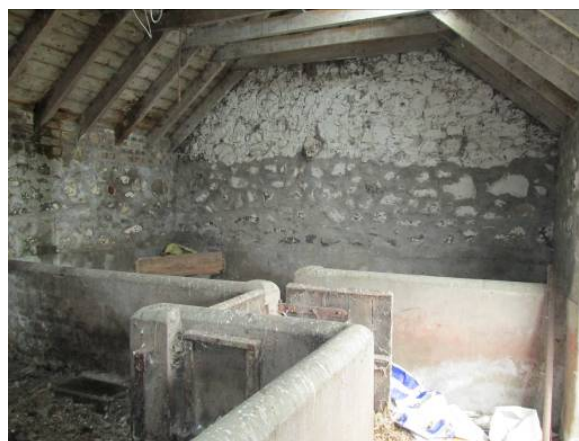
Plate 23 Interior of Area F showing 049 (040)

The interior has been subdivided into 3 pens by narrow walls (*plate 23*), presumably built of brick and covered with cement render (*049*). The north wall is topped by a timber plank and braced partition which extends to the rafters. The individual pens have timber doors. A skin of cement has been applied to the lower section of the masonry. This would make the pens easier to clean. A trough has been built from stone and timber diagonally across the south east corner of the south pen. There has been a single skin of brick built up from the east wall head to meet the rafters. The upper section of the gable walls is whitewashed and we can assume the whole interior was treated this way prior to the insertion of the pens and application of the cement. Small slapping's have been made through the east wall to accommodate vents to improve ventilation.

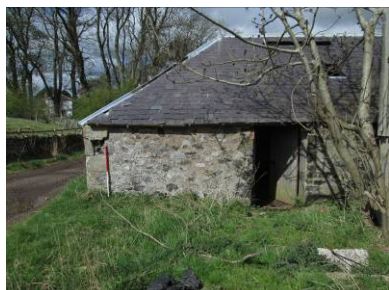
Plate 24 Byre G looking West(038) Plate 25 Byre G North interior (147) Plate 26 Byre G South interior(148)

Area G is located in the south east corner of the Steading between the east and south ranges. It is accessed via a door on the east side of the Steading (*plate 24*) and has a small, unglazed window with a timber shutter, looking on to the courtyard. It has a gable wall on the east and south side with a hipped roof to the east. Internally the south part of the area is open (*plate 25*), the floor is strewn with fertilizer sacks and other rubbish. The north half has a raised concrete floor with a wide drainage channel running east west. Against the south wall there are four animal stalls (*064*) with what appear to be single width brick partitions with cement render (*plate 26*). The walls are also treated with the same cement render to the height of the rafters, the render stops at the same height on the gable walls. Above this level the bare masonry is whitewashed. Each of the stalls has a ventilation whole which is covered by a rectangular grill on the exterior.

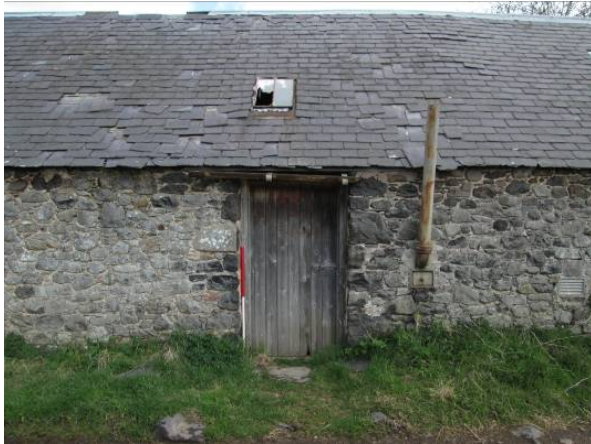
Plate 27 Workshop exterior showing 044 (041)

This small room is entered from the south side (043), and there are no windows or other openings (plate 27). It appears to have been used as a small workshop, though latterly as a chemical and general store. There are two roof lights, off set to the north and south, the concrete floor is visible and the walls are whitewashed. There is a high narrow timber work bench along the west wall with a low table and set of drawers against the east wall. To the left of the door a whole has been slapped through the wall (044) and patched around with cement (plate 28), on the external wall face a small metal plate that can be removed has been fitted with a reused cast-iron down pipe above. There was probably a small stove fitted on the interior to warm the workshop. A short length of cast iron gutter has been fitted above the door to catch run off from the roof.

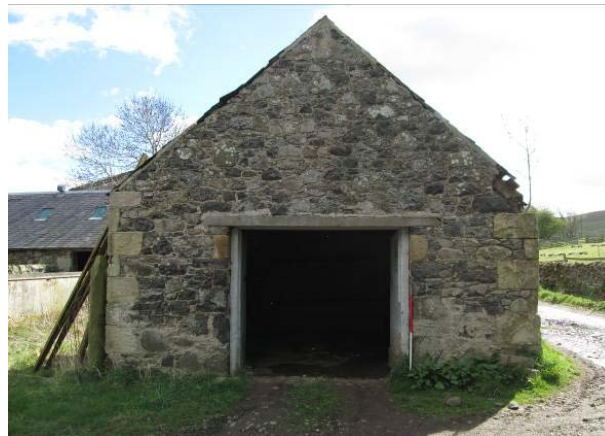
Plate 29 Area I shed exterior (045)

Area I is a large simple open shed at the west end of the south range (plate 29), it has no roof lights or windows and is entered via a set of large timber doors in the west gable (042). The quoins are of large squared greyish yellow sandstone. The top quoin on the south corner is missing and the roof above damaged. There is evidence of broached dressing with polished margins, but the stone is generally heavily eroded. The lintel above the opening is timber, there is a sandstone jamb on either side of the opening towards the top, the remainder of the jamb stones are rubble field stone as in the main build.

The interior walls are whitewashed and the floor is concrete. It is currently used for storing feed troughs. The large opening and lack of windows would suggest it was designed to accommodate carts or agricultural machinery.

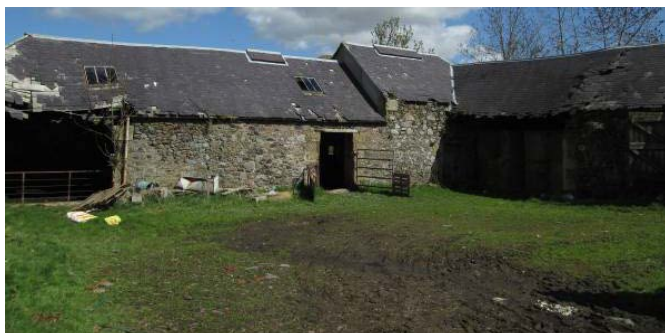
*Plate 30 Courtyard looking North East (094)*

The earliest plan from 1826 does not show any walls or subdivisions within the courtyard. By the first edition there are two large enclosures against the south and east range, each has a gate on the west side. By the time of the second edition the west wall of the enclosures continues to abut the north range. There are now three uneven enclosures but only the smallest southern area has an opening marked. The second west east division has a sharp dog-leg. It seems likely that the short length of north south stone rubble wall (039), and the return that abuts the east range surviving are those described above. The remaining walls have been demolished and a narrow single width brick wall (041), coated with cement has been built parallel to the original wall forming a narrow passage into area F. As previously mentioned the courtyard surface is not visible (*plate 30*).

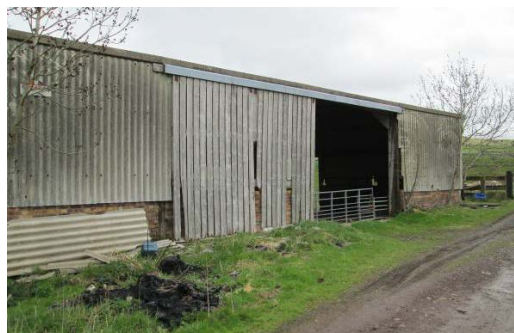
*Plate 31 Modern cattle shed looking North East (235)*

There are three modern buildings out with the Steading, but forming part of the complex. The largest is a cattle shed to the east of the Steading (*plate 31*) the lower wall is brick with the upper part and roof built of corrugated asbestos. There is a smaller open sided hay barn to the west of the Steading, and a small lean-to structure has been built at the North West corner for the storage of farm machinery.

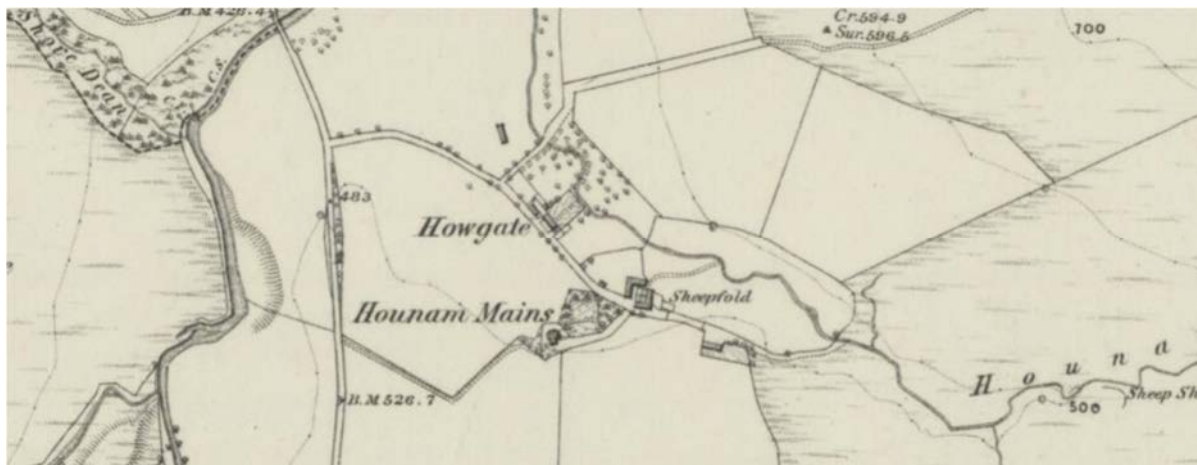
Extracts from the first (figure 2) and second (figure 3) edition 6 inch to the mile Ordnance Survey show the layout of the farm buildings in the mid to late 19<sup>th</sup> century. The place name is still spelt as *Hounam* at this time. The second edition survey also shows the mill dam and lade running down to the corner of the Steading building.

Figure 2 : Detail from 1<sup>st</sup> Edition OS Map, Roxburghshire, Sheet XXII  
Survey date: 1859; Publication date: 1863. NMLS.

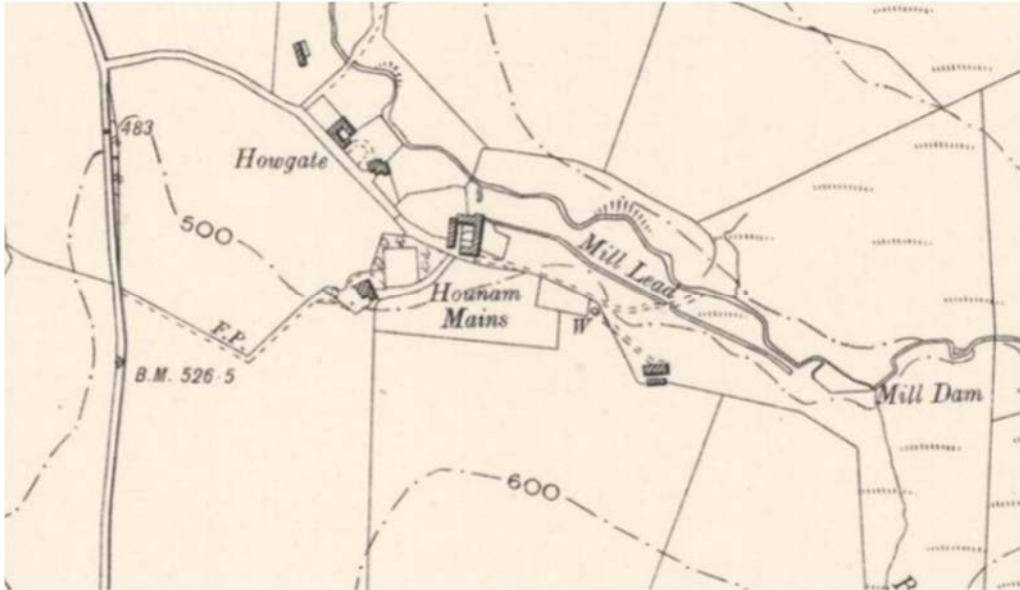
Figure 4 : Detail from 2<sup>nd</sup> Ed OS, Roxburghshire, Sheet XXII.NE Publication date: 1899 Revised: 1896. NMLS

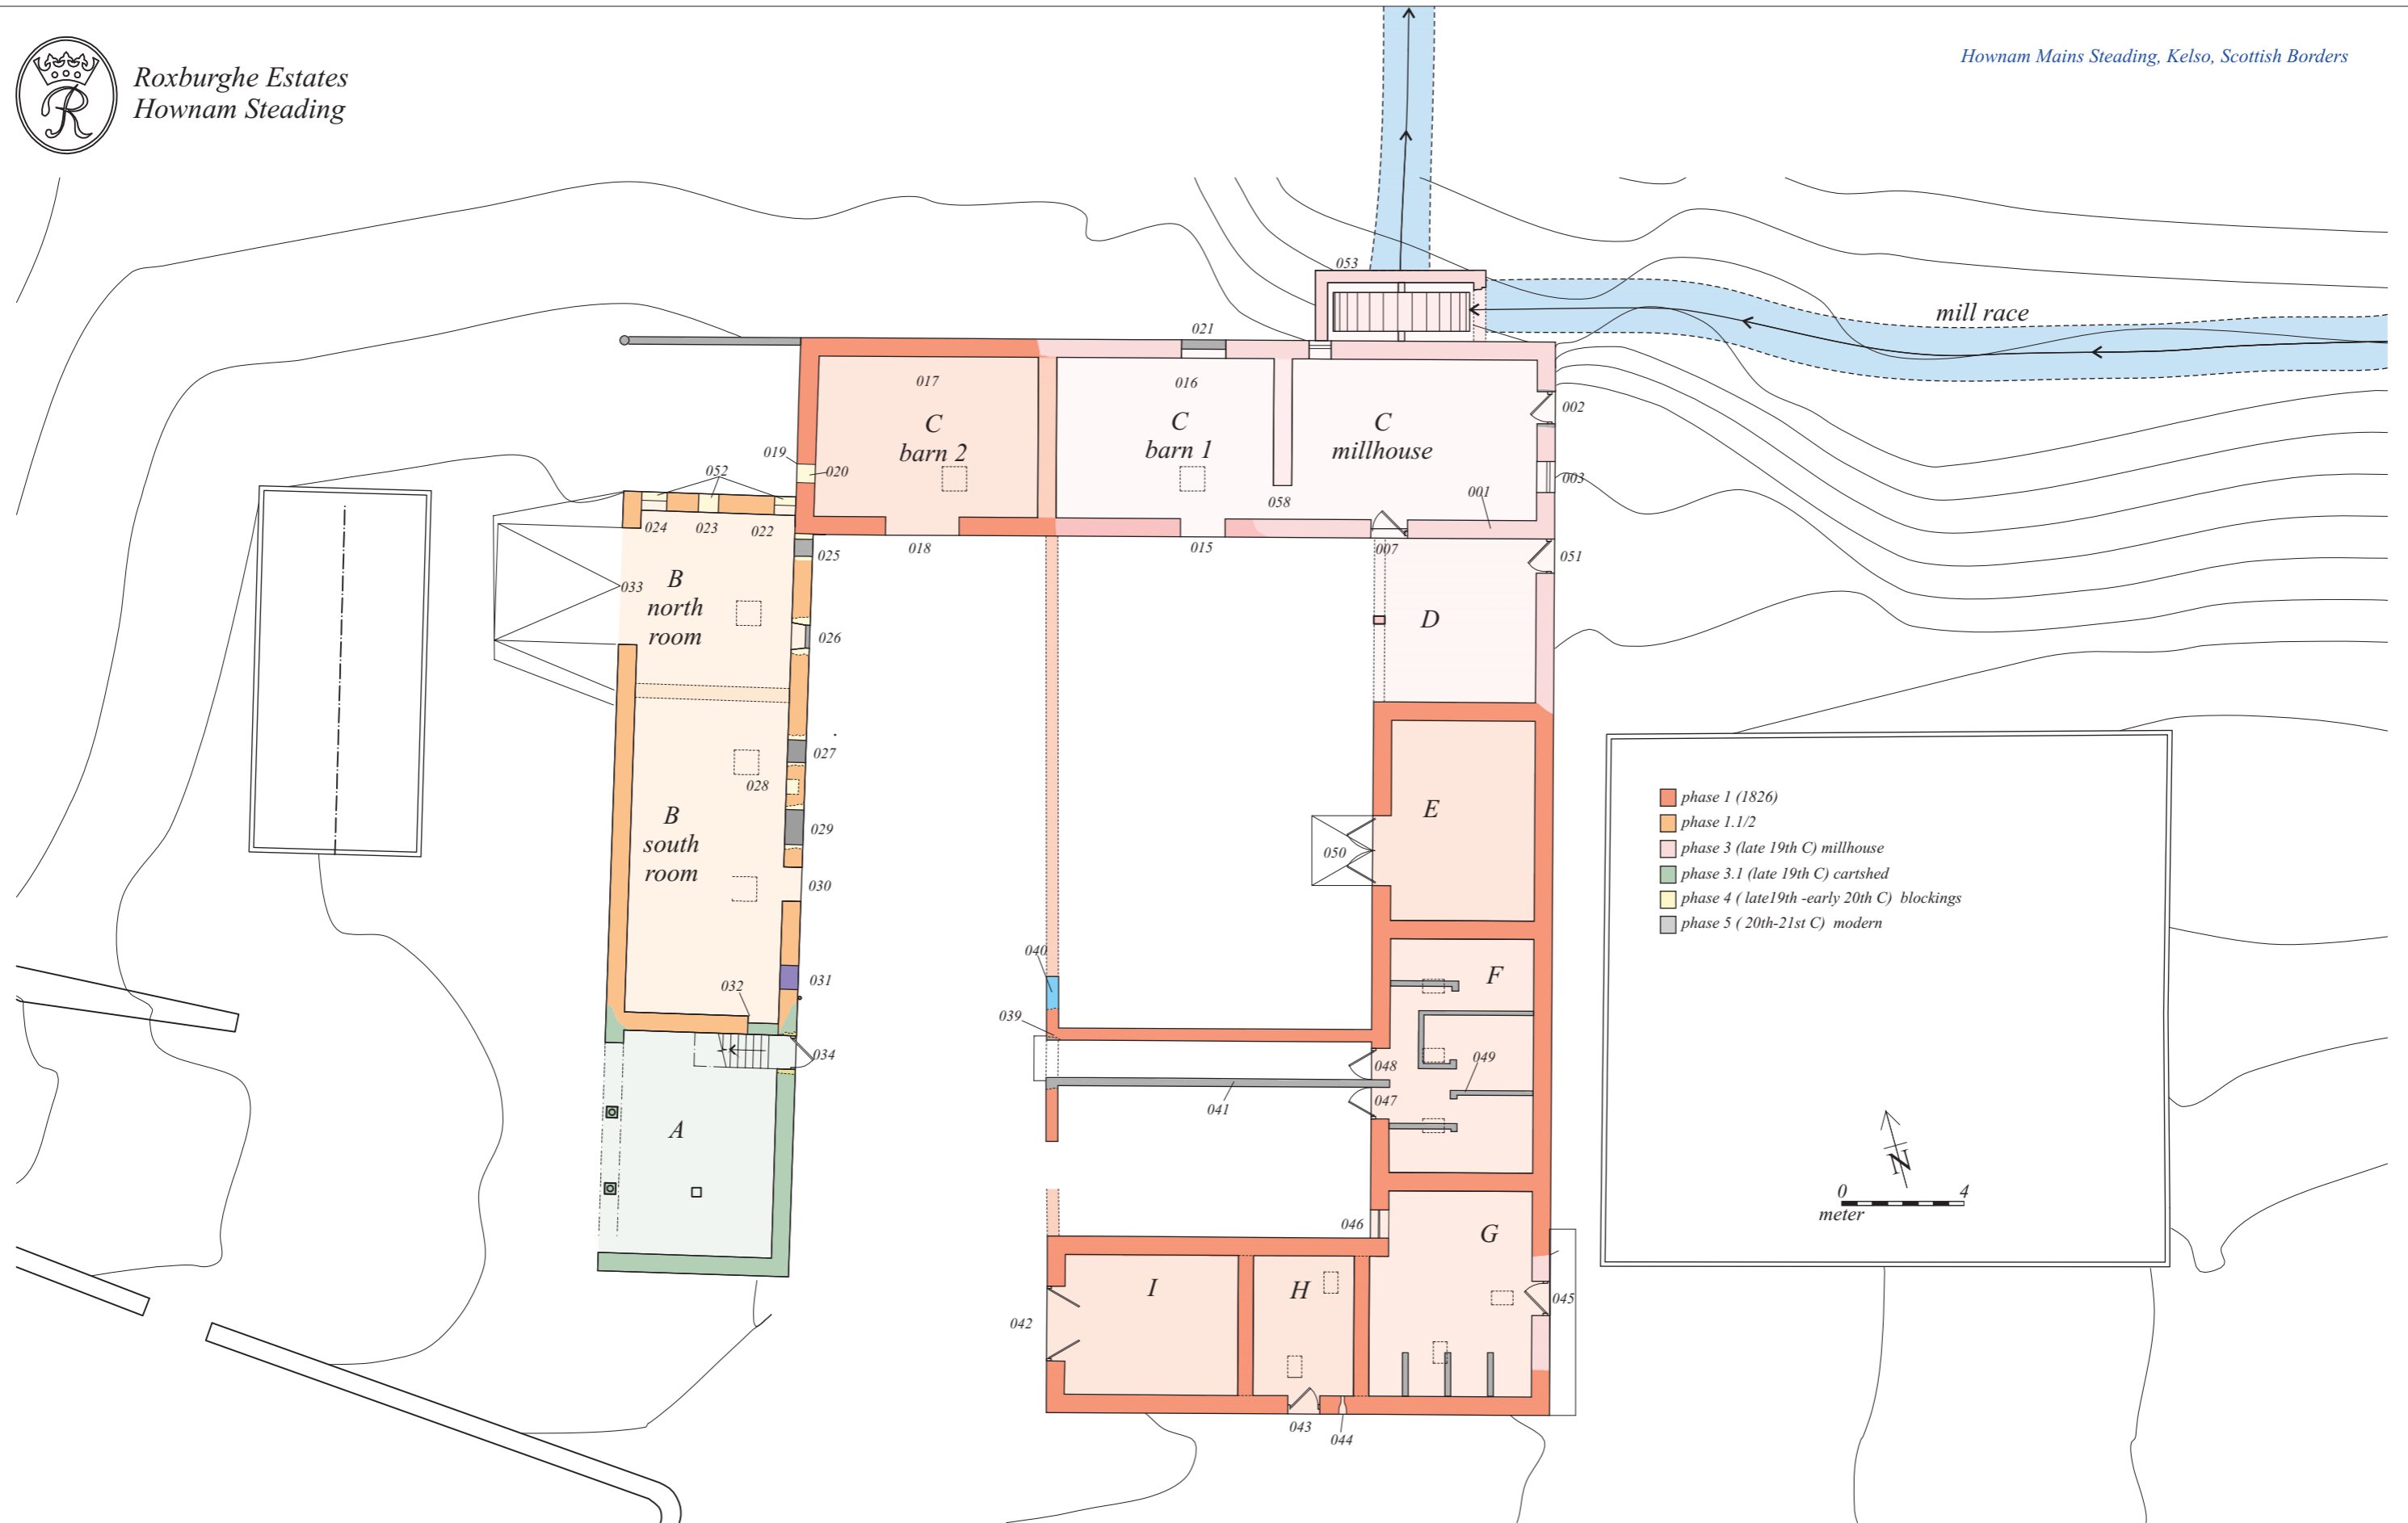
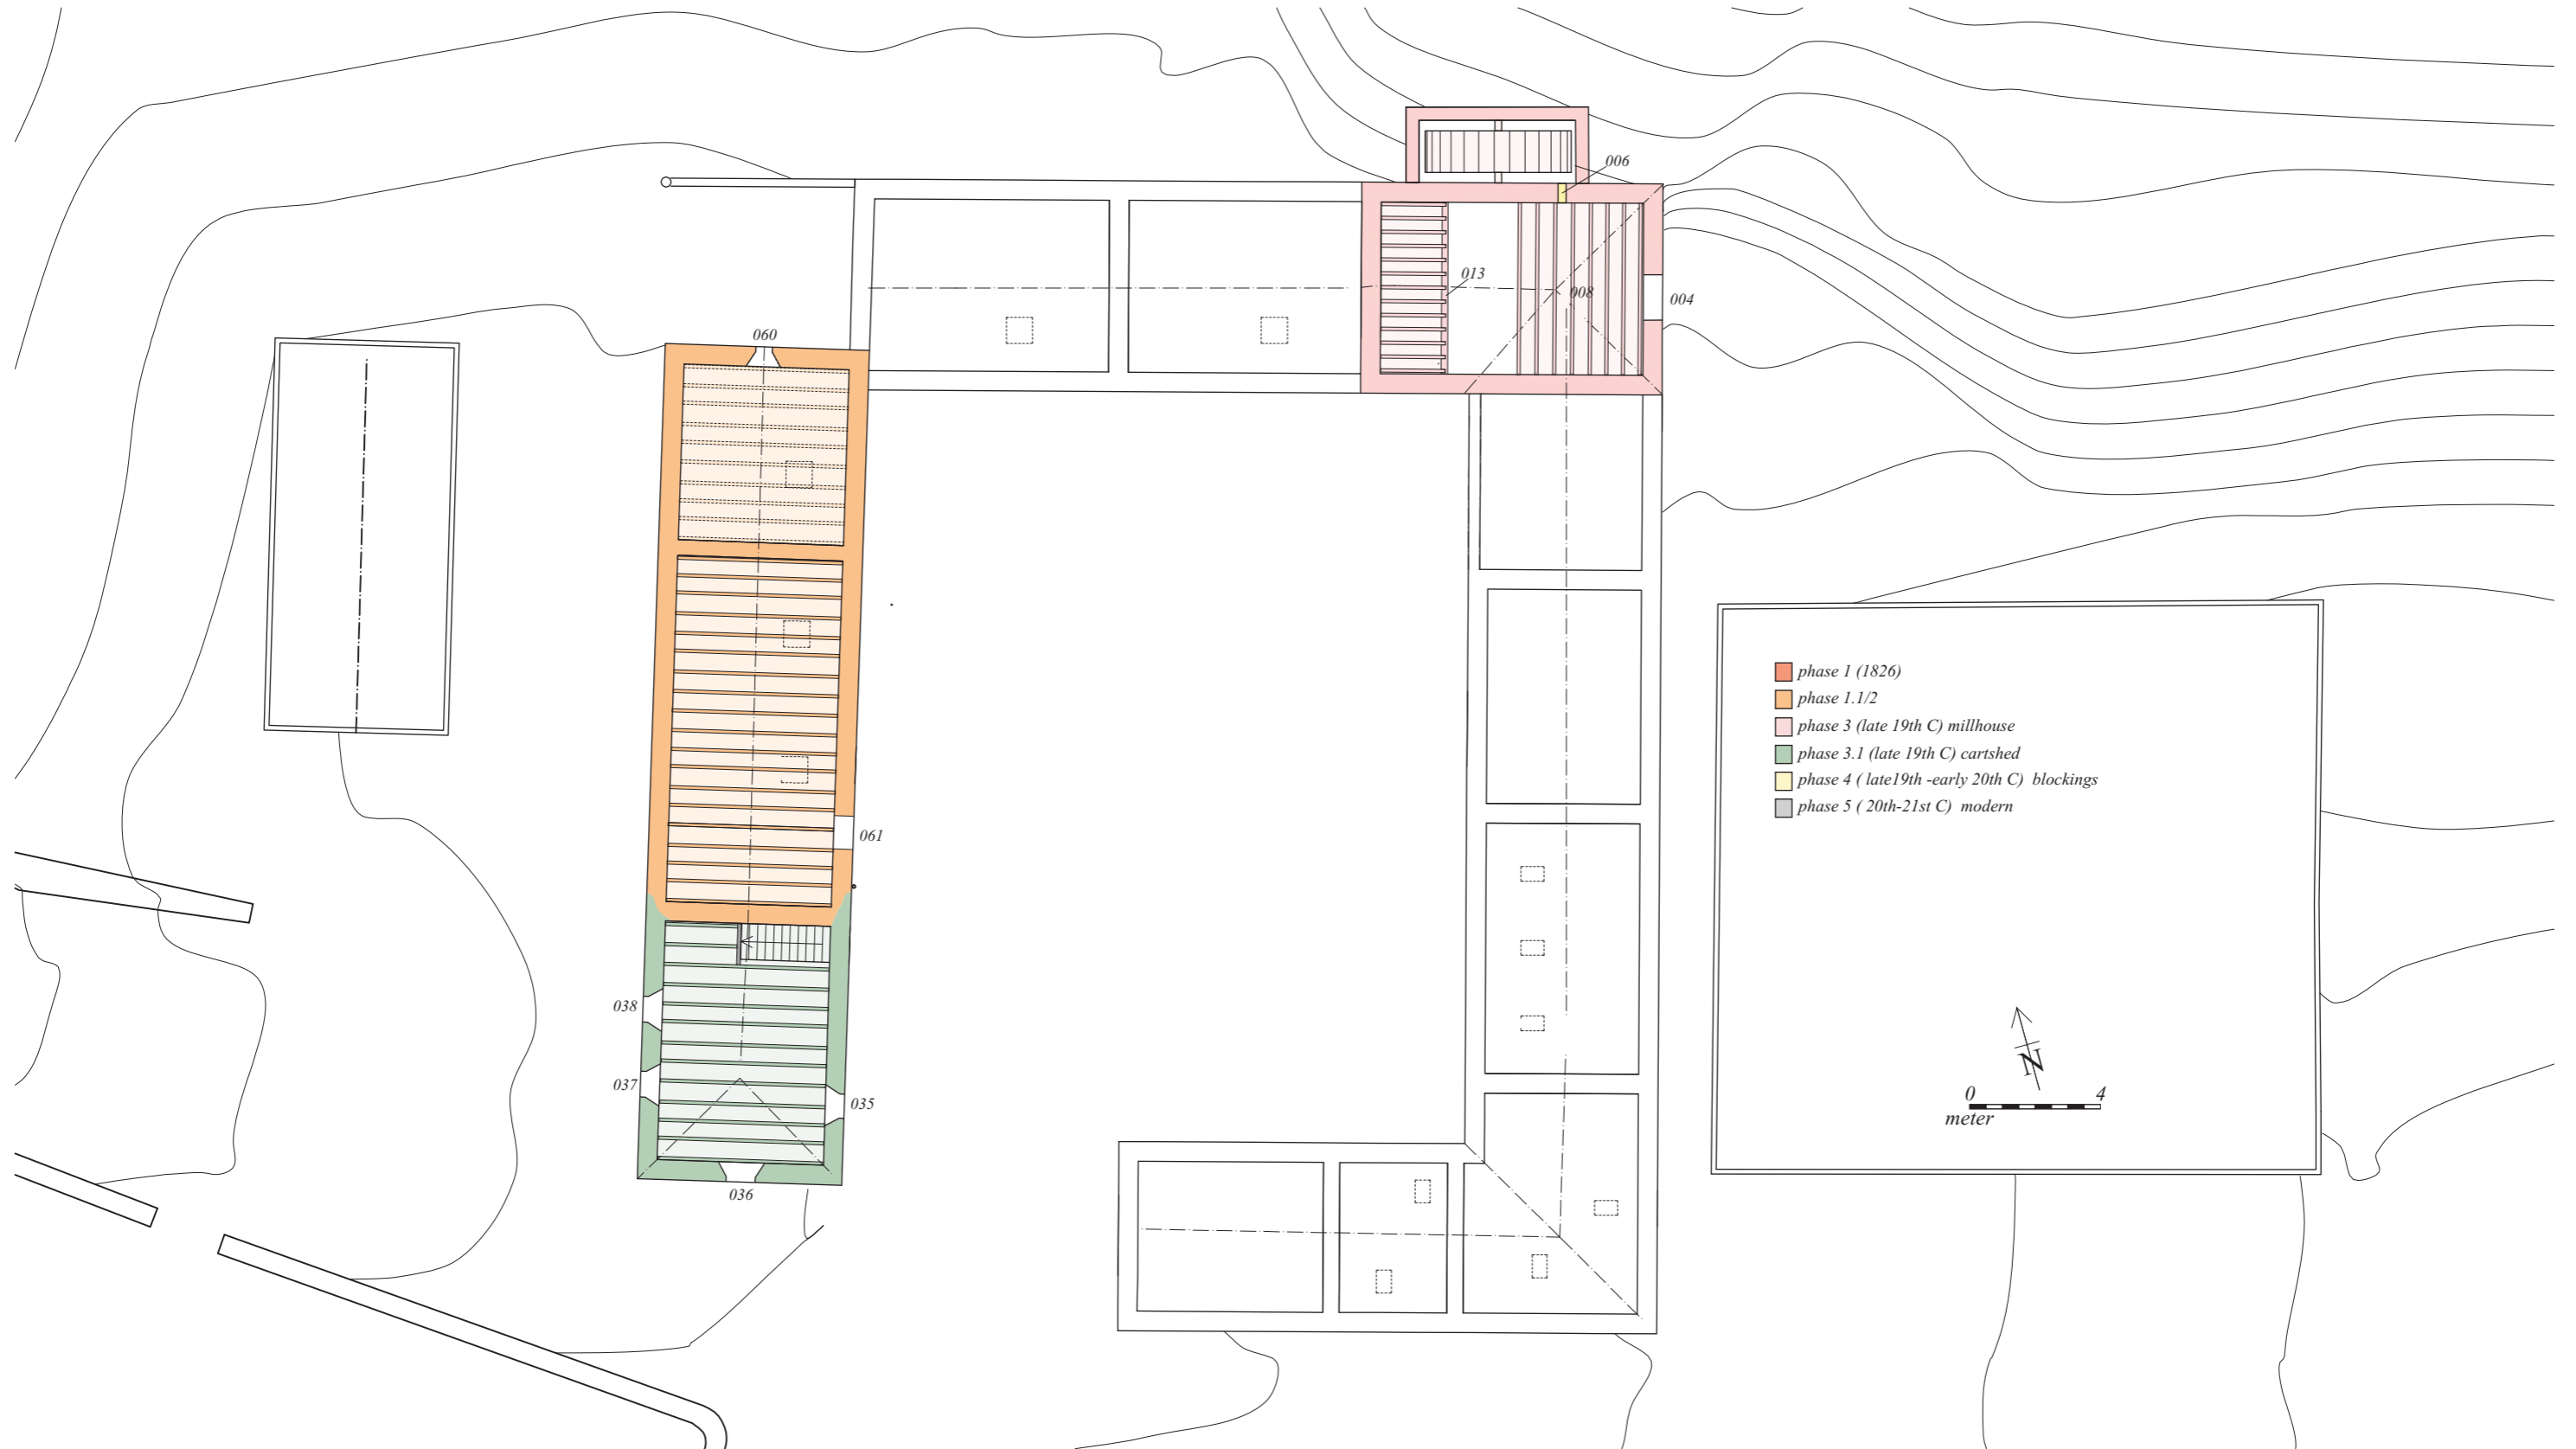
- phase 1 (1826)
- phase 1.1/2
- phase 3 (late 19th C) millhouse
- phase 3.1 (late 19th C) cartshed
- phase 4 (late 19th - early 20th C) blockings
- phase 5 (20th-21st C) modern
