# **Merchiston Castle**

# Colinton Road, Edinburgh

# Watching Brief: August 2015

Job number 2083.00

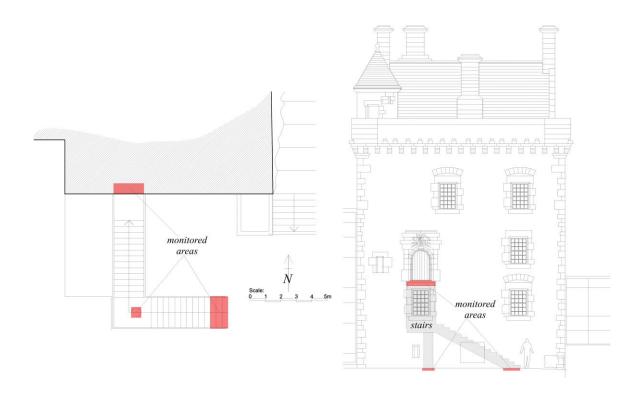
Figure 2 plan and elevation showing areas of monitoring

Prior to the start of the monitoring the bulk of the freestanding reinforced concrete stair had been demolished by a remote controlled hydraulic breaker. The last stubs of the reinforced concrete down to near ground surface or wall face were left *in situ* to be removed under archaeological supervision.

The removal of these last remnants of concrete was monitored by a qualified archaeologist and any archaeologically significant deposits or features were to be recorded by photography as well as in drawn plan, section and context description. Within the monitored removal of concrete no archaeological significant deposits or features were noted; accordingly only a basic photographic record was made of the works.

The breaking up of the upper concrete within the two small areas of foundations was initially performed by the remote control hydraulic breaker and then cleaned by hand. Within these two foundations the concrete was removed down to about 0.10 m below the ground with the intention to make good the holes by laying paving to match the surrounding. As such the concrete of the foundations was not bottomed and it was clear that the concrete continued down for some distance or was at least founded into something solid ie bedrock.

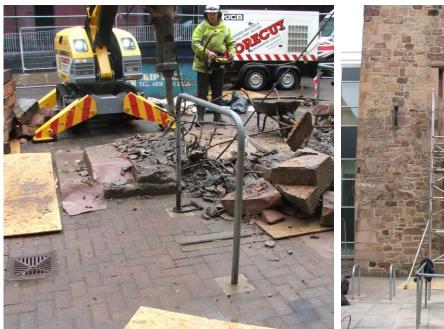
Plate 1 pre excavation view of foundations and junction with castle

The only find of note was a plastic biro pen jammed between the foundation and the surrounding paving; this find was not retained.

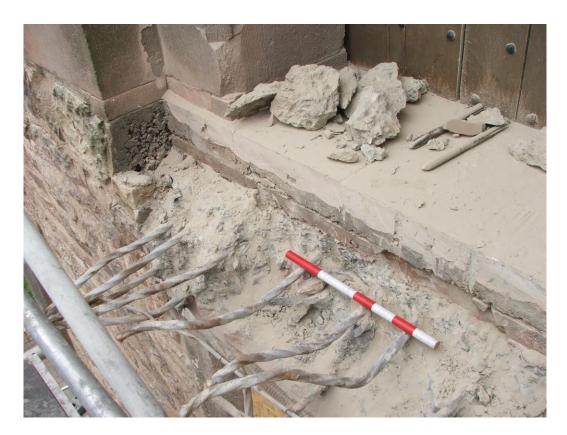
Plate 2 mid excavation view of concrete within door threshold (0.40m scale)

Removal of the concrete slab within the door threshold on the south elevation was undertaken by hand using a small electric pneumatic breaker, this was used in order to minimise potential damage to the surrounding masonry.

The concrete proved to be solid and removal was slow. It appeared to have been poured *in situ* and appeared to continue through the full width of the wall. The concrete was removed back to the line of the door in order to give enough of a tail to support the new balcony; this involved the removal of the mid-20<sup>th</sup> C sandstone threshold stone (bedded into the concrete slab). Again, as in the foundation trenches, the concrete was not bottomed; enough space was made for the proposed balcony to fit without removing all the concrete. No historically significant masonry was noted around the area of the excavation; all nearby masonry seemed to relate to the mid-20<sup>th</sup> C insertion of the door and window below.
