# The Gates, Unit 33

*Durham, County Durham*

Monitoring and Building Recording : July 2015

*Job number 2125.00*

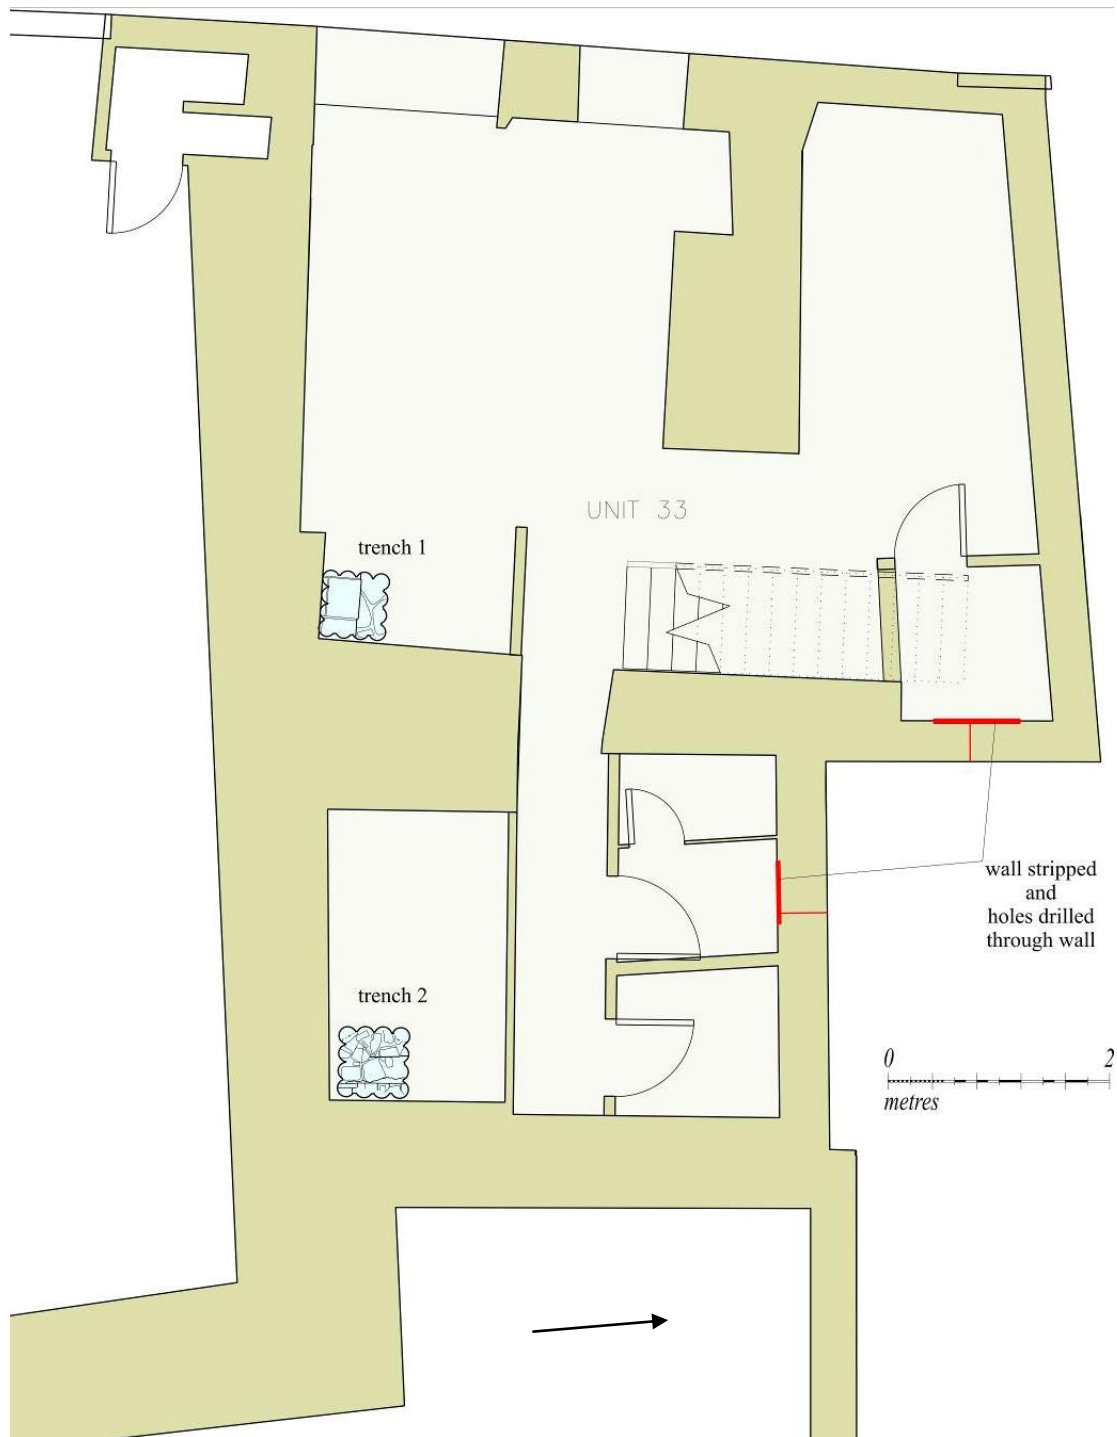
Figure 1 Ground floor plan showing location of investigations

Two localised coring exercises were carried out on the north side of the building at ground floor level, see *figure 1*. These consisted of small holes being broken through interior linings and then coring through the walling behind, through to the exterior. The exercise was intended to confirm that these wall sections – the side (north) wall of the rear range, and the short east-facing return section of the frontage range – to be of modern fabric (of the 1970s works) and non-historic.

For both investigations it was revealed that the inner walling was of cement-bedded concrete block construction, to which an external skin of sandstone rubble had been applied, again cement-bedded. No historically significant fabric was encountered.

At ground floor level two investigations were made through the existing floor surface into the underlying deposits. The first was located at the south-east interior corner of the frontage range, and the second at the south-east interior corner of the rear range – figure 1.

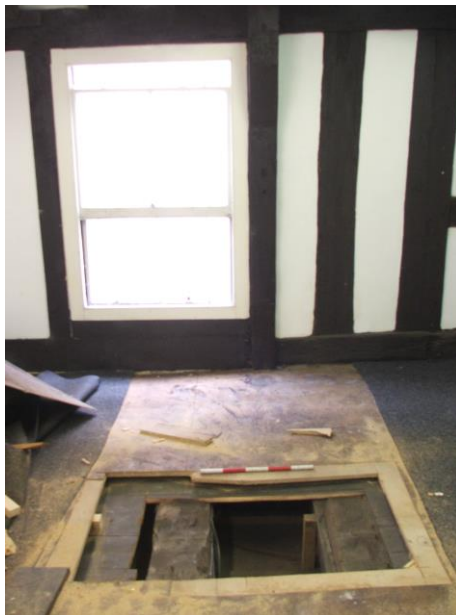
Plate 4 First floor - joisting revealed to south of stack

Existing floor boards were lifted in two localised areas within the frontage range, these on either side of the fire stack that sub-divides the space, *figure 4*. Floor boards were aligned north-south in both areas; these were lifted to reveal the underlying joisting structure. In both areas oak joists of substantial section were revealed. On the south side of the stack these corresponded to the noses of jetty beams visible to the exterior (west frontage – see cover) – two early joists were revealed, *plates 4* and *5*. On the north side of the stack two further early joists were revealed and, to their north side, a further modern sawn pine joist, evidently part of the 1970s works, *plate 6*. The survival of parts of the early first floor floor structure on the north side of the stack had not been previously confirmed.

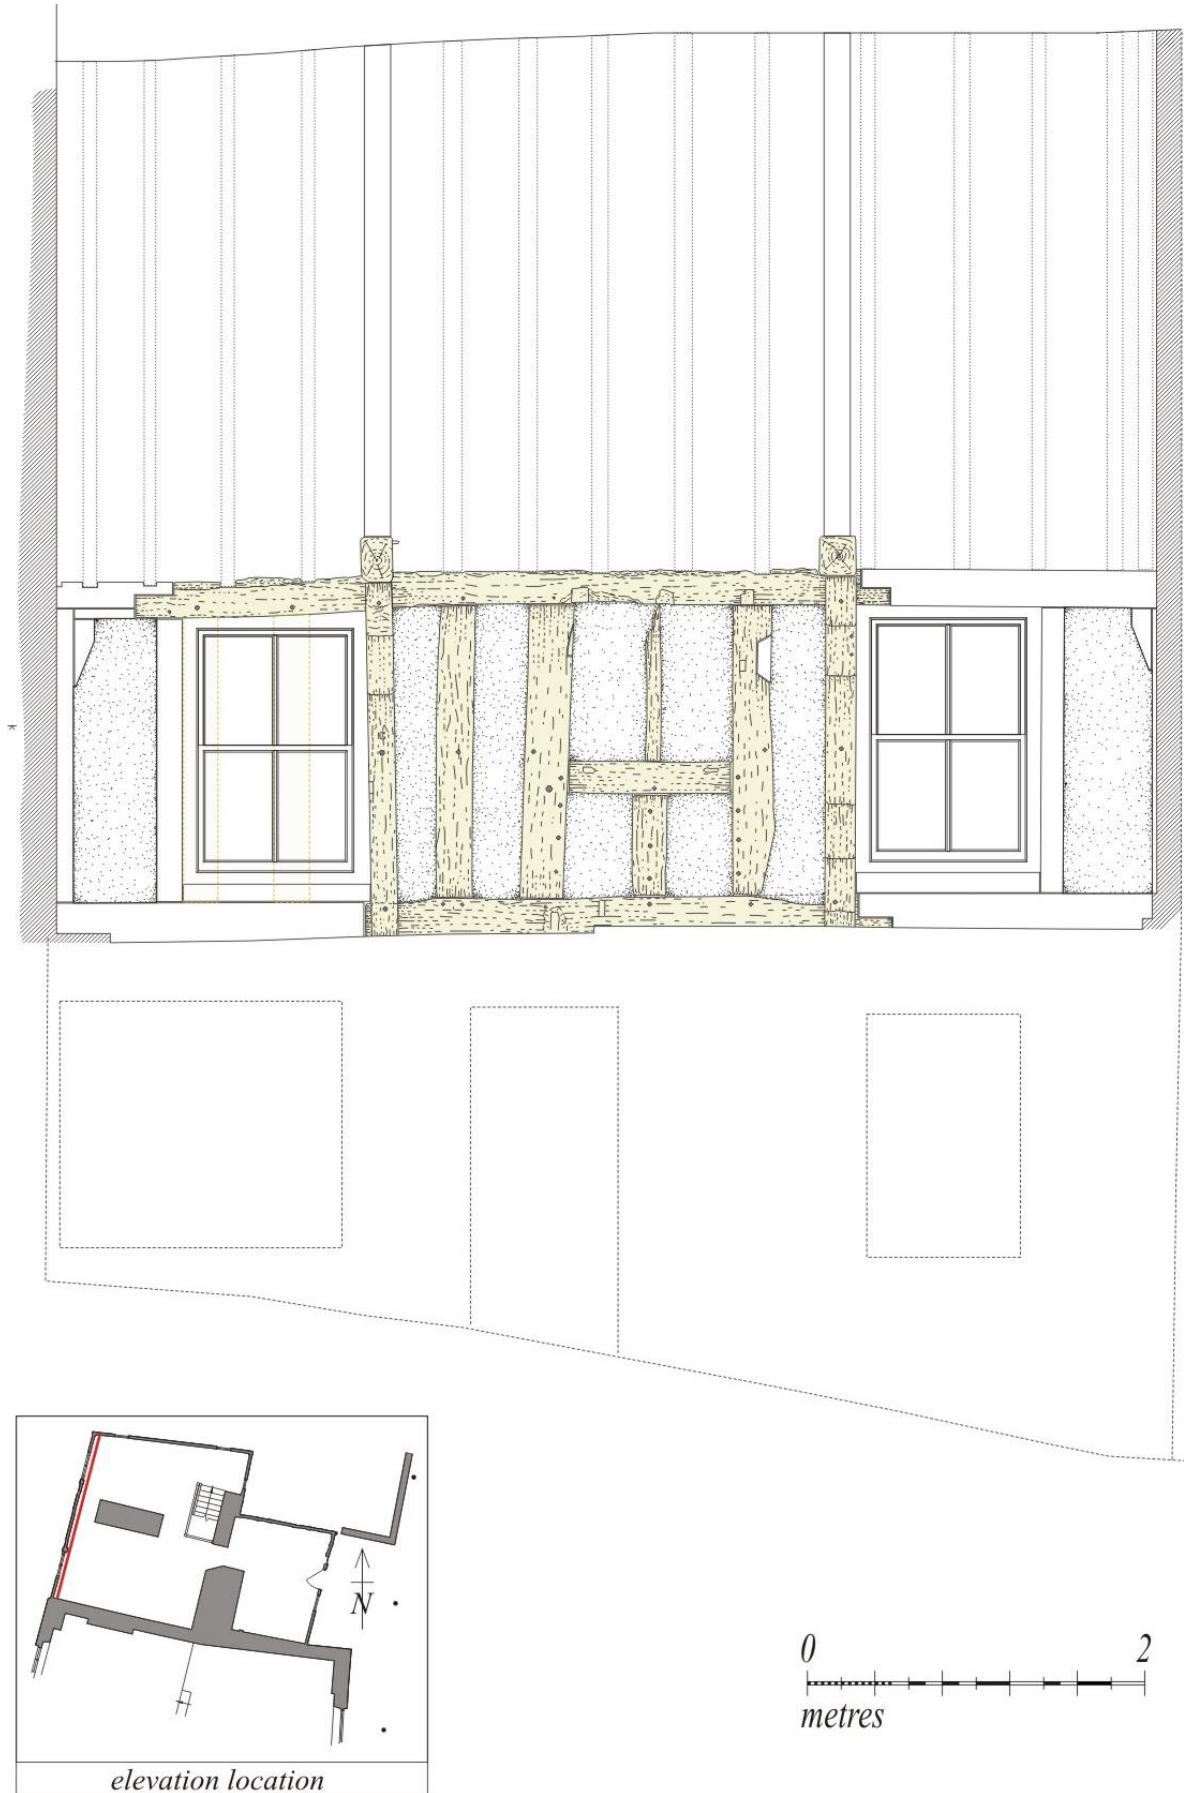
Figure 5 First floor – record of the interior of the west wall

Details of the survey record of the roof trusses made in April 2015 were checked and some additions made, and the record enhanced in general. The early timber framing of the interior side of the west (frontage) wall of the principal range was recorded in detail. This included the evidence for an early, possibly original window; this feature was subsequently blocked, perhaps at the time of the insertion of the existing stack. Corresponding to the position existed a series of augered / drilled holes and other sockets (above) and evidence of fixings that didn't relate to the construction of the framing. However it remained unclear to what these features related.
