Blair Adam House

By Kelty, Kinrossshire

South Range: Historic Building survey: June-August 2015

South Range : Historic Building Survey : June-August 2015
Job number 1854.00

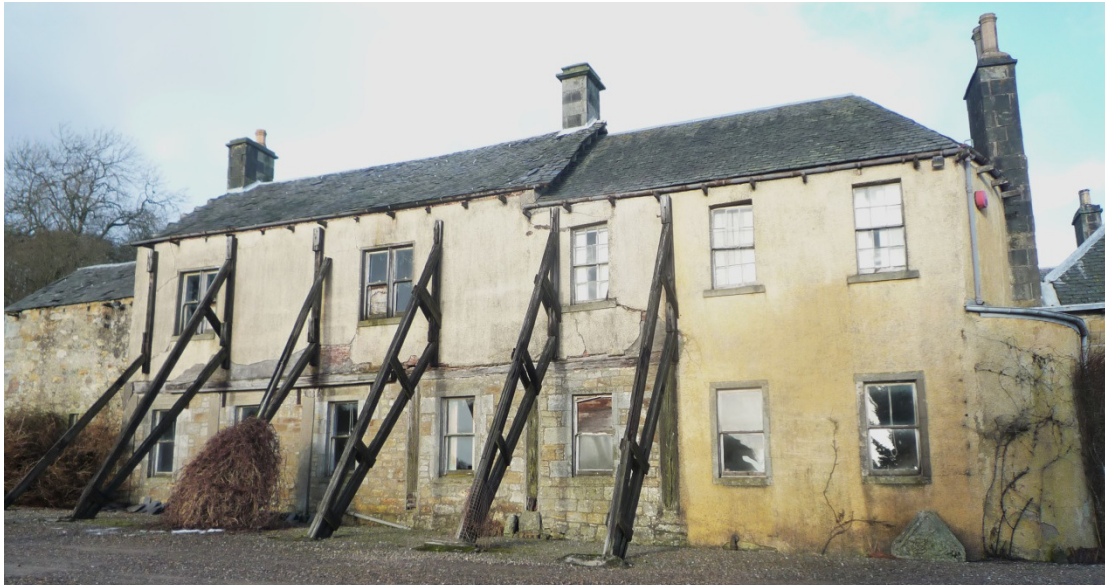
Plate 1 The south range in January 2011

Addyman Archaeology were commissioned to carry out recording and monitoring works before and during the partial dismantling of the central body of the south range of Blair Adam House on the Blair Adam estate by Kelty, Fife. The poor condition of the range had necessitated its partial dismantling on safety grounds. This resulted in the removal of the roof, the frontage (south) wall at first floor level, and parts of internal partitions and the end walls to east and west, *plates 1 and 2*.

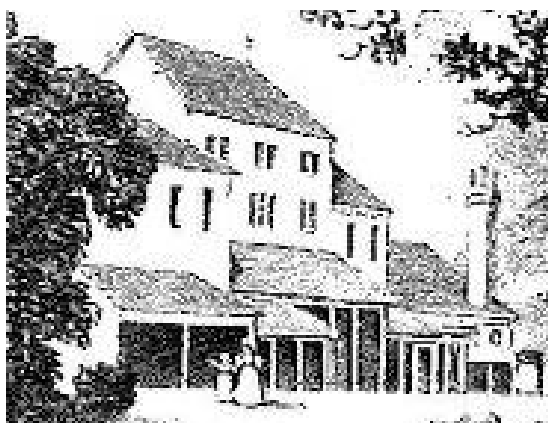
Figure 2 Lithograph of 1835 showing the south range as it had originally been built, drawn by John Clerk of Eldin – view from the south-west

Much of the basic history of the building has been previously outlined in Catriona A Hill's '*Blair Adam: Kinross shire, The Design and Realisation of a Scottish Estate*' (Hill 1995). Approximate dates of works were assigned to individual phases observed during the opening up and demolition works based on this history (*figure 1*). The present works revealed that the south range was more complex than the three phases assigned in previous historic works (*figures 2 and 3*).

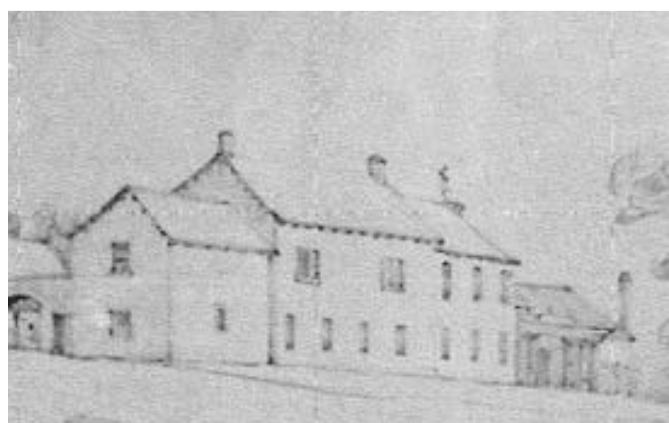
Figure 3 View showing the south range (to left), from the south-east 1847

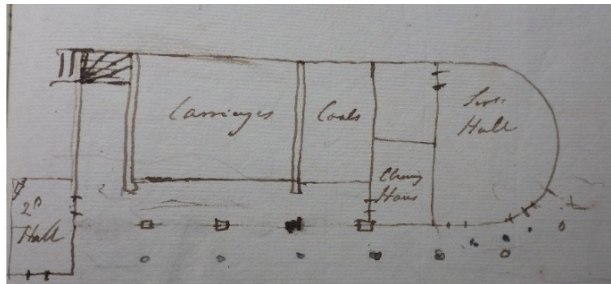
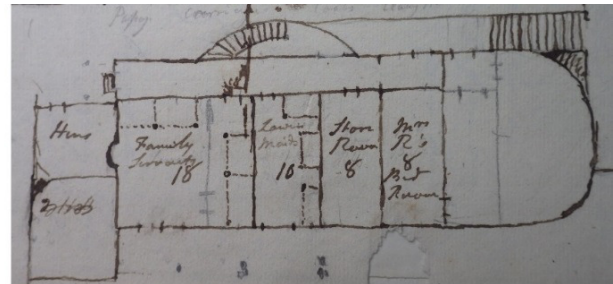
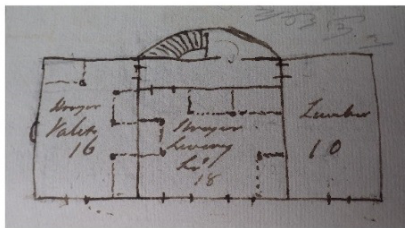
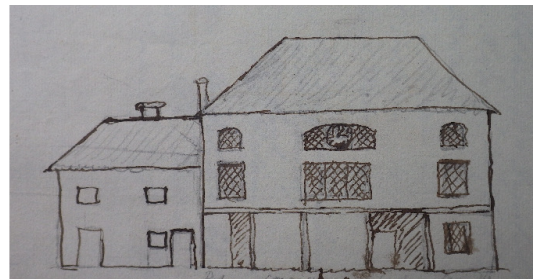
Figure 4 Sketches of the south range from Adam's notebook of 1800 -1814

The South range was originally built by William Adam circa 1805 (figures 4, 5 and 6). It formed an arrangement of service buildings to accommodate servant's carriages and coal and was initially attached to the farm buildings of the west range; it was not necessarily connected to the main house to the east.

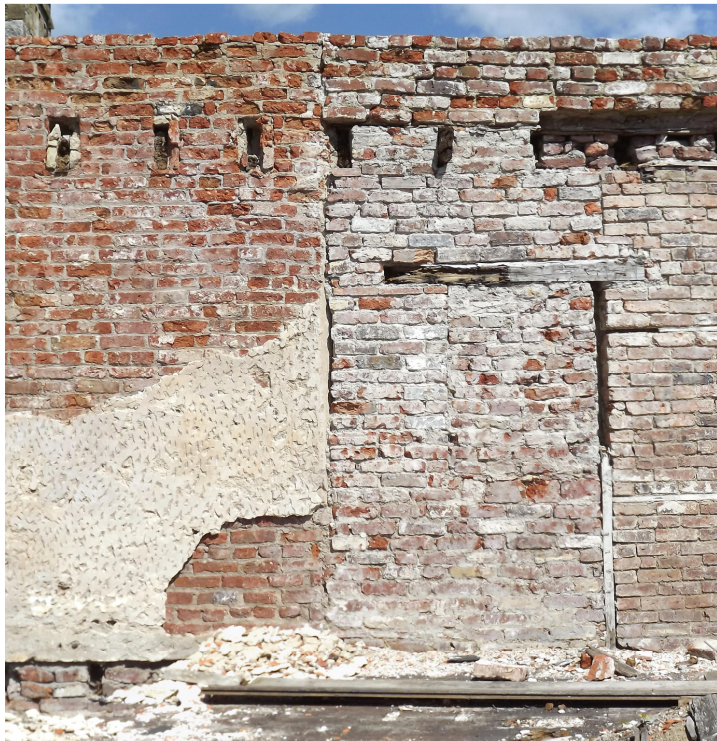
Plate 3 west end of 010 shown by plaster returning to north behind brickwork 024

The projecting curved stairwell 010 appeared to be integral to the brick masonry of 006 in the central building (plates 3-5). It is possible that this stairwell was supported by piers at ground floor level and only ran from the first floor up to the second floor, providing internal access between the two floors. The stairwell was plastered on the hard with plain white wall plaster.

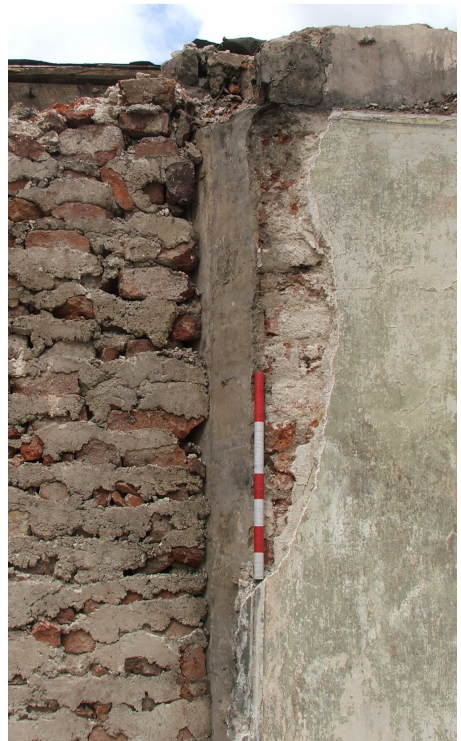
Plate 4 east end of 010 plaster behind 024 blocking and later plaster to right

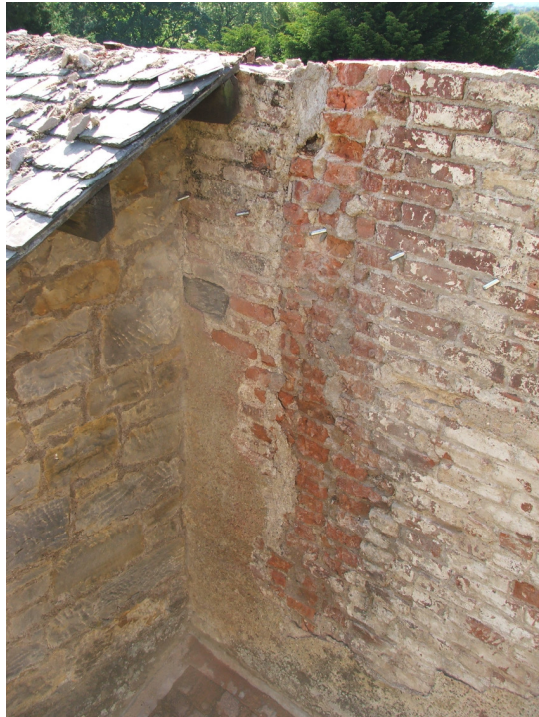
Plate 5 exterior stub of 010 clawed back flush (mid frame) and infill 024 brickwork to left behind later lean-to

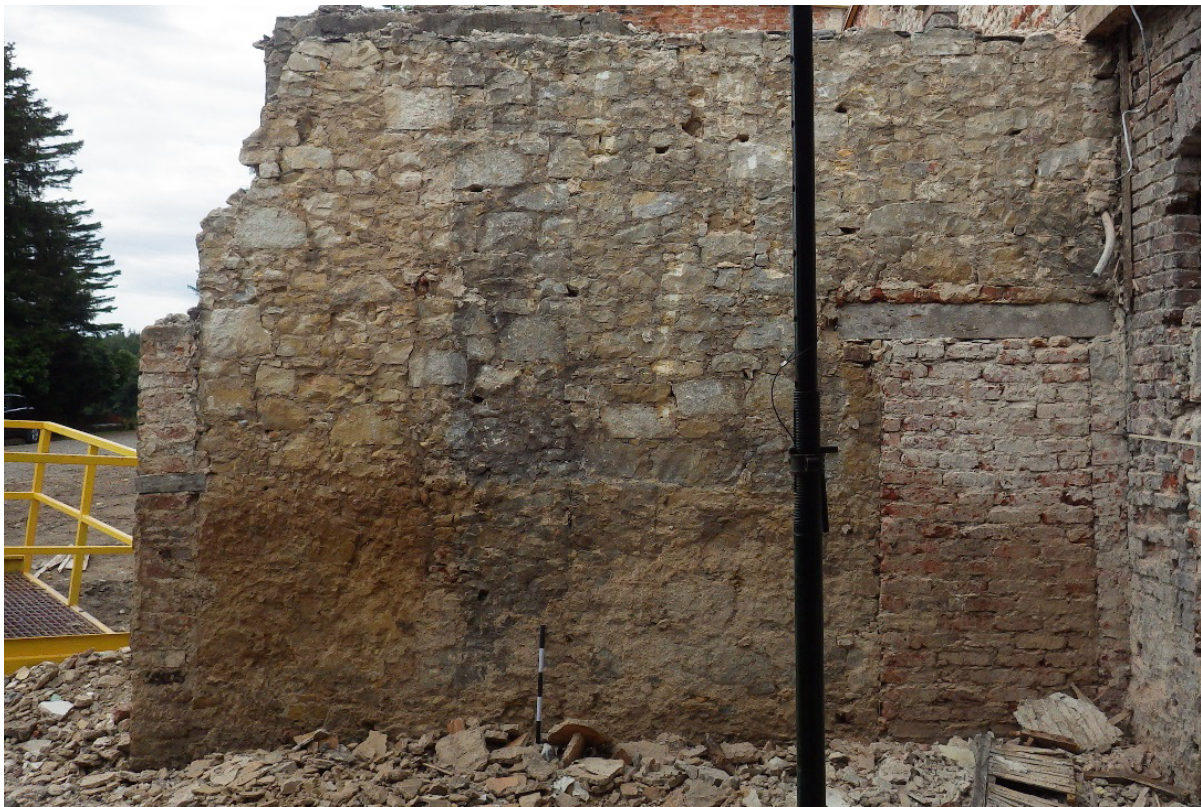
Plate 6 masonry 031

The partition between bays four and five was of sandstone masonry 031 (*plate 6*) and still survived following the moving of the front elevation (see below). This was a secondary modification of *phase 1* and abutted the brick masonry of 001 at the north and south. This perhaps suggests that the layout on the historic plan was not entirely the original layout, or that it was altered. Although this wall is likely to be the wall shown on the plan, there is no door on the south end of the surviving masonry as shown on the plan.

Probable evidence for an east-west partition as shown on the plan was evident as a dark shadow running up the masonry (*plate 6*)¹; this was not tied in and is secondary to 031. This was also not central to the room as it appeared on the plan.

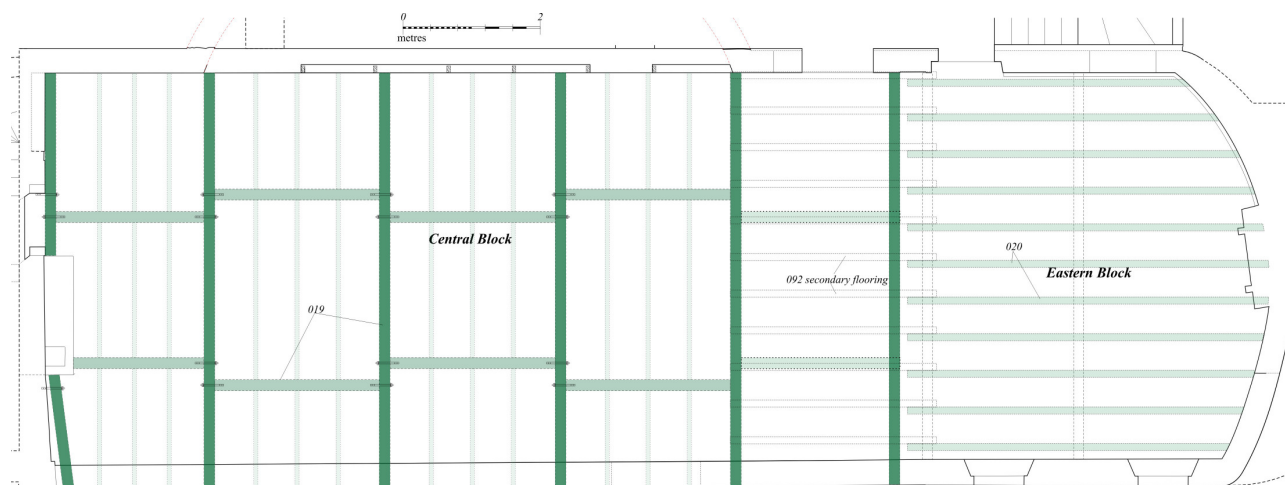
Figure 7 floor structure at 1st floor

The flooring of the central block at first floor level appeared to have been replaced with a major joisted floor to span the wider width; this was detailed with interesting jointing. This floor originally had six north-south aligned substantial joists 019 built into the north and south masonry. Between these (*figure 7*) running east-west ran pairs of joists staggered in alignment between the bays. These were most notable for the complex tusk tenon jointing detail into the main north-south beams (*figure 8*).

The main timber beam 014 along the frontage and holding up the masonry above was also of note in its construction. This was in three parts overlying the six uprights. The central part of the beam was positioned over the central bay and was jointed with a ‘hooked scarf’ joint onto the beams either side to form a single continuous beam; these joints were also bolted together for added security. The six uprights were tenoned into the 014 beam.

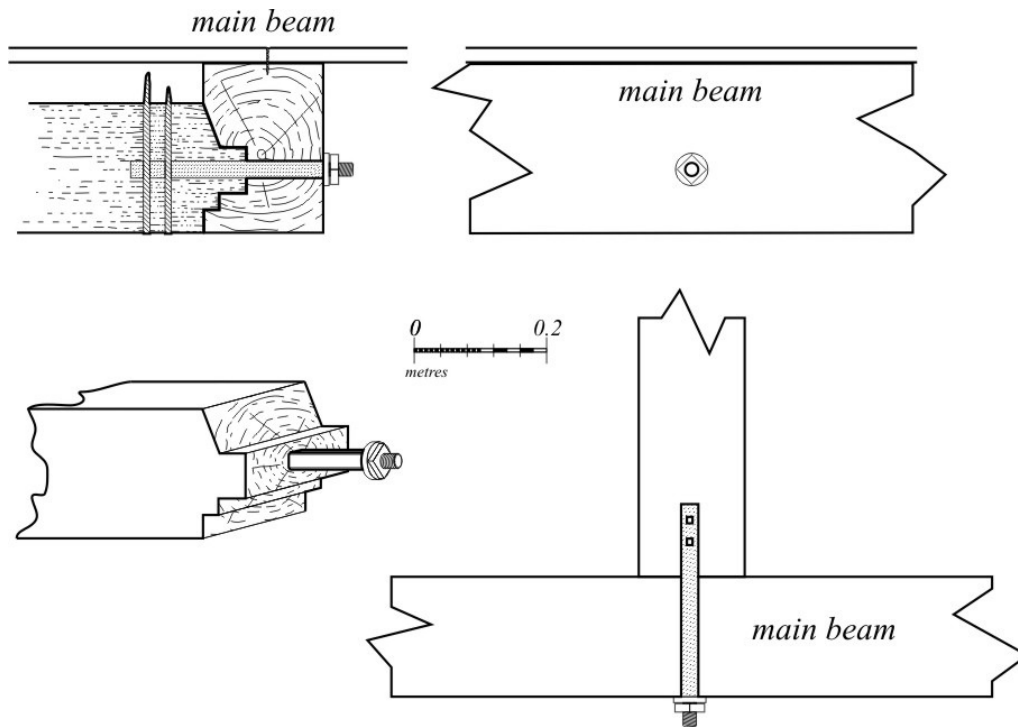
Figure 8 detail of tusk tenon joint

The ‘tenons’ were of iron threaded on the end and held in place with two iron spikes. The joint was tightened and held together by a bolt on the threaded end. The staggering of the east-west joists was to allow the tightening of these bolts.

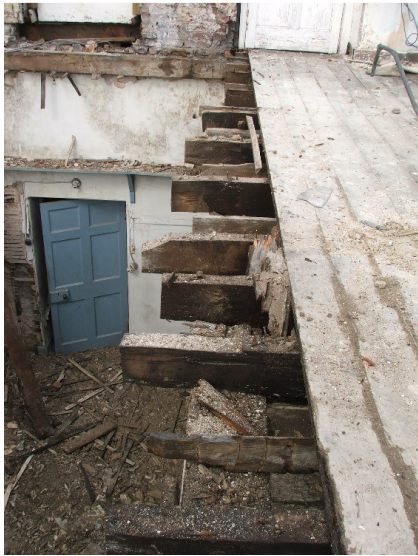
The removal of the wall 011 meant that the eastern floor 020 needed new supports as the joist ends were formerly embedded into the masonry. Two round timber supports (possibly reused ship masts) supported two horizontal north-south aligned beams 091 bedded into the north and south elevations supporting the joists.

Despite the removal of the upper floors, the floor plan of the first floor curved stairs may have survived as a room for a short time. The area was partitioned off with a brick infilled timber partition 021, which clearly overlay the neat plaster lining the stairwell; a door was constructed within this 022 to the east (*plate 7*). The partition was neatly plastered on the north face.

Plate 7 West joist ends of east floor 020 formerly bedded into 011

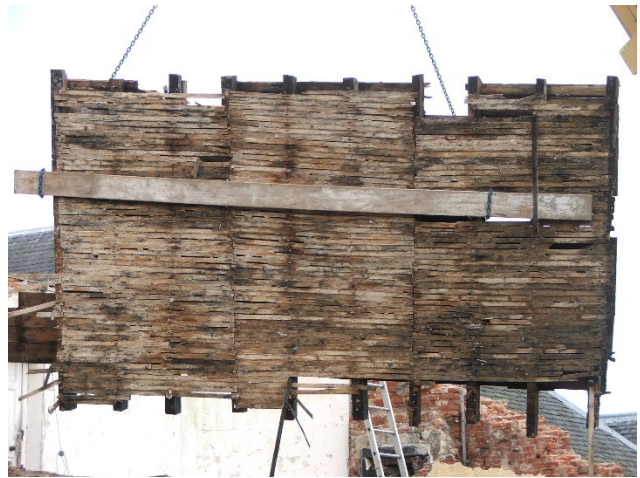
Plate 8 Floor 092 within bay 5 being lifted out in 1 piece

At first floor level, following the removal of the brick masonry partition 011 (*phase 3*, above) the floor level 092 within the eastern room of the central building (the fifth bay) was lowered to the level of the east floor 020. This newly lowered floor 092 was bedded into the top of 031 to the west and was supported by the north-south support beam 092 to the east; this was lifted out in 1 piece during demolitions (*plate 8*).

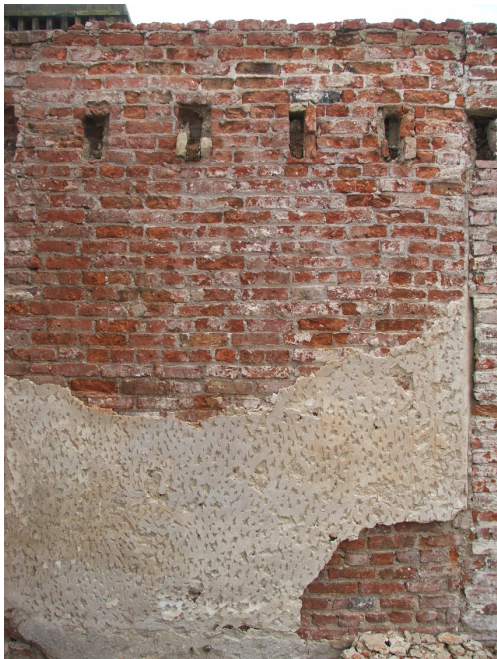
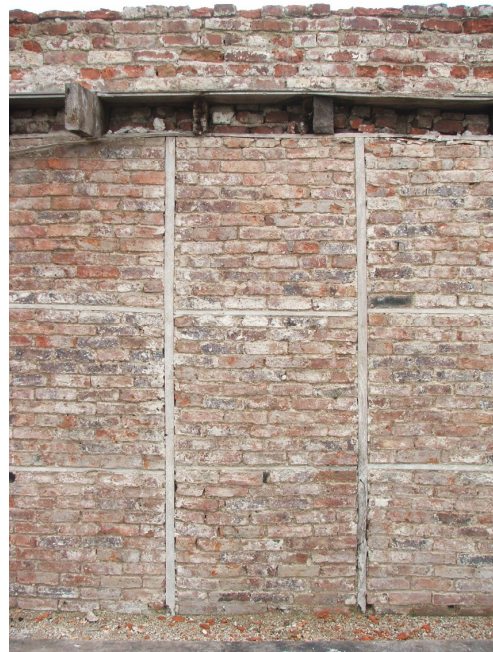
Further evidence for the partition 021 being secondary was evident where the floor joists of the ‘floor’ above were cut into the early masonry 006 but associated with the 021 partition, *ie* the partition was built up to or the joists 070 were sitting on top of the partition (*plate 9*). This related to the removal of the upper stories and subsequent lowering of the upper floor: the floor joist ends would have truncated the partition had it had been in place at that time.

The floorboards on top of the joists 070 of the lowered floor were preserved *in situ* and had been built over with later brick 024. Interestingly, they appeared to be situated within the curved stair floor space at the upper level, perhaps indicating that this space was still usable at this time and that the upper part of the stairs was not entirely demolished when the second floor was removed.

Plate 9 Early 006 brickwork with 070 joists ends cut into and partition 021 built up to /with 070 joists and flooring above

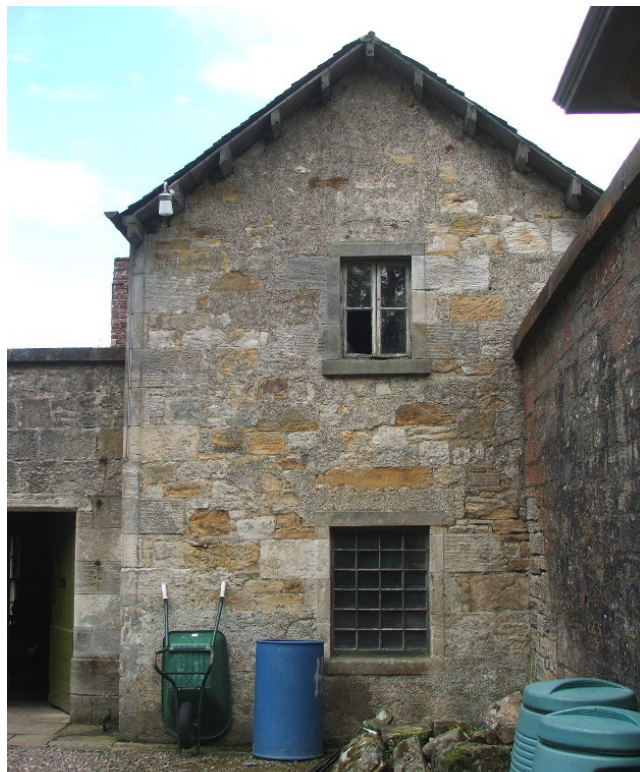
The openings of this phase were detailed similarly throughout. Windows at first floor level were plain jambed with a projecting sill to the courtyard side (north) and with a raised margin and projecting sill on the western gable exterior to the courtyard (and so visible to visitors, *plate 11*). Windows and doors were detailed with a raised margin throughout at ground floor level with light horizontal tooling on the margin and deeper horizontal tooling on the tails. Corners were also detailed with a raised margin to match.

Plate 11 West gable showing detailing

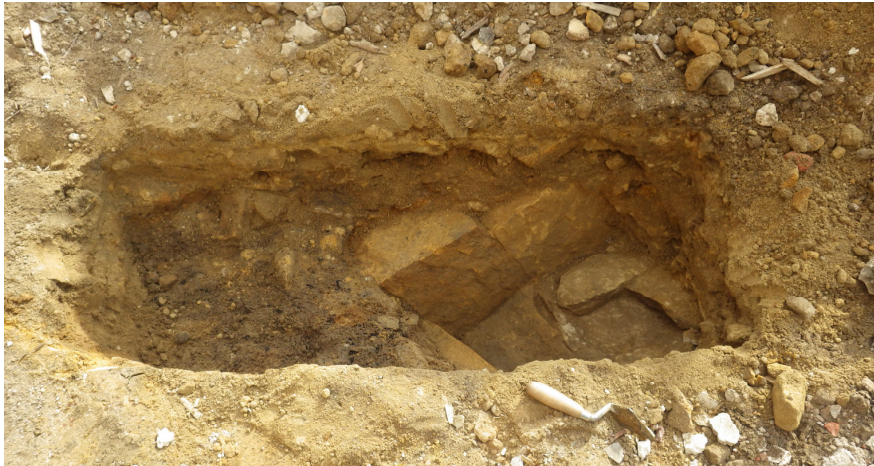
A 1.50m north-south by 0.6m wide trench was excavated by hand across this line. However, within the trench only a thin spread of redeposited mixed soils trampled onto truncated bedrock was noted. Overlying this was a deep deposit of mixed gritty sands and broken bedrock infill (*plate 12*).

Plate 12 trench across former frontage line truncated bedrock to right and redeposited soil trample over bedrock to left

No evidence for the frontage line was noted and it was considered that if the former frontage was supported by timber piers as in the later phase (as seen in the early drawings) that a continuous foundation would not be needed, only isolated bases for the piers.

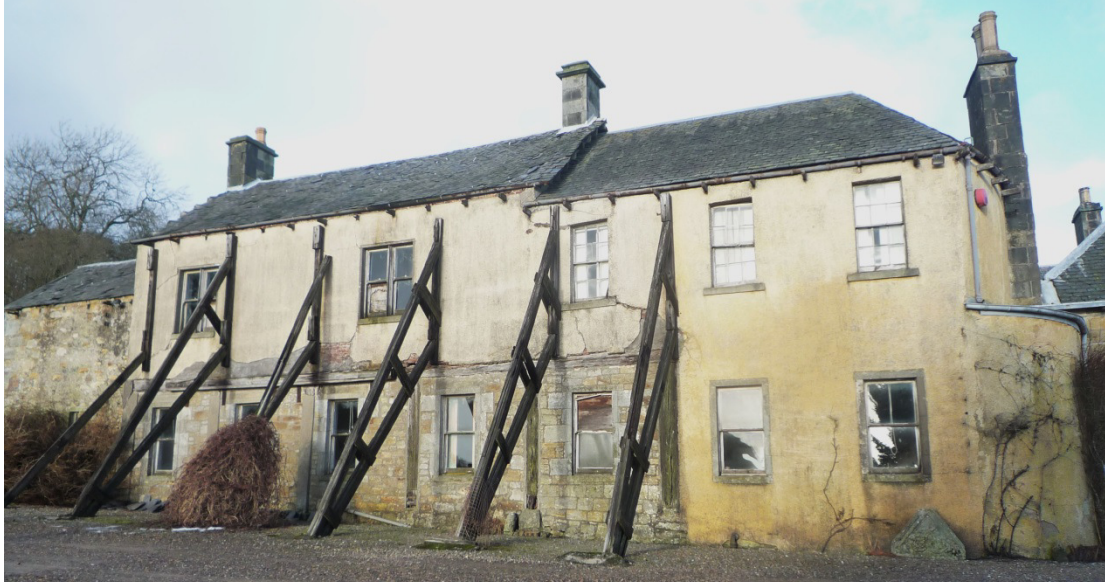
Plate 1 The south range in January 2011

The ground floor front (south) elevation was divided into five bays defined by substantial timber piers supporting the upper floors (*plates 1 and 2*) with a veranda with matching piers in front. The rear (north) elevation was largely of blank brick.

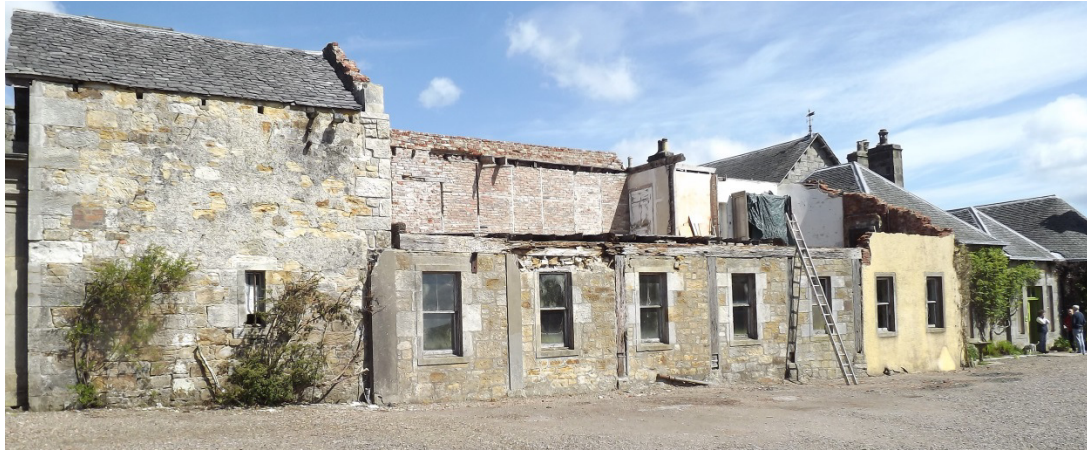
Plate 2 The south range in May 2014

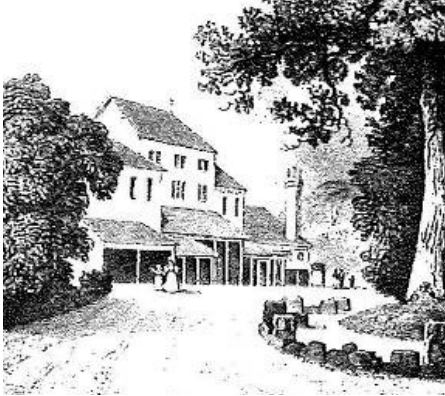
After 1805, William Adam, later Lord Chief Commissioner, built a new service wing which finally completed the south side of the complex's courtyard. It appears that this addition was intended to accommodate servants, carriages and coal. An 1835 lithograph of the south elevation shows that the three-storey block and adjacent servant's hall were built behind the line of the existing façade, allowing the curved end of the east range to protrude (figure 2). In front of the façade, was a timber lean-to loggia or veranda which created a covered walkway from the carriages to the entrance of the house.

Figure 2 Lithograph of 1835 showing the south range as it had originally been built, drawn by John Clerk of Eldin – view from the south-west

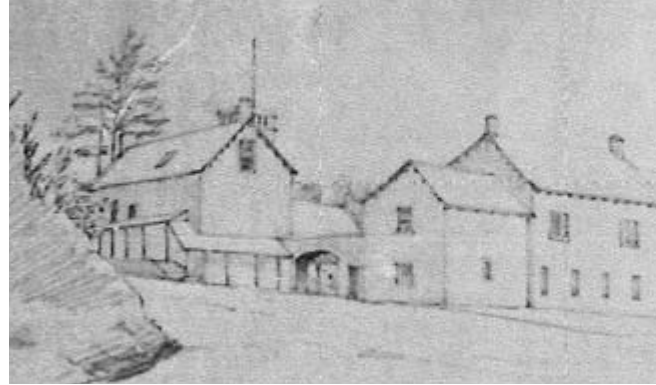
Figure 3 View showing the south range (to left), from the south-east

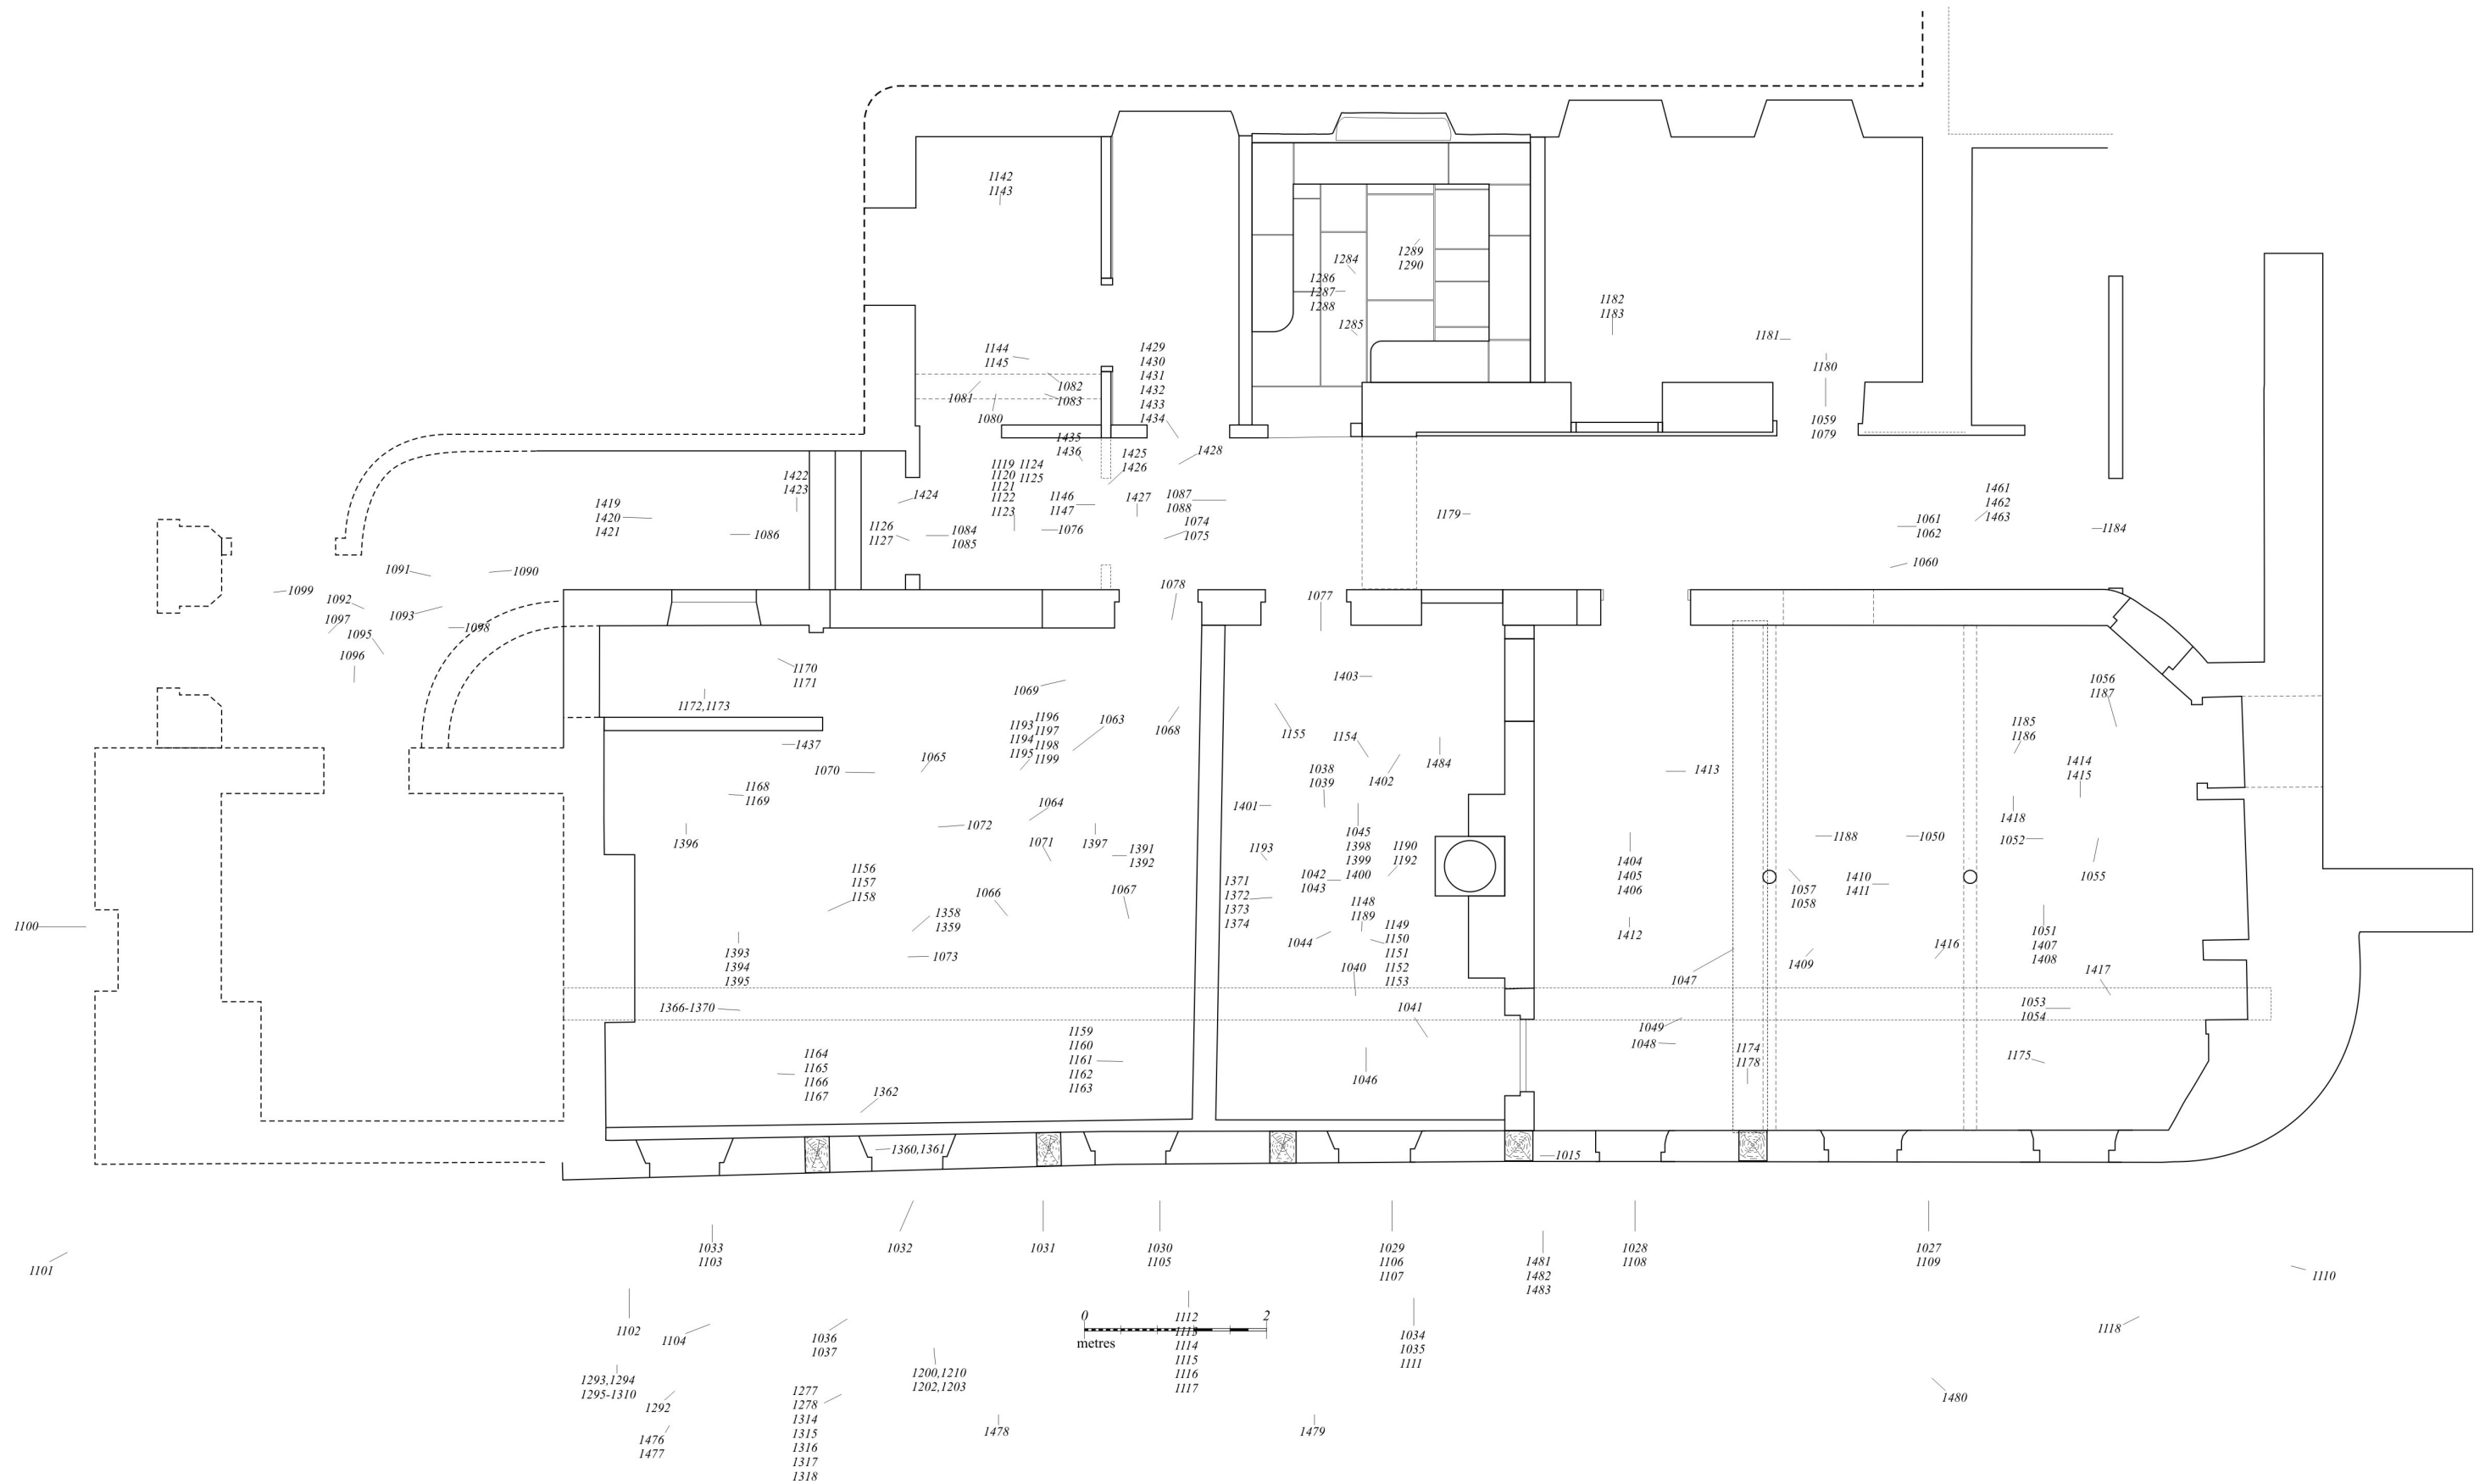
Ground floor photo locations (Addyman Archaeology 2015)

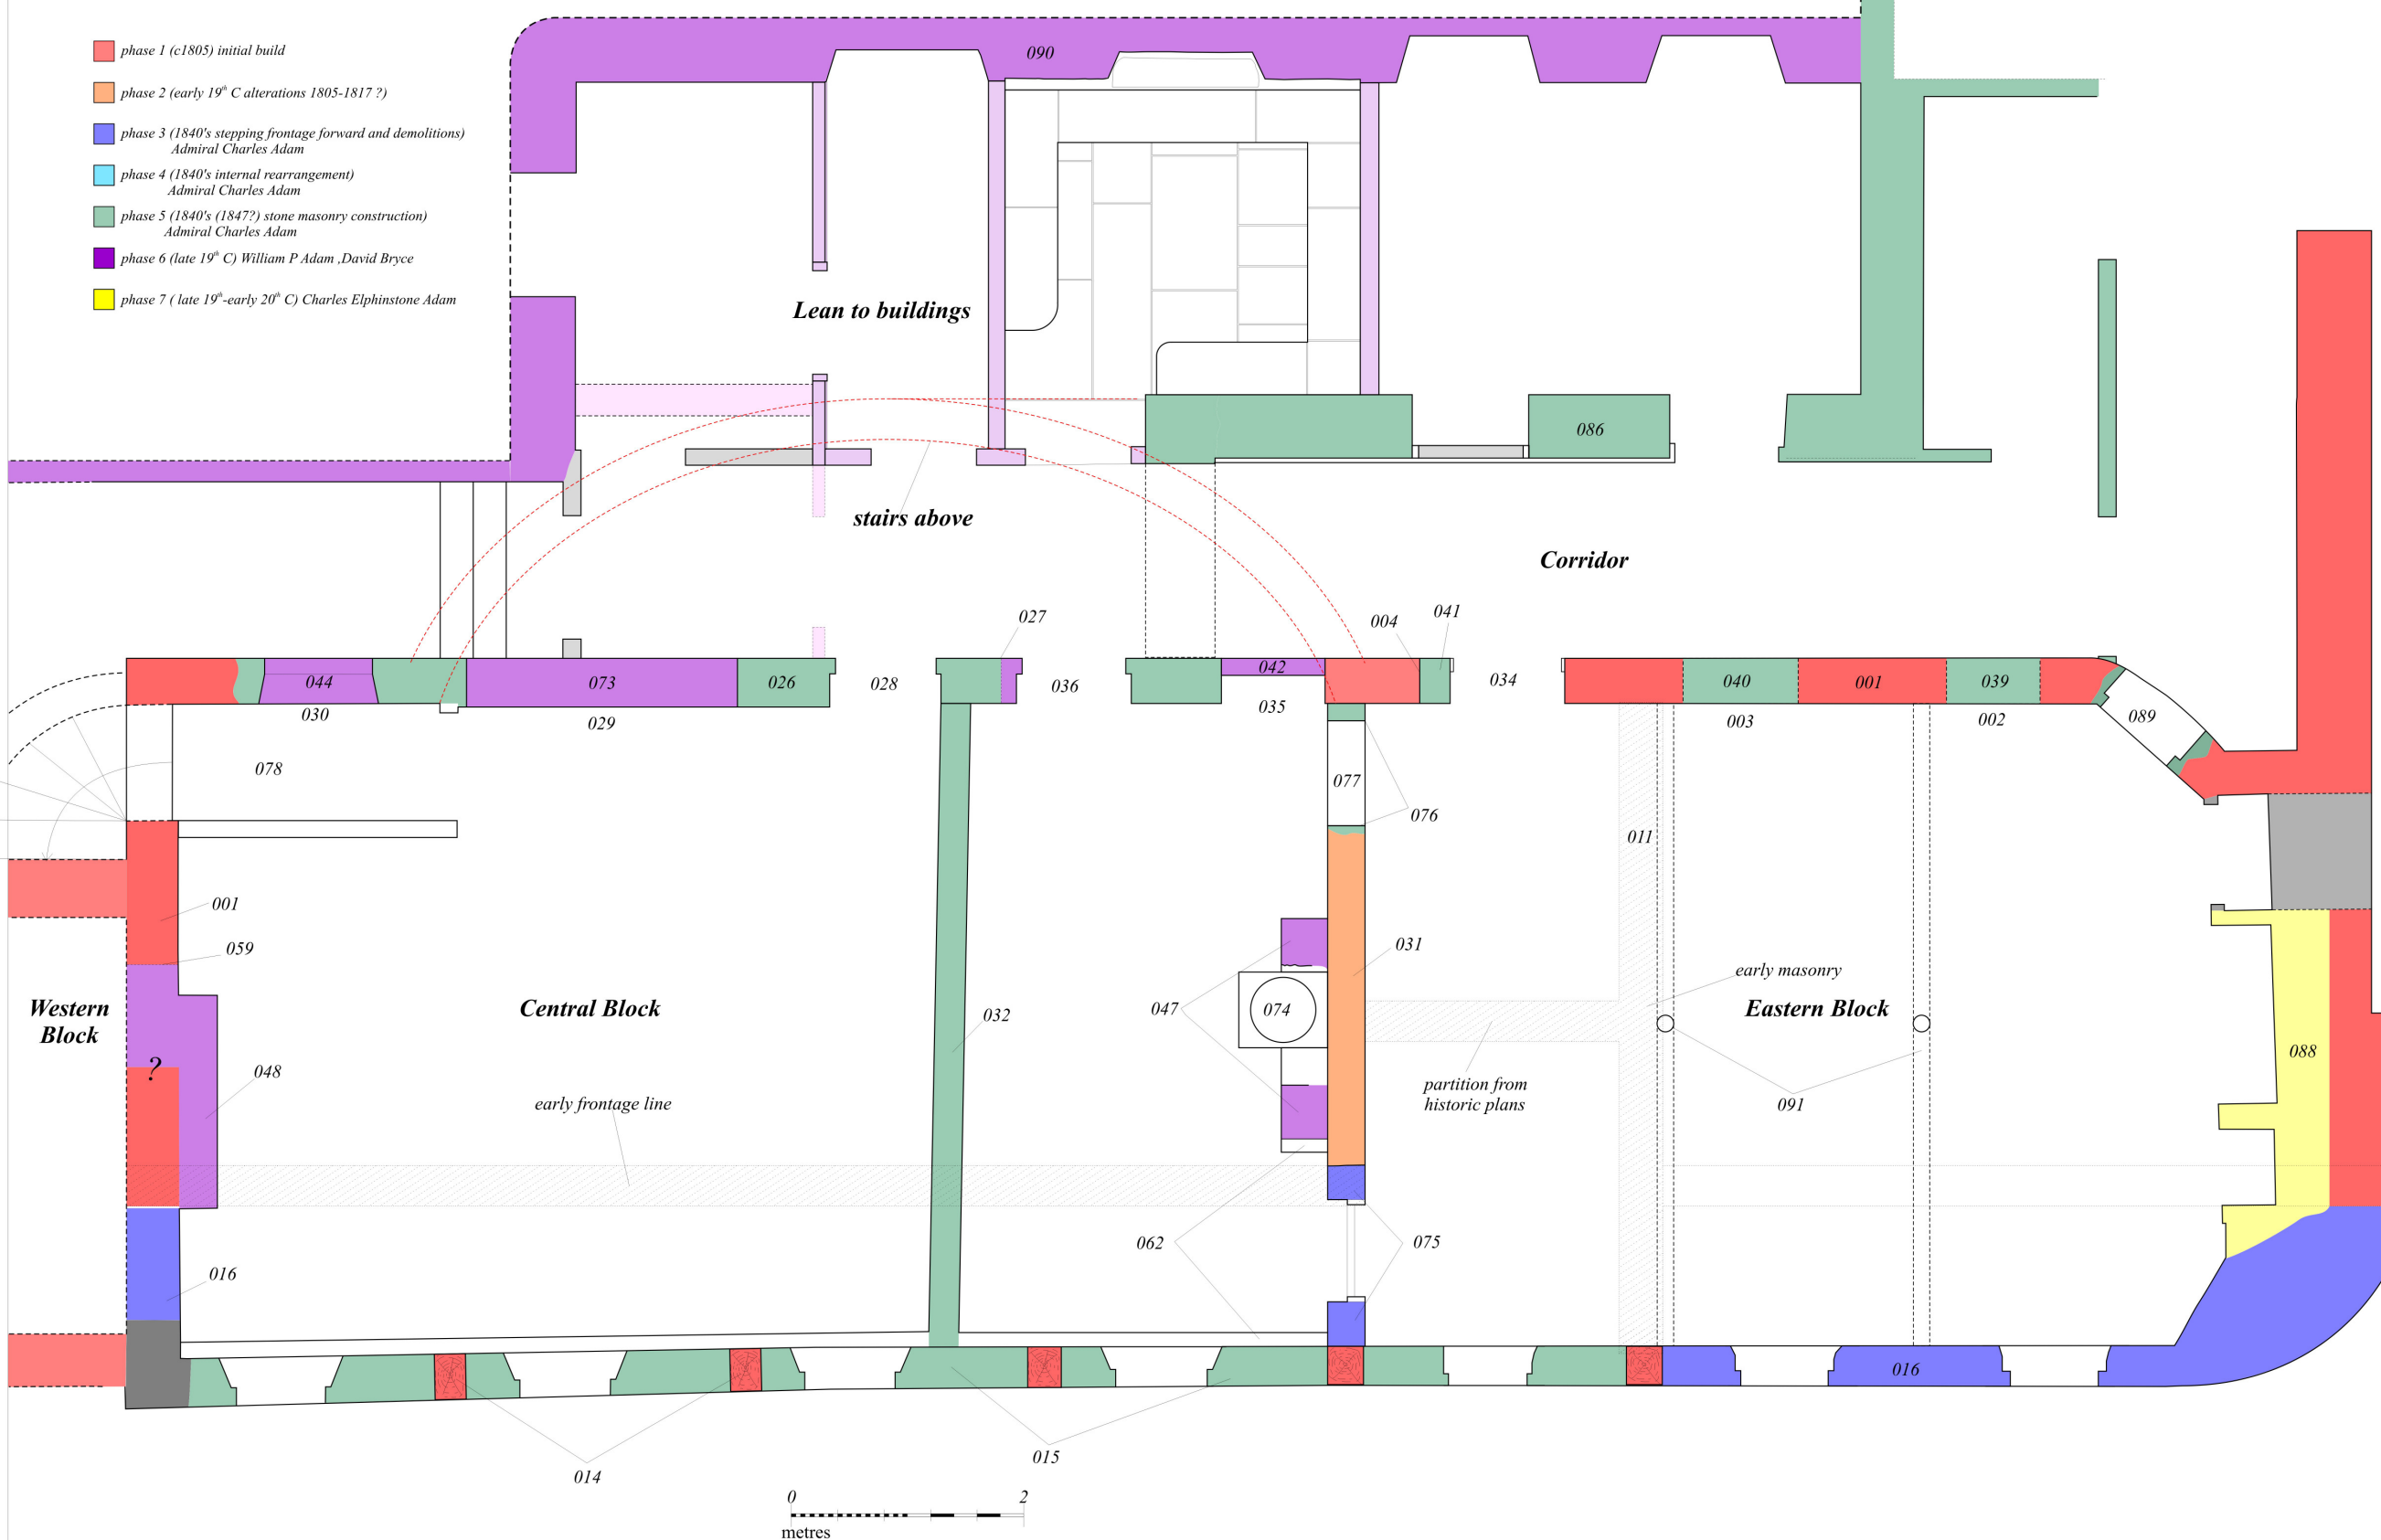
- phase 1 (c1805) initial build
- phase 2 (early 19th C alterations 1805-1817 ?)
- phase 3 (1840's stepping frontage forward and demolitions) Admiral Charles Adam
- phase 4 (1840's internal rearrangement) Admiral Charles Adam
- phase 5 (1840's (1847?) stone masonry construction) Admiral Charles Adam
- phase 6 (late 19th C) William P Adam ,David Bryce
- phase 7 (late 19th-early 20th C) Charles Elphinstone Adam

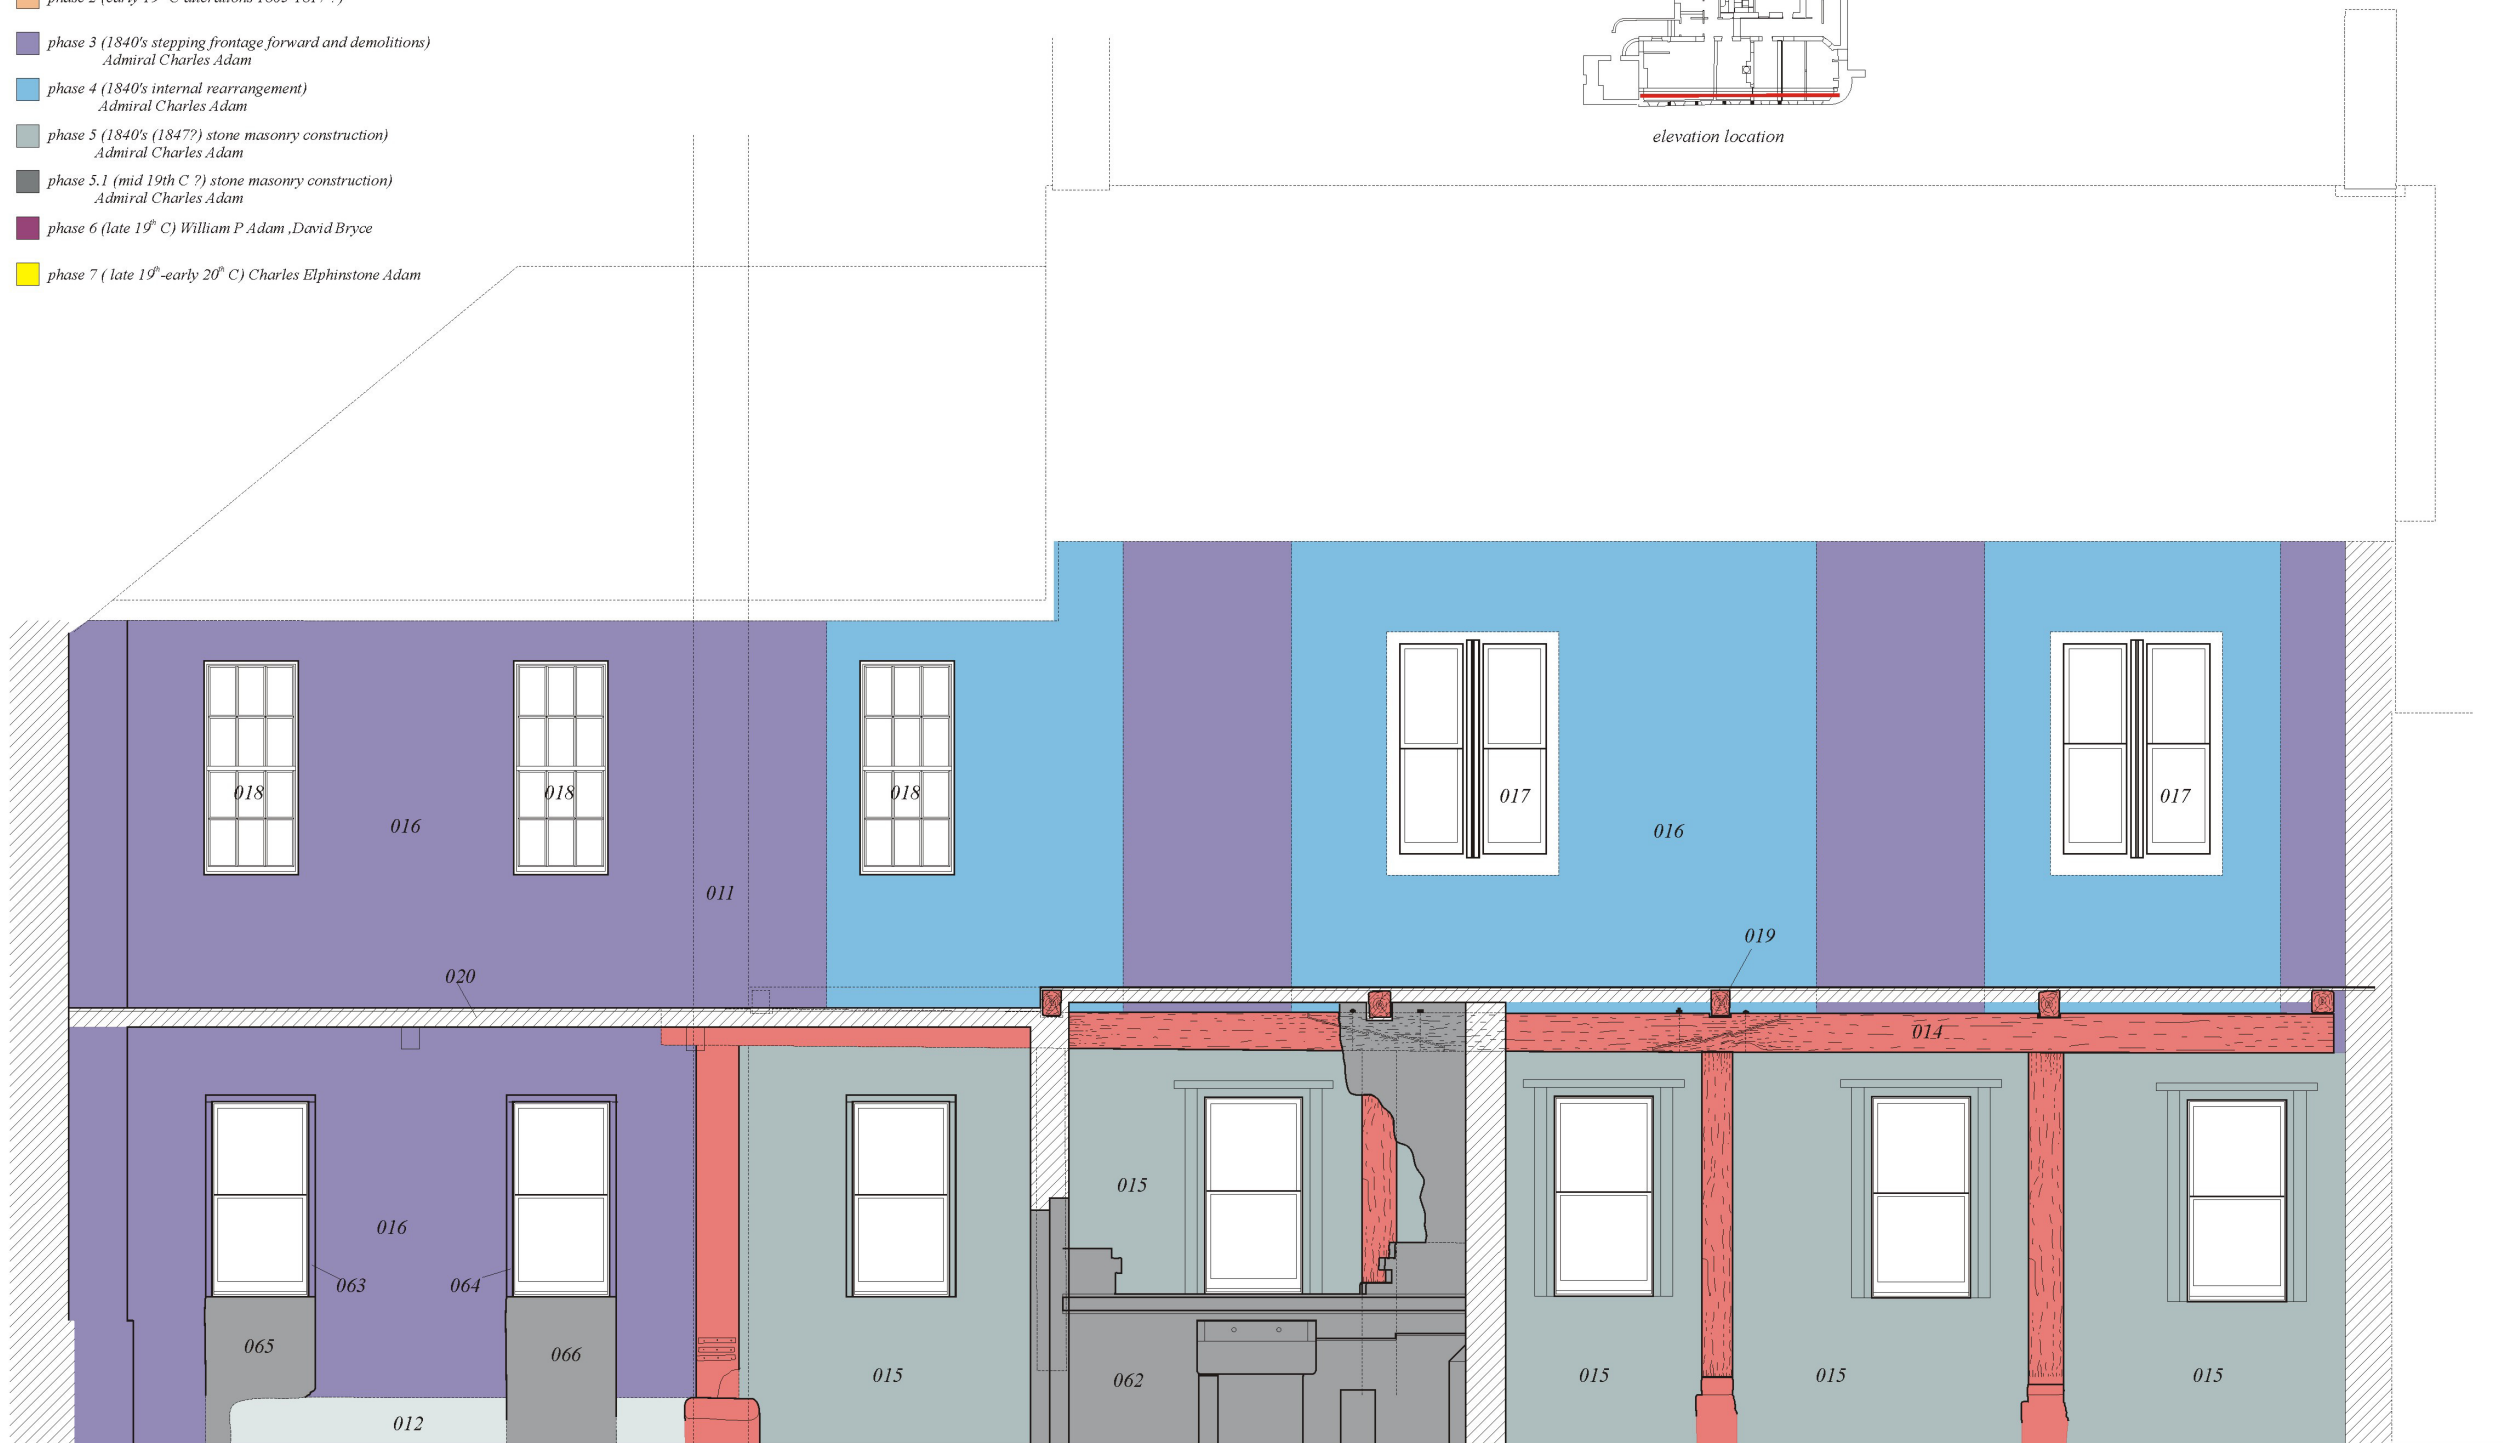
- phase 1 (c1805) initial build
- phase 2 (early 19th C alterations 1805-1817?)
- phase 3 (1840's stepping frontage forward and demolitions)
Admiral Charles Adam
- phase 4 (1840's internal rearrangement)
Admiral Charles Adam
- phase 5 (1840's (1847?) stone masonry construction)
Admiral Charles Adam
- phase 6 (late 19th C) William P Adam, David Bryce
- phase 7 (late 19th-early 20th C) Charles Elphinstone Adam
