Blair Adam House

By Kelty, Kinrossshire

South Range: Historic Building survey: June-August 2015

South Range : Historic Building Survey : June-August 2015
Job number 1854.00

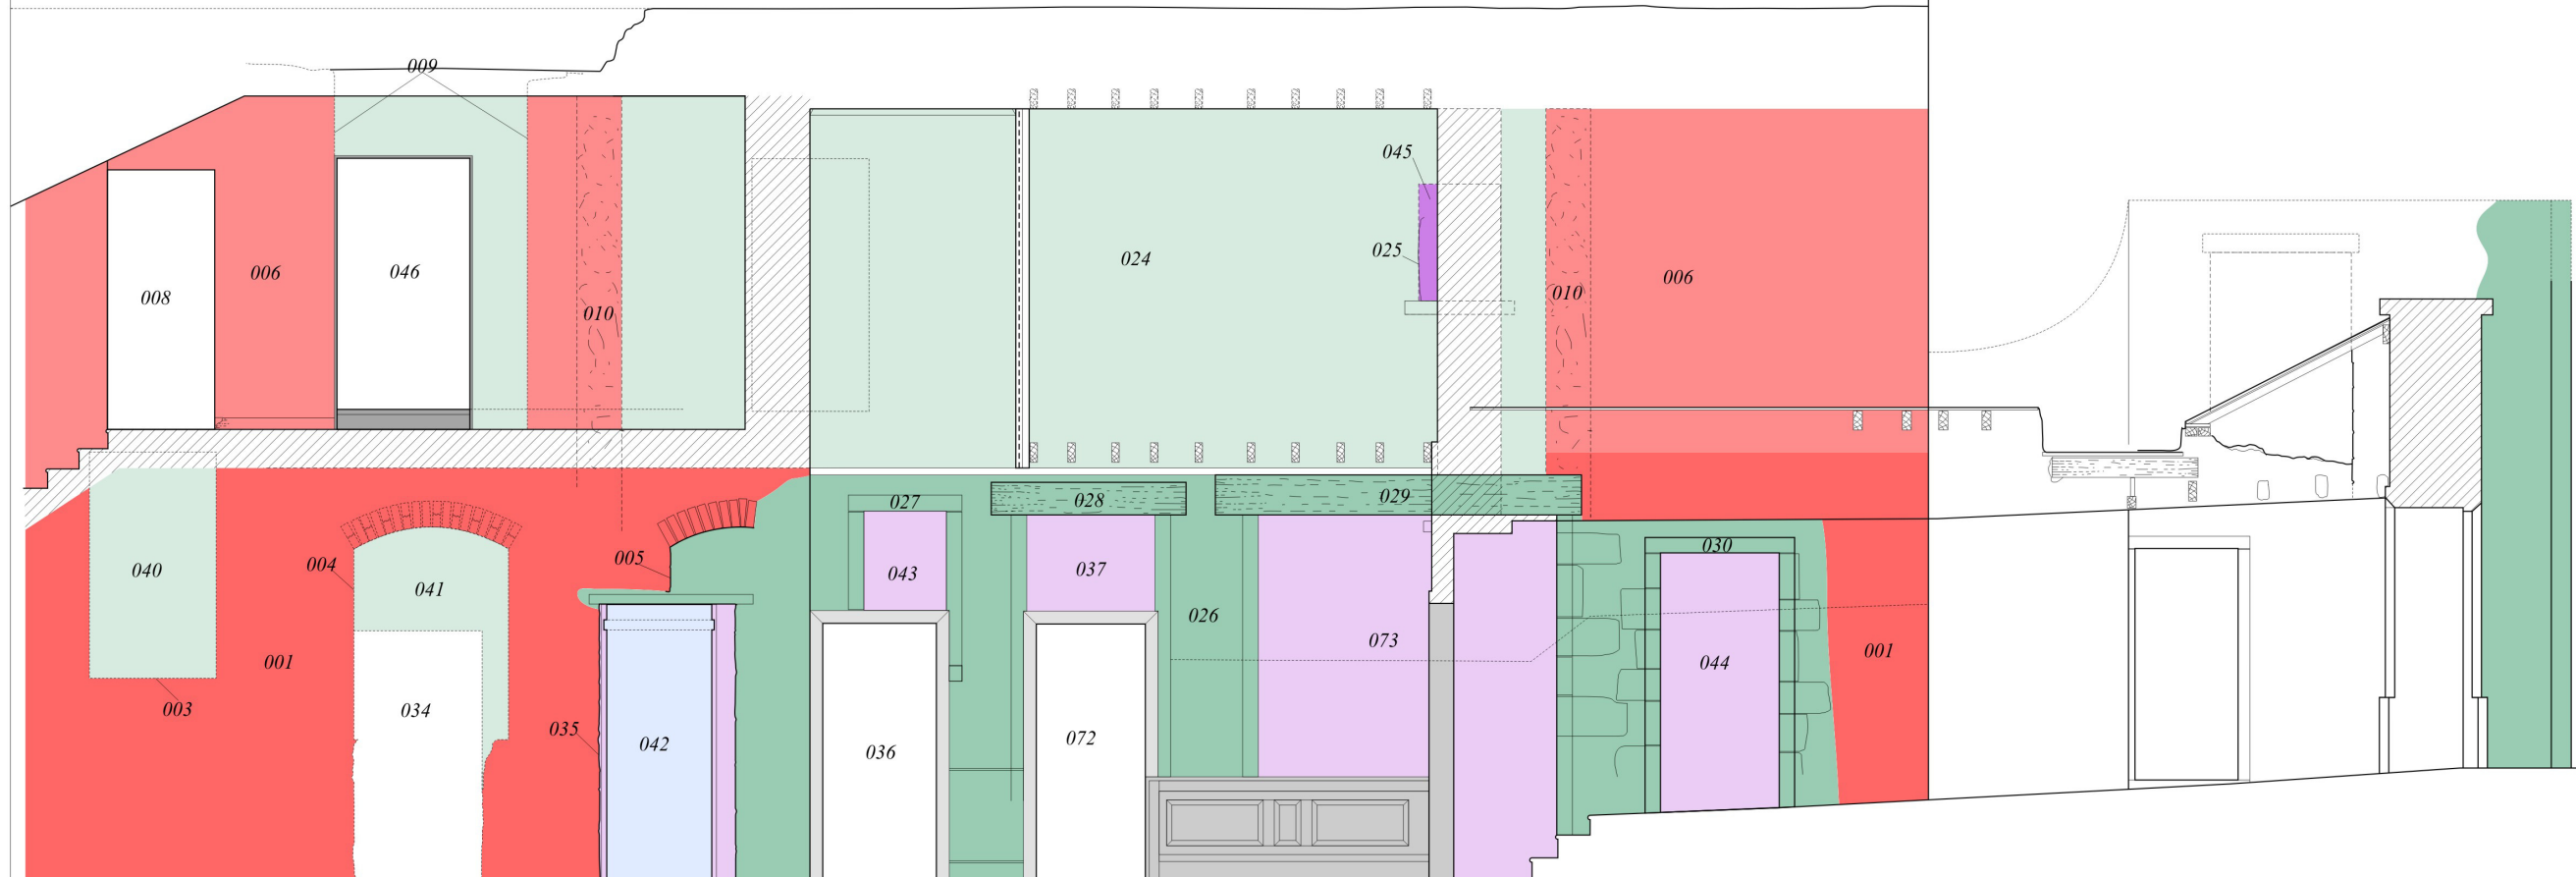
- phase 1 (c1805) initial build
- phase 2 (early 19th C alterations 1805-1817?)
- phase 3 (1840's stepping frontage forward and demolitions)
Admiral Charles Adam
- phase 4 (1840's internal rearrangement)
Admiral Charles Adam
- phase 5 (1840's (1847?) stone masonry construction)
Admiral Charles Adam
- phase 6 (late 19th C) William P Adam, David Bryce
- phase 7 (late 19th-early 20th C) Charles Elphinstone Adam
