Longniddry Steading

Longniddry, East Lothian

Archaeological Desk-Based Assessment

Wemyss and March Estate

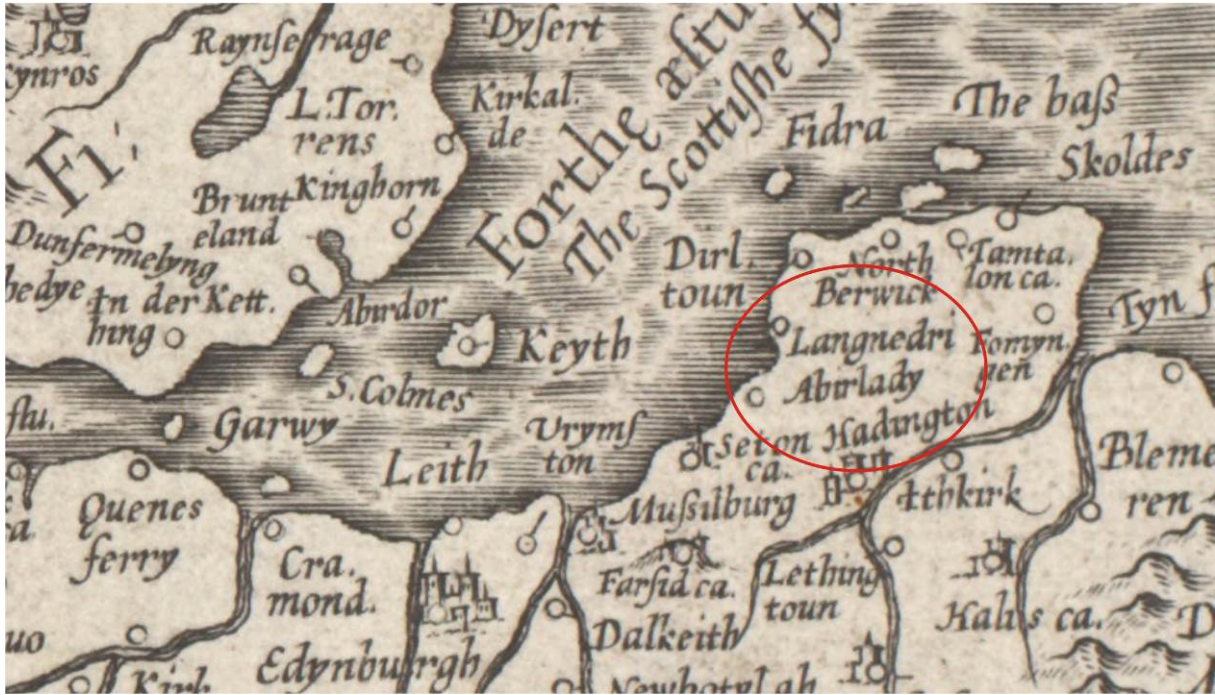
Figure 12 Extract from 'Scotiae Regnum (South Sheet)/per Gerardum Mercatorem per privilegio' by Gerhard Mercator. 1595. NLS

The earliest map consulted that shows the place name for Longniddry, is the 1595 map ‘Scotiae Regnum (South Sheet)’ by Gerhard Mercator (*Figure 12* below). Mercator’s map depicts the coastlines of Scotland fairly accurately, and also gives the relative positions of major waterways, showing the points at which they empty into the Forth. The major cities, towns, and villages are listed, with an attempt to place them in their correct locations, and in correct relation to one another; an error has been made, however, in the placement of ‘Langnedri’ (Longniddry), as it is shown along the coast to the north-east of ‘Abirlady’ (Aberlady). It is most likely that this may be down to a transcription error, associating the placement of the settlements with the incorrect settlement name.

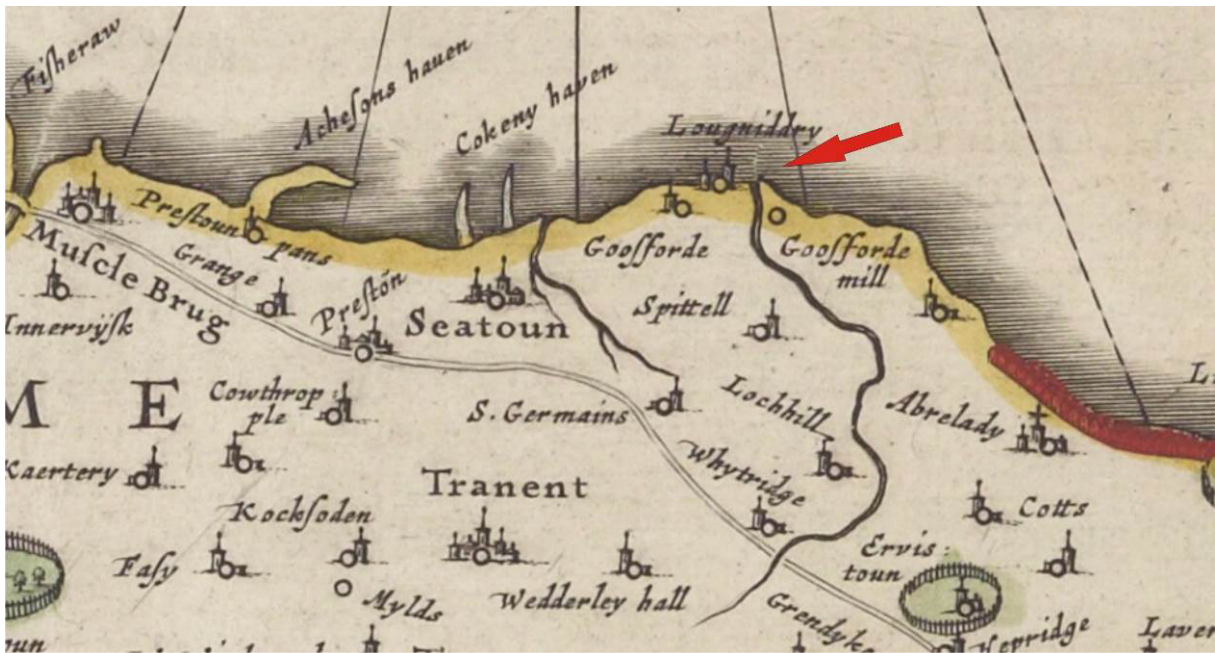
Figure 13 Extract from 'Lothian and Linlitquo/ Joh. Et Cornelius Blaeu exc. Blaeu Atlas of Scotland' by Joan and Cornelius Blaeu. 1654. NLS

The 1654 map 'Lothian and Linlitquo' by Joan and Cornelius Blaeu (**Figure 13**), is the first of the consulted maps to place Longniddry in its correct location. Interestingly, this map is also the first to use the spelling of 'Longniddry' as it is used today. More effort appears to have been made in the depiction of the coastline and coastal features, while settlements and estates are depicted in their correct relative positions, with the main road from Edinburgh shown running eastwards. Here, Longniddry is positioned near the mouth of a larger burn, possibly a depiction of the same burn that cuts its course through the centre of the proposed development area.

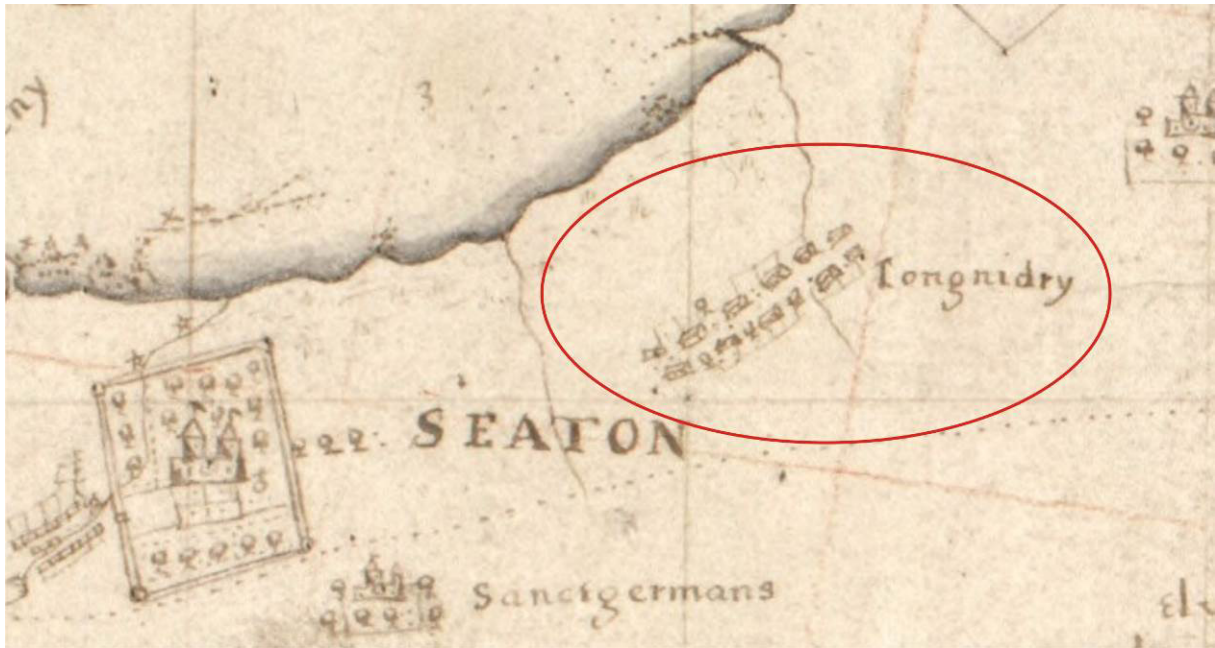
Figure 14 Extract from 'East Lothian/ authore Johanne Adair' by John Adair. 1682. NLS

The map 'East Lothian' by John Adair, 1682 (**Figure 14**), shows a much smaller scale and a greater level of detail than previously seen. The village of 'Longniddry' is situated along the course of a waterway, at roughly the correct distance from the shoreline. Two rows of houses are shown facing on to a main, north-east/south-west orientated street, with garden plots situated to the rear. The depiction of the village is likely to be a representation of the settlement lining the main street, rather than an accurate portrayal of the exact number and layout of dwellings.

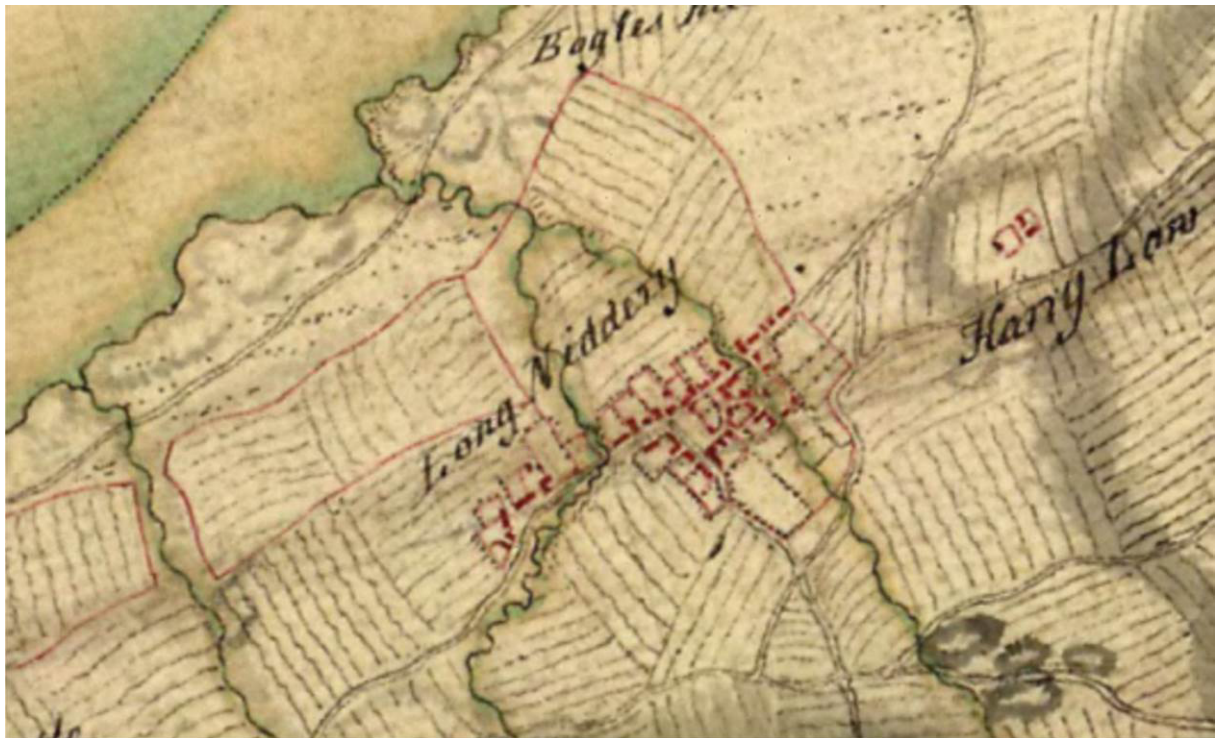
Figure 15 Extract from 'Roy's Military Survey of Scotland. Lowland Scotland' by William Roy. 1752-1755 © The British Library Board. All Rights Reserved (Roy Military Survey of Scotland)

Roy's military survey of lowland Scotland (**Figure 15**) was conducted between 1752 and 1755. Here, the map shows the village of 'Long Niddery' as clusters of crofts situated along the roadway towards North Berwick, straddling the courses of two burns, and surrounded by cultivated field-systems. The proposed development area occupies the land south of the road and west of the easternmost burn; Roy's map shows this area to be a network of cottages, plots, and routeways, demolished in the late 18th century as part of the Estate's agricultural improvements.

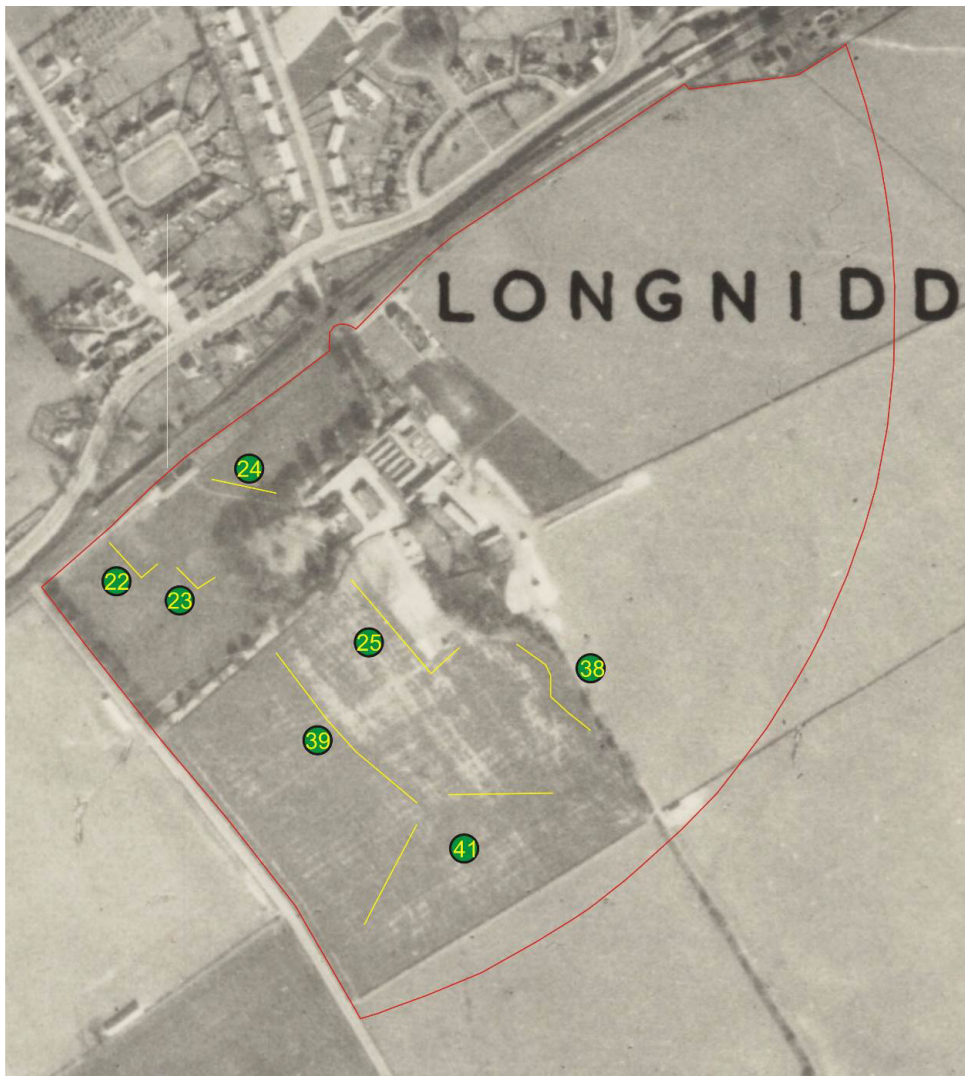
Figure 22 Excerpt from OS Air Photo mosaics of Scotland 'NT 47 N.W. & NT 37 N.E. East Lothian' 1946. (Addyman Archaeology after NLS)

The Ordnance Survey air photo mosaic, taken 1946 (**Figure 22**), shows the Longniddry Farmstead as it existed post-WWII, prior to the construction of the modern barns to the east, but largely as it appears today.

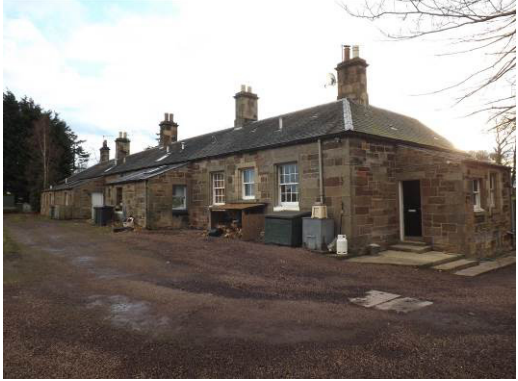
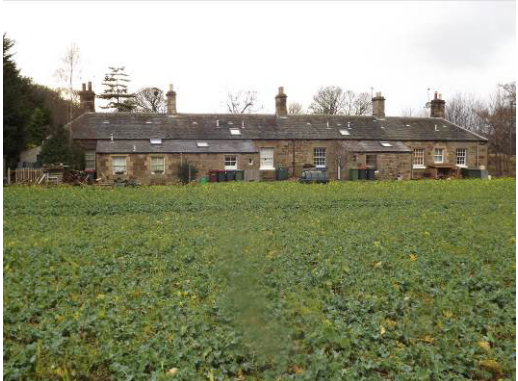
<p>Plate 1 Farm Cottages from N (photo 008)</p>

<p>Plate 2 Farm Cottages from SE (photo 123)</p>	<p>Late 19th century, Pre-1892</p> <p>NT 44327 76076</p>	<p><u>Name:</u> Longniddry Farm Cottages (No.3-6)</p> <p><u>Description:</u> Contiguous block of four single-storied farm labourer's cottages, stone-built of mixed sandstone. Stone-built extensions to the rear. Renovated 1992. Currently inhabited.</p> <p><u>Listing:</u> Category C Listed</p> <p><u>Condition:</u> Good</p> <p><u>Significance:</u> Moderate</p>

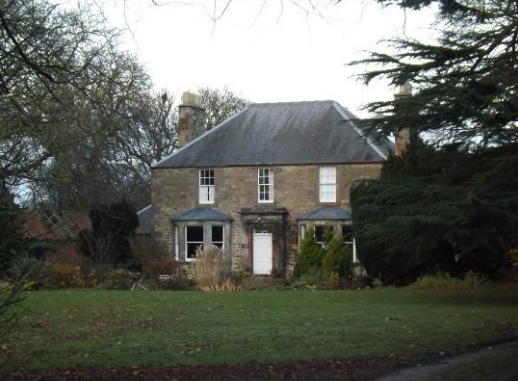
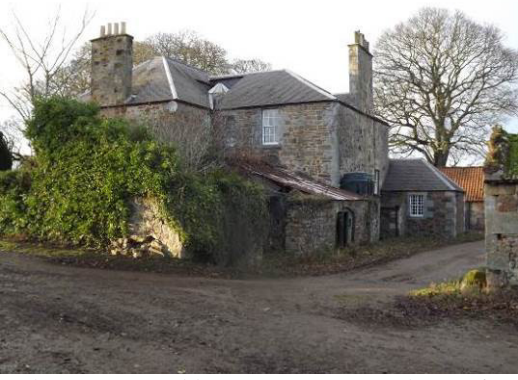
<p>Plate 3 Longniddry House, from W (photo 105)</p>

<p>Plate 4 Longniddry House from E (photo 163)</p>	<p>1790's</p> <p>NT 44272 75946</p>	<p><u>Name:</u> Longniddry Farmhouse</p> <p><u>Description:</u> Key structure within the wider complex. Late 18th century rectangular structure with later 19th century additions. Two-storied, 3-bay building of classical proportions and detailing with a hipped slated roof. Bay windows to the principal west-facing elevation may be secondary. Sandstone rubble construction with pale grey sandstone dressings. Surviving sections of a thin coat of exterior harl. Currently inhabited.</p> <p><u>Listing:</u> Category B Listed</p> <p><u>Condition:</u> Good</p> <p><u>Significance:</u> Considerable</p>

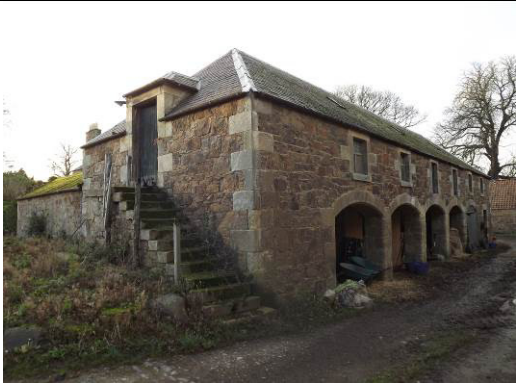
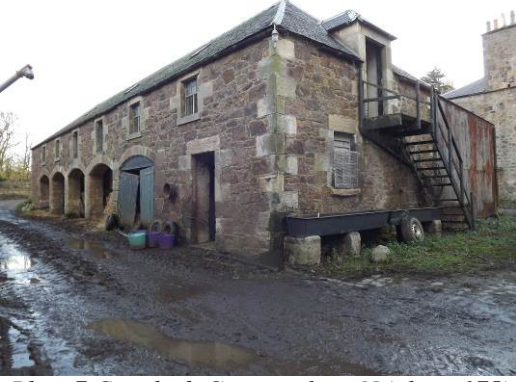
<p data-bbox="308 1075 810 1108">Plate 6 Cartshed, Granary from E (photo 170)</p>

<p data-bbox="308 1500 810 1534">Plate 7 Cartshed, Granary from N (photo 175)</p>	<p data-bbox="842 694 954 828">Late 19th century Pre- 1892</p> <p data-bbox="842 862 954 963">NT 44300 75959</p>	<p data-bbox="978 694 1385 761"><u>Name:</u> Longniddry Farmsteading-Cartshed and Granary</p> <p data-bbox="978 795 1401 1097"><u>Description:</u> Two-storied, six bay cartshed and granary with five arches at ground level and workshop to the north. Six first floor openings and doors at either gable end with external stairs from ground. Rubble sandstone with dressed grey sandstone quoins. Currently used as a stable block.</p> <p data-bbox="978 1131 1305 1164"><u>Listing:</u> Category B Listed</p> <p data-bbox="978 1198 1185 1232"><u>Condition:</u> Good</p> <p data-bbox="978 1265 1313 1299"><u>Significance:</u> Considerable</p>

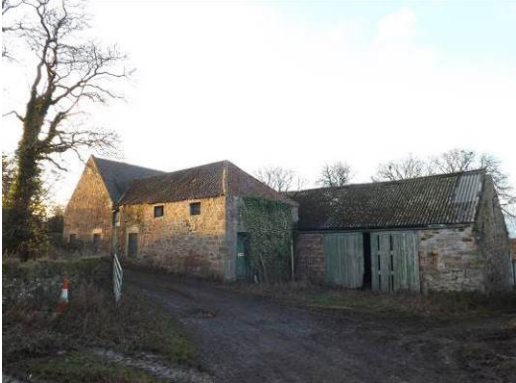
<p data-bbox="308 1926 810 1960">Plate 8 Site 004 overall from E (photo 073)</p>	<p data-bbox="842 1545 954 1780">Late 18th century, c.1790, also 1850- late 19th century</p> <p data-bbox="842 1814 954 1915">NT 44329 75961</p>	<p data-bbox="978 1545 1401 1612"><u>Name:</u> Longniddry Farmsteading-Mill, Threshing Barn, and Granary</p> <p data-bbox="978 1646 1401 1982"><u>Description:</u> Late 18th century, with 1850, and later 19th century additions. Houses overshot waterwheel located below the structures (Site 012). Two-storied mill above waterwheel contains lintel inscribed '1850'. Threshing barn to south, and granary to east. Surviving original fixtures within the interior.</p> <p data-bbox="978 2016 1305 2049"><u>Listing:</u> Category B Listed</p>

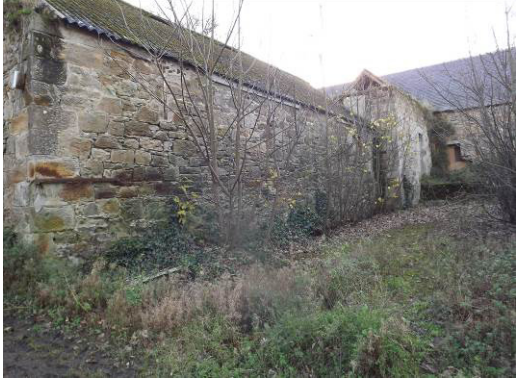
<p>Plate 9 Site 004 overall from N (photo 158)</p>	Late 19 th century, pre-1892	<p><u>Name:</u> Longniddry Farmsteading-Granary</p> <p><u>Condition:</u> <i>Moderate</i></p> <p><u>Significance:</u> <i>Moderate</i></p>

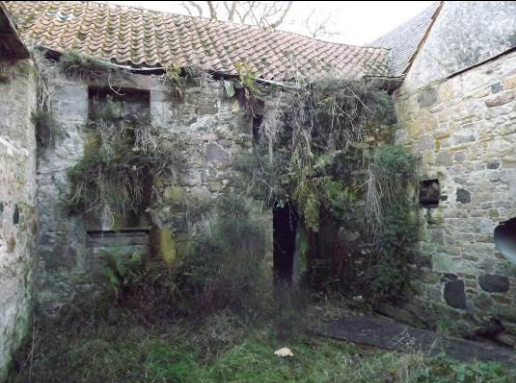
<p>Plate 10 Interior of mill from N (photo 232)</p>	1850	<p><u>Name:</u> Longniddry Farmsteading-Mill</p> <p><u>Condition:</u> <i>Poor</i></p> <p><u>Significance:</u> <i>Considerable</i></p>

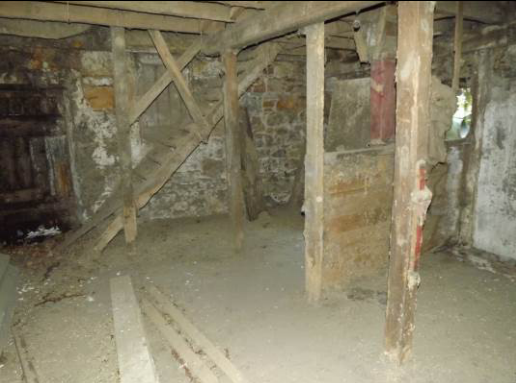
<p>Plate 11 Interior of barn from NE (photo 226)</p>	1790's	<p><u>Name:</u> Longniddry Farmsteading-Threshing Barn</p> <p><u>Condition:</u> <i>Moderate</i></p> <p><u>Significance:</u> <i>Considerable</i></p>

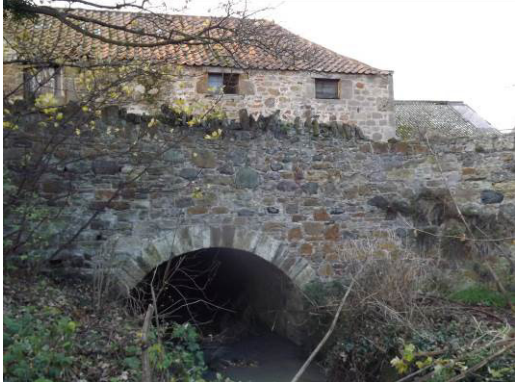
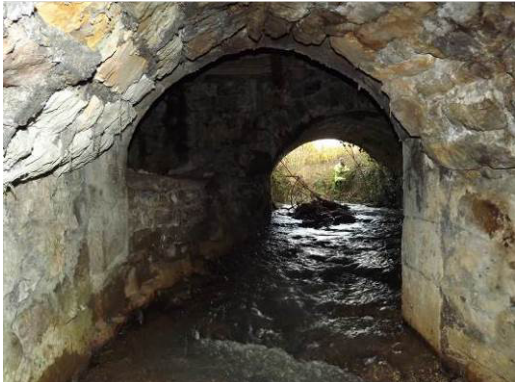
<p>Plate 12 Lade towards mill from SE (photo 197)</p>

<p>Plate 13 Lade beneath mill from NW (photo 212)</p>	<p>Early 19th century, Pre-1853</p> <p>NT 44343 74942</p>	<p><u>Name:</u> Longniddry Farmsteading-Sluice and Mill Lade</p> <p><u>Description:</u> Redirected burn forming mill lade entering a walled garden over a sluice. Enters under roadway and threshing barn via archway, continuing under farmstead to north. Channel to west diverts water beneath walled garden towards overshot waterwheel, boxed wooden aquaduct below threshing barn no longer extant.</p> <p><u>Listing:</u> Category B Listed</p> <p><u>Condition:</u> <i>Moderate</i></p> <p><u>Significance:</u> <i>Considerable</i></p>

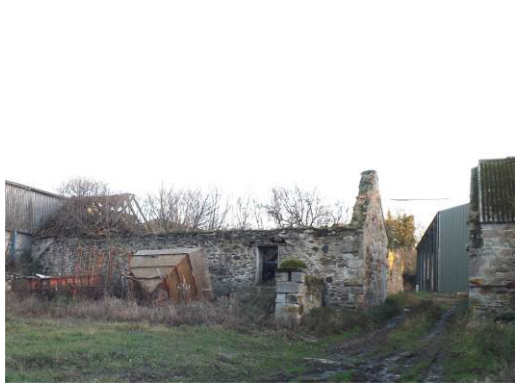
<p>Plate 14 Structure from NW (photo 088)</p>	<p>Late 19th century, Pre-1892</p> <p>NT 44351 75978</p>	<p><u>Name:</u> Longniddry Farmsteading-Cattle Courts to south-east</p> <p><u>Description:</u> Rubble sandstone structure with courtyard to the south-east. Now in ruins. Associated with Site 004 granary, and formerly joined via arched gateway. Part of the late 19th century expansion.</p> <p><u>Listing:</u> Category B Listed</p> <p><u>Condition:</u> <i>Poor</i></p> <p><u>Significance:</u> <i>Moderate</i></p>

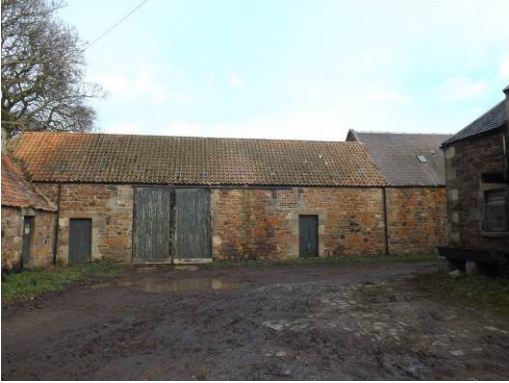
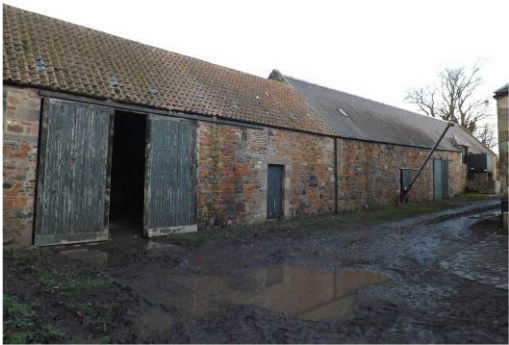
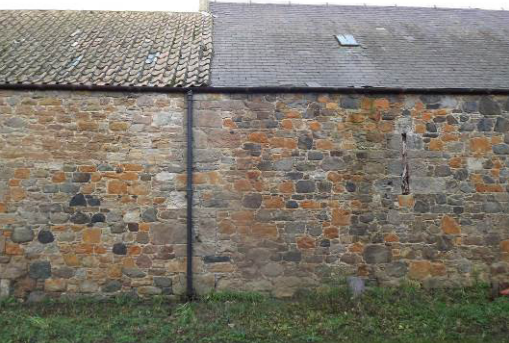
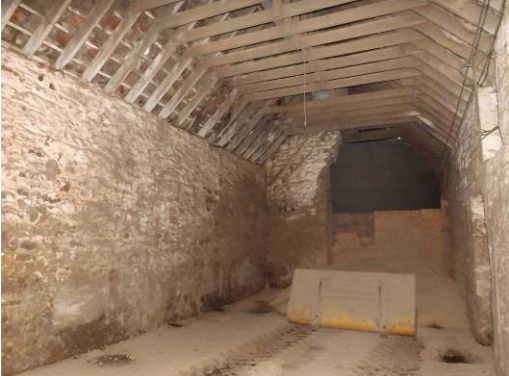
<p data-bbox="357 1877 762 1906">Plate 18 Interior from NW (photo 057)</p>	<p data-bbox="847 264 932 427">1790's NT 44308 75972</p>	<p data-bbox="983 264 1402 360">Name: Longniddry Farmsteading-Steading and Cattle Courts, north-west/south-east orientated range</p> <p data-bbox="983 398 1402 831">Description: North-west/south-east orientated section of L-shaped range to the rear of Longniddry House. Associated with Site 008 stables. Mixed sandstone rubble construction. South section wider with taller slate roof, north section covered with pantile, and shows evidence of roof having been raised. Part of the original 1790's farmstead, now used as a granary. Evidence of surviving original fixtures within the interior.</p> <p data-bbox="983 869 1302 898">Listing: Category B Listed</p> <p data-bbox="983 936 1182 965">Condition: <i>Good</i></p> <p data-bbox="983 1003 1302 1032">Significance: <i>Considerable</i></p>

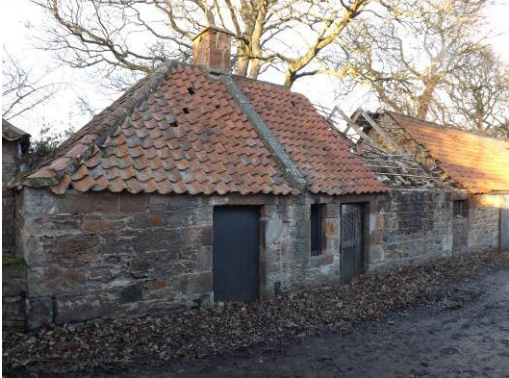
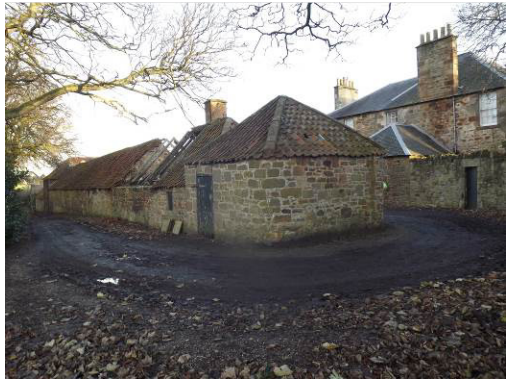
<p>Plate 21 Stable range from N (photo 034)</p>	<p>1790's NT 44275 75976</p>	<p>Name: Longniddry Farmsteading-stable Range to north-west, south-west/north-east orientated</p> <p>Description: South-west/north-east orientated section of L-shaped range to the rear of Longniddry House. Associated with Site 007 granary. Former stable block/byre. Mixed sandstone rubble construction with pantile roof. Part of the original 1790's farmstead, with late 19th century addition to the south-west. A partial ruin, surviving bays now used for storage.</p> <p>Listing: Category B Listed</p> <p>Condition: <i>Moderate</i></p> <p>Significance: <i>Considerable</i></p>

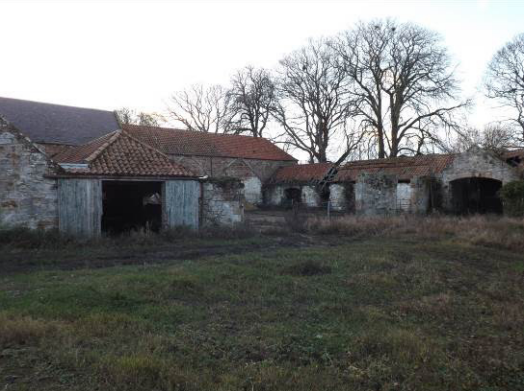
<p>Plate 22 Cattle Courts from E (photo 082)</p>	<p>Post 1790, pre 1853 Also, late 19th century, pre 1892 NT 44314 75085</p>	<p>Name: Longniddry Farmsteading-Cattle Courts to north-east</p> <p>Description: Cattle courts to the rear of the range at Site 007. Site includes early 19th century range to south and adjoining barn adjacent to Mill.</p> <p>Listing: Category B Listed</p>

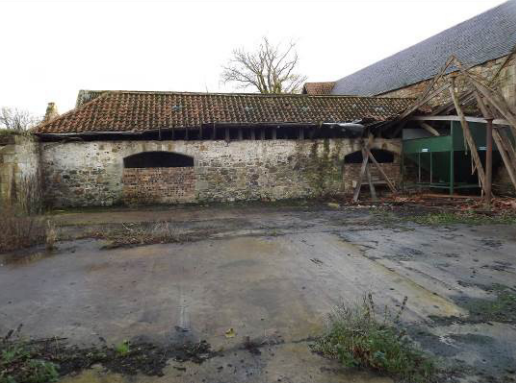
<p data-bbox="316 651 802 712"><i>Plate 23 Range on 1st edition, S end of Cattle Court (photo 155)</i></p>	<p data-bbox="850 264 954 365">Post 1790, pre 1853</p> <p data-bbox="850 398 954 499">NT 44318 75981</p>	<p data-bbox="986 264 1401 331">Name: Longniddry Farmsteading-Cattle Courts to north-east.</p> <p data-bbox="986 365 1401 600">Description: Range at south end of Cattle Court, appears on 1st edition map of 1853. Likely altered later 19th century as part of the Cattle Court construction. Likely contemporaneous with the Mill and Threshing Barn to the south.</p> <p data-bbox="986 633 1233 667">Condition: <i>Moderate</i></p> <p data-bbox="986 701 1305 734">Significance: <i>Considerable</i></p>

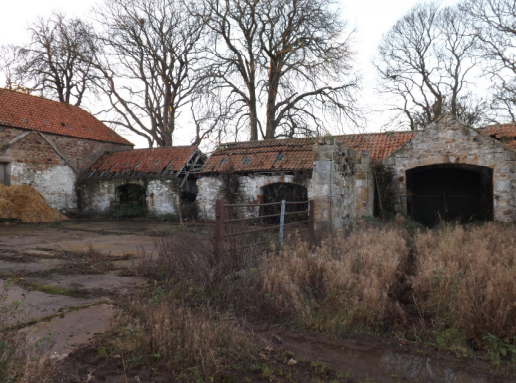
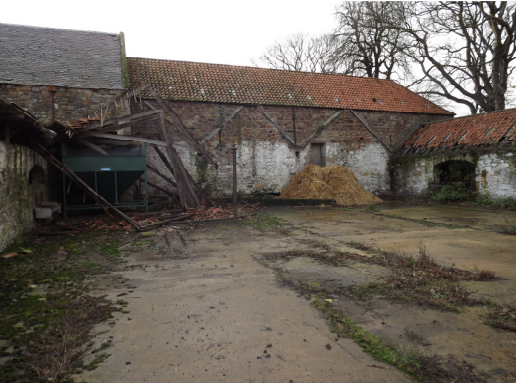
<p data-bbox="316 1473 802 1529"><i>Plate 24 Late 19th century Cattle Courts to north-east (photo 086)</i></p>

<p data-bbox="316 1955 802 2011"><i>Plate 25 Late 19th century Cattle Courts to north-east (photo 140)</i></p>	<p data-bbox="850 1081 954 1182">Post 1853, pre 1892</p> <p data-bbox="850 1216 954 1317">NT 44311 75989</p>	<p data-bbox="986 1081 1401 1149">Name: Longniddry Farmsteading-Cattle Courts to north-east.</p> <p data-bbox="986 1182 1401 1417">Description: Cattle courts to the rear of the range at Site 007. Entered via arch-gabled pend from the north. Formerly roofed cattle courts to the west, cast iron columns and stone feeding troughs. Red pantile roof.</p> <p data-bbox="986 1451 1177 1485">Condition: <i>Poor</i></p> <p data-bbox="986 1518 1305 1552">Significance: <i>Considerable</i></p>

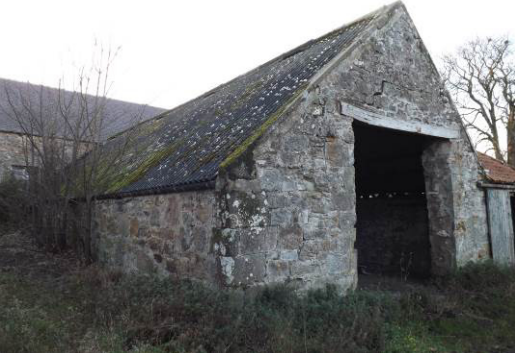
<p>Plate 26 South Range from E (photo 077)</p>	<p>Post 1853, pre 1892</p> <p>NT 44324 75975</p>	<p>Name: Longniddry Farmsteading-Cattle Courts to north-east. South Range.</p> <p>Description: Rubble built, north-east/south-west orientated range with dressed sandstone quoins. Possibly contemporaneous with Granary (Site 004.1) to south. Cracked gable and split lintel.</p> <p>Condition: <i>Poor</i></p> <p>Significance: <i>Moderate</i></p>

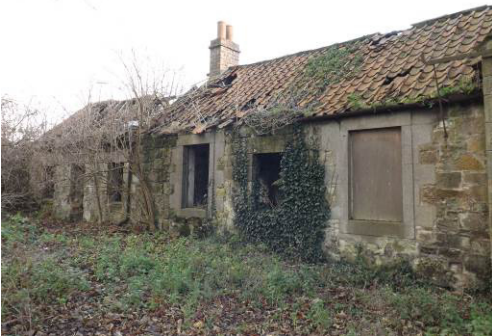
<p>Plate 27 Structures from W (photo 021)</p>	<p>Late 19th century, Pre-1892</p> <p>NT 44320 76014</p>	<p>Name: Longniddry Farmsteading-Cattle Courts to NE, NW facing structures</p> <p>Description: Two single-storied cottages three bays each. Dressed sandstone and pantile roof. Part of Site 009 Cattle Court complex to the south.</p> <p>Listing: Category B Listed</p> <p>Condition: <i>Poor</i></p> <p>Significance: <i>Considerable</i></p>

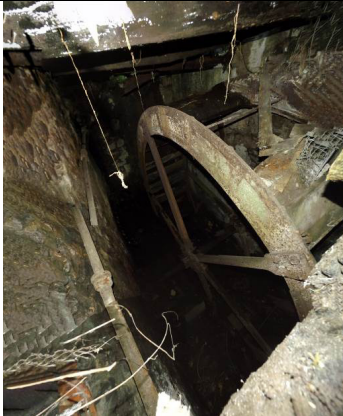
<p>Plate 28 Waterwheel from N (photo 217)</p>	<p>Likely 1850's</p> <p>NT 44323 75961</p>	<p>Name: Longniddry Mains Waterwheel</p> <p>Description: Overshot waterwheel, c.1850, housed below ground level under Mill (Site 004). Wood and iron construction.</p> <p>Condition: <i>Poor</i></p> <p>Significance: <i>Considerable</i></p>

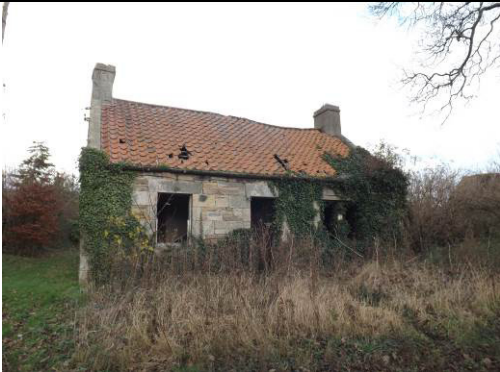
<p>Plate 29 Bothy from SW (photo 010)</p>	<p>Late 19th century, Pre-1892</p> <p>NT 44313 76033</p>	<p>Name: Longniddry Farmstead-Bothy</p> <p>Description: Two-storied, dressed sandstone, 3 bay structure with pantile roof. Referred to as a Bothy. Toilet range addition to south. Now ruinous.</p> <p>Condition: <i>Poor</i></p> <p>Significance: <i>Moderate</i></p>

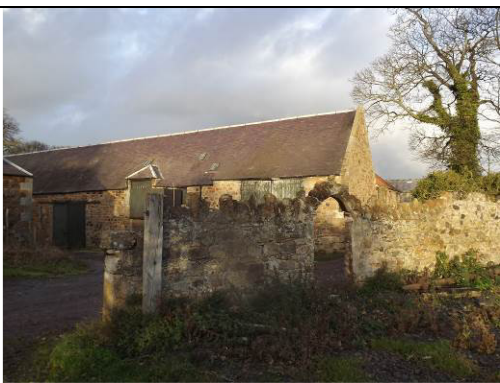
<p>Plate 30 Site 014 from S (photo 161)</p>	<p>Early 20th century, Pre-1906</p> <p>NT 44324 75930</p>	<p>Name: Enclosure/Sheepfold west of Walled Garden</p> <p>Description: Enclosure or sheepfold surviving as a single upstanding wall with arched doorway. Shown as an enclosure on the 1906 OS.</p> <p>Condition: <i>Poor</i></p> <p>Significance: <i>Neutral</i></p>

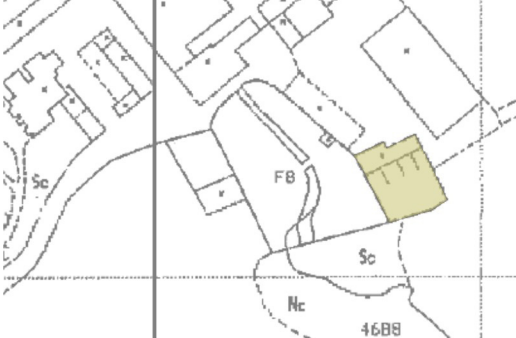
<p>Figure 40 Site 015, Enclosure east of Walled Garden (OS 1993)</p>	<p>Late 19th century, Pre-1892</p> <p>NT 44382 75922</p>	<p>Name: Enclosure/Sheepfold east of Walled Garden</p> <p>Description: Enclosure or sheepfold surviving as a series of overgrown pens and boundary walls. First shown on the 1892 OS map.</p> <p>Condition: <i>Poor</i></p> <p>Significance: <i>Moderate</i></p>

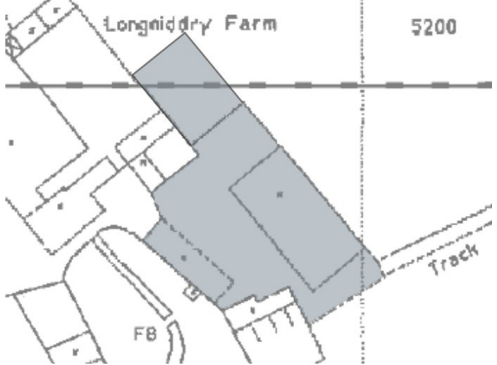
<p data-bbox="311 627 810 683">Figure 41 Site 016, Modern barns and Cattle Court to east (OS 1993)</p>	<p data-bbox="842 264 954 398">Late 20th century, Pre-1993</p> <p data-bbox="842 436 954 533">NT 44377 75958</p>	<p data-bbox="976 264 1412 331"><u>Name:</u> Modern Cattle Court and Barns to the east of the Lade</p> <p data-bbox="976 369 1412 504"><u>Description:</u> Three modern open-sided steel structures used for cattle-penning and storage set around a central courtyard.</p> <p data-bbox="976 537 1189 571"><u>Condition:</u> Good</p> <p data-bbox="976 604 1236 638"><u>Significance:</u> Neutral</p>
017

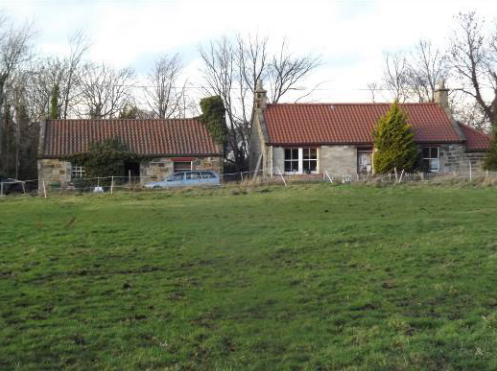
<p data-bbox="311 1500 810 1545">Plate 31 Farm Cottages from SE (photo 183)</p>	<p data-bbox="842 1131 954 1265">19th century, Pre-1853</p> <p data-bbox="842 1299 954 1395">NT 44165 75977</p>	<p data-bbox="976 1131 1412 1232"><u>Name:</u> Longniddry Farm Cottages, north-west of Longniddry Farmhouse</p> <p data-bbox="976 1265 1412 1534"><u>Description:</u> Two single-storied 19th century farm cottages in dressed sandstone with pantile roofs. Currently inhabited. Western cottage first appears on the 1853 OS 1st edition, while the eastern cottage is first shown on the 1892 OS revision.</p> <p data-bbox="976 1568 1189 1601"><u>Condition:</u> Good</p> <p data-bbox="976 1635 1236 1668"><u>Significance:</u> Neutral</p>

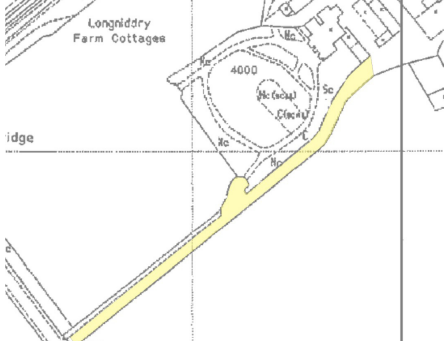
<p>Figure 45 Site 020 Access road from west (OS 1993)</p>	<p>Early 19th century, Pre-1853</p> <p>NT 44205 75850</p>	<p><u>Name:</u> Access Road from west into farmstead</p> <p><u>Description:</u> Historic trackway from the roadway to the west, providing access to the front of Longniddry house and the farmstead beyond.</p> <p><u>Condition:</u> Good</p> <p><u>Significance:</u> Moderate</p>

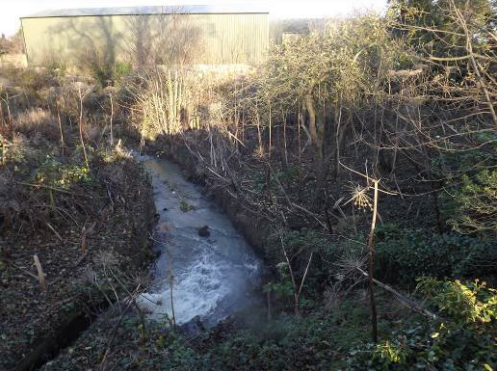
<p>Plate 32 Interior from SW (photo 112)</p>	<p>Late 18th century, 1790's</p> <p>NT 44335 75923</p>	<p><u>Name:</u> Walled Garden</p> <p><u>Description:</u> Irregular-shaped, roughly subrectangular, sunken walled garden. Rubble sandstone boundary wall with formal pathways and arched footbridge across the mill lade. Incorporates sluice, and mill lade. Overgrown with Hogweed.</p> <p><u>Condition:</u> Moderate</p> <p><u>Significance:</u> Considerable</p>

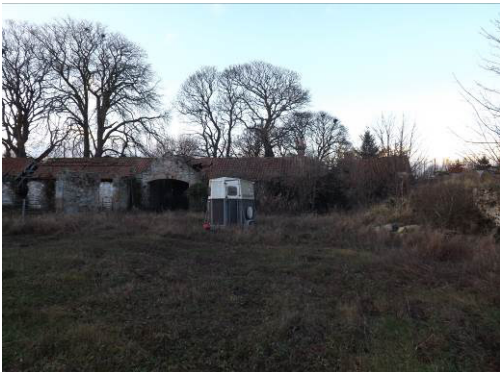
<p>Plate 34 Site 027 looking north (photo 081)</p>	<p>Late 19th century, Pre-1892</p> <p>NT 44337 75997</p>	<p><u>Name:</u> Longniddry Farmsteading-cattle Courts to the east of Site 009</p> <p><u>Description:</u> Shown on the 1892 OS map as a series of structures and stalls in the north-east of the steading complex. Four bays shown, possible a feeding area. No longer extant.</p> <p><u>Listing:</u> Category B Listed</p> <p><u>Condition:</u> Destroyed</p> <p><u>Significance:</u> Neutral</p>

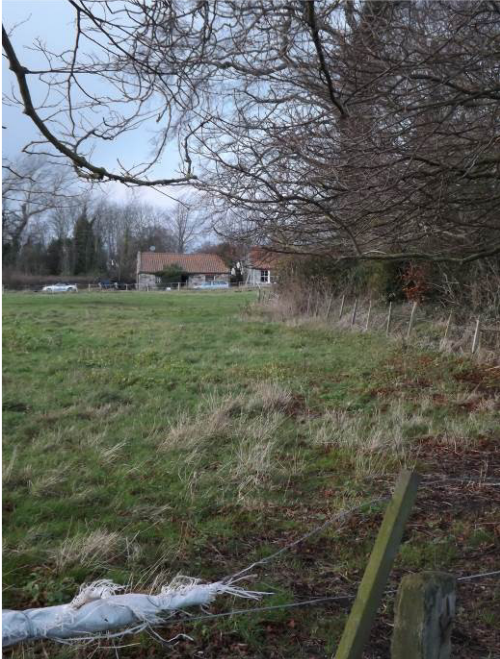
<p>Plate 35 Location of Legate Road (photo 108)</p>	<p>Pre 1778</p> <p>NT 44212 75904</p>	<p><u>Name:</u> Former roadway, north extent of Legate Road</p> <p><u>Description:</u> Former formal roadway from the south towards the village of Longniddry. North section survived into mid-19th century, connecting western farmstead access with farm cottage to north. Likely survives below ploughsoil. Possibly metalled with ditches along both sides.</p> <p><u>Condition:</u> Destroyed</p> <p><u>Significance:</u> Neutral</p>
