1703 Dumfries House – Memorial Garden works
Dumfries House Estate, near Cumnock, East Ayrshire

Archaeological Watching Brief: March 2016

The Great Steward of Scotland's Dumfries House Trust

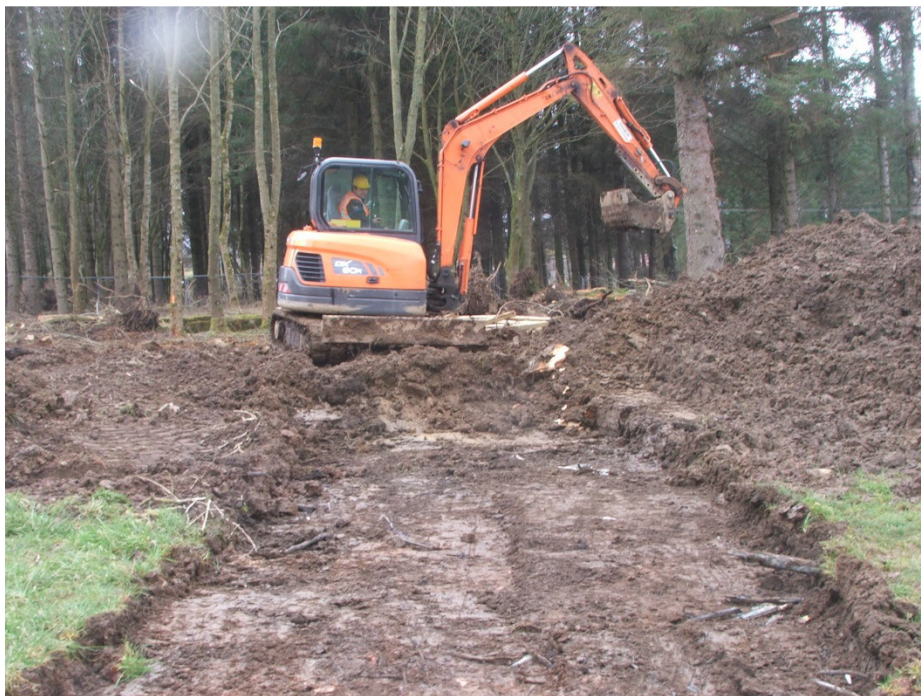
The topsoil within the semi-circular pathway at the front of The Temple was removed by machine from west to east (*plate 1*). Topsoil comprised dark brown soft clayey silt [1001], 0.2-0.3m in depth. On the west side of the path this overlay lighter brown clayey silt [1002] up to 0.1m in depth; this formed the limit of excavation on the western side. The centre of the path was excavated through a former spoilheap and consequently much of the soil in this area had been redeposited and natural subsoil [1003] was not exposed. This area contained numerous roots.

Plate 1 Path under excavation. Building [1004] can be seen to the rear of the machine, behind the trees.

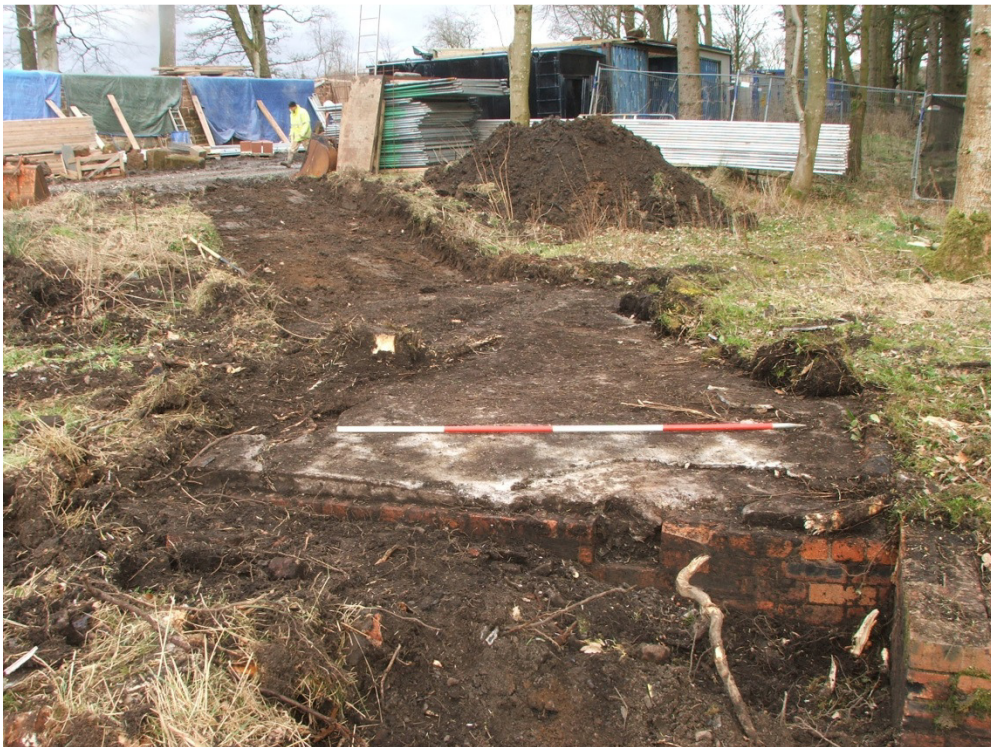
Building [1004] comprised a rectangular brick-built foundation. The bricks were mortar bonded and covered with a concrete floor, approximately 0.05m thick. The structure measured 11.4m north to south, by 5.9m east to west and was upstanding to 0.55m high (5 courses) at the southern end; at the northern end it was 0.1m below the turf (*plate 2*). The bricks were laid in stretcher bond, with the top course laid side to side. There were metal folded strips at the north-west corner of the building, thought to have been for attaching the wooden superstructure to the concrete base. The building was covered in moss but clearly visible among the trees, with a number of semi-mature trees growing close to its edges. The northern part of the building was partially removed during excavations for the path. The bricks were marked 'DICO', which refers to the Dalmellington Iron Company, located around 12 miles to the south of the site. Two complete glass bottles and a metal fork were recovered during the removal of the walls.

Plate 2 Building [1004] as exposed during excavation of path.

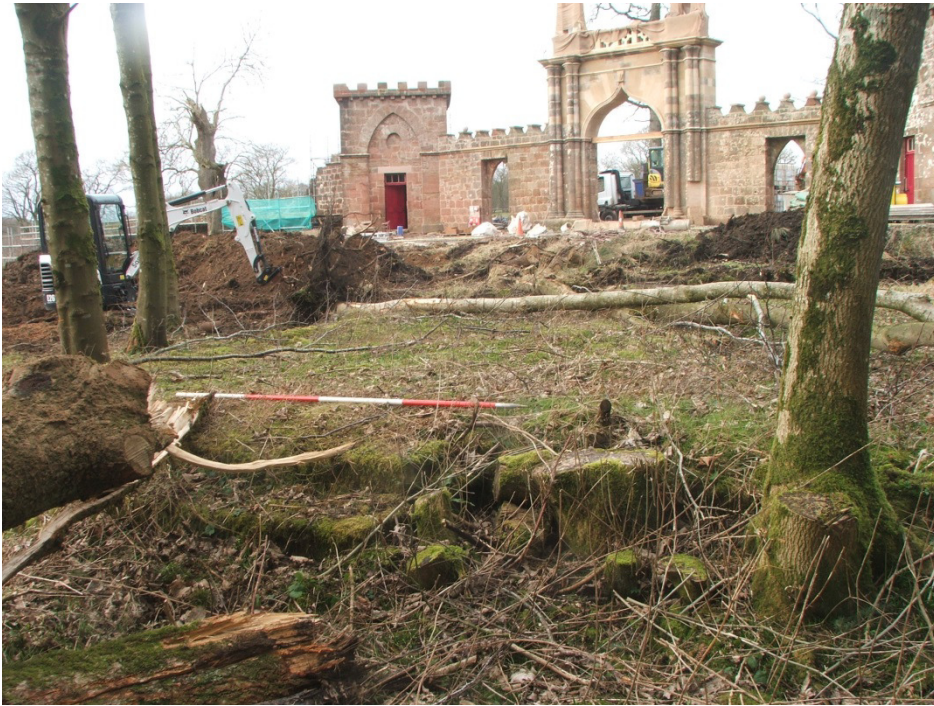
There were a set of three steps set centrally at the south end of [1004], 1.8m wide, presumably forming the main entrance (*plate 3*). A second set of steps along the western wall [1005] were partially truncated by the new path. These steps would have led to a small side door and comprised two double-skinned brick walls with two steps in between (*plate 4*). The bottom step had been surfaced with compacted mortar; the mortared surface was absent from the top step but would presumably have been the same. The steps were 1.1m wide and of six courses in height, with each step 0.25m high. The steps were laid on a concrete base, which was left *in situ*. To the north of the steps was a small gap in the brickwork, possibly for drainage (*plate 2*).

Plate 3 Steps at south end of Building [1004].

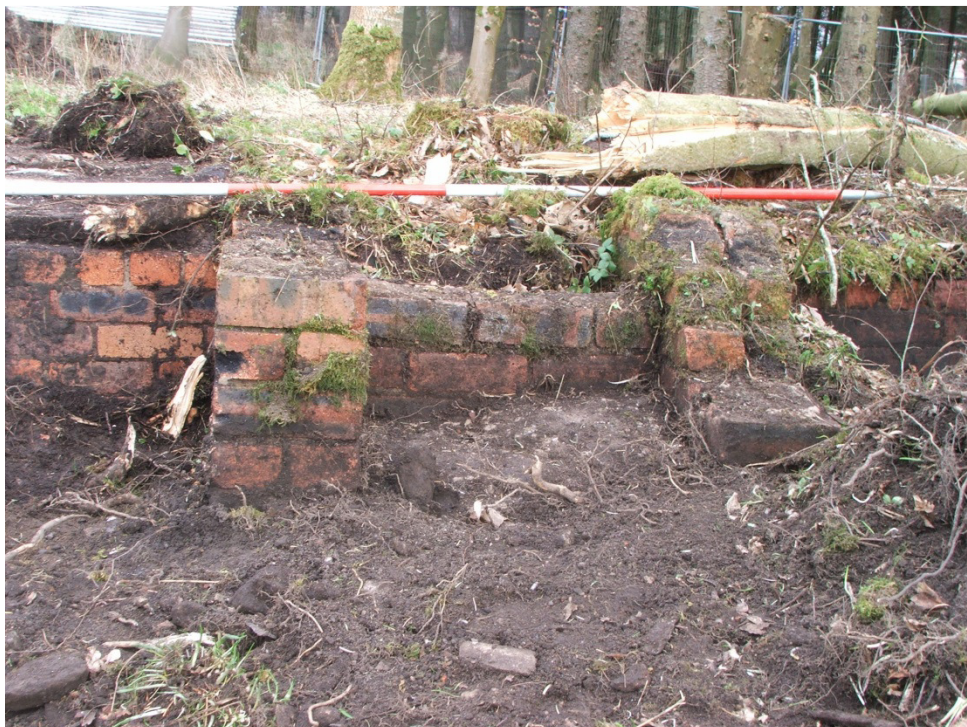
Plate 4 Steps [1005] on west side of Building [1004].

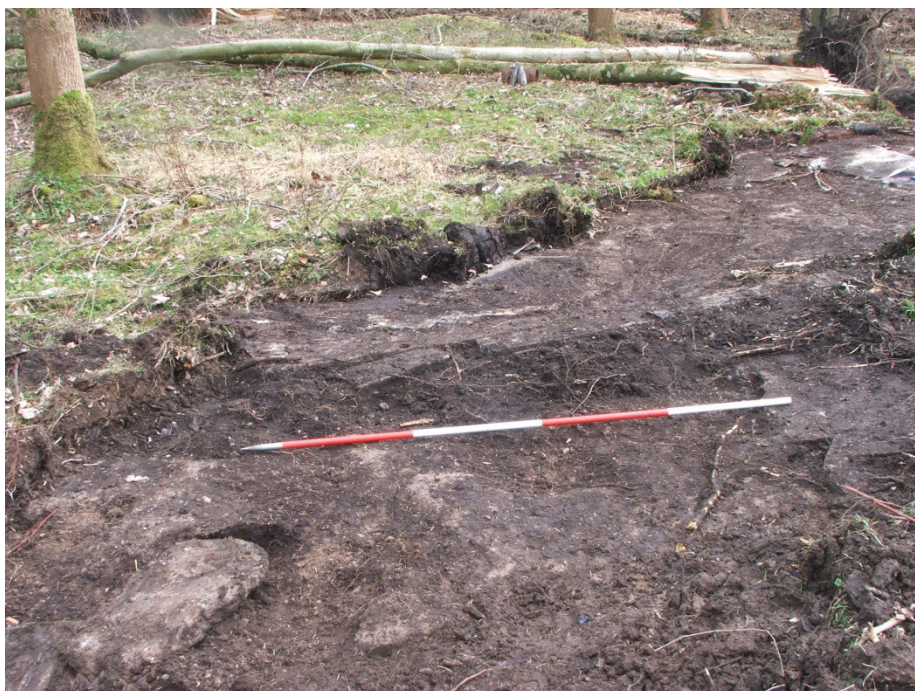
At the north end of building [1004] was a layer of thick concrete [1006], forming an area of hard-standing (*plate 5*). The upper surface of this was 0.05m thick and smooth, but was broken off in chunks to reveal rough-cast concrete with aggregate beneath, up to 0.2m thick. There was a small gap between the concrete and the wall of [1004].

Plate 5 Concrete [1006] on north side of Building [1004].
