Former Goods Shed, 14 Kirkgate, Currie *Edinburgh*

*Data Structure Report on Historic Building Recording:
May 2016 2016*

Historic Building Recording

Job number 2222

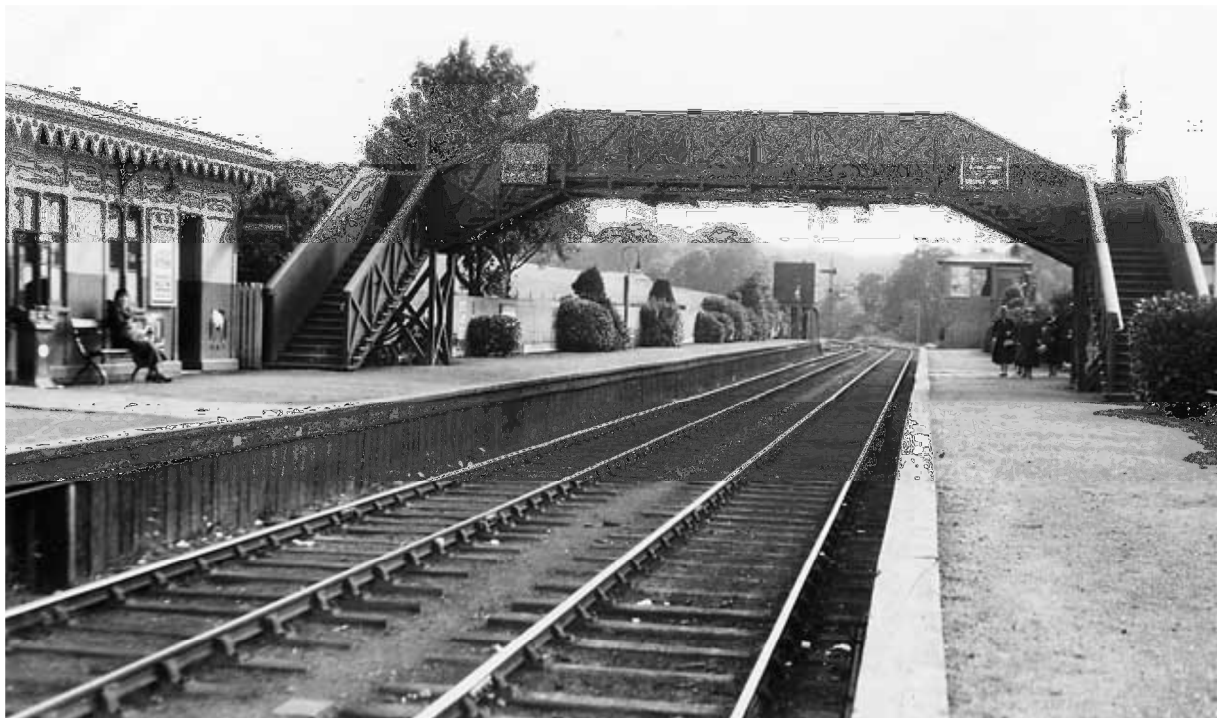
Figure 2 View of Currie station looking west. Water tank (directly under bridge) is located on northern boundary of site. ©RCAHMS

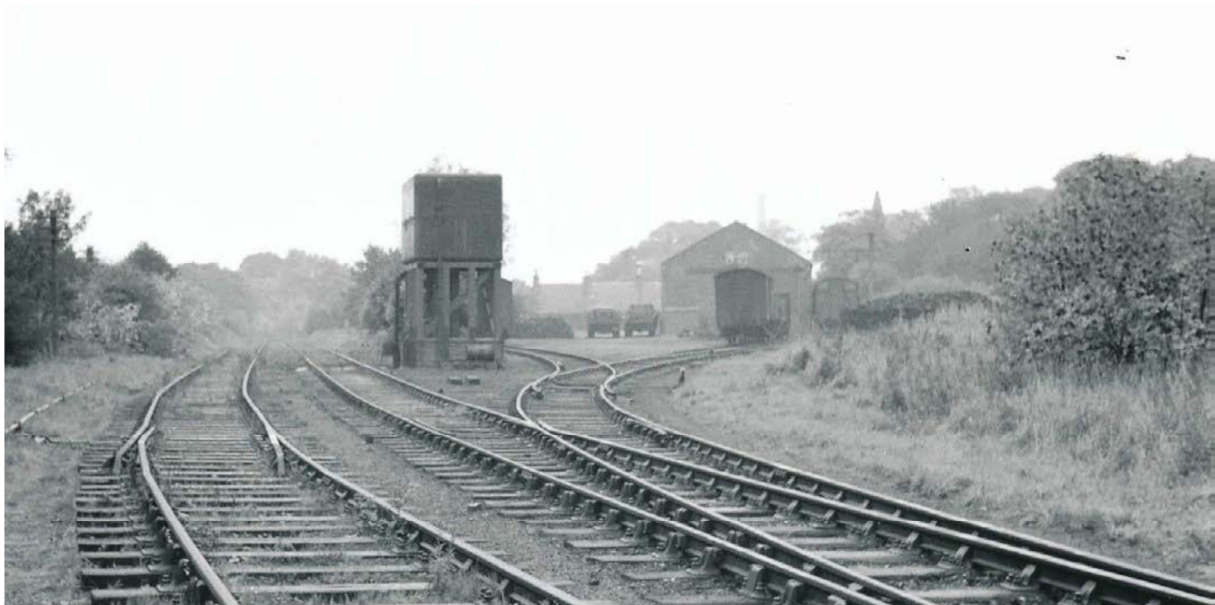
Figure 3 View of Currie sidings looking east after removal of the footbridge and station. The Goods station is on the right with the water tank in the centre of the picture. ©RCAHMS

Currie station and passenger services closed in 1943, while the goods line was closed and the track taken up in 1968 (*figure 3*). Today the only physical evidence of the station are the raised banks to either side of the Water of Leith walkway.

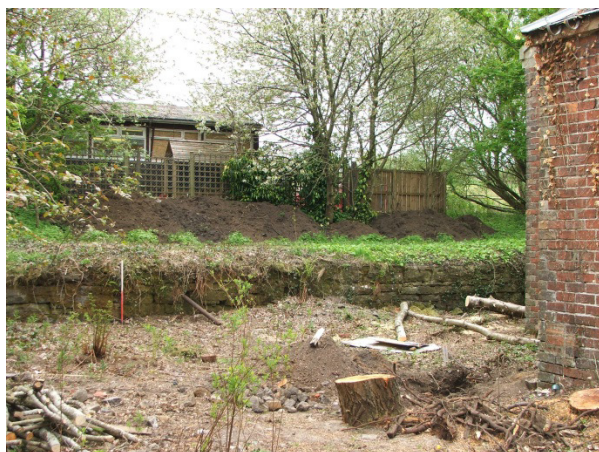
Figure 9 Platform to rear of goods shed

The platform to the south of the building comprises six courses of squared sandstone, laid in alternate courses of large and smaller blocks (*figure 9, above*). The platform wall runs the length of the rear of the building before dipping downwards and disappearing among the overgrown vegetation to the west end of the site.

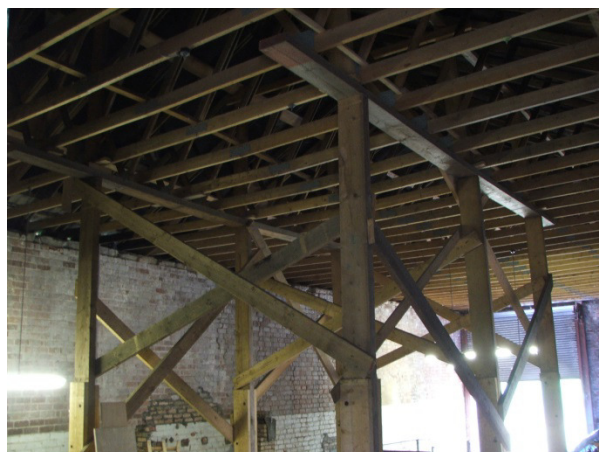
Figure 10 Timber propping up modern roof

The Former Goods Shed comprises a large brick-built shed, with a smaller single storey office building, with raised floor, keyed in and adjoining it at the east end. The main shed measures 22m long by 10m wide with train doors on the gable walls and five internal divisions, comprising loading platforms and arched openings. The shed is of stretcher bond in red brick, with blond bricks used at the entrance archways on the northern elevation and on the corners and blond sandstone coped gables and wallheads. There is evidence of whitewashing along the lower 2m of walling all around the shed, although this has largely faded and been replaced by graffiti, particularly on the western and southern sides. The roof has been rebuilt in more recent years using timber joists and trusses with concrete tiles; these are undersized for the weight of the concrete tiles and sagging and this has necessitated the addition of wooden supporting piers internally (Kate Perry, pers comm; *figure 10*).

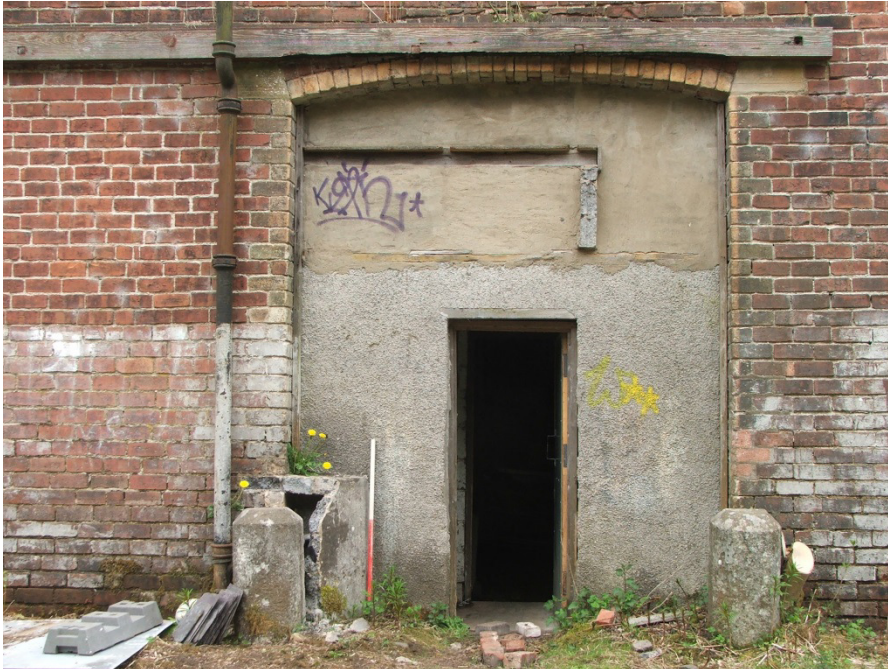
Figure 11 Eastern blocked archway in northern elevation

The front (northern) elevation has two arched openings, both bricked up with inserted doorways. The easternmost archway had white cement harl across the lower half and cement plaster across the top half; with a number of timber and cement fixtures set within the top half (plate). The doorway contains a new wooden door. There is a cast iron drainpipe on the east side of the arch, with an outlet pipe leading to it boxed in with cement (*figure 11*). The western archway has also been infilled with brick and the wooden door covered with a metal plate (*figure 12*). Outside each of the entrances are cement bollards (*figures 11 & 12*). The entrance to the office building is via a flight of five steps, constructed of stone setts and into a newly fitted door (*figure 13*). The office building is also of brick; the roof is piend and slated (*figure 13*). The office floor was level with the loading platforms on the inside of the shed, hence the external steps.

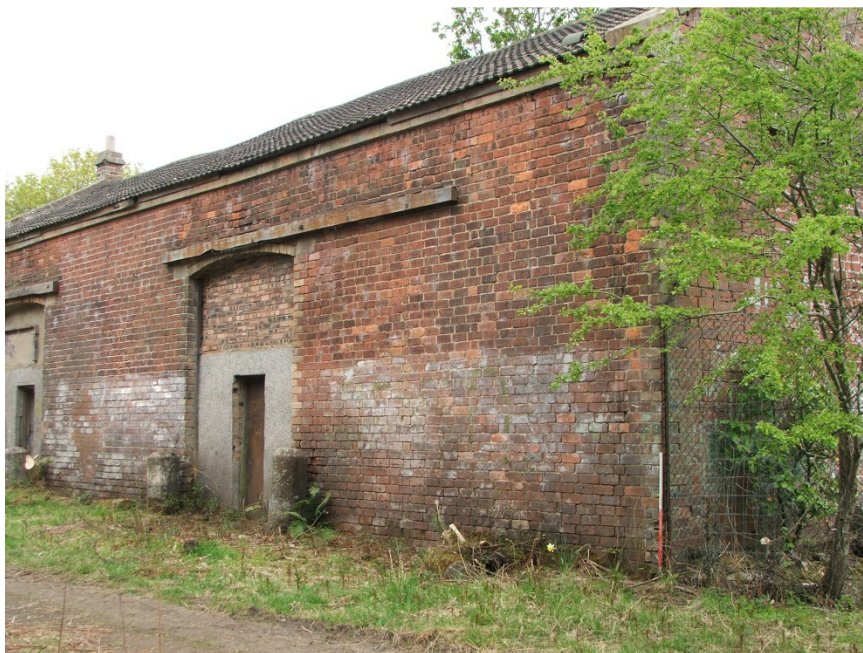
Figure 12 Western blocked archway, looking south-east

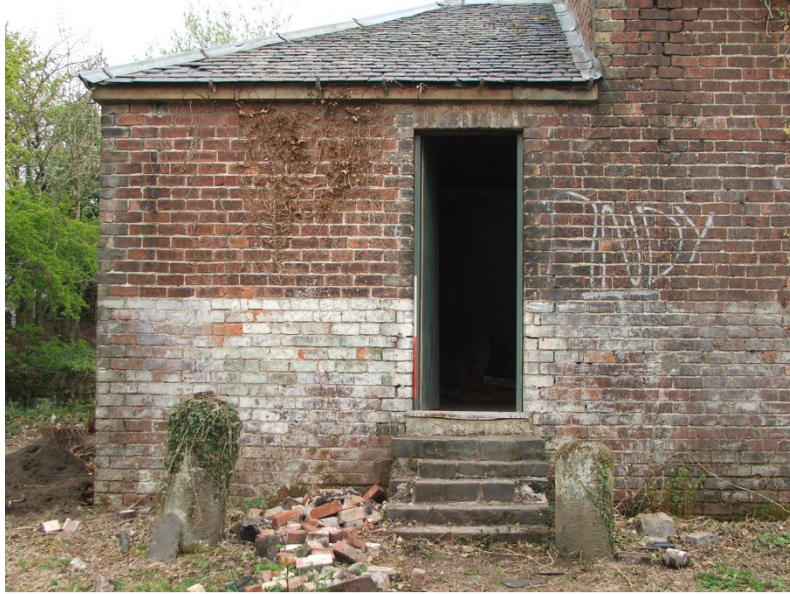
Figure 13 Office block, north elevation

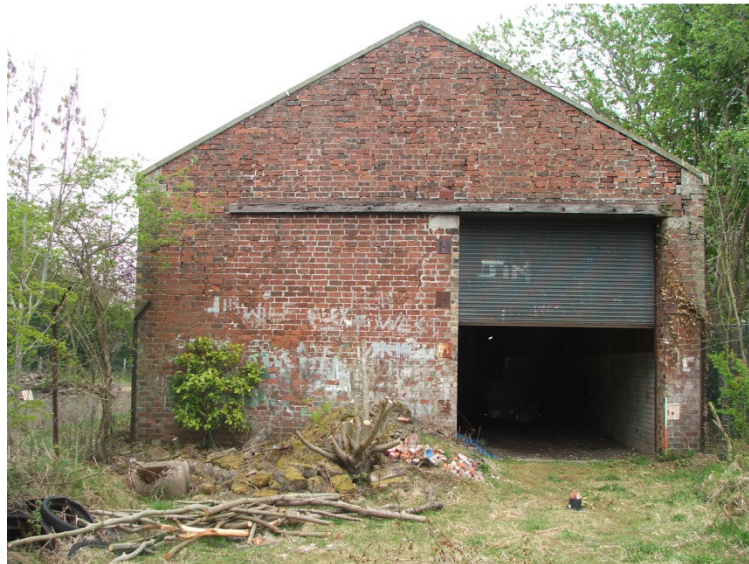
Figure 14 West elevation

The western elevation has a single entranceway, which has been fitted with a (still working) roller shutter. Either side of the opening are five square iron fixings with central bosses (*figure 14*). Beneath the upper two fixings runs an iron beam with a wooden beam fitted into it; the wooden beam has a series of iron bolts along its length. This would presumably have held a sliding door to cover the entrance to the shed. Immediately below the beam on either side are blocks of blond sandstone; apparently inserted, perhaps when rebuilding the roof, for support. There is also some evidence of repointing on the northern side of the entranceway.

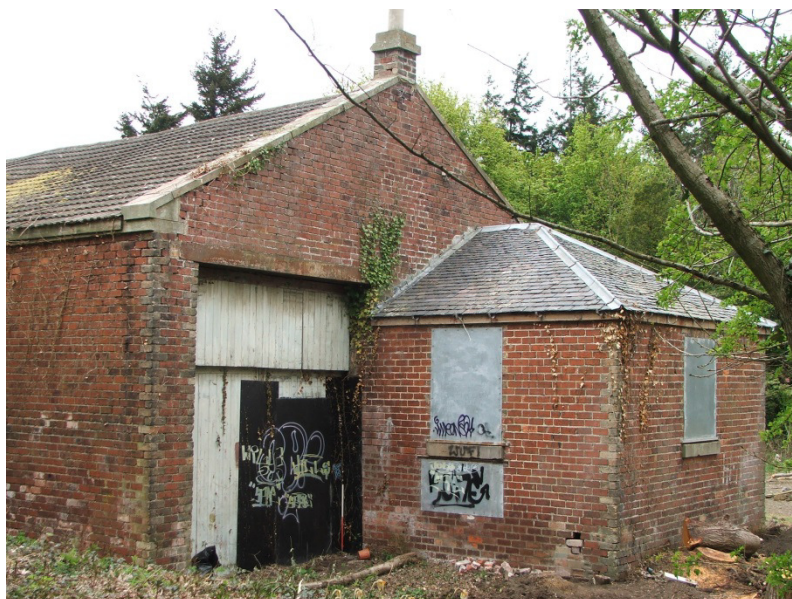
Figure 15 East elevation and office block, looking north-west

The eastern elevation of the shed has the office building on the northern side and a set of wooden painted doors within the square opening on the south side (*figure 15*). The wooden doors rise to just below the roofline, with the upper part of the opening filled with wooden panelling. There is a metal lintel across the top of the opening, but no other external fixings.

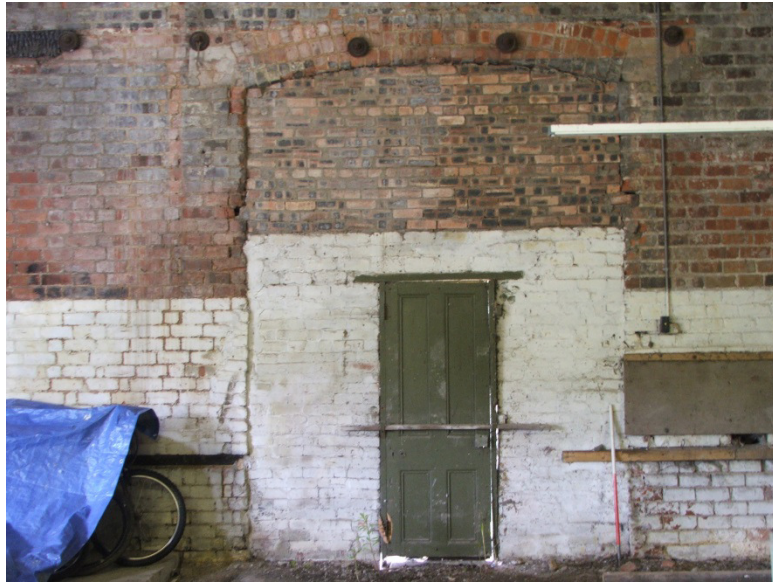
Figure 16 Internal north wall showing blocked archway and inserted door; openings in the brickwork to the right of the door indicate the position of the loading platform.

Within the west entrance archway is the original wooden inserted door (*figure 16*). To the east of this door and immediately above the burnt wooden beam are five openings in the brickwork, not visible externally. These would presumably have held joists for the wooden platform. A piece of wooden board and a new piece of timber partially cover these holes. Within the eastern archway, a breezeblock toilet cubicle was inserted during the time the building was used by the City of Edinburgh Council for Youth Training. This was accessed via a door immediately to the left as you enter through the door from outside, marked 'GENTS'. The small room was filled with broken debris from the toilet and sink.

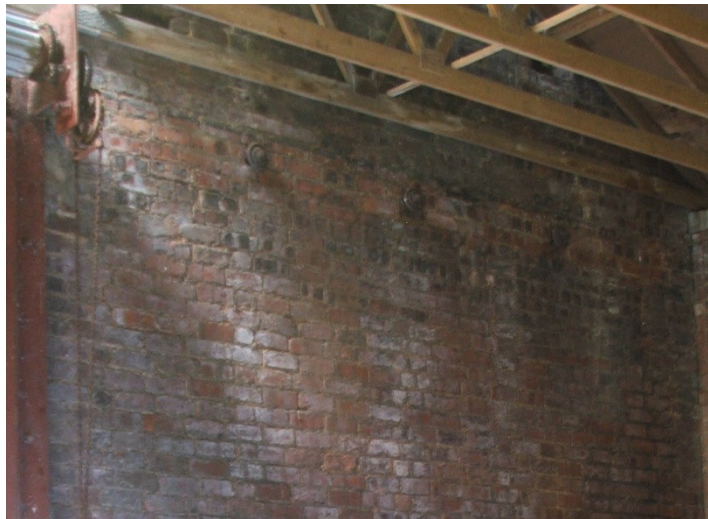
Figure 17 Iron bosses to right of roller shutter on west internal elevation

The western internal elevation contains the large square opening with roller shutter door and the iron fixings for this (figure 17). To the right of the door at the same height are four large iron bosses, with markings on the wall perhaps indicating the former location of a wooden beam.

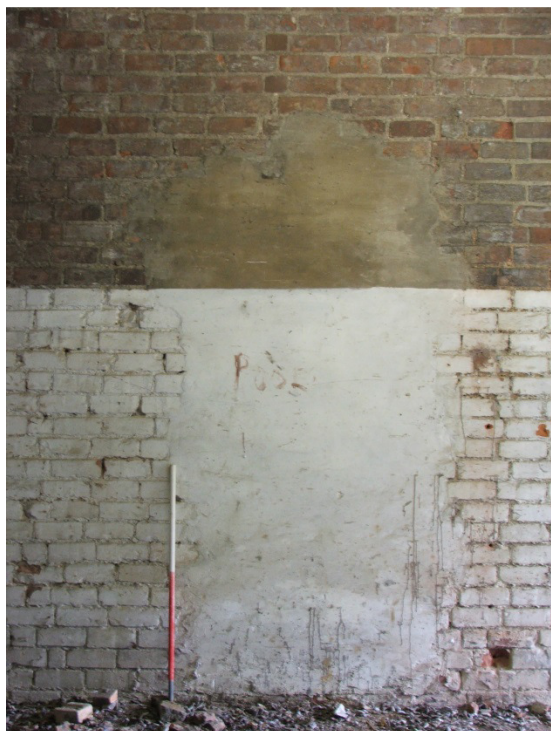
Figure 18 Blocking in southern internal elevation

The southern elevation contains a blocked opening towards the west end, presumably the doorway as seen externally (figure 18). However, there is no clear evidence whether this was an original or later doorway and the blocking and painting is such that there is no lintel or defined surrounds evident, suggesting the opening may represent repaired damage or collapse. An area of obvious repair to the east of this may support this assertion. There is a pair of modern brick pillars towards the centre of the wall, with no clear function; they may represent buttressing. Much of the eastern end of the wall was obscured by the contents of the shed.

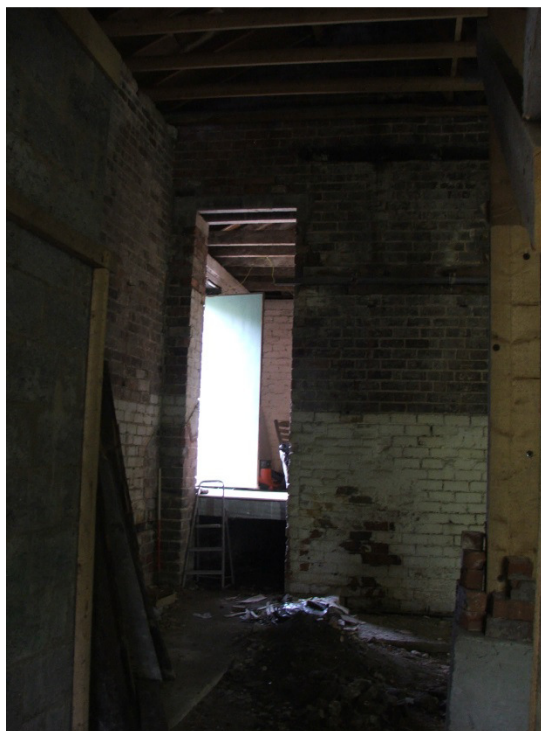
Figure 19 View into office from shed

The ceiling of the office building had been removed and a new floor inserted. The interior walls were whitewashed. The office was accessed internally from the goods shed via full height opening in the eastern elevation using a small stepladder, although the office floor would formerly have been level with the loading platforms, now removed (*figure 19*).

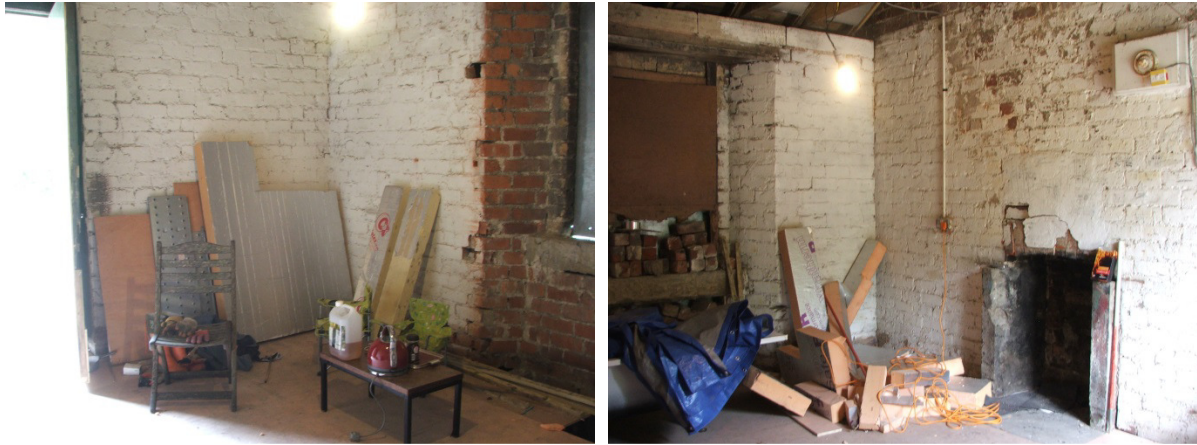
Figure 20 Internal view of office looking north-east Figure 21 Internal view of office looking south-west

The northern elevation contained only the external doorway, which had a newly replaced door. The eastern internal wall of the office contained a central recessed window, blocked with a metal plate. On the north side of the window were a number of small holes in the brickwork, of unknown function. To the right of this was an electricity meter and wiring boxes (*figures 20 & 21*). The southern wall contained a further central recessed window, blocked with hardboard and bricks. Beneath the stone sill, the wall appears to have partially collapsed and has been blocked again with brick.

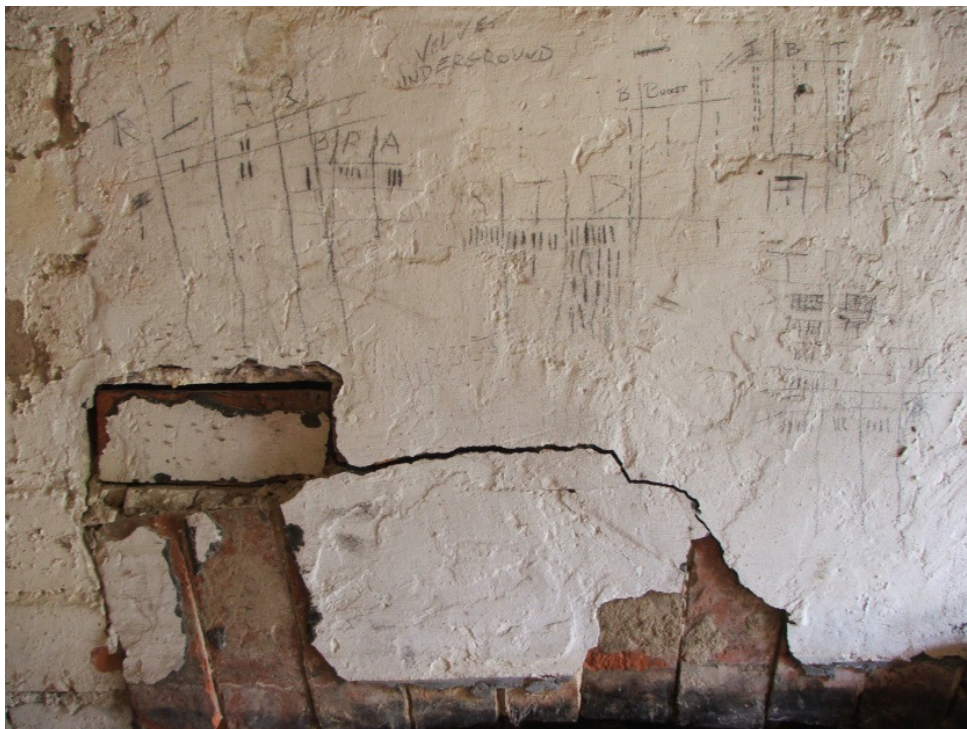
Figure 22 Graffiti above fireplace

The western wall contained a fireplace, with stone cheeks arched with red brick, which had been recently unblocked (Kate Perry, pers comm). The upper part of the surround had been plastered and was covered in graffiti (*figure 22*).

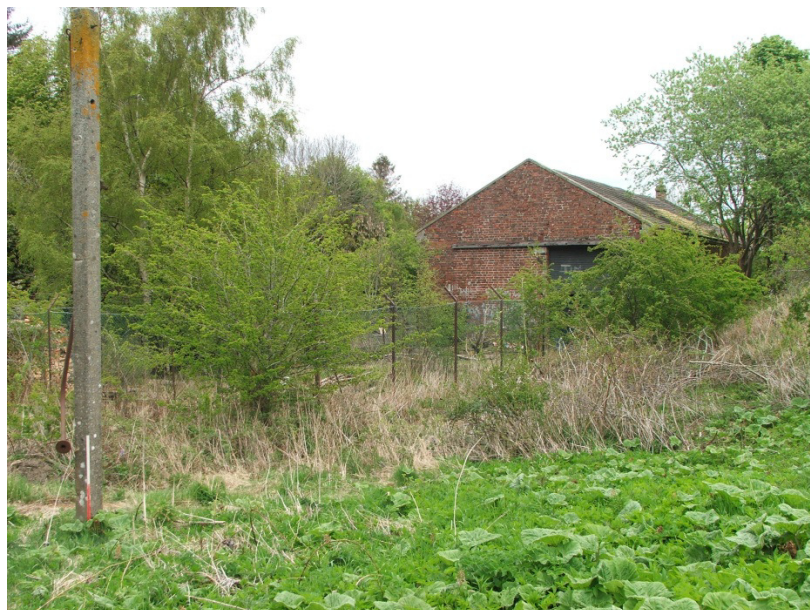
Figure 23 View of concrete pole looking towards west end of goods shed

sidings. There was a tall concrete pole with metal fitting in the area immediately west of the fenced compound (*figure 23*). This was a loading gauge - to check that wagons weren't loaded too high before entering the shed (Alasdair Gordon, pers comm).
