Cowane's Hospital Bowling Green & Garden *Stirling*

Archaeological Evaluation : September 2016

Cowane's Hospital Maintenance Trust

October 2016

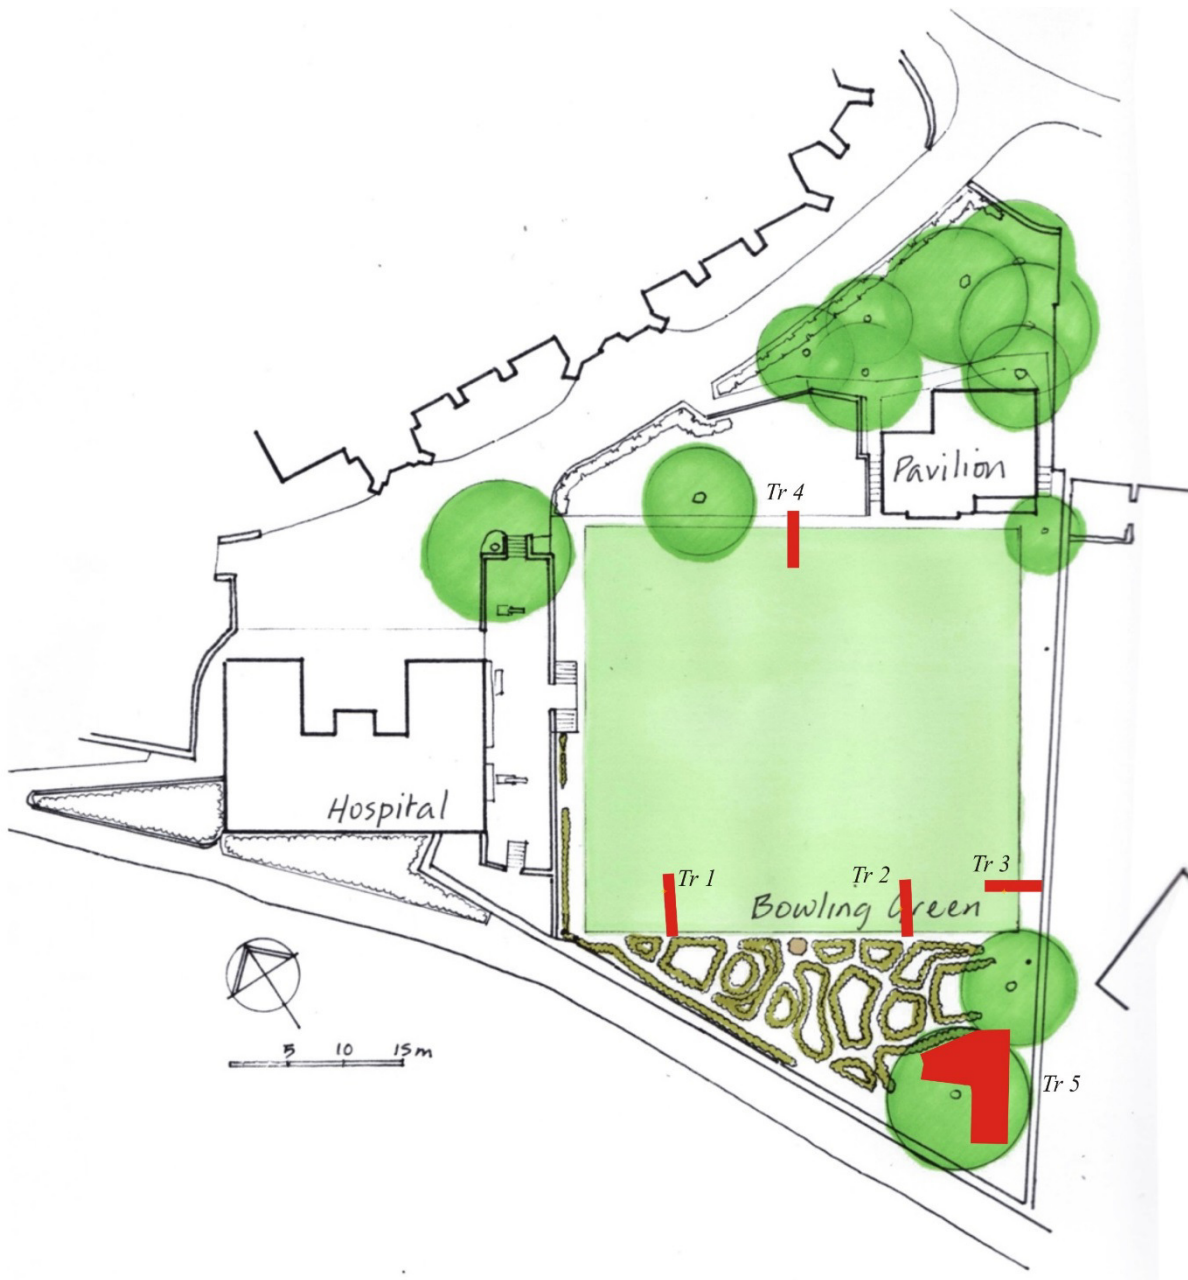
Figure 2 Trench Locations (Addyman Archaeology after Dorrian & Taylor 2014: fig 1)

Trenches 1 –4 were positioned across three sides of the existing bowling green (*Figure 2*), and were sited in consultation with Elizabeth Dorrian. The trenches were designed to investigate the bowling green edges, their associated stratigraphy, and, if possible given the time and funding constraints of the project, any underlying, pre-green deposits. Two trenches, 1 and 2, were positioned along the south side² of the existing green. Historical plans and documents indicate that this edge was differently aligned (possibly following the edges of the Hospital terrace) (Dorrian & Taylor 2014) and the two trenches along this side were designed to provide evidence for their original alignment. Trench 1 was 5.50m x 1m in extent; trenches 2-4 were all 5 x 1m.

Trench 5 was positioned in the south-west corner of the parterre garden (Figure 2) where the hedge and planting bed-pattern had become degraded and lost. It was a roughly L-shaped trench, 10m x 7.60m, running parallel to the Jail wall and extending westwards into the parterre garden around the existing mature yew tree. The trench was excavated by tracked mini-digger using a flat-bladed ditching bucket under archaeological supervision. Stripping was conducted to a depth of the first significant archaeological horizon by machine and subsequently hand-cleaned and identified features preliminarily investigated. The main focus of the trench was the identification of the original garden path network; other intrusive features were identified but not fully excavated (see below). The trench was backfilled by machine at the close of excavation; by request the identified lines of the garden path were marked out using bamboo canes.

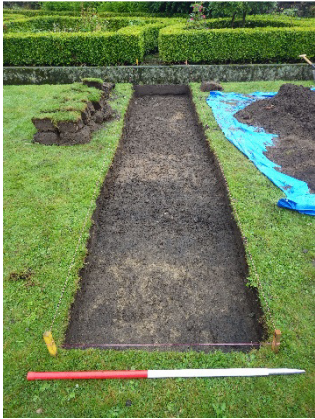
Plate 1 Trench 1 showing deposits (110) in foreground, (102) as middle dark band and bowling green levelling deposit (101) in background. Facing SW.

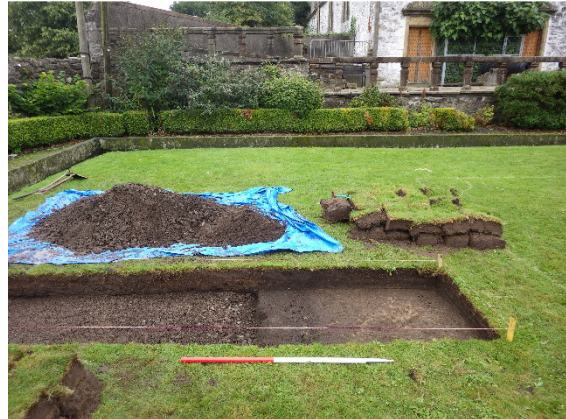
Plate 2 Trench 1 showing pea gravel fill (103) to left, fill (102) as middle dark band and bowling green levelling deposit (101) to right. Facing NW

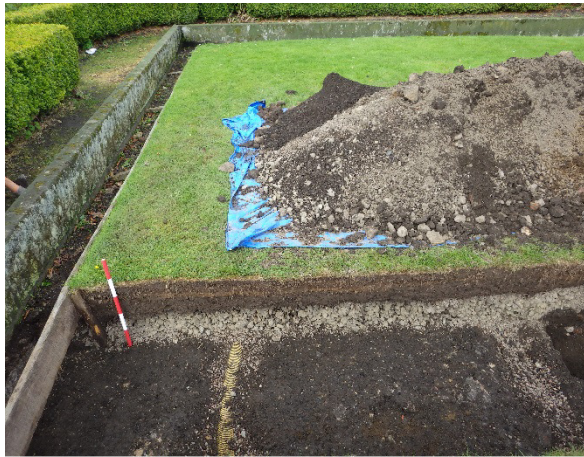
Plate 3 Trench 1, south end, showing Deposit (104) and modern pipe cuts. Facing NW.

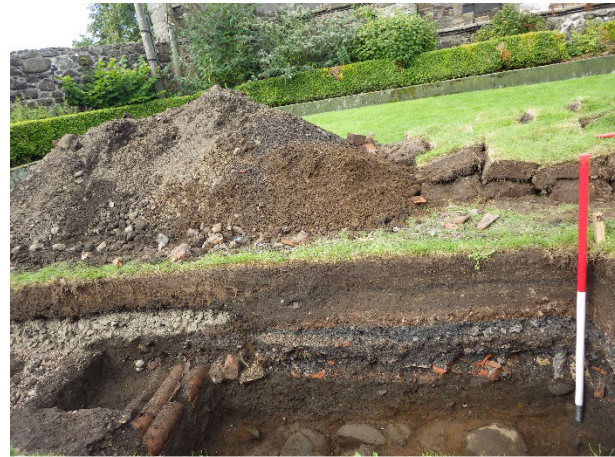
Plate 4 Trench 1, north end bowling green levelling deposits and brick rubble foundation layer. Facing NW.

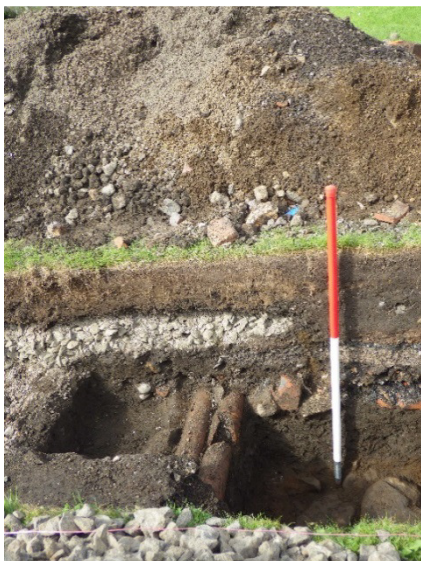
Plate 5 Trench 1, detail of south-east facing section with modern cut [105] filled with pea gravel and stakehole [118]. Facing NW.

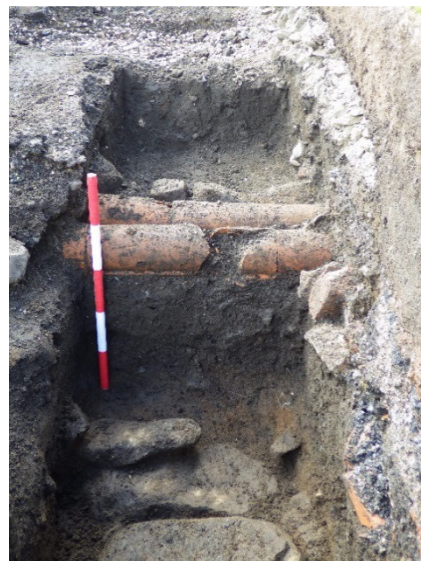
Plate 6 Trench 1 detail of ceramic drainage pipes [123]. Facing SW.

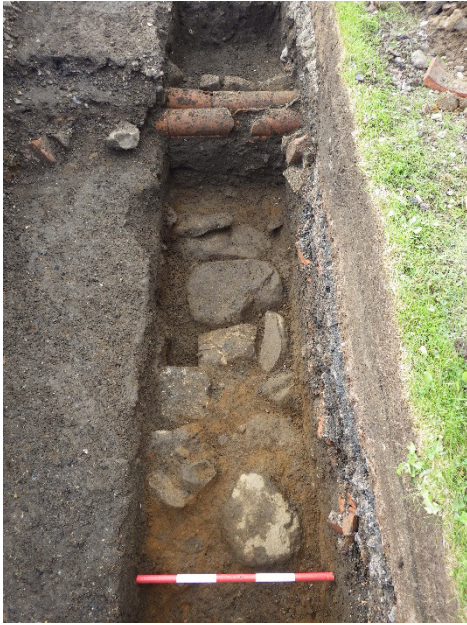
Plate 7 Trench 1 general view of pre-bowling green Deposit (121). Facing SW

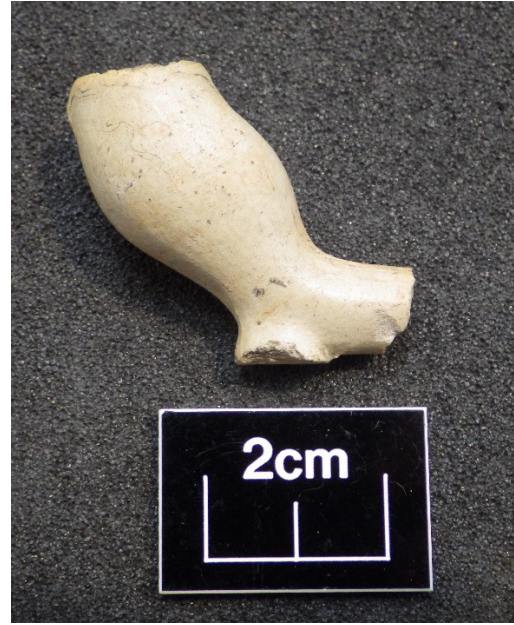
Plate 8 Stamp-impressed clay pipe bowl. SF 019.3

Deposits pre-dating the imposition of the bowling green were also encountered in Trench 1. Deposit (117) itself appeared as a midden or garden-soil deposit typical of post-medieval urban sites. Below Garden Soil (117) a horizon of mixed mid-orangey brown sandy silt was encountered, Deposit (121). Within this horizon were sub-angular and sub-rounded stones which may represent the *ex situ* rubble of levelled buildings, though no coherent structures were identified in the small area excavated. Finds from Context (117) included oyster shell, green glaze ceramic and a stamp-impressed rouletted-rim clay pipe bowl; the stamp impression on the projecting heel is a star within a star-burst, indicating local Stirling manufacture in the mid-late 17th century (*plate 8*).

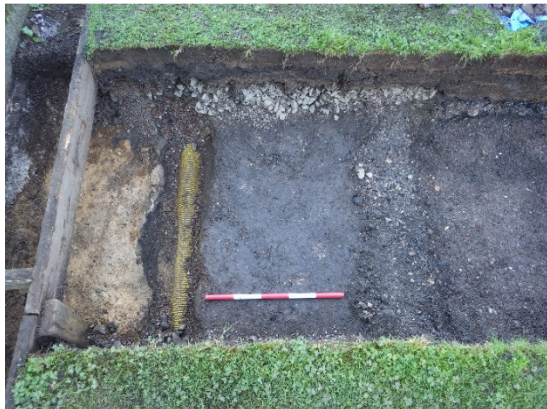
Plate 11 Trench 2, detail of southern extent showing path deposit (213) at left, compacted garden soil (211) at middle and edge of cinder deposit (207). Facing NW.

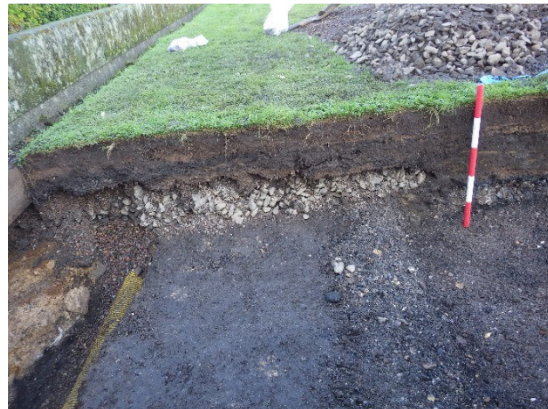
Plate 12 Trench 2, detail of east-facing section with post-hole/timber planking [223] to left of scale. Facing SW

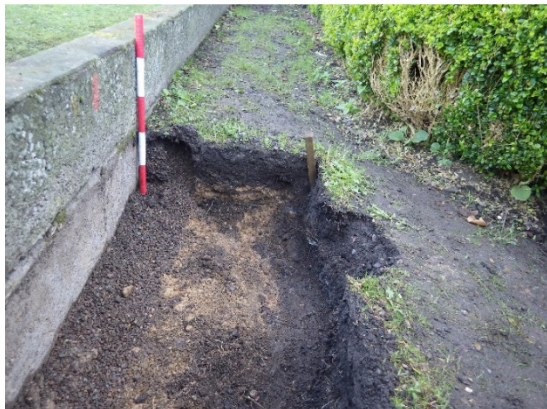
Plate 13 Trench 2, detail of far south end showing parterre garden path (208) and planting bed deposit (209) Facing NW.

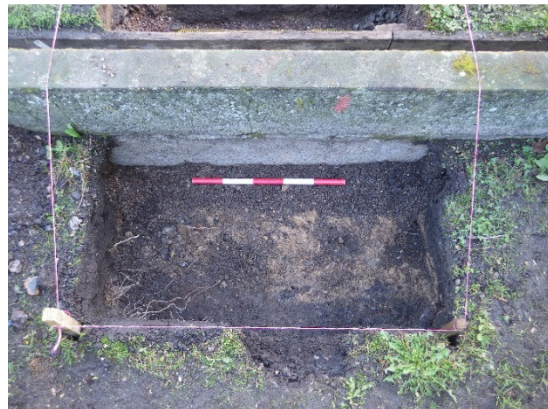
Plate 14 Trench 2, detail plan view of far south end showing parterre garden path (208) and planting bed deposit (209) Facing NE.

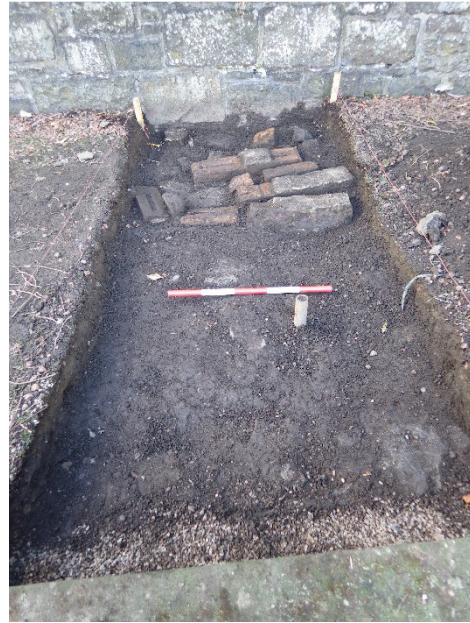
Plate 16 Trench 2, east end detail with brick tumble (315) and Stanchion [316]. Facing east.

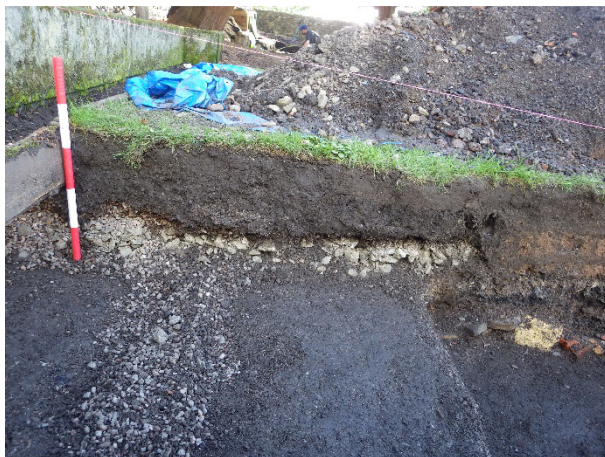
Plate 17 Trench 3, north-facing section detail with Cut [304]. Facing south-west.

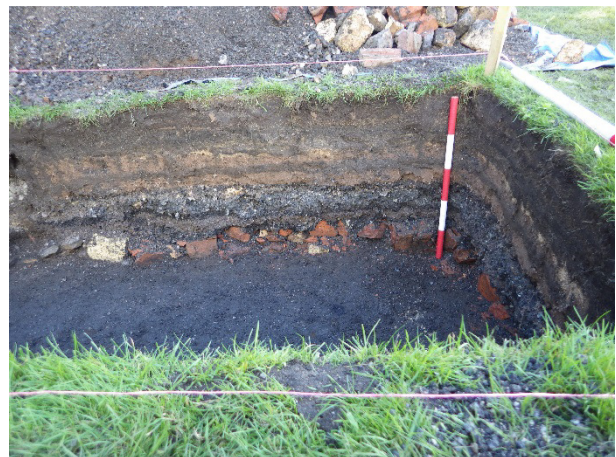
Plate 18 Trench 2, north-facing section detail with Deposits (300), (317), (305), (306), (307). Facing south-west.

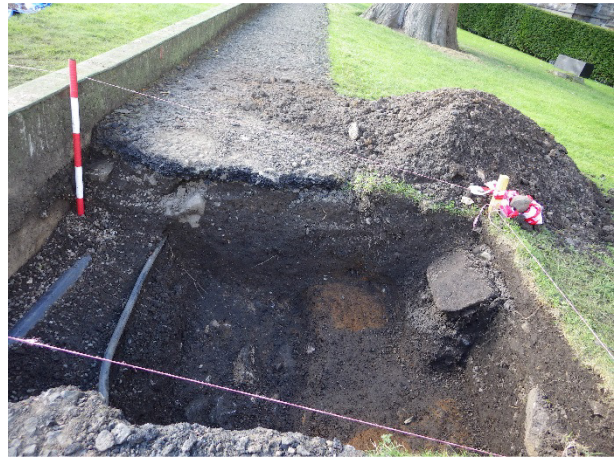
*Plate 20 Trench 4, north end with Deposit (415).
Facing north-west.*

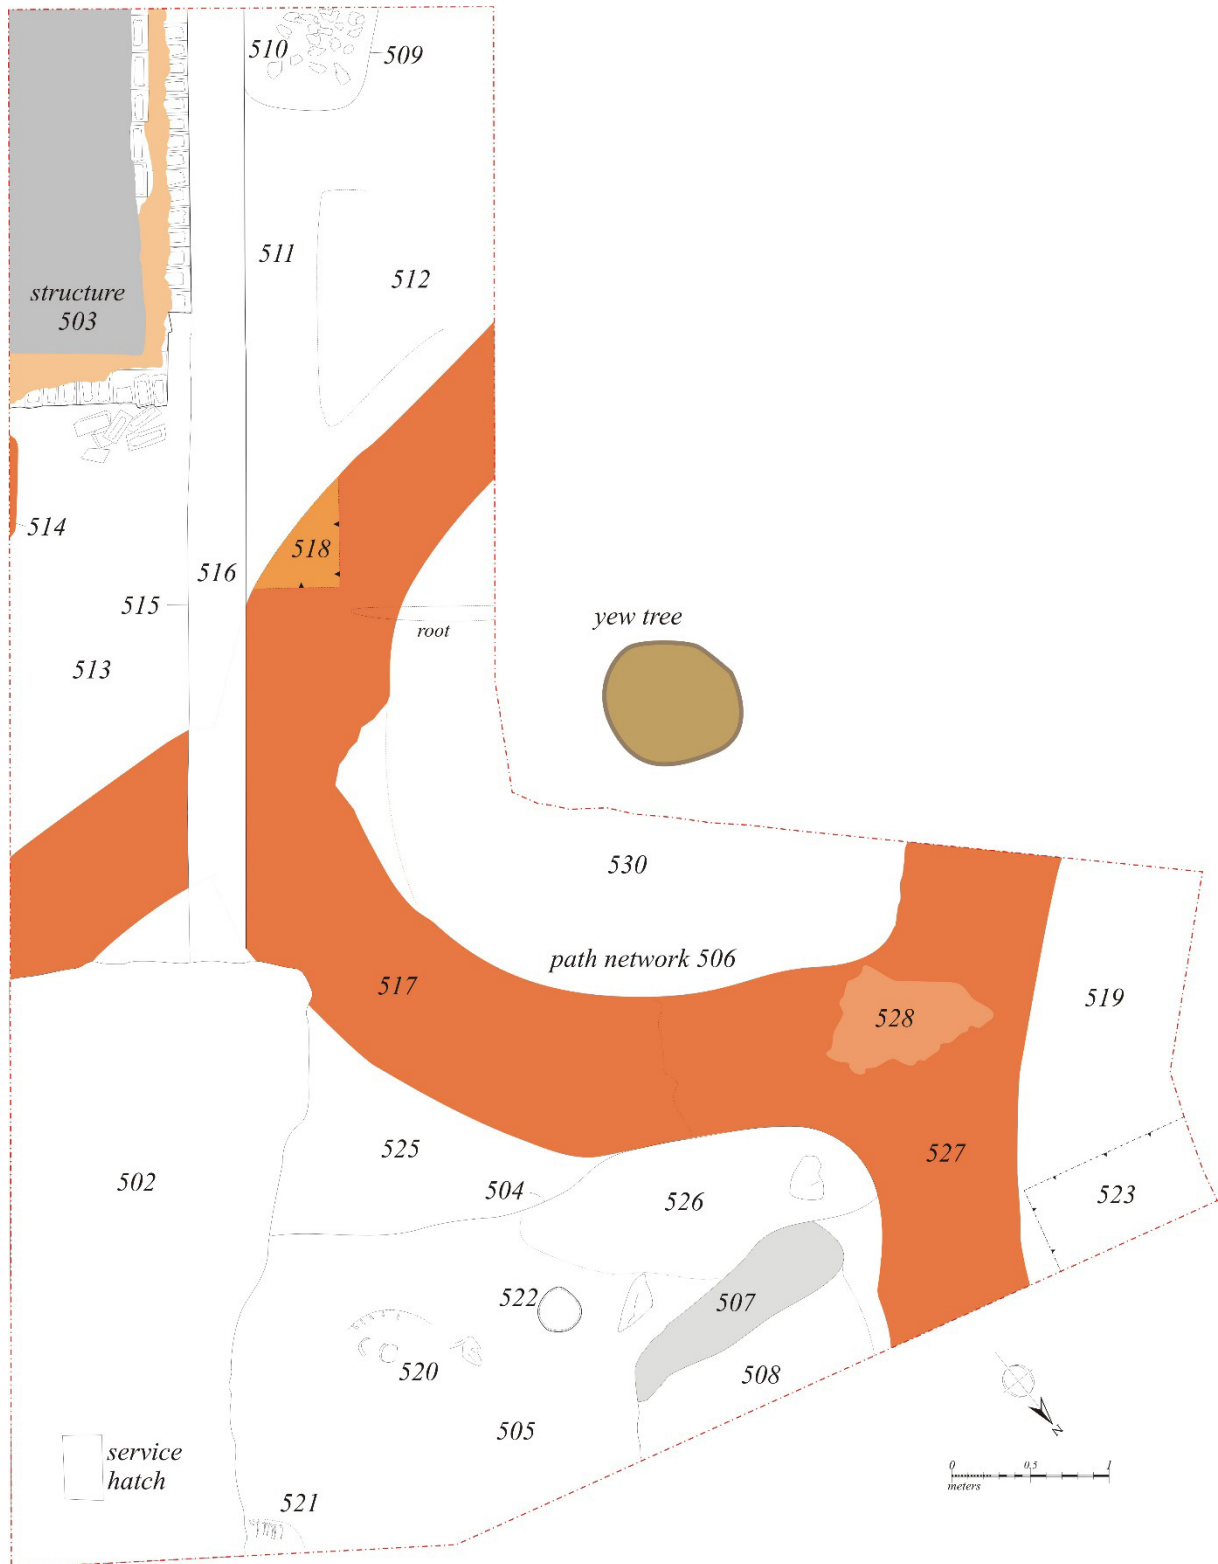
Figure 11 Plan of Trench 5

the compact band of Deposit (511) and the looser (512) (see *Figure 11*) may suggest (511) as a planting bed to the south of the parterre path. One bedding area did provide evidence for a clay-rich deposit around the edges of a possible planting bed, possibly for water retention or PH-value regulation. Hedge-beds as distinct from planting beds were not identified during the evaluation.

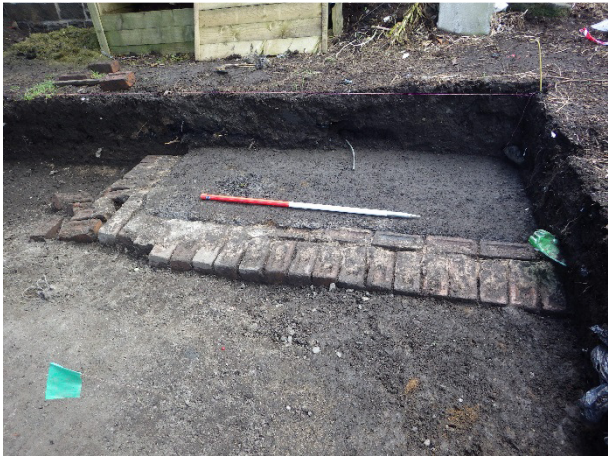
Plate 25 Trench 5, detail of structure [503]. Facing south-east.

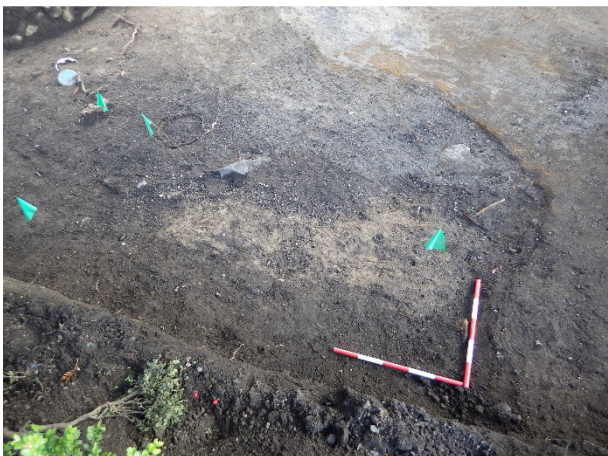
Plate 27 Trench 5, detail of clay deposit (507) and planting bed (508). Facing south.

Along the eastern edge of excavation, however, possible planting bed features were identified. A mid greyish-brown sandy clay Deposit (507) extended in an irregular rectangular area some 1.60m long and 0.40m wide; it was abutted by Deposit (508), a dark brown to black sandy loam garden soil. The clay-rich Fill (507) was not otherwise noted on site and may be related to planting bed functions of water-retention or soil improvement, and (507) and (508) together may therefore represent discrete planting beds.

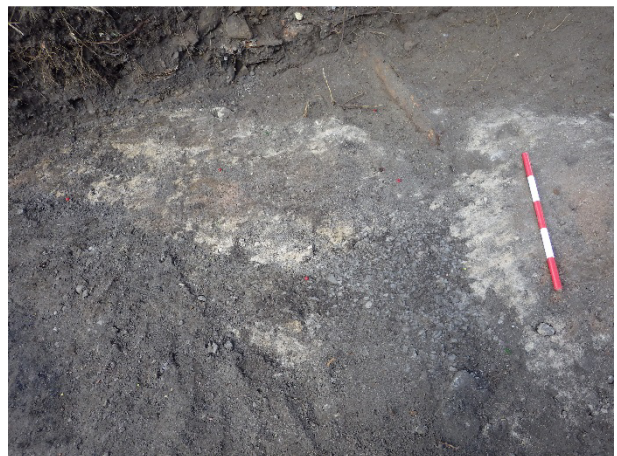
Plate 28 Trench 5, detail of path construction showing gravel (518) and matrix (517). Facing north-west.

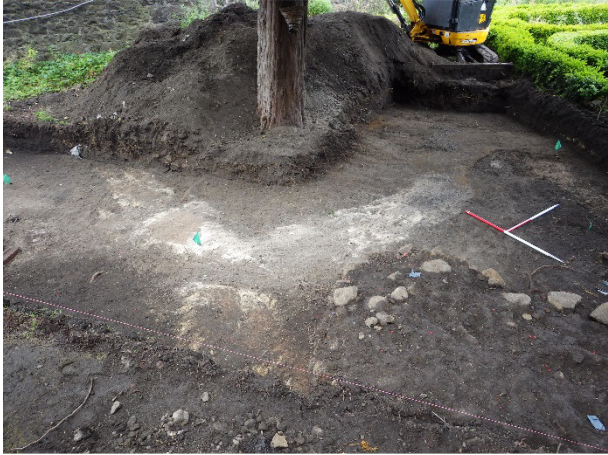
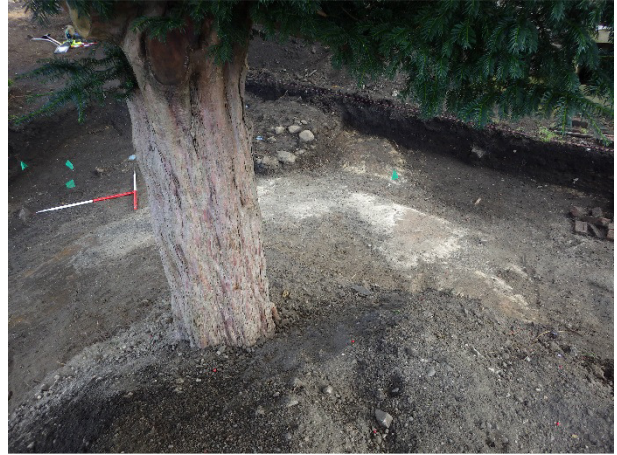
Plate 29 Trench 5, general view of path network [506]. Facing west.

Plate 30 Trench 5, general view of path network [506]. Facing east.

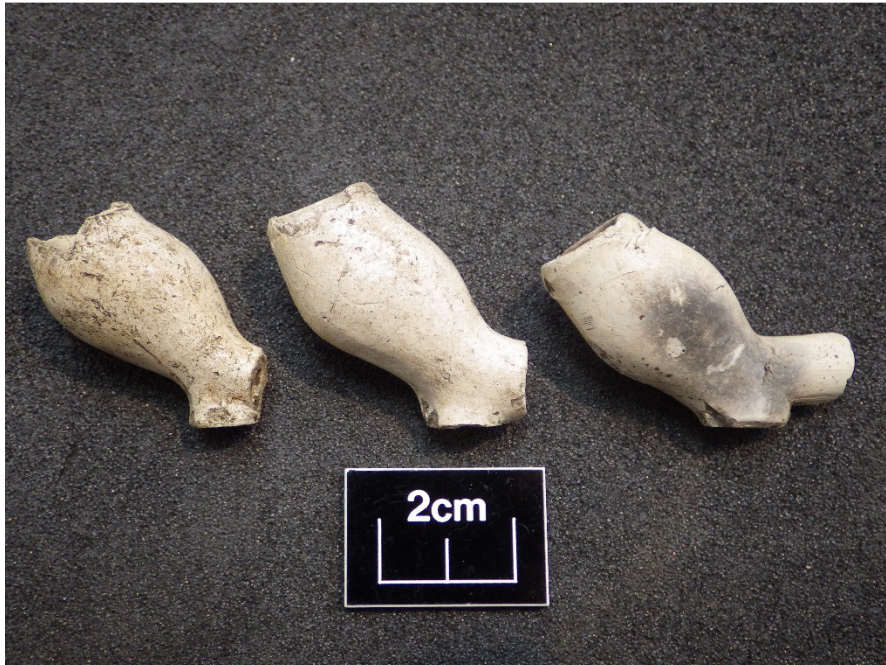
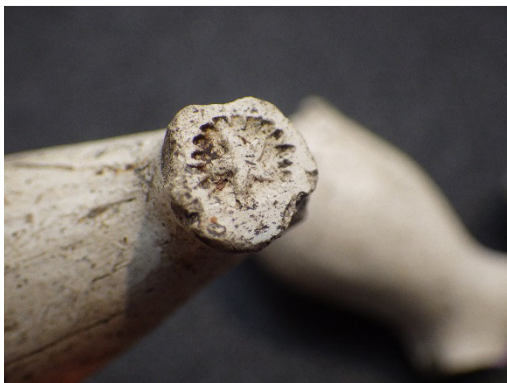
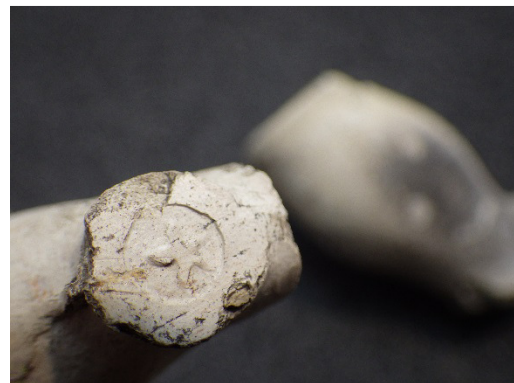
Plate 31 Stamp-impressed clay pipe bowls from Trench 5. SF030, 031, 036

Plate 32 Star stamp of SF036

Plate 33 Star stamp of SF030

rouletted rims, three of which bear 5-pointed star stamp impressions on their heels (*plates 31-33*); unglazed red earthenware fragments and fragments of green-glazed ware. These finds point to dates from the 16th to mid-to-late 17th centuries in the area.
