# Appleton Tower

## Crichton Street, Edinburgh

*Archaeological Watching Brief*

*Job number 2237*

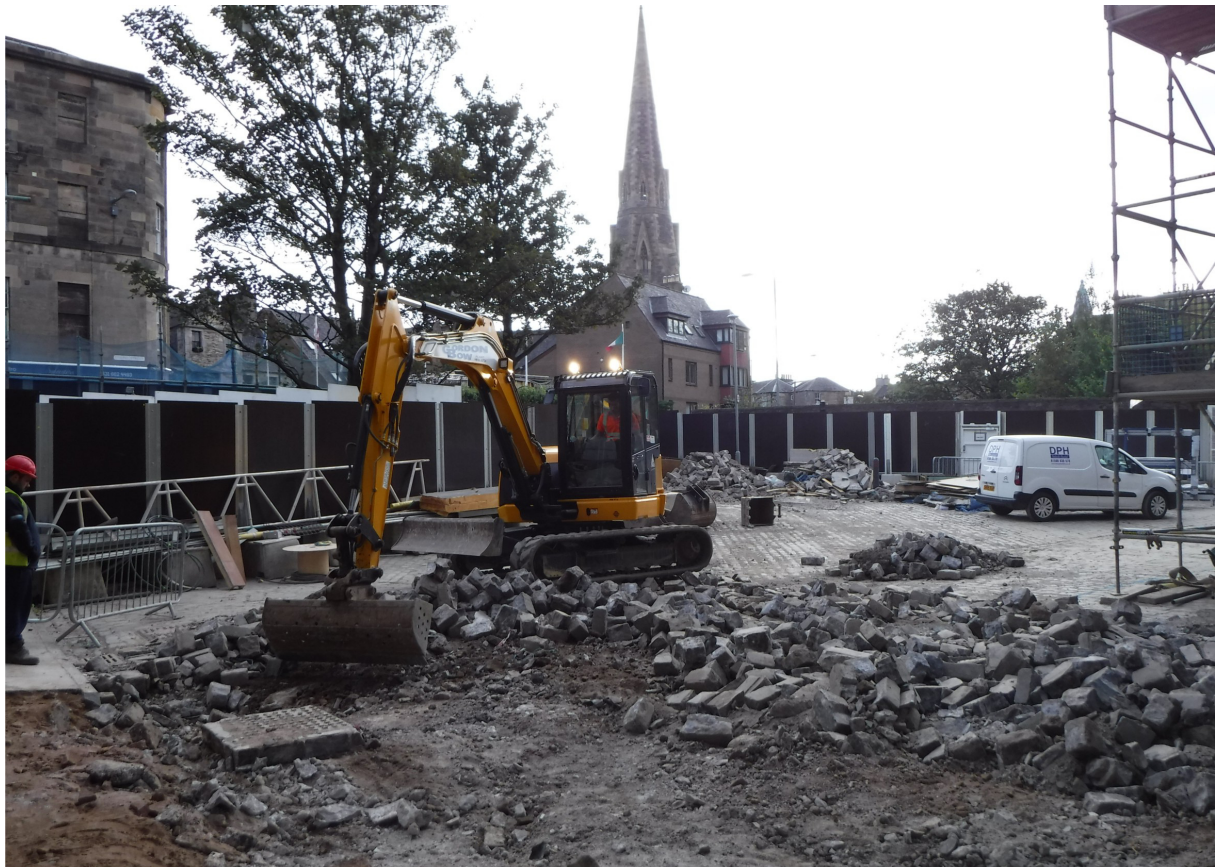
*Appleton Tower Cobble Removal (photo 001)*

Cobble removal and ground works to the south of the excavation area did not extend below the level of the cobble bedding material, and did not reveal any archaeological features.

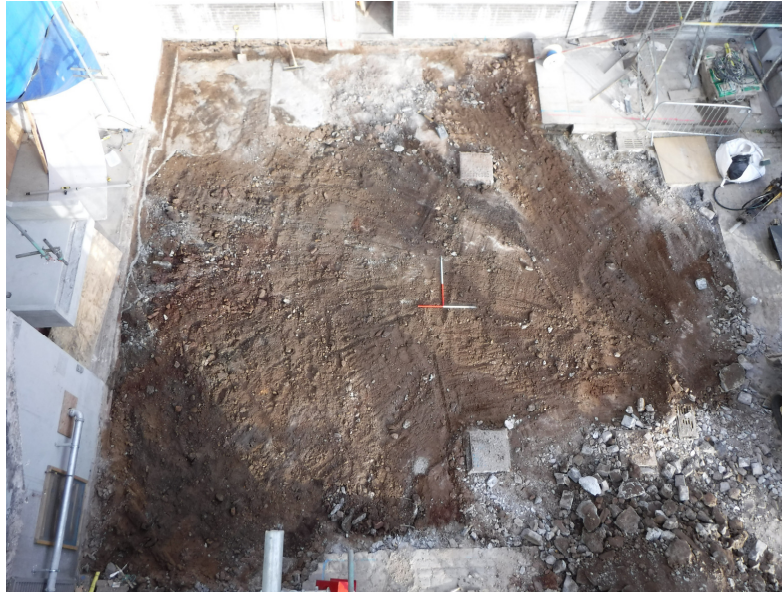
Plate 1 East extension excavation, Mid-ex (photo 010)

Excavations began with the removal of the surface layer of concrete bonded cobbles, followed by the removal of a concrete platform extending approximately 1.5m east of the entrance. Both the cobbles and the concrete platform were found to overly a made-ground deposit of demolition rubble and mixed soils (**Plate 1**). A deep concrete foundation was noted at the north end of the excavation area, projecting from the building's base approximately 1.5m and extending below the maximum excavation depth of 1.0m (**Plate 3**).

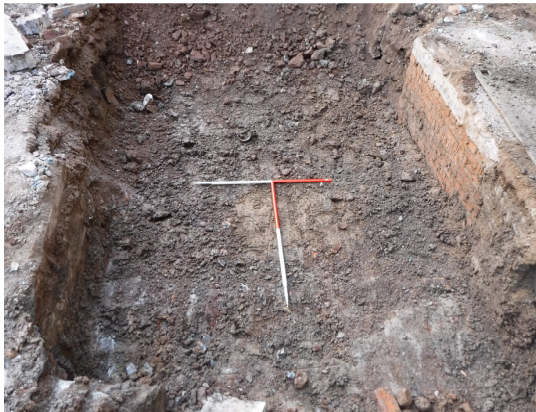
Plate 2 Depth of excavation (photo 020)

A network of active, deep brick-built sewer drains (**Plate 2**) extend over the eastern half of the excavation area, and are likely to be up to or over 2.0m deep in places; plastic and concrete encased drains were also noted. The excavated area was found to be entirely within made-ground deposits associated with the construction and use of Appleton Tower.
