Legerwood Steading

Earlston, Scottish Borders

Historic Building Recording and Archaeological Watching Brief

Job number 2205.00

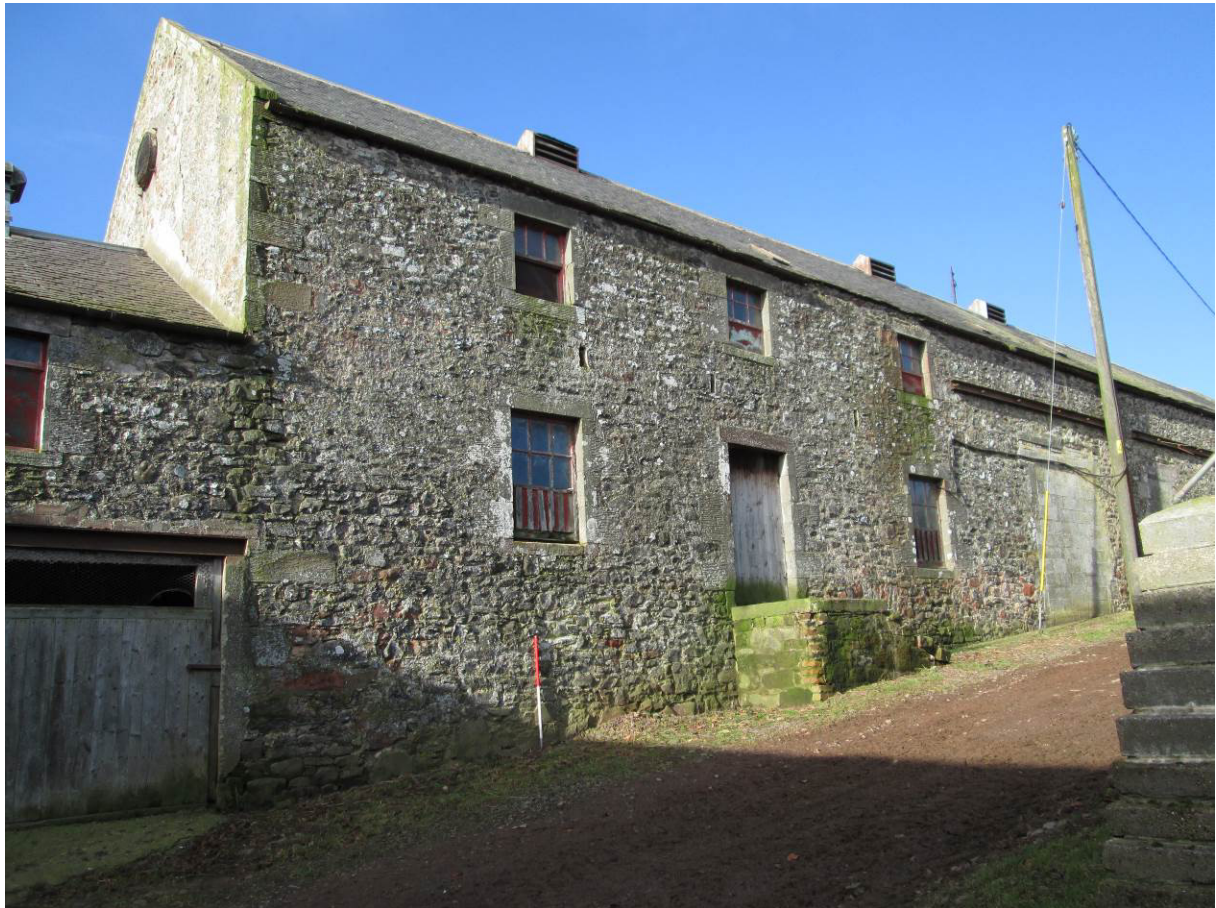
West Range, East Elevation (photo 045)

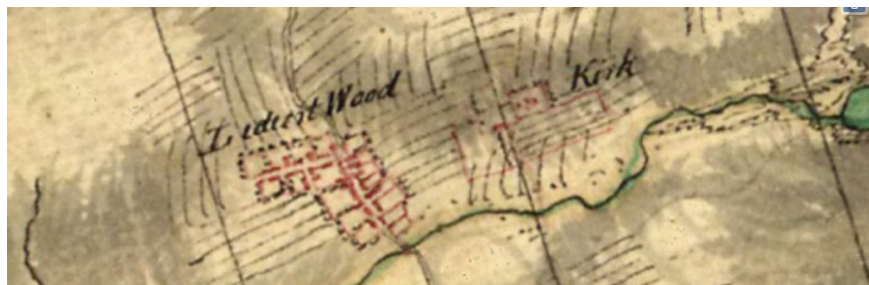
Figure 2 Extract from 'Roy's Military Survey of Scotland. Lowland Scotland' by William Roy, 1752-1755 © The British Library Board. All Rights Reserved (Roy Military Survey of Scotland)

The earliest map to show Legerwood in detail is Roy's *Military Survey* (Figure 2). As is common with earlier maps, the spelling is different from the current spelling, but it is clearly referring to the same place. The church is also shown. The buildings and areas of enclosed land surrounding them are far more extensive than the current farm buildings and appear to represent a small hamlet. The areas of cultivation can be seen extending in all directions around the settlement including eastwards to the church and beyond.

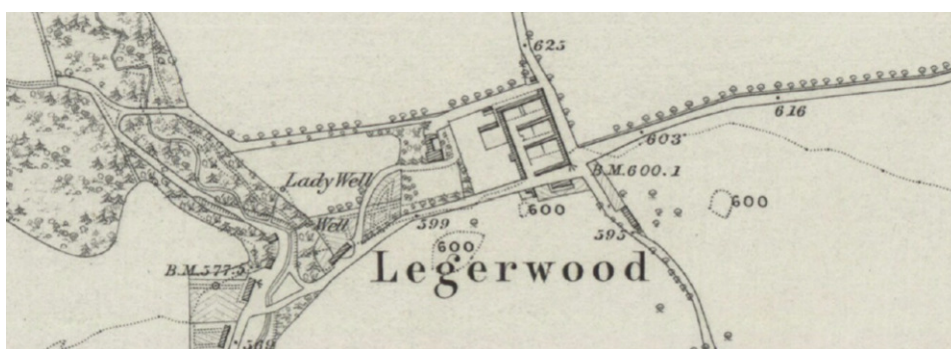
Figure 3 Extract from 'Ordnance Survey 1st edition' 6 inch to 1 mile. 'Berwickshire sheet XXVI' Surveyed 1857, Published 1862. (NLS)

The next map to show Legerwood in sufficient detail is the First Edition Ordnance Survey map Six-inch to the mile (Figure 3). The arrangement of buildings depicted is very similar to what is visible at Legerwood today. The farmhouse and Steading buildings are in the same location as they are now, and the large numbers of small buildings with associated gardens are gone. It is probable that they were cleared to make way for agricultural improvement and the construction of the current steading in the early 19th century prior to the survey in 1857.

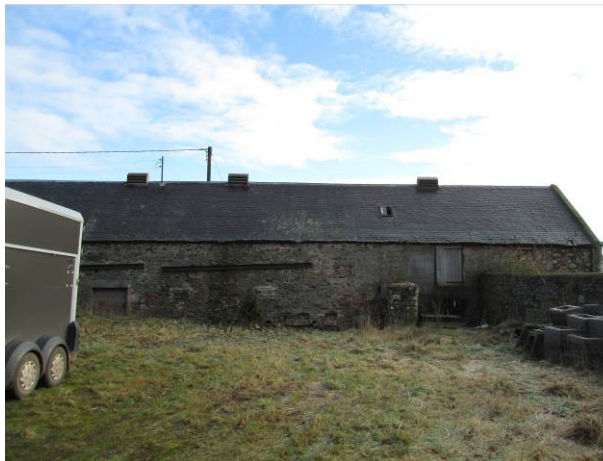
Plate 1 Upper part of west range, from west (photo 008)

The buildings forming the west range (*plate 1*) step down following the slope to the south; this can be seen clearly in *Plate 2*. Along the upper part of the range a deep channel runs along the wall of the building (*plate 3*), it is largely infilled now with rubble, which would have formed a retaining wall on the west side. It is assumed that this channel was a lade for directing water towards a wheel which would have been mounted on the side of the building, which in turn would have operated machinery within. None of the historic maps depict a mill on the site; often mill lades and mill dams are indicated. Although the Old Statistical Account mentions three threshing mills and two corn mills, it does not state to which farms these belonged; although the physical evidence demonstrates there was a mill at Legerwood. The absence of a mill lade on the OS map makes it likely that this mill was a water powered threshing mill rather than a corn mill, as the latter would be more likely to appear on the historic maps.

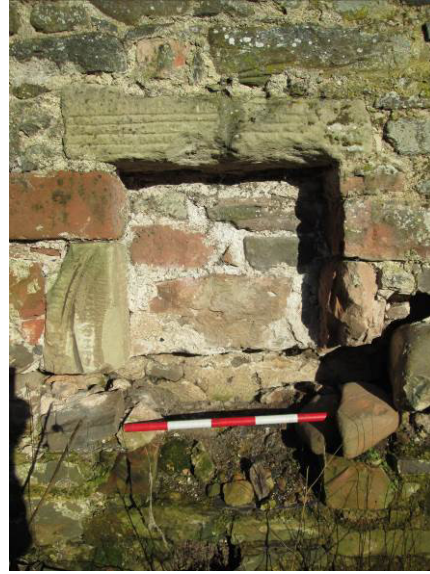
Plate 4 Mark from wheel on sandstone jamb (photo 202)

Circular wear marks on the sandstone jambs of a blocked opening on the west side of the mill building show where a wheel has rotated (*Plate 4*), and would have been connected by a shaft running through the opening to the threshing mill within. There are a number of openings in the wall relating to the building's use as a mill, which have been subsequently blocked. The only ground level opening on the west side of the building has also been blocked with breezeblocks. In several places, metal ties have been secured to the exterior of the building to give support.

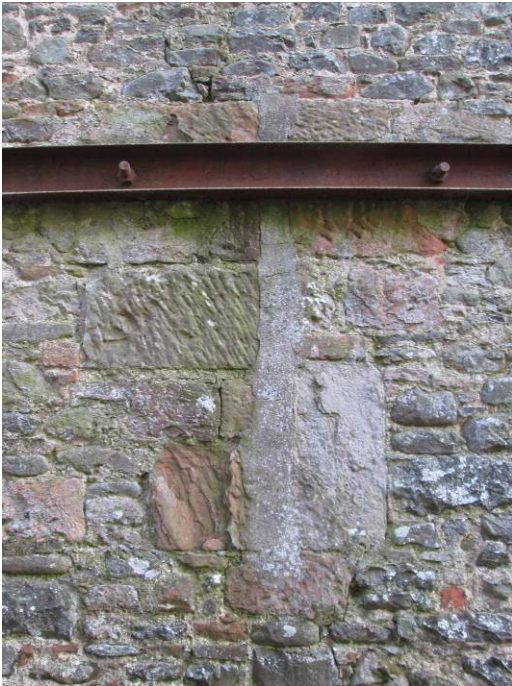
Plate 5 Ventilation slit on west elevation (photo 021)

At the north end of the building, there are two unusual vertical openings (*Plate 5*). They are long and very thin, with the opening, now blocked with an iron bar and cement, measuring only 0.1m across. An identical pair of openings are also visible on the east elevation of the building (*Plate 6*), which appear to have been part of the original build. Interestingly although their position within the building and dimensions are similar, they are constructed differently. On the east side of the building facing into the courtyard, they have dressed sandstone jambs, sills and lintels. The jambs are made of a single long thin piece of sandstone. On the west side, which generally has a less formal appearance, the jambs, sills and lintels are formed from sandstone rubble. Presumably, their function was to improve ventilation within the building in a controlled manner.

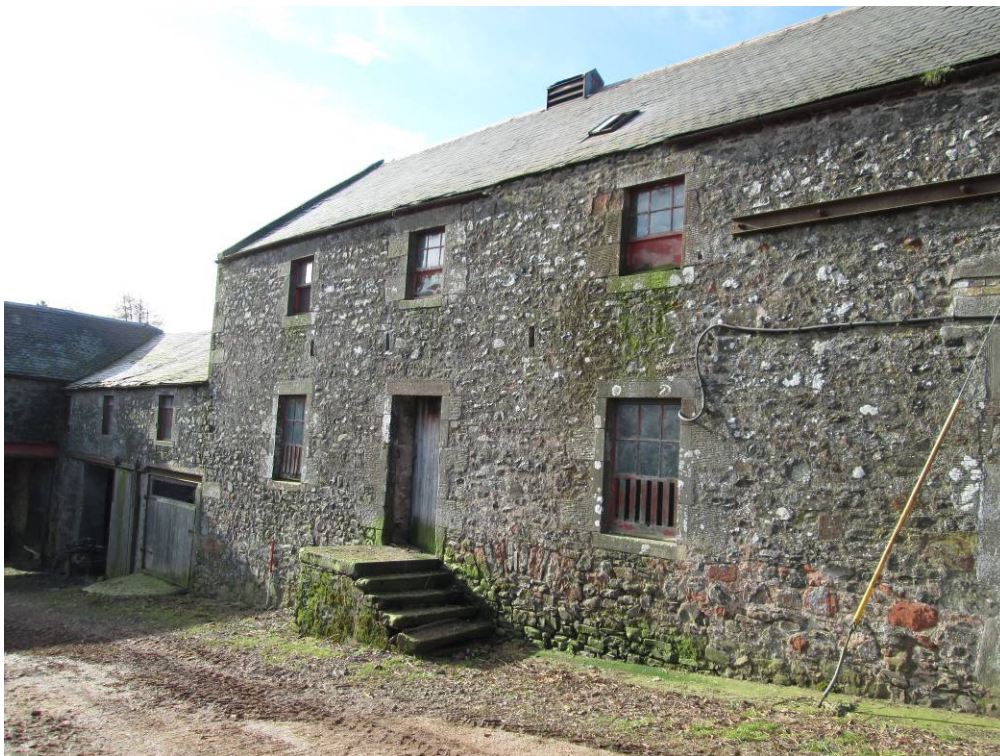
Plate 7 East elevation of west range, central section (photo 046)

The next section of the building has a very domestic appearance, with a door and five evenly spaced windows (*Plate 7*). The door is reached by a short flight of stone stairs, and has a window above at first floor level. The other windows are arranged evenly either side of the doorway. The windows retain their timber frames and glazing. The windows are only partially glazed, with the other half formed by vertical widely spaced timber slats to allow ventilation.

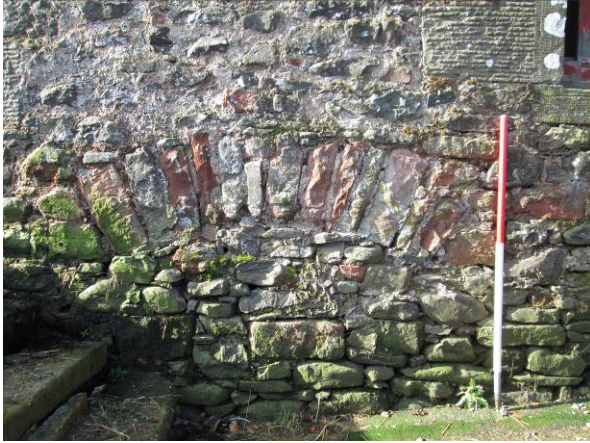
*Plate 8 Relieving arch on west range, beside steps
(photo 065)*

To the right hand side of the stair is a shallow relieving arch below window level (*Plate 8*). There are no sides visible in the masonry below to suggest there was a blocked opening, therefore it must have been to spread the weight of the masonry above. These are often placed above windows or in relation to features inside the building such as a fireplace. In this case, there is no evidence remaining of internal features that would require the relieving arch.

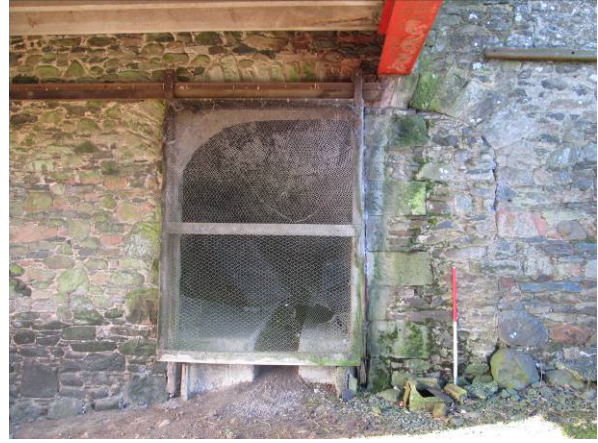
*Plate 9 Partially blocked cartshed opening, south and
west range (photo 058)*

As the ground slopes down to the south, the buildings also step down, but also reduce in height. Quoining is present at the top, but there are also a few quoins visible lower down. This may indicate that the lower section of the building is later in date. Alternatively, it may be that the quoins formed the right hand jamb of a window; the large slapping to form the current opening would have removed the remainder of this window. Further to the south, a second large opening has been slapped through the masonry. It is possible that these replaced original arched cart shed openings. To the south of this opening, is an earlier arched cart shed opening, which has been partially blocked. The sandstone arch forming the top, and sandstone quoins that formed the sides are clearly visible (*Plate 9*).

The blocking is of sandstone with neat quoining forming the edge. It is likely that this work was done in order to provide more support when the south range was extended to bridge the original opening.

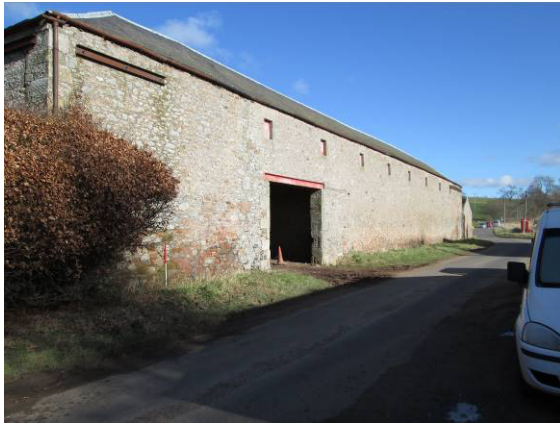
Plate 10 Exterior elevation, south range (photo 096)

This building was built in several phases. We know this from both the map evidence and the physical evidence within the building. The different phases of construction are most clearly visible on the very plain south elevation (*Plate 10*) and can be summarized as follows:

- Phase 1: Rubble field boundary mixture of sandstone and whin rubble.
- Phase 2: Single storey building as seen on First Edition Ordnance Survey
- Phase 3: Full height as at present, original entrance bridged, can be seen to abut east range

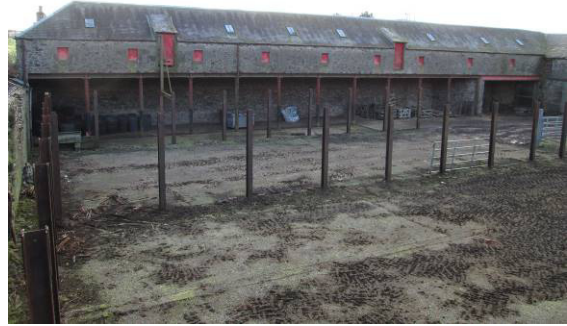
Plate 11 Interior/courtyard elevation, south range (photo 127)

The south range has less structural detail than the west range and forms a large single structure of one function. The ground floor is open onto the courtyard with the first floor supported on an iron beam resting on round iron columns. The room at first floor level is a single long space, with a subdivision at the east end that was not accessible. There are multiple openings for ventilation on both sides just above floor level, and full height doors for bringing in grain. Roof lights on the north pitch of the roof provide light. There are many small hatches in the floor, some of which still have small timber chutes raised and lowered on chains. These were presumably for filling carts parked below.

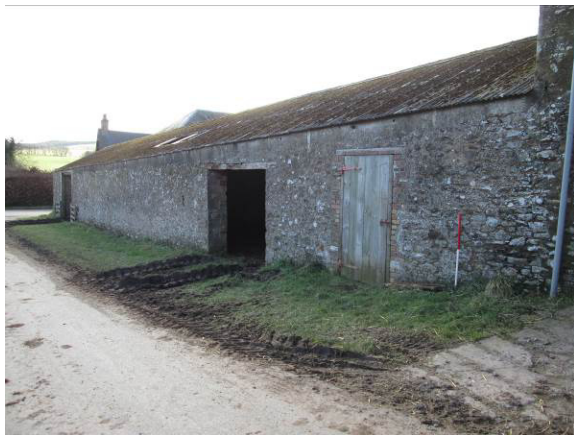
Plate 13 Exterior elevation of east range (photo 125)

The east range is a simple single storey structure built largely from whin field stone, with some red sandstone rubble on the south gable. The quoins on the east side of the south gable clearly show that this range was built before the south range. There was originally a doorway in the south gable with a sandstone lintel and quoins. The roof, which is now corrugated asbestos, has a lower pitch than the original, which is assumed to have been slate to match the rest of the buildings. The walls have been heightened to accommodate this change. The large opening on the east elevation has been raised using brick. The next large opening appears original with stone quoins and a timber lintel. The doorway to the north has been slapped through and the jambs built in brick. The internal partition is also brick and possibly built at the same time. The only other features are a series of rough narrow ventilation slits along the east elevation.

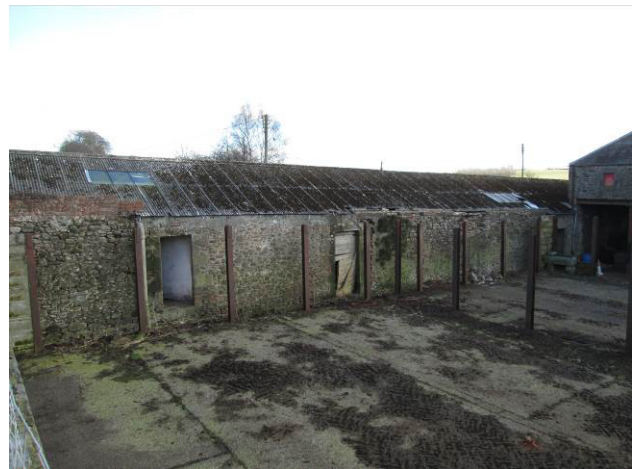
Plate 14 Interior/courtyard elevation of east range (photo 126)

In contrast to the more formal finish of the south and west ranges, the courtyard elevation of the east range is very roughly built from rubble field stone. There are three doorways with stone lintels and jambs. The southernmost doorway has a timber lintel on the interior, which is heavily charred (Plate 15). It may be that the building caught fire at some point, which could explain the different roof from the rest of the buildings. The masonry on this elevation is in poor condition with patches of the facing stones missing.

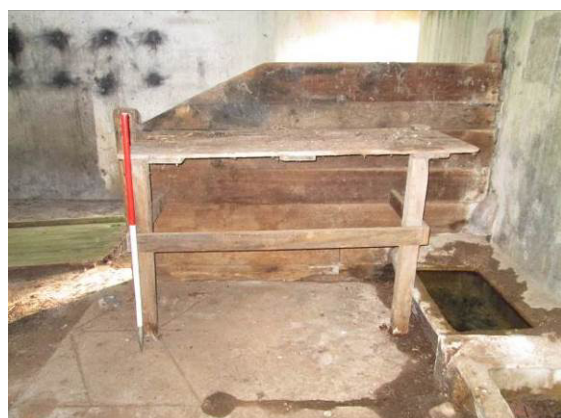
Plate 16 The interior features, east range (photo 219)

The main area of this range is open to the roof with no internal features or linings. The small area portioned off at the north end has a timber stall, workbench and three stoneware troughs (Plate 16)

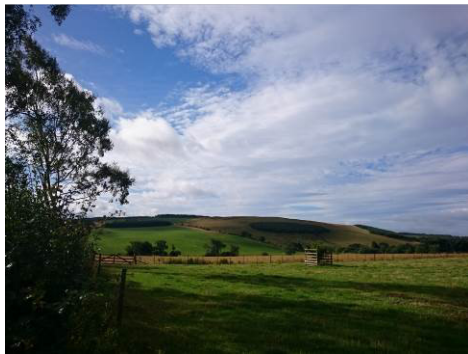
Plate 17 Location of excavation, looking south (photo 235)

The excavation area is roughly centred on NGR NT 58635 43243, and lies to the immediate south of the main steading, within an open field to the west of, as well as cultivated pastureland to the south and southwest of, the farm cottages known as ‘The Granary’. The topography of the site is relatively flat, sloping gently to the southwest towards the Eden Water. The site is bound by a drystone field boundary and the road from Legerwood to Kirkhill to the north, a drystone and wire fenced field boundary at The Granary cottages to the east, and open fields to the south and west.

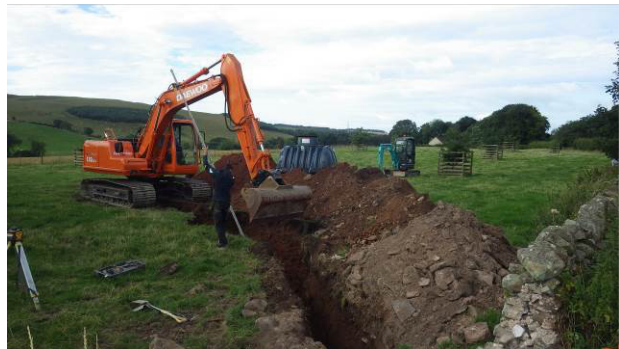
Plate 18 Excavation of the septic tank pit (photo 241)

The excavation of the septic tank pit was undertaken using a bladed bucket to remove the topsoil and clean down onto the natural subsoil, and down to over 1.0m before switching to a toothed bucket to dig to the 2.90m required depth. The pit was rectangular in plan, roughly orientated north-south, and measured approximately 2.60m in width by 3.70m in length. Topsoil depth in this area measured 0.30-0.40m, and was found to directly overlie the natural sandy clay subsoil. Two sherds of 19th century stoneware and one green bottle glass shard was noted in the topsoil but were not retained.

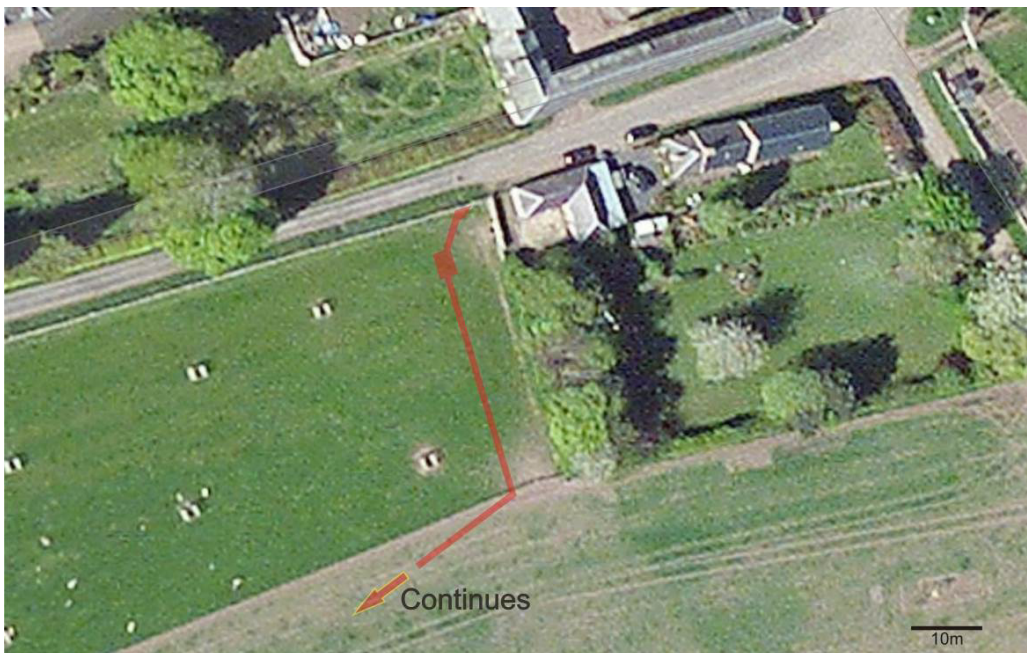
Figure 5 Site Location with excavated area in red (Addyman Archaeology after Bing Maps)

Figure 5, below, shows the area affected by the ground works, with the machine excavations shown in red; these works comprised the excavation of a pipe trench leading from the roadway towards a large pit for the accommodation of a septic tank, and a long pipe trench extending to the south, crossing the southern field boundary, and changing in direction to the south west for the purpose of septic outflow and diffusion. The directional arrow indicates a continuation of the excavated outflow trench; the continuation of this trench was not monitored archaeologically, as an agreement was reached between the client and council archaeologist that these works could be considered to come under the classification of farm-related activities.

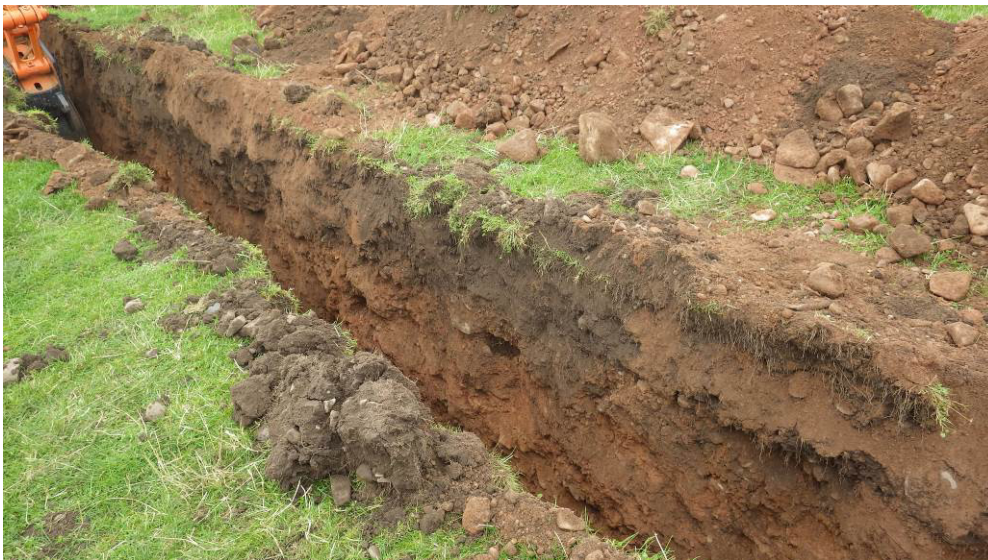
Plate 19 Septic outflow trench stratigraphy, east facing section (photo 248)

The septic outflow trench extended approximately 30.0m, due south, from septic tank to fence line, and measured 0.80m in width by 1.90m in depth, becoming shallower with the natural slope of the land as it moved southwards. The depth of the topsoil/ ploughsoil varied, measuring from 0.20-0.30m towards the centre of the field, deepening to around 0.40-0.50m towards the southern fence line. Infrequent sherds of late 19th century ceramics, including stoneware and transfer printed white wares, were noted in the topsoil and were not retained.
