Alnwick Castle Estate Offices

Alnwick, Northumberland

Archaeological Desk Based Assessment and Historic Building Recording

January 2017

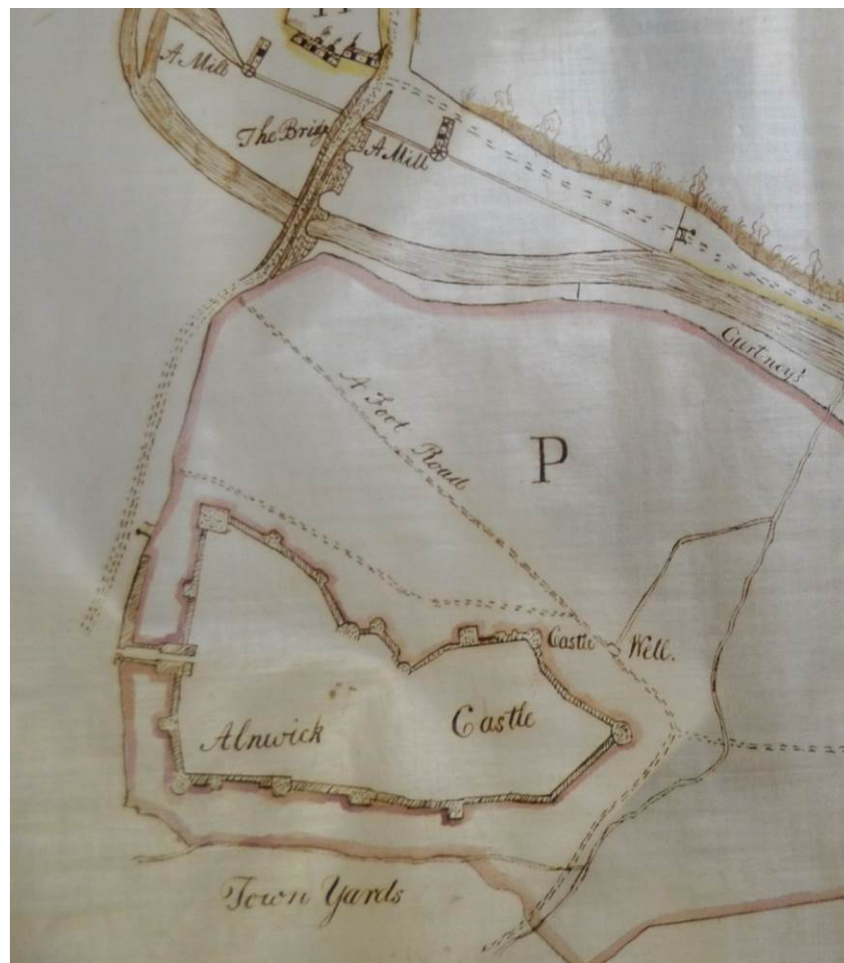
Figure 5 Plan of Alnwick, with close up of Castle, Robertson 1737, Alnwick Castle Archives

The earliest detailed mapping of the castle held in the castle archives is on Robertson's Town Plan of 1737, which shows the castle in some detail (*figure 5* below). This details the barbican entrance at the west and shows the southern curtain wall in front of the 'Town Yards', although there is little detail of the town buildings. The earlier bridge over the River Aln is also shown to the north.

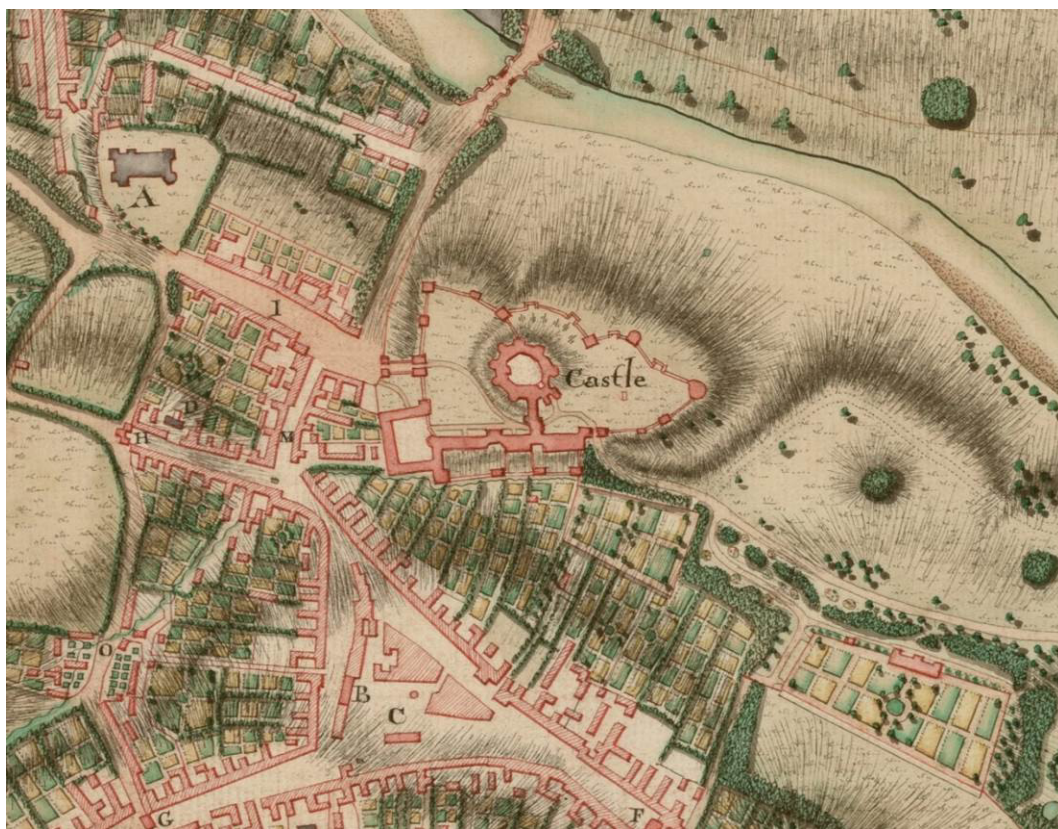
Figure 9 Map of Alnwick Sauthier 1788, Alnwick Castle Archives

Sauthier's plan of 1788 (*figure 9*, above) shows the same general ground plan of the castle. It depicts the development of buildings to the west of the new stable courtyard and greater detail of the burgage plots extending northwards from Bondgate. The buildings are clustered on the street frontage, with the backlands predominantly gardens.

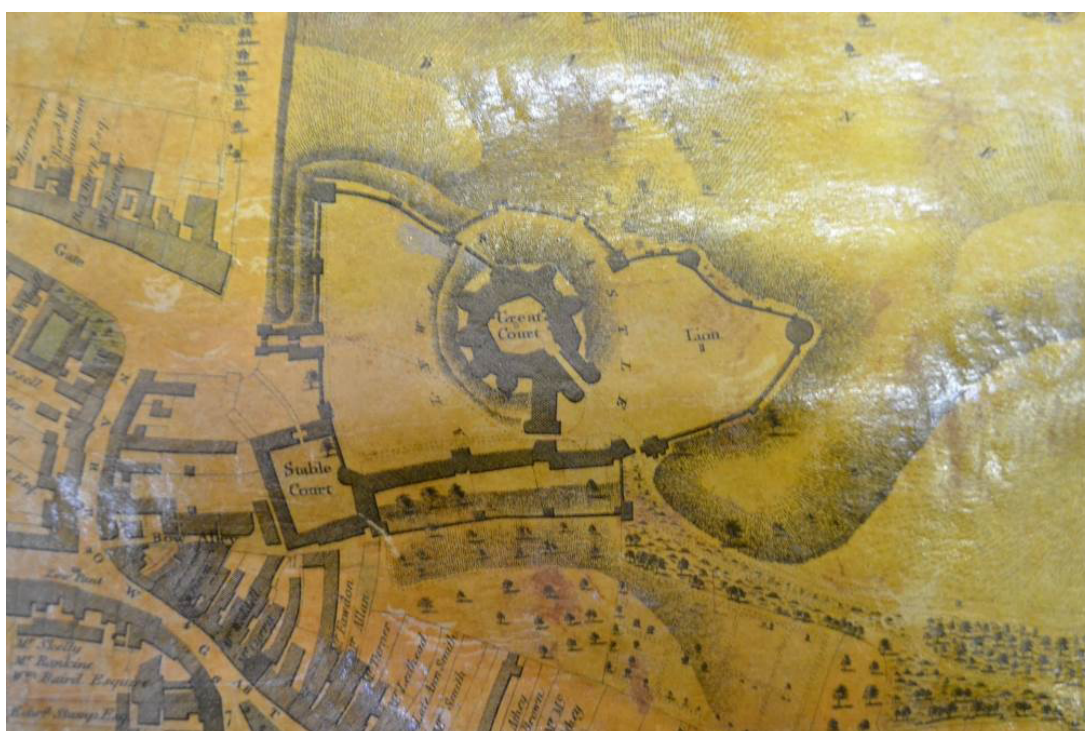
Figure 10 Ward's plan of Alnwick, close up of castle 1827, Alnwick Castle Archives

Ward's plan of 1827 is the first to show the alterations to the southern part of the Stable Courtyard and the southern wing of the Estate Office (*figure 10* above). Both these buildings appear to have been wholly or partially rebuilt with far wider buildings than previously, although the small square building is still visible. The detail of these 19th century alterations is shown on Delamotte's plan of the castle from 1865 (*figure 11* below). The Estate Office, Stables and new Riding School are all depicted as part of the new phase of works undertaken by the 4th Duke of Northumberland between 1854 and 1864.

Although the plan of the *Estate Offices* (17) and the *Laundry* (18) remain the same as in the 1776 plan, the conclusion is they must also have been subject to some alterations at this time. The south wing of the L-shape has been foreshortened by the addition of the new *Guest Hall* (19), which has replaced the *Coach Houses* at the southern end of the stable courtyard. The small square building has also been removed and the south wall of the *Guest Hall* is now flush with the boundary wall, which now has a dog-leg to join with new buildings on the east side of the Auditor's Tower. The new *Riding School* (21) has been added to the west of the stables and there have also been alterations to the west range.

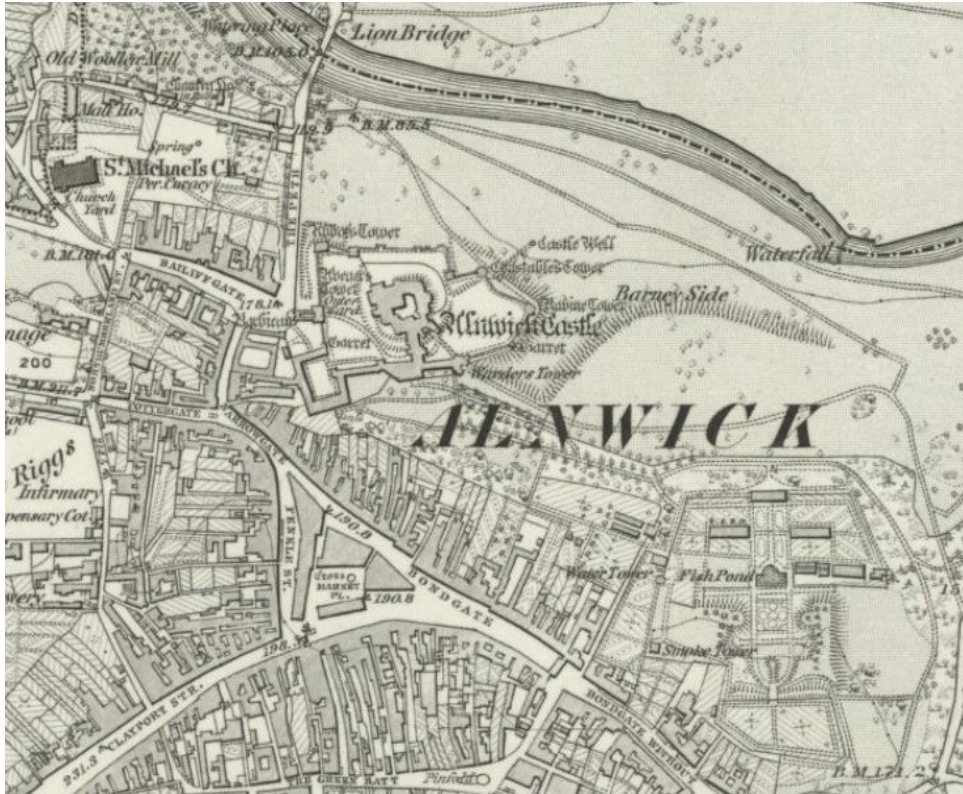
Figure 14 Ordnance Survey 1st edition 1867 6 inch: mile, Northumberland XXXII (includes: Denwick; Lesbury; Littlehoughton; Longhoughton.) Surveyed: 1861 to 1864

The Ordnance Survey 1st edition map of 1867 shows the same layout as that on Ward's plan, although the Riding School, as shown on Deloitte's plan is not marked; the buildings shown on Ward's plan close to the southern edge of the stables are no longer shown and there is an open area to the south of the stables (*figure 14* below). Elsewhere the post-medieval pattern of burgage plot lengths can still be identified, although there has been further development of the town. The formal gardens to the east of the castle, including fishponds are shown in great detail. The 2nd edition of 1899 (*figure 15* below) shows the Riding School and has also marked the Guest Hall. The buildings in the Market Place are shown in greater detail but otherwise there is little change to the general layout.

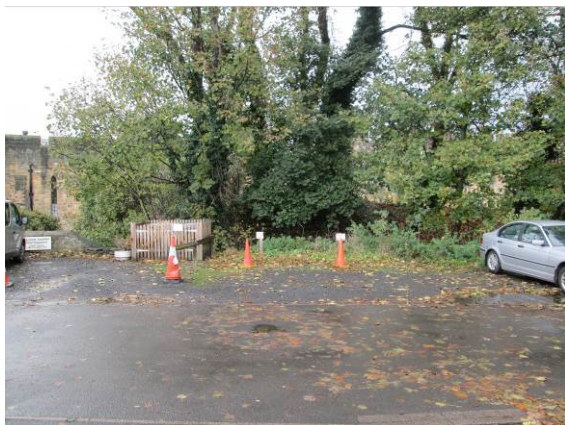
Plate 1 View from carpark on Greenwell Lane

To the south and south east of the drying green area there is a steep embankment which is topped with mature trees. This blocks all views of the proposed extension from the rear of the listed properties on Bondgate that back on to Greenwell Road (*plate 1*). From further west the west wing of the Guest Hall blocks all views when approaching from Bondgate.

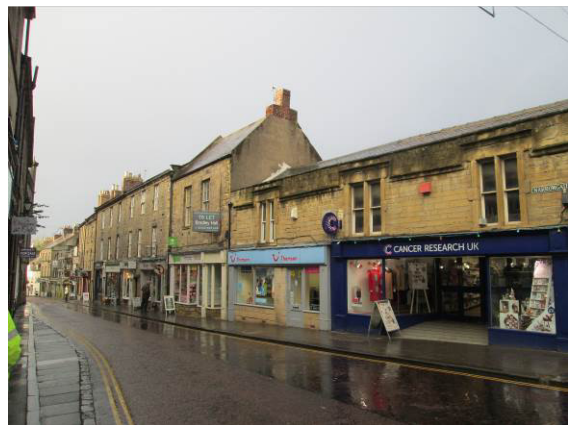
Plate 2 View from Bondgate

The buildings on Bondgate within all front away from the castle towards the south-west, so there is no impact on the townscape views as the Estate Office is not visible from Bondgate (*plate 2*) due to the height of the buildings. It is therefore clear that there will be no visual impact on any of the buildings on Bondgate or elsewhere in Alnwick town centre. The Scheduled Monument of Bondgate Tower was not accessed during the site visit, however the site is not visible from the lower level of the tower.

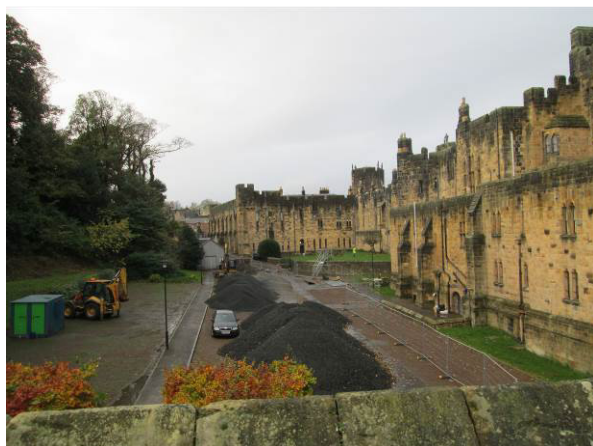
Plate 3 View from Duchess Bridge

The listed Duchess Bridge, which lies directly to the south west of the drying green area will be directly within the line of sight of the proposed extension. A full photographic survey was made from the bridge showing the drying green (*plates 3 and 4*). However, this is only one of a number of views from the bridge. The predominant setting of the bridge is of approaching and entering the castle, and from this viewpoint, the proposed extension would lie towards the edge of the picture, with the dominant view being that of the castle entrance.

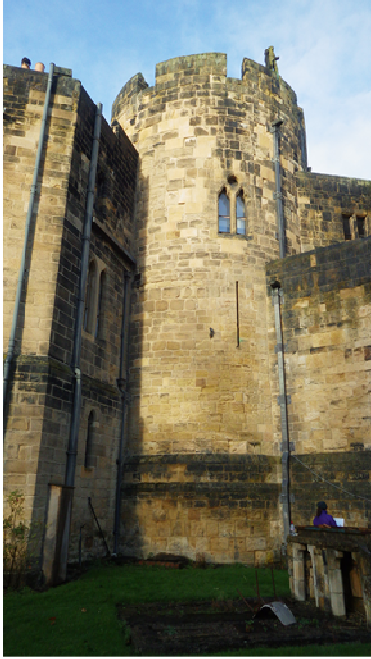
Plate 5 Auditor's Tower

The earliest part of the castle bordering the Drying Green is the large tower in the north east corner, and dates to the 14th century (*plate 5*). There is considerable evidence within the masonry for repairs and patches to the stone work. The decorative window and arrow slit below are later modifications that may replace earlier features, or be newly added during the mid-19th century construction of the Guest Hall and alterations to the south facing elevation.

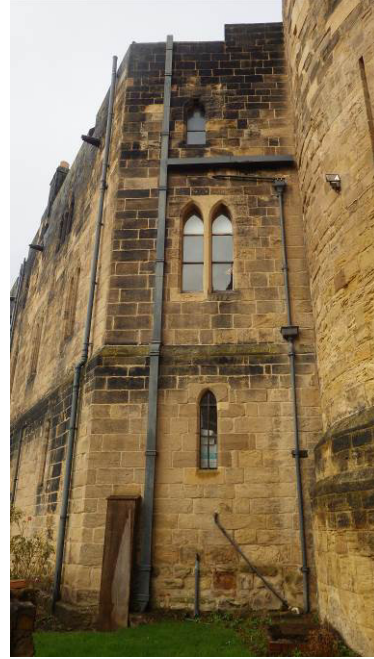
Plate 6 Estates Office

The long south facing elevation was added in the 18th century (*plate 6*). The lower section of the south west facing elevation may also be of 18th century date due to similarities in the masonry.

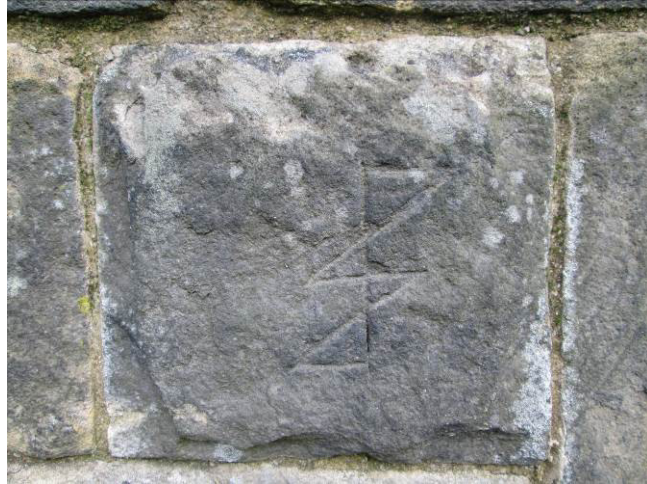
Plate 9 Mason's mark on south-west facing elevation

The south west facing elevation was built as part of the same programme of works. A mason's mark was recorded on one of the stones, which may have been reused from elsewhere in the castle (*plate 9*).

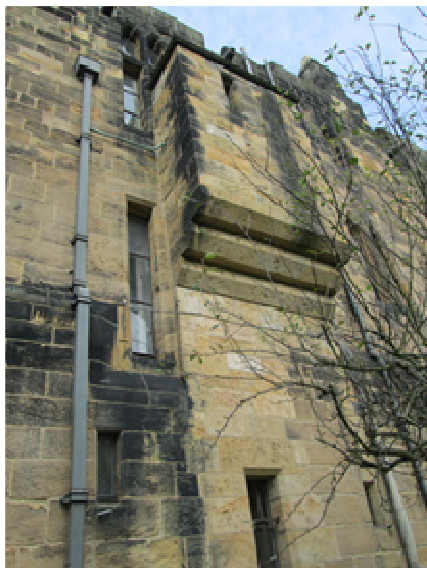
Plate 10 20th century window insertion in south facing elevation

The most recent alterations are in the centre of the south facing elevation on the Drying Green, immediately below the projecting wall (*plate 10*). It includes a simple window (*plate 11*) and appears to be 20th century in date.

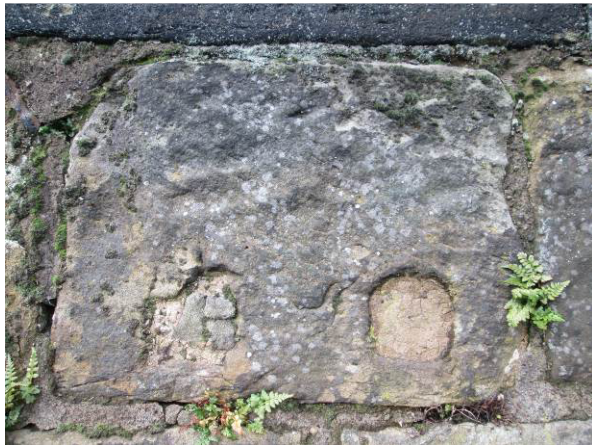
Plate 12 Possibly reused stones in retaining wall

There were several stones within the wall that appeared to have been reused from an earlier structure, though it is not possible to determine what date of structure they are from.

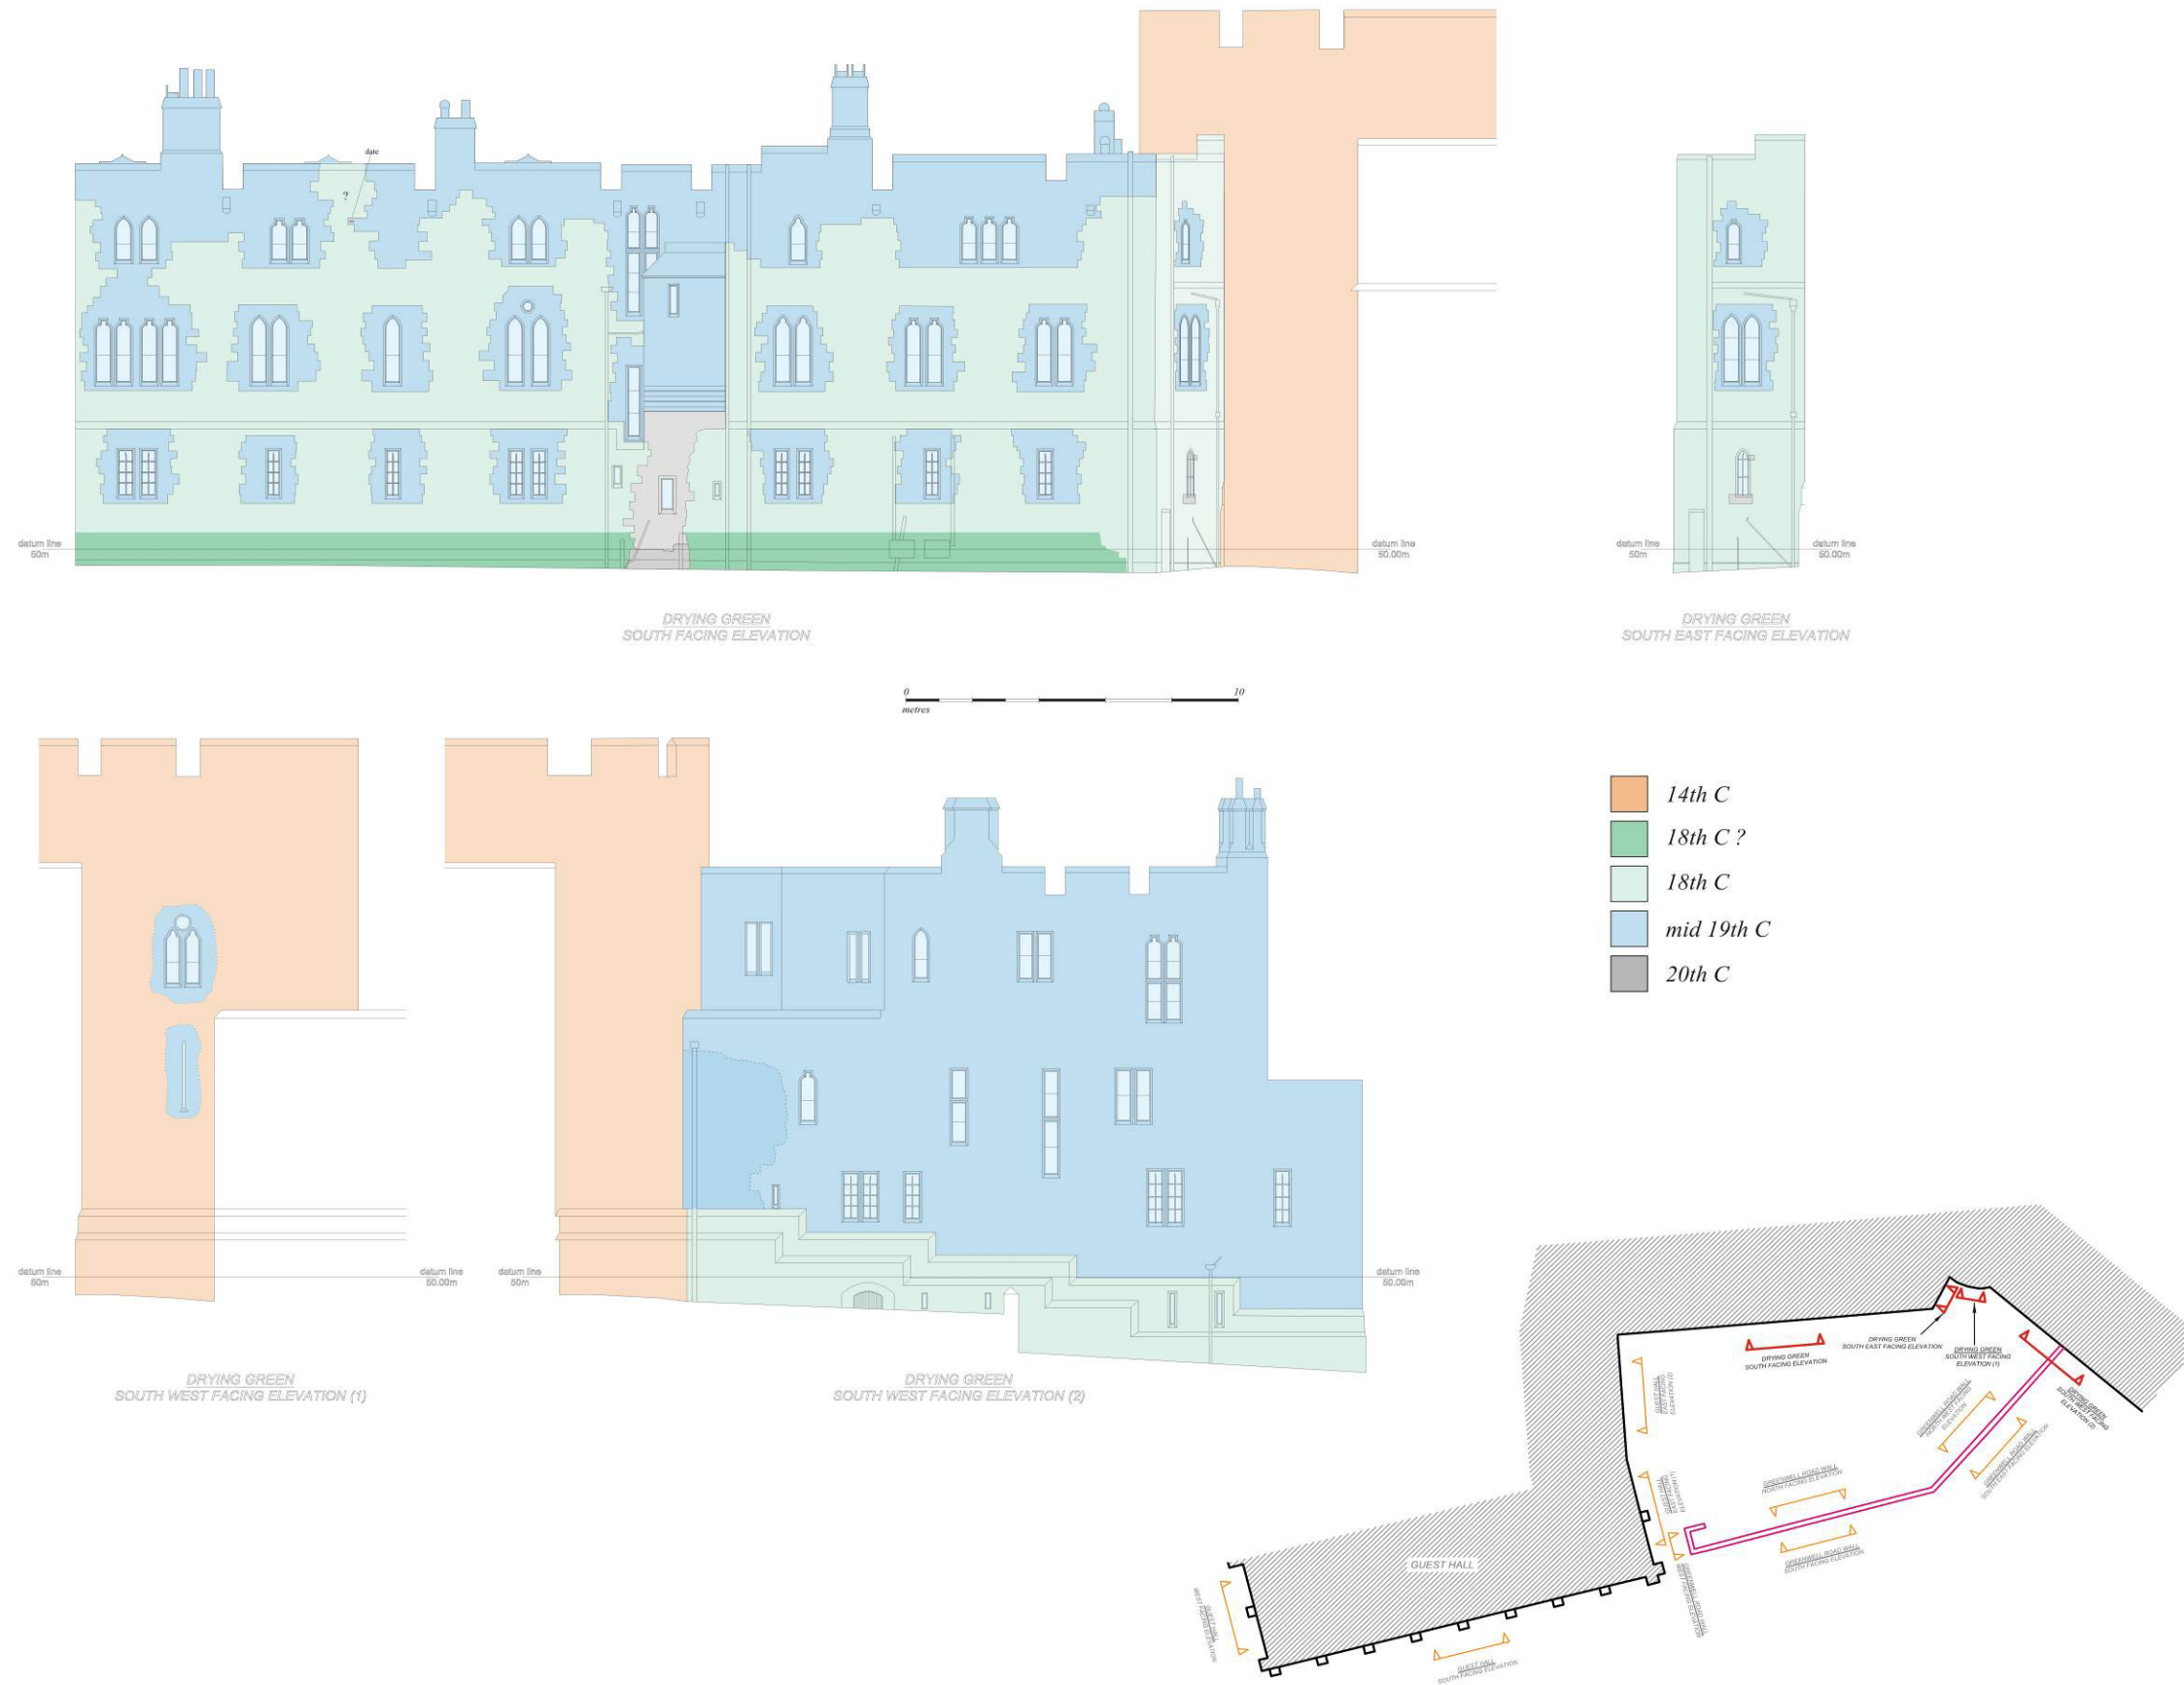
Appendix 3 Elevations

- 14th C
- 18th C ?
- 18th C
- mid 19th C
- 20th C
