# Glenside Farm

## Dumfries House Estate, Auchinleck

*Historic Building Recording and  
Archaeological Watching Brief during Demolition Works*

*Job number 2244.00*

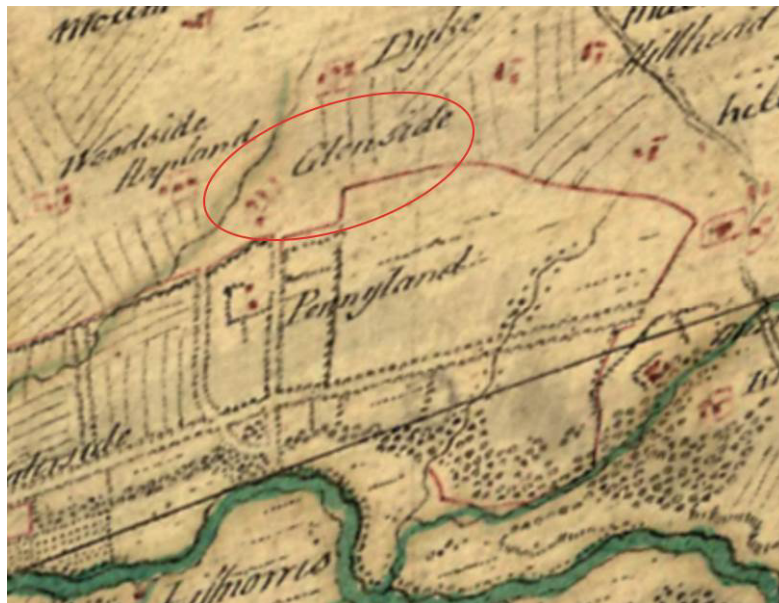
Figure 3 : Extract from 'Roy's Military Survey of Scotland. Lowland Scotland' by William Roy. 1752-1755  
© The British Library Board. All Rights Reserved (Roy Military Survey of Scotland)

In order to properly assess the archaeological potential of the development site prior to works commencing, a brief map regression was undertaken, consulting materials readily available online through the *National Library of Scotland's Map Resource*, as well as *Google Earth*. Roy's Lowland Military Survey of Scotland, surveyed from 1752 to 1755 (**Figure 3**), is the earliest map to show Glenside Farm in detail. The map shows a grouping of four structures north of Pennyland, bound by a burn to the west, and surrounded by cultivated fields. This map roughly depicts Glenside Farm as it existed pre-improvement, though the placement and number of structures shown may not be accurate.

Building 8 is a 'T' shaped structure at the southern extent of the farmstead, and is a combination of farmhouse, byre, store, and what is described as a bothy. This building is shown on the 1<sup>st</sup> edition OS map of 1857 as an 'L' shaped structure, adjacent to a linear structure representing Building 2 (**Figure 4**). Earlier building fabric noted within the eastern half of the structure indicates a pre-improvement phase, and may represent one of the structures indicated on Roy's Lowland Military Survey of 1752-1755 (**Figure 3**).

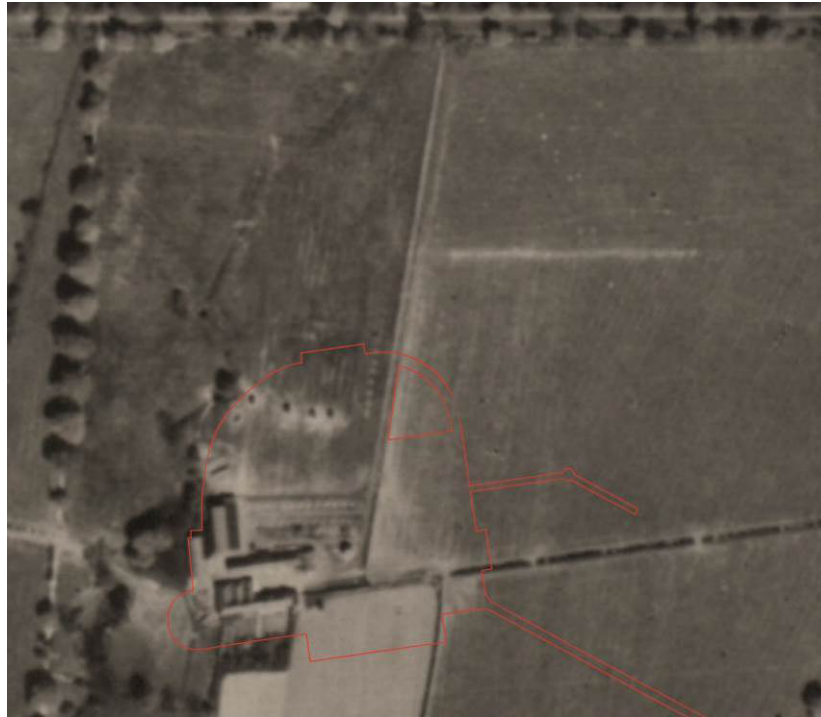
*Figure 6 : Extract from 'Ordnance Survey RAF Air Photo Mosaic' 6 inch to 1 mile. Surveyed May 1950, Published 1951. NLS (with site overlay)*

The RAF aerial image from May 1950 (**Figure 6**) shows the farmstead largely as it exists today (compare with the Google Earth image from 2016- **Figure 7**), with the notable difference being the arrangement of three north-south orientated pitched roofs along the west range building 8, as well as variations to structures 1 and 7, in the western half of the site. Both the 1950 and 2016 images show evidence of cultivation in the form of rig and furrow in the surrounding north, south, and eastern field systems.

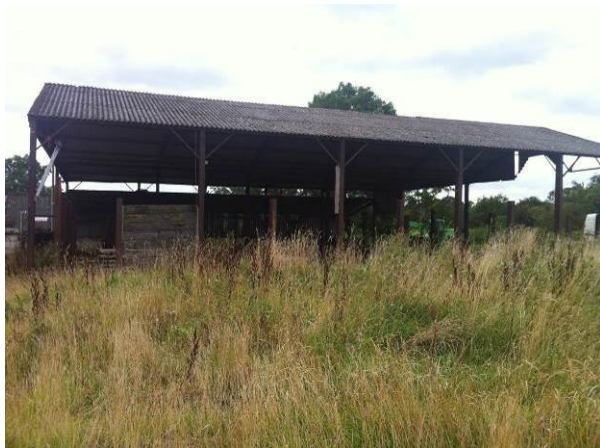
Plate 1 : Structure 1, from east (photo 484)

Located in the north-west region of the steading, Structure 1 was an open sided, steel beamed structure with a pitched corrugated roof, and poured concrete slab foundation. Though photographed at an earlier date, the superstructure was removed prior to the survey taking place, so was not fully recorded. Map evidence shows a, likely earlier, rectangular structure in this location on the Ordnance Survey 2<sup>nd</sup> edition revision of 1909 (see **Figure 5**), while the 1950 Air Photo (**Figure 6**) depicts an earlier phase of the current structure, prior to a later eastern extension. The Google Earth image from May 2016 (**Figure 7**) shows the structure as still being roofed.

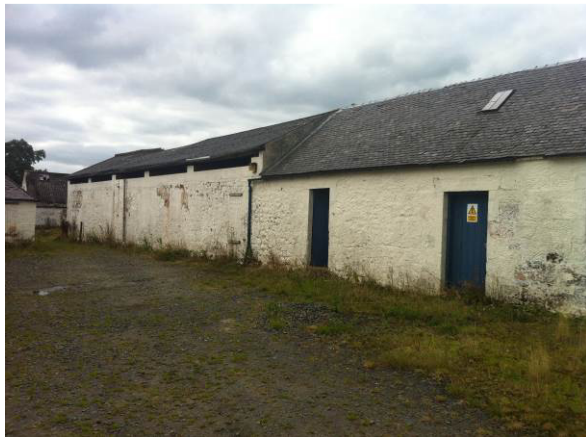
Plate 3 : Building 2, south elevation (photo 470)

Unroofed at the time of the main survey, the building showed multiple phases of rebuild and heavy alterations with little evidence of original fabric remaining. Original fabric was likely to have survived within the south-facing elevation, as well as the upstanding gable dividing the byre to the west from the rest of the structure, as well as within a small section of the north-facing elevation. For the purposes of the survey, the building was divided into three rooms: the eastern room 'Room A', was the late 19<sup>th</sup> century extension; the central room was referred to as 'Room B'; while the western room, or byre, was referred to as 'Room C'.

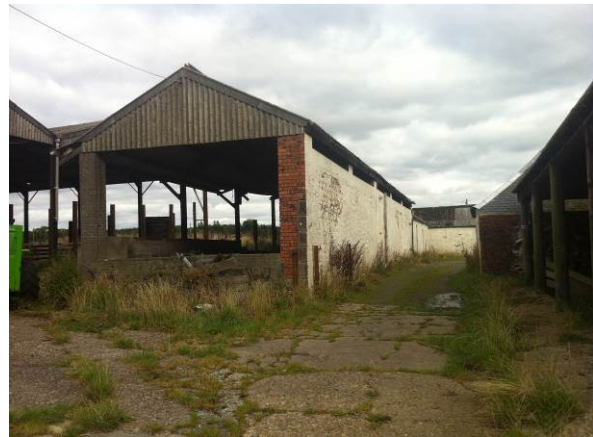
Plate 4 : Building 2, from southwest (photo 477)

Orientated roughly east-west, Building 2 was the long, linear range located directly opposite the steading farmhouse to the north (**Figure 10**). Appearing on the 1<sup>st</sup> edition Ordnance Survey map of 1857 (**Figure 4**), this building may have pre-dated the improvement period, and may represent one of the structures indicated on Roy's Military Survey map of 1752-55 (**Figure 3**). The Ordnance Survey 2<sup>nd</sup> edition map of 1895 (**Figure 5**) indicates a recent extension at the south end of the building, now extending beyond the line of the farmhouse to the south.

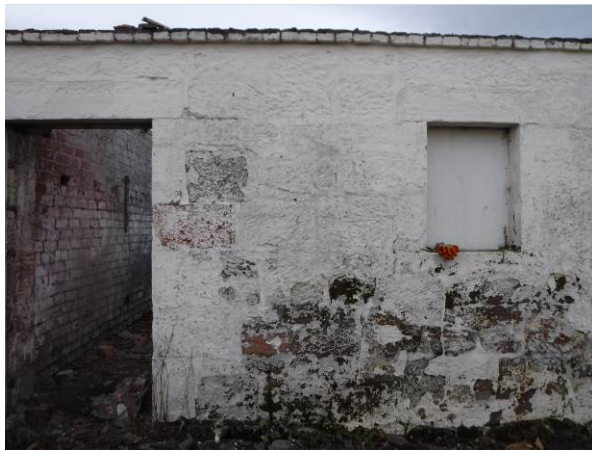
Plate 5 : Building 2, Room A, south facing exterior  
(photo 029)

Room A was constructed of a mix of dressed stone and re-used rubble, and was separated from Room B by a brick dividing wall. Accessed via doorway to the south, the room had a single window built into the south elevation (*Plate 5*). The north facing elevation within the room's interior showed evidence of alteration, with the appearance of quoining and a later blocking within the elevation, likely indicating a formerly open façade, possibly once used as a garage or storage bay.

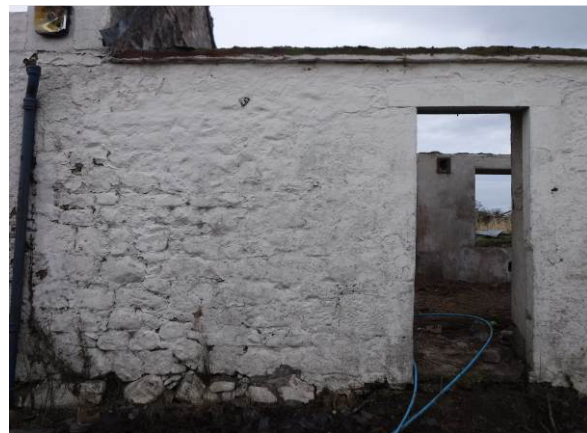
Plate 7 : Building 2, Room B, south facing exterior  
(photo 032)

Room B was divided from Room C by a large, upstanding gable, and from Room A by an inserted brick partition wall. The upstanding gable contained multiple phases of repair and alteration (*Plate 9*), particularly relating to the roof structure, and was likely an original feature contemporaneous with the construction of the building. Room B contained two windows with splayed reveals in the northern elevation (*Plate 8*), and a single entrance in the southern elevation. A former partition, later removed, would have divided the room at a point between the two windows to the north, and meeting the southern wall just east of the door. Early building fabric appears to have survived in small amounts within the interior gable, and made up a large amount of the west half of the building's south facing elevation, having been replaced by more formal, dressed stone in the later alterations to the building's eastern half (*Plate 7*).

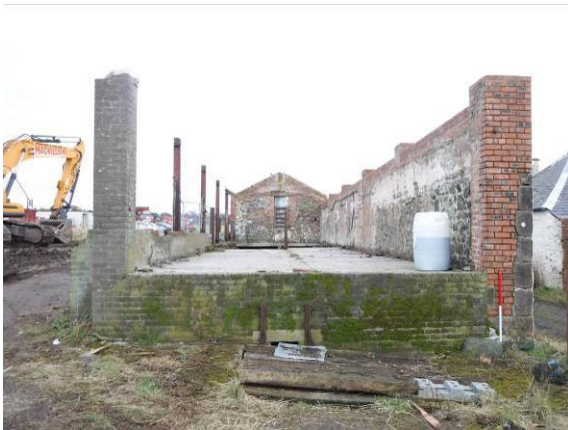
Plate 10 : Building 2, Room C, west elevation (photo 081)

Room C formed the western half of Building 2, and was lately in use as a Byre. This section of the structure had been heavily modified, with the small amounts of remaining early building fabric confined to the upstanding southern elevation. The west and north elevations had been removed to create an open-sided, steel beam façade (**Plate 10**), with the interior excavated down to create a lower slurry pit, capped by a concrete slat floor surface (**Plate 11**). Former window and door openings within the southern elevation had been blocked with mortared brick, possibly associated with a phase of repairs to the raised doorway within the east interior gable.

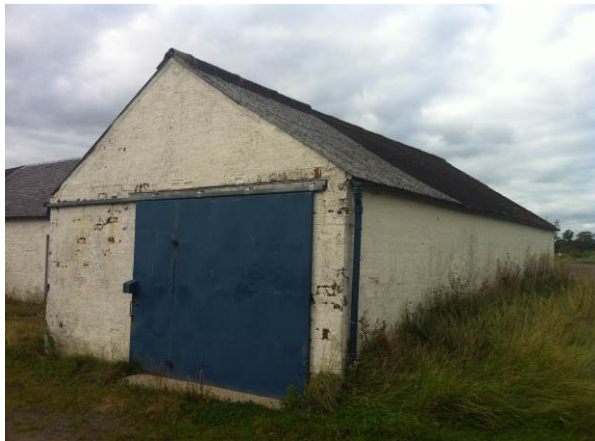
Plate 12 : Building 3, south-east corner (photo 468)

Building 3 was located directly east of Building 2 (*Figure 11*), and was orientated roughly north/south. Rectangular in plan, the building was a simple, windowless, brick-built structure atop a poured concrete foundation, with high pitched roof and large sliding steel door within the south elevation. Likely a single phase, Building 3 first appears on the 1895 Ordnance Survey 2<sup>nd</sup> edition (*Figure 5*), though the ‘DICO’ froged bricks noted during demolition suggest a post-1920’s build-date<sup>2</sup>; it is possible that the recorded structure may have replaced an earlier structure previously occupying the same footprint.

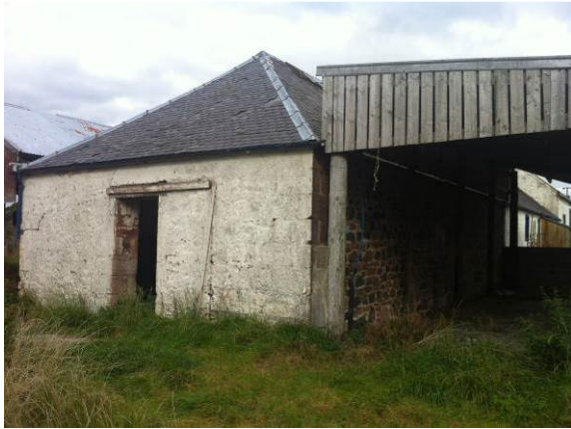
Plate 16 : Structure 5, in right of shot (photo 478)

Similar to Structure 4, Structure 5 was an open-sided, lean-to type build that utilised the southern elevation of Building 8 as its north wall (**Figure 13**). Built of large, upright wooden beams and a sloped roof (**Plate 16**), the structure contained a vehicle entrance within the north half of the western elevation, and was enclosed by a low cinder block wall along the west, south, and east elevations; the base of the structure consisted of a poured concrete pad (**Plate 17**).

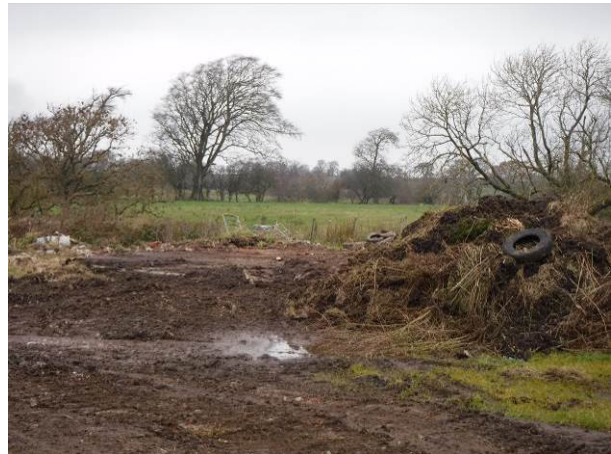
Plate 18 : Structure 6, Slurry Tank from south east (photo 400)

Structure 6 represents the circular Slurry Tank at the north end of the farmstead (**Error! Reference source not found.**). There was no upstanding structure at this location, and the base could not be surveyed due to its use for the storage of asbestos removed during the pre-demolition works.

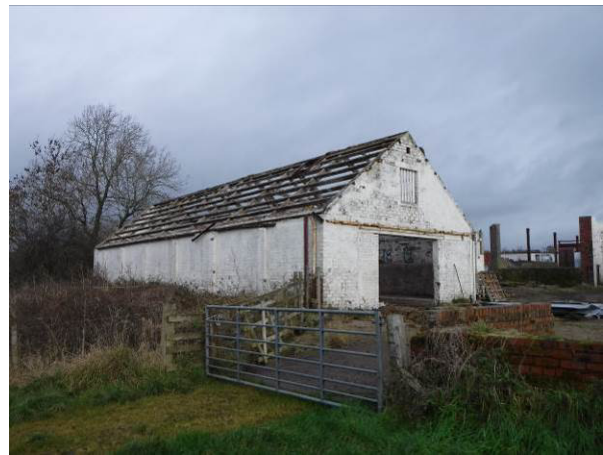
Plate 19 : Building 7, from south west (photo 133)

Building 7 is a single-phase, brick-built byre, with high-pitched corrugated roof (likely asbestos) over wooden beams. There is an entrance within the east elevation, and the north and south gables both have high windows and ground-level openings with fixtures in place to accommodate steel sliding doors. The larger bay opening in the south gable has been altered, with the bricking up of a doorway to the east of the opening, as well as the bricking-up of the west side to reduce the opening's width; a reused track rail has been positioned above the opening to act as a lintel (*Plate 20*).

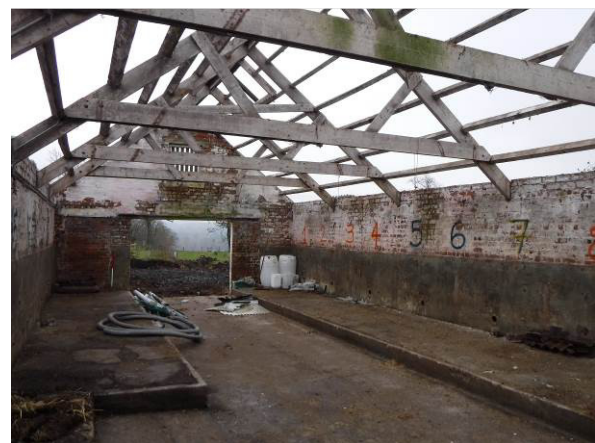
Plate 21 : Building 7, interior (photo 360)

The interior of the structure is of concrete, open plan with no internal partitions. Raised platforms line the western and eastern walls, with a lower passageway down the centre and to the opening in the eastern elevation. Painted numbers along the long walls denote individual 'bays' (*Plate 21*) – a possible indicator that this building may have been used for dairying.

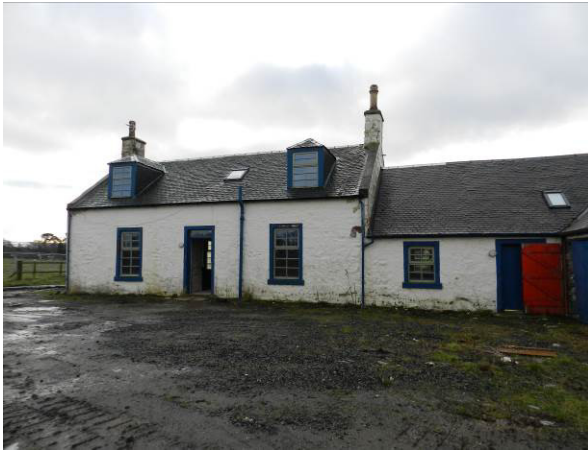
Plate 22 : Building 8, Farm House (photo 710)

The farmhouse in Building 8 is a small, two-storey cottage, with three bays on the ground floor, and two dormer windows in the north elevation's upper storey (*Plate 22*). The cottage is a mix of mortared stone rubble and dressed stone construction, with an earlier building phase evident within the east gable and north elevation. The building has been enlarged (likely during the agricultural improvement period of the 18<sup>th</sup> and 19<sup>th</sup> centuries) by extending the width of the building to the south, and by raising the wall height and adding an upper storey. The earlier phase and later alteration can clearly be seen within the fabric of the east gable, with a series of dressed quoins marking the former south elevation and roof pitch. The image below (**Error! Reference source not found.**) shows a vertical line of dressed quoins set within the building's fabric to the right of the photo scale, rising to the pitch of the former single storey roof; the rubble construction can be followed across the gable to the north-east corner, where the same dressed quoins mark the current corner of the building.

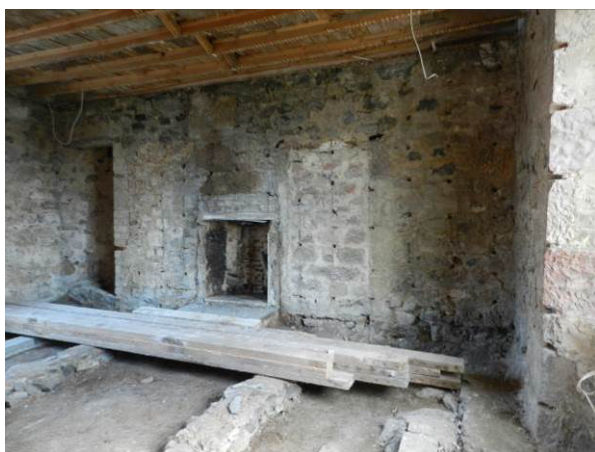
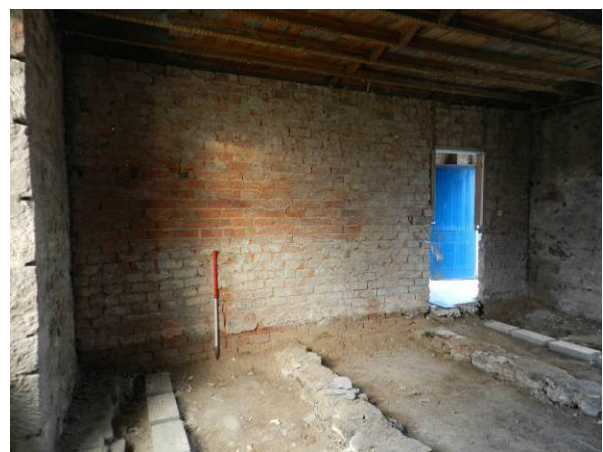
The easternmost room within the ground level of the farmhouse is marked on the architectural plans as the living room. Within this room, there is clear evidence of the building's earlier phase, with original fabric surviving in the south and west facing elevations. The west facing elevation, pictured in *Plate 29* above, shows a blocked door immediately south of the fireplace, with wooden lintel still in situ. Alterations have been made to the north of the fireplace, to create a recess within the wall fabric for storage.

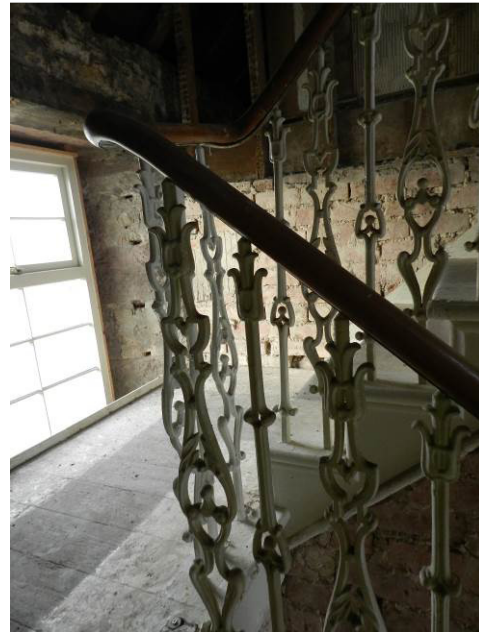
*Plate 32 : Building 8, Stair (photo 673)*

The hall and stair is accessed via the entrance within the north elevation, and is situated between the living room to the east, and kitchen and store to the west- separated by the brick partition walls created during the secondary phase of building remodelling (*Plate 31*). The brick partition walls appear to be a single phase, and abut the front entrance door jambs. The staircase (with decorative iron railing) is lit by a window with splayed reveals in the south wall, and accesses the upper storey via a landing (*Plate 32*).

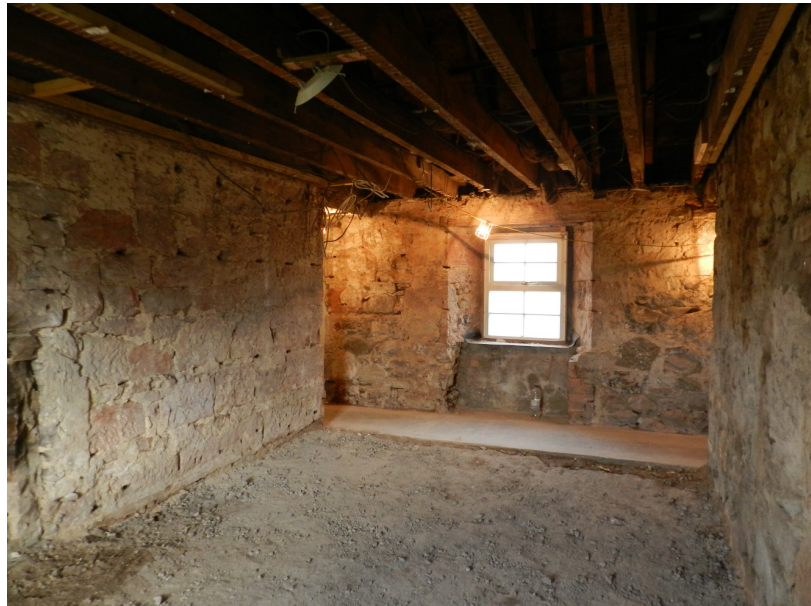
Plate 38 : Building 8, Dining Room, north wall (photo 621)

The dining room is located west of the kitchen range, and is accessed via the passage in the south end of the east wall. The north partition wall shown on the architectural plans (**Figure 17**) separating the dining room from the hallway has been removed. The east and north wall of the dining room contain earlier building fabric with later phase rebuild and alterations, while the south and west walls date to the building's remodelling.

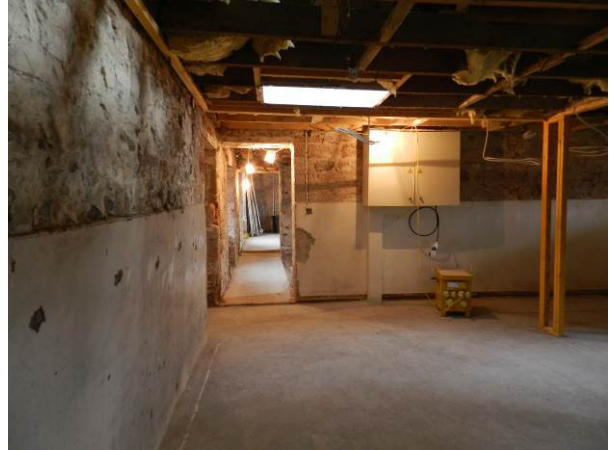
Plate 40 : Building 8, Family Room (photo 654)

The family room and bathroom (as marked on the architectural plans -**Figure 17**), is located between the dining room to the east, and the byre to the west (**Plate 40**). There is an exterior entrance to the family room within the south wall, and the bathroom has been created in the room's southwest corner (**Plate 39**). The family room and bathroom are later additions, likely within the eastern end of a once longer byre, and there is evidence of an earlier building fabric within the structure's north wall.

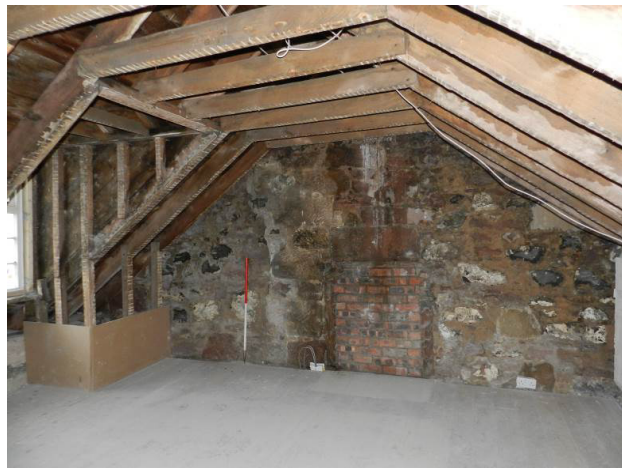
Plate 41 : Building 8, Bedroom 1 (photo 699)

The upper floor of the farmhouse was added during the building's remodelling, likely prior to or during the first half of the 19<sup>th</sup> century, and is accessed via the staircase opposite the front entrance. Bedroom 1 (**Plate 41**) is located at the east end of the building, and is separated from Bedroom 2 (**Plate 42**) at the west end by a box room and landing (**Plate 43**). Bedroom 1 contains a brick-blocked fireplace within the east gable, while Bedroom 2's fireplace remains open. Both bedrooms are lit by a single dormer window each, and the boxroom is lit by an inserted skylight.

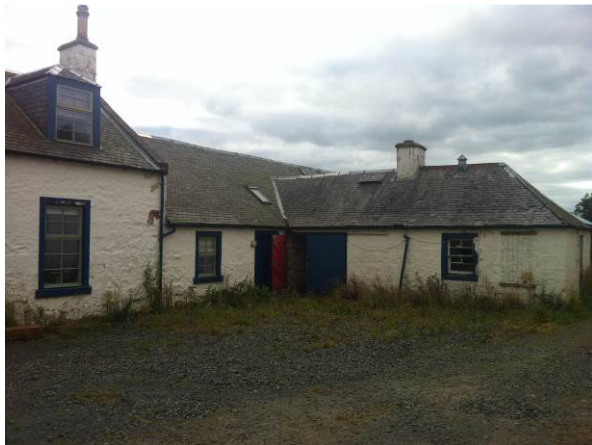
Plate 44 : Building 8, Store and Bothy (photo 472)

Forming the north/south orientated range of Building 8 are the external store and bothy (**Plate 44**), which are first shown on the Ordnance Survey 1<sup>st</sup> edition map of 1857 (**Figure 4**) and may predate the improvement farmstead period. Originally double the width, the structure has been reduced to the west, evidence of which survives as remnants of the wall return, still visible within the north-facing wall of the byre (**Plate 49**), and in the brick repairs to the northwest corner of the bothy (**Plate 48**).

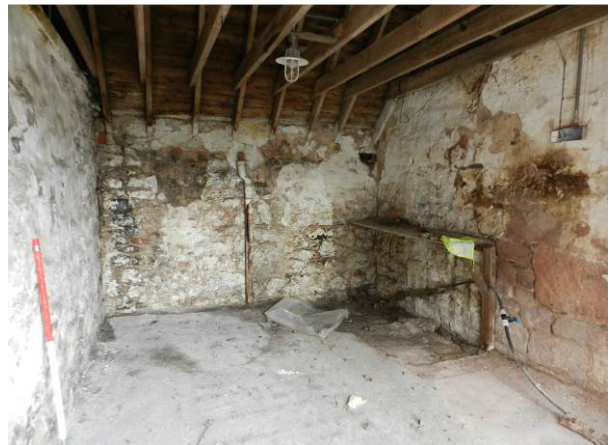
Plate 45 : Building 8, Store interior (photo 666)

The interior of the store (**Plate 45**) shows that the west wall abuts the north wall of the original east/west structure, with no internal access to the family room to the south. The bothy is accessed via the north facing elevation (**Plate 46**), has a single window in the eastern wall, is floored with flags, and has a fireplace within the partition wall dividing the bothy from the store room to the south (**Plate 47**).

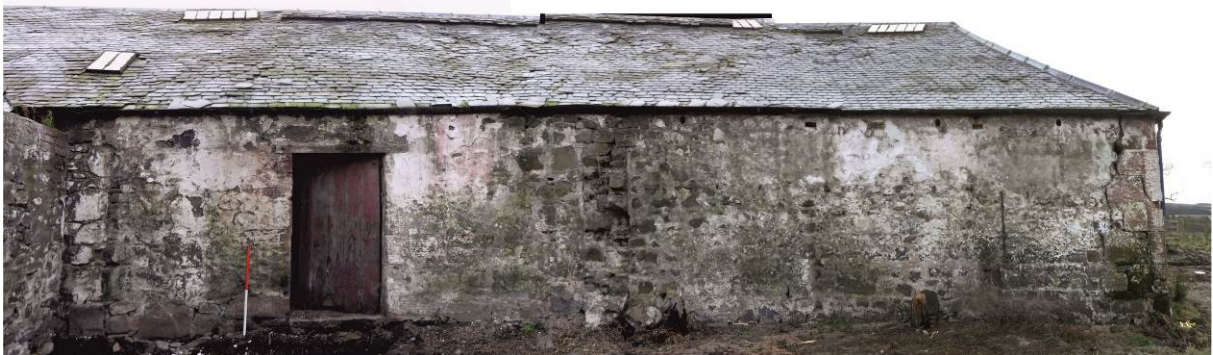
Plate 49 : Building 8, Byre, north-facing elevation (photo 291-4)

The byre forms the western range of Building 8. The remnants of the wall return visible within the north facing elevation (**Plate 49**) likely marks the original western extent of the structure as shown in the Ordnance Survey 1<sup>st</sup> edition map of 1857 (**Figure 4**). The 1895 Ordnance Survey 2<sup>nd</sup> edition shows a new westward extension to the byre (also visible on the 1908 OS revision **Figure 5**), at which point it would seem that the wall height was also increased. The northwest corner, west, and south facing elevations of the byre appear to be a later rebuild, with the occasional dressed quoin visible within the south elevation (**Plate 52**). Entrances to the windowless byre are through the family room, and from the north and west elevations.

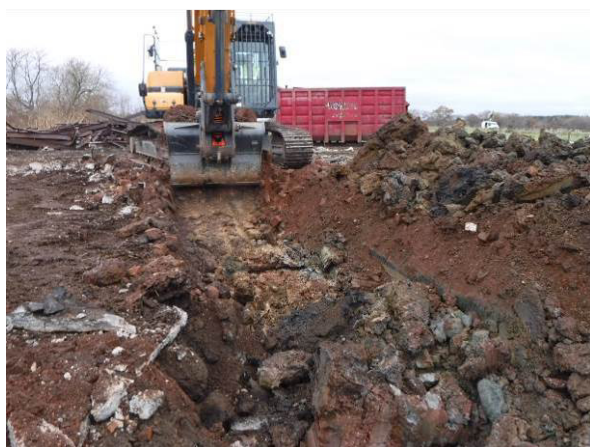
Plate 56 : Structure 1, mid-demolition (photo 019)

The concrete slab of Structure 1 (**Figure 9**) was demolished on the 30<sup>th</sup> of November, and was found to overly a bedding deposit of mixed blaze and brick rubble atop a grey-brown to orangey-red clay natural (**Plate 56**). The steel uprights were set into concrete bases cut into the natural clay subsoil. No earlier features or deposits were noted beneath Structure 1, and it seems likely the ground was levelled prior to construction.

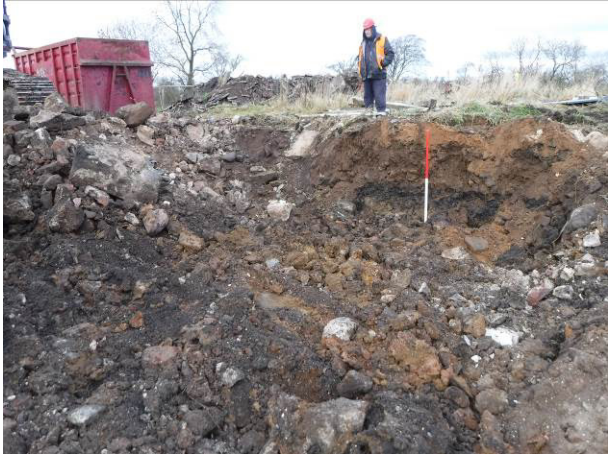
Plate 58 : Building 2, south facing section (photo 163)

Building 2 (**Figure 10**) was demolished on the 1<sup>st</sup>, 2<sup>nd</sup>, and 5<sup>th</sup> of December, starting with the eastern end, and finishing with the removal of the slurry tank below Room C to the west. The building's foundations were found to sit directly atop the underlying clay, and were terraced into the sloping ground to the north, with larger boulders acting as a form of retaining wall. The floor surface within Room A was brick overlying an ashy/cinder bedding deposit atop the underlying clay, while the floor surface within Room B was poured concrete overlying clay. The interior of Room C was created by digging down into the underlying clays, in order to accommodate the concrete slurry tank inserted within the building (**Plate 59**). No earlier features or deposits were noted beneath Building 2.

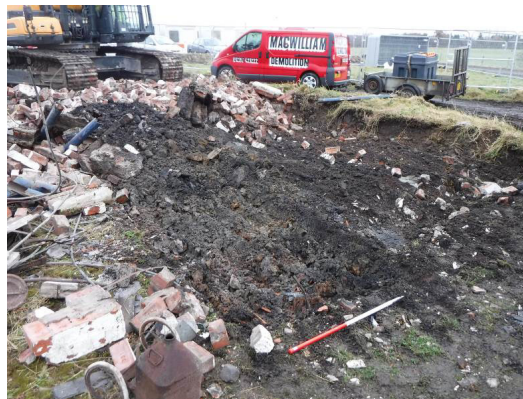
Plate 60 : Building 3, post-demolition (photo 147)

Building 3 (*Figure 11*) was demolished on the 1<sup>st</sup> of December 2016, immediately prior to the commencement of the Building 2 demolition. The concrete slab was overlying a pebble bedding deposit, with the whole structure terraced into the sloping ground to the north (*Plate 60*). No earlier features or deposits were noted beneath Building 3.

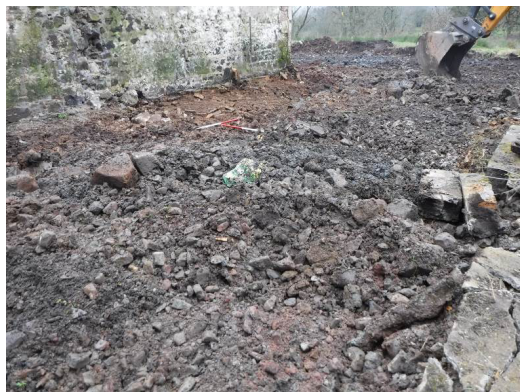
Plate 61 : Structure 4, post-demolition (photo 393)

The demolition of the concrete pad making up Structure 4 revealed traces of the former wall extending from the north facing elevation, and a brick surface abutting the northwest end of the byre. No additional features or deposits were noted.

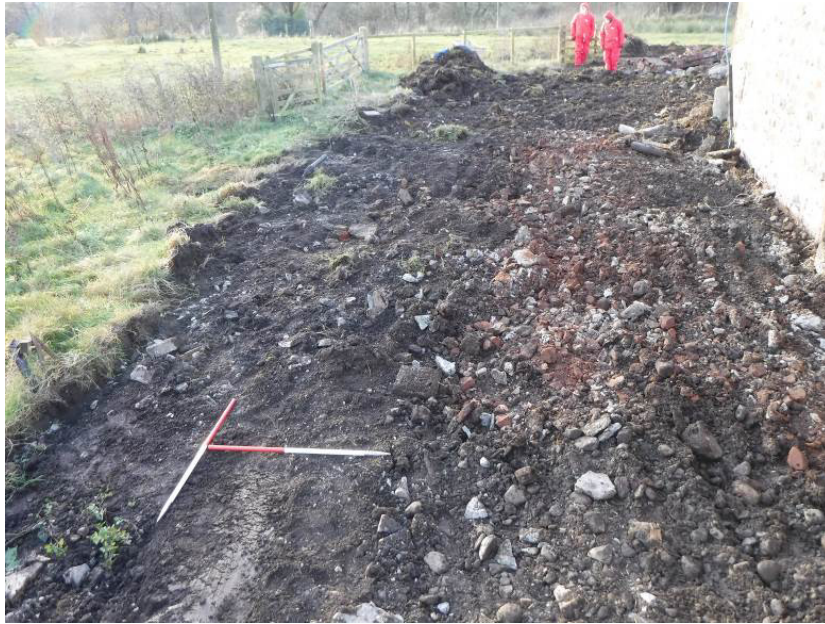
Plate 62 : Structure 5, post-demolition (photo 327)

Structure 5, located to the south of the byre (**Figure 13**) was demolished on the 5<sup>th</sup> of December 2016. The removal of the concrete slab revealed an underlying bedding deposit of stone and rubble overlying cultivation soils, as well as the rubble remnants of a possible red sandstone wall or lean-to structure (**Plate 62**), potentially depicted on the Ordnance Survey 2<sup>nd</sup> edition of 1895, and 2<sup>nd</sup> edition revision of 1908 (**Figure 5**).

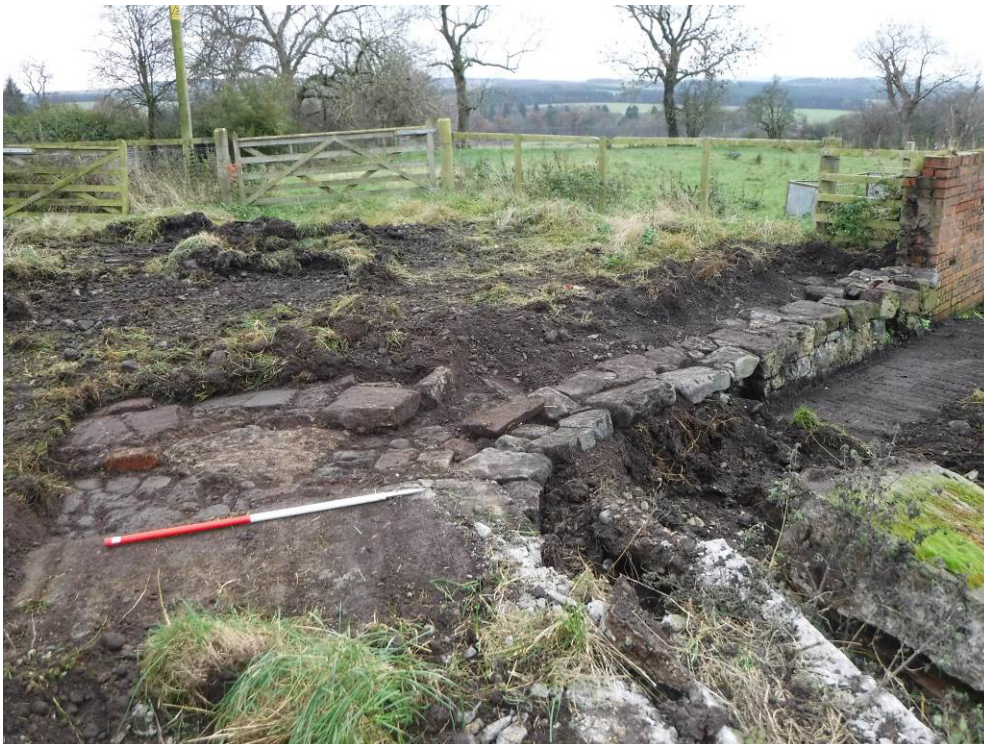
Plate 63 : Structure 9, Stone wall and surface, post-ex (photo 244)

Orientated northeast/southwest, the earlier drystone wall measured approximately 6.0m in length, by 0.50-0.60m in width, and 0.50m in height (**Plate 63**). The wall was of un-bonded stone rubble, with some worked and weathered sandstone reuse noted. Thought to be a courtyard retaining wall associated with the Building 8 byre extension, the wall was abutted by a cobbled surface to the south (**Plate 64**) and the Structure 9 brick wall to the southwest.

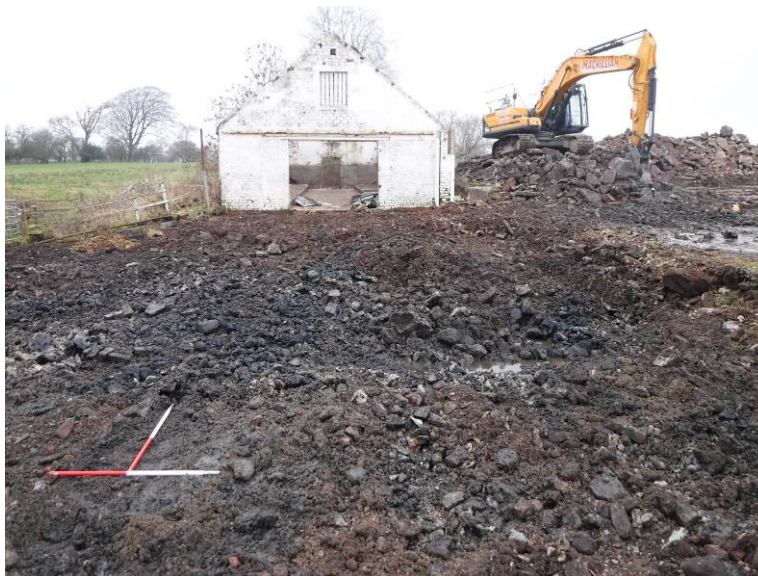
Plate 66 : Structure 9, post-demolition (photo 346)

The removal of the concrete surface within Structure 9 revealed a silty grey gravel overlying an earlier concrete surface, which, in turn, overlay a mix of stone/gravel, and cobble fragments within a black/wet silty clay atop the natural clay subsoil (**Plate 66**).

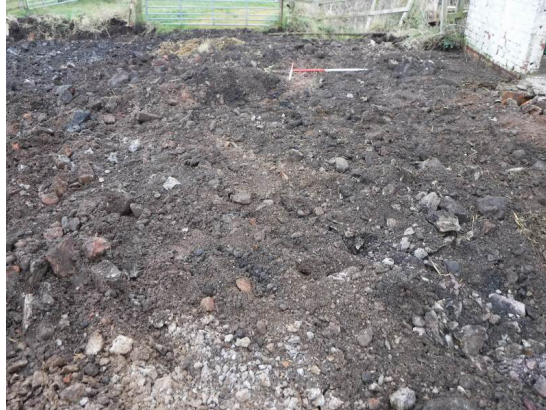
Plate 67 : Post-concrete removal, South of Building 7 (photo 352)

The concrete surfaces east and north of Structure 9, between Buildings 7 and 8, was removed on the 6<sup>th</sup> of December 2016. The concrete south of building 7 was noted to overly a mix of rounded pebbles and sealed topsoil, with no evidence of cobbles (*Plate 67*).

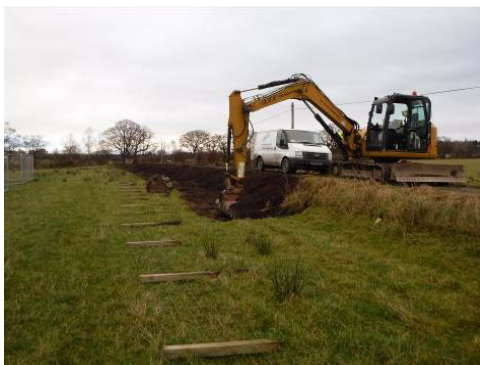
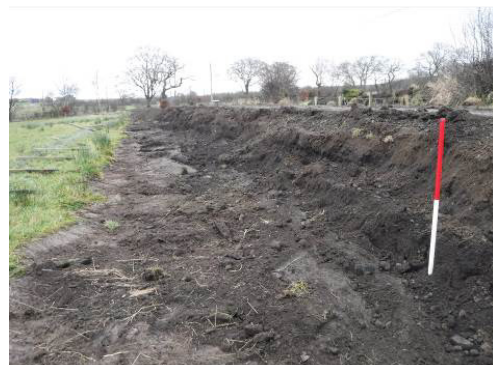
The road make-up was a mix of redeposited soil, rubble, and industrial waste material, reaching a height of approximately 1.0m above the surrounding topsoil. Stripping to the west of the road did not extend below the level of the topsoil/cultivation soil, and no archaeological finds or features were noted.

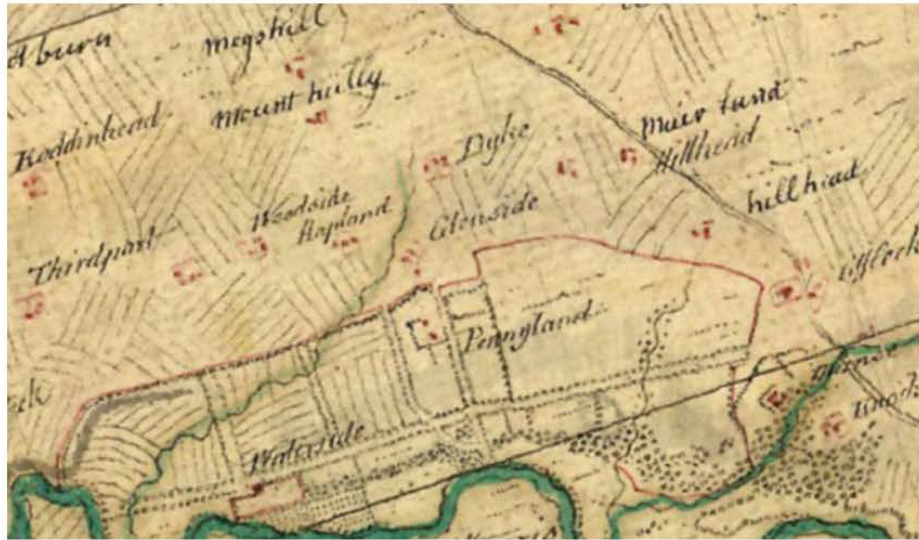
Figure 1: Extract from Roy's Military Survey of Scotland 1747 – 55, showing Glenside Farm

The earliest depiction of Glenside farm is shown on Roy's 'Military Survey of Scotland' from c1750 (*figure 1*, below). This depicts a settlement named *Glenside* immediately to the north of the boundary of Dumfries House Estate, shown as a red boundary line. The land north of The Temple boundary was in the ownership of the Boswell family of Auchinleck Estate until the mid-19<sup>th</sup> century; the farm now lies within the current boundaries of the modern estate (Dovecot Architecture & Design Ltd 2016). The name *Pennylands*, shown within the Estate Boundary is the name given to the later WWII camp within the estate.

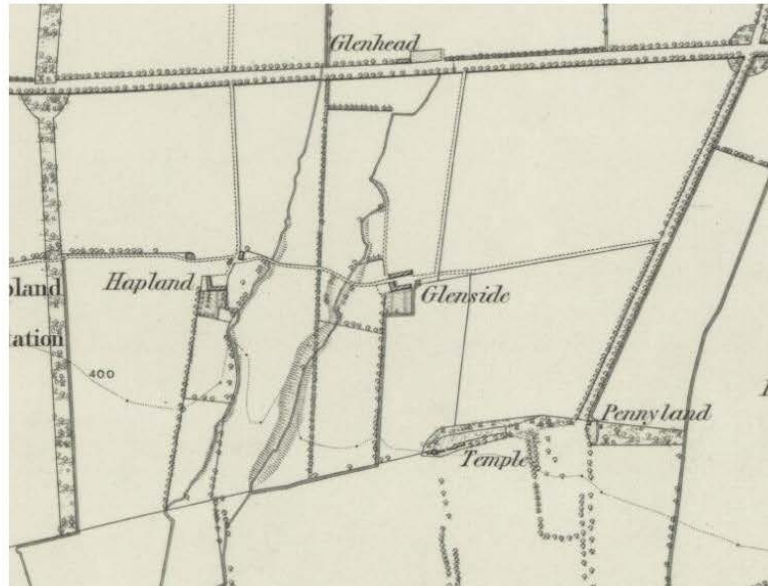
*Figure 2: Extract from Ordnance Survey 1860 Ayrshire Sheet XXXV, 6 inches to 1 mile, surveyed 1857*

The first edition Ordnance Survey map of 1857 (*figure 2*, below) depicts the existing traditional buildings on the site and comprise a farmhouse with adjoining bothy and byre and a small range of stone sheds, partially enclosing a small courtyard.
