# Church of St. John the Evangelist, Princes St. Edinburgh, City of Edinburgh Council

## *Archaeological Mitigation: 2016*

*Job number 2145.00*

by Philip Karsgaard

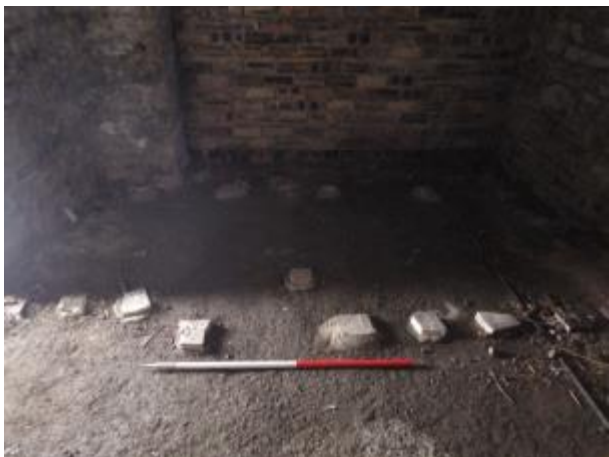
Plate 9 Reused broken inscribed memorial stones in undercroft. Facing west.

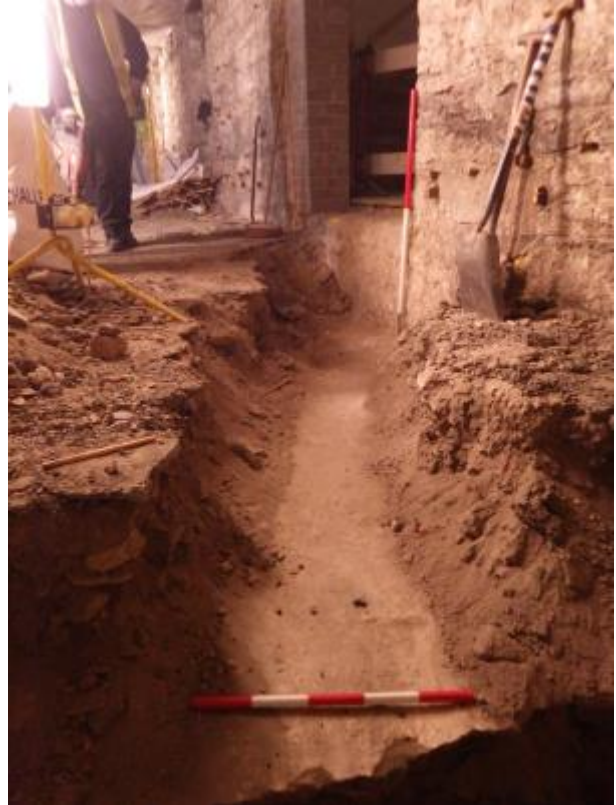
*Plate 12 ST4, oblique take-off with Surface (027). Facing NW*

Service Track 2 as just described continued north through the existing steps to the undercroft area and was recorded there as ST4; it includes a NW-SE oblique take-off. Here, the existing timber flooring was lifted, exposing the concrete underfloor. This revealed that during previous works in the undercroft and the installation of the timber flooring, broken marble memorial stones had been used as floor props. These were retained below the reinstated floor surface. Below the concrete floor screed lay levelling Deposit (009), a pale greyish construction deposit of limestone rubble, 0.40 – 0.45m thick. This overlay compact lime-plaster Surface (027), the probable constructional surface of the church. Surface (027) overlay the blueish-grey natural clay and bedrock existing in this area.

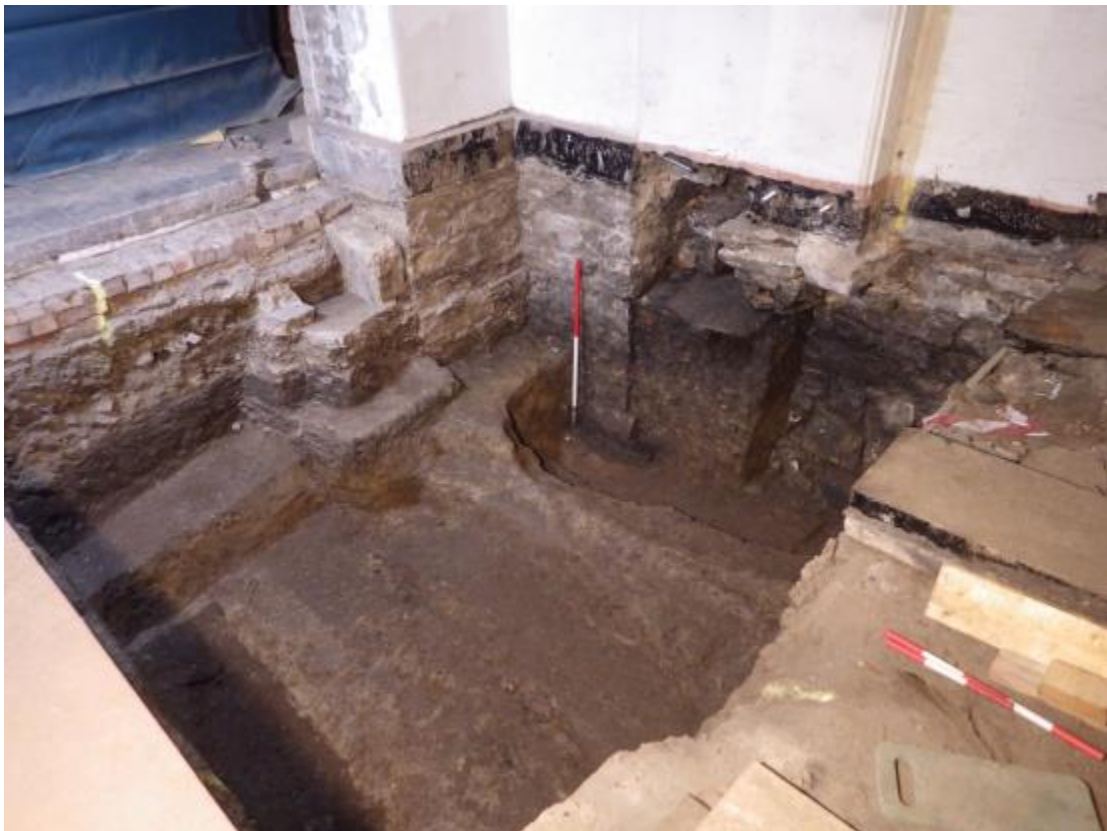
*Plate 15 Paterson Lair excavation trench showing natural clay (045) throughout Facing north-west.*

The underlying geology of the area was encountered across the base of the crypt excavations trench as Context (045), a distinctive firmly compacted light yellow clay with mid orangey-grey mottling and occasional small stones, at about 1.39m below the existing concrete floor screed. This deposit was sterile. Overlying this was Deposit (036), a firm mid- to dark-brown clay silt containing frequent charcoal flecks, occasional small stones, and occasional CBM fragments. It extended across the totality of the trench (where not cut by burial and structural cutting) and was found to be generally 0.36 – 0.42m thick. From it sherds of glazed redware and creamware of 18<sup>th</sup> century date were obtained, with a castle-stamped clay pipe fragment of the early 18<sup>th</sup> century. Deposit (036) was sealed by a thinner deposit, (038), a 0.08m-thick layer of firm mid orangey-brown silty clay; this may represent either a hiatus between the market garden activity of Deposit (036) and the construction of the church, or a ‘capping’ of the softer soils at the beginning of the church construction activities. These deposits are visible in the trench sections where not cut by burial activity (*figure 7*).

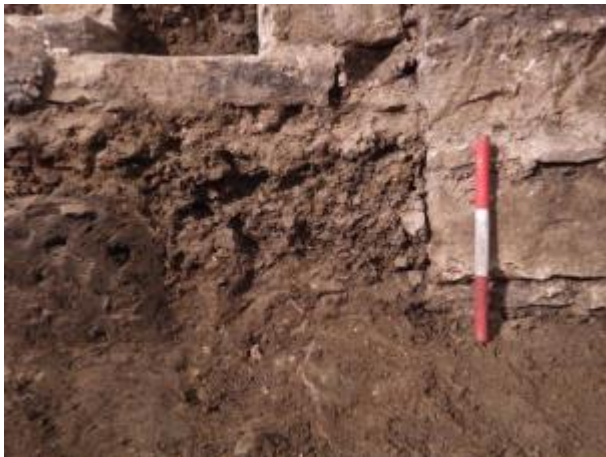
Plate 16 Detail, W-facing section showing Foundation Trench [035] cutting Garden Soil (033) (on left) below Drain [032]. Facing west

The trench itself was bounded at its northern extent by the north walls of the crypt, also related to this phase. A foundation trench, [035], 0.40m wide and filled by (034), was identified associated with the north-west buttress and the north wall. Excavations against the north wall revealed that two distinct structural elements could be identified: the western extent of the north wall, ending at the buttress, is the main church building wall, and returns to the north at the eastern extent of the buttress. A gap of 0.90m separates this main wall from the east-west continuation of the north wall of the crypt; Drain [032] was built in the upper extent of this gap.

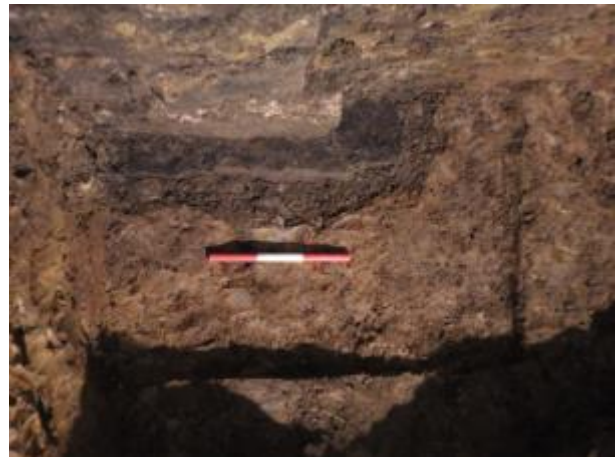
Plate 17 Foundation Trench [035] and buttress. Facing north

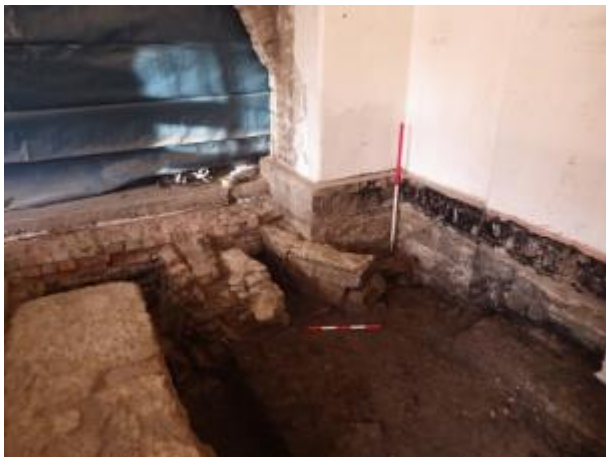
Plate 18 General view Drain [032]. Facing north-west

This Drain [032] (*figure 7, centre*) was encountered in the north-west of the excavated area. It was composed of sandstone and lime mortar gently curving walls [024] (its northern wall) and [025] (its southern wall), with a flagstone base [029]. Deposit (028), firm dark grey-brown silt and clay laminated deposits, 0.04m thick, directly overlay the flagstone drain surface [029] and was clearly a water-laid deposit associated with the use of the drain; it was overlain by (026), loose light greyish-brown sandy silt with high density mortar flecks and frequent small to medium angular limestone rubble fragments, a deposit associated with this drain structure falling out of use. Drain [032] abutted the north-west buttress on the Drain's northern side, curving gently around it. Its eastern extent was cut by the grave cuts for Burials 5 and 4; as these burials were the earliest in the Paterson lair (the first in September 1826) this drain must have fallen out of use soon after its construction. No evidence of water pooling or water-laid deposits was detected in the surrounding soils. Once the area below the northern wall monument was cleared, it became apparent that Drain [032] originally continued across the Paterson plot and ran northwards in the gap left in the north wall of the crypt, as noted above.

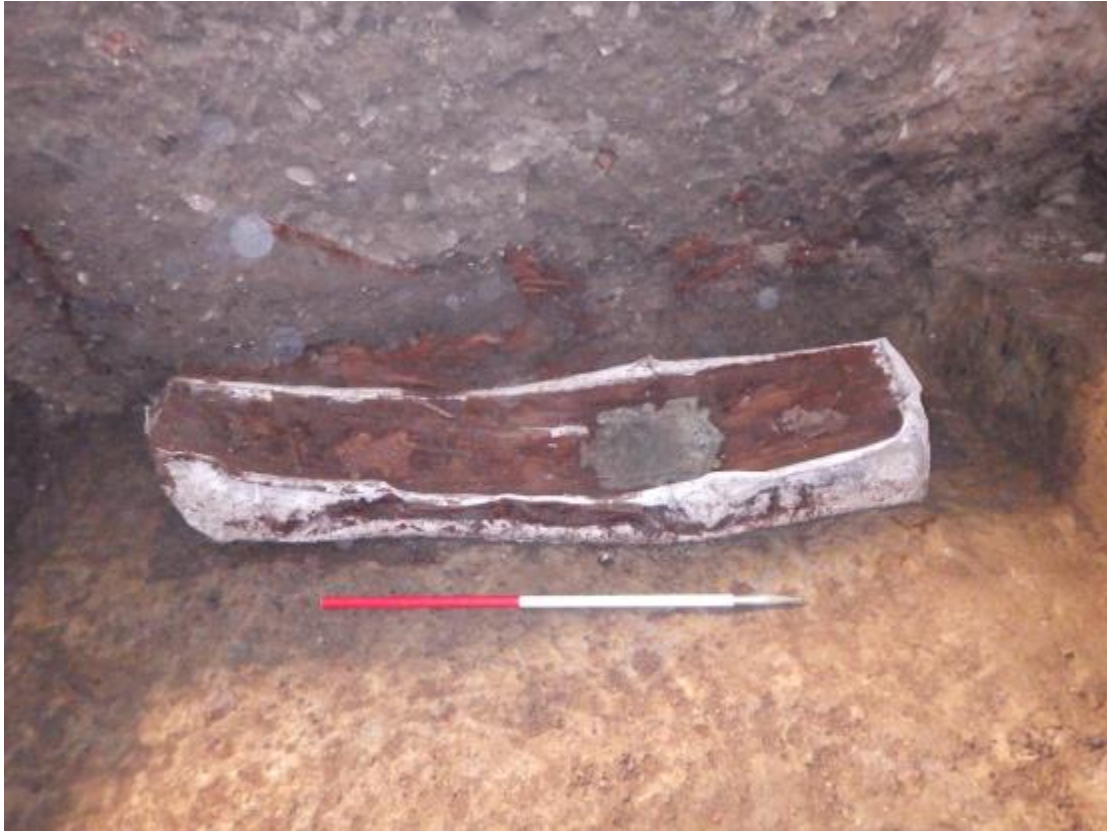
Plate 45 Burial 03, general view after removal outer case showing zinc-alloy shell. Facing south

The inner zinc-alloy shell was largely intact: a soldered and sealed box standing 0.38m high at the head end, where the sealed seams of the shell preserved its original height. The rest of the shell was partially buckled, with breaks in the fabric near the seam joints; otherwise the structure had maintained its integrity. No attempt, therefore, was made to open or further disturb the coffin, which was lifted with the A-frame gantry and set aside in a designated area of the crypt until re-internment. George Pape was interred in the south plot on the 26<sup>th</sup> October 1854.

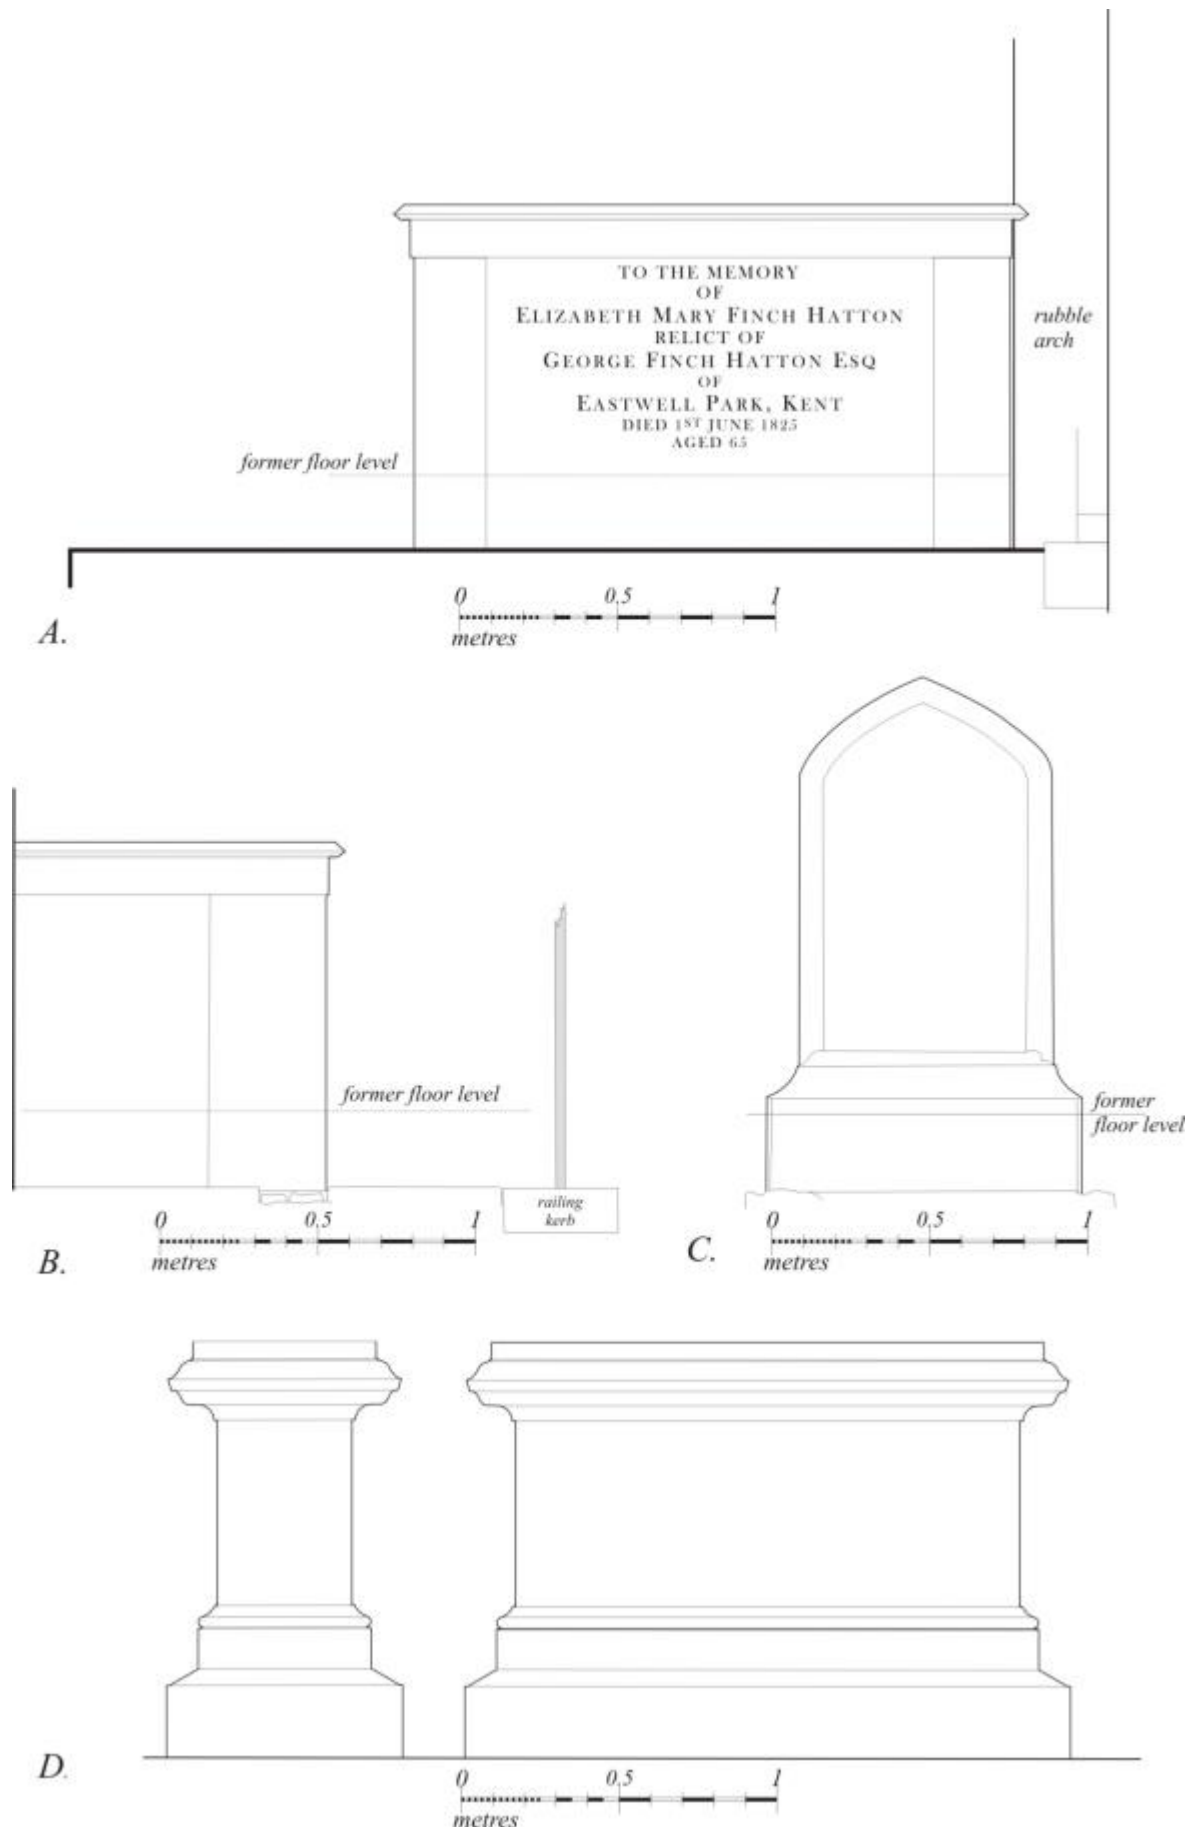
Figure 16 Elevations of Crypt Monuments. A, S-facing elevation of Finch Hatton; B, W-facing elevation Finch Hatton; C, E-facing elevation MacDowal; D, E-facing and S-facing elevations Paterson.

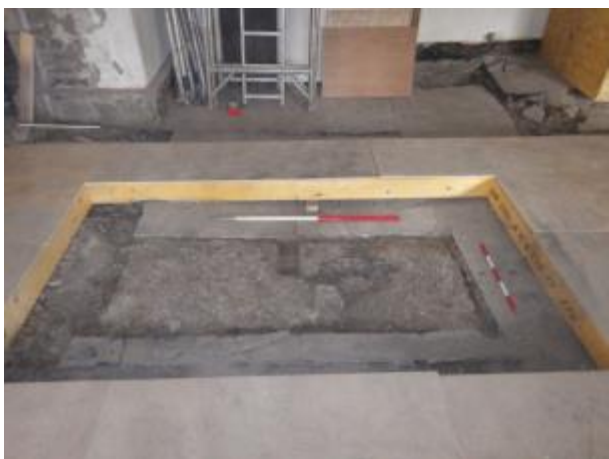
Plate 66 Foundations [017] after removal of overlying Paterson monument. Facing north.

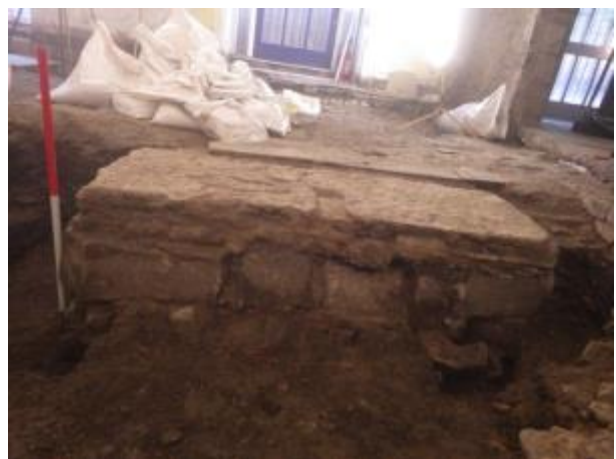
Plate 67 Foundations [017], N-facing elevation. Facing south.

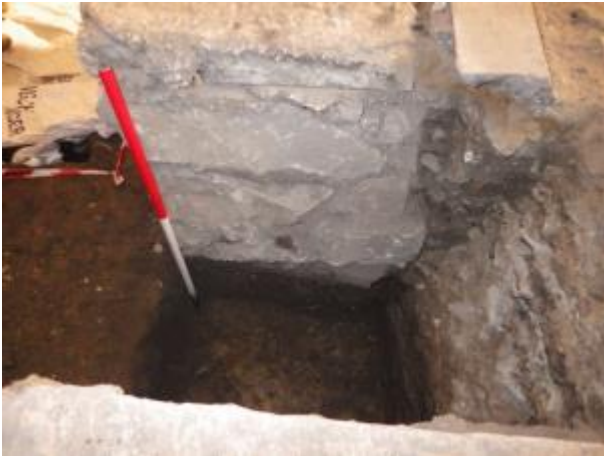
Plate 68 Foundations [017], W-facing elevation. Facing east.

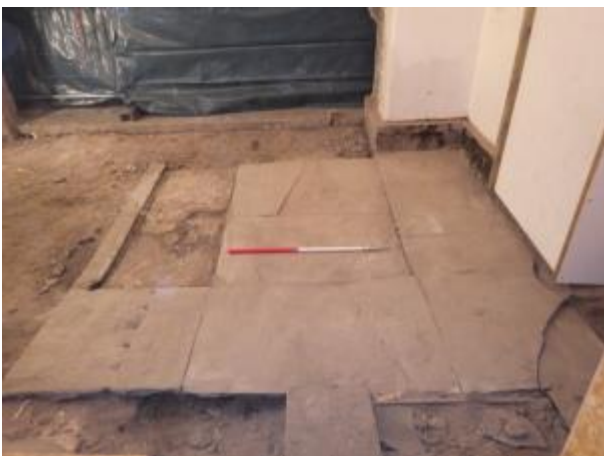
Plate 72 Ledger stones (010)–(016) and Fs [017] after removal of Paterson Monument. Facing west.

Associated with the installation of the monument, and revealed by the removal of the bitumen skim (001), which underlay the existing timber floor in the crypt area, were the flat, uninscribed sandstone ledger slabs (010), (011), (012), (013), (014), and (016), the last stone furnished with five circular dowel holes with a sixth partially preserved on its broken eastern side (*figure 15*). On the south side of the Paterson monument, edging stones (015) formed the southern limit of the lair. These ledger stones were bedded in a deposit of mid-brown sharp sand, (019), a levelling deposit with a noticeably concave base. This was initially interpreted as a shallow cut in the surrounding grave soils, but was probably the result of subsidence caused by the slumping of Burial 01 in the middle plot. The removal of Deposit (019) revealed the mixed grave soils (018) which formed the bulk of the material excavated in the trench<sup>11</sup>.

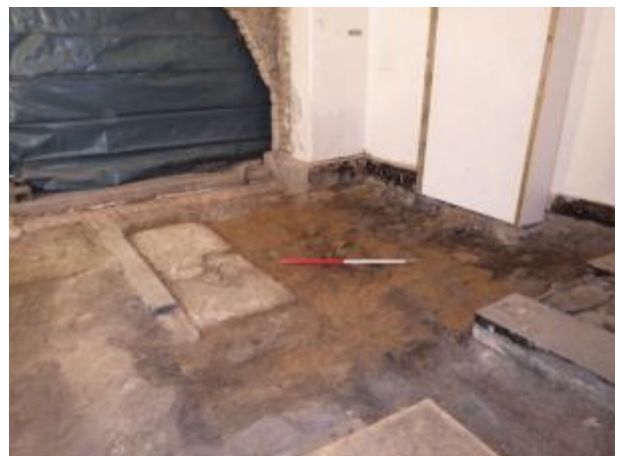
Plate 73 Bedding sand (019) and Foundations [017]. Facing north-west.

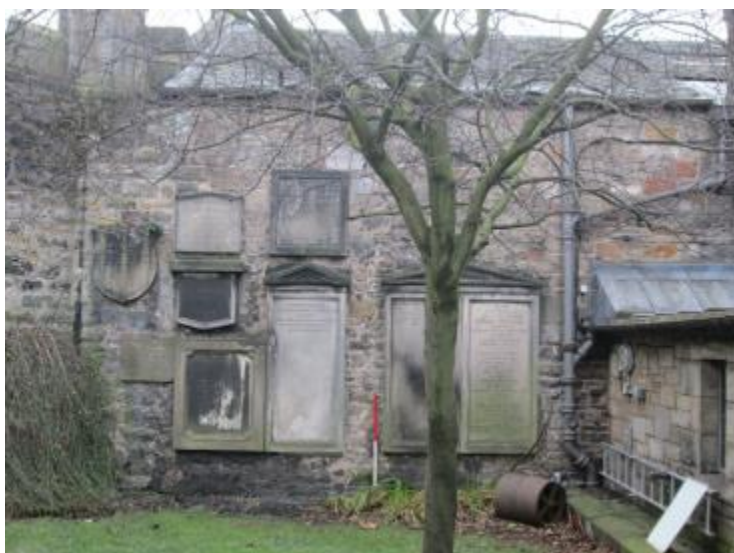
*Plate 74 South wall of St John's dormitory*

The Swinton monument itself similar to most of the other monuments on the dormitory wall is carved from a pale yellow sandstone. There are two large panels with a simple pediment above. It is built in to the south wall of the dormitory. The majority of the dormitory wall is built from yellow sandstone random rubble bonded with a pale lime mortar. However it is apparent that there have been alterations carried out a various times. This included a large area that has been repointed above the Swinton Monument. The upper courses are built from more regular squared blocks of yellow sandstone, as is the west end of the wall, above the low lean-to structure. The random rubble that characterises the majority of the masonry also forms the bulk of the conjoining wall to the east.

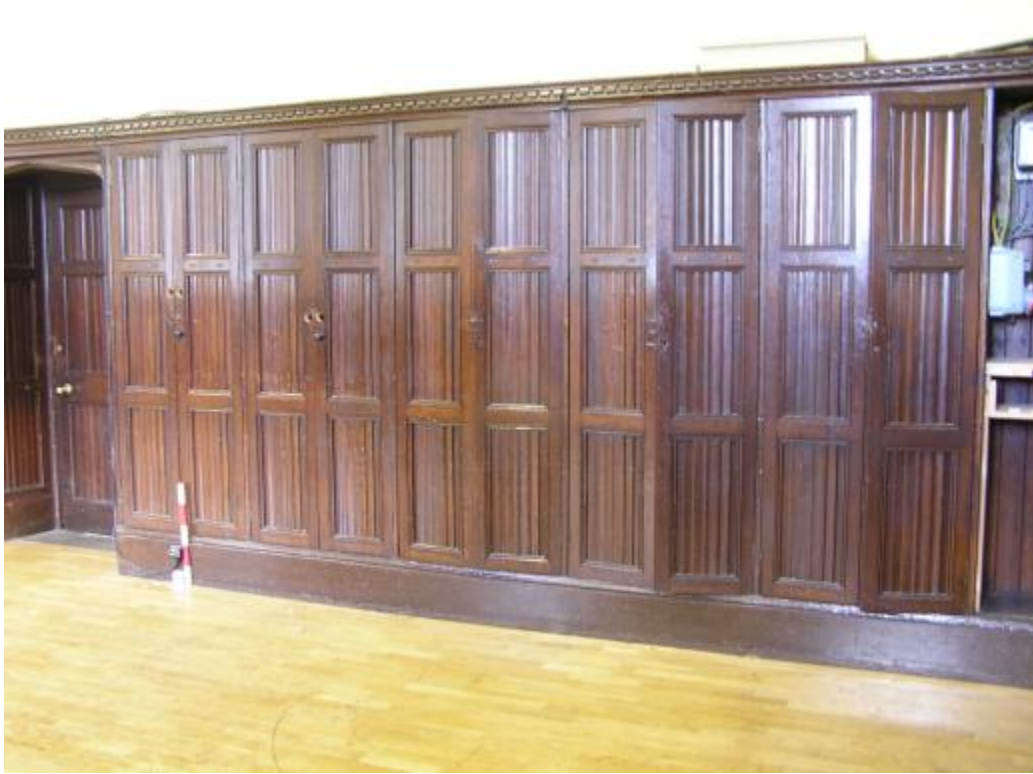
*Plate 76 Linen fold doors in the hall*

The interior of the church hall was generally very plain with modern painted plaster walls. The roof beams are exposed and decorated with moulded edges. The ceiling is formed by timber panels. The most notable feature is the built in cupboards along the north wall which have linen fold moulding on the doors, this is echoed in the main doors of the hall which have Tudor gothic arches above. A single line of billet moulding runs above the timber panelling. There is also a small cupboard on the south side of the hall with matching linen fold doors.

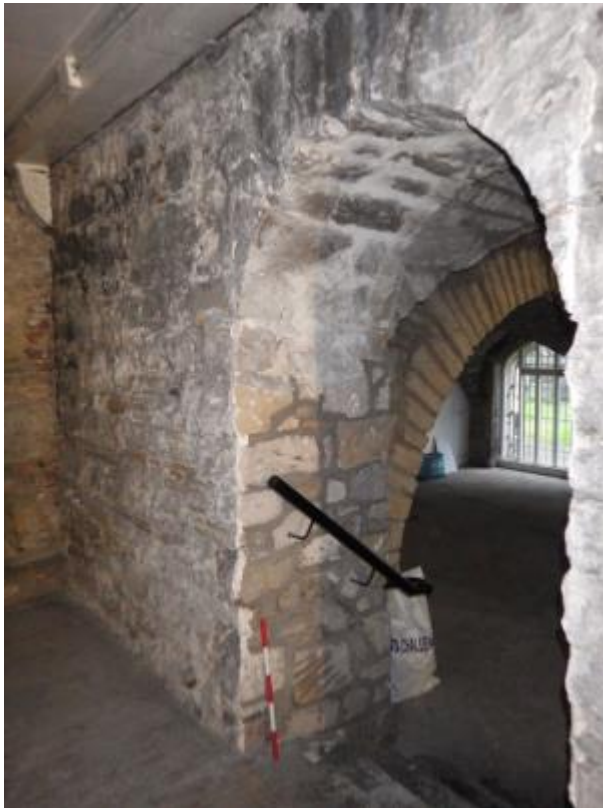
*Plate 77 General view from undercroft to crypt at David Boyle Lair with cut-through round-headed door. Facing south-east.*

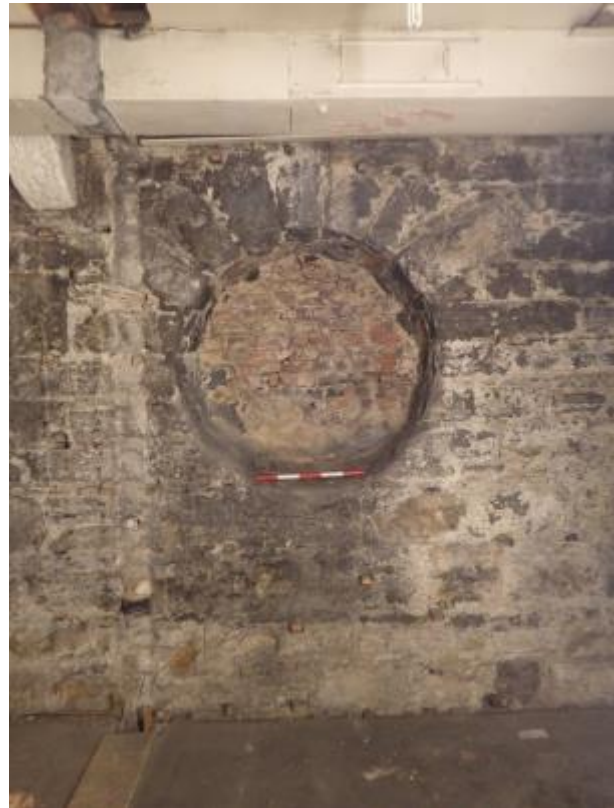
*Plate 78 Blocked round light in undercroft. Facing north.*
