Camp 22 Pennylands

Dumfries House, Cumnock, East Ayrshire

Community Excavation: March 2017

Report Date: August 2017

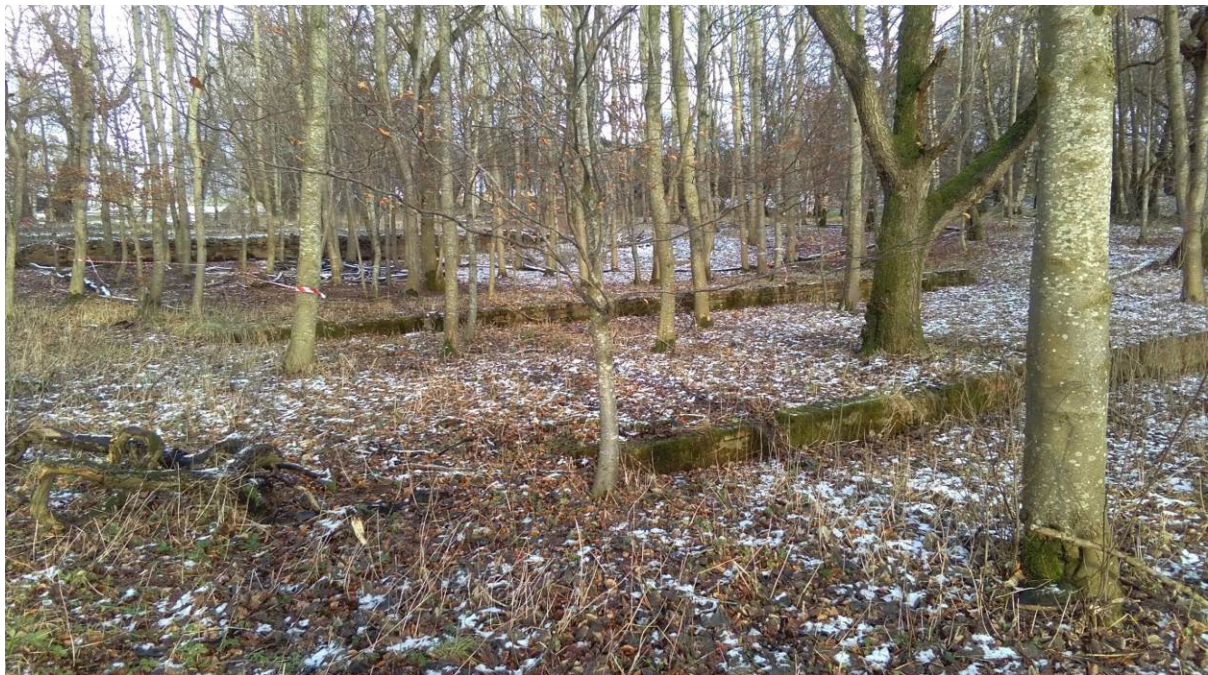
Plate 1 View of site in January 2017, looking north-east

The community excavation area was located within the grounds of Dumfries House Estate, Auchinleck, East Ayrshire (*figure 1*). The military camp is situated on the west side of the village to the north of the Lugar Water. The excavation was focused on the last surviving section of the camp, located in the south-east corner of the military camp (NGR NS 54177 21114). The site itself was located within an area of woodland adjacent to the estate road (*plate 1*).

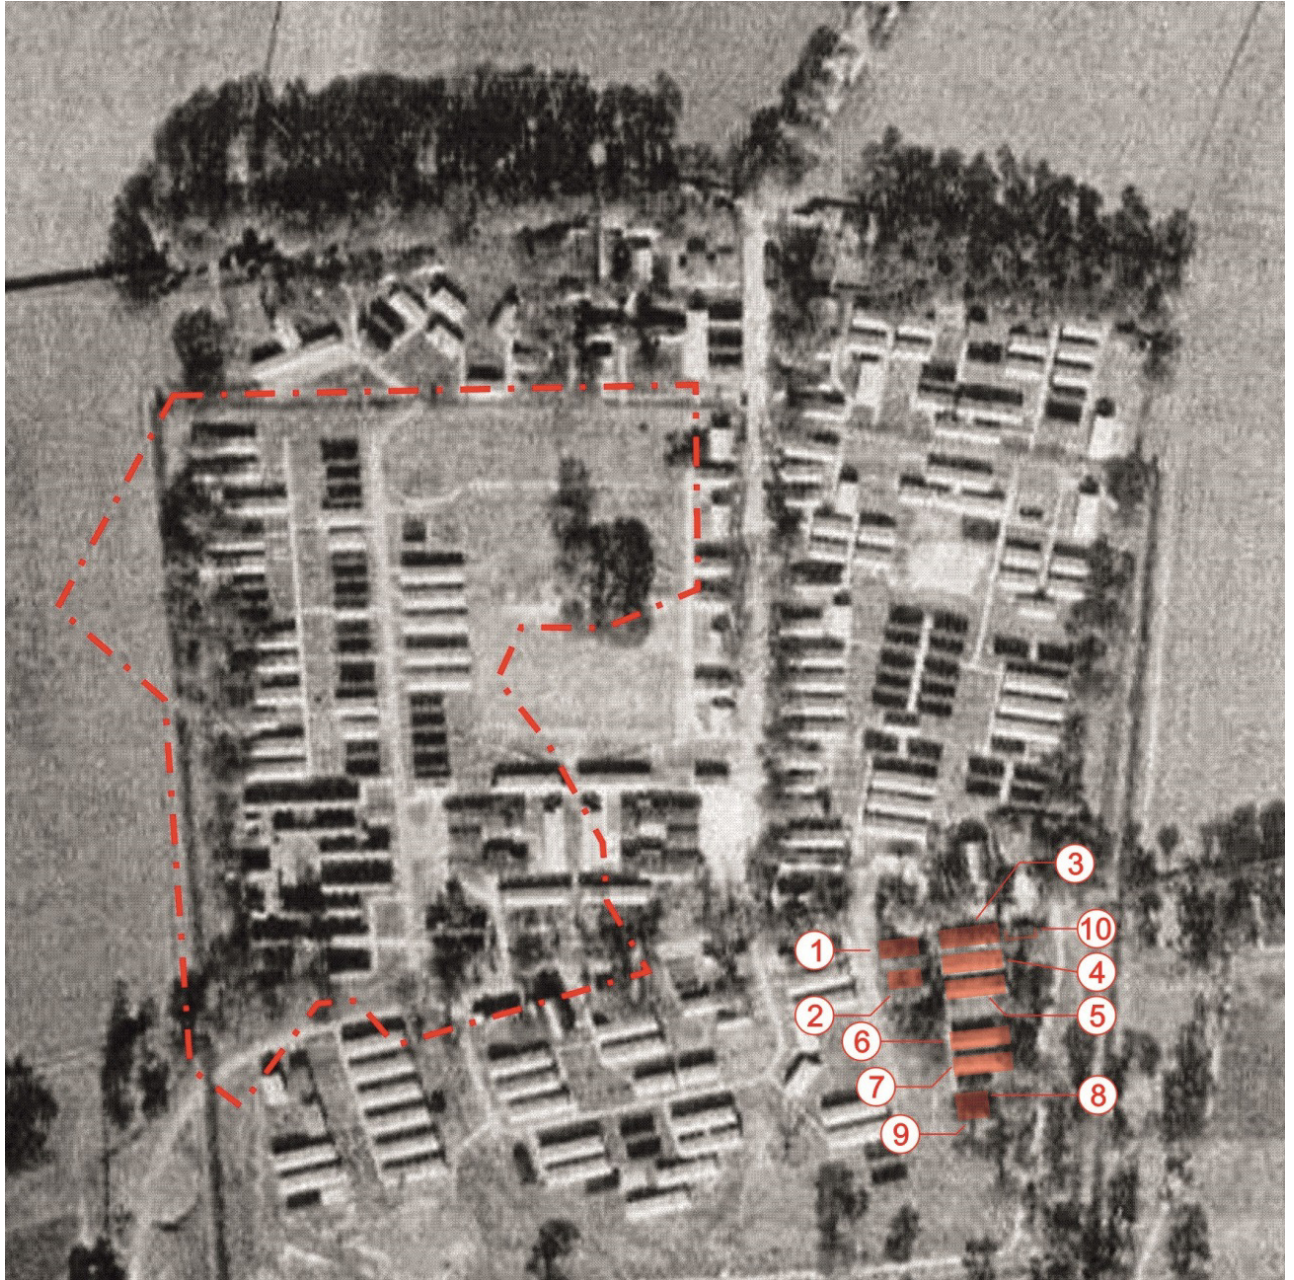
Figure 3 Aerial photograph of camp showing buildings identified in bottom right hand corner. The area of the previous excavations is outlined in red (north to top).

Nine huts were surveyed in the woodland area under investigation. The layout has been superimposed on the aerial photograph of the site, showing those huts which were identified (*figure 4*). Of the two huts in the western row, the first (Hut 1) was cleared of vegetation and recorded (see below). The evidence suggests that this was a shower/washing block, with rows of basins set out. The adjacent hut (Hut 2) is thought to have been a toilet block, by association.

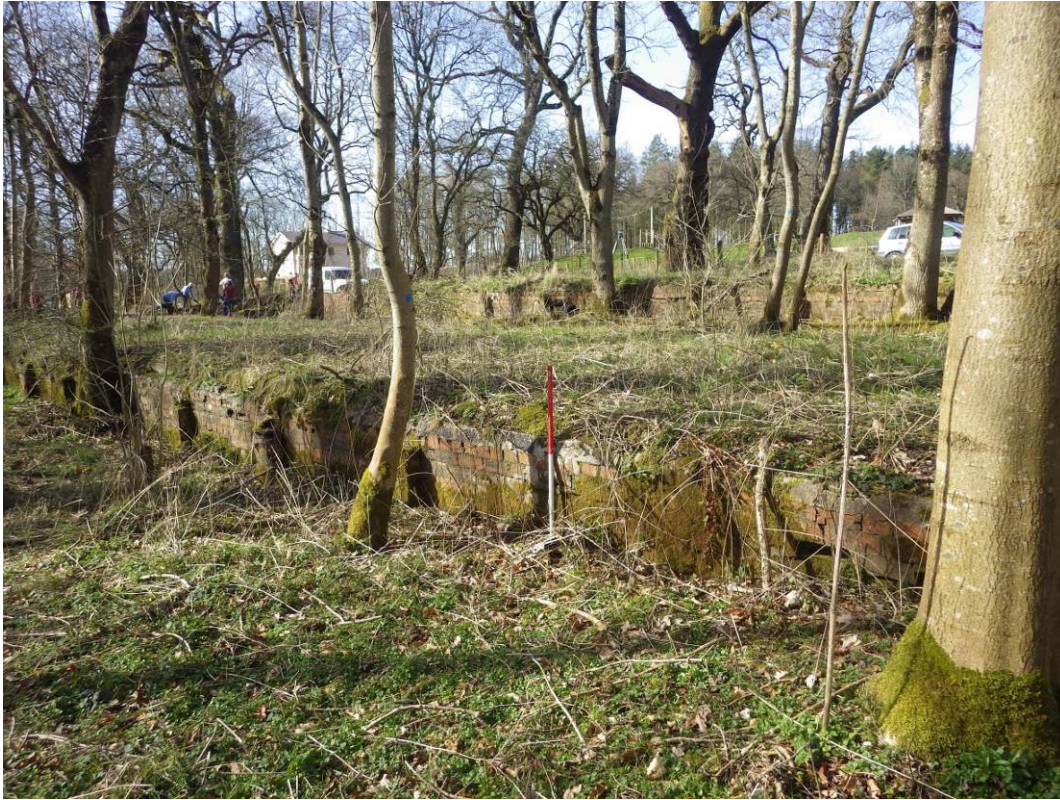
Plate 2 Hut 4, with Hut 3 in the Background, looking north-west

On the eastern row, the first 5 huts (Huts 3 – 7) are of similar dimensions and are thought to have been accommodation blocks (*plates 2 and 3*). These were of similar size to those uncovered during the excavation in 2016 (Scott Coulter pers comm). The larger gap between huts 5 and 6 is likely to be due to topography. The accommodation blocks measured 21m by 6m. All the huts had been built

into the slope so that the northern elevations only survived as high as the concrete floor, with the southern elevations between 0.63 - 1.05m in height, with around 7-8 courses of bricks on average; Hut 5 survived to the greatest height of 1.05m with 12 courses exposed (for more detail on each hut, see *Appendix 1*).

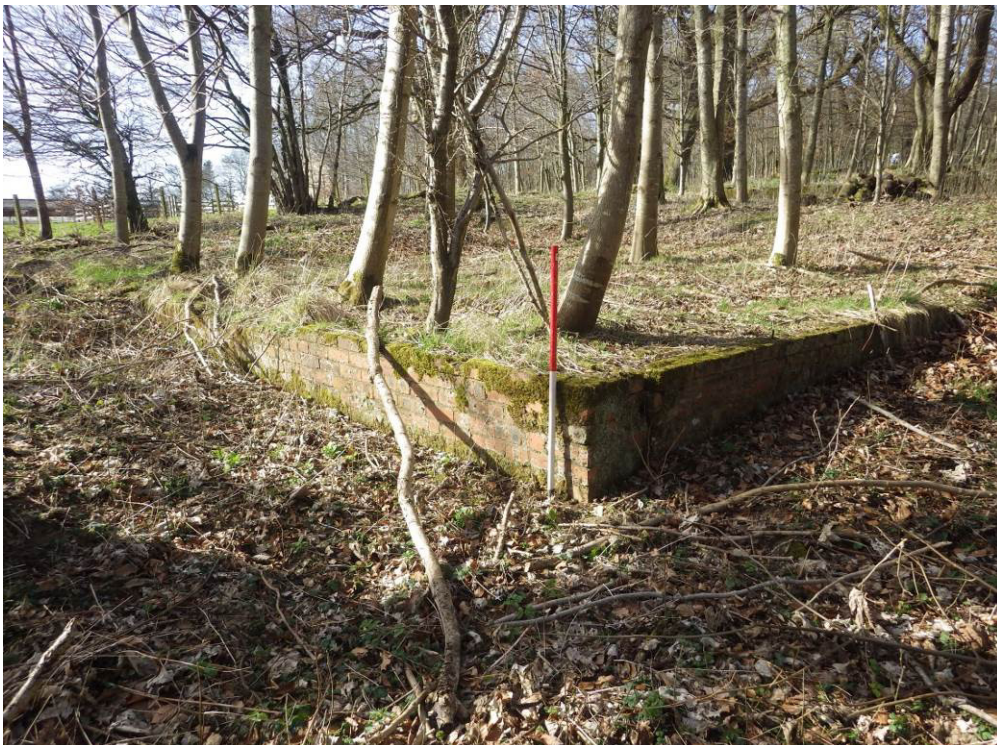
Plate 4 Hut 9 looking north-west

Further down the slope were two additional huts (Huts 8 and 9; *plates 4 and 5*). Their smaller size suggests they were used for something different and it is suggested that they may have been stores or workshops. Hut 8 was very overgrown and only identified by its corners protruding through the grass (*plate 5*). It measured 11m by 3m and was 0.24m in height on the southern side, with three brick courses visible at the highest point in the south-west corner. It was only one metre north from Hut 9, which measured 11m by 5m and was 0.5m high with six courses and was far clearer (*plate 4*). A further hut (Hut 10) was identified 3m to the east of Hut 3 (*plate 6*). The north side of Hut 10 was not

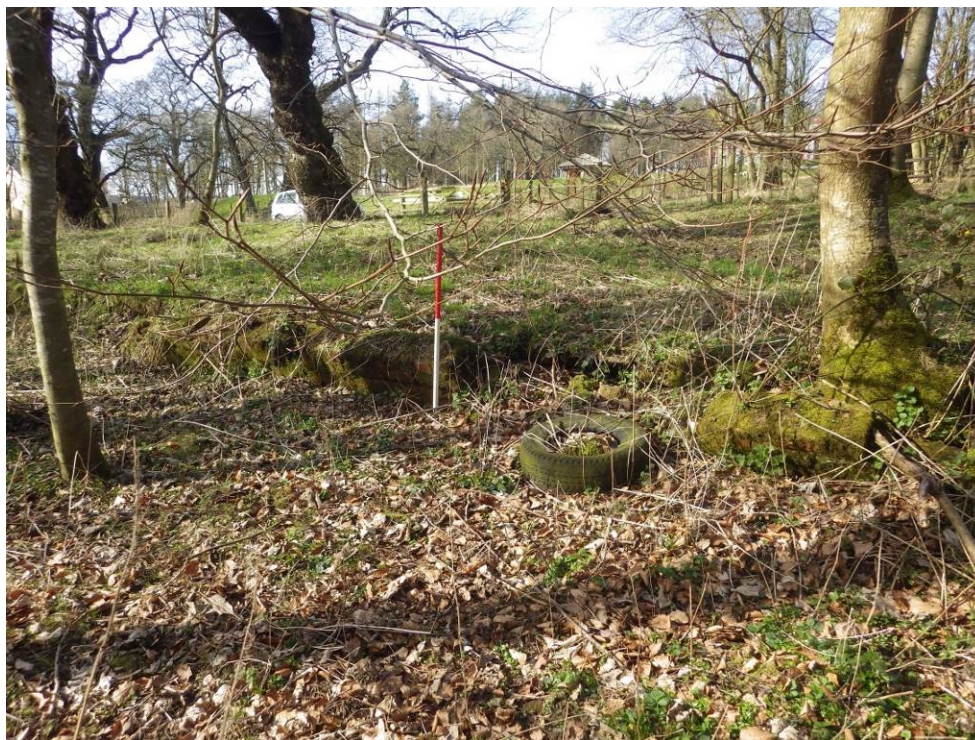
Plate 6 Partly buried south wall of Hut 10, looking north-west

found, but the southern side ran on the same line as the southern side of Hut 3 and was 11m in length. The southern side was 0.87m in height and 10 courses high and the wall had partially collapsed; the hut was partially buried and the sides were also not clearly visible. The dimensions are similar to Hut 9 so it is likely to have had the same purpose, perhaps as a workshop associated with the blocks at the top of the slope.

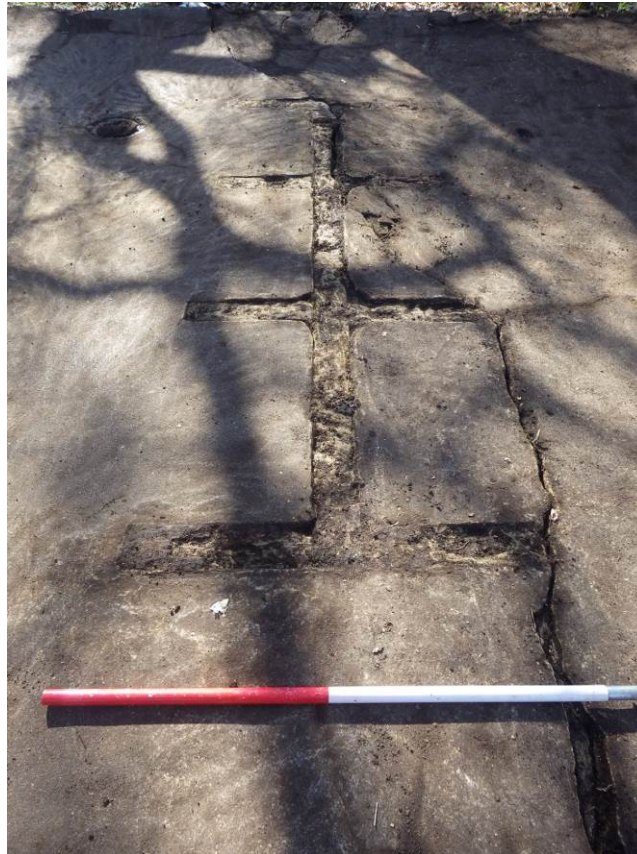
Plate 8 Hut 1, Detail of Westernmost Basin, Brickwork and Drain, looking south

Within the floor were three sets of brick-built basin supports, two aligned east to west [2006, 2007] and one at the west end aligned north to south [2008]. The brickwork for the supports was one brick wide. The location of four downpipes were also identified – one associated with each of the banks of basins and one with a drainage point in the floor [2005]. This separate drain was surrounded by a circular dip in the floor approximately 1.50m in diameter (*plate 8*). The associated pipework would have been above floor level.

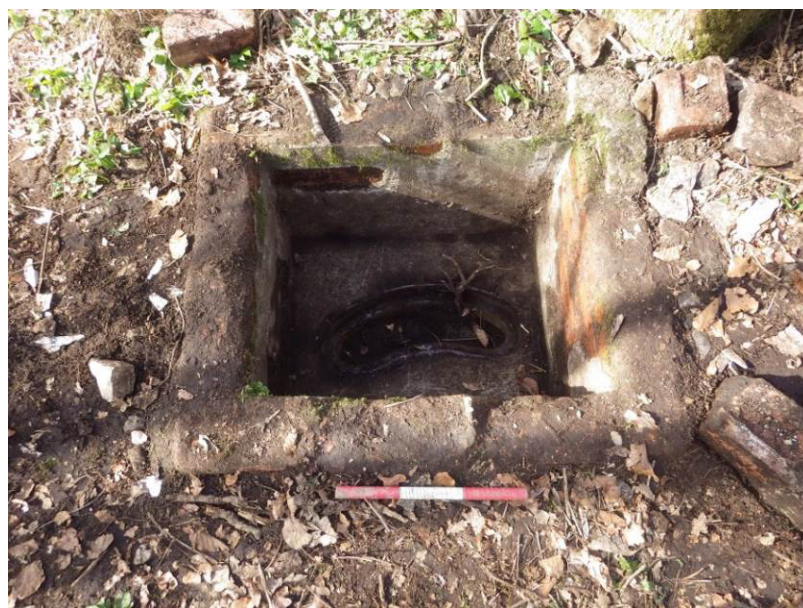
Plate 9 Hut 1, Brick Drain [2002] looking north

There were a number of associated drains on the southern side of the building. Near the south-west corner was a rectangular brick-built drain with internal dimensions of 0.60 x 0.50m and 0.40m deep [2002]. The interior was rendered and there was a kidney-shaped silt trap in the base (*plate 9*). The drain was filled with a mixture of silt and rubble [2001], containing a number of fragments of white ceramic sanitary wares stamped 'Adamsez Ltd Scotswood on Tyne' (*plate 10*). Adamsez was originally established in York as *Adams and Co* making automatic cisterns and tanks. In 1902 Adams and Co took over *W. C. Gibson and Co* of Scotswood and moved the sanitary ware arm of the business to Scotswood, near Newcastle-upon-Tyne; the Gibson takeover included the Scotswood Fireclay Works and collieries which led Adamsez to diversify into firebrick manufacture (<http://www.gracesguide.co.uk/Adamsez>). The need of the camp for both firebricks and sinks may have made them a useful supplier.

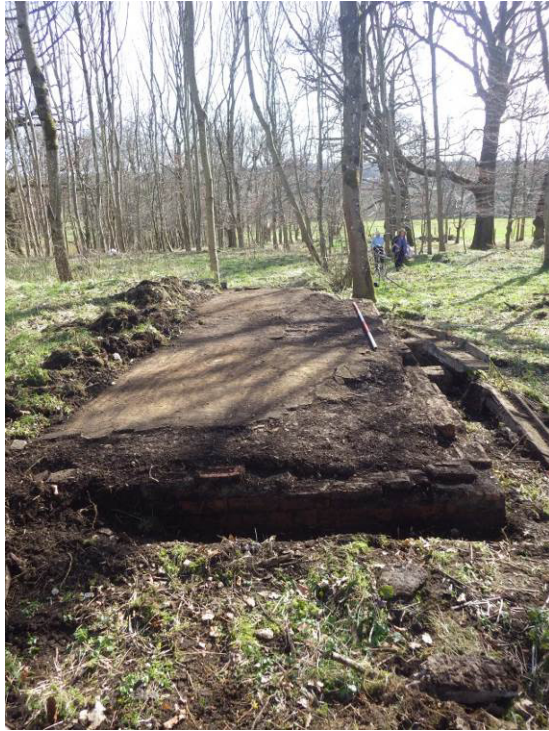
Plate 11 Hut 3, looking south

The accommodation block was only partially excavated, primarily to expose the western elevation and a curious concrete structure that was up against it (*plate 11*). The western wall of the building survived up to 0.46m in height, with 4-5 courses exposed. In the centre of the side elevation were parallel brick piers, which would have supported concrete or wooden steps to the entrance, as seen on a number of the previously excavated huts. The concrete structure was approximately the width of the building (6m), although it did not appear to be *in situ*. It was formed of a single piece of cast concrete, tapering at both ends from a width of 0.3m in the centre. The uppermost side was recessed to form a shallow rectangular basin, separated by a series of concrete 'bars' across the basin. This appeared to relate to drainage or run off and may have been formerly located at the side of the building to drain the water away downslope.

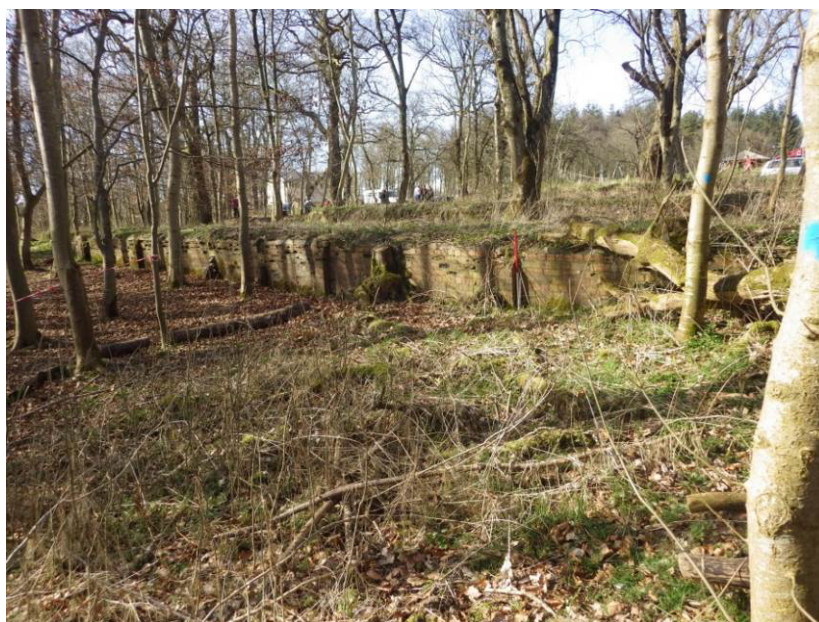
Plate 13 Hut 5, south elevation, looking north-west

An elevation drawing was made of the southern elevation of Hut 5; the elevation was identical to those of Huts 3 and 4 but was most clearly exposed at Hut 5. The elevation exposed walls of at least 0.8m in height and was 21m in length. A series of brick piers were visible at approximately 2m intervals along the length of the elevation; these were a single brick wide (0.2m) and six bricks high, which had been laid on their sides (*plate 13*).
