*AA2275*  
*Hillslap Tower, Langshaw*  
*Scottish Borders*

*Archaeological investigations: 2017*

## AA2275

#### Archaeological investigations

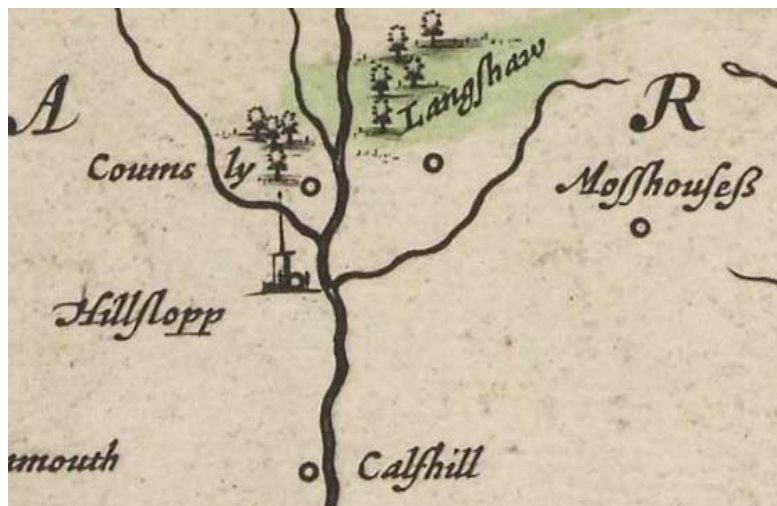
Figure 2: Blaeu 1662-5 Atlas Maior Volume 6, Teviota Vulgo Tivedail

The earliest map to show Hillslap Tower is in Blaeu's Atlas of 1665 (*figure 2*). This depicts *Hillslopp*, as a tower or church and also depicts *Langshaw* and *Coumsly* adjacent, although these are just shown as locations. *Calfhill* is shown on the west side of the river to the south.

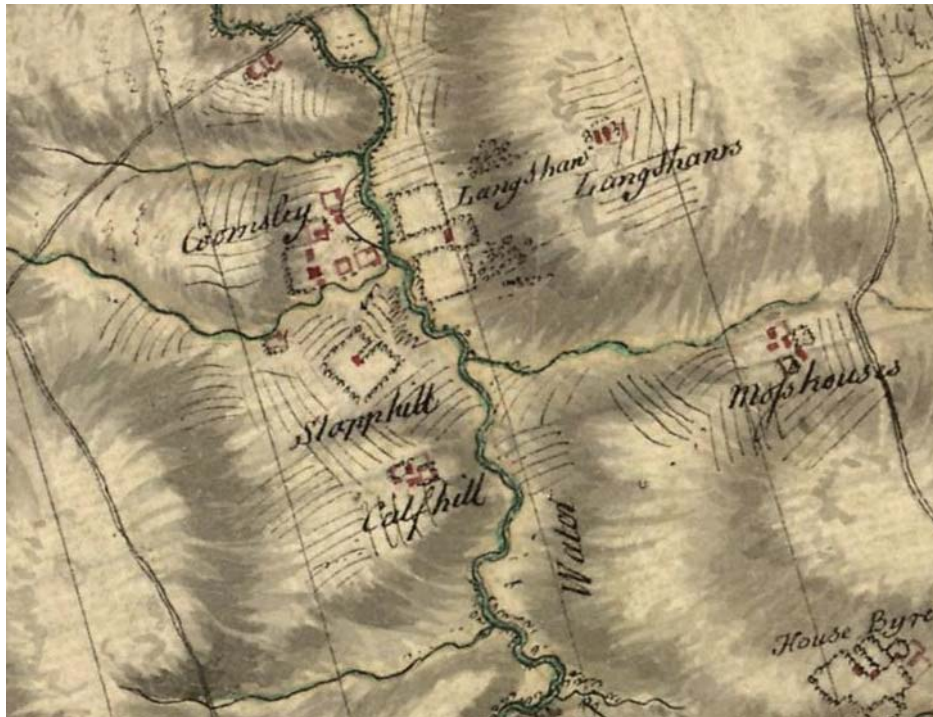
Figure 3: Roy, W c1750 Military Survey of Scotland, Lowlands

Roy's map shows the site and the surrounding towers and landscape in some detail (figure 3). The site is depicted as *Slapphill*, and shown as a building with a surrounding enclosure or wall; *Calfhill* is to the south and comprises a number of small buildings with smaller enclosures. The adjacent tower of *Coomsley* is shown with a series of adjacent buildings, while *Langshaws* appears similar to *Slapphill*, with a central building and adjacent rectangular enclosures, with further buildings of a smaller settlement to the east.

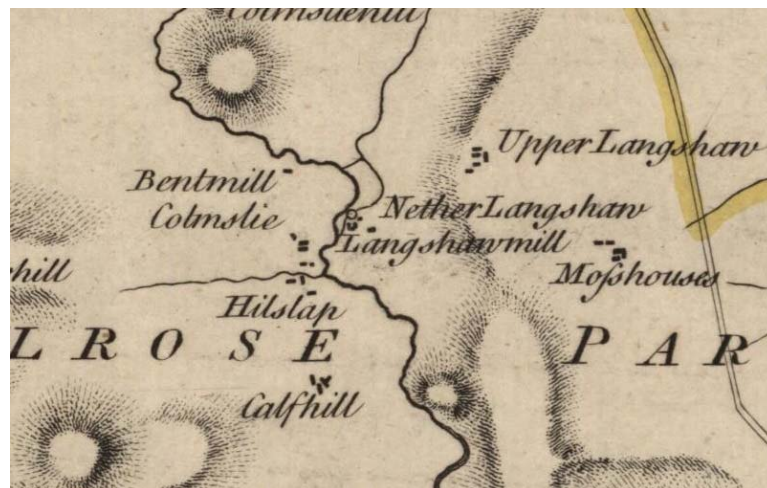
Figure 4: Stobie, M 1770 A map of Roxburghshire or Tiviotdale, North West section

Stobie's map of 1770 again shows each of the small settlements, but in less detail; the two settlements of Langshaw are now *Upper* and *Nether Langshaw*, with a mill associated with the latter. The spelling of *Colmslie*, has altered again as has *Hilslap*; while *Calfhill* is again depicted to the south. Thomson's later map of 1822 shows the same features.

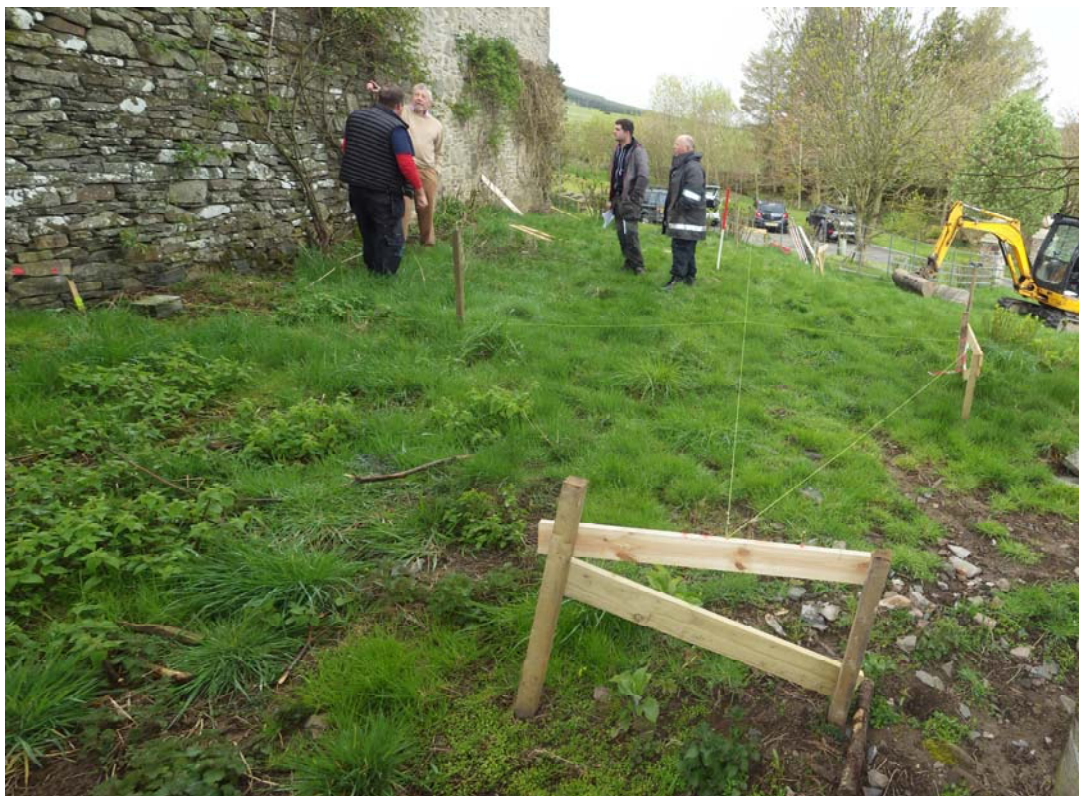
*Plate 1 pre excavation view of building with foundations laid out*

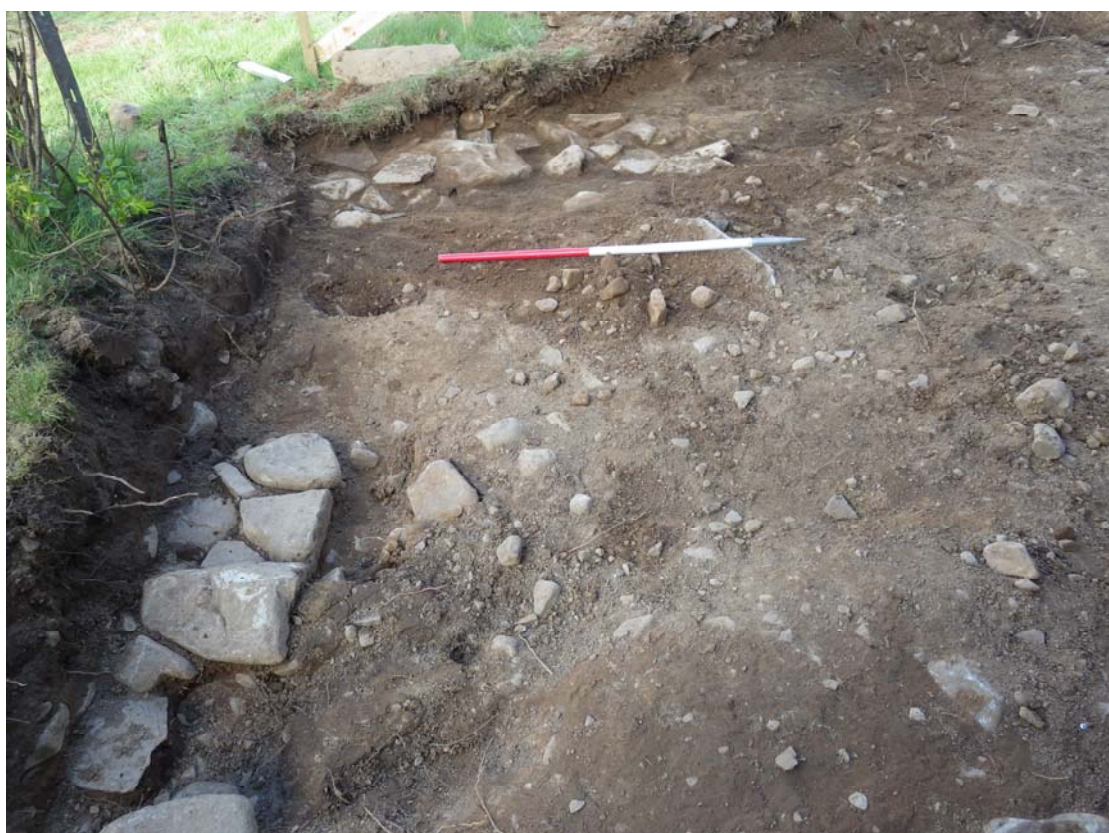
*Plate 2 initial area strip with rubble built features to west first exposed (modern service cut runs diagonally from bottom left to top right )*

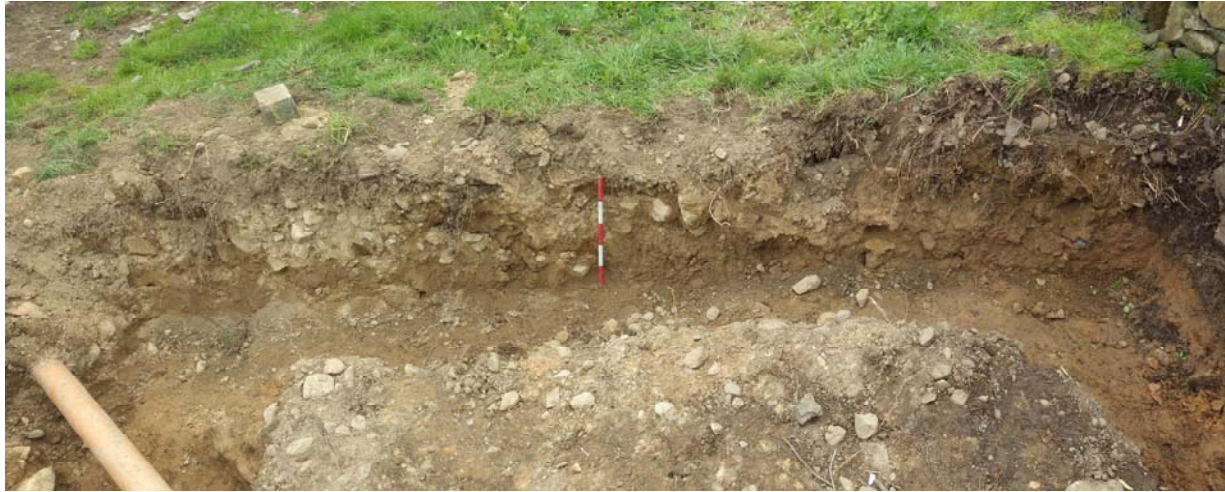
The east trench was opened up first and was the easiest to excavate, the only features exposed were the cut for the modern 003 (late 20<sup>th</sup> century) walling to the south and a modern drain 004/005 (late 20<sup>th</sup> century) to the north. The majority of the deposits were natural 006 and this varied from solid pinkish brown clay to the south to a very stony gravelly sand elsewhere and was overlain with a thin topsoil layer 001 likely to be of recent deposition.

*Plate 3 east trench section (0.50m scale)*

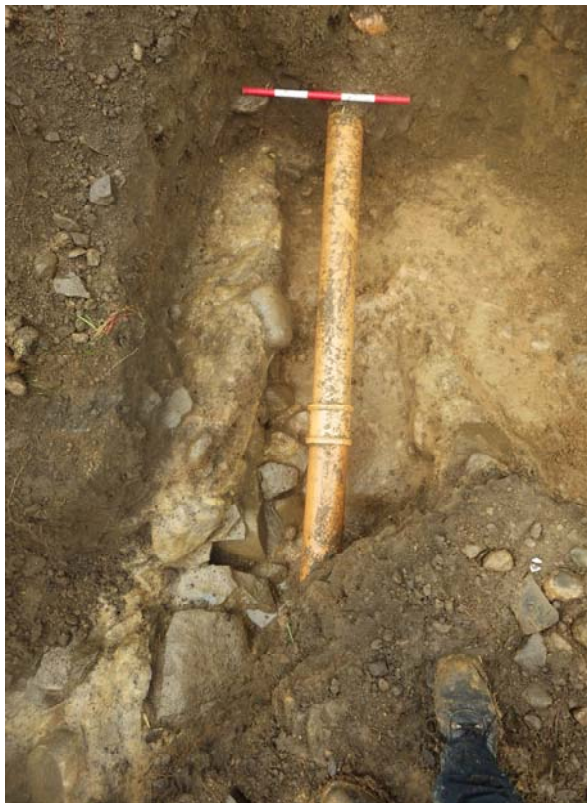
To the east this mass of clay and rubble stone 014 had been cut by the eastern modern pipe 004/005. However after cleaning up around the pipe it appeared that the deposits to the east were natural gravel/sands 006 and the pipe had cut along the edge and parallel to the clay and stone deposit 014 just clipping the deposit.

*Plate 4 junction of north and east trench showing pipe 004/005 as first exposed (and repaired) cutting 014 to the left (west) with natural 006 to the right*

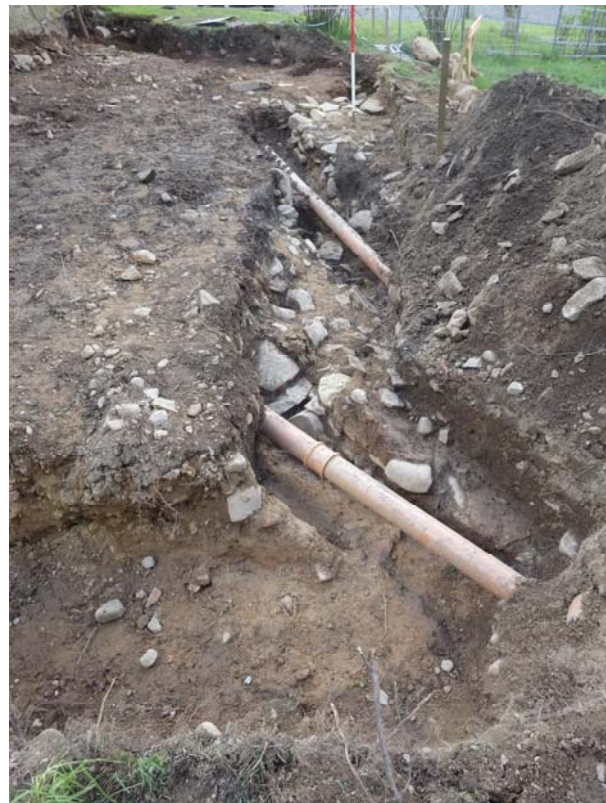
The lowest deposit as seen in the other trenches was a sandy gravelly natural deposit 006; this was only noted to the western and eastern ends of the trench. The bulk of the trench was taken up by a large mass of yellow clay and rubble stone 014. On initial uncovering this was felt to be a large mass of clay bonded masonry, although the initial interpretation was hampered by two late 20<sup>th</sup> century foul and rainwater pipes that cut through this, the latter at an oblique angle. These pipes also hampered the trench excavation.

*Plate 5 north trench general view to west showing 014 clay and rubble stone cut by modern services*

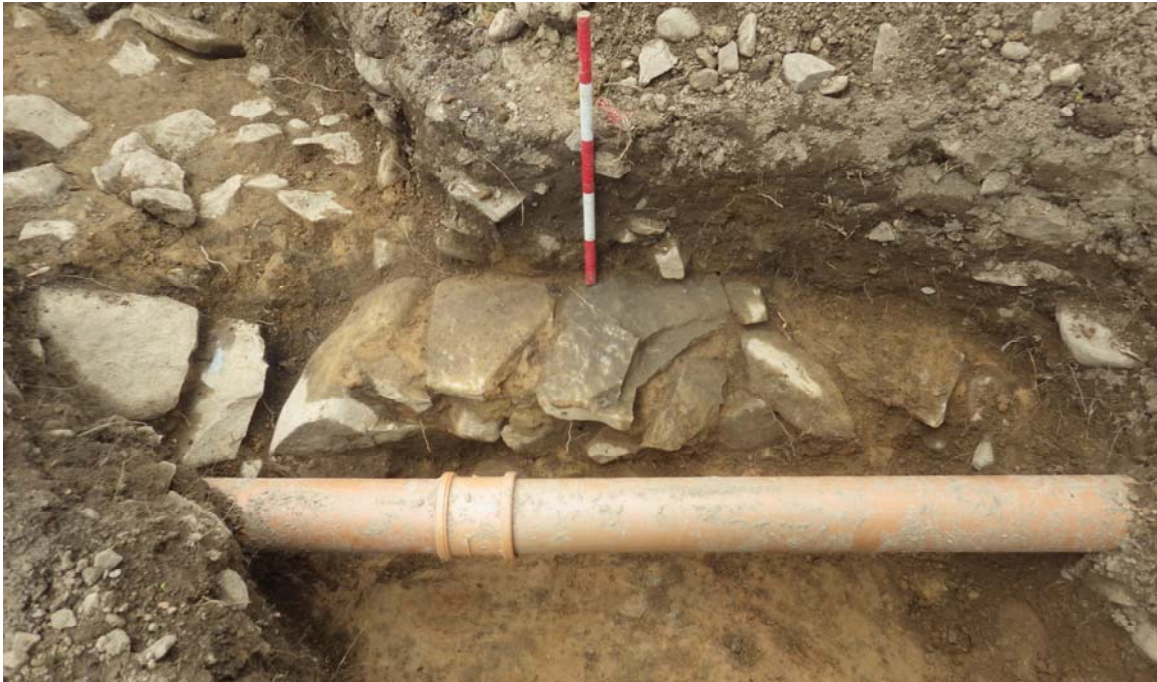
Excavating through the clay and stone deposit 014 proved that rather than *in situ* clay bonded masonry, the deposit was a collapsed clay bonded structure. The structure's eastern extent was defined by a 0.3m thick clay bonded rubble masonry wall 015; this structure had been sunken into the ground (cut 016). The upper parts of the cut were lost by the insertion of the modern pipe but the cut could be seen below cutting into the natural. The eastern face of this cut 015 was rough and unfinished showing it to be built against the cut and the western face was formed with a good face and continued below the limit of excavation (LOE). The base of the structure was not located within the excavation.

Plate 6 rear of masonry 015 exposed

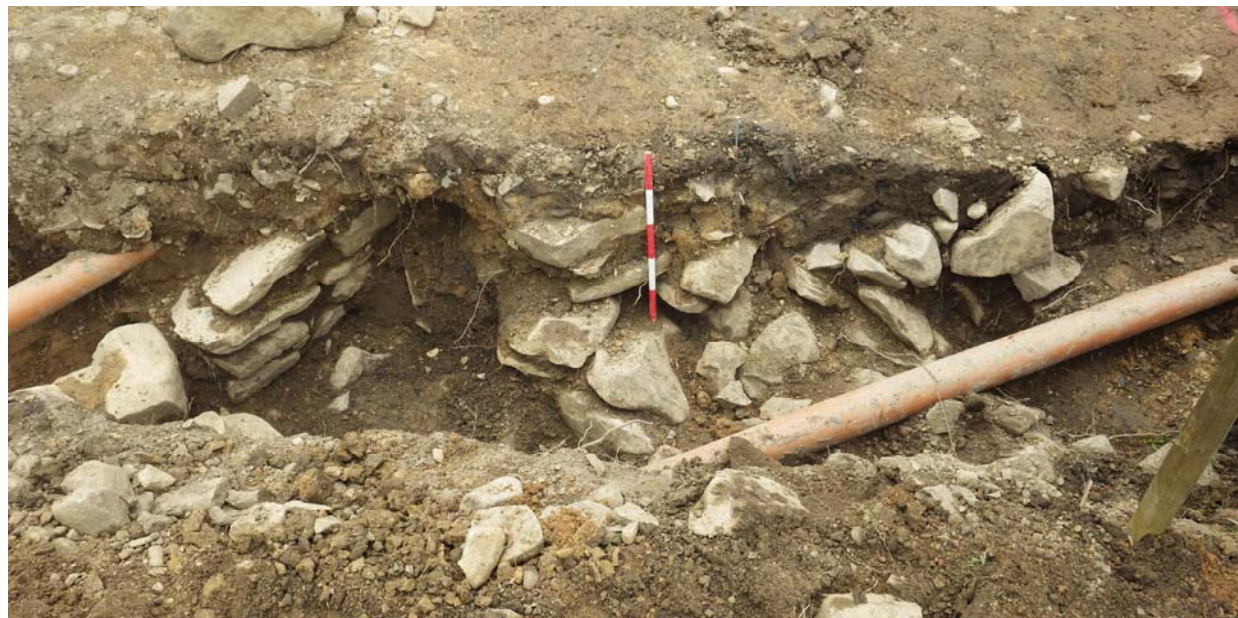
The western line of the 015 masonry building appeared to return to the east approximately at the line of the trench edge to form a gable; the corner was thus just clipped in the trench. This return/gable was largely historically reduced during the initial demolition. This lack of survival of the southern gable was clear within the mid trench where the cut 016 for the structure was clear but the upstanding masonry of 015 was wholly lost and the cut infilled with 014. The full width of the western masonry was not seen within the trench and it appeared to be much wider than the eastern wall.

*Plate 7 eastern face of 015 as exposed (to left) with rubble collapse 014 to right*

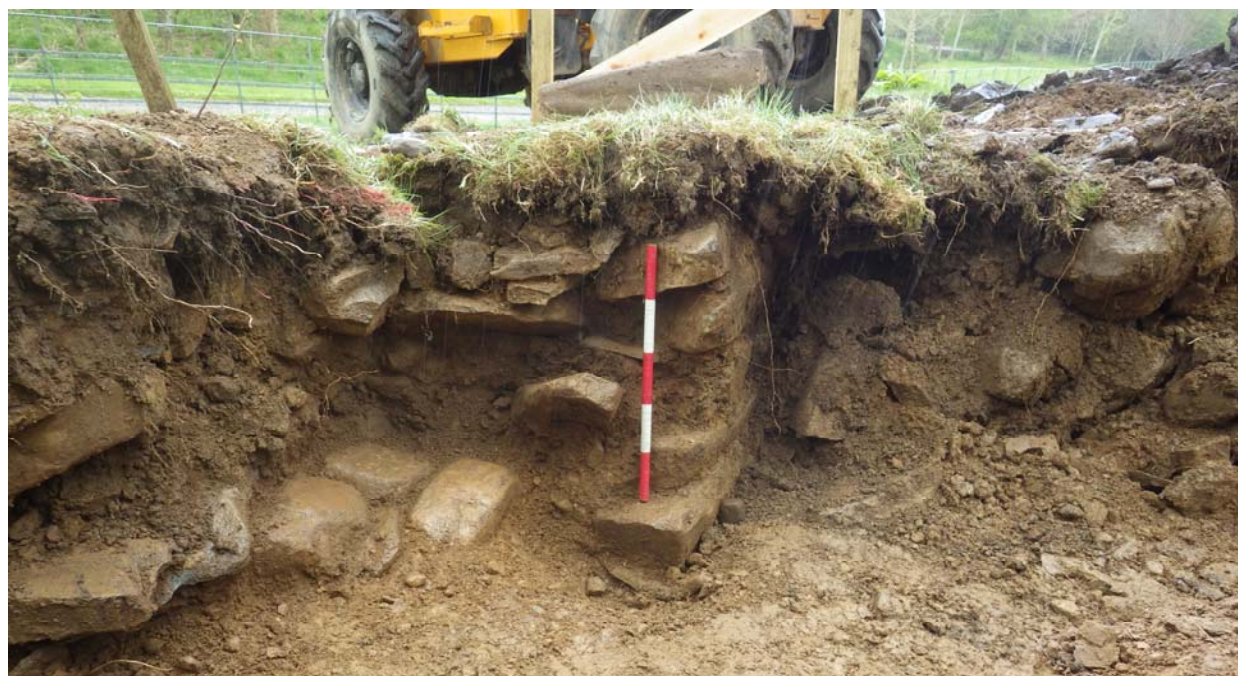
*Plate 8 western corner of 015 as exposed at LOE, wall makeup to left and masonry collapse 014 to right. Corner of the structures return was approximately in line with the scale*

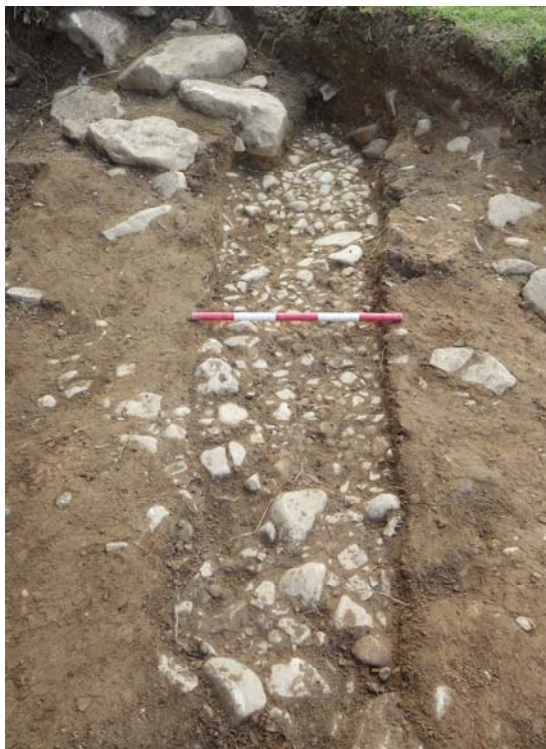
Within this trench natural 006 was exposed for the full length. To the north this was cut by 016, the cut for the 015 structure. To the south a small area of metalling 007 survived; this was a well formed surface gently sloping up to the east and truncated to the east on the line of the modern fence, to the south by modern buildings and north by modern services. This small triangular area of metalling sat directly upon the natural.

Plate 9 metalling 007 within sondage with wall 008 at top

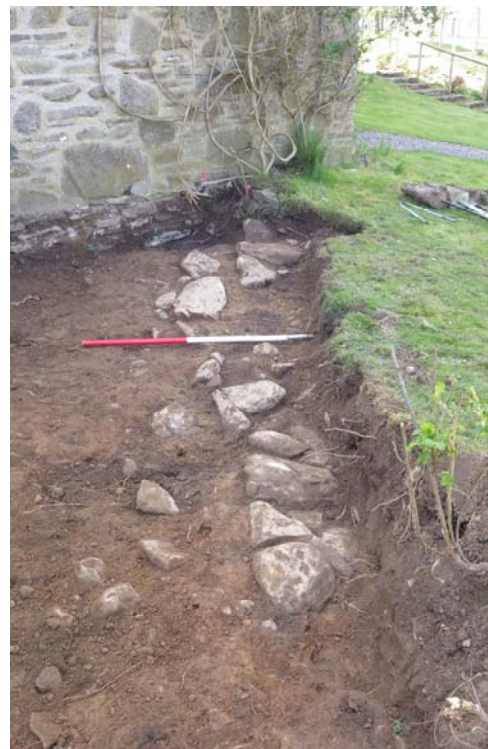
Plate 10 wall 008 as exposed, collapsed stones and modern drainage cut beneath scale

Built directly upon this metalling was a clay bonded rubble wall 008. This wall was largely demolished and only small segments survived but enough remained to show a good face to the east; the west face was beyond the LOE so the full width was not identified. The wall was formed from large rounded field stones within a yellow/brown clay mortar; some similar large and generally flat but rounded stones loosely associated with this were scattered alongside and likely represent collapse and landscaping in the past. Also on top of the metalling and abutting the wall 008 was 009 redeposited natural clay sands.

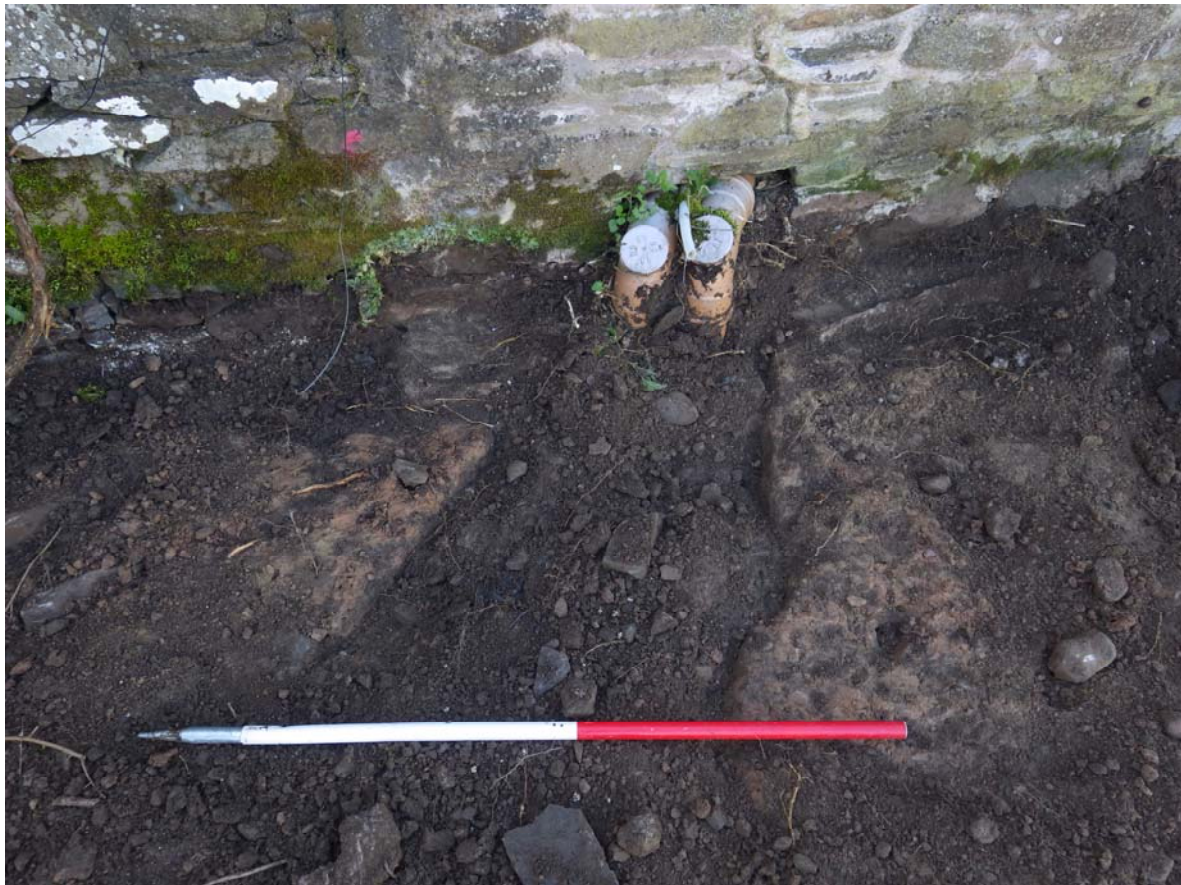
The deposits seen within the southern trench were almost all of a truncated natural. This was cut to the south by the late 20<sup>th</sup> century retaining wall 003 to the east and the late 20<sup>th</sup> century building 002 to the west; modern services 004/005 running out from 002 also cut the natural. Much of the upper deposit was a modern redeposited soil 001 with many bricks and plastic inclusions relating to the 20<sup>th</sup> century. Only a limited area of *in situ* deposits survived; these were located to the extreme west and comprised metalling 007 and wall 008 as already noted in the west trench.

*Plate 11 cut 004 as it comes out from 002*

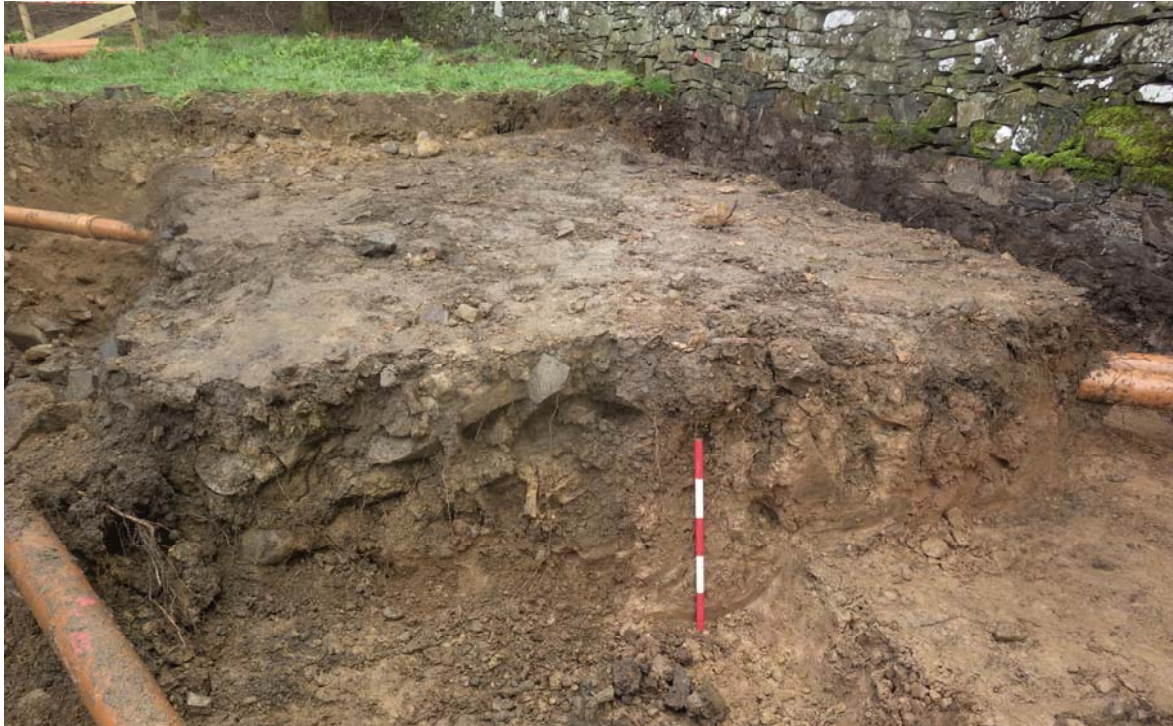
The deposits of the southern half were natural 006 below redeposited topsoil 001; however the northern half of the deposits comprised clay rich rubble infill 014. The clay and stone deposit 014 sits within a gently sloping cut 016 and shows the southern extent of structure 015; within this area the upstanding structure had been completely demolished to below the LOE.

*Plate 12 mid trench section showing southern extent of cut 016(to left of scale)*

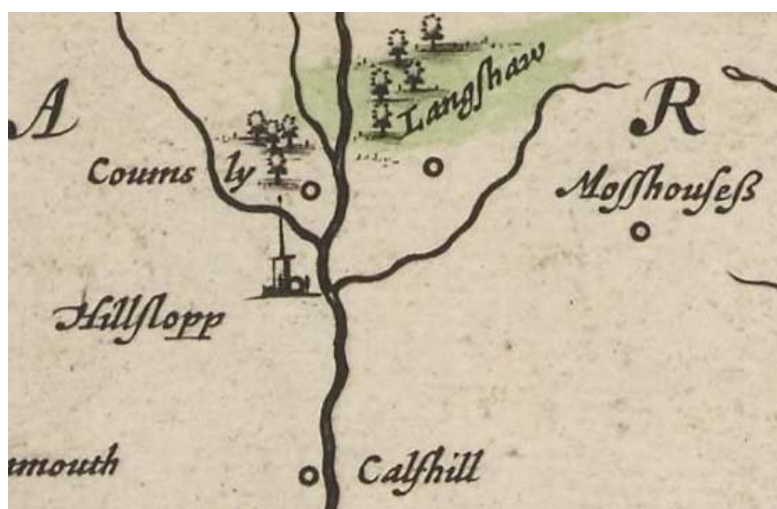
Figure 2: Blaeu 1662-5 Atlas Maior Volume 6, Teviota Vulgo Tivedail

The earliest map to show Hillslap Tower is in Blaeu's Atlas of 1665 (figure 2). This depicts *Hillslopp*, as a tower or church and also depicts *Langshaw* and *Coumsly* adjacent, although these are just shown as locations. *Calfhill* is shown on the west side of the river to the south.

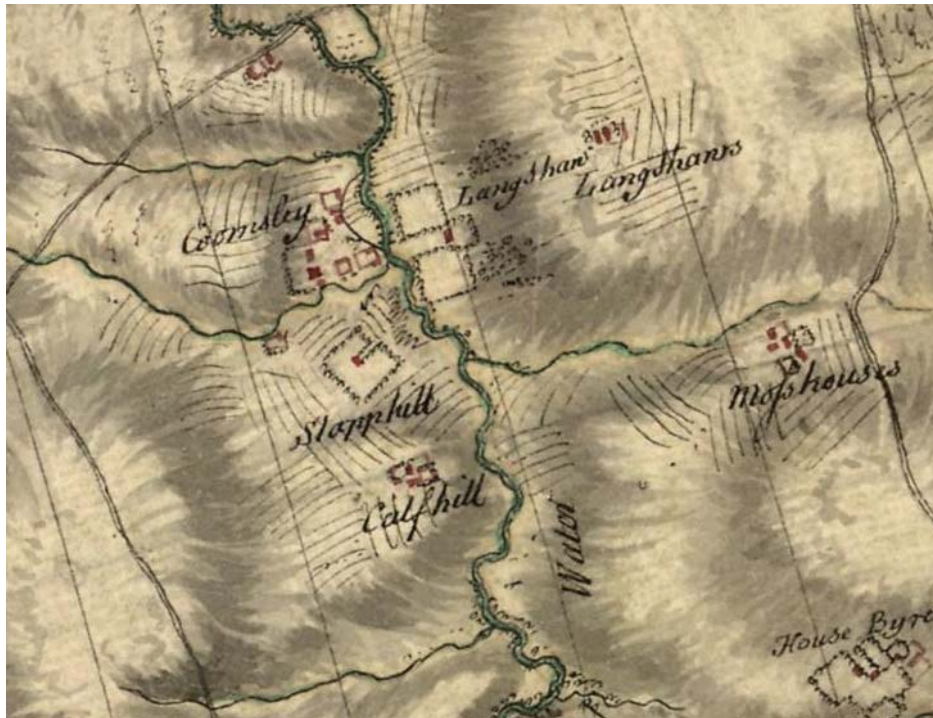
Figure 3: Roy, W c1750 Military Survey of Scotland, Lowlands

Roy's map shows the site and the surrounding towers and landscape in some detail (figure 3). The site is depicted as *Slapphill*, and shown as a building with a surrounding enclosure or wall; *Calfhill* is to the south and comprises a number of small buildings with smaller enclosures. The adjacent tower of *Coomsley* is shown with a series of adjacent buildings, while *Langshaws* appears similar to *Slapphill*, with a central building and adjacent rectangular enclosures, with further buildings of a smaller settlement to the east.

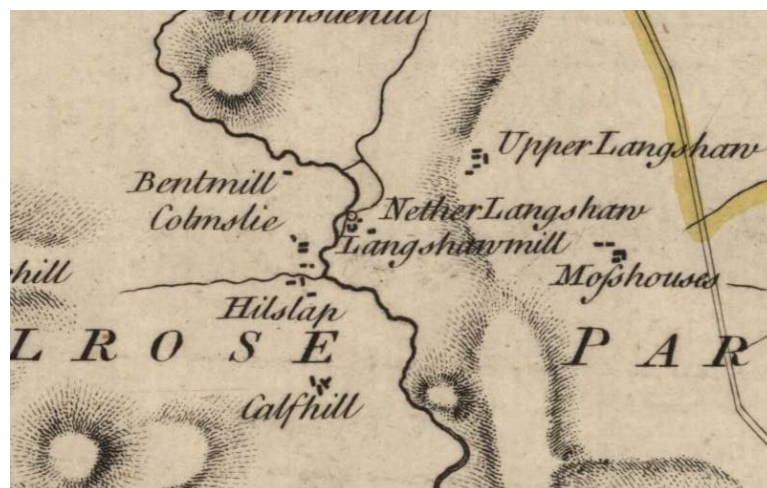
Figure 4: Stobie, M 1770 A map of Roxburghshire or Tiviotdale, North West section

Stobie's map of 1770 again shows each of the small settlements, but in less detail; the two settlements of Langshaw are now *Upper* and *Nether Langshaw*, with a mill associated with the latter. The
