Brisbane Observatory
Brisbane Estate, Largs, North Ayrshire

Analytical Assessment and Historic Building Record: Data Structure Report

for Brisbane Observatory Trust

February 2016

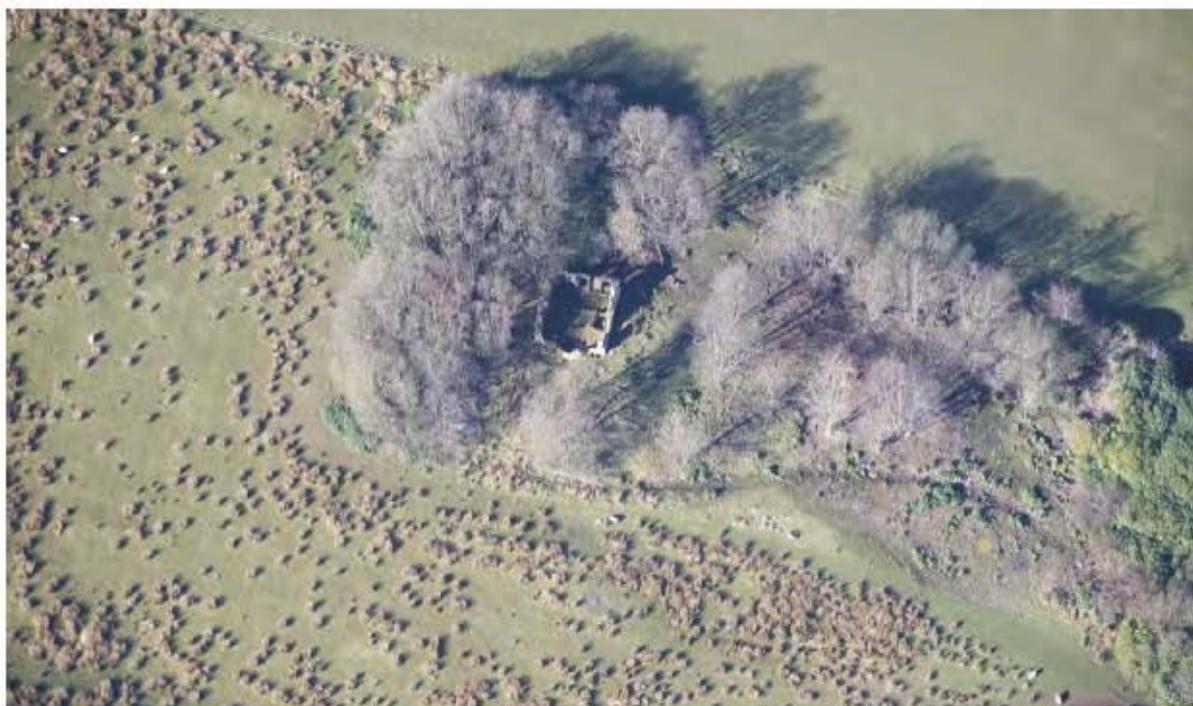
Plate 1 Aerial view of the observatory ruin in March 2014 following clearance (HES – CANMORE DP186220)

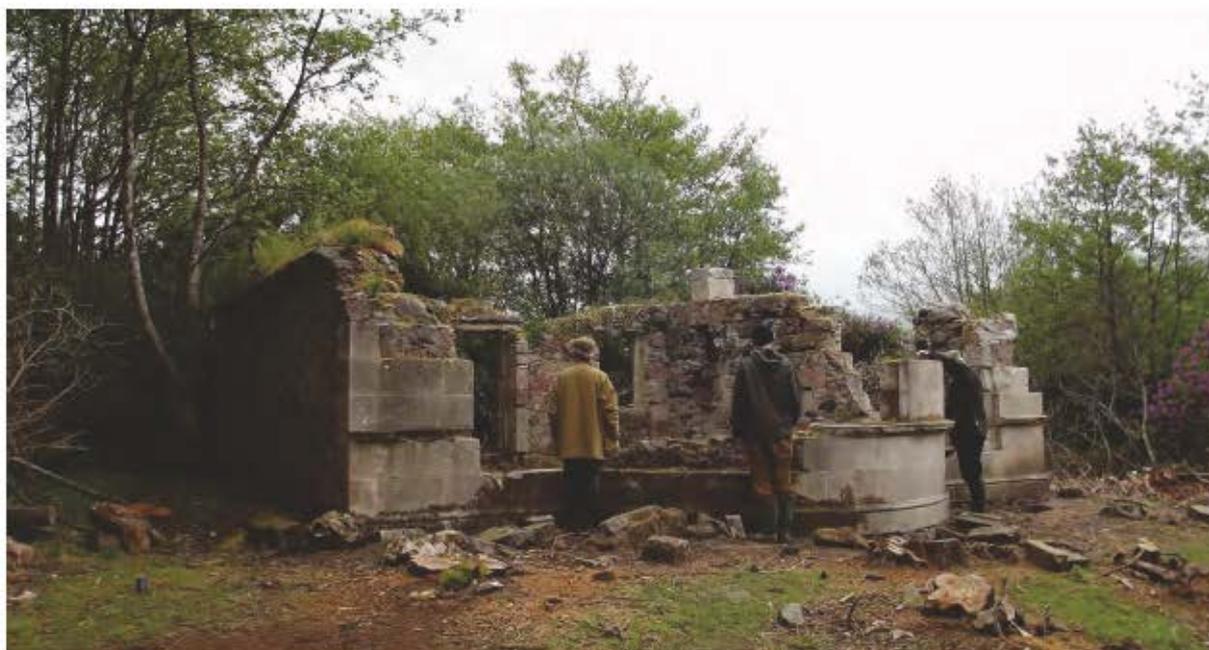
Figure 4 The observatory following clearance of enveloping ponticum; south side

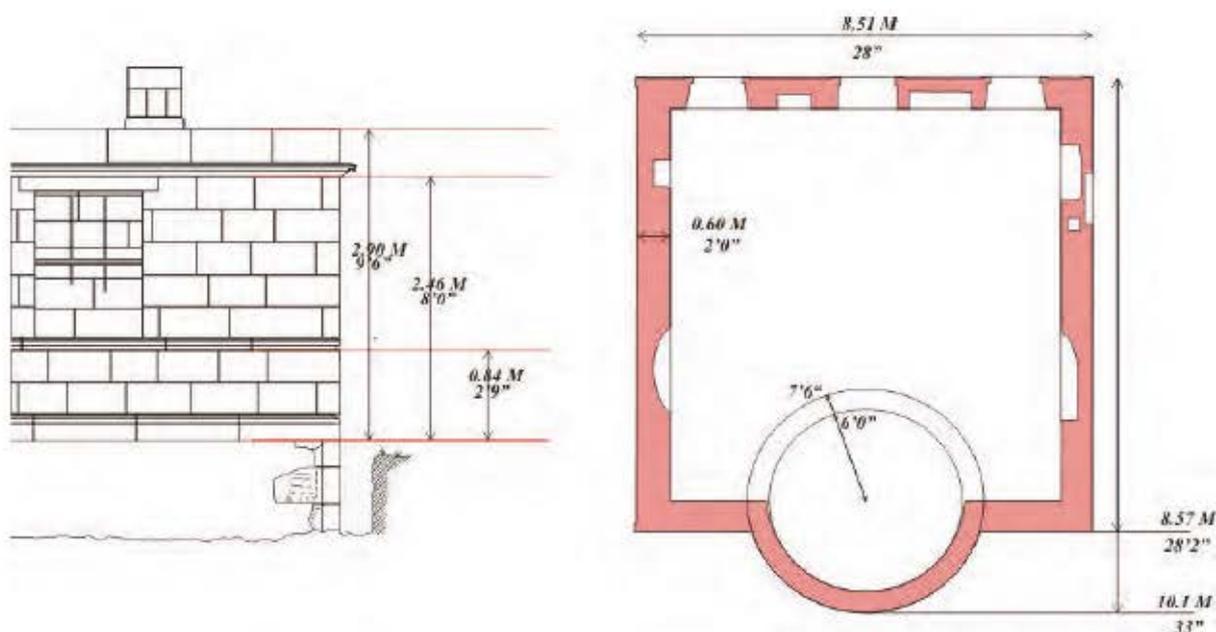
The observatory is almost precisely square in plan at 28'0" by 28'2" (8.51m by 8.57m). The most striking feature of the plan is the near semi-circular bow that projects from the centre of its south elevation, this had supported the observatory's dome. Its walls rise from base of plinth course (the original ground surface) to wall head for 9'6" (2.90m).

Figure 5 General dimensions of the observatory

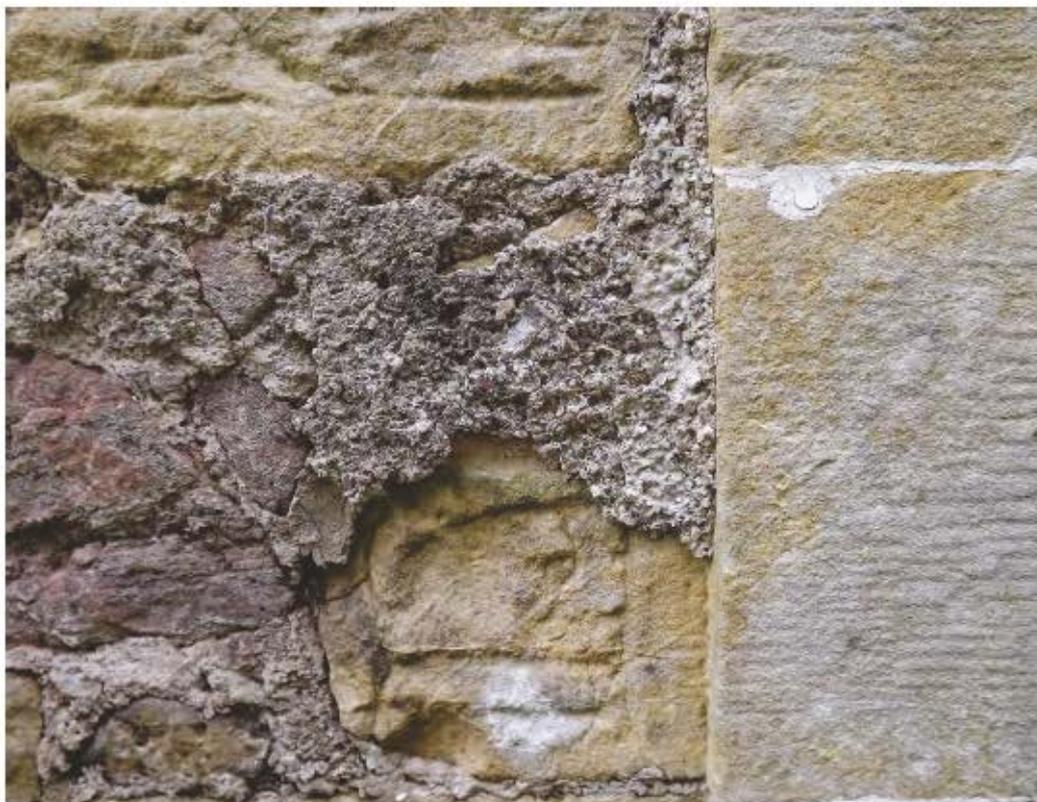
Plate 5 North wall, remains of lime harl (036) and limewash over

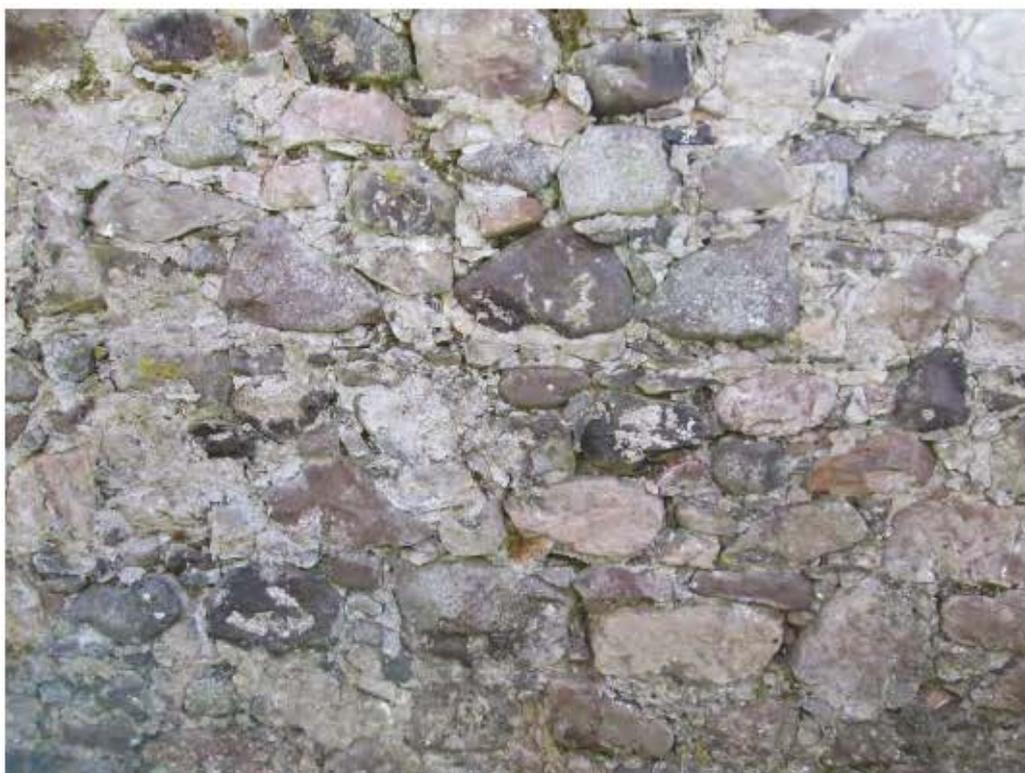
Plate 6 Character of the general rubble construction – west exterior

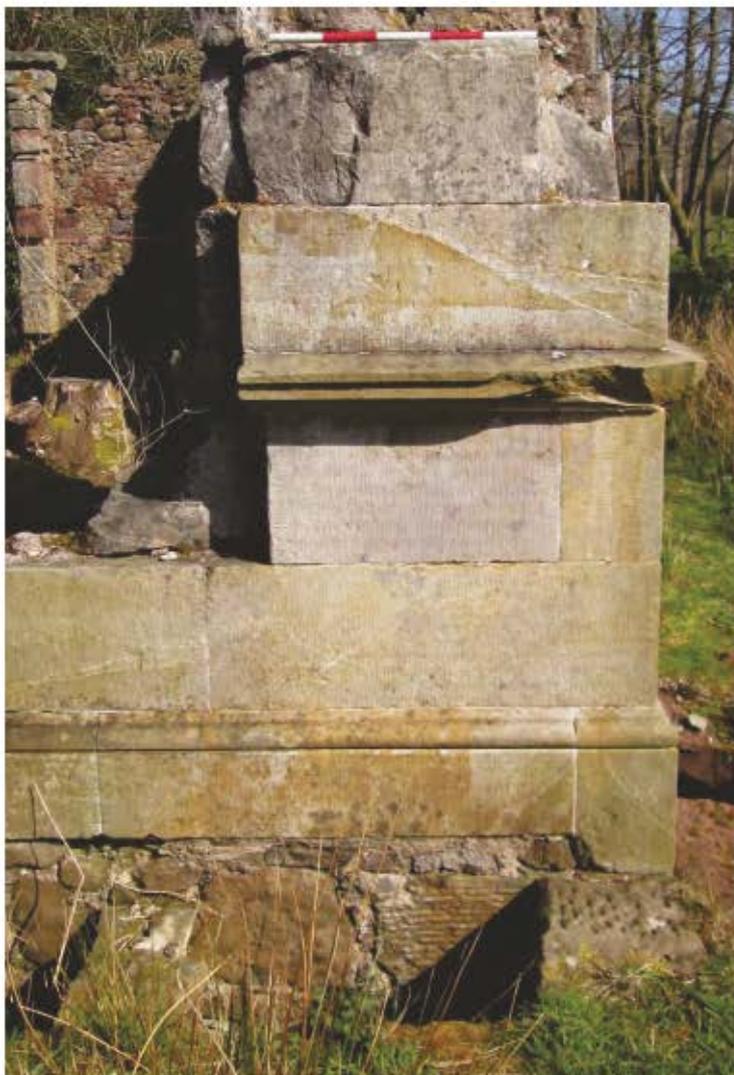
Plate 7 South frontage, detail of the character of the ashlar facings at the SE corner

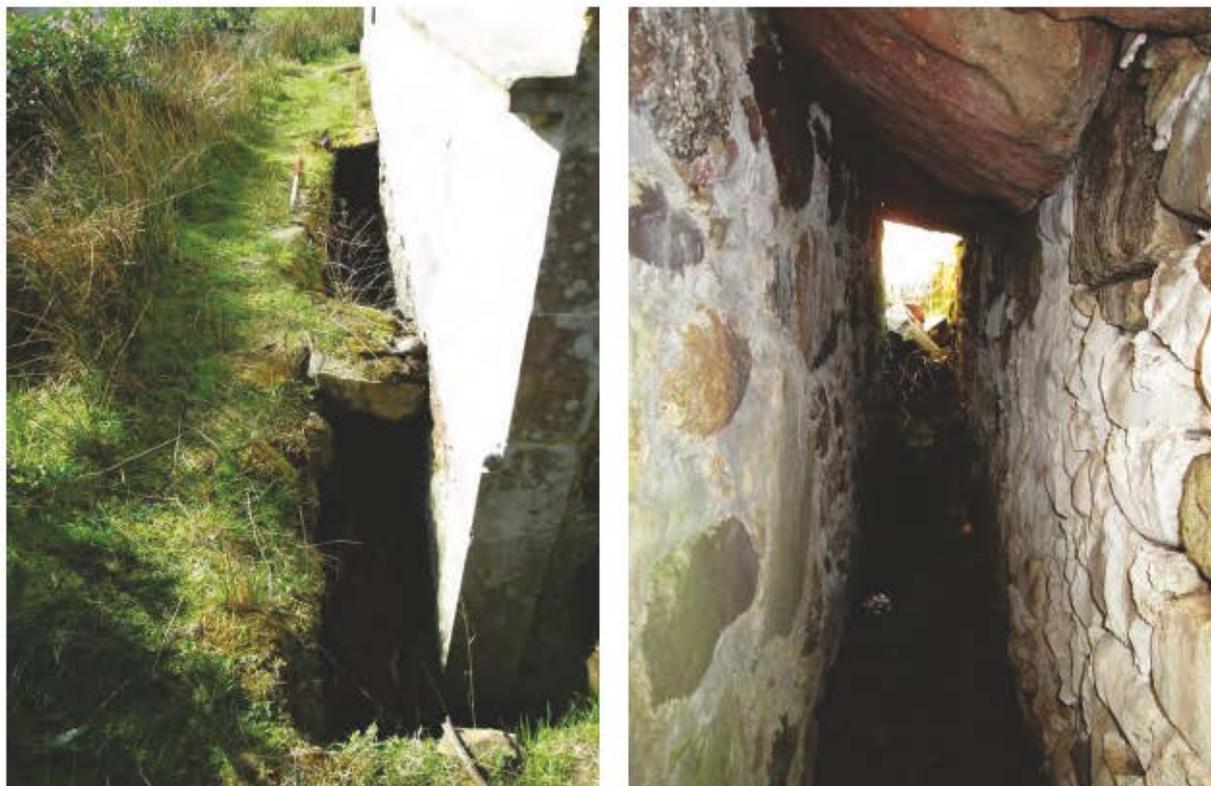
At the perimeter wall foot there exists a substantially constructed rubble-walled drain-like feature, perhaps more properly termed a covered channel that seems likely to have run around all sides of the building, 007. It is now visible along the east side and where it returns along the eastern parts of the south and north walls, this accessible where capstones have fallen or have been removed. Though the base of the channel was not visible, being obscured by debris and vegetation build-up, the feature measured at least 0.8m in depth by approximately 0.40m in width where visible. The channel had been carefully coped-over with interlocking coarse-hewn slabs set at a slight inclination, sloping away from the wall-feet.

Plate 8 Left - perimeter covered channel as running southwards from the north-east corner (007)
Plate 9 Right – channel interior, looking north

The covered channel may have reached a bedrock foundation (though this is yet to be determined) and was intended to ensure the building closely retained its orientation and isolated it from surface vibration.

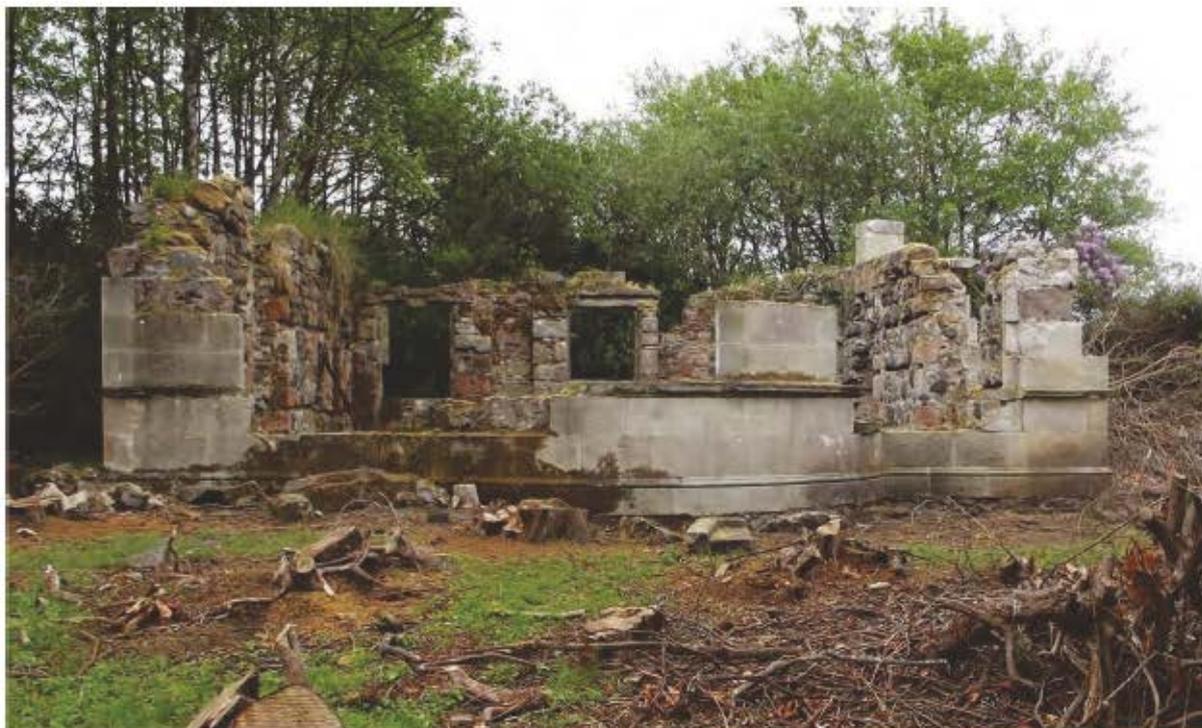
The principal feature of the elevation is the central apsidal projection of near semi-circular plan that had contained one of the three principal instruments within and that supported the observatory's dome above, 046. At plinth level the diameter of the circle projected from it measures 4.65m (15'3"); historic sources describe the dome itself as being of 12 feet in diameter (Brisbane, 1860, 66).

Plate 10 South exterior, following clearance

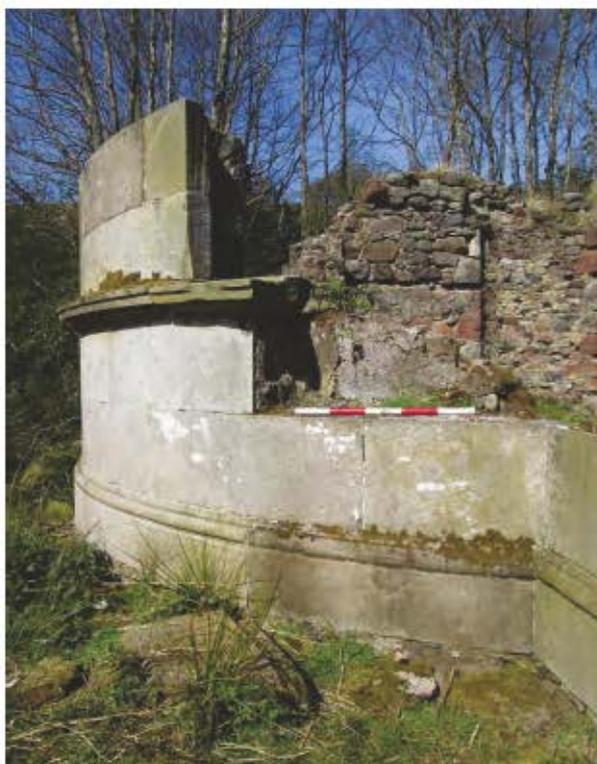
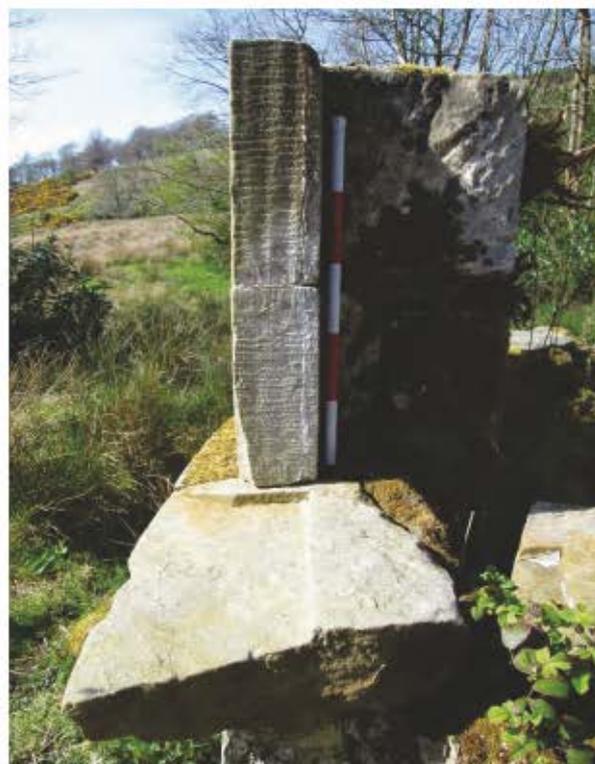
The apse had been detailed with three apertures, a central window that seems certainly to have functioned, 022, and two further window openings on either side that may or may not have been blind, 021 and 023 respectively. Of these only a part of the pier between windows 021 and 022 and their respective sill stones still remain; window 023 is now wholly robbed.

*Plate 11 Left – side view of the apsidal bay projection, 046
Plate 12 Left – side view Right - detail of the surviving jamb of window 021*

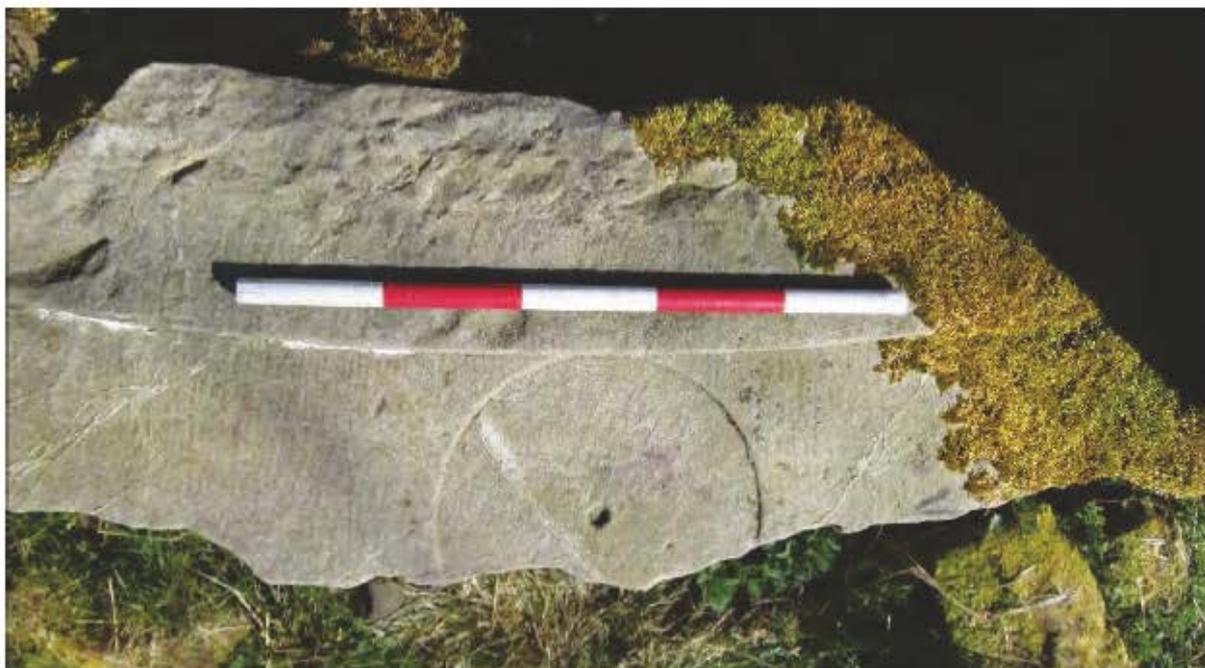
The sill stone of the apse's central window retains a circular seating, some 25.5cm (10") in diameter, with a central socket or fixing point, 045. This was possibly for the mounting of a *dipleidoscope*, an instrument used to determine local noon (*Pers. comm*, Allen Simpson).

Plate 13 Sill of the 022 window, with setting for an instrument, possibly a *dipleidoscope*, 045

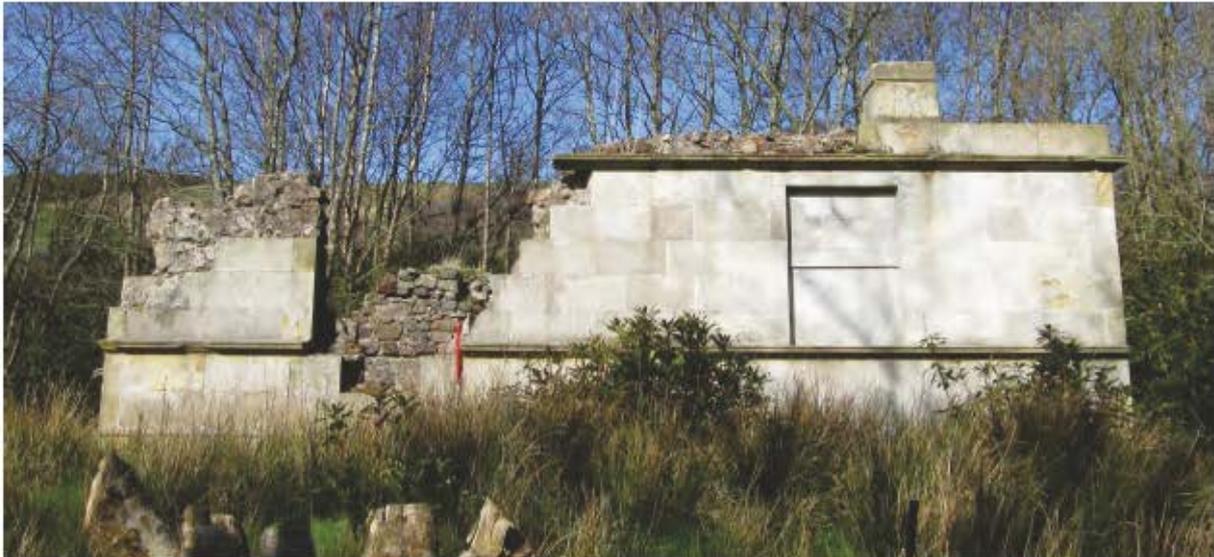
The ashlar-fronted east elevation of the observatory has also been damaged by stone robbing, particularly in its southern parts. The mid-section survives up to the cornice, only missing the plain facings of its wall head course; these latter still remain at the north end. The principal features of this frontage are two blind windows, in-filled with vertically-set flags and originally *tromped* to suggest sash and case windows. The northern of the two windows remains intact and preserves such evidence of paintwork 028; the southern window only preserves its south jamb 029.

Plate 14 The east elevation, general view

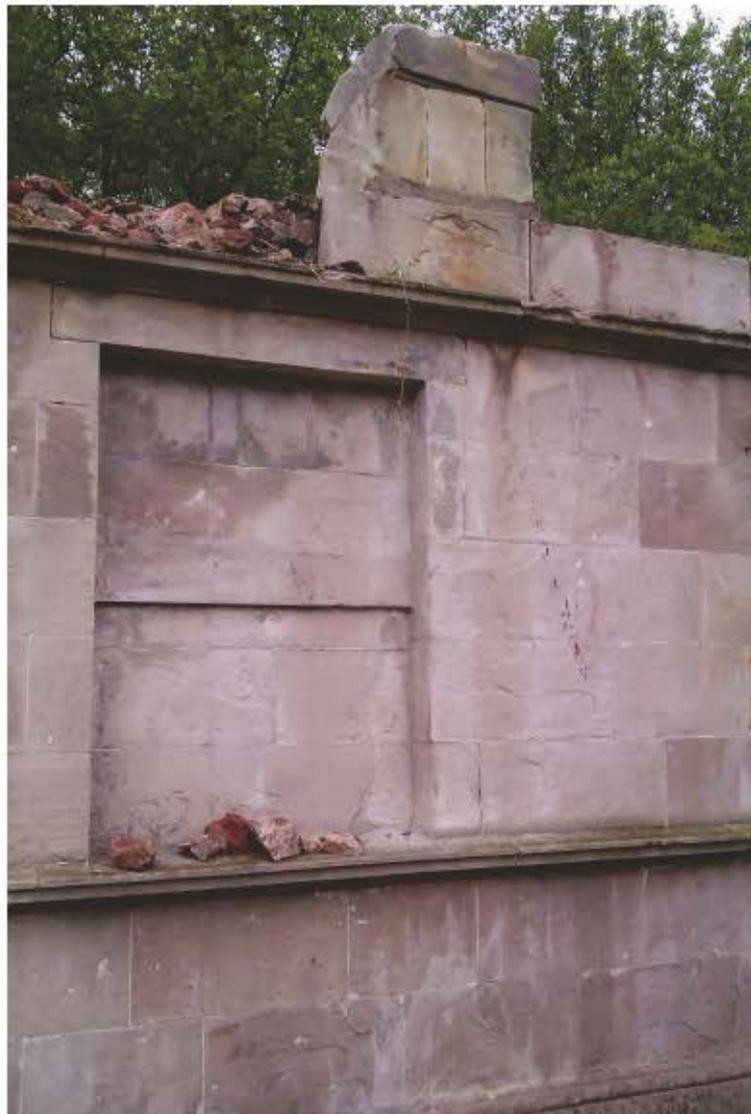
The other feature of this frontage is a simple square chimney located towards its north end, 030. Set upon a plinth slab the chimney seems perhaps to have lost its upper parts. The existing upper stone is somewhat curiously detailed with a channel, possibly a rustication detail, at its lower angles.

Plate 15 Detail of blind window 28 showing traces of tromped glazing bars and framing, 030 chimney above

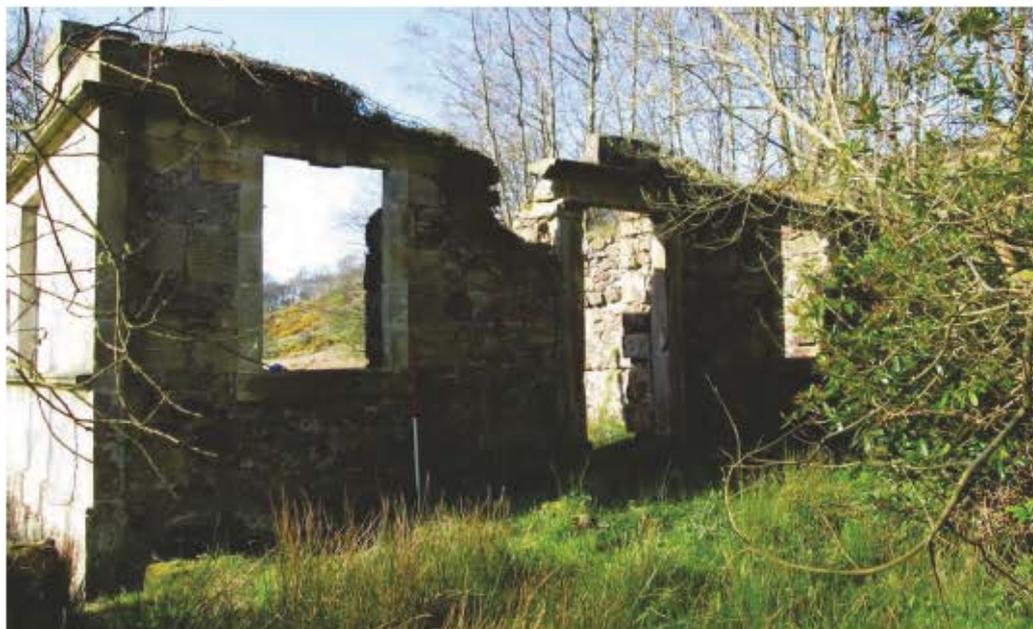
The north wall of the observatory is symmetrically arranged, with paired window openings on either side of a central entrance. The windows are detailed with ashlar dressings brought to a raised polished margin that is only interrupted by a slightly projecting key-stone above. The window head runs up to the cornice that returns along the elevation; there are corresponding projections of the cornice above the key-stones. The tails of the dressings are horizontally broached. There are some surviving areas of lime harl upon the rubble body of the wall, particularly towards the wall foot.

Plate 16 North exterior, general view

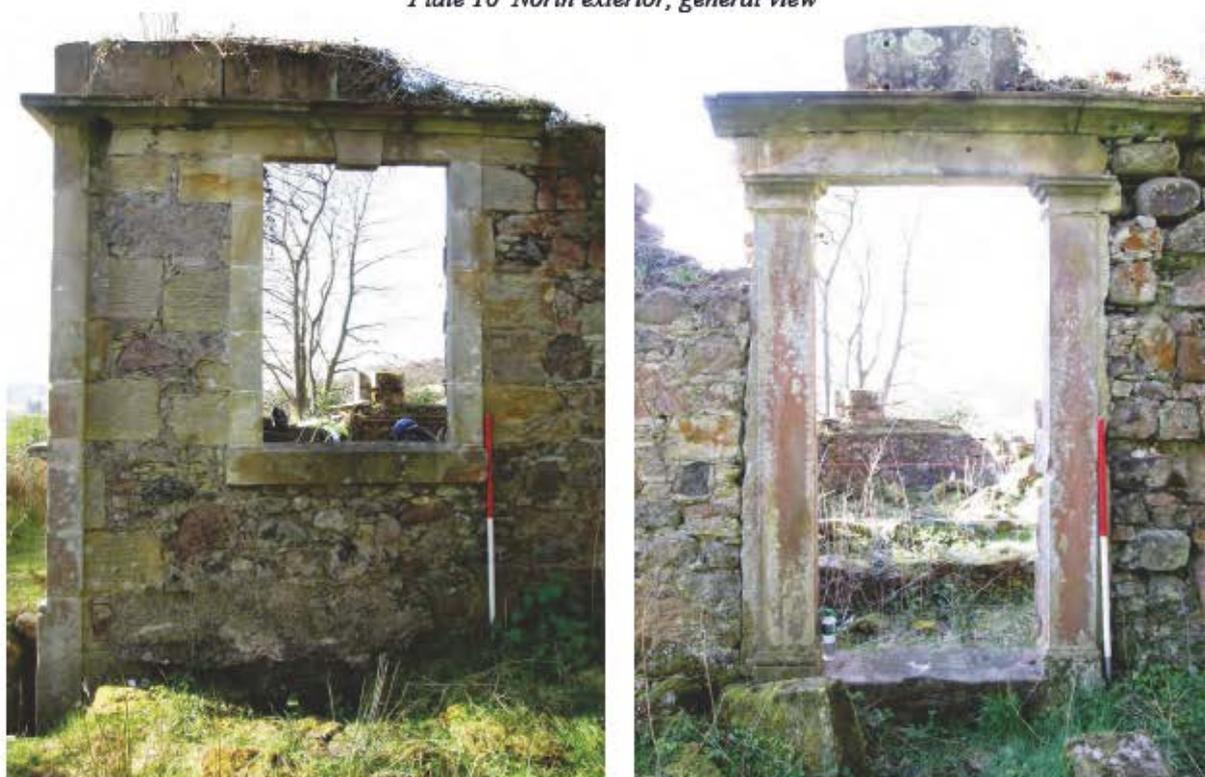
Plate 17 North wall, eastern window 014, showing masonry detailing

Plate 18 North wall – central entrance 012

The jambs of the entrance are formed of monoliths that rise up from moulded bases to capitals that in turn support a single plain lintel stone. The fine carved work of the columnar jambs and architrave project slightly from the general plane of the wall face; this again further expressed by a slight corresponding projection of the cornice course. Centrally set above the entrance is an ashlar block, 035, part of the plain wall head course that is now mostly missing. The block preserves a projecting panel upon which are seatings, fixing points for a dedicatory panel since removed. However the panel itself still survives, though now re-set into a modern cairn monument at the Three Sisters in Largs.

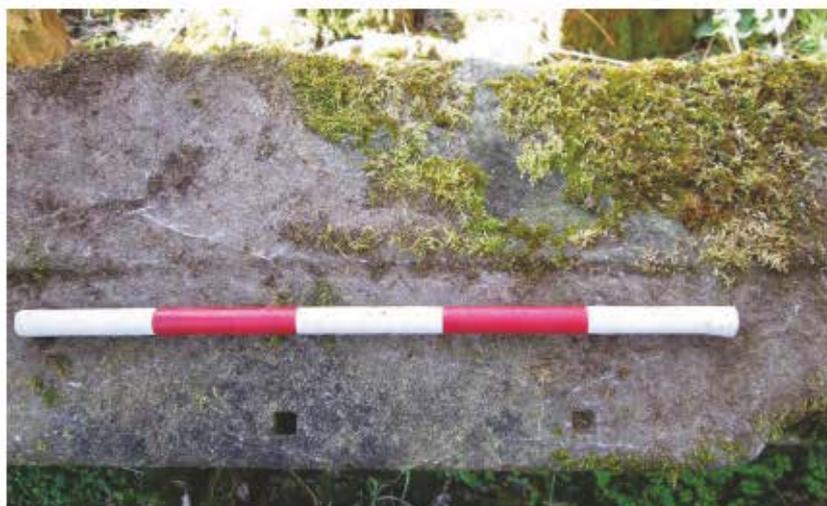
The sill stone of the western window 010 has upon it two neatly cut square seatings spaced some 21cm apart close to its outer edge, 051. Their position and lack of any corresponding holes elsewhere on the window's surround indicate that these were not for window bars, and none of the other windows featured bars. It is possible that these are the seatings for an instrument setting – a rear-sight to the northern meridian pillar in Brisbane Glen?

Plate 19 Paired seatings cut upon the sill of the 010 window, 051

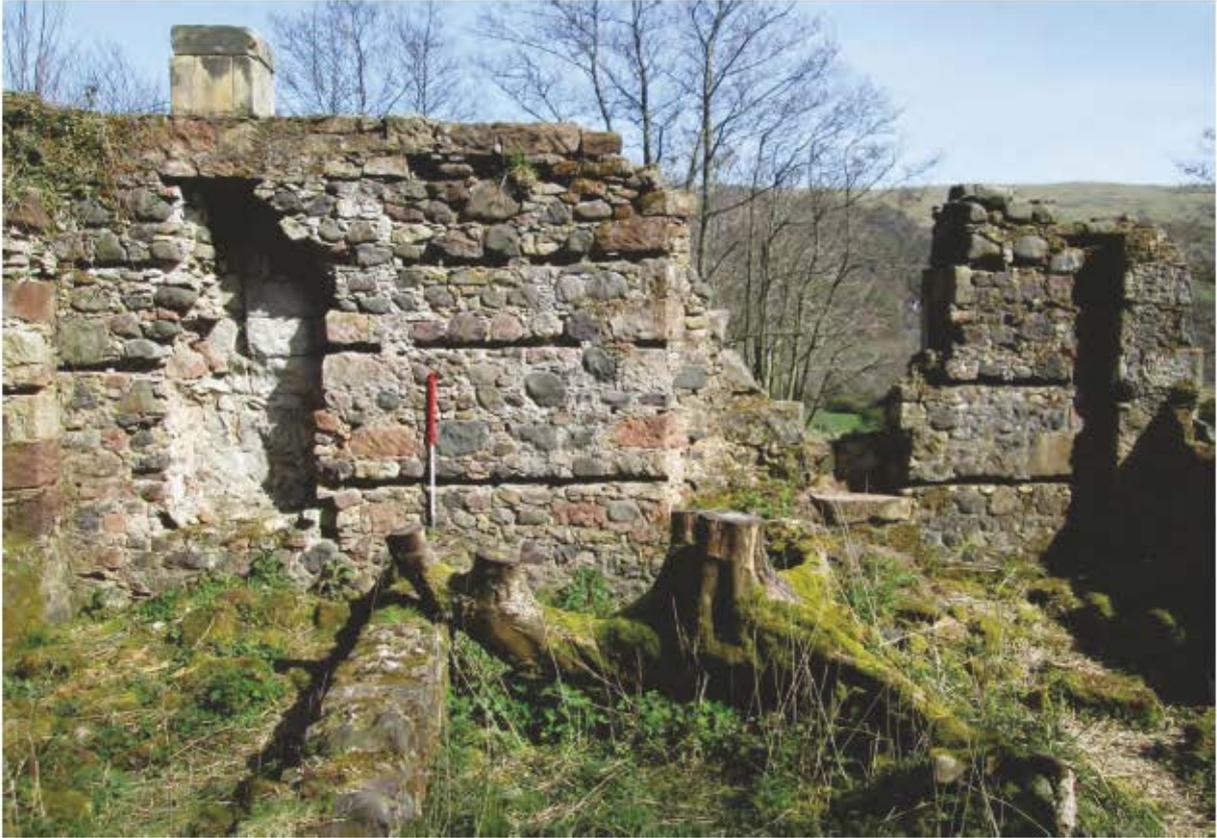
Internally the observatory was rubble-walled and, evidently on the basis of multiple dook holes (small seatings, 009) visible upon most wall faces and sockets for embedded batons 008, it was lined-out, most likely with lath and plaster.

Plate 20 Interior of the east wall

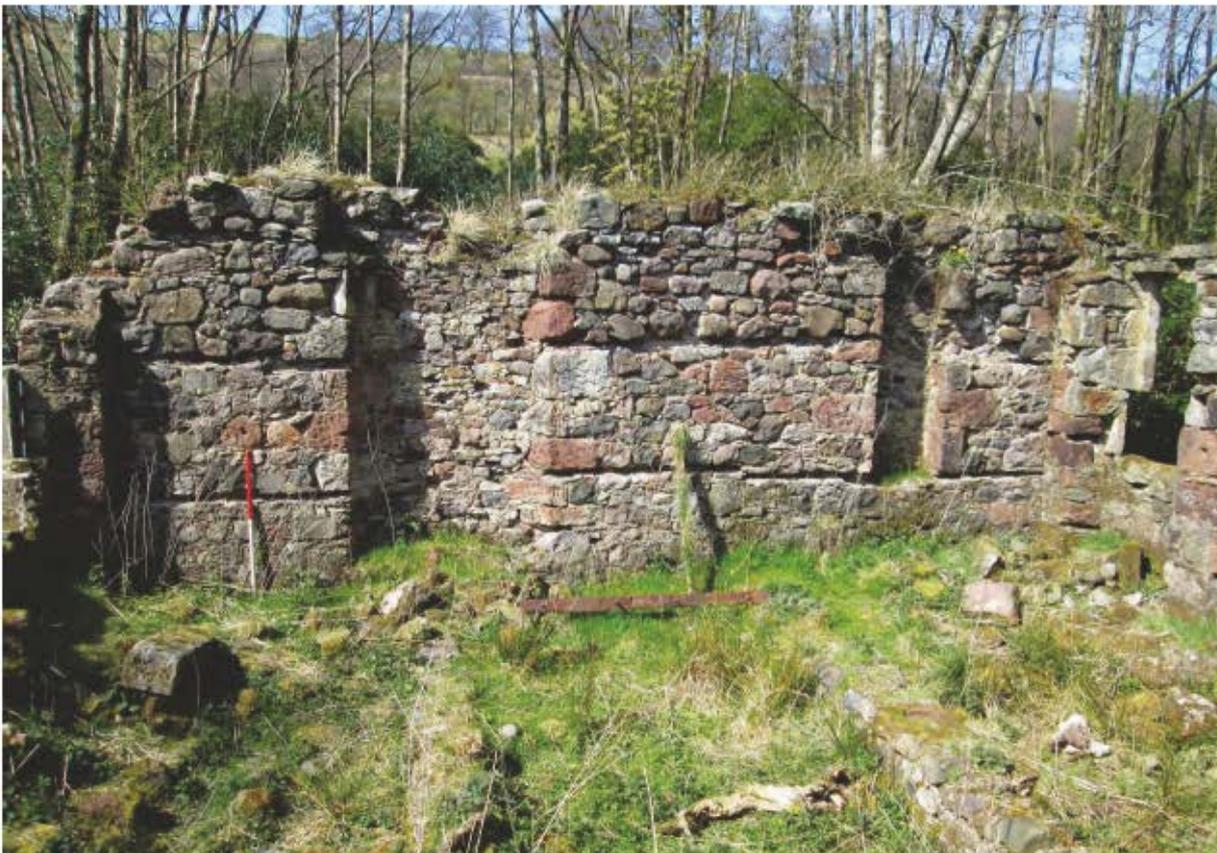
Plate 21 Interior of the west wall

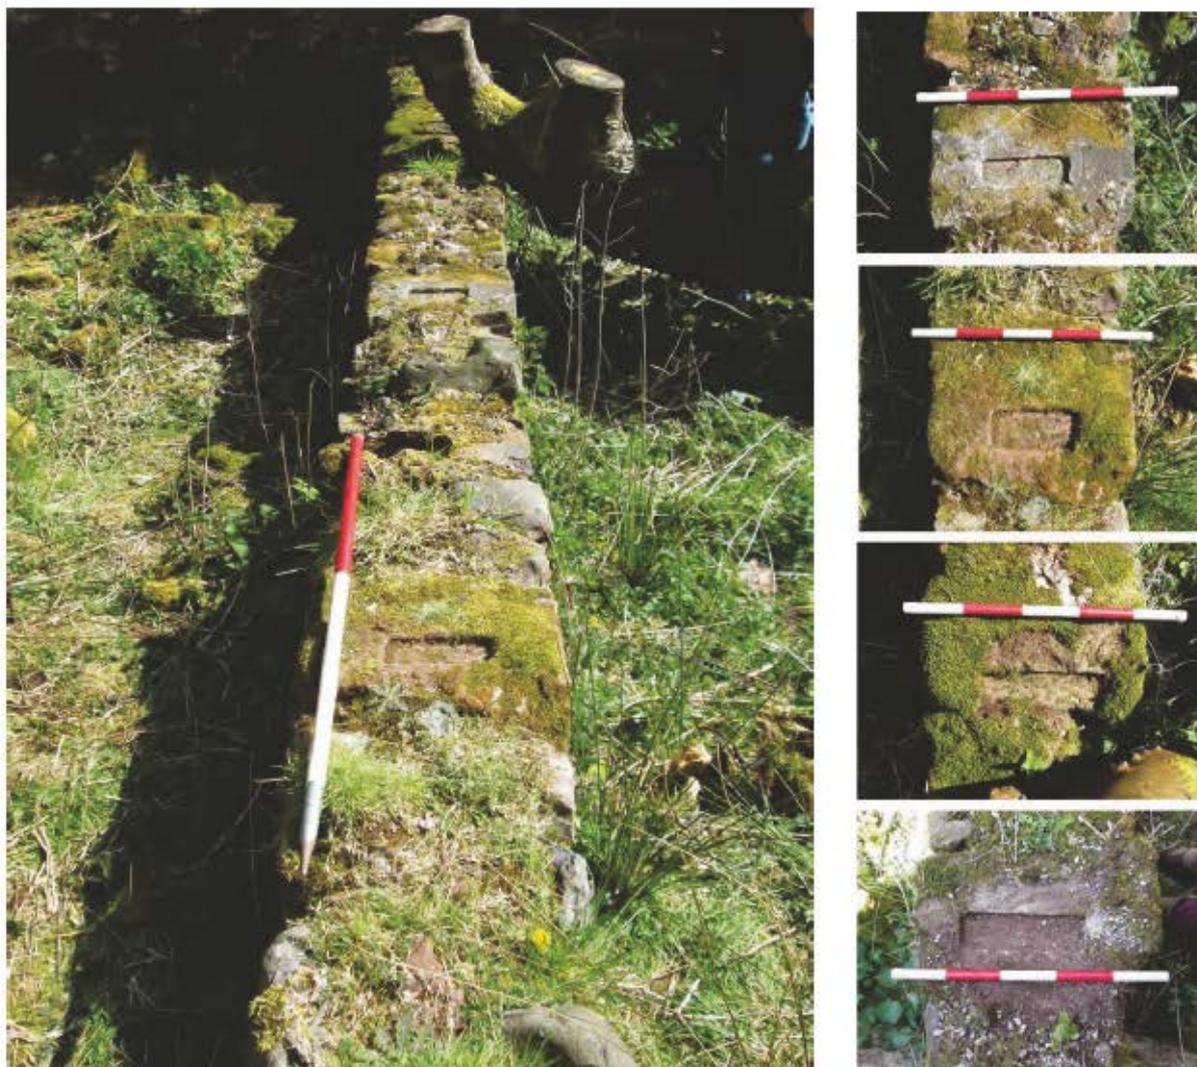
The interior of the observatory was sub-divided into two chambers, this by means of an east-west aligned framed cross-partition supported upon a masonry sleeper wall. Sockets for four vertical studs are still visible cut into stone blocks embedded within the upper part of the sleeper wall, 005. A pair of these sockets to the east correspond to the site of an entrance 006, whose position appears on the plan of c.1860 (figure 6). Similar evidence for a second entrance at the western end of the partition wall, 042, also shown on the historic plan, was not observable at the time of survey.

Plate 22 Left - the northern sleeper wall 003 that had supported the 005 principal partition, looking east
Plate 23 Right - details of individual stud sockets - the lower two had relate to an entrance, 006

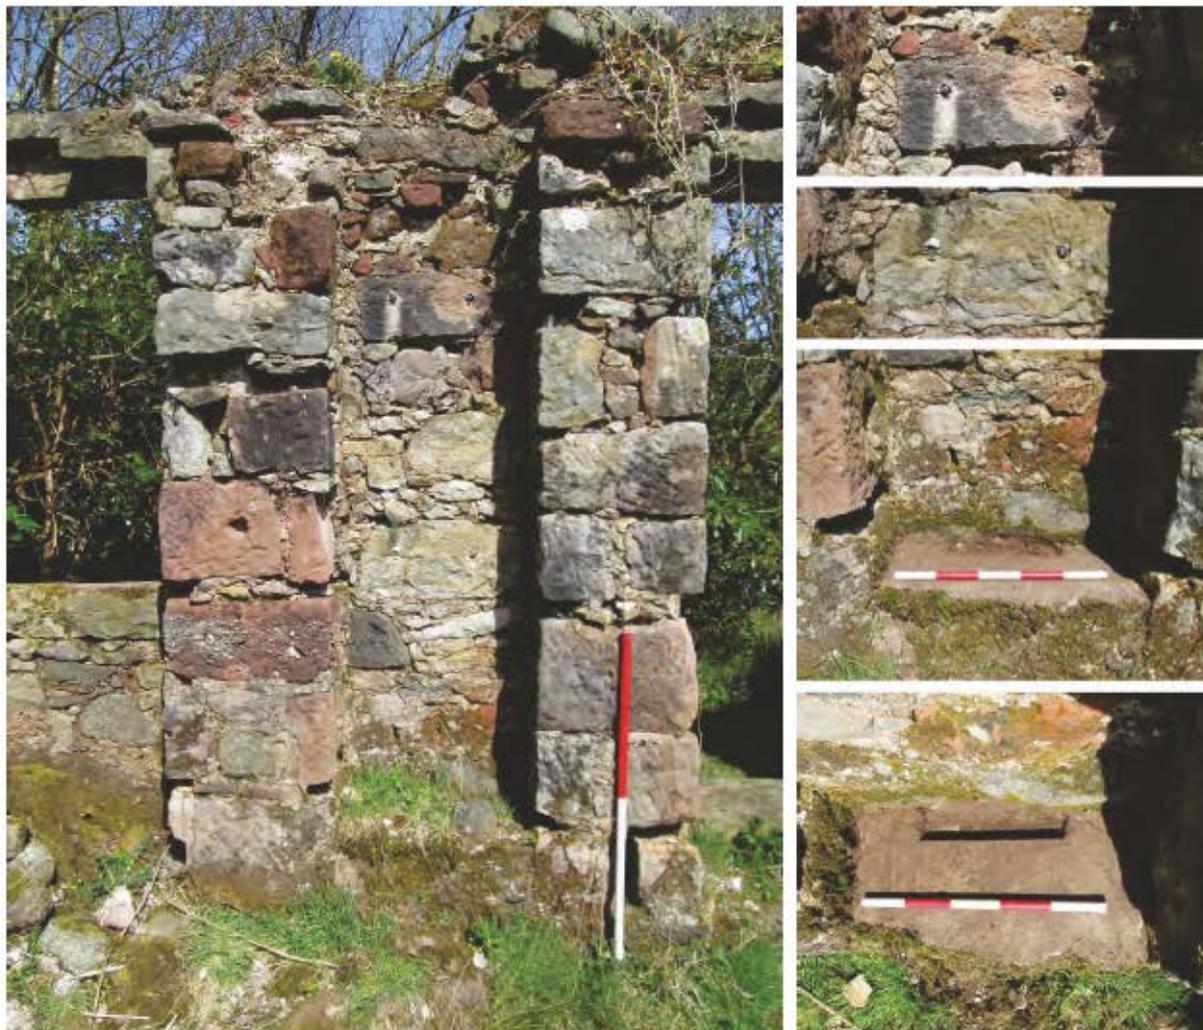
043, and the sandstone slab at its base with displays a neatly cut rectangular socket to its centre rear, 044. This is likely to be for the William Hardy Sidereal - time regulator clock, as the fixing shown on the rear of this instrument appear to correlate with those identified in the wall.

Plate 24 Details of the 011 recess, including 043 fixings and the 044 socket at base

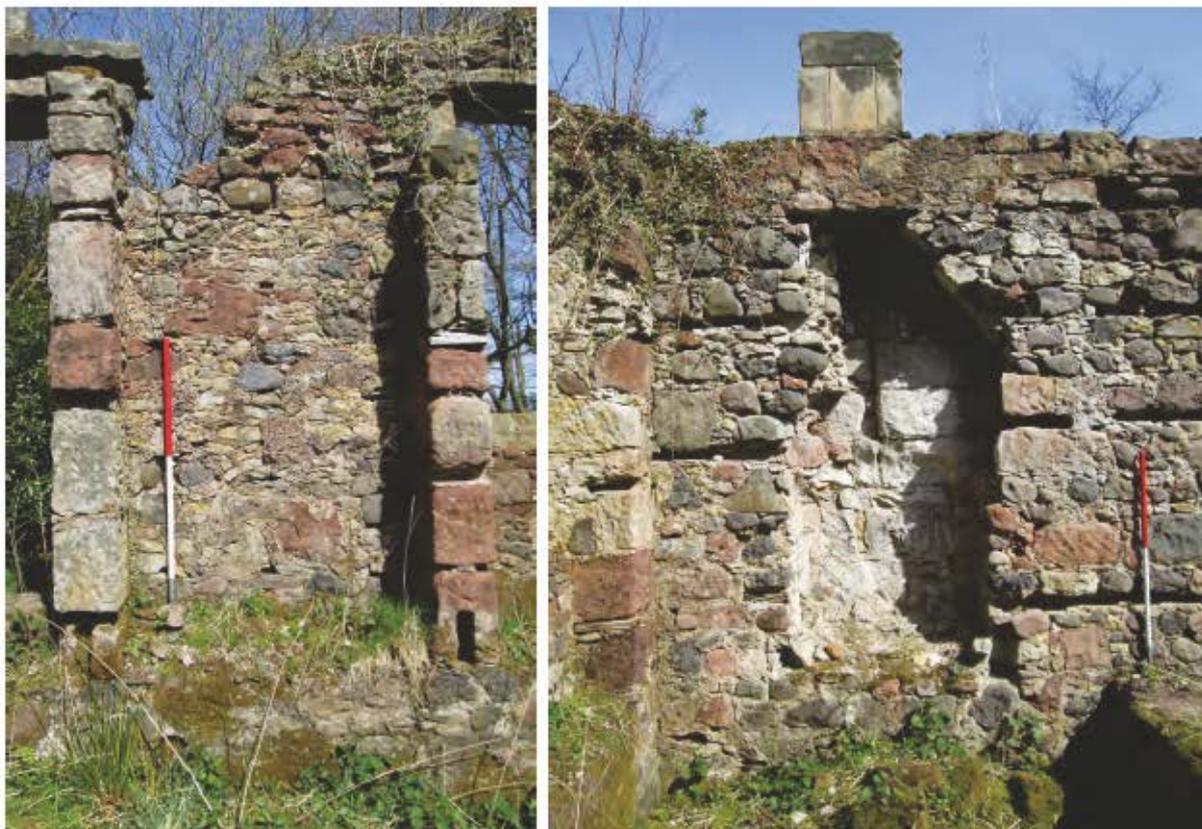
Also in the north wall, between the entrance and the eastern window, is a further somewhat broader 1.16m wide mural recess, 013. In the rear of this are multiple dooks. It is possible that this had functioned as a shelved book press (or had even contained a fold-down bed?).

The principal feature of the east wall of the ante-room is a centrally-located fireplace, 016. The dressings have been robbed though their mortar impressions suggest two vertically set jamb stones supported a lintel. The above-lintel masonry has also been broken away to reveal the flue rising above to the 030 chimney. The 016 flue track is joined by another running diagonally in on its south side, 017. This second flue, which rises up from the under-floor area, may have formed part of a sub-floor ventilation system.

*Plate 25 Left – the 013 recess, possibly contained shelving (or a fold-down bed?)
Plate 26 Right – void of robbed fireplace, 016, with flue rising to 030 chimney above*

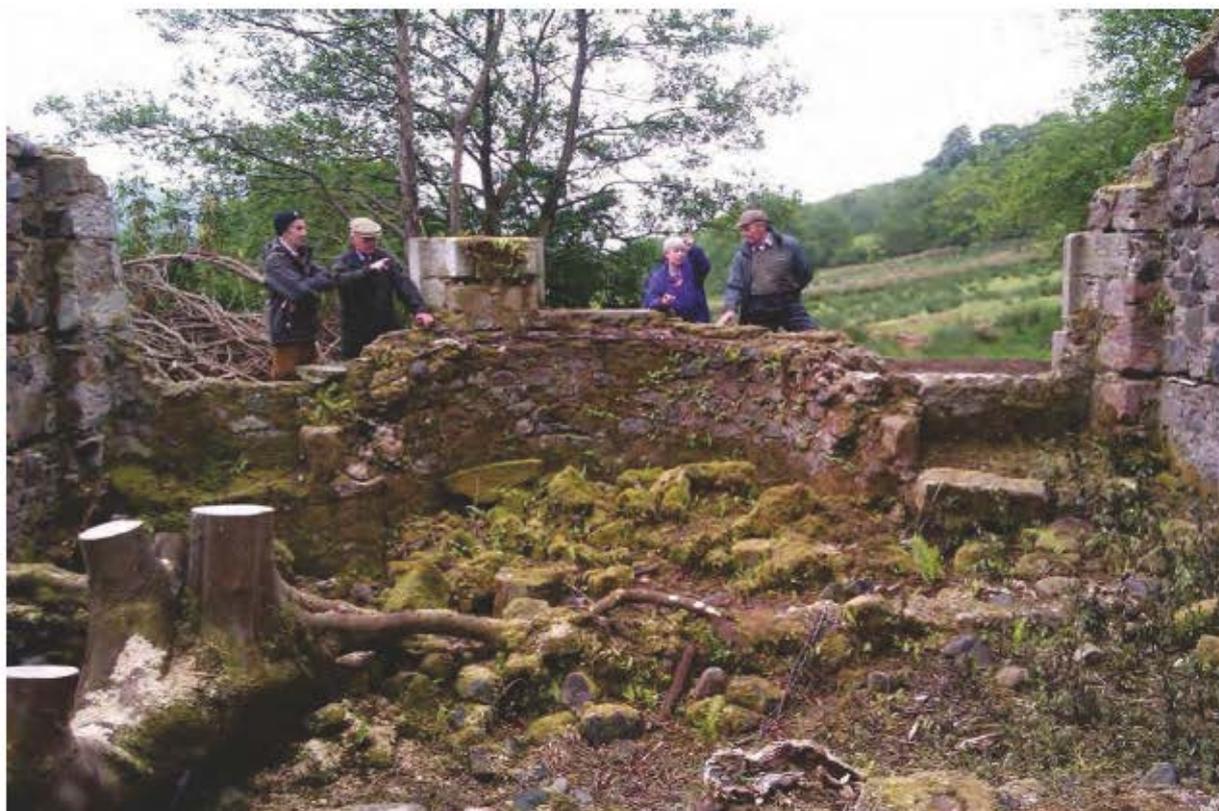
Presently there is no observable indication in the rubble-choked interior as to whether parts of a pillar base for the central instrument still survives. However it is presumed that there had been an independent foundation and that it may be identified on excavation of the interior of the building.

Plate 27 The interior of the observatory looking south

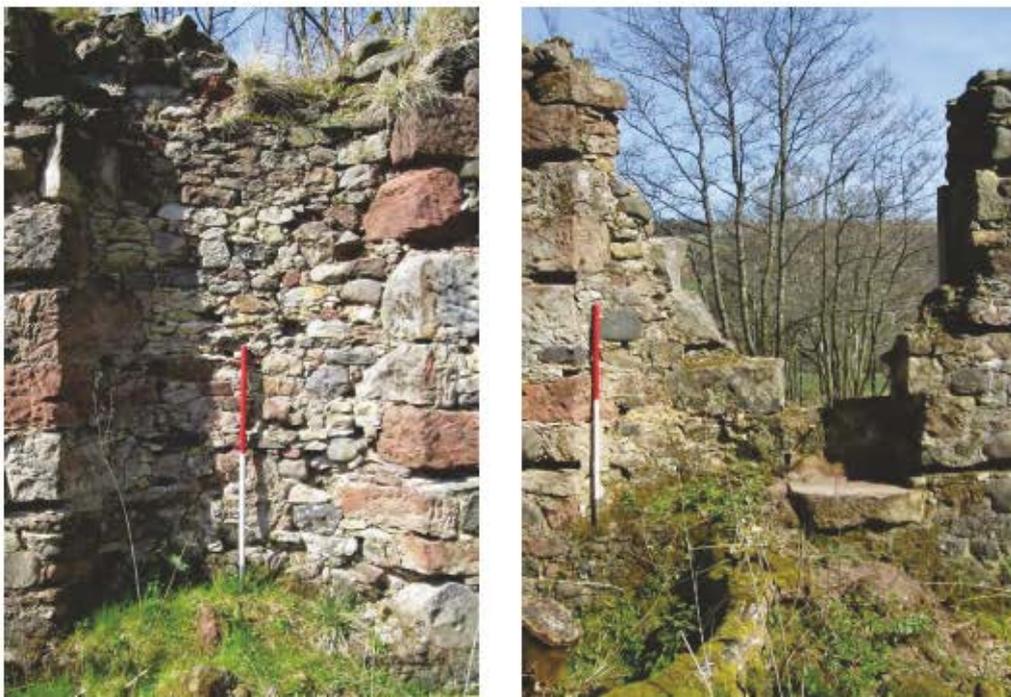
The west wall displays a broad curved recess, located at the room's centre-point. Measuring 1.60m by 0.31m maximum depth the feature was to permit movement around the mural circle, the curvature corresponding to its position. Multiple *looks* within the curvature of the recess suggest it had been lined and plastered.

Plate 28 Left – The 026 recess, looking west

Plate 29 Right – the 018 curved recess, whose south side has been cut back to form an instrument housing, 019

A further shallow curved recess exists in the east wall of the main chamber, also centrally positioned, 018. In a similar manner this recess permitted access around the former position of the twin-pier supports for the transit instrument. The upper parts of the walling in this area have been broken down and the recess itself is now much damaged; however it evidently measured about 1.64m by 0.30m in depth. There are dook holes within the curvature of the recess that again evidently relate to wall lining.

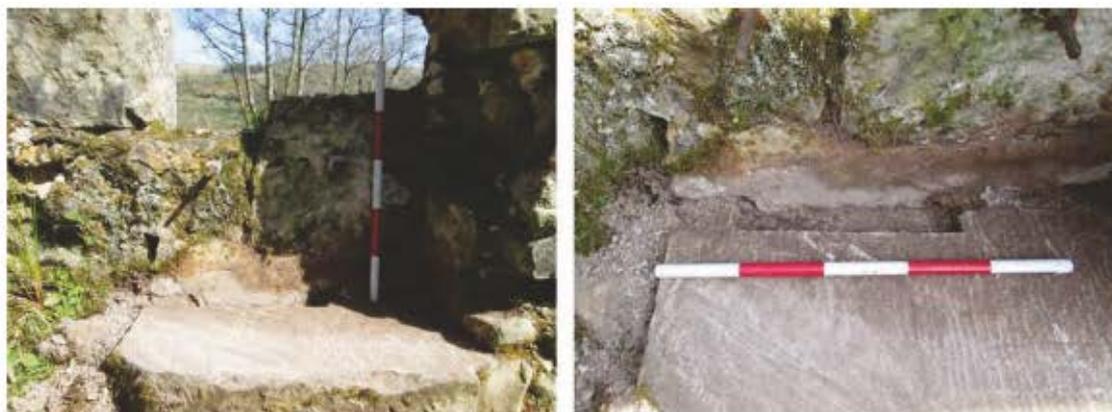
The southern side of the 018 recess seems to have been modified at a secondary stage - 019. Its interior appears to have been cut back in order to fashion a narrow and deep rectangular recess of very similar character to 011 on the north wall of the ante-room. The remaining lower part of its rear side displays lead-fast iron fixings that still considerably project, 047. A sill stone was inserted as part of the recess's construction, a sandstone slab that slightly projects at the wall face. In common with the 011 recess this slab was detailed with a neatly cut rectangular socket to the centre-rear – this evidently for the installation of a clock for timing star transits, such as the Journeyman Sidereal Clock or the Principal Sidereal Clock 048.

Plate 30 Base of the 019 recess showing lead-fast fixing point to rear

Plate 31 the basal slab, tooling and instrument socket, etc.

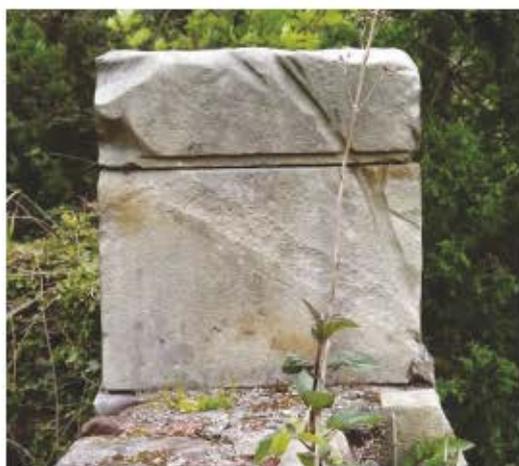
Plate 32 Raggle on chimney showing roof pitch
