Brisbane Observatory
Brisbane Estate, Largs, North Ayrshire

Analytical Assessment and Historic Building Record: Data Structure Report

for Brisbane Observatory Trust

February 2016

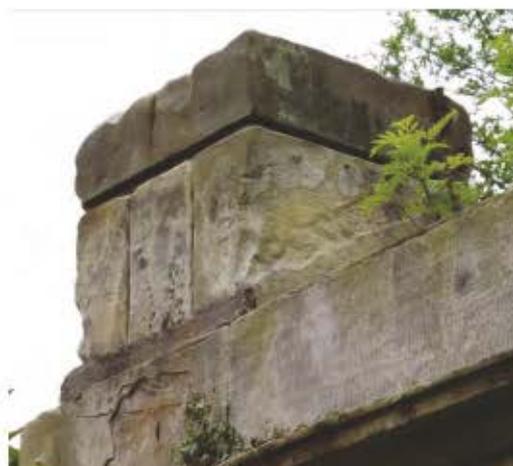
Plate 33 Matching raggle on other side of chimney

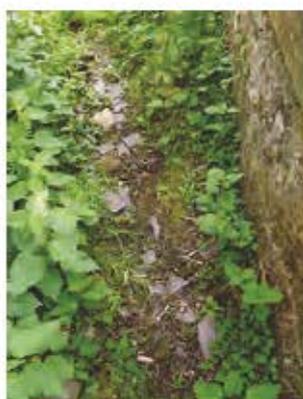
Plate 34 Fragments of slate at base of wall

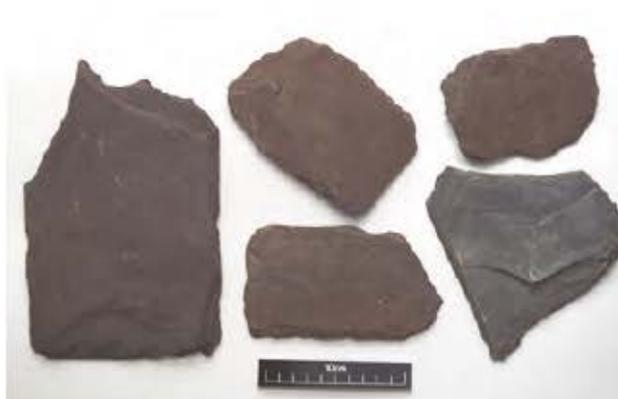
Plate 35 Detail of slate fragments

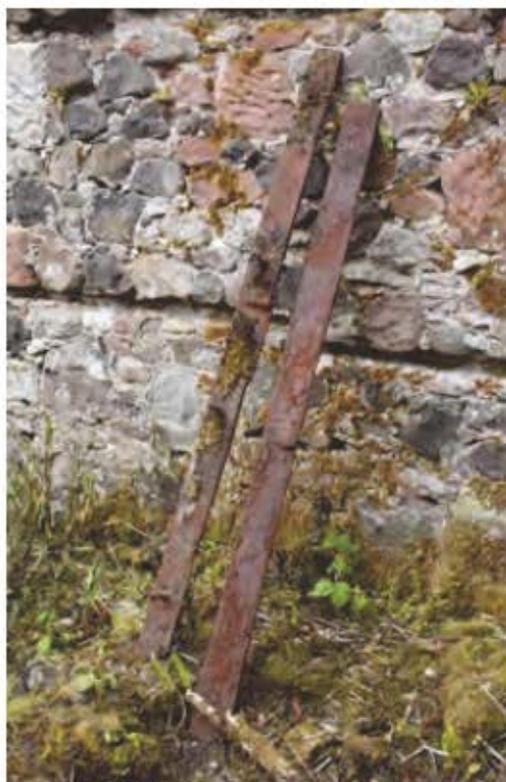
Further features that seem likely to be roof-related may be a number of wrought iron sections. Four of these have been recorded on site, 037 - 040. All are of similar detail – long strips that display fixing spikes or bolts and a central shallow recess. They are all 1.85m in length, 0.10m across and 0.4m thick, the bolts protrude by around 0.10m. It is possible that these are strapping elements for roof trusses.

Plate 36 Structural ironwork visible loose within the observatory ruin

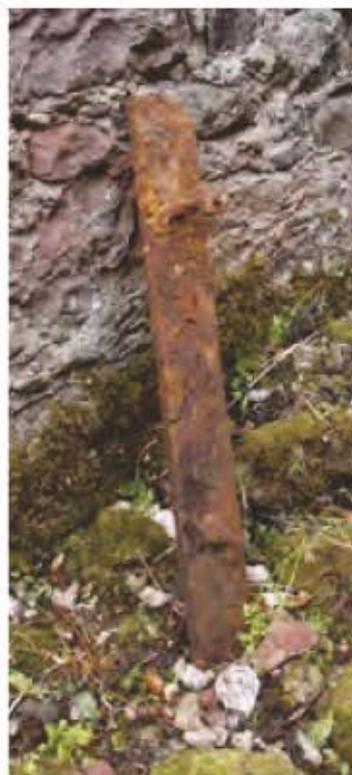
Plate 37 Structural ironwork detail

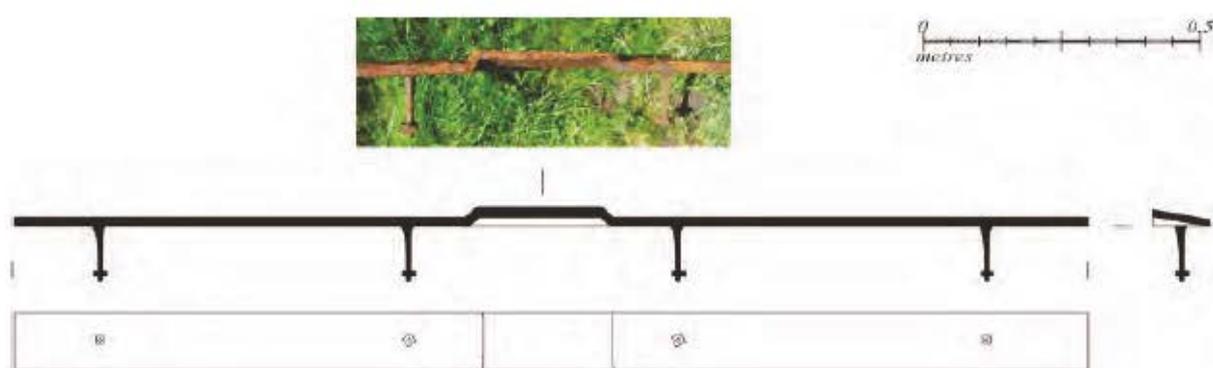
Figure 6 Plan and section of structural ironwork

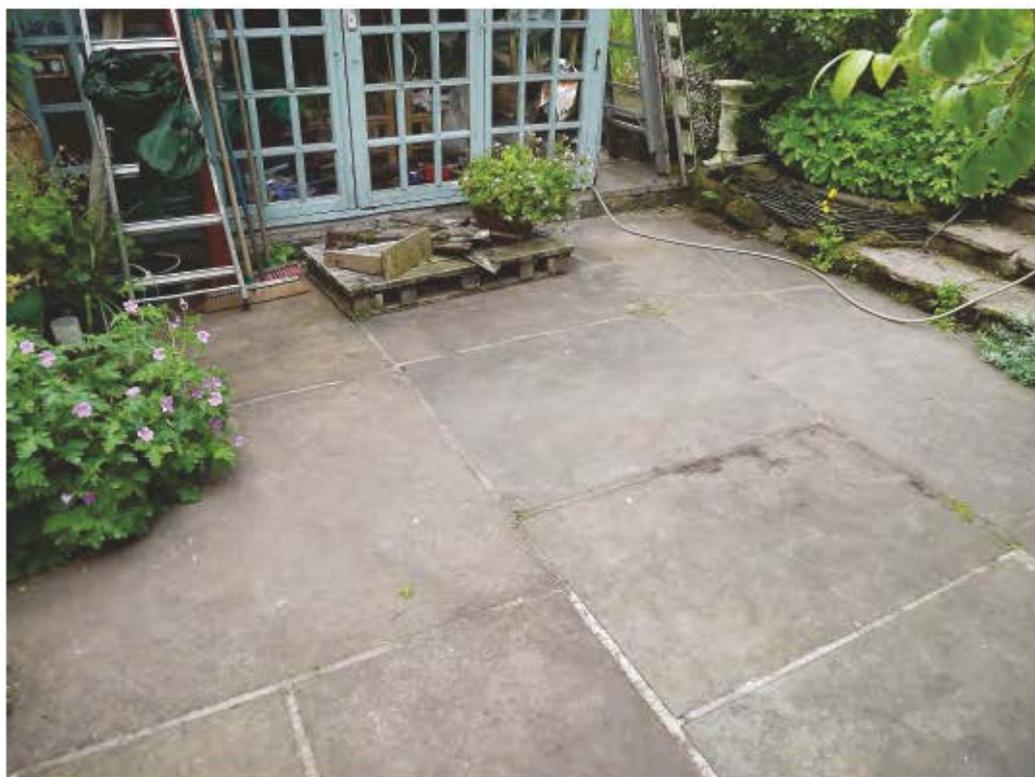
The observatory had self-evidently been partly dismantled, and some of its materials removed. This likely included its roofing materials, other fixtures and fittings, and certainly much stonework. Stonework removal concentrated upon the high quality dressings of the south frontage and parts of the east side wall. Elsewhere floor slabs were removed *in toto*. The destination of much of this material can be identified locally, at one house in the vicinity, substantial slabs employed for a patio (pictured) are likely part of the observatory's flagged flooring, and elsewhere further stones for a fire-surround are thought to have been taken from the top course of the observatory walls. However, further survey work is required to fully confirm this.

Plate 38 *Recycled flooring slabs from within the observatory*

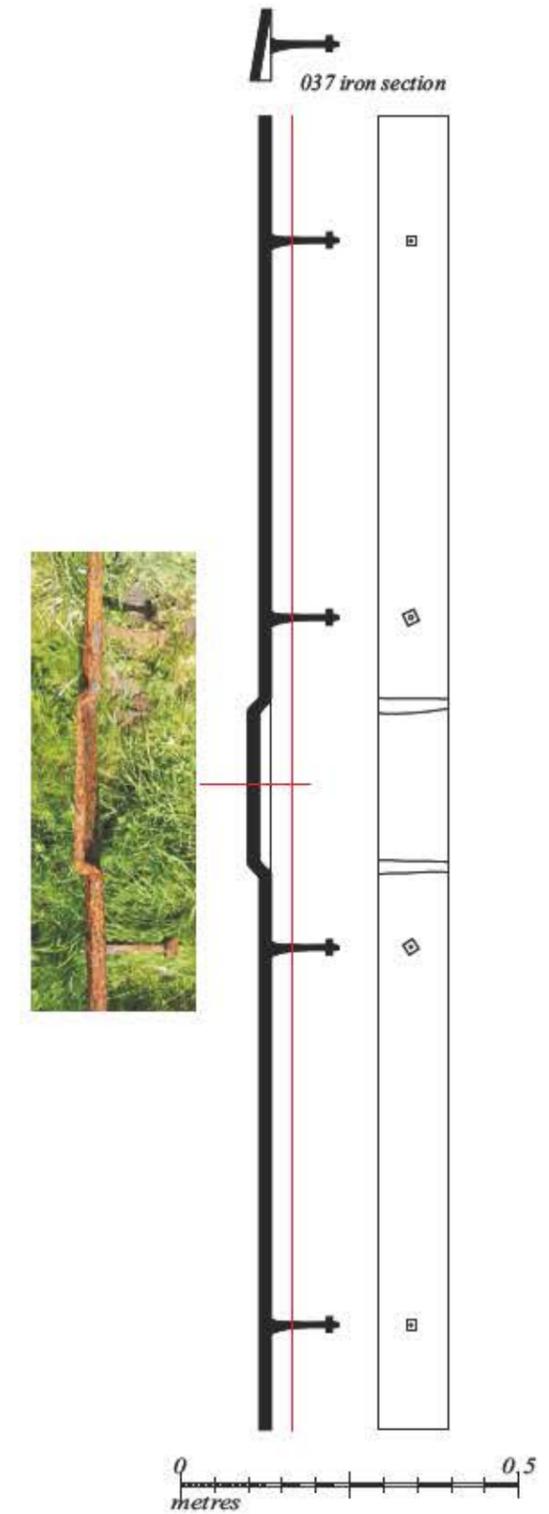
Detail of structural ironwork

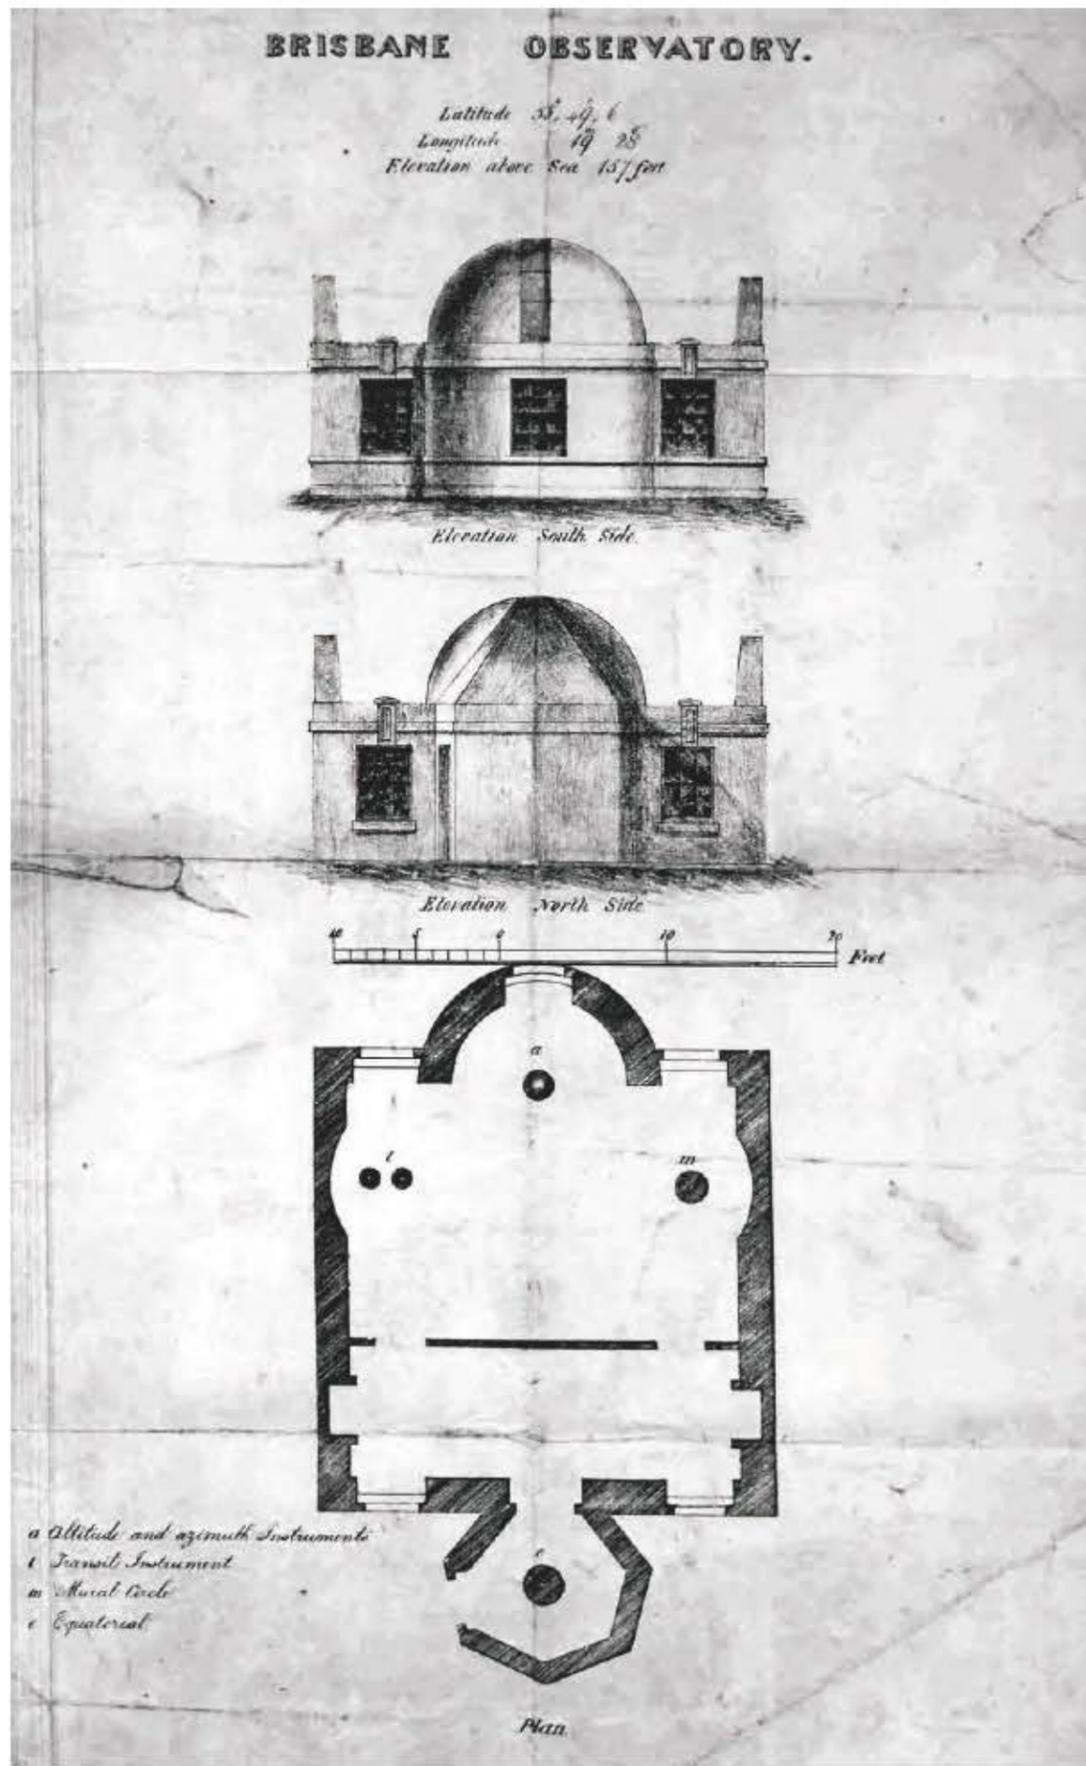
*Engraved plan and elevations of Brisbane Observatory, c. 1860
(Courtesy of the Librarian and Archivist, Royal Observatory, Edinburgh)*

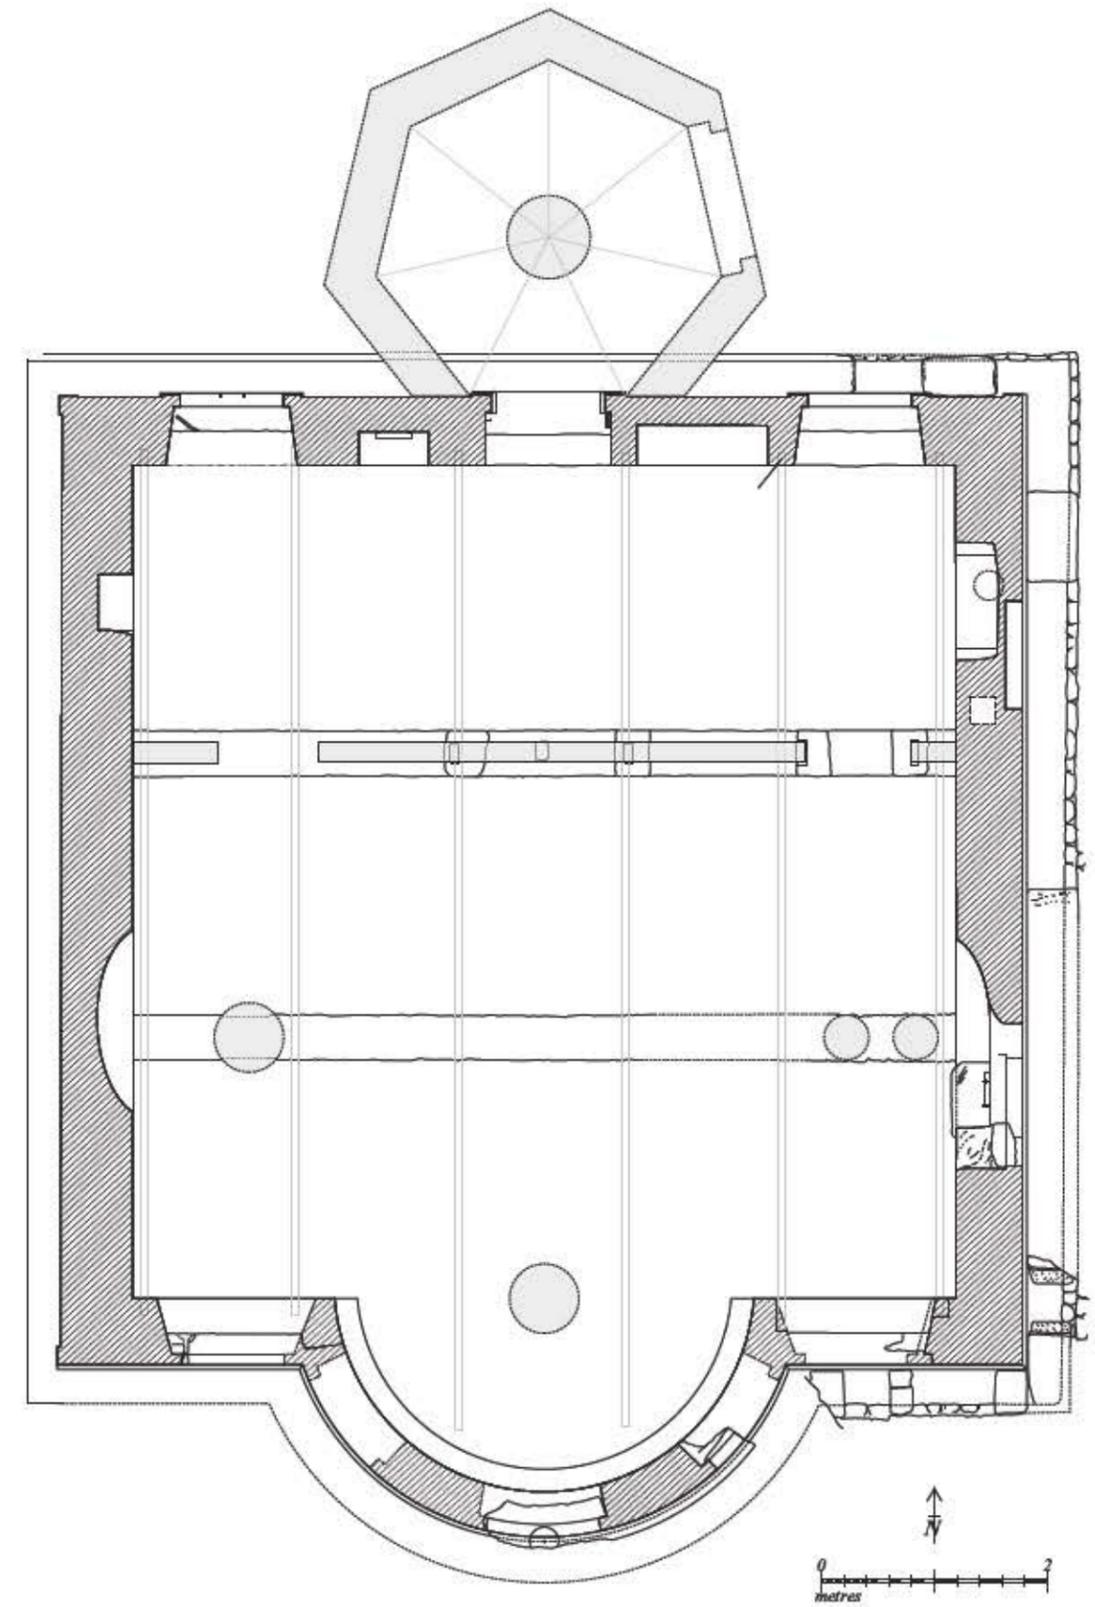
*Plan showing projected walling and features as suggested by the engraving of c. 1860,
and from the archaeological evidence*
