# Morpeth County Hall

## *Morpeth, Northumberland*

*Archaeological Desk Based Assessment*

*Job number 2236.00*

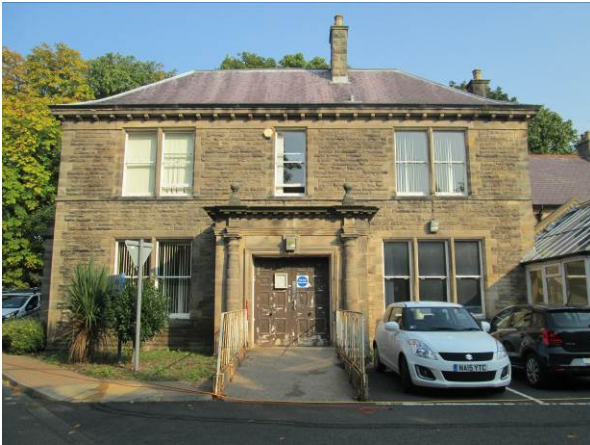
*Plate 1 Front elevation of Merlay Croft (020)*

The desk based assessment did not identify any sites of archaeological interest; furthermore none were identified during the walkover survey. The building called Merlay Croft identified on the map regression and photographed on the site visit is known to be very late C19th century or most probably early C20th in date. It has no historical or architectural merit and has been extensively extended and altered internally. As a photographic record has been made of the exterior and principal interior rooms and features no further recording work is recommended.

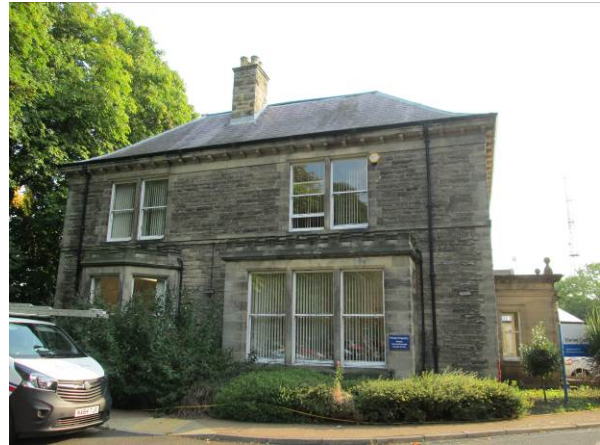
*Plate 2 West elevation with square bay window (023)*

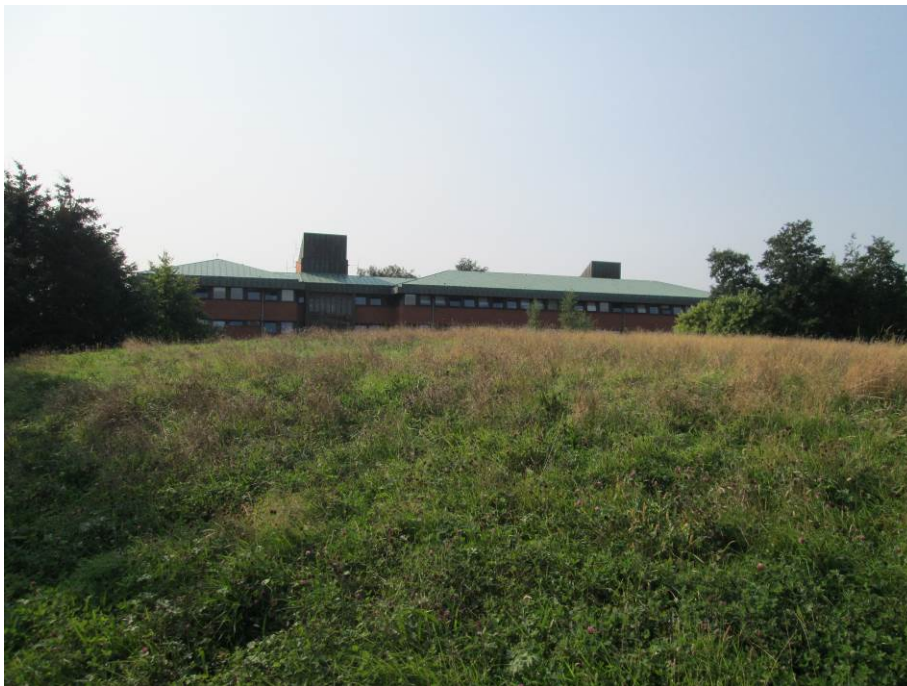
At the north east of the site there is a small hill covered in long scrubby grass. This hill appears to be the result of landscaping carried out at the time of the construction of County Hall, rather than a natural feature.

*Plate 3 Low grassy hill facing south towards County Hall (055)*

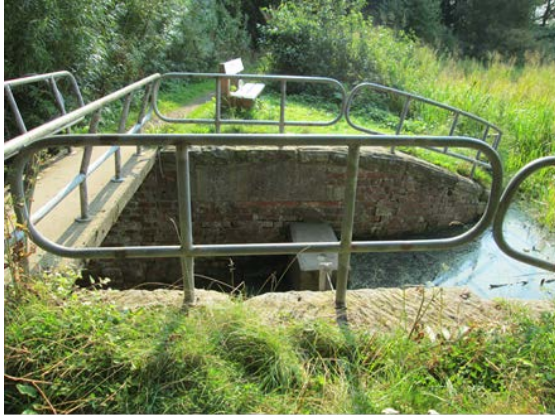
Along the east side of the site there was no evidence of the well (HER 11743) identified on the first edition Ordnance Survey map and HER. The cistern (HER 17990) which was initially built to provide water to the adjacent railway, and later enlarged, is now an overgrown pond. Its shape and size however matches that shown on the second edition Ordnance Survey map. There are no upstanding buildings relating to the associated pumping station. Stone and brick walls form the outflow from the pond, which is controlled by a sluice. The sides of the outflow appear to have been patched and repaired at various times.

*Plate 4 Outflow from reservoir facing south (059)*

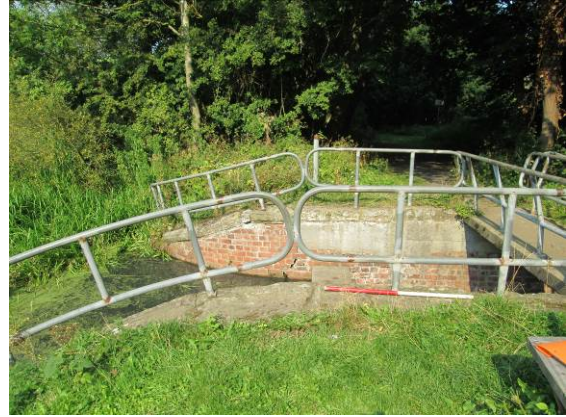
*Plate 5 Site Outflow from reservoir facing north (061)*

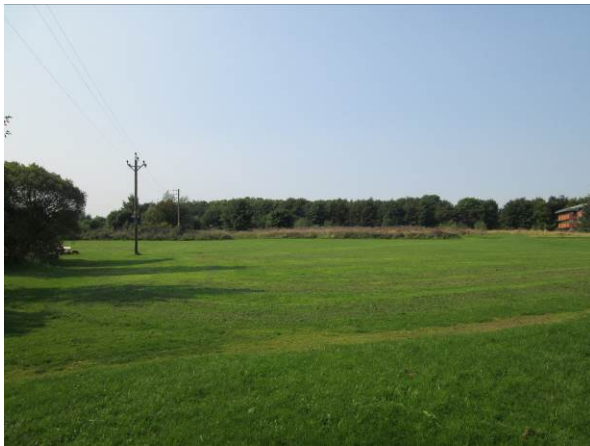
*Plate 6 General view of short grass looking west (058)*

The central area of the site is dominated by short grass, whilst the south and eastern side has more natural tall grass and scrub indicating that this area has not been subjected to the same level of landscaping and maintenance.

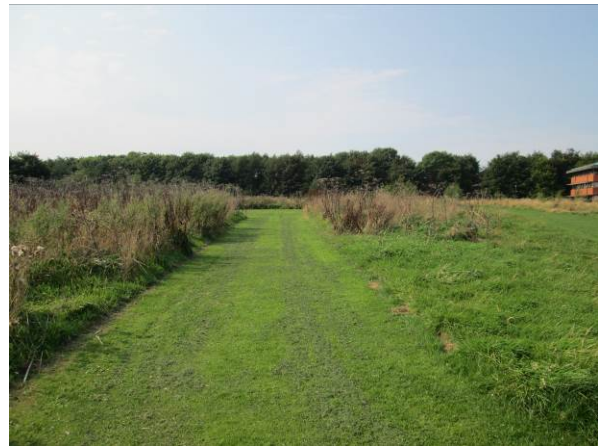
*Plate 7 General view showing contrast in vegetation (061)*

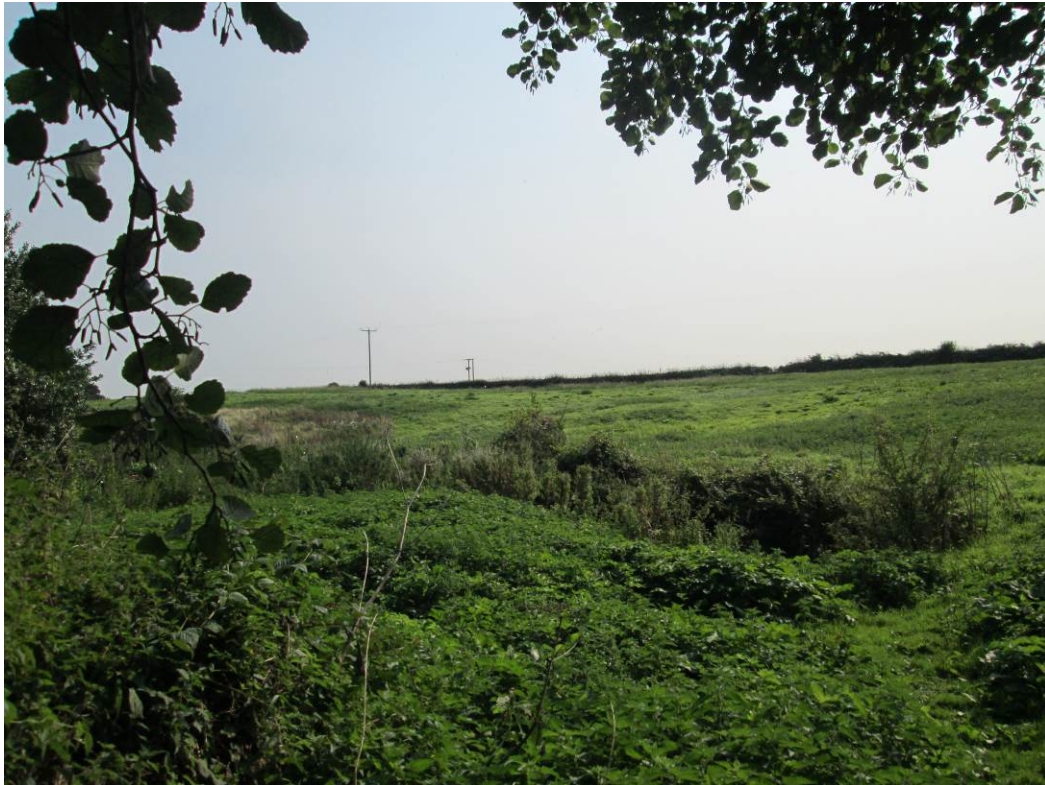
Lying directly to the south of the site boundary across the Catchburn is HER site 11720. This site was described as an enclosure, which respected the ridge and furrow hence suggesting that the ridge and furrow was later than the enclosure. Neither the ridge and furrow nor the enclosure was visible on the ground.

*Plate 8 General view of location of Catchburn enclosure HER 11720 (065)*
