4-6 Grassmarket

Archaeological Excavation : December 2017

Job number 2165.06

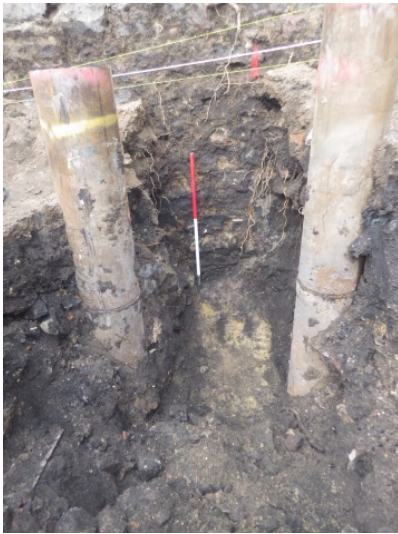
Plate 1 PT1, general view post-ex with Flodden Wall face and Deposit (120) above natural (121). Facing W

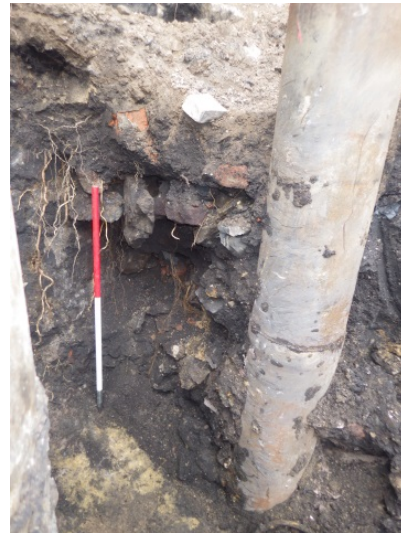
Plate 2 PT1, S-facing section with Deposit (119) abutting Flodden Wall. Facing NW

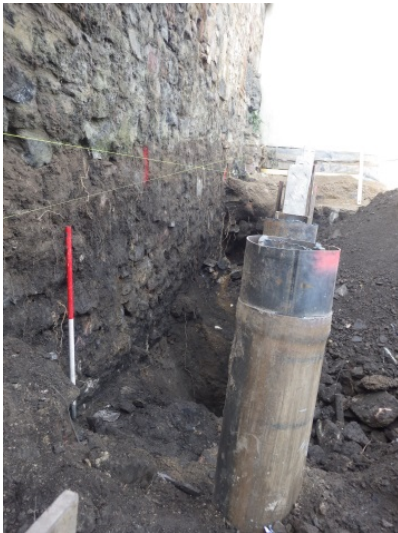
Plate 3 General view of Flodden Wall base. Facing NW

The base of the Flodden Wall was exposed across these trenches (*plates 3-4*), though given the conditions of excavation, not hand-cleaned. Across this stretch of the base of the Wall, the basal masonry sat on a gently elevated ridge of the natural clay (*121*) which sloped down immediately to the east. No foundation trenching was apparent on the east side of the Wall, and with the exception of Deposit (*119*) directly abutting it at its base, no further preserved stratigraphy. Apart from the later 18th and early 19th century insertion at the south end of the Wall (the ‘Phase 2’ walling of Lawson & Reed 2003: 7ff and *Illus 4*), the masonry of the Wall appeared coherent and single-phased, with no intrusions, cross-walls or earlier masonry noted in this area.

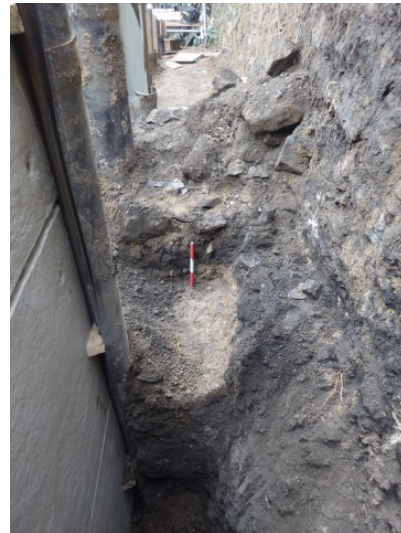
Plate 4 General view of Flodden Wall base with Deposit (120). Facing SE

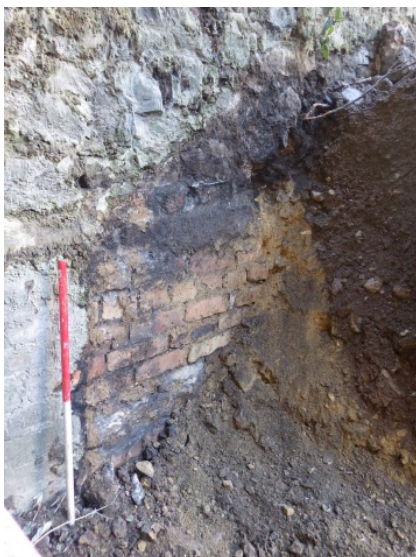
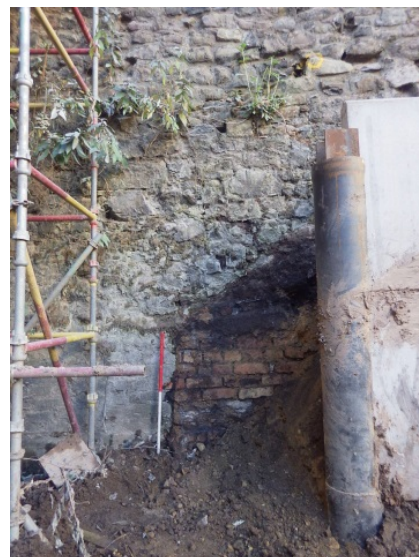
Plate 5 Brick underpinning at south extent of Flodden Wall in Area A. Facing NW

Plate 6 Brick underpinning at south extent of Flodden Wall in Area A. Facing NW

The furthest southern extent of the Flodden Wall in Area A was exposed in the area immediately outside the northern gable end of the standing Robertson Memorial building, where a strip of land had been terraced away to the Building’s internal ground floor level (*c.* 64.75 OD) during its initial construction (as can be seen on the historic architects’ plans marked ‘Area’ on *figures 11 and 12*). This stretch of the Wall – itself of probable 19th century date) had been underpinned with brick masonry, the southern extent with a cement plaster render (*plates 5-6*). This underpinning suggests that the masonry observed in the shuttering trenches indeed represents the basal courses of the Flodden Wall, which therefore in this stretch is not deeply trenched-in.

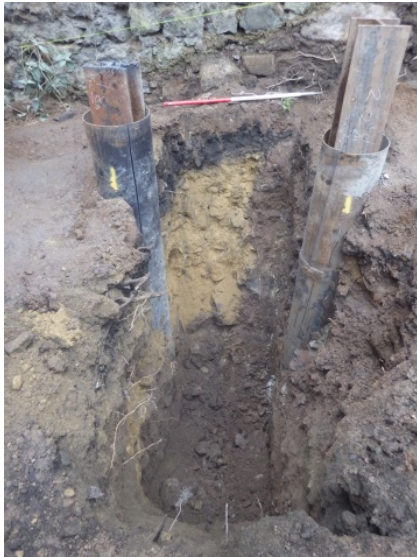
Plate 13 Cut [122] as exposed in PT9 with Fill (123) to left, natural (152) to right. Facing W

The southern extent of this flat, terraced natural is defined by a long linear Cut [122], first revealed in PT9 and found to extend eastwards across to the eastern edge-of-excavation (*plates 13-14*). Cut [122] was oriented east-west, with sharp breaks-of-slope, near-vertical sides and a flat base. It was filled with Fill (123), a mixed deposit largely composed of sharp yellow sand with lenses of mid-brown silt and orangey-brown and purplish clay redeposited natural material, as well as some angular rubble. The southern extent of Fill (123) is retained by the round-headed coped sandstone-faced wall standing at the time of the present works, itself a part of the Robertson Memorial building (*plates 15-16*).

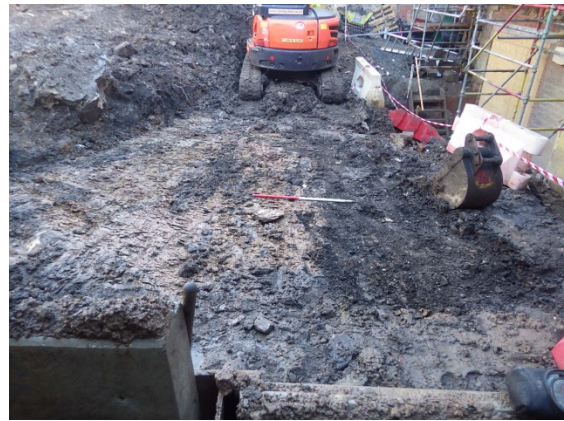
Plate 14 General view of Cut [122] exposed during stripping. Facing E

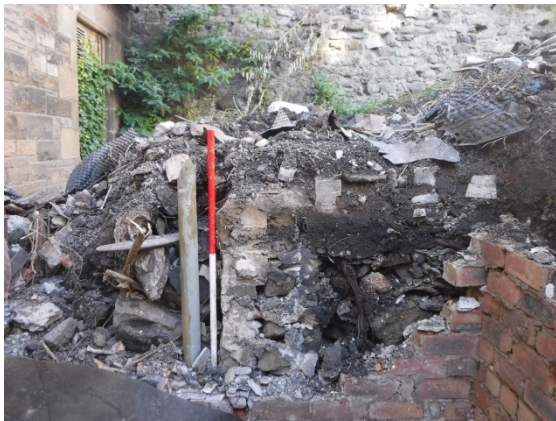
Plate 15 Robertson Memorial retaining wall with Fill (123) behind. Facing W

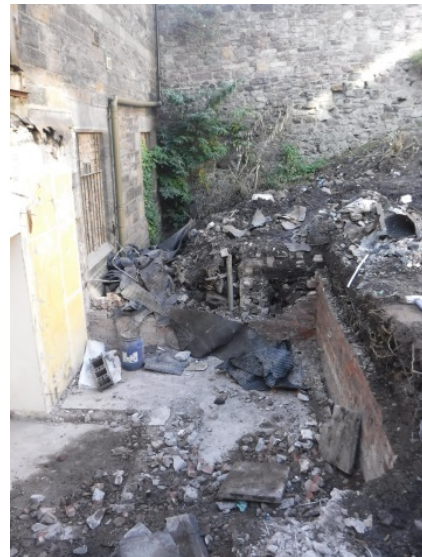
Plate 16 General view of retaining wall with Fill (123) to north. Facing W

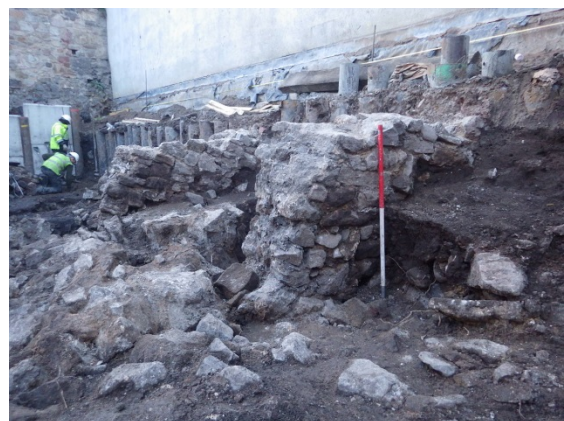
Plate 26 General view of Walls [102] (left) and [103] (right). Facing NW

Wall [103] was perhaps the best-preserved of these walls (*plates 26-27*); at 1.90m east of Wall [102], it extended 1.50m south of the northern edge-of-excavation; traces of mortar similar to that bonding the wall masonry found on the rubble collapse [146] immediately south of the wall may suggest that

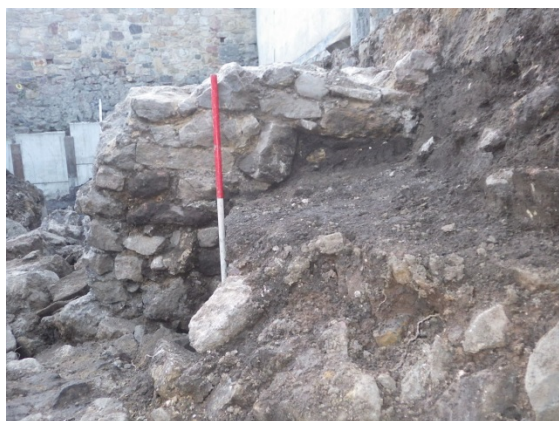
Plate 27 Wall [103], east elevation with Deposit (150) abutting. Facing W

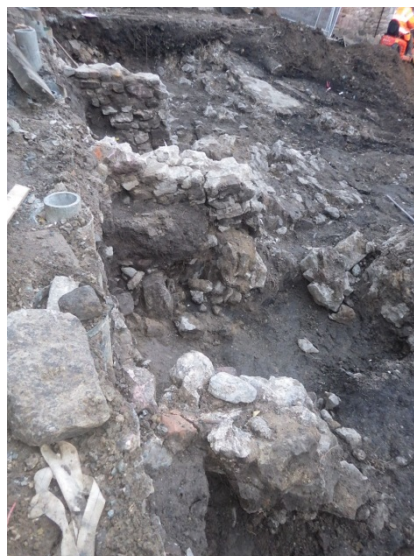
Plate 28 General view of Walls [106] (foreground), [102] (centre) and [103] (background). Facing E

The morphology, facing, and construction of these walls (*plate 28*), and the lack of any internal or external surfacing associated with them, suggests that these walls functioned as buttresses, designed to support a structure slightly to the north of the present edge-of-excavation. This structure may be attested by the suggestions of east-west aligned masonry revealed between Walls [106] and [102]. This masonry, [159], is slightly more coherent than the rubble surrounding it; only its southern face was exposed (*plate 29*) along a 1.20m stretch of the northern edge-of-excavation section, and was composed of whin and grey limestone rubble blocks bound in a beige sandy mortar with lime flecks, preserved 0.42m high, 3-4 rough courses; its eastern and western ends appeared truncated, but this masonry, unlike the others recovered, appears to be founded on the ridge of higher natural clay which runs along the northern edge-of-excavation.

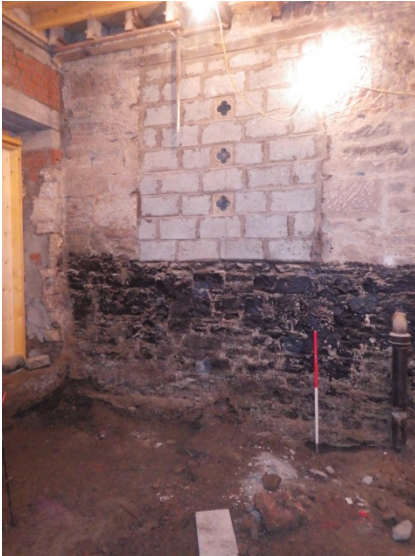
*Plate 32 Ground floor east wall internal face.
Blocked window with quatrefoil vents re-inserted.
Facing E*

On the ground floor, this included the recording of the interior face of the north wall of the Robertson Memorial Building, which had been stripped of later surface treatments. The three original window apertures in this wall had been blocked, with brick on their outer face and concrete breezeblocks on their inner face. Between the west and central window on the interior face, the removal of the former kitchen wall-treatment exposed an original fireplace (*plate 30*), the westernmost of two that had heated the main Meeting Hall as visible on the historic plans (*figure 9*). Its companion fireplace, further east on the north wall, had been slapped through to accommodate a doorway to the cold store, which was an addition of the early 20th century (blocked again during the present works); the late 20th century concrete lift shaft base was also installed to its east along the north wall. The original east window in the north wall, sealed with breezeblocks as the others, had the original iron quatrefoil vents reincorporated into the breezeblock wall stretch and were salvaged during the present works (*plate 31*). This pattern is also attested on the east wall of the meeting hall, in which an original window aperture was sealed with similar quatrefoil vents incorporated into the fabric. This east wall, stripped of later surface treatment, was seen to be clad in a bituminous skim on its lower course. The surviving window had been modified with breezeblocks at its base (*plates 32-33*).

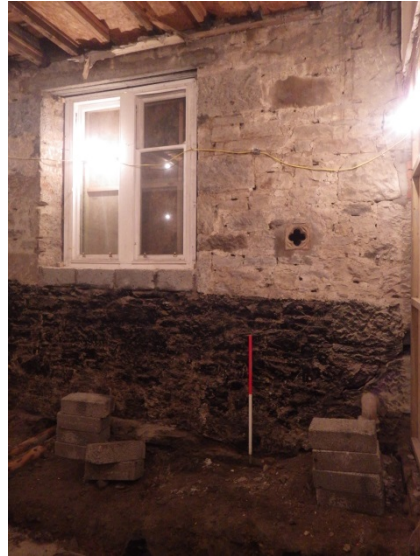
*Plate 33 Ground floor east wall internal face, original
window with modified lintel. Facing E*

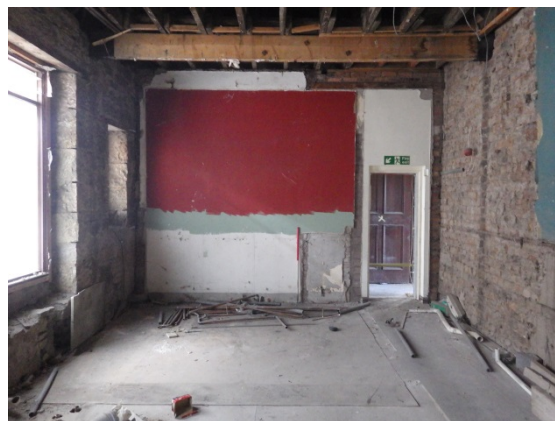
Plate 36 First floor, east flank with brick partition wall. Facing S

On the first floor, the interior face of the north wall was again more fully exposed since the initial building recording. On the western side of the building, the original main meeting hall, the north wall alcove was fully exposed (*plate 34*). On the east side, the removal of the mid-20th century lift-shaft revealed the brick-blocked fireplace in the original vestry room, with the wall-alcove to its east and the later exterior door slapped through the wall (*plate 35*). On this floor the main partition wall dividing the original Church hall from the vestry and lavatory on the east flank was composed of brick rather than the sandstone rubble of the exterior walls (*plate 36*).

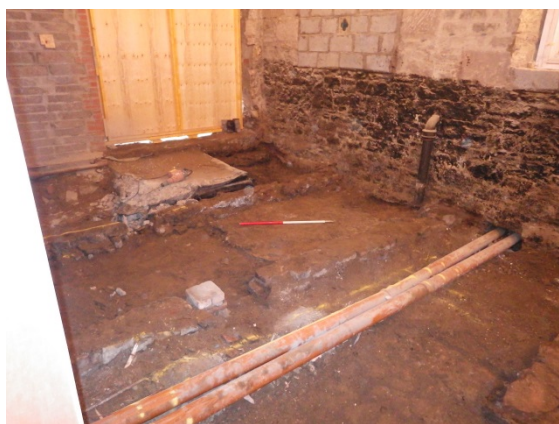
Plate 37 Sleeper walls [107]—[109] with existing lift shaft concrete foundations. Facing NE

Where the existing timber floor was lifted, four east-west sleeper walls, [107], [108], [109] and [110] were exposed (*plates 37-38*). These walls extended from the slightly kicked-out foundation course of the east wall of the Robertson Memorial building, against which they clearly abutted, westwards across the ground floor; their western extents were not exposed in the current works. These walls were contemporary and very similar in construction, composed of rough sandstone and whin quarried rubble, bound in a thin friable lime mortar, 0.32m wide and preserved 2-3 courses high. Wall [107], the northernmost, abutted the north wall of the Robertson Memorial Building, and was cut by the concrete foundations of the mid-20th century lift shaft base which had been installed against the north wall. Walls [108], [109] and [110] had all been truncated approximately half-way along their exposed lengths by a north-south linear service cut, and Wall [109] had been repaired with a brick insertion at the western edge of this cut. A concrete screed [113], 2.30m x 1.75m, extended from the south face of Wall [108] to the north face of Wall [109]. The walls were founded on Deposit (112), a compact, mid orangey-brown sandy silt with frequent white limestone chips and charcoal flecks, and abutted by Deposit (111), loose mid-grey silty constructional debris, which itself directly underlay the existing timber floor.

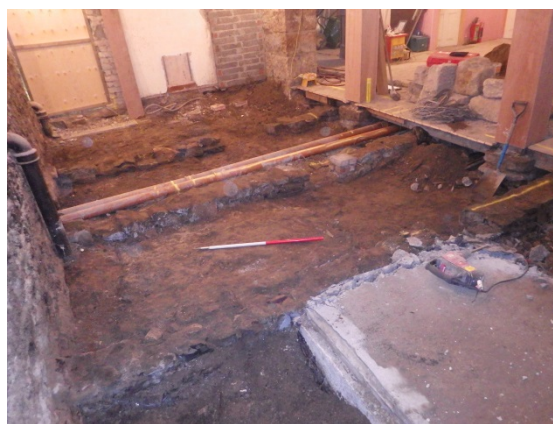
Plate 38 Sleeper walls [108] (foreground) – [110], general view. Facing SW

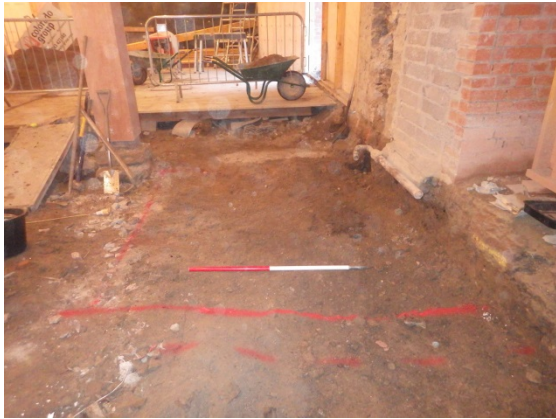
*Plate 41 General view lift shaft trench pre-excavation.
Facing W*

In the lift shaft trench (*figure 10* and *plate 41*), natural compact pinkish-grey mottled clay (133) was found across the trench at 63.85 to 63.88m OD, 0.87-0.90m below the level of the existing timber floor; this geological horizon was found to extend across the area excavated without any evident cut features (*plate 42*).

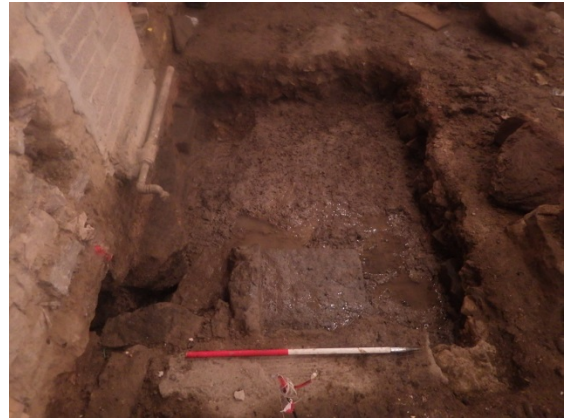
*Plate 42 Natural clay (133) exposed across lift shaft
trench. Facing N*

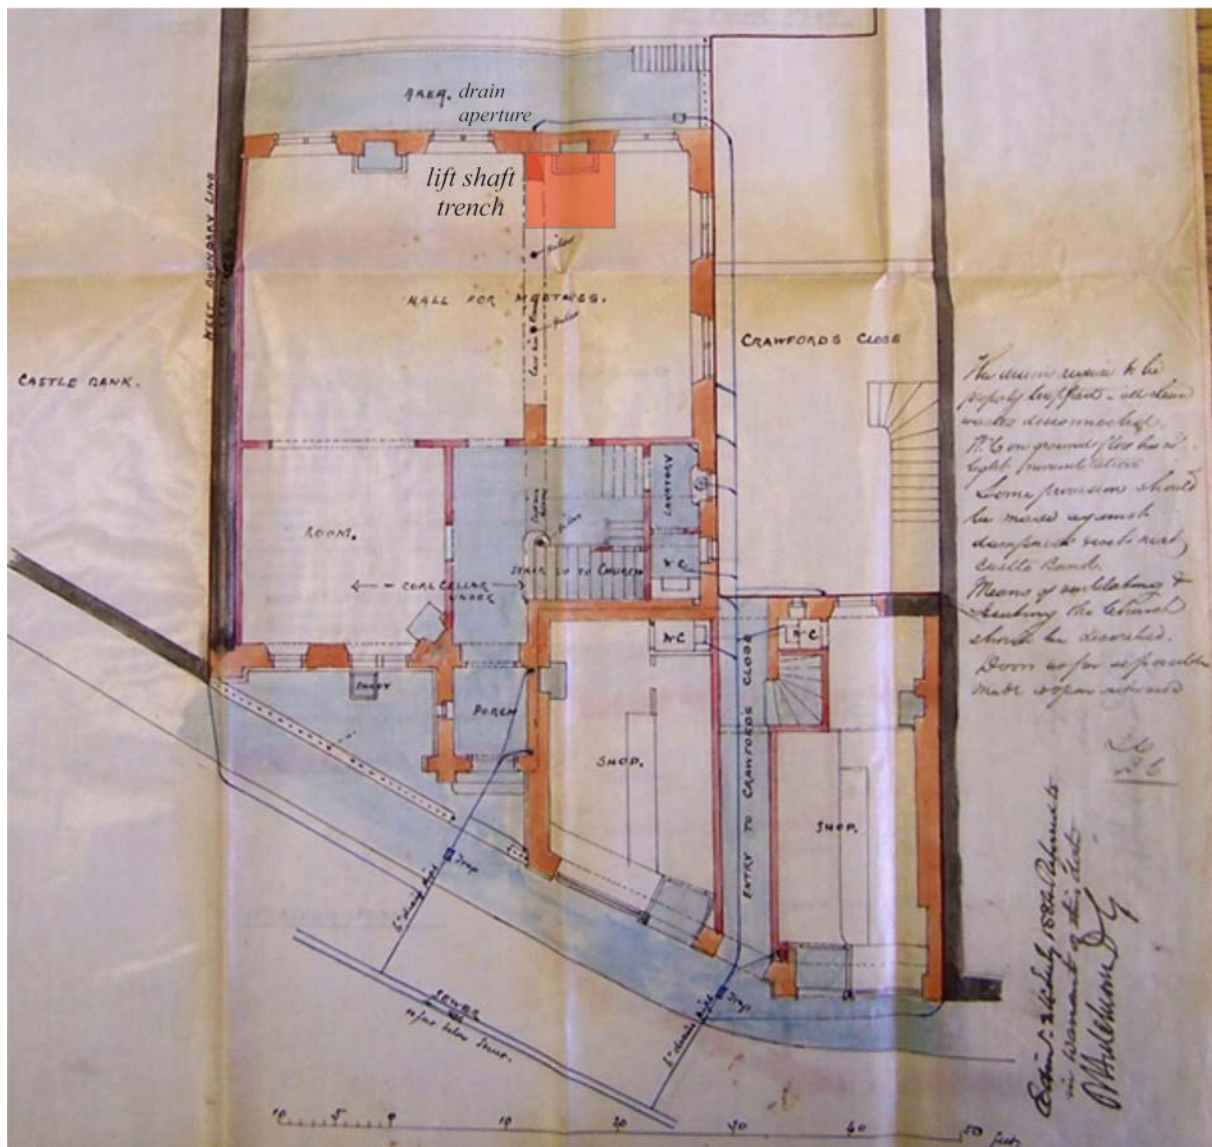
Figure 11 Historic ground floor plan with lift shaft trench location. Hardy & Wight, 4th July 1884. City of Edinburgh Council Archives
