Old Castle Lachlan

Strachur, Argyll and Bute

Evaluation: 19-21st of March

Excavation of Test Pits

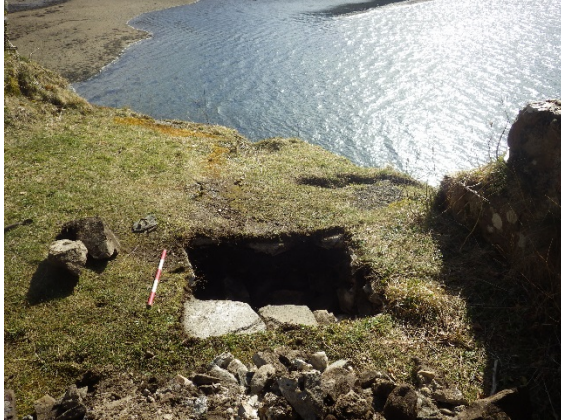
Plate 1 Location of Test Pit 1.(2253_032)

Test Pit 1 was excavated at the south west corner of the West Hall, close to the point at which access is gained to the hall at present. The concrete in this area was very cracked and broken with parts missing and a thin layer of soil and grass growing on top.

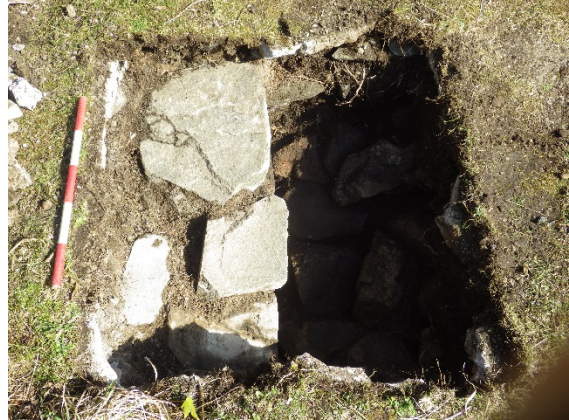
Plate 2 Wall 006 exposed in Test Pit 1 (2253_025)

At the north side of the Test Pit c.20cm below the current ground surface the remains of a wall were uncovered. Only the south face of the wall was exposed within the test pit; its total width is it was at least 0.4m wide, and the face was exposed to a height of 0.4m. The masonry was mortared with coarse cream lime mortar with small animal bones used as pinnings. It runs parallel to the main south wall of the castle. The remainder of the Test Pit contained loose dry stone rubble; there was a component of loose soil and roots which had entered into the rubble through the broken concrete. The rubble consisted of large angular and sub-angular stones with considerable voids and was visible to a depth of 0.8m below the current ground surface.

According to the RCAHMS Survey of the site, the wall located in Test Pit 1, is above the oven and chimney area of the kitchen. It is possible that the loose rubble is infilling the void of the chimney.

The purpose of the evaluation was to gain an understanding of what lay beneath the current failing concrete floor in order to inform further conservation and restoration work. The results were interesting in that each of the test pits revealed completely different deposits beneath. Within the West Hall Test Pit 2 uncovered evidence of the original flagged floor surface, indicated by the presence of bedding material. This deposit together with the uncovering of the hearth slab shows the level of the original floor. No floor surface was visible within Test Pit 1 which revealed a great depth of loose rubble and a mortared cross wall thought to relate to the kitchen chimney beneath.

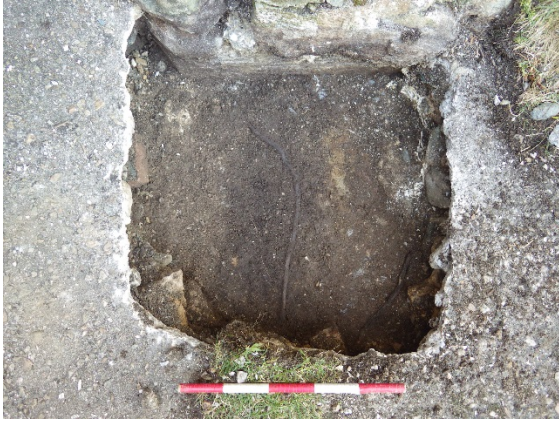
Plate 3 Plan view of Test Pit 2.(2253_008)

Test Pit 2 was located towards the centre of the West Hall abutting the blocked fireplace. It was positioned in order to reveal the base of the carved stone fireplace and if possible establish the original floor level. The excavation of the Test Pit revealed the base of the carved stone and uncovered part of the hearth slab. The level sand deposit recorded beneath this is believed to have been the bedding material for the original flag stone floor. This deposit, together with the hearth slab provides reliable evidence to show the level of the original floor (*plates 3 and 4*).

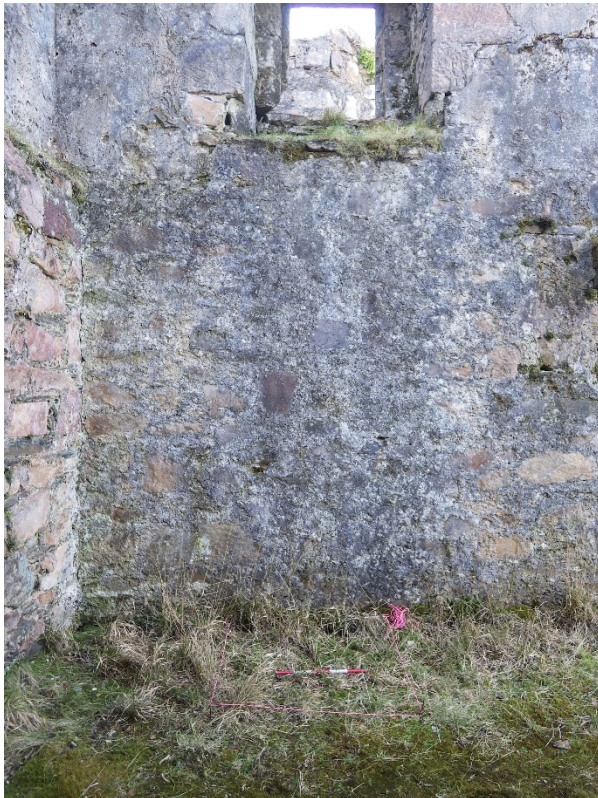
Plate 5 Location of Test Pit 3.(2253_020)

Test Pit 3 was excavated in the south west corner of the East Hall. It abutted the wall where the masonry had undergone extensive rebuilding and or blocking (*plate 5*). Immediately beneath the concrete was a deposit consisting of loose stone rubble and a large number of roof slates, 0.2-0.3m in depth (008). This deposit was most probably laid to create a level base for the concrete. There was very little soil within the rubble, unlike the similar rubble deposit encountered in Test Pit 1. It is thought that this was due to the concrete being intact in this area preventing soil and vegetation being washed down amongst the rubble. The clean and uniform nature of the deposit indicated that it was deliberately laid rather than being formed by a gradual accumulation of rubble and debris from the degrading walls of the building over time. This was reinforced by the lack of mortar within the deposit.

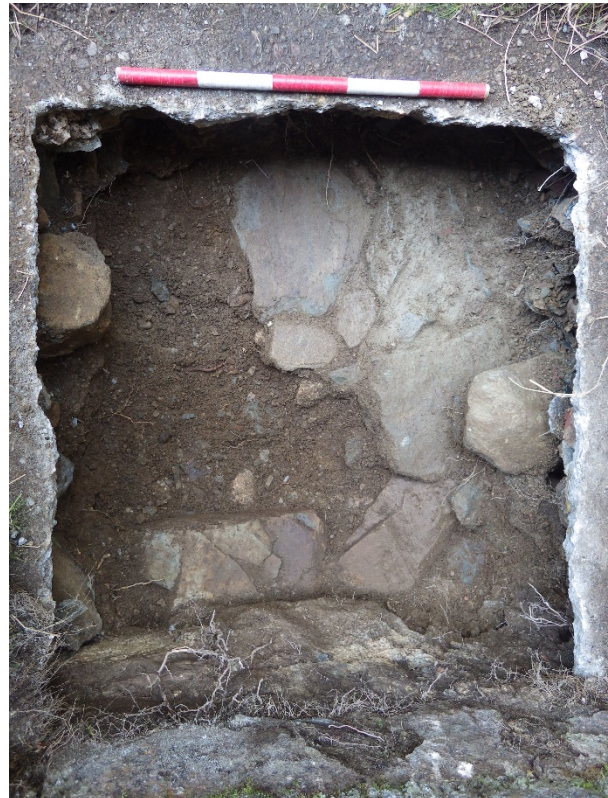
Plate 6 Post-ex shot of Test Pit 3 (2253_046)

Beneath the rubble levelling deposit, but only present in part of the Test Pit was a compact strong reddish brown deposit, which contained large lumps of lime mortar (009); this deposit was directly above the possible stone surface (012). This surface was composed of a series of medium and smaller flat stones, possibly bedded in loose sandy pea grit deposit (010); this deposit was only visible where the stones were missing. The stones were not removed therefore it is not certain if deposit (010) continued beneath them. Only visible in the south east corner of the Test Pit, was a very clean compact deposit of light bluish grey clay (011). This material would have been ideally suited to improve waterproofing above the vaulted ceiling beneath, though further excavation would be necessary to establish if this was its function.

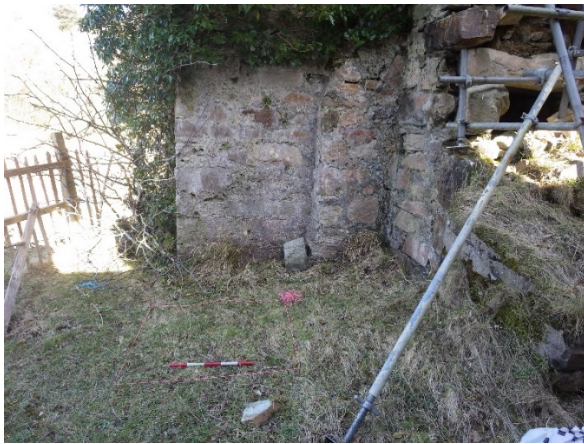
Plate 7 Location of Test Pit 4.(2253_035)

Test Pit 4 was excavated at the north east corner of the East Hall; the concrete in this area was relatively sound with no obvious large cracks. Directly beneath the concrete was a layer of loose beach sand and gravel (013). This deposit overlay a layer of rubble consisting of flat and rounded boulders (014,015). During excavation two numbers were allocated due to the difference in the shape of the stones, however following partial excavation it was clear that they formed a single deposit. Beneath this rubble was a thin layer of humic sandy soil (016) which represented an earlier layer of turf. The turf appeared to have accumulated on the top of the vault which was visible beneath (017). There was no evidence directly above the vault for bedding material on which flags could have been laid, as the turf layer peeled off cleanly on to the masonry below. This may indicate a timber rather than a flag floor in the Hall as it is unlikely that that bedding material would have been carefully removed following the removal of the floor.

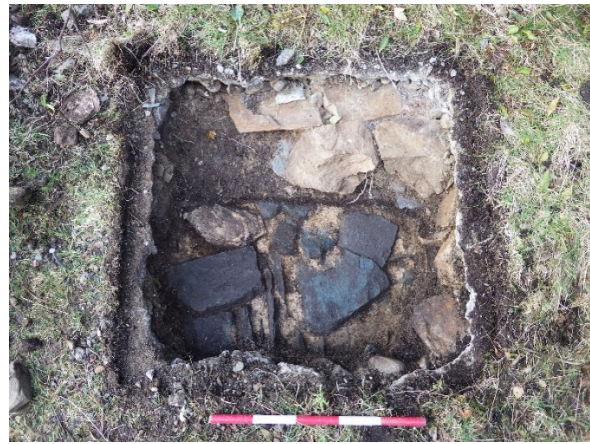
Plate 8 Post-ex shot of Test Pit 4 (2253_051)

The top of the vault was built of lime bonded masonry. A number of the stones were set almost vertically within a creamy lime mortar.

Within the East Hall Test Pit 4 was the only location where the top of the vaults beneath were exposed. The deposits above the vault suggested a timber floor had been present rather than flag stones. Although archaeological deposits were present within Test Pit 3, including a number of finds, it was difficult to interpret them within the scope of the current project. The clay deposit was clearly deliberately laid but further excavation would be required to understand its purpose.
