# Land South of 33 Stannington Station Road

## Stannington, Northumberland

### *Archaeological Evaluation : August 2018*

*Job number 2336.03*

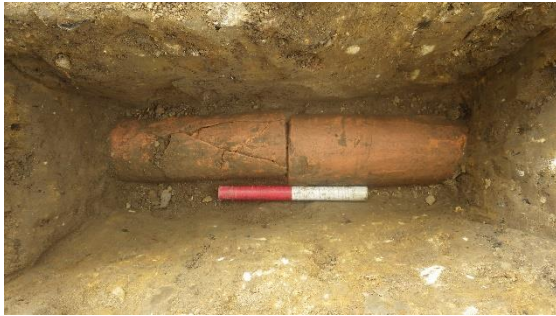
The northernmost drain runs through trenches 3, 4 and 5 ([305], [405] and [503]). The drain is sloping from west to east (see *figure 3* and *plates 1* and *2*).

*Plate 1 Drain [305]*

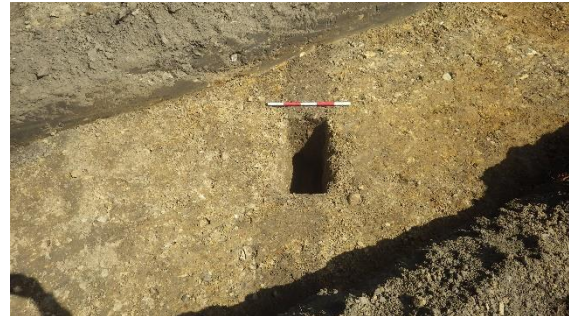
*Plate 2 Drain [507]*

The central drain runs through trenches 2, 3, 4 and 5 ([209], [303], [407] and [507]). This drain is also sloping from west to east.

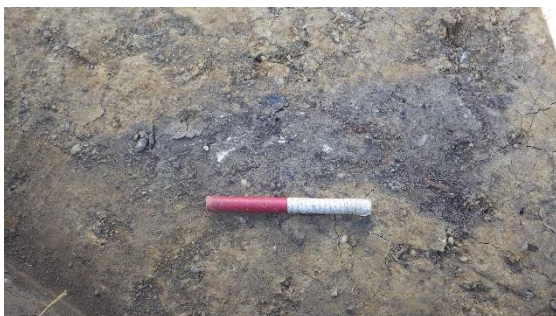
Other agricultural features were found in the form of a series of roughly N-S, plough strikes [111] in Trench 1 and an E-W furrow [207] in Trench 2.

*Plate 3 Plough Strike [111]*

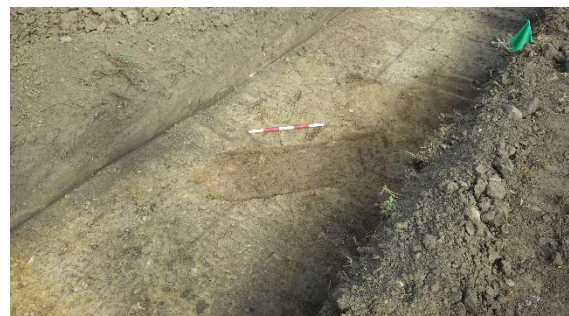
*Plate 4 Furrow [207]*

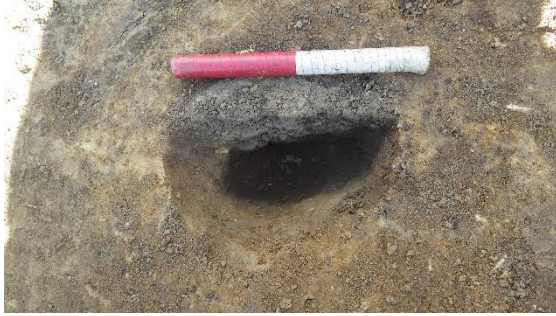
A modern circular post hole [105], 0.19m in diameter and 0.12m deep, was uncovered in Trench 1, backfilled by topsoil. This could have been part of previous fencing of the lot (*plate 5*).

*Plate 5 Posthole [105]*

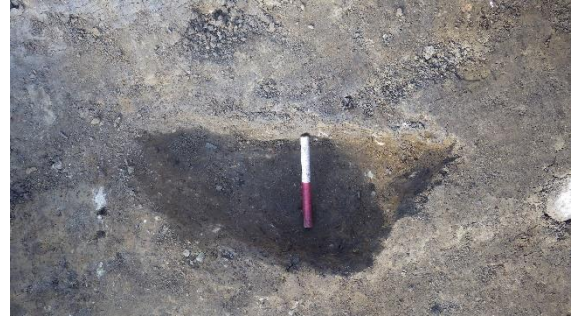
Lastly, three modern midden pits were found in Trench 1 ([107] and [114]) and in Trench 5 [505]. Pit [114] was a 0.62m by 0.46m, 0.17m deep sub-circular cut, filled by a dark grey-brown sandy-loam with patches of redeposited natural. Excavation revealed 19<sup>th</sup> century ceramic fragments, the disarticulated skeleton of a complete infant pig, 3-6 months old (Silver, 1969) and a copper alloy ornament (*plate 6*).

*Plate 6 Pit [114]*
