Land adjacent to 11 Hillside Gardens

Dolphinton, South Lanarkshire

Watching Brief : March and August 2018

Job number 2316.00

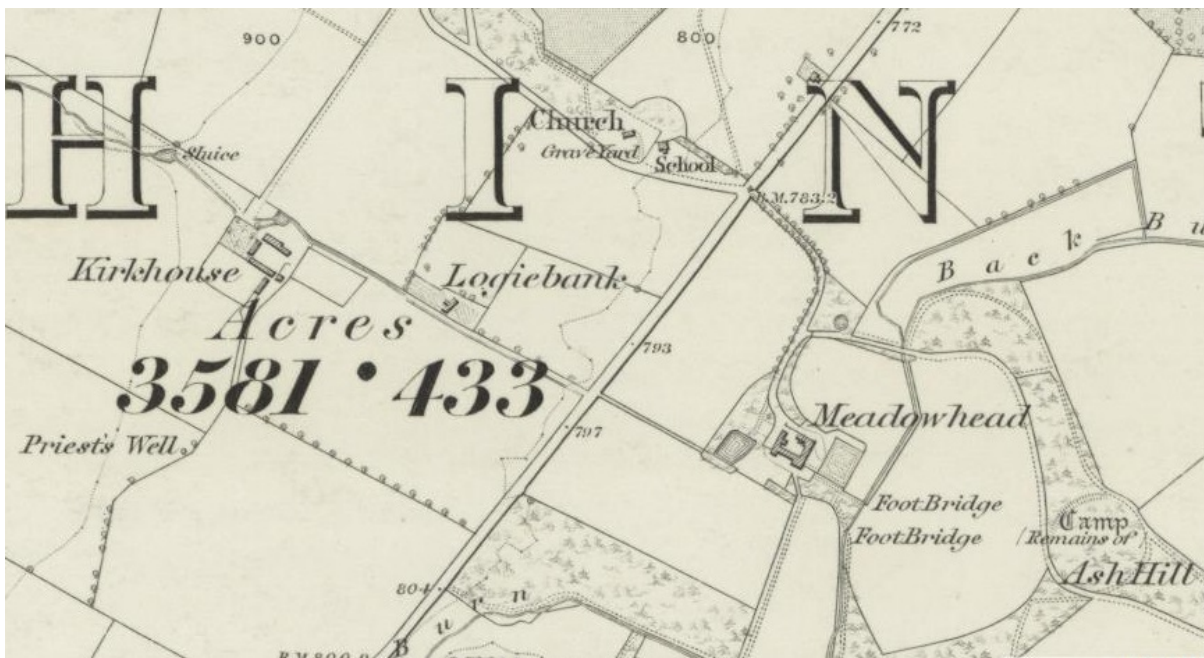
Figure 2 First Edition Ordnance Survey map of Lanarkshire, Sheet XXVII, Surveyed 1859

Roy's map of Scotland (1745-55) and John Thomson's later map of Peebles-shire (1832) both depict the village of Dolphinton but do not show the site in any detail. Roy's map depicts the immediate Dolphinton area as being intensively under rig and furrow cultivation and it is likely that the present site was under cultivation at this time. The earliest map that shows the site in any detail is the first edition Ordnance Survey map of 1859 (*figure 2*), which shows Logiebank House, although Hillside Gardens is not yet built. The Parish church at Dolphinton is shown, as is a Camp (hillfort) at Ash Hill to the south-east of the site, now thought to be a tree bank (WoSAS PIN 11175). Modern Ordnance Survey maps indicate the course of the Roman Road but not the Roman Camp.

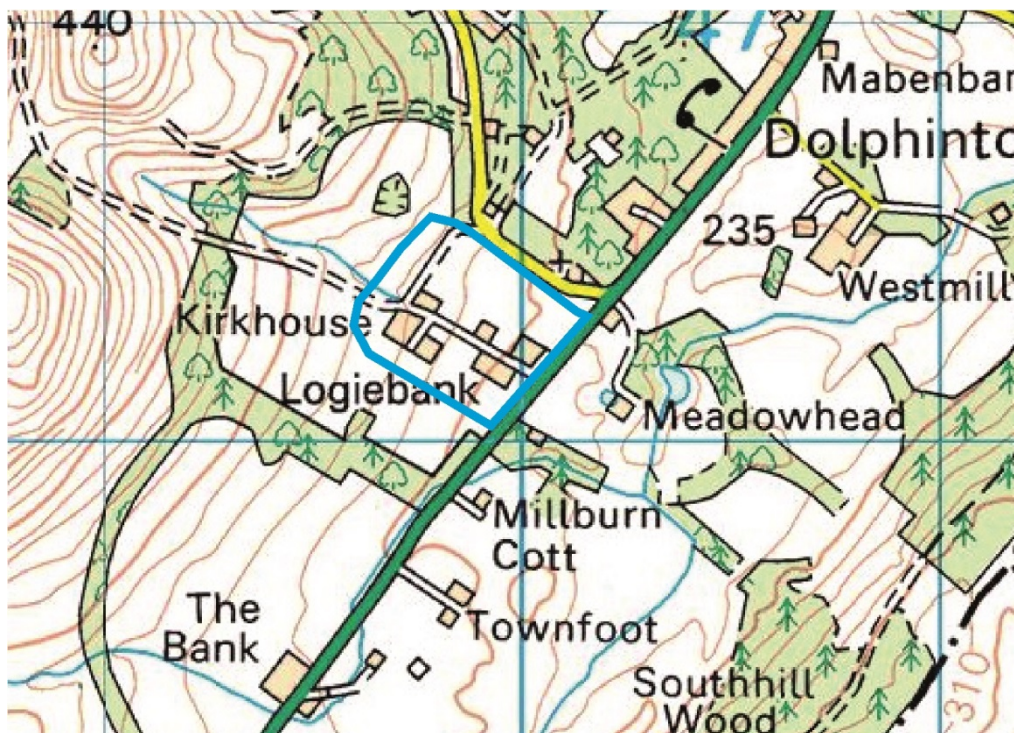
*Figure 3
Approximate location of Roman Camp, after WoSAS*

The archaeological potential of the site is detailed in the consultation response from WoSAS. This centres on the location of the development site near the centre of the Kirkhouse/Dolphinton Roman Camp (WoSAS PIN 11027; *figure 3*). The camp was identified from aerial photographs in 1983, with cropmarks indicating a single entrance on the north-west side and excavation showed that it extended south of the presumed line of the Roman road and probably pre-dated it. It measures c435m NW-SE by 360m (15.66ha), with a ditch varying from 3.25 to 2.4m wide and 0.8 to 1m deep. In size and relation to the road it may be compared with Carlops (Maxwell and Wilson 1987). Antiquarian sources and 18th and 19th century maps make no reference to the presence of archaeological features at this location, suggesting that the boundaries of the camp had been levelled before this date, either by ploughing or potentially even deliberately during the final abandonment of the camp (Richardson and Kirby 2007).

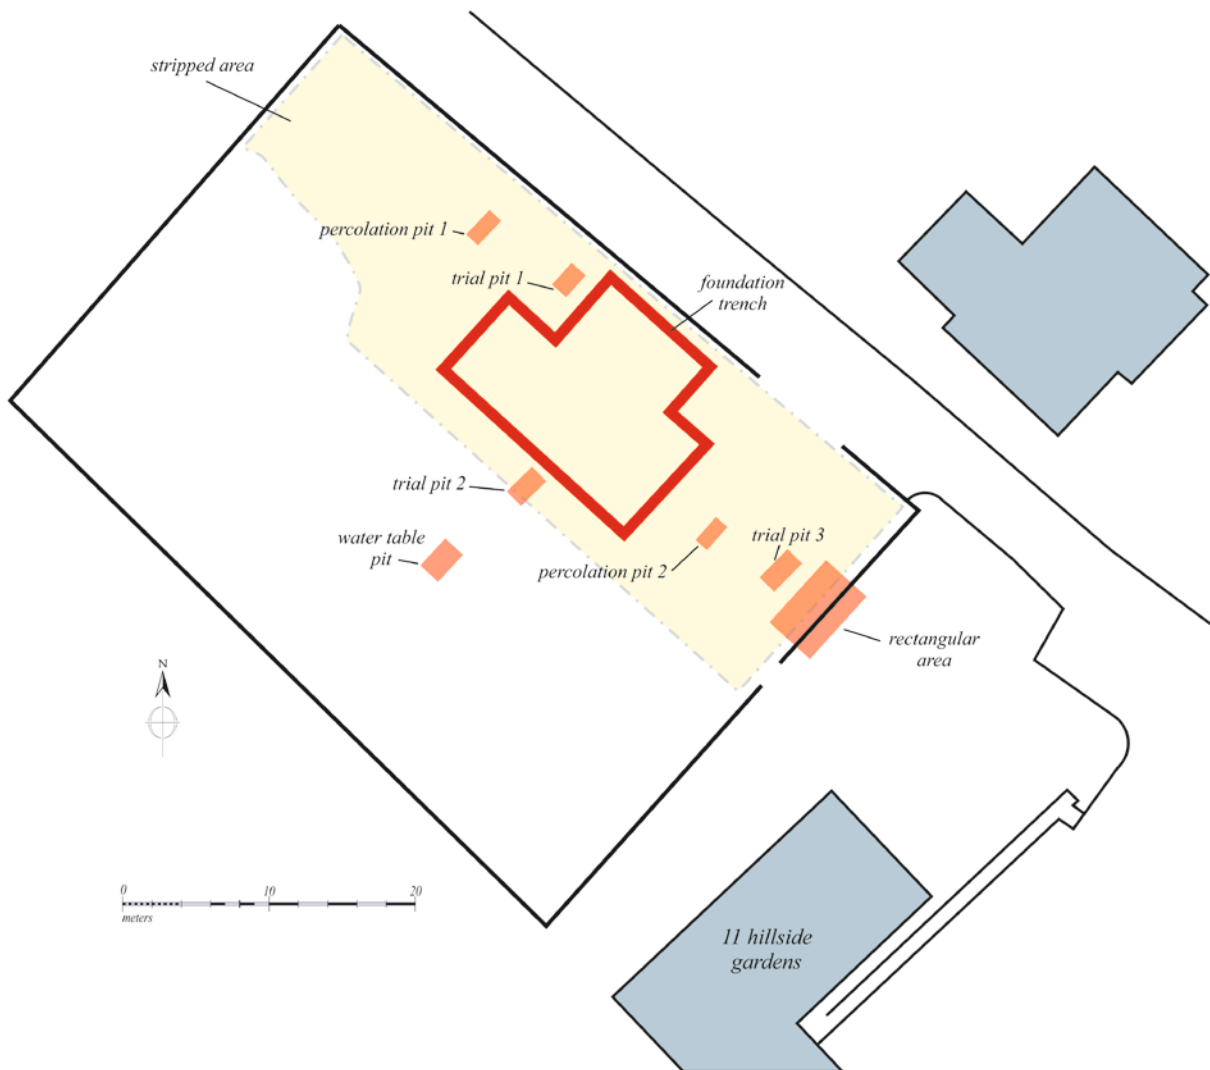
Figure 4 Site plan

Ground works took place in two phases. Firstly, on the 12th of March, six test pits were excavated. Secondly, the excavation for the foundation of the new build took place between the 23rd and the 31st of August. *Figure 4* shows the locations of excavations.

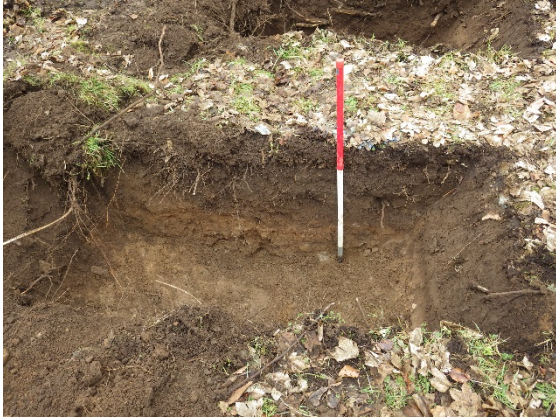
The topsoil (401) was lying directly over the subsoil (402), itself covering the natural (403) (see *Plate 1 and 2*). No agricultural markers were noted on the natural. Percolation pit 1 presented no archaeological features.

Plate 1 Percolation Pit 1, north facing section showing the structure found in all the pits

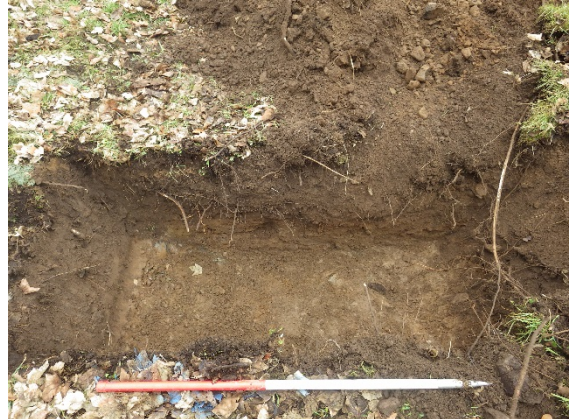
Plate 2 Percolation Pit 1, exposing the natural (403)

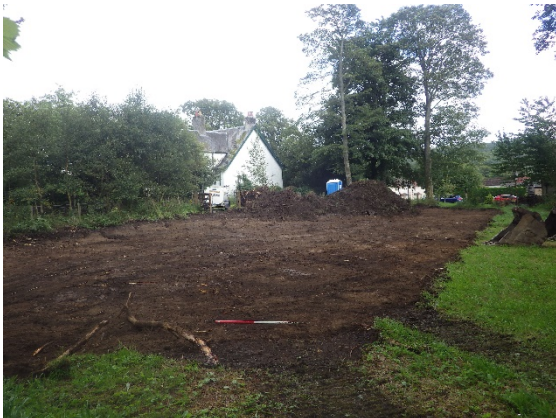
The general levelling and down-takings of the whole area (see *Plate 3* and *Plate 4*) were all within the loamy topsoil (701) and no archaeological features were revealed. Some porcelain shards and ceramic pipe fragments were recovered from the topsoil which have not been retained. Furthermore, as it was noted in the Water Table pit, a few deposits of construction material were found within (701), with dumps of Type 1, concrete, and even tools (see *Plate 5* and *Plate 6*). The dumped material had a depth ranging from 0.1-0.25m. A silted section of ceramic pipe field drain was discovered and given a context number, (703), until it became evident that it was *ex-situ*, and indeed a single fragment of a destroyed field drain. Furthermore, smaller fragments of similar pipe were found mixed in the topsoil.

Plate 3 General view of the site after stripping, looking east

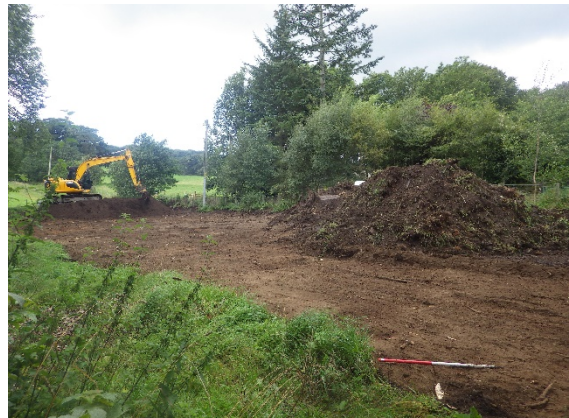
Plate 4 General view of the site after stripping, looking north

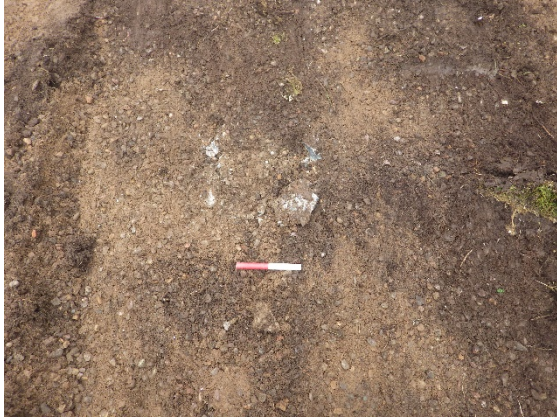
The topsoil (601) was lying directly over the subsoil (602), itself covering the natural (604). A dump of beige bricks and large stones was discovered 0.2m below the surface in the west end of the pit. The deposit appeared to continue to the west and north. This deposit is most likely linked to the construction of the house at 11 Hillside Gardens in the 1980s. The large stones were redeposited after being excavated during building along with a few bricks. No associated cut was discernible in the topsoil and the dump did not reach the subsoil. No agricultural markers were noted on the natural. Percolation pit 2 presented no archaeological features.

Plate 5 Construction material dump: Type 1

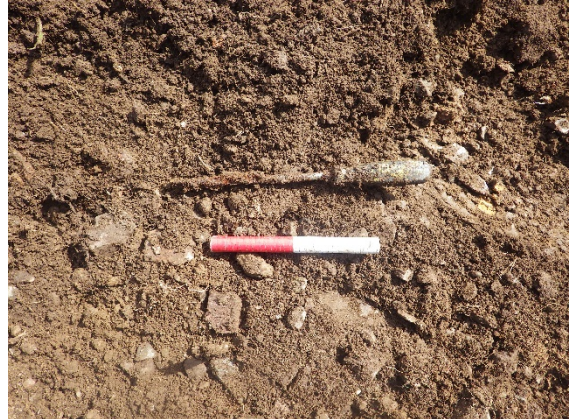
Plate 6 Screwdriver found within (701)

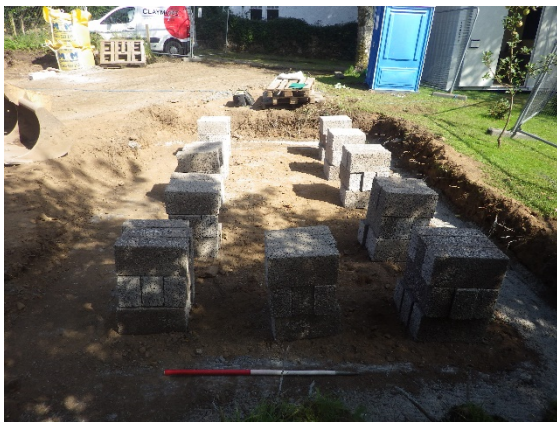
A 3.5 m by 5.5 m rectangular area, was excavated south-east of the building (see *Plate 7*). This area was excavated down 0.5m, which remained within (701), reaching the rubble-rich sandy clay subsoil (702) only for a few centimetres.

Plate 7 Rectangular excavated area, south-east of the building

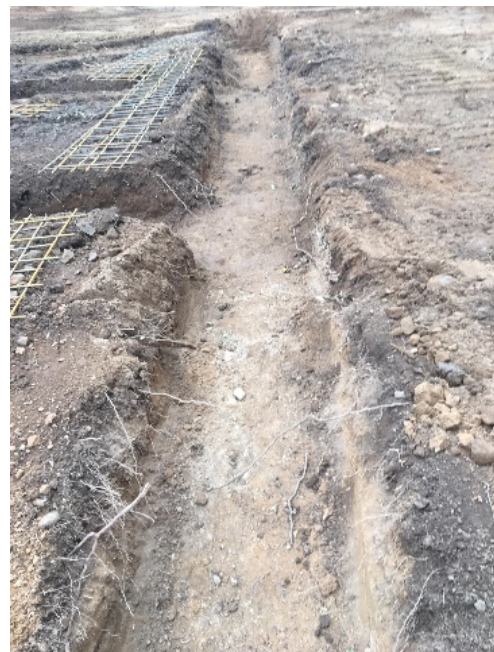
The foundation trenches were excavated following the outline of the building to a depth of 0.14-0.42m down to the formation level (see *Plate 8*). The foundations were deeper to the north-west and shallower to the south-east. Most of the trench was excavated through the topsoil (701) until the more stable subsoil (702) was reached. As the deposits follow the natural slope of the terrain, the north-west end was dug within (702) for up to 0.17m. The natural clay, as encountered in the test pits was not reached.

Plate 8 View of excavated foundation trenches
