Lindisfarne Castle, BT Trench

Holy Island, Northumberland

Watching Brief: 3rd – 20th September 2018

The National Trust

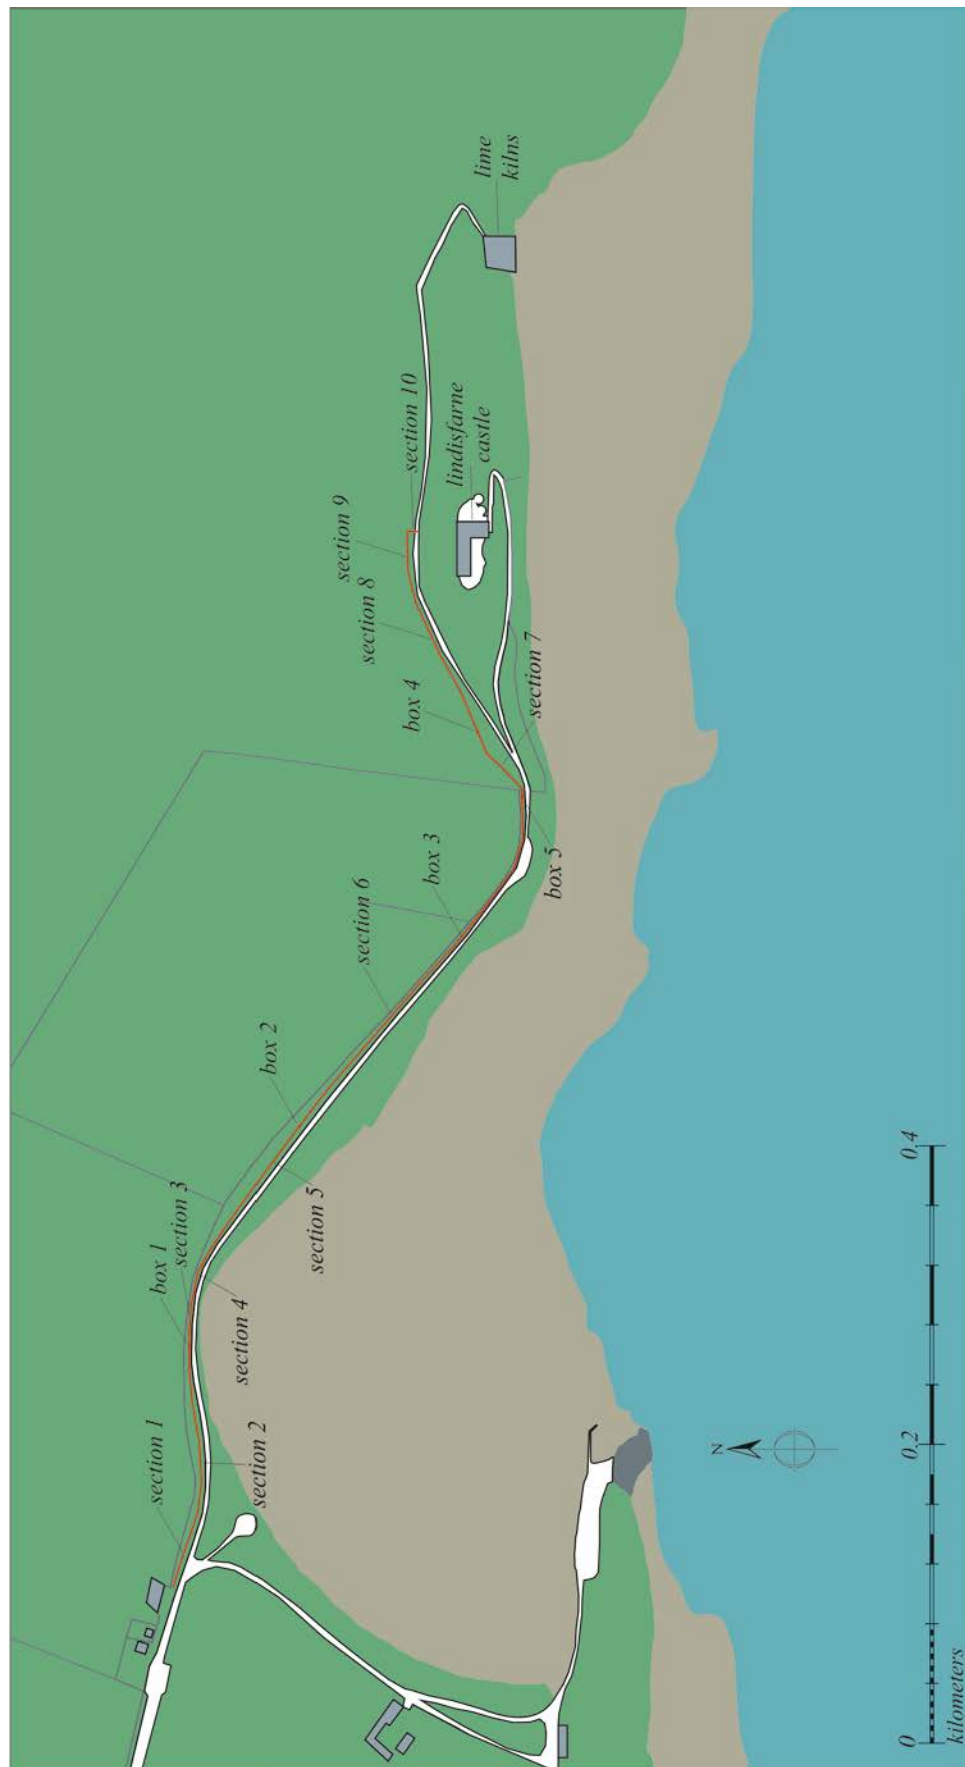
Figure 4 Site Plan

A trench 860m in length was excavated from the *Window on Wild Lindisfarne* Building to the north of Lindisfarne Castle, directly under the Larder, connecting to a recently installed BT box (see *Figure 4*). The trench was excavated by a mini digger fitted with a flat bladed bucket. The trench was 0.17 – 0.25m wide and 0.2 – 0.4 deep. Five boxes were installed along the course of the trench (Box 1: 0.5 x 0.9 x 0.72m, Box 2: 1.1 x 0.8 x 0.7m, Box 3: 0.95 x 0.55 x 0.75m, Box 4: 1.4 x 0.75 x 0.8m and Box 5: 1.38 x 0.88 x 0.8m). All ground breaking was conducted in the presence of an archaeologist. The trench was excavated in 9 to 12 metre sections; the ducts were laid and subsequently backfilled and the turf was replaced. Excavation took place from the 3rd to the 20th of September; on the 17th, the team split into two crews and works happened simultaneously at both end of the remaining area.

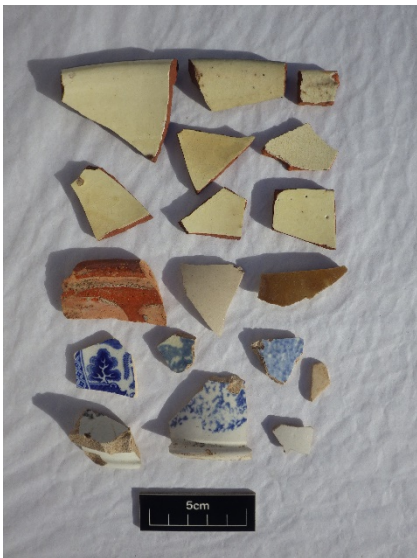
Plate 1 SMF5, 19th Century Ceramic Assemblage

As two ends of the trench were being excavated concomitantly, two contexts (002) and (009) were created for the topsoil. Once the two trenches joined, however, it became apparent that they were the same. A few 19th century ceramic fragments (see *Plate 1*) along with modern plastic rubbish (see *Plate 2*) were found within the topsoil (002).

A total of 54 objects were uncovered during the excavation, most of them ceramic fragments. The complete finds list can be found under Appendix B. All datable finds were from the 19th and the 20th century (see Plate 1). Only the topsoil (002) contained a little amount of artefacts. It seems that the ceramic encountered in the topsoil are secondary or even tertiary redeposition as manuring. A few late 20th century objects, along with quite modern plastic rubbish, were found deep within that context, such as a 1971 New Penny (SMF3) and a glass marble (SMF004). The most complete find was a beer or ginger beer bottle (SMF1) from Berwick-upon-Tweed, the name of the brewer is unfortunately fragmentary, with only W^m (William) Hi...ng & C^o. Very few faunal remains were encountered and were quite late in date, with sawing marks (SMF2) indicating a date to the second half of the 19th century.

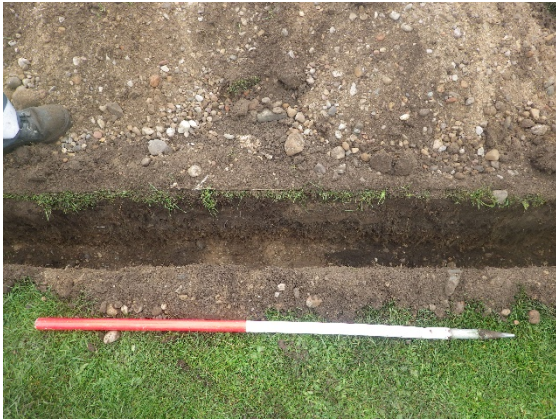
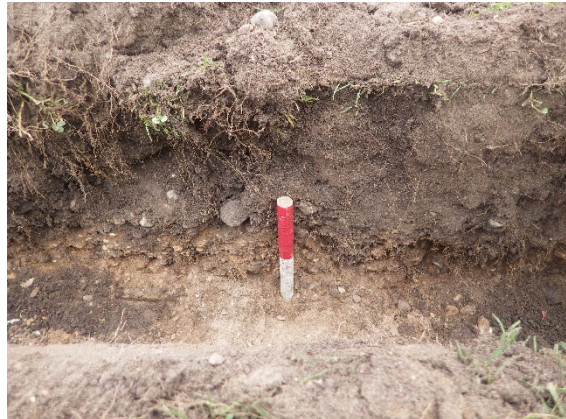
Section 1 (*Figure 5*) presents the south facing stratigraphy encountered at the beginning of the trench, with turf (001) over the loamy sand topsoil (002) over orange-yellow natural sand (003) (see *Plate 3* and *Plate 4*).

Plate 3 Trench at Section 1, General View

Plate 4 Trench at Section 1, South facing Section

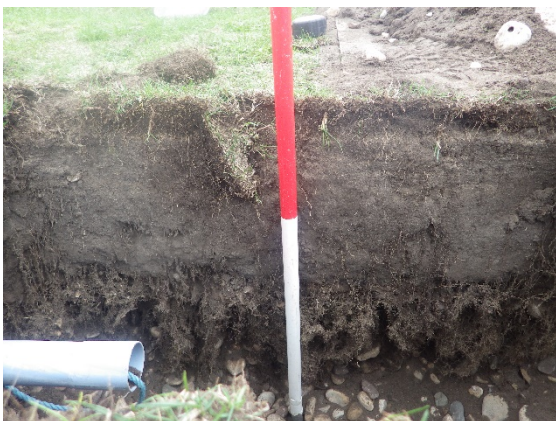
Plate 5 Box 1, South facing Section

Section at Box 1 (*Figure 5*) presents the south facing stratigraphy encountered when that box was excavated. The boxes required deeper and wider excavation than the rest of the trench. Box 1 measured 0.9m by 0.5m and reached a depth of 0.72m. The turf (001) was laying over the loamy sand topsoil (002), itself over natural small to medium beach cobbles (005), with occasional shell, similar to the existing beach cobbles (see *Plate 5*).

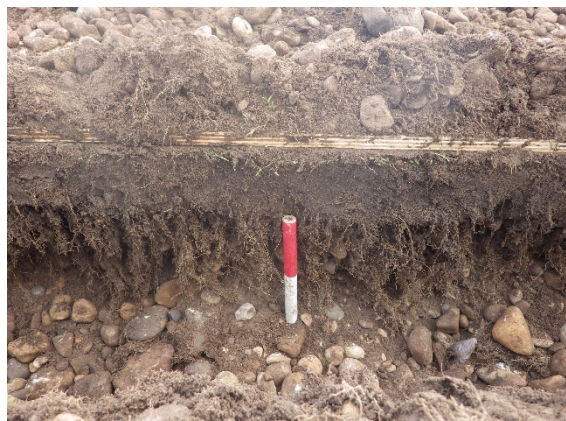
Plate 6 Section 3, South facing Section

Section 3 (*Figure 5*) presents the south facing stratigraphy encountered at that location, with turf (001) over thin loamy sand topsoil (002), over natural beach cobble (005) rising up (see *Plate 6*). This appears to be simply following the naturally marine deposited beach, especially considering the proximity of the shore to that point.

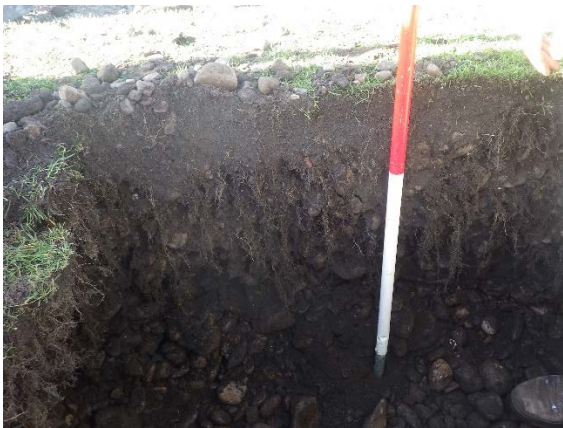
Plate 7 Box 2, South facing Section

Section at Box 2 (Figure 5) presents the south facing stratigraphy encountered when that box was excavated. Box 2 measured 1.1m by 0.8m and reached a depth of 0.7m. The turf (001) was laying over the loamy sand topsoil (002), itself over natural beach cobbles (007) (see Plate 7Plate 5).

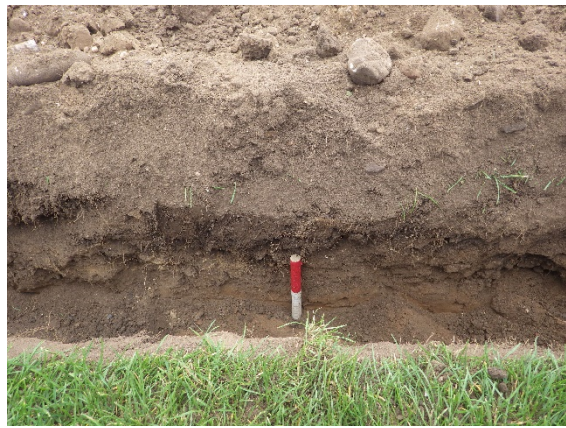
Plate 8 Section 6, South facing Section

Section 6 (Figure 5) presents the south facing stratigraphy encountered at that location, with turf (001) over loamy sand topsoil (002), over natural reddish yellow sand (008) (see Plate 8). There are a few waterborne lenses of yellow sand.

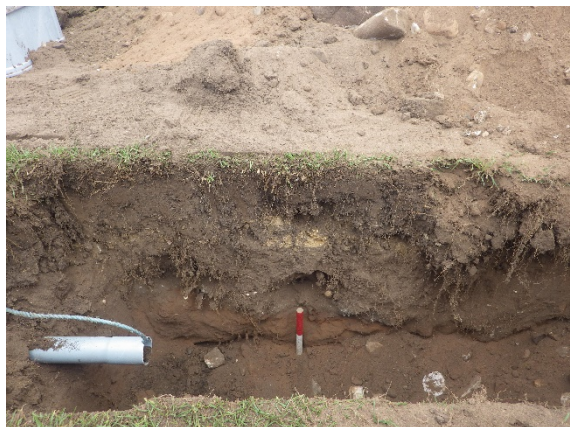
Plate 9 Box 3, South facing Section

Section at Box 3 (Figure 5) presents the south facing stratigraphy encountered when that box was excavated. Box 3 measured 0.95m by 0.55m and reached a depth of 0.75m. The turf (001) was laying over the loamy sand topsoil (002) with yellow sand lense, itself over natural reddish yellow sand (008), which contained a few beach cobbles (see Plate 9Plate 5).

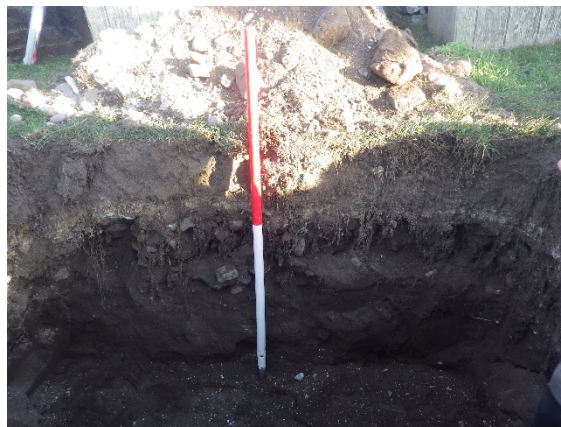
Plate 10 Box 5, South facing Section

Section at Box 5 (Figure 5) presents the south facing stratigraphy encountered when that box was excavated. Box 5 measured 1.38m by 0.88m and reached a depth of 0.8m. This box was where the two ends of the trench joined and was excavated next to the gate leading to the Castle grounds. The turf (001) was lying over thin loamy sand topsoil (002), itself over orange-beige lime rich deposit,

which contained a few small sub-angular stones and some coal nodules (014); this deposit was thicker towards the road and it appears that it is lime kiln waste material used as road make-up. Under the lime rich deposit was a dark brown sand deposit (013), quite similar to (002) but cleaner (see *Plate 10*). It is unclear if this deposit is natural or an imported deposit used as levelling for the access road. The full extent of the deposit was unfortunately not reached within the trench, as it was too deep.

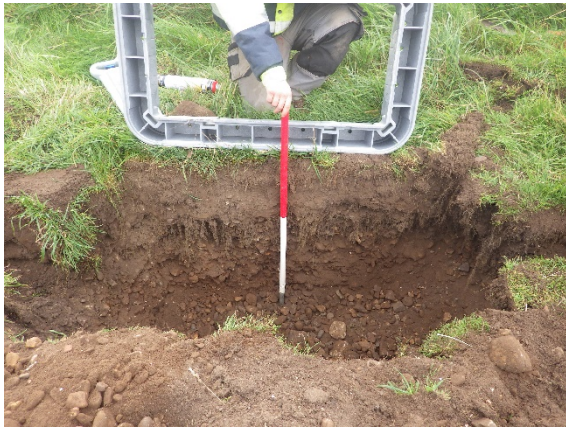
Plate 11 Box 4, North facing Section

Section at Box 4 (*Figure 6*) presents the south facing stratigraphy encountered when that box was excavated. Box 4 measured 1.4m by 0.74m and reached a depth of 0.8m. The turf (001) was laying over the loamy sand topsoil (009), itself over natural small beach cobbles (012), with occasional shell (see *Plate 11*). Those cobbles are of a smaller calibre than seen in other contexts.

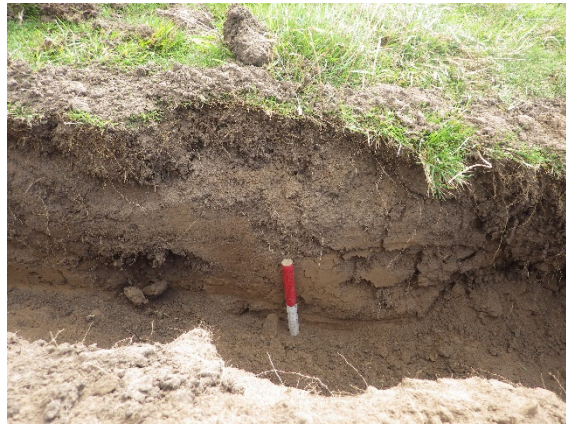
Plate 12 Section 8, North facing Section

Section 8 (*Figure 6*Figure 5) presents the south facing stratigraphy encountered at that location, where the slope breaks. Turf (001) is very thin in the slope and covers the loamy sand topsoil (009) or natural yellow-brown sand (010) (see *Plate 12*).

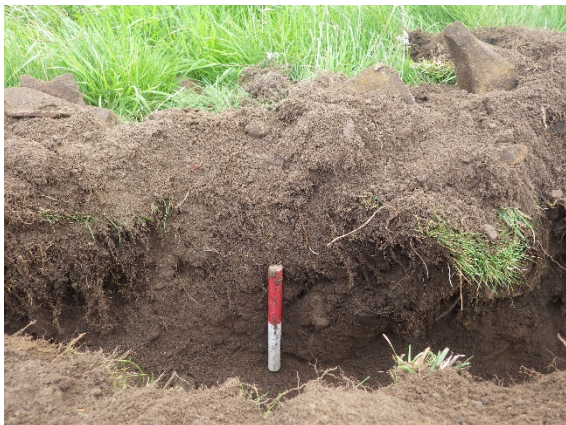
Plate 13 Section 9, North facing Section

Section 9 (*Figure 6*Figure 5) presents the south facing stratigraphy encountered at that location, with turf (001) over loamy sand topsoil (009) (see *Plate 13*)

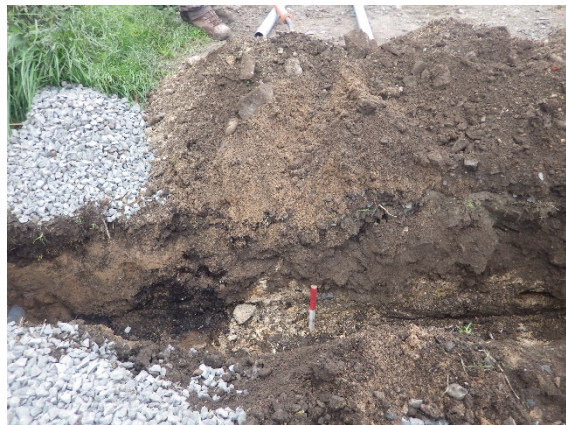
Plate 14 Section 10, East facing Section

Section 10 (*Figure 6*Figure 5) presents the east facing stratigraphy encountered across the access road, connecting a recently installed box down the north slope of the Castle (see *Plate 14*). A spread of small sub-angular stones represents make-up for the road surface. The 0.6m cut for the recently installed box is visible and has been backfilled with clean yellow sand and the turf (001) replaced. Directly under the stone surface of the road, the loamy sand topsoil (009) can be found. Near the bottom of the trench, sealed by (009) were a black silty sand midden deposit (015) (cut by the installation of the box) and two patches of orange-beige lime rich deposit. The latter contained a few small sub-angular stones and some coal nodules (016) and was very similar to the deposit (014). It seems that those deposits were used as levelling for the access road. To the north, as the slope breaks, the turf (001) covers uninterrupted loamy sand topsoil (009), until the trench turns to the west.
