Scotch Whisky Experience

Castlehill, City of Edinburgh

Watching Brief: April 2018 – October 2018

Job number 2324.00

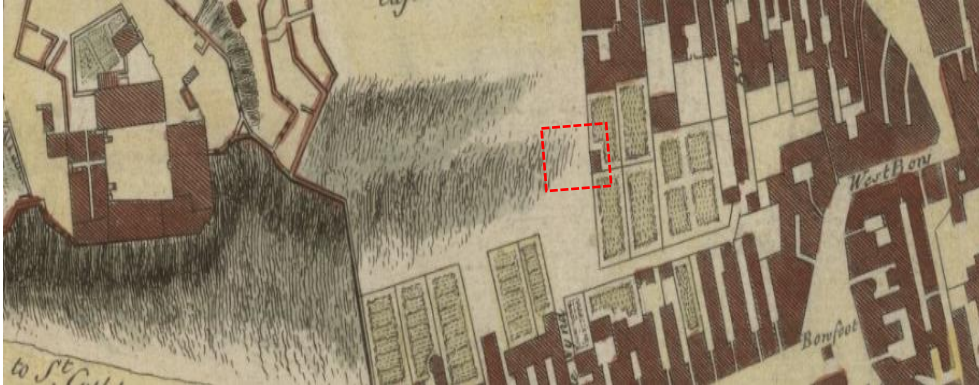
Figure 3 *Plan of the city and castle of Edinburgh* by Willm Edgar 1765 © nls

By the mid eighteenth century the overcrowding depicted on the earlier map has much reduced (*figure 3*). The site is now occupied by one or two large properties with open areas to the rear and gardens at the south, where a lane can be seen forming the southern boundary.

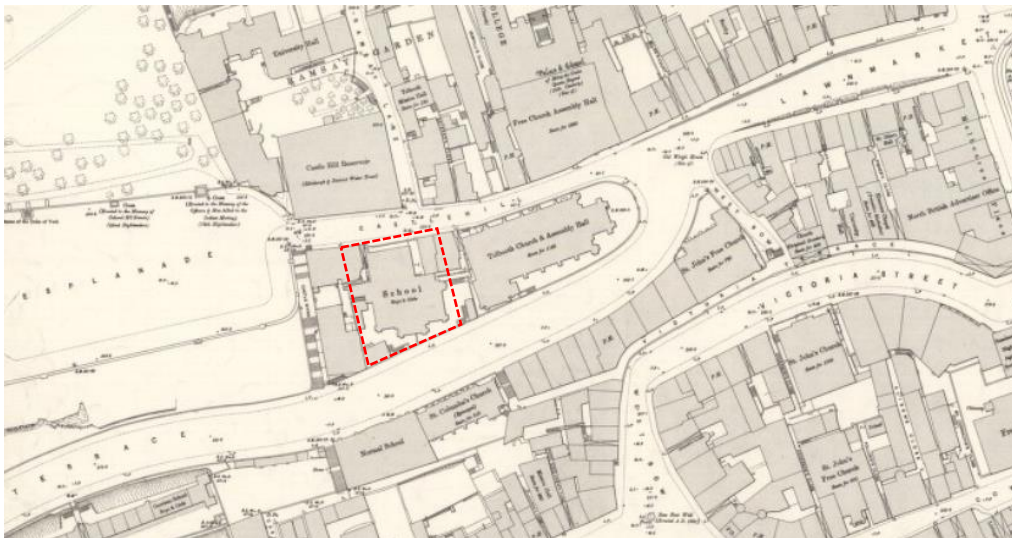
Figure 5 Ordnance Survey large scale town plan sheet 11.7.20 surveyed in 1894 published in 1895 © nls

The first edition Ordnance Survey of 1852 (*figure 4*) shows a major development with the construction of Johnston Terrace at the south edge of the site removing the garden areas. As we know, Castlehill School was built 35 years later in 1887, and is depicted together with the playground and janitors house on the Second edition Ordnance Survey of 1894 (*figure 5*). The main buildings and layout of the site have remained unchanged up to the present.

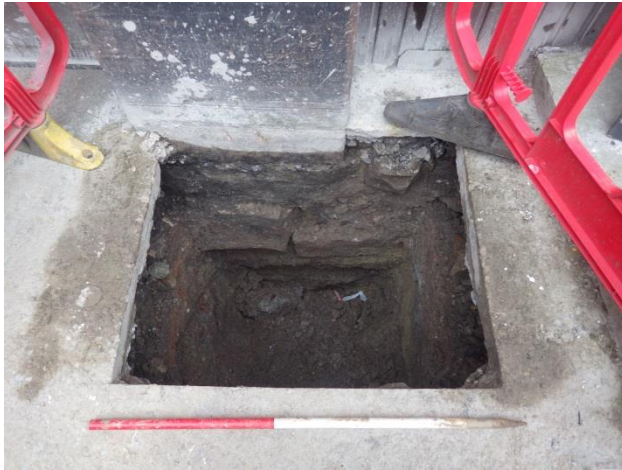
Plate 1 Trial Pit 1, General View

Trial Pit 1 was excavated against the western pier of the main range, to the south of the masonry. The pit was dug by the contractors and inspected on the 16th of April 2018 (see *Plate 1* and *Plate 2*). Considering the small size of the pit (1.09m by 0.88m, with a depth of 1.8m) and instability of the section, all recording was done from the top. This trench presented only loose bedding (002) for the concrete surface (001) over three backfill/levelling deposits [(004), (005), and (006)].

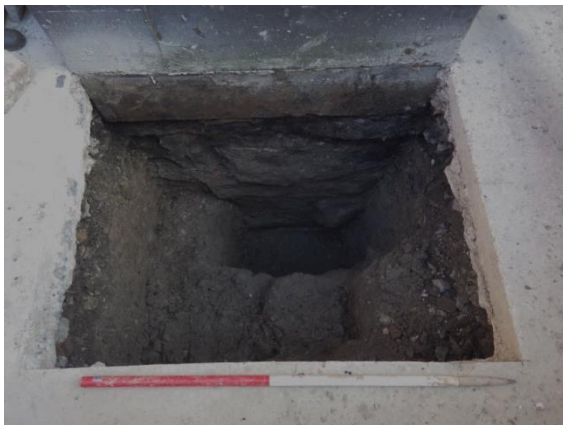
Plate 3 Trial Pit 2, General View

Trial Pit 2 was excavated against the south-east buttress of the main range, to the south of the masonry. The pit was dug by the contractors and inspected on the 19th of April 2018 (see *Plate 3* and *Plate 4*).

Measuring 1.38m by 1.03m and with a depth of 2m, Trial Pit 2 presented the same configuration as Trial Pit 1, with loose bedding (007) for the concrete surface (001) but over unique though motley backfill/levelling deposit (008).

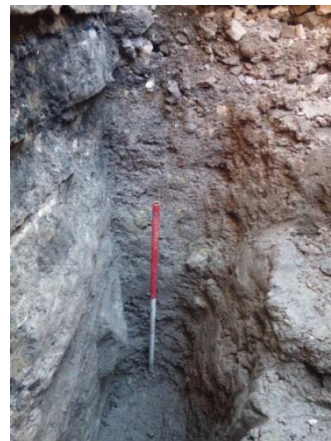
Plate 4 Trial Pit 3, West facing Section

Trial Pit 3 was excavated inside a store room in the east range of the building, to the south of a brick partition wall. The pit was dug by the contractors and inspected on the 19th of April 2018 (see *Plate 5* and *Plate 6*).

Trial Pit 3 measured 1.3m by 0.75m and was quite shallow, only 0.38m. Again a loose rubble deposit (010) was used as bedding for the concrete surface (001). The bottom of the pit exposed the natural subsoil (013). A linear, east-west foundation trench [011] for the foundation of the brick partition wall [012] was cut directly into the natural.

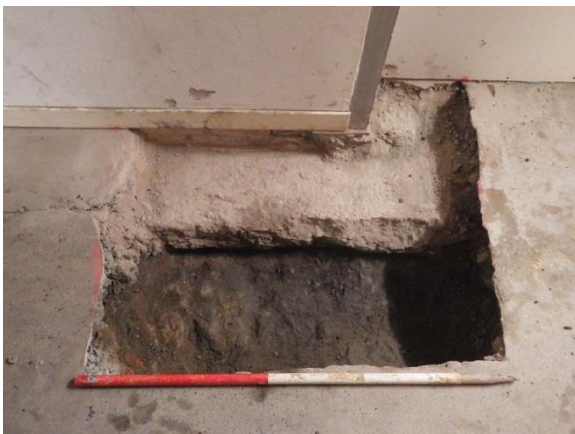
Plate 7 Trial Pit 4, General View

Trial Pit 4 was excavated inside the main range of the building, to the south of an east-west partition wall. The pit was dug by the contractors and inspected on the 19th of April 2018 (see *Plate 7* and *Plate 8*).

Trial Pit 4 measured 1.13m by 0.98m and was quite shallow, only 0.31m. There was a concrete pad used as foundation for the brick partition wall [018]. Again, a loose rubble deposit (016) was used as bedding for the concrete surface (014). The latter was different from the concrete surface encountered elsewhere and was poured directly over the concrete pad. It appears that concrete [014] was secondary to concrete (001) and was poured when wall (014) was built. The bedding (016) for the concrete was overlying a clay rich backfill (017).

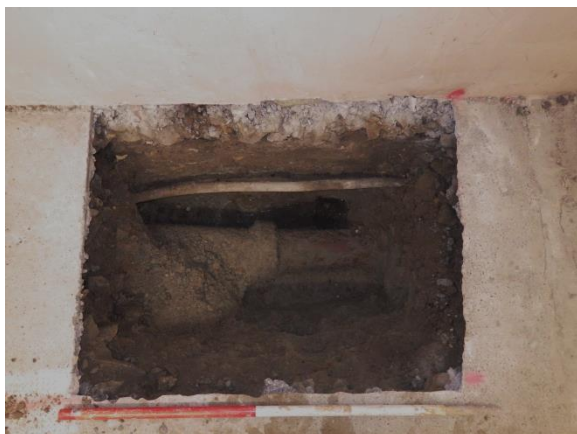
Plate 9 Trial Pit 5, General View

Trial Pit 5 was excavated inside the main range of the building, to the west of a north-west load bearing wall. The pit was dug by the contractors and inspected on the 19th of April 2018 (see *Plate 9* and *Plate 10*).

Trial Pit 5 measured 1.04m by 0.83m and 1.07m deep. A loose rubble bedding (018) under the concrete surface (001) overlay two service trenches and their associated fills: a lead pipe (021) and a ceramic sewer pipe (023). Only the cut [020] for the lead pipe was visible. Furthermore, six courses of the foundations [022] of the load bearing wall were exposed.

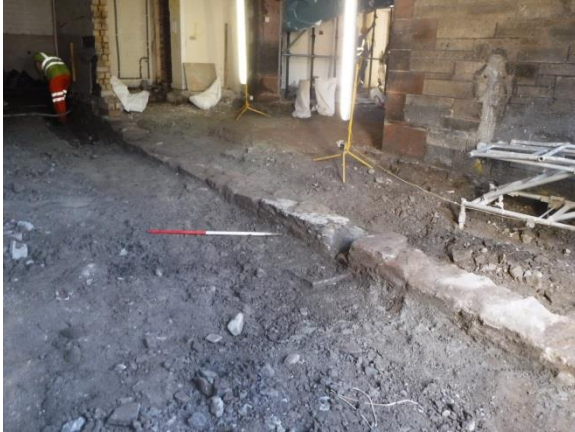
In the centre of the main range, the same configuration was encountered, with shallow natural exposed. The foundations of a north-south sleeper wall [024] upon which a north-south brick partition wall, were found bedded into natural deposits. It appeared that the sleeper wall was the same as the load bearing wall foundations [022] found in trial pit 5. The sleeper wall [024] was 0.5m at the south end and was exposed to a depth of 0.3m. The sleeper wall was traversed by a ceramic drain, originating from the south-east wall of the main range and connected to an inspection chamber against the wall (see *Plate 11*).

Plate 11 Sleeper Wall [024], showing Break for Ceramic Drain

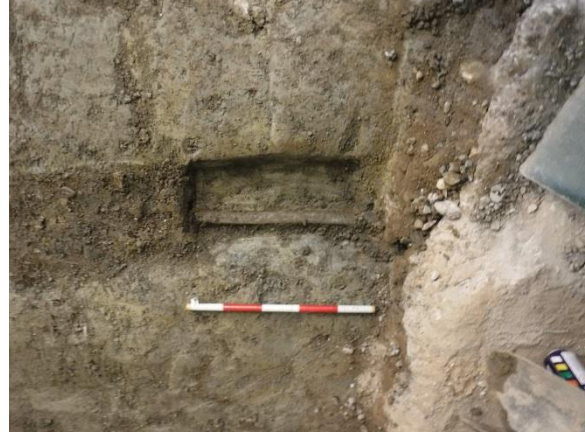
Running alongside the sleeper wall, was a pipe trench [056] for the sewer pipe (023) (as encountered in trial pit 5). Another feature associated with the existing school building was a service trench [025] for a lead pipe (026) running east-west 1.35m from the transverse wall (see *Plate 12*).

Plate 12 Service Trench [025] with Lead Pipe (026)

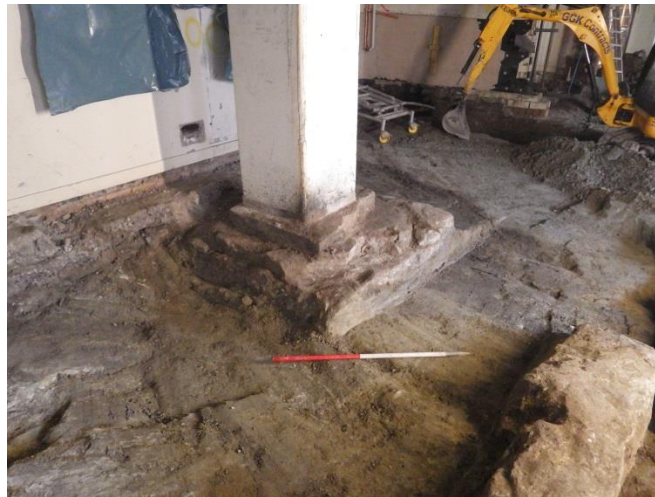
A sandstone rectangular foundation [057] was noted under the western central pillar of the main range (see *Plate 13*).

Plate 13 Pillar Sandstone Foundations [057]

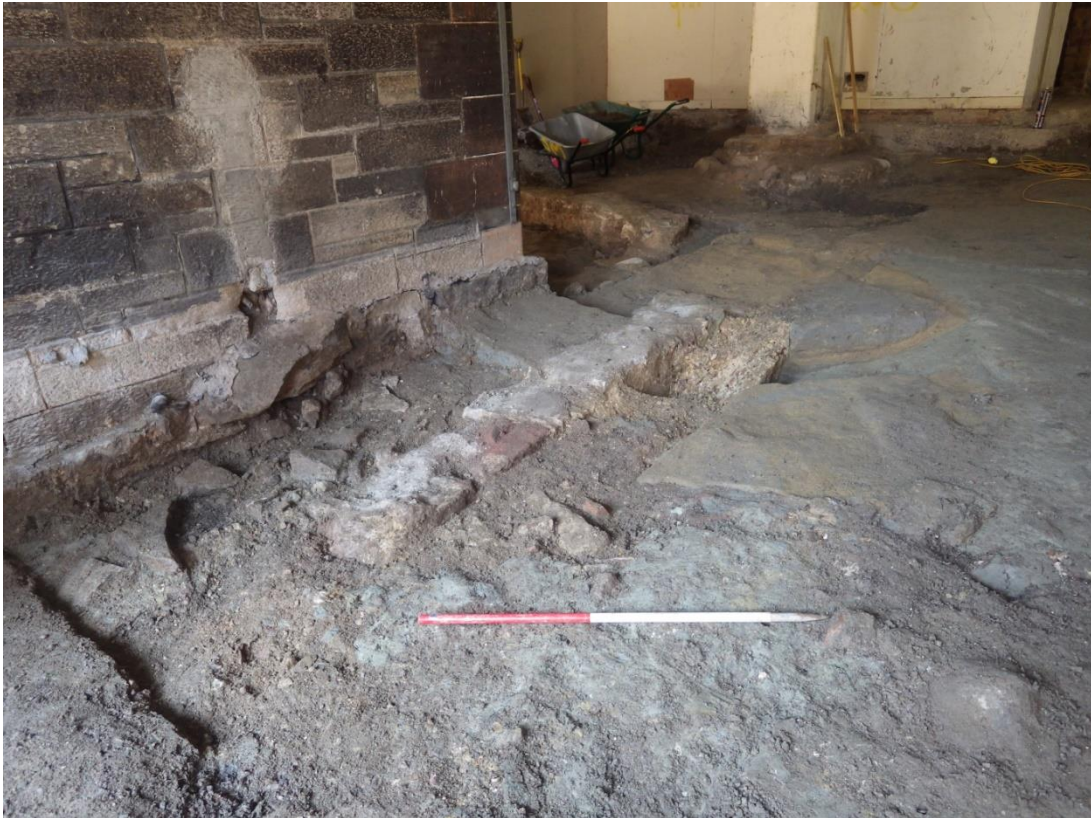
A few features predating the erection of the school building were found in the south west area of the main range and into the west range. In the north end of the area, the bedrock was sloping up towards the north-west and the castle. To the south, it appeared that the natural extended to a break in the slope or a cut [036]. To the south, redeposited natural (037) appeared to have been used to level the area for construction. In the south of the main and west range, two earlier walls were uncovered (see *Plate 14* and *Figure 7*).

Plate 14 Walls [031] and [038]

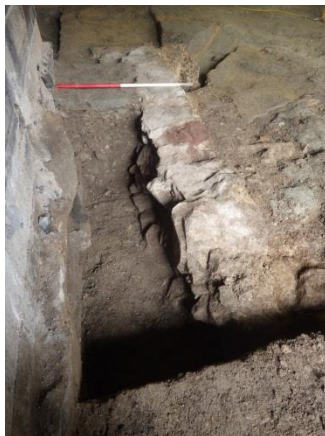
Wall [031] is oriented north-south, west of the existing south east wall of the main range. The school building foundation appears to cut it (see *Plate 15*, *Figure 7* and *Figure 8*). Based on the general aspect of the construction, it seems that this was the foundation courses of the wall.

Plate 15 Wall [031] and showing the West faced cut by the Foundations of the School

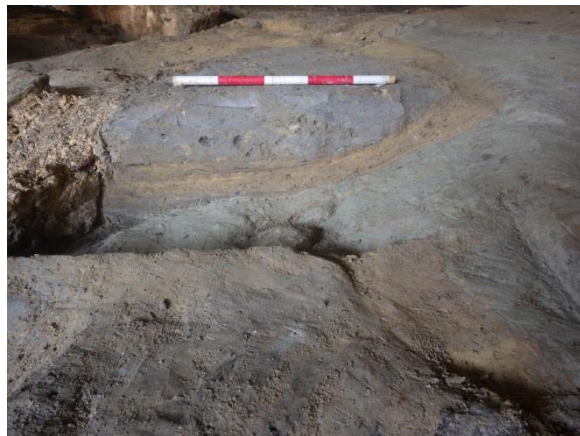
The construction of wall [031] appears to have been conducted in different stages. First the area was prepared by cutting into the natural (Cut [029]) which was then backfilled by sandy lenses (028) and redeposited natural (027), probably to level the area (see *Plate 16*). The foundation trench [034] was then cut through the two deposits (see *Figure 9*) and backfilled with construction waste material (030) and (035) to the south, including a large lump of concreted mortar.

Plate 16 Cut [029] with Backfills (027) and (028)

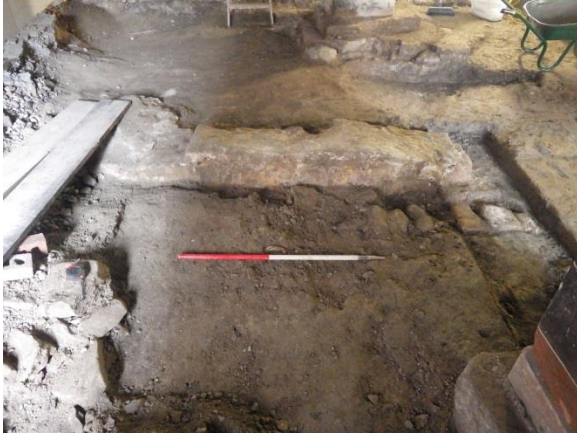
Wall [038] is oriented east-west and presents a plastered face to the south (see *Plate 17*), which indicates an upstanding elevation. Considering the depth at which this wall was discovered, it is highly likely that it was a cellar wall. It appears then, that walls [038] and [031] were not part of the same building, but different construction phases, with wall [031] predating wall [038]. To the south of the wall, a small manhole was noted at the east end. This feature might have been connected to the possible rubble drain, running parallel to the south face of the wall (see *Plate 18*)

Plate 17 Wall [038], South Face, showing Plaster

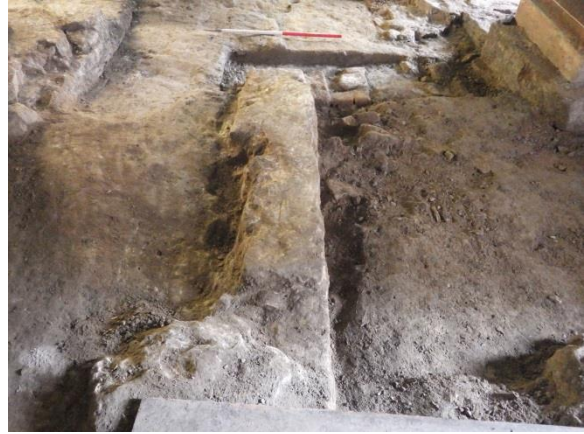
Plate 18 Wall [038], showing the possible Rubble Drain to the right of the Wall

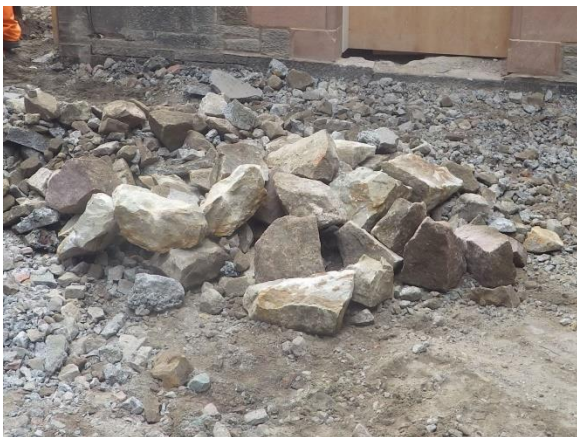
Externally, the down taking works started in the west courtyard, in the area between the West Range of the School Building, the Annex Building and the Janitor's House. The concrete floor (001) was first removed onto a very loose rubble bedding (043). Under the bedding, the whole area was covered with a loose silty sand deposit with a high frequency of medium to large sandstone blocks and fragments (see *Plate 19*) and bitumen patches and occasional clay patches. It appears that this is the backfill of the construction of the School. The previous buildings, as depicted on the OS maps were probably destroyed (as indicated by the sandstone blocks) and the area appears to have been stripped to the natural, at least in some areas, before the same natural material was spread over the area for levelling. Further evidence of this is found in the presence of various drains and metallic pipes for the School building ([045], [047], and [048]), for which installation required the bedrock to be cut [053] in some places or is directly overlaying the natural (054) (see *Plate 20*, *Plate 21*, and *Plate 22*).

Plate 19 Large Sandstone Blocks in (044)

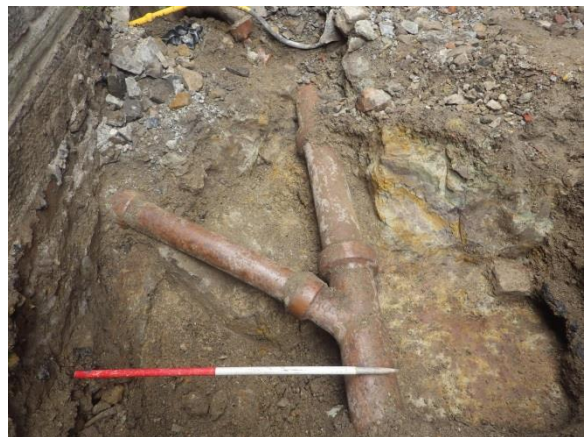
Plate 20 Drains [045] and [048]

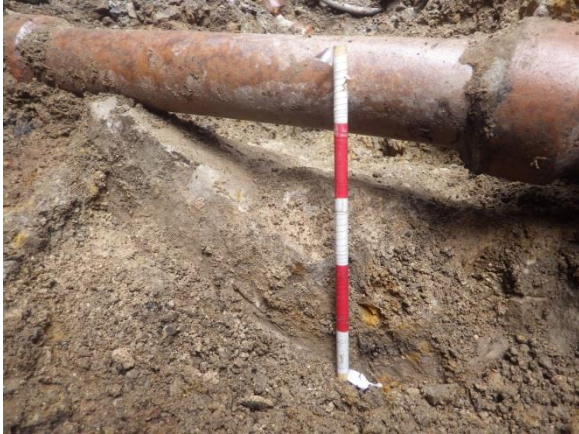
Plate 21 Drain [048] showing Cut in Bedrock

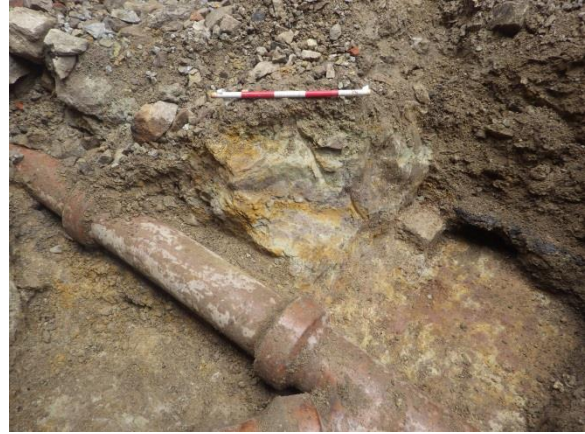
Plate 22 Drain [045] and Cut [055]

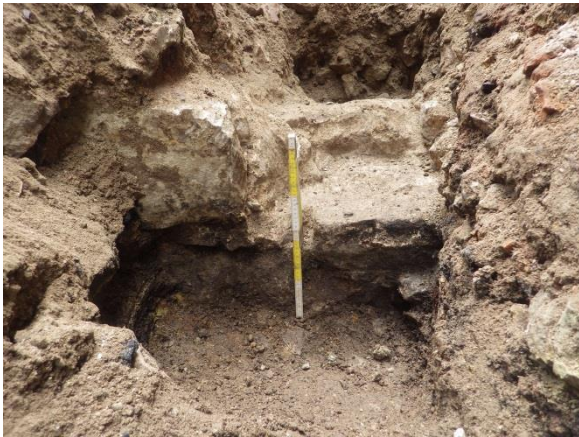
Despite the terracing and demolition conducted in order to build the School, a short section of an earlier wall was uncovered in the Western Courtyard (see *Figure 12* and *Plate 23*). Wall [049] is made of large sandstone blocks, bonded with beige lime mortar. The wall survives only for a length of 0.90m and a depth of 0.40m. It appears that the full width (0.70m) still survived. The foundations were directly overlying and against the bedrock (*Figure 13*, *Plate 25* and *Plate 26*). A concave cut [050] was found running along the north face of the wall, with a wooden beam lain parallel to the wall in a dark charcoal rich fill (051), this could have been installation for floor joists of the original building (see *Figure 11* and *Plate 24*).

Plate 23 Wall [049] as first exposed

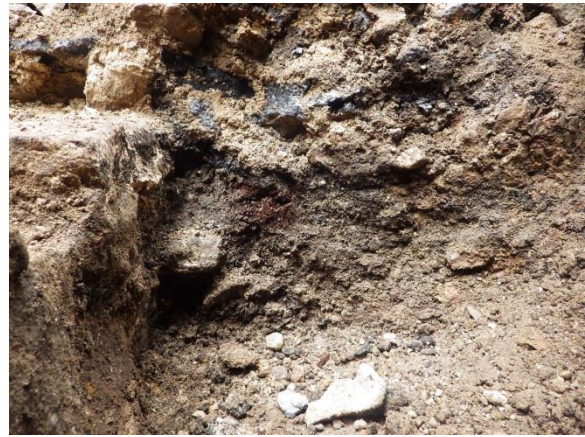
Plate 24 Cut [050] with Wooden Beam

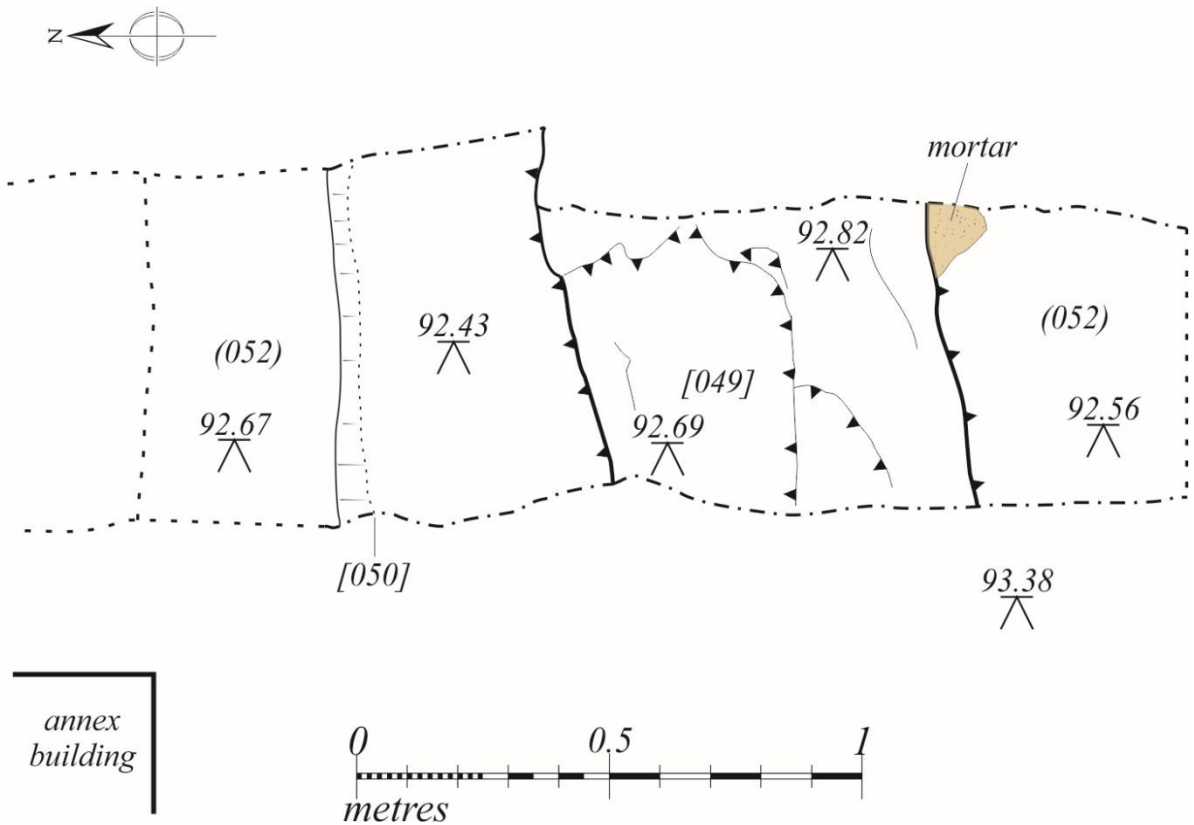
Figure 12 Plan of Wall [049]

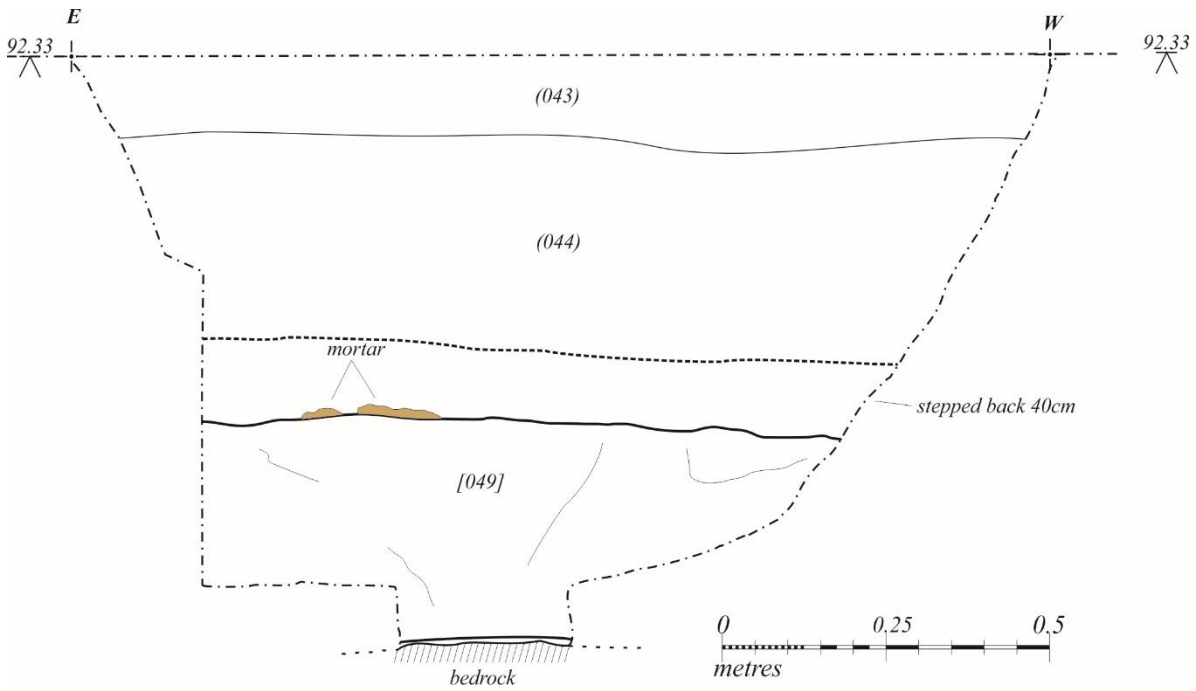
Figure 13 Elevation of Wall [049]

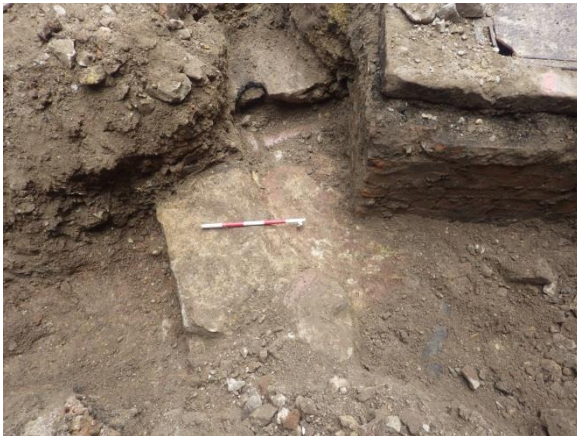
Plate 25 Wall [049] showing Bedrock to the Right

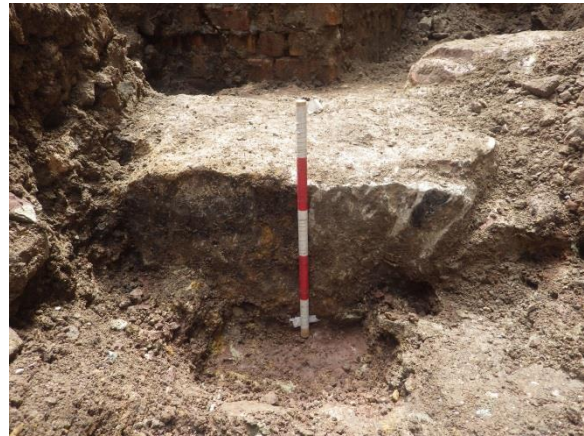
Plate 26 Wall [049] directly lying over Bedrock

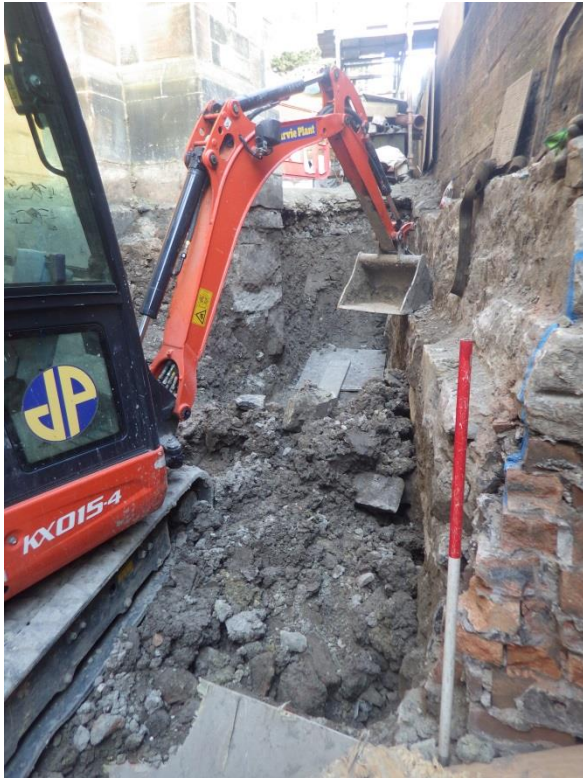
Further monitoring was undertaken in October 2018 within the southern courtyard. Much of this area had been previously disturbed. The works involved the ground reduction between the southern wall of the building and the retaining wall on to Johnston Terrace. This revealed the foundation courses of the boundary wall to Johnston Terrace (Plate 27) and of the school (Plate 28).

Plate 27 View of excavations southern courtyard, school building to N, retaining wall to S

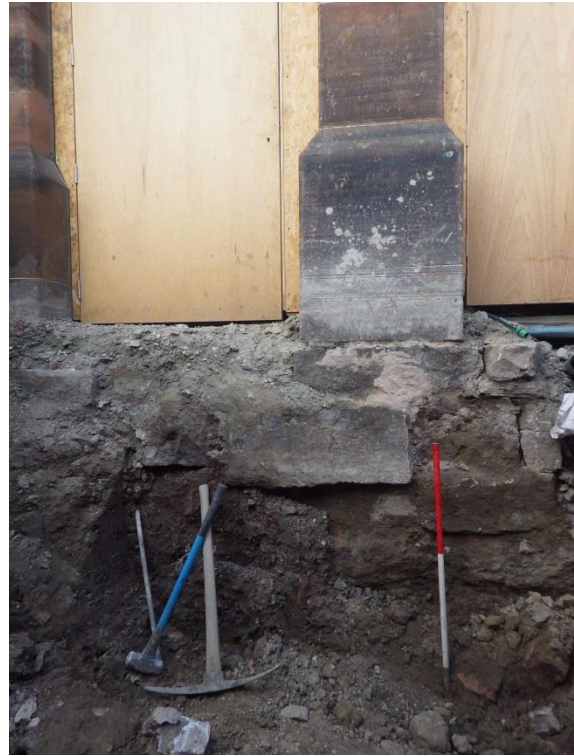
Plate 28 Exposed foundations of school building from southern courtyard excavations

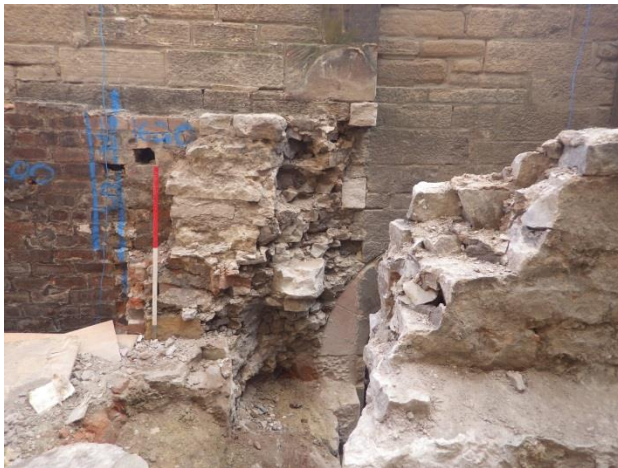
Further excavations revealed the remains of the former steps and masonry walling associated with the present building; no earlier remains were seen (Plate 29 and Plate 30).

Plate 29 Remains of former steps

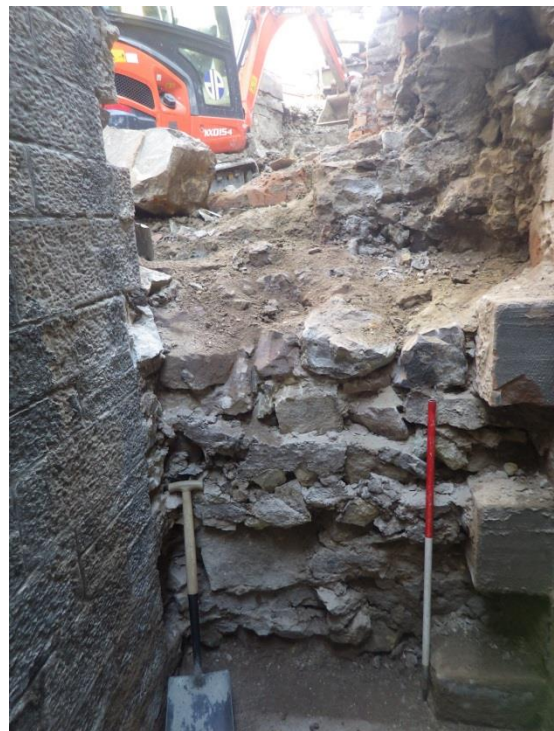
Plate 30 General view of excavations of southern courtyard, rubble blocking

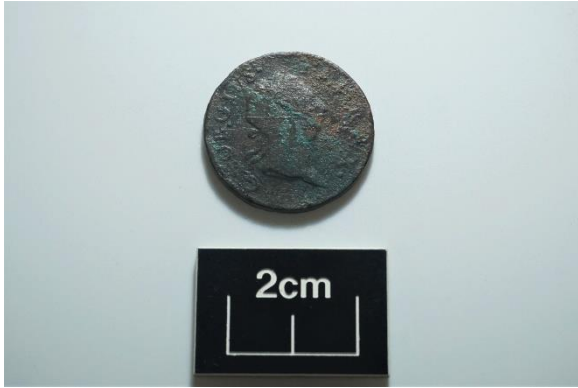
Plate 31 SF001, George III Half Penny, Obverse

The coin was found within fill (051) of cut [050], the possible foundation trench of wall [049]. It is a half penny of George the III (see *Plate 31*) minted in Ireland, as indicated by the cláirseach on the reverse (see *Plate 32*). This particular mint is dated to 1769. It is unclear if this deposition is related to the construction of the wall, the installation or repair of the floor, or if it was simply dropped between two floor boards during the occupation of the house.

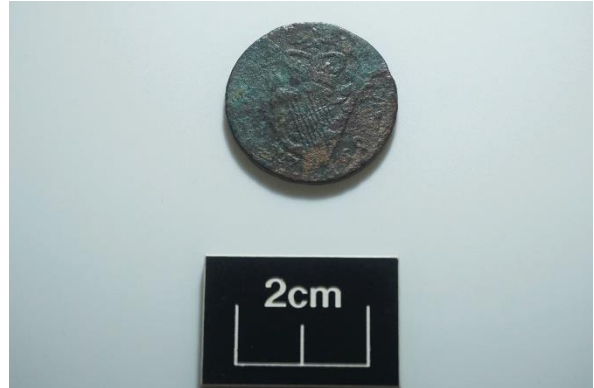
Plate 32 SF001, George III Half Penny, Reverse

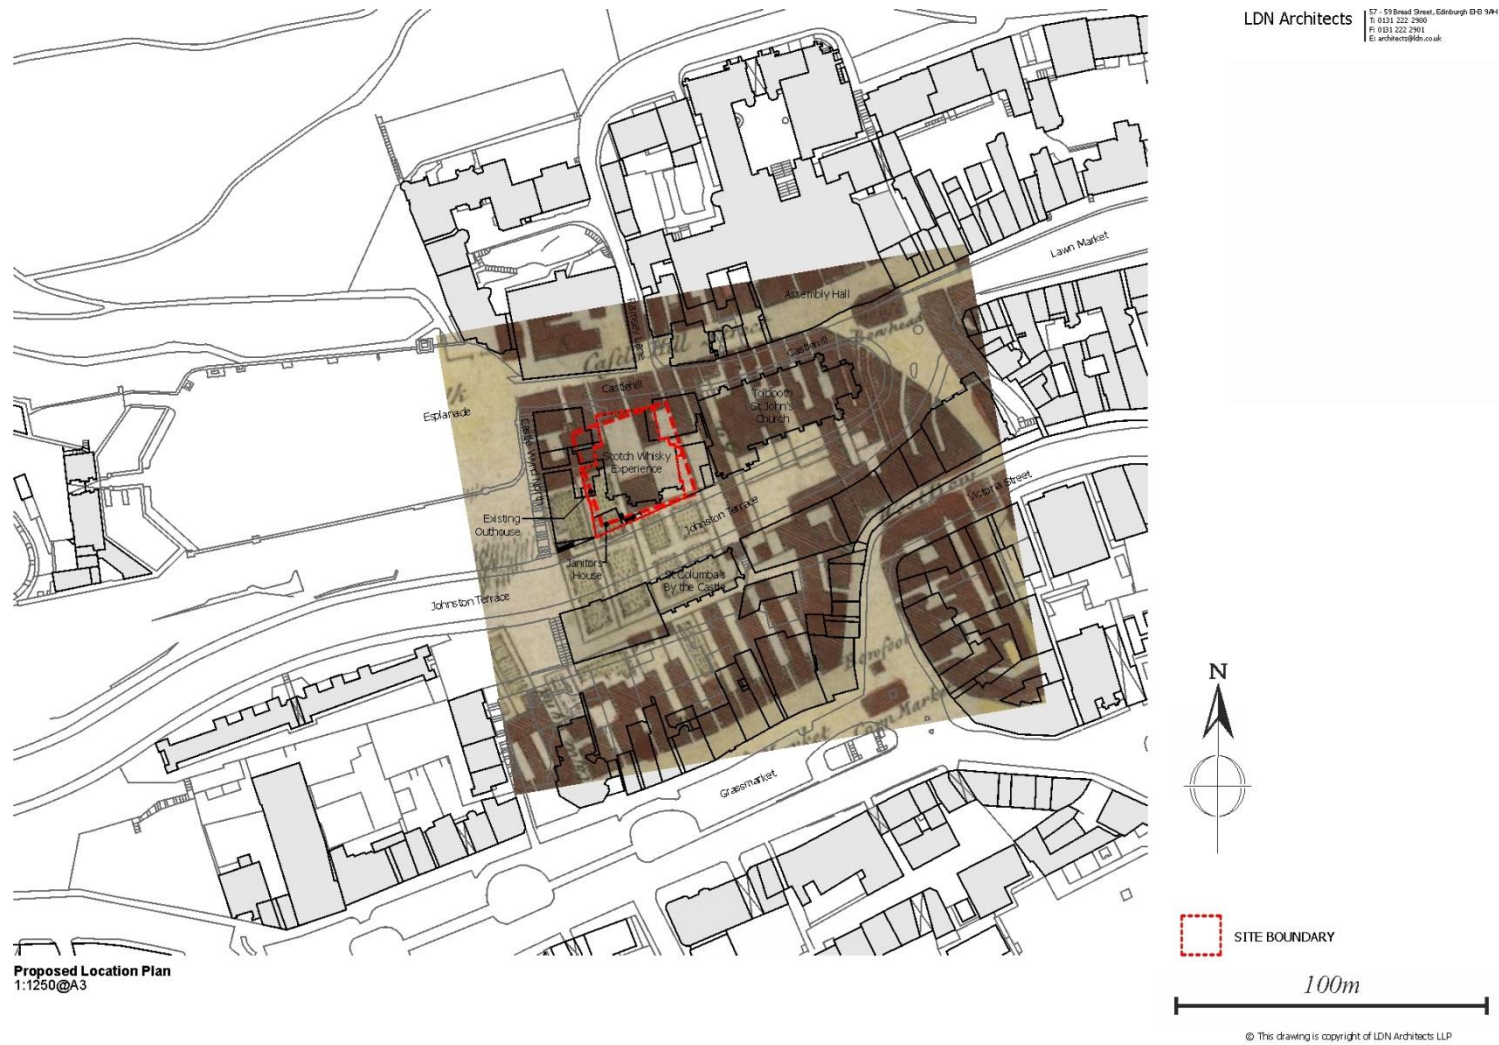
The excavations within the building revealed a number of walls pre-dating the school building. The site plan has been overlaid on to earlier maps in order to compare the walls discovered with mapped buildings (*Figure 14* and *Figure 15*). Edgar's map of 1765 shows a square building at the southern edge of the site, fronting on to what is now Johnston Terrace. At the time, this building was located in a backlands plot to the rear of Castle Hill in front of some laid out gardens, which would later be demolished to make way for the new street. The north-south wall discovered during the excavations is roughly in line with the eastern wall of this building; the return of the excavated wall to the west suggests that these walls may represent the north-east corner of the building as depicted in *Figure 14*.

Figure 14 Overlay of Edgar's plan of 1765 on to site plan; the walls discovered may correspond to the north-east corner of the building on Johnston terrace
