28-30 The Close

Newcastle upon Tyne, Tyne and Wear

Archaeological Excavations: 2007-2010- Full Analysis Report

March 2019

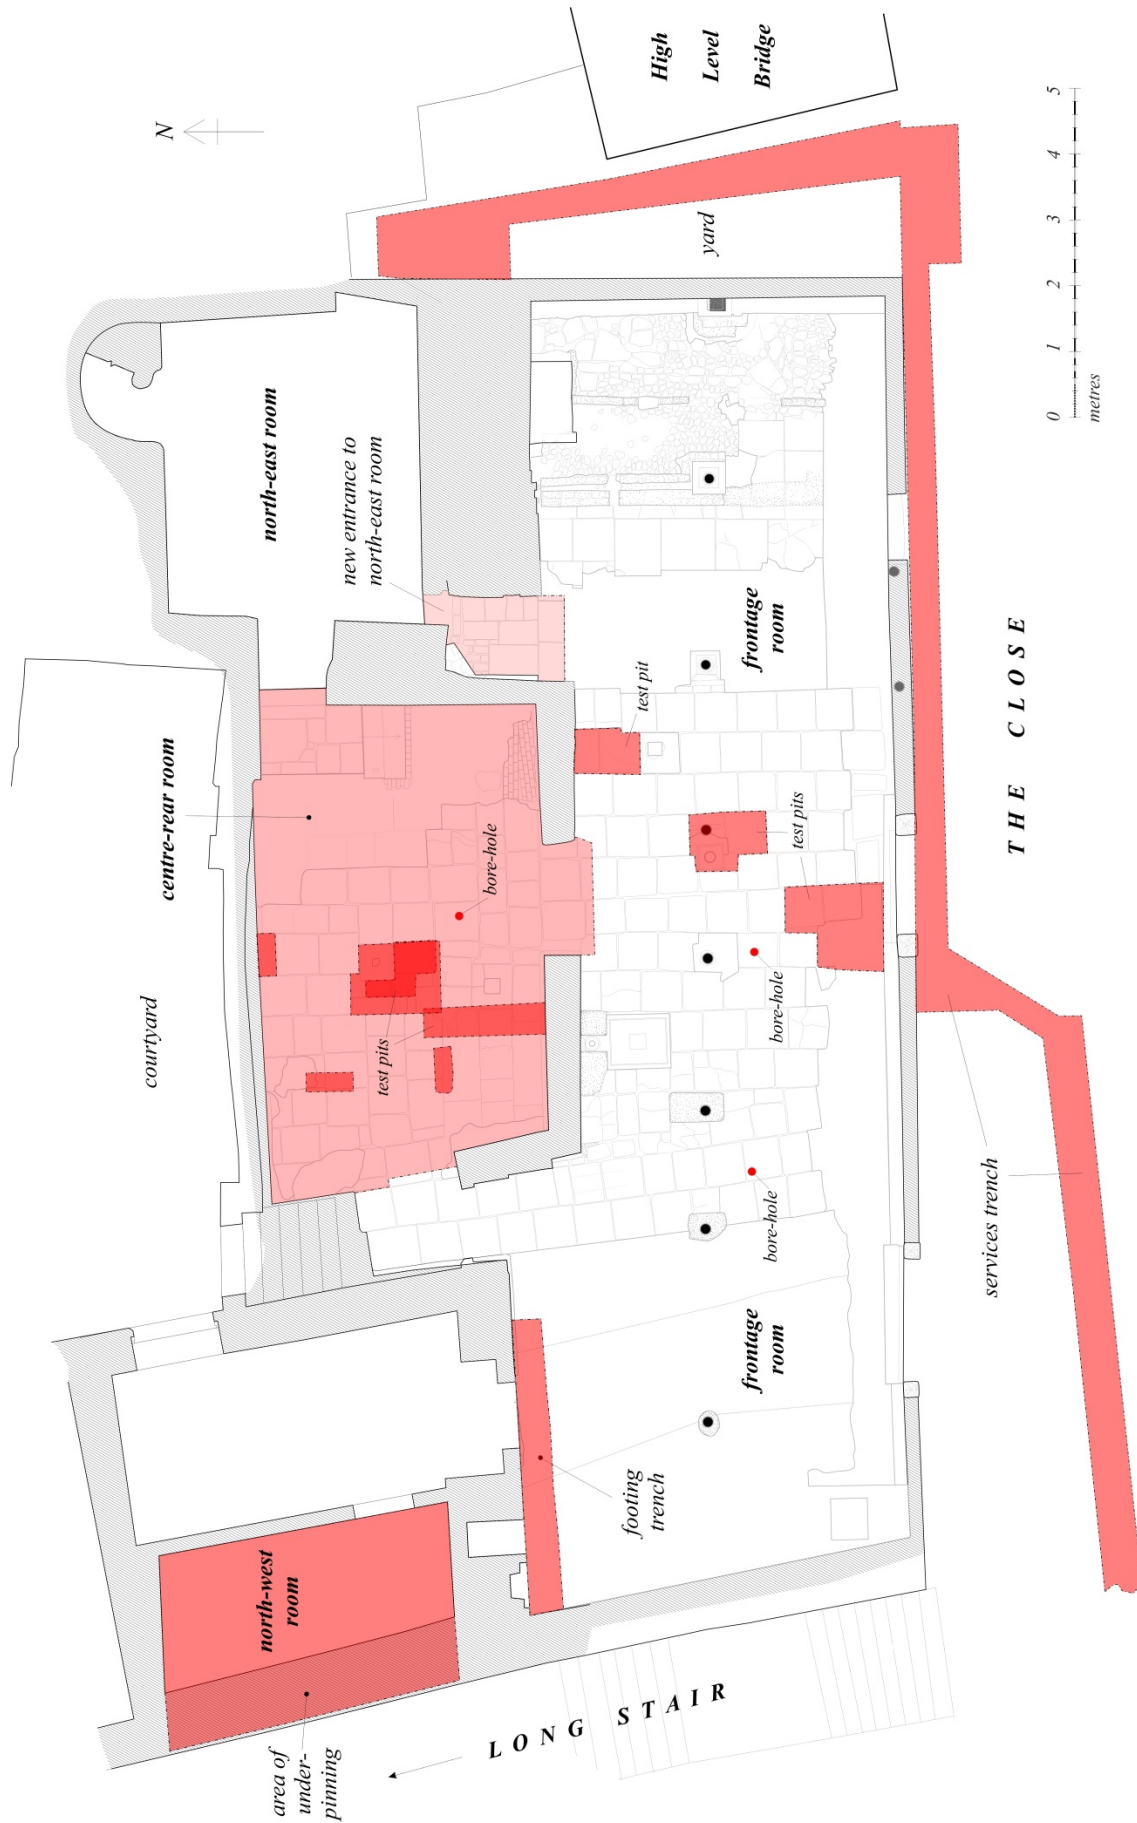
Figure 4 Plan of excavation areas

However, the first stage of excavation between 2-6 February 2009 revealed considerable further complexity, including later 18th century / early 19th century drainage systems, structural remains of probable late 17th or early 18th century date, and further masonry features and more complex dumping activity that were clearly of medieval date. These finds necessitated a change of excavation strategy (in agreement with Jennifer Morrison at a site meeting, 13 February) whereby a much higher proportion of the site was subject to formal archaeological excavation, and only limited areas remained for supervised removal by contractor. This second stage of work was carried out between 23-27 February. Excavations proceeded in the central rear room with the laying-out of north-south and east-west baulks to maintain stratigraphic control, and the room was therefore excavated in four quadrants, *A-D*.

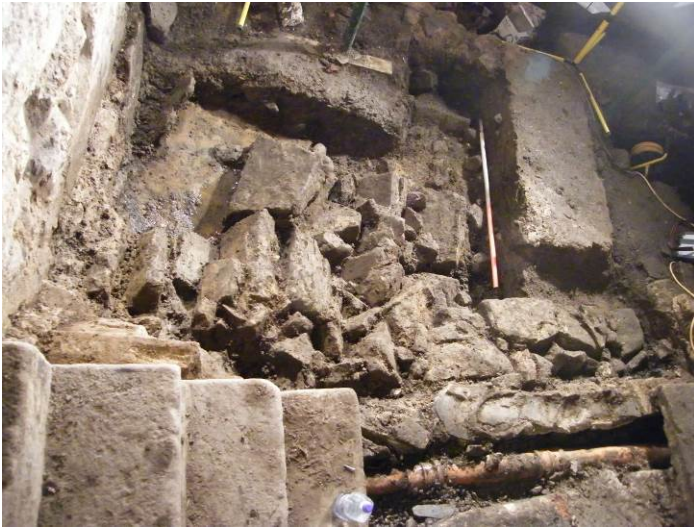
Plate 1 Remains of early collapsed wall along the north wall foot of the rear room (038), looking east

Intermingled with the stones throughout and overlying them to a considerable depth was a major deposit of very dark grey-brown humic silt, (008), discussed further in the next section. With regard to the wall it is possible that this had been material upslope that had been retained by the wall – a deep topsoil and associated build-up.

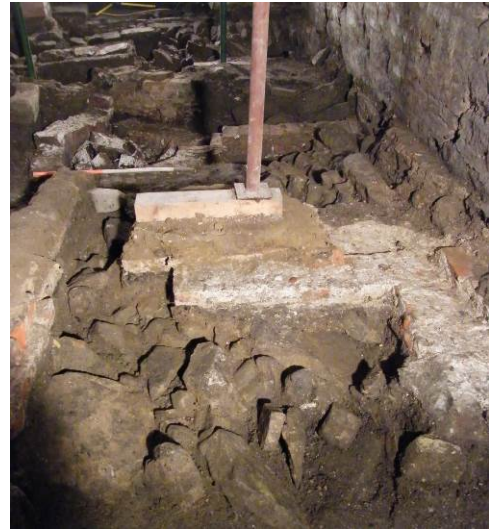
Plate 2 Remains of early collapsed wall along the north wall foot of the rear room (038), looking west

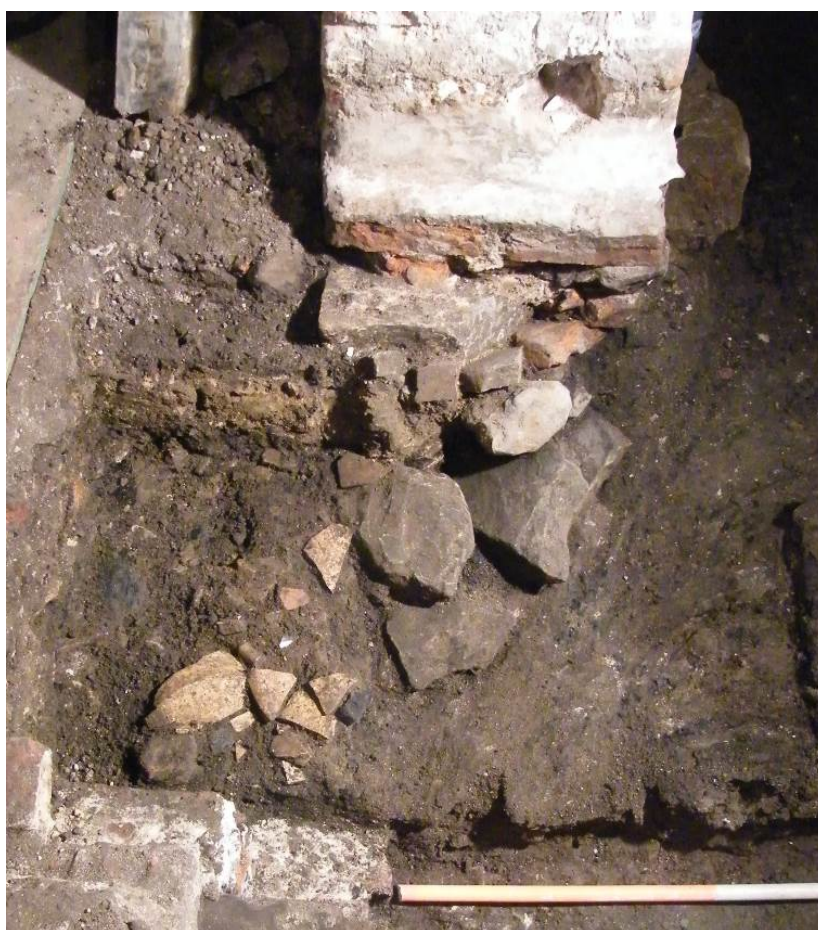
Plate 3 Early make-up deposits within the area of the archway in the south wall of the rear room, looking west; note pottery spread, the associated stone rubble deposition (centre – 034), and to right the underlying (008) make-up level; at top the brick walling can clearly be seen to be founded upon a stone predecessor (048)

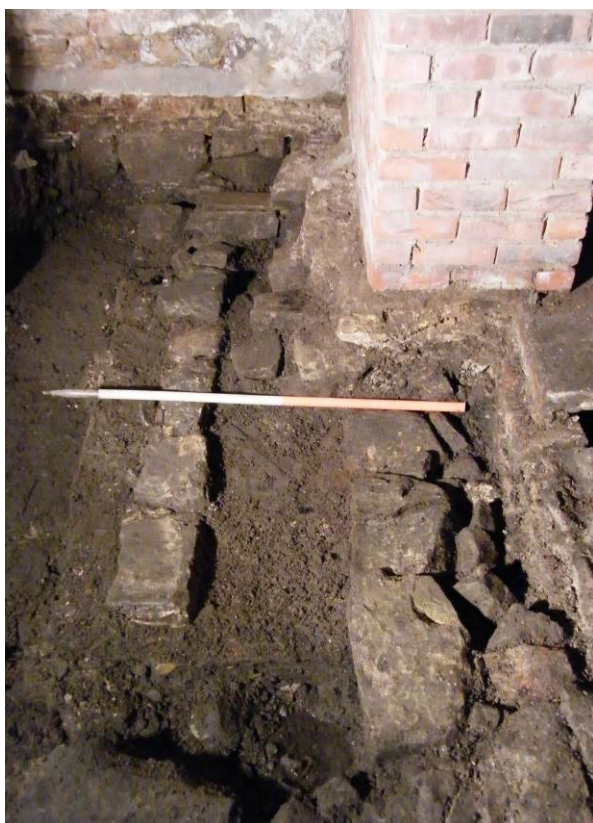
Plate 4 Stone-lined drain (040), looking south, running below early wall footing at top (048)

Of somewhat uncertain date was a stone-lined drain with mortared masonry walls, stone slab base and cappings, that ran in north-south alignment along the west side of the excavation area - (040) (plates 4-5 and Figure 6). Cut into the medieval deposits from above, its chronological and stratigraphic relationship to these otherwise remained uncertain – whether of similar date or built quite considerably later (late medieval or even early post-medieval). Up-slope the drain had been truncated in a similar manner to the surrounding medieval deposits, the interior partly becoming in-filled with associated debris and finds of varied date. Down-slope the drain clearly ran under the brick-built south wall of the rear room (broadly dated to c1700) and, importantly, an underlying earlier wall footing – (048) of pre-1700 date. Further, the four pottery sherds recovered from the fill (045) of stone-lined drain (040) were very fragmentary and spanned the early- 13th to late-14th century (Sage, Appendix2A). While possibly residual, these sherds may suggest the feature was indeed earlier rather than quite considerably later.

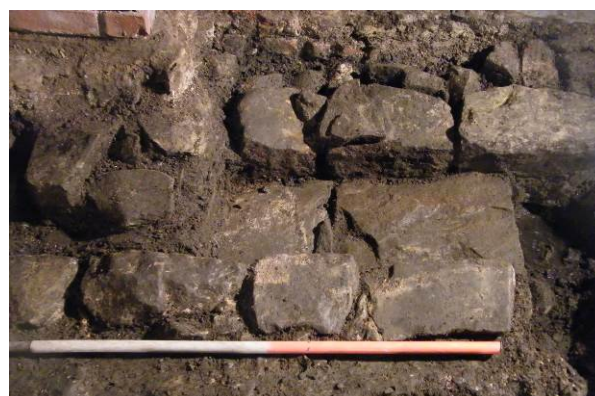
Plate 5 Stone-lined drain (040), detail of drain looking west, following removal of part of fill

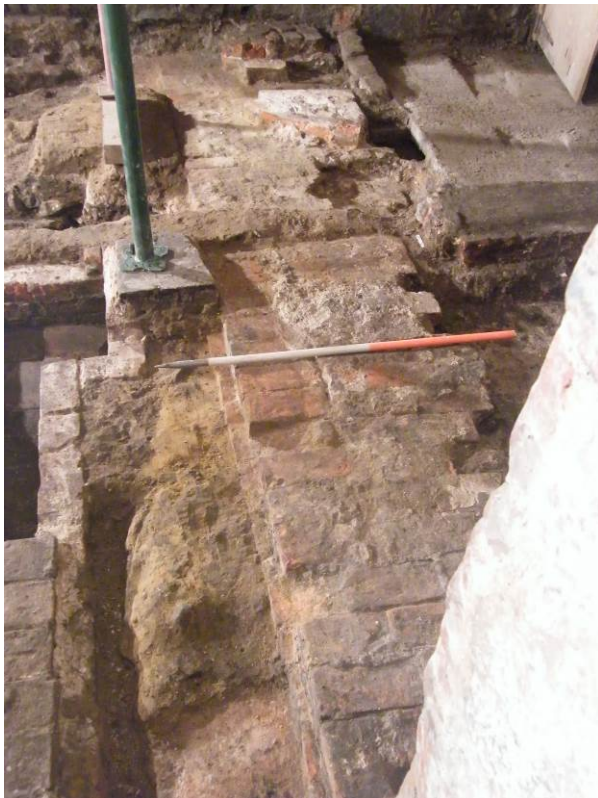
Plate 6 Brick-built footing (014) for a cross-wall and base of a wooden stair, looking north

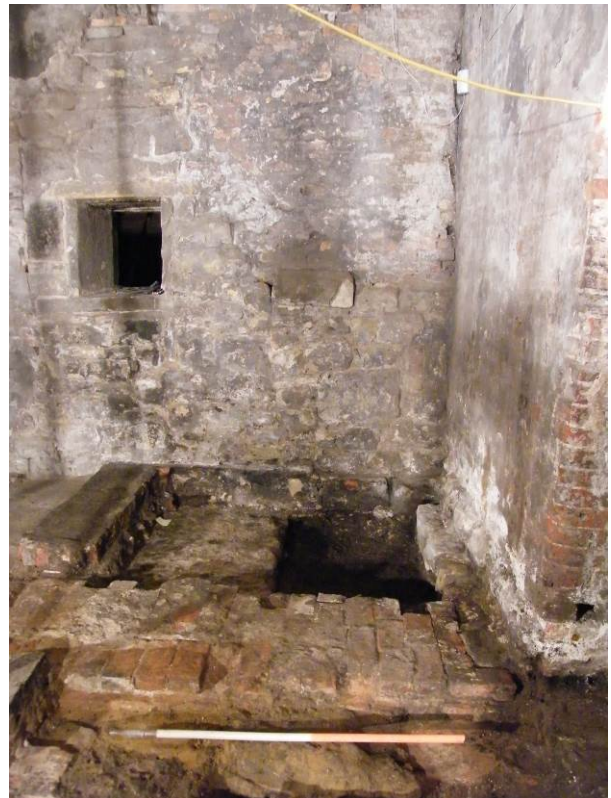
Plate 7 Area of base of stair, looking east; the walling above preserves the diagonal silhouette of part of the stair timberwork superstructure

The important evidence for the stair adds considerably to the understanding of this part of the standing structure and how it had functioned at this period. The stair rising at this angle may also have extended to second floor level. It seems to have given access between the first floor chambers, evidently the principal accommodation, to what seem to have been service arrangements at least at the lower level of the rear wing. Relating these below-ground remains to the upstanding structure will be examined in more detail in the Historic Building Record report.

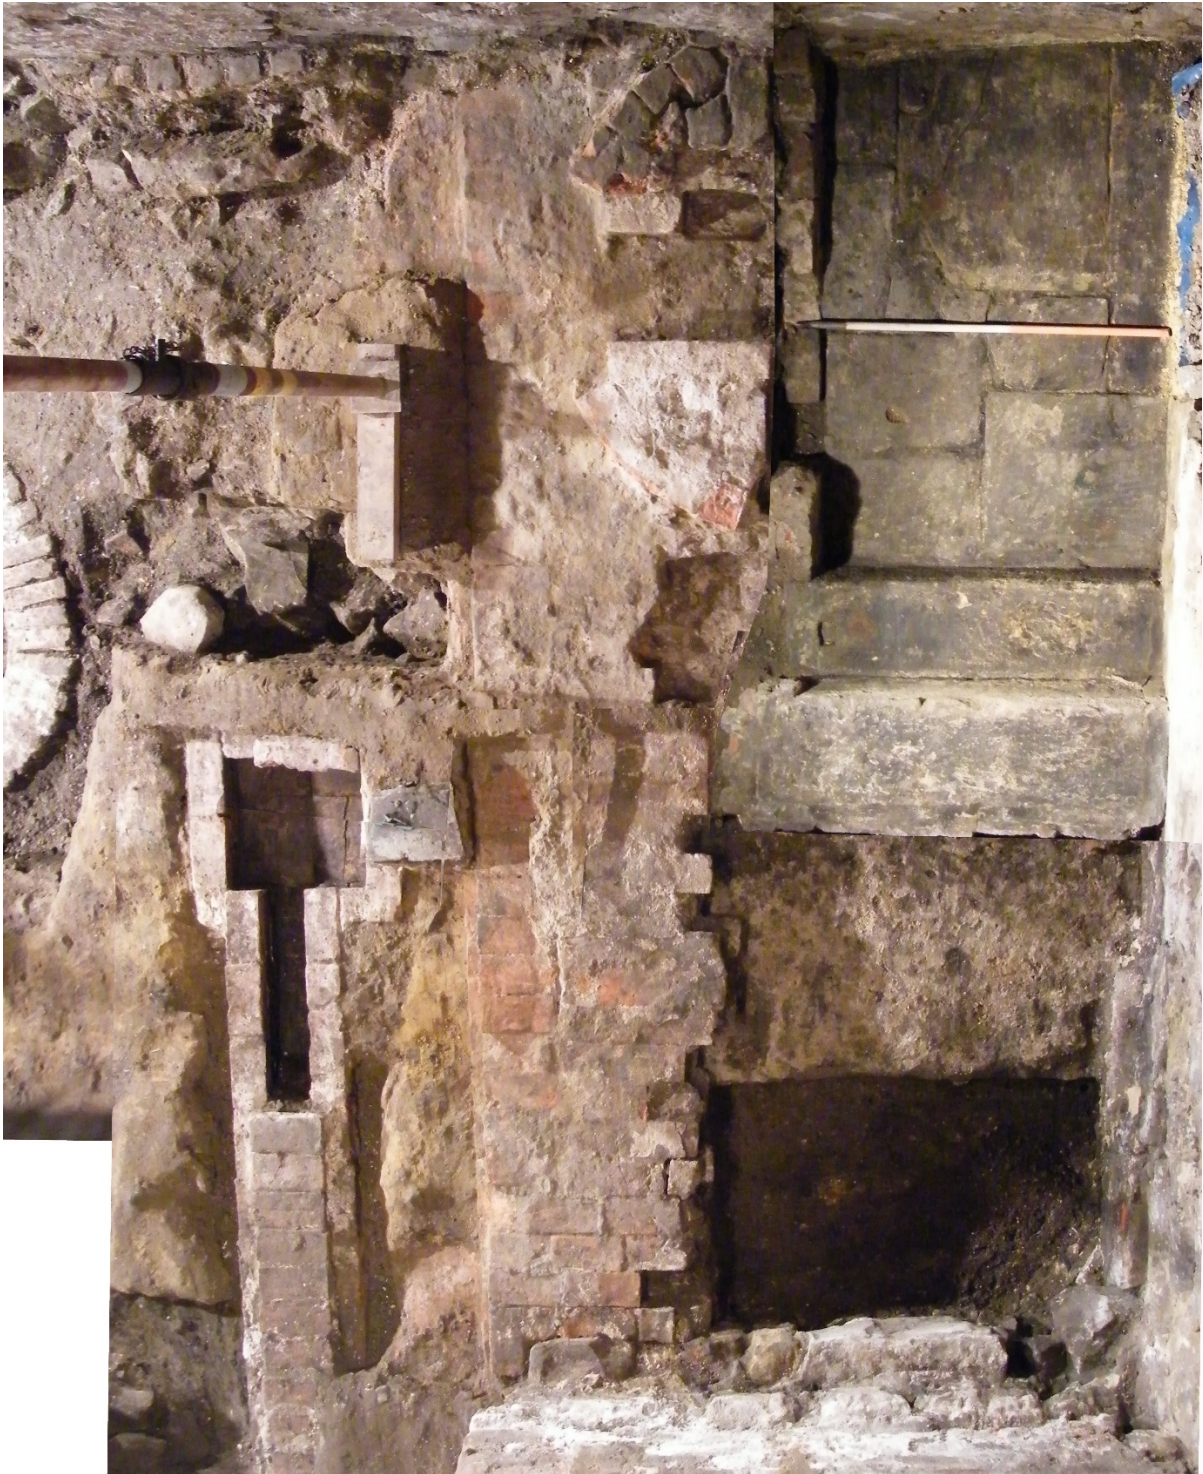
Plate 8 Vertical view of the eastern side of the excavation area showing the surviving extent of the (014) brick platform, the later sunken stair and paving to top right (005, 043) and later drain to lower left (010); north at top

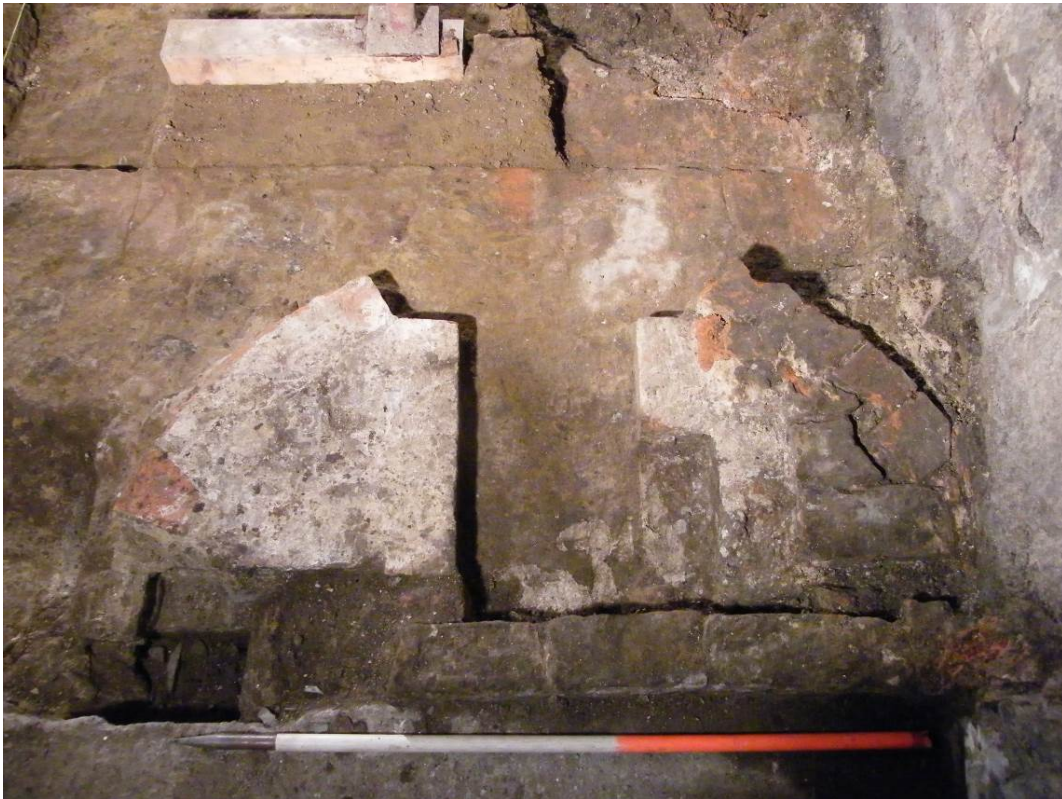
Plate 9 The fragment of the circular brick-built feature, (001), overlying the northern part of the brick platform, (014), looking west; at top abutting the platform are further mortar remains, (036)

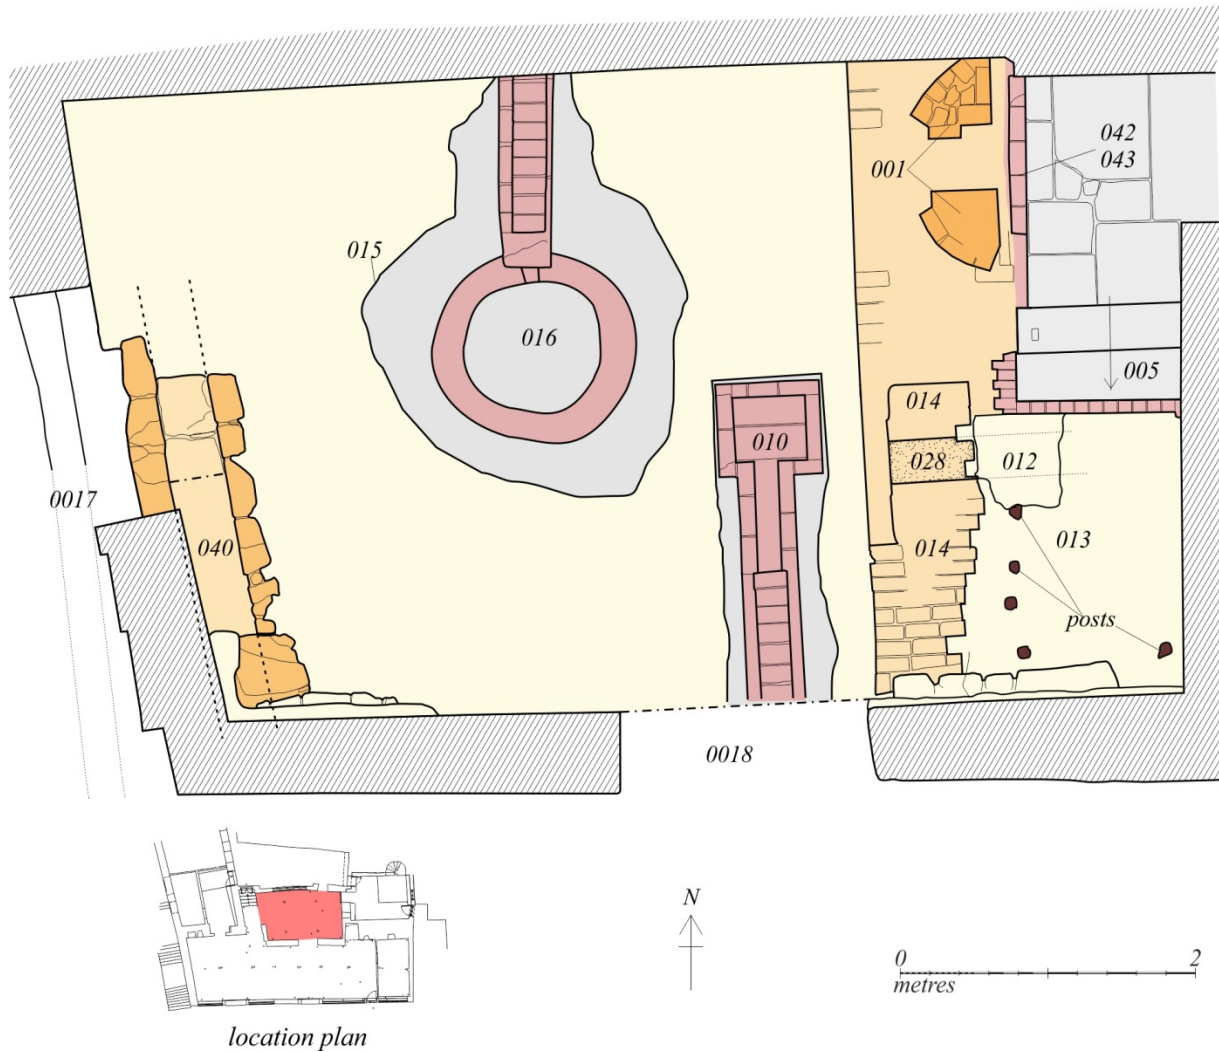
Figure 6 Centre-Rear Room plan of excavated features

Excavation revealed the entirety of the clearly defined well cut (015), see Figure 6 above. From its uppermost edge extended a vertical-sided cut of about 2.0m in diameter. Finds from within the humic, mortar rich and rubble-packed fill of the cut (006) included pottery and a tobacco pipe bowl, the latter suggesting a mid-later 19th century date for the well construction. However, it was revealed that the upper part of the fill had seen secondary disturbance, described in the next section. Finds from further down within the cut fill included sherds of white salt-glazed tablewares of later 18th century date that perhaps suggest a slightly earlier origin for the feature, perhaps c1800 or the following decades. It is also possible that the well may be a much earlier feature whose upper parts were remodelled at this time – unfortunately there was no necessity to empty the fill further.

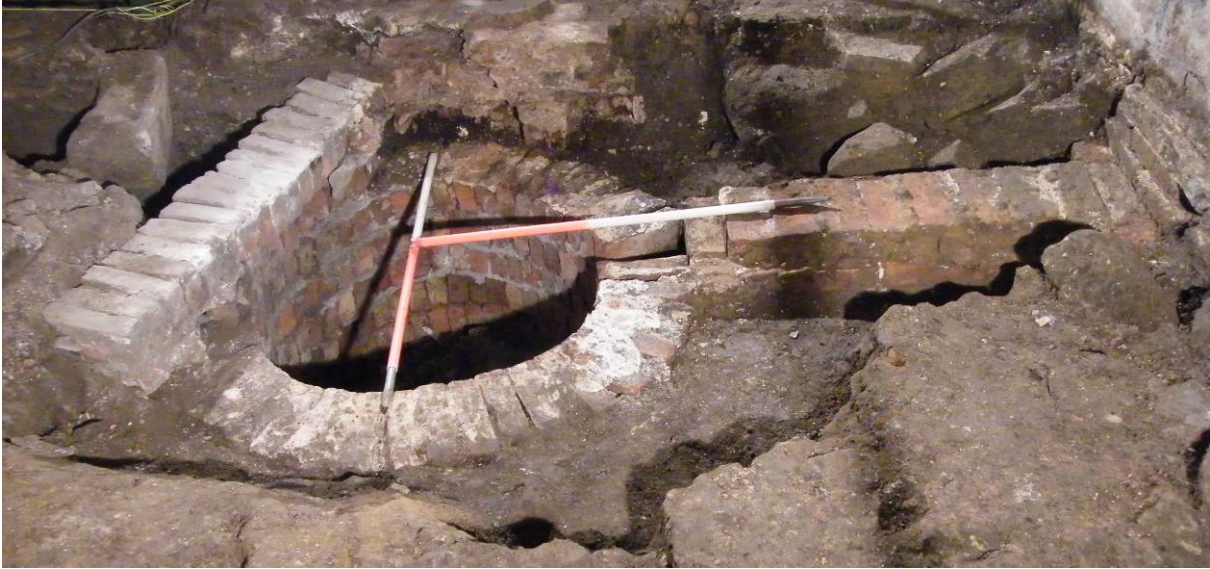
Plate 10 Brick-built well (016), channel running in from the north (018), and later brickwork relating to capping (017); looking west

A substantial well was revealed at the centre of the room at the evaluation stage, (016) (plate 10). During the excavation most of its details were revealed. It was found to be wholly brick-built down to the maximum depth of exposure of about 2m below floor level; the bricks were header-bedded and set with lime mortar, of coarsely produced *common* type and of larger dimension than those of earlier phases (24cm x 11cm x 6.5cm). The well-sides appeared to be stable though sub-oval rather than circular in plan. At the existing top of the well shaft it was apparent that upper courses of brickwork had been removed and that the well lining had originally risen to a higher level than at present.

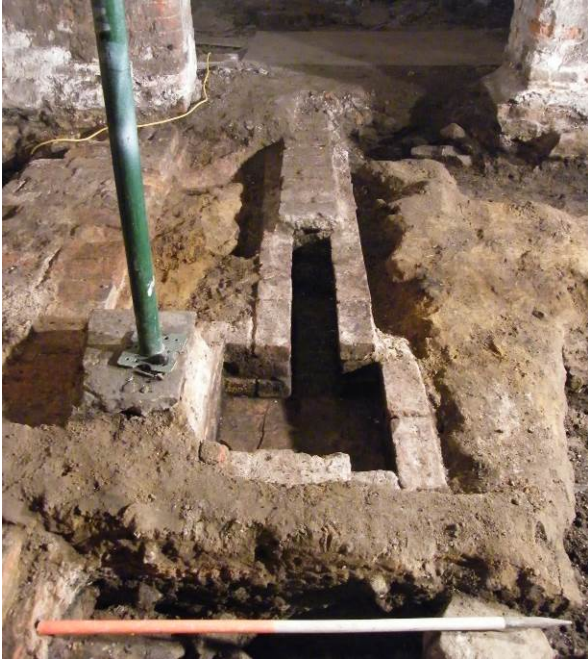
Plate 11 The (010) brick-built drain as revealed, looking south

A little to the east of the well, but not directly associated with it, a further brick-built drainage feature was encountered: an apparent sump, square in plan, with a brick-lined channel running southwards from it, (010) (*plates 11-12*). The feature was neatly constructed of mortared brickwork of very similar character and construction detail as the channel running into the well, (016). The channel extended through the broad arched entrance within the south wall of the rear room, and into the frontage room beyond the limit of excavation; it very gently sloped down in that direction. The feature lay within a well-defined vertically-sided cut, (021). The drain fill (022) was of silty/humic material with considerable rubble content – crushed mortar, some stones and broken brick.

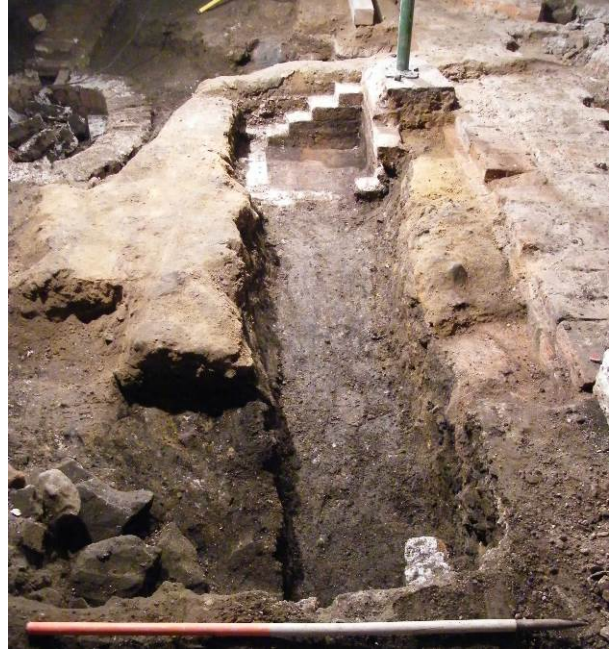
Plate 12 The (010) brick-built drain and its construction trench following partial removal, (021); note the yellow sandy make-up levels associated with the c1700 works on either side – looking north

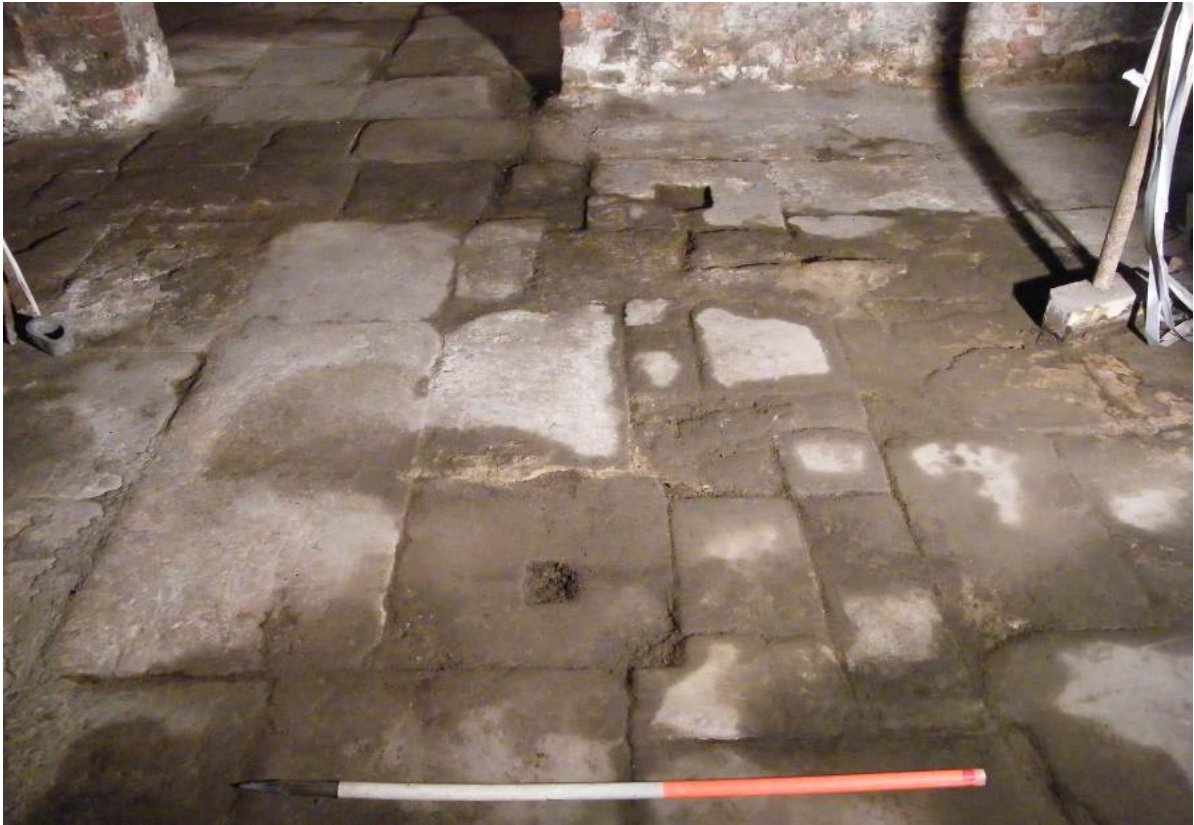
Plate 13 Flagstone flooring within the central part of the rear room, looking south

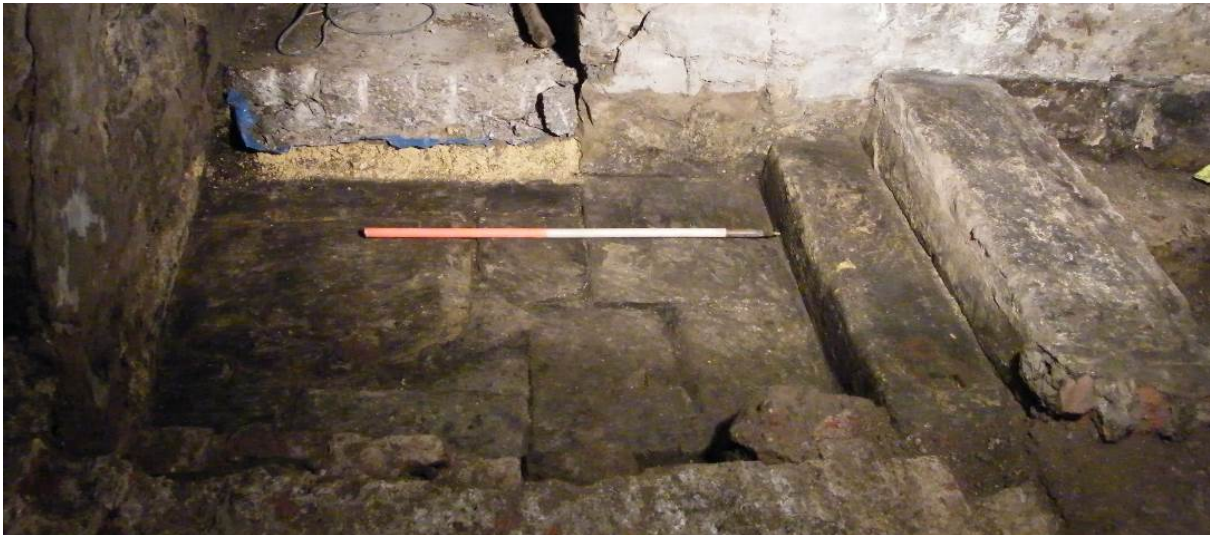
Plate 14 Masonry stair (005), sunken area and paving as revealed at the NE corner of the room, looking east

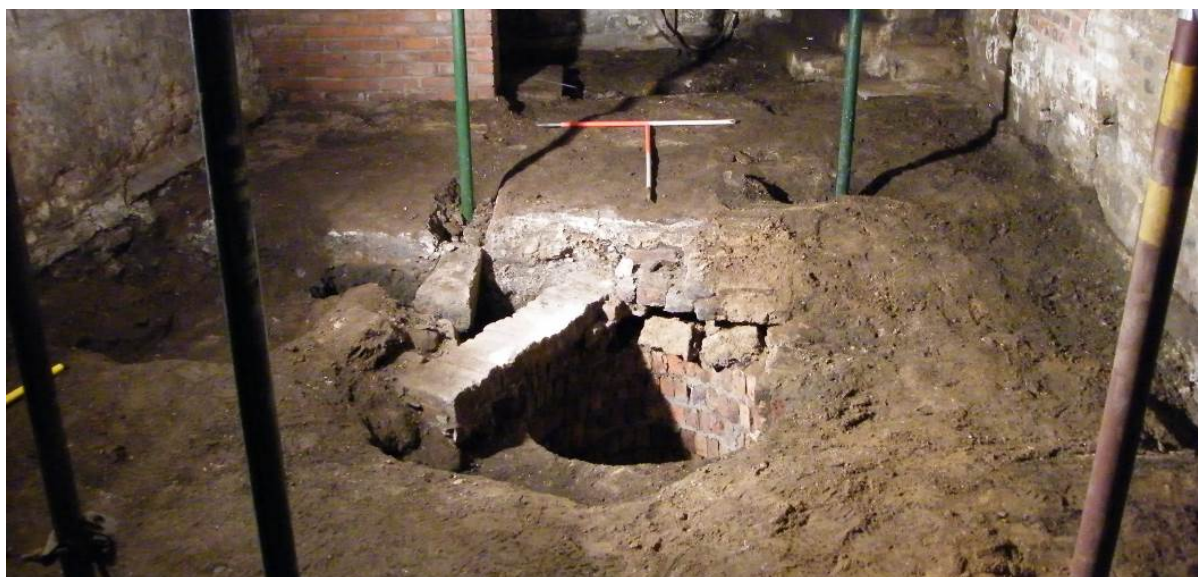
Plate 15 Pre-excitation photograph showing the extent of the (002) make-up beneath the flagstone floor, with the well (016) encountered in the central part of the room and associated modifications; looking west

Removal of the flagstone flooring revealed an underlying make-up deposit (002) across much of the room interior – generally a mix of sand and crushed lime, but somewhat rubbly at points and generally to a depth of up to 0.10m (*plate 15*).

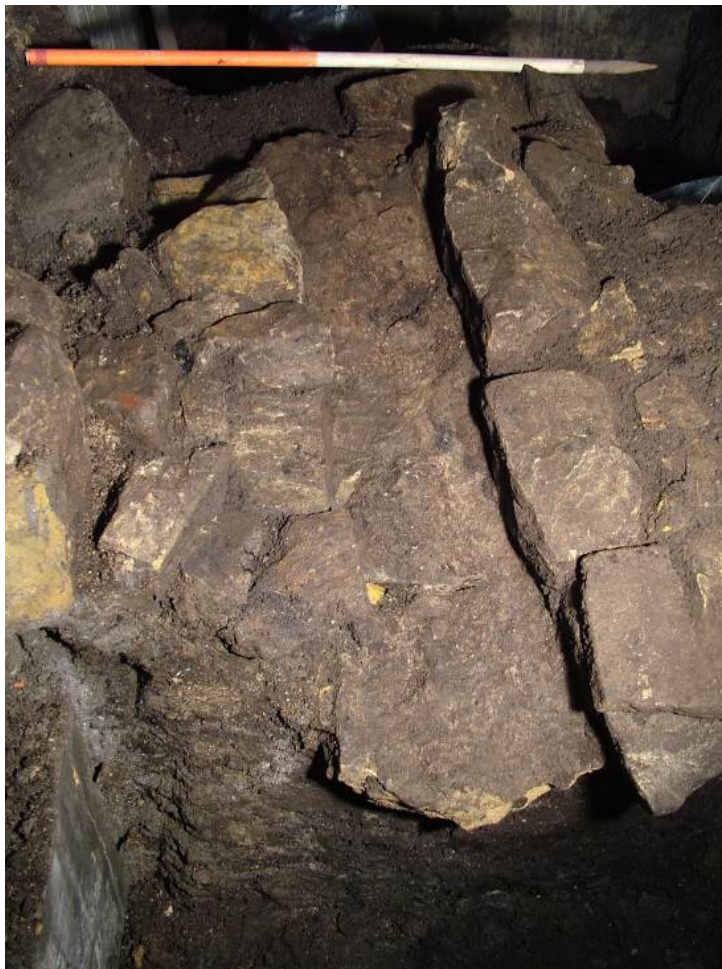
Plate 17 Drain (065), middle surviving section, once capstone lifted and emptied, looking north

To the south, drain (065) had been cut through and built over by the masonry of (052), making it obsolete as a functioning feature. It must have formerly continued southwards and into the street beyond, either into a street drain or possibly directly into the river. This drain must have related to the use of the building prior to the frontage ground-level reduction, thus before phase 5 of the building sequence ('c.1700').

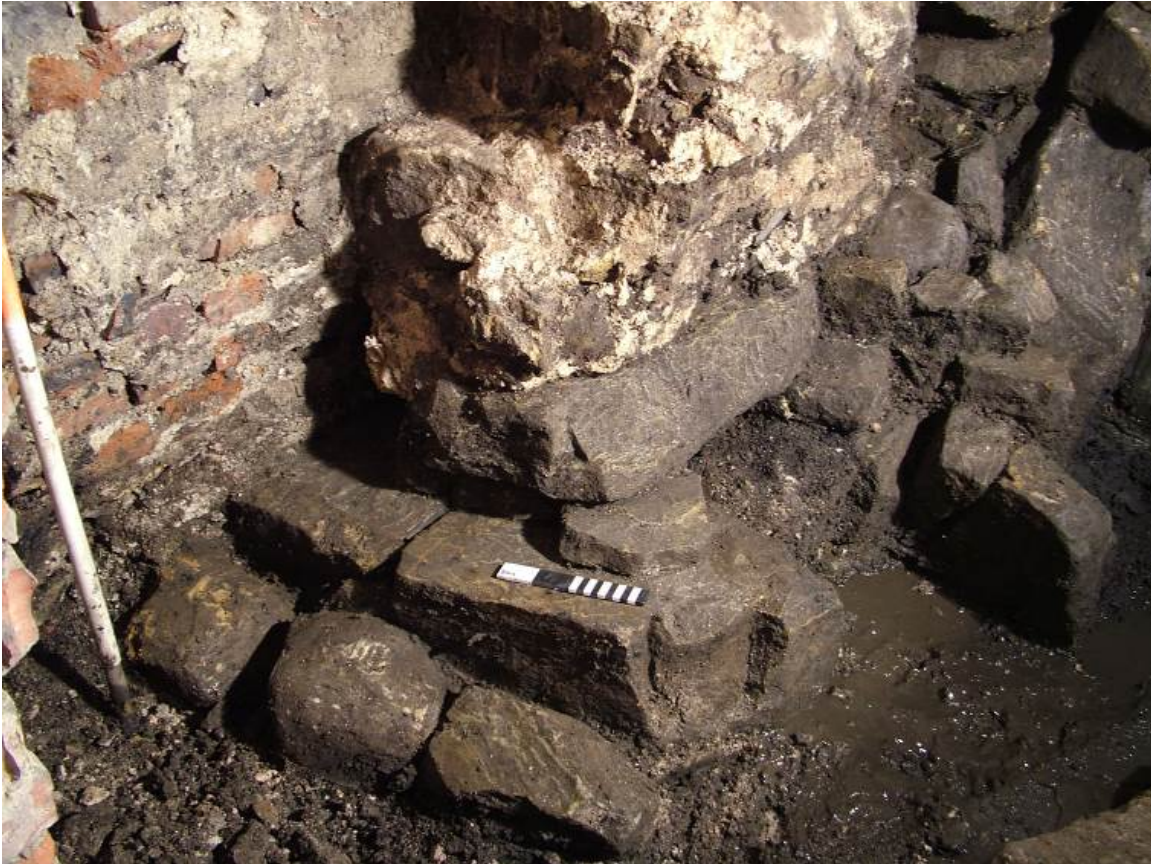
Plate 18 *Wall footing 052, sectioned with drain [080] mid ground and alignment of 3 stones to left*

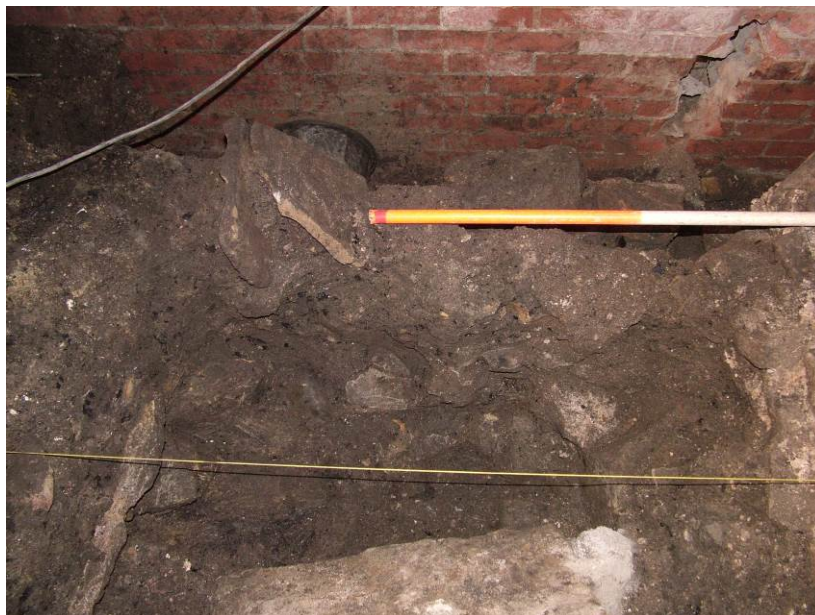
Plate 19 Feature (061) as seen in the section of late pit (050)

A small slab-built feature survived in part at the SW of the room (*plate 19*). It also had been heavily truncated by the 1980s works, to the west by pit cut (050) and to the east by cut (049) for the new partition wall; its upper extent was truncated during floor reduction. All that survived were two (formerly) vertically-set thin sandstone slabs cut into deposit (066), with an earthen floor between, possibly originally forming an open channel. During the earlier works the sides had been pushed over and the space between infilled with a mortar-rich deposit (064). The assemblage from deposit (066) broadly mirrored that from the later dumping deposits described above (057/067/095), late 13th to early 14th century.

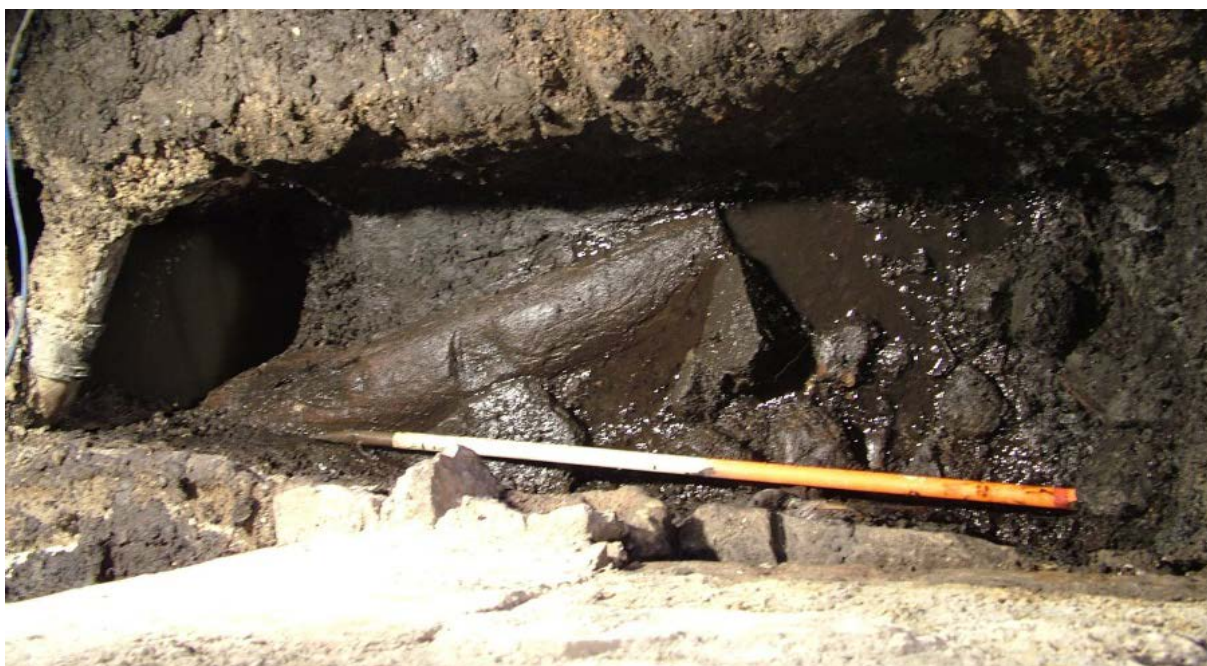
Plate 20 Timber (087) with rubble spread (088) to right

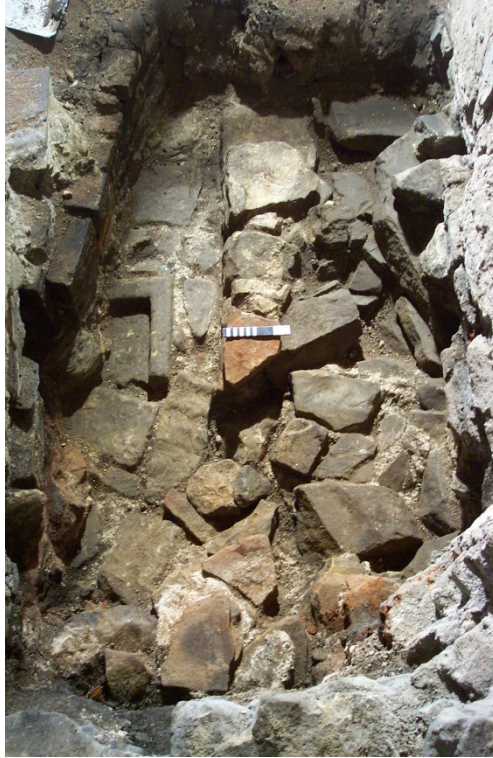
Plate 21 Masonry walls 108 and 110 and cobbles 111 as exposed

Associated with masonry (108) was (110), which appeared to be a secondary masonry wall, running S from (108), with sandstone blocks defining its faces. No bonding material was noted within the exposed masonry. Between these two wall elements extended a cobble surface (111). These elements represent the earliest standing masonry structures of the building, and were left intact.

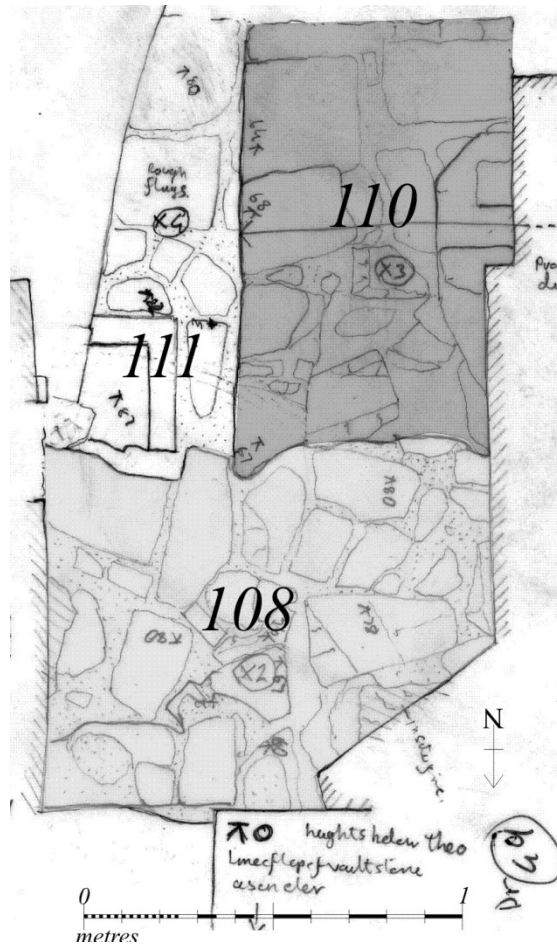
Figure 12 Masonry walls 108 and 110 and cobbles 111 as exposed

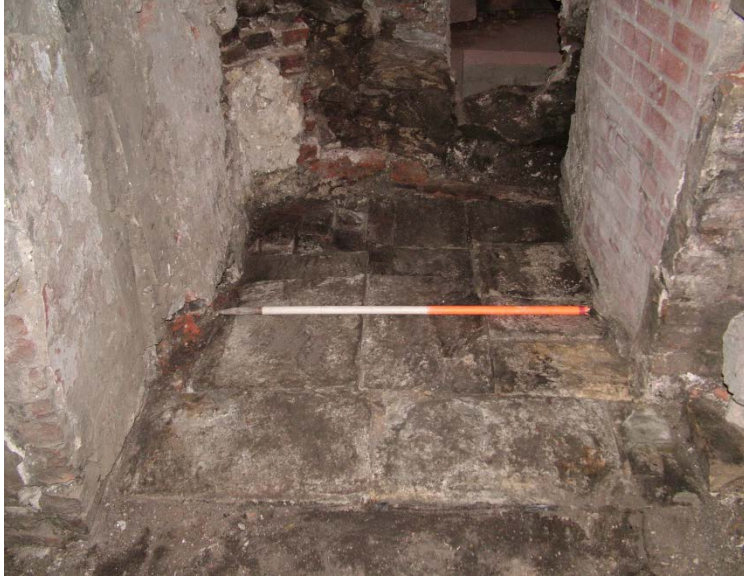
Plate 22 Flagged floor (113) as exposed, looking N

The floor within the recess was reduced to allow a new concrete floor to be laid; this reduction was excavated by hand, within this excavation a former flagged floor (113) was exposed beneath the latest timber floor (plate 22).

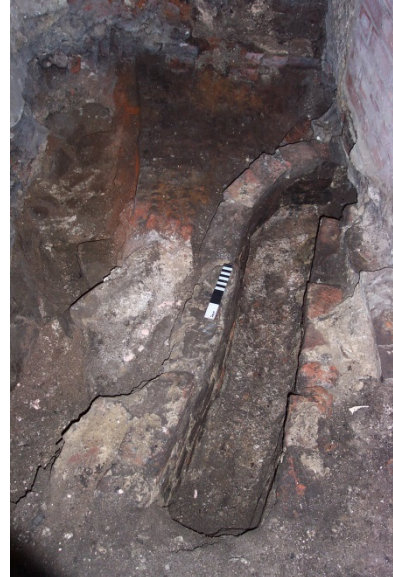
Plate 23 Drain (101) below flags (113), emptied out. Looking N

These flags sat on a mixed mortar rich bedding (114) and were of well-cut square sandstone slabs with a patch of brick in the NW corner. This represented the flooring within the cupboard recess latterly covered over by a secondary timber floor.

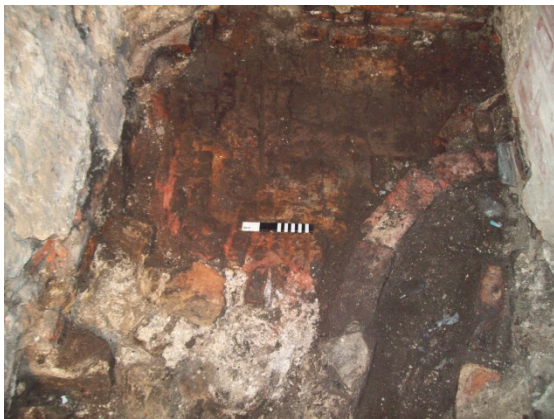
Plate 24 Brick firebase (106) as first exposed, looking N

The original full-width fireplace was floored with edge-lain early brick (106) (plates 24-25). These were worn and heat affected on the surface and sloped down towards the front and middle of the fireplace. The back of the fireplace was also of brick (100), (112).

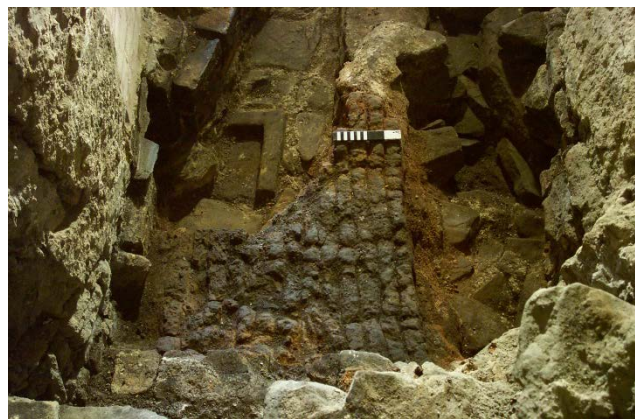
Plate 25 Brick firebase (106) showing heat damage and wear, looking south

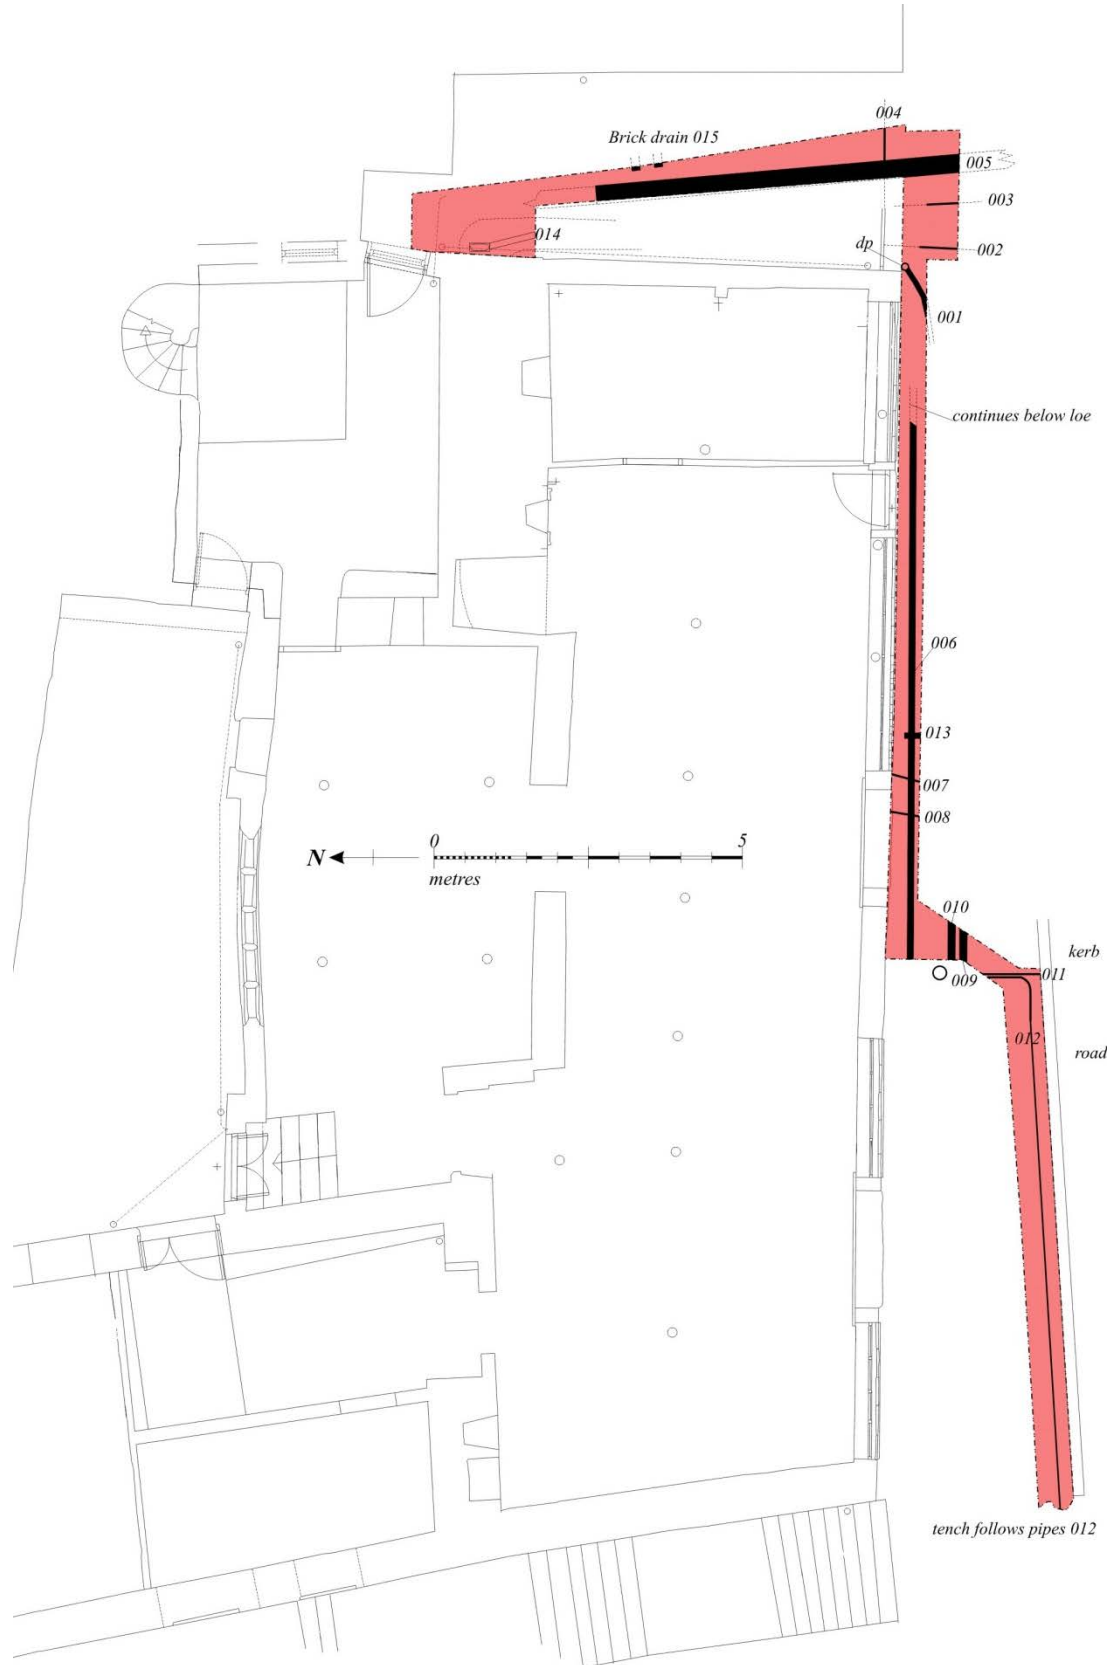
Figure 13 Exterior service trench location plan
