28-30 The Close

Newcastle upon Tyne, Tyne and Wear

Archaeological Excavations: 2007-2010- Full Analysis Report

March 2019

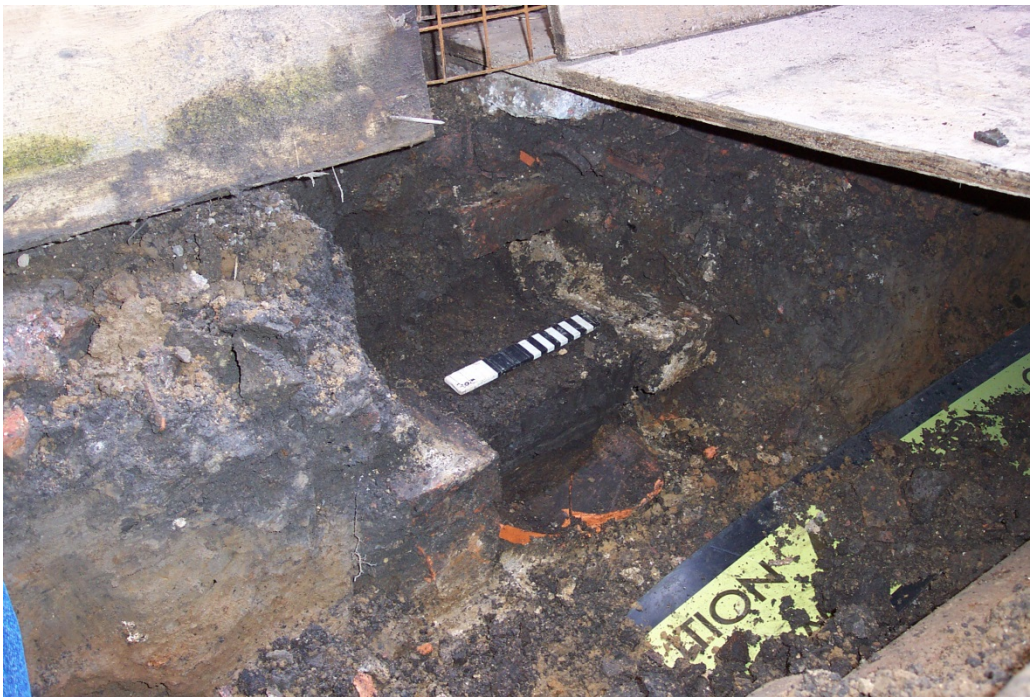
Plate 26 Detail of drain 015

The bricks of the drain (015) were hand made with dimensions about 6 x 11cm, of similar character to those seen within the building around well (016) and associated features. It was cut through what appeared to be in situ natural riverside silty sand deposits.

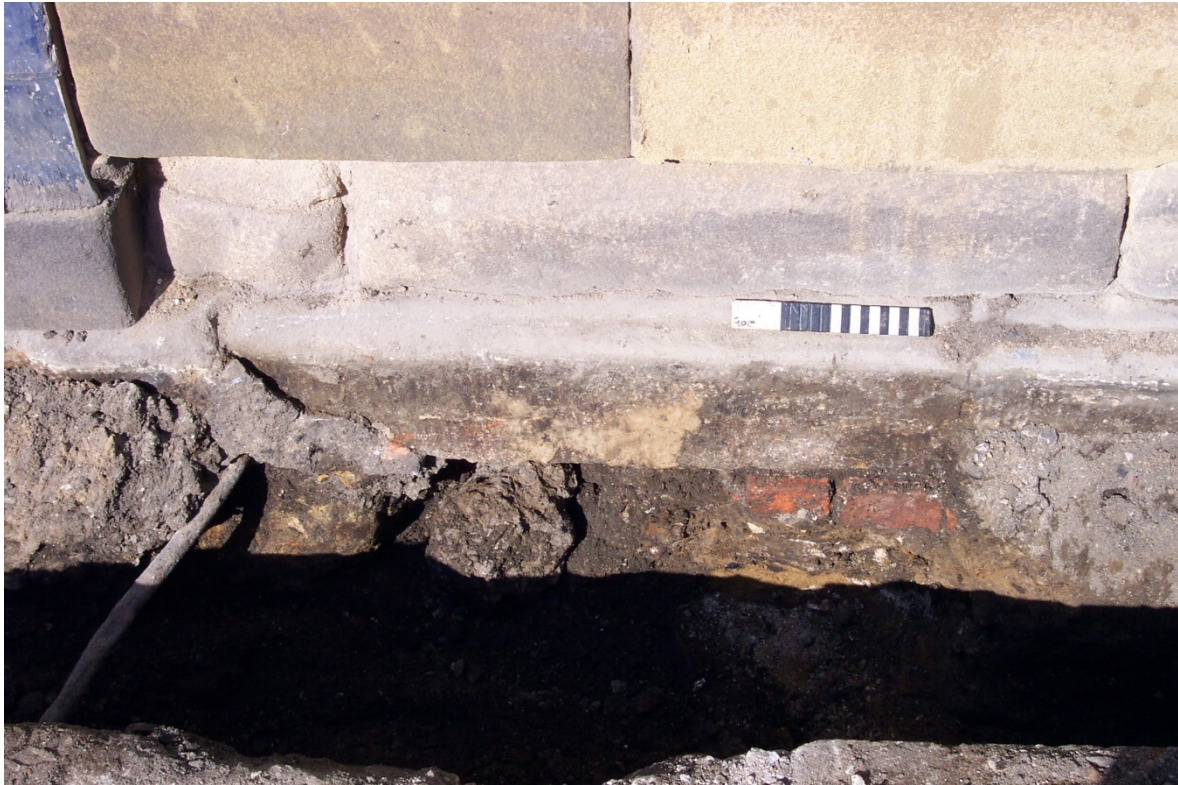
Plate 27 Wall foundation exposed below ground, 20cm scale

Within his trench the wall foundations were partially exposed (*plate 27*). The sandstone wall face continued below ground for 0.20m, better preserved than the upper exposed sections. This showed the masonry to have been detailed with vertical tooling. Within the exposed area, the surviving foundations below this masonry appeared to be a course of brick.

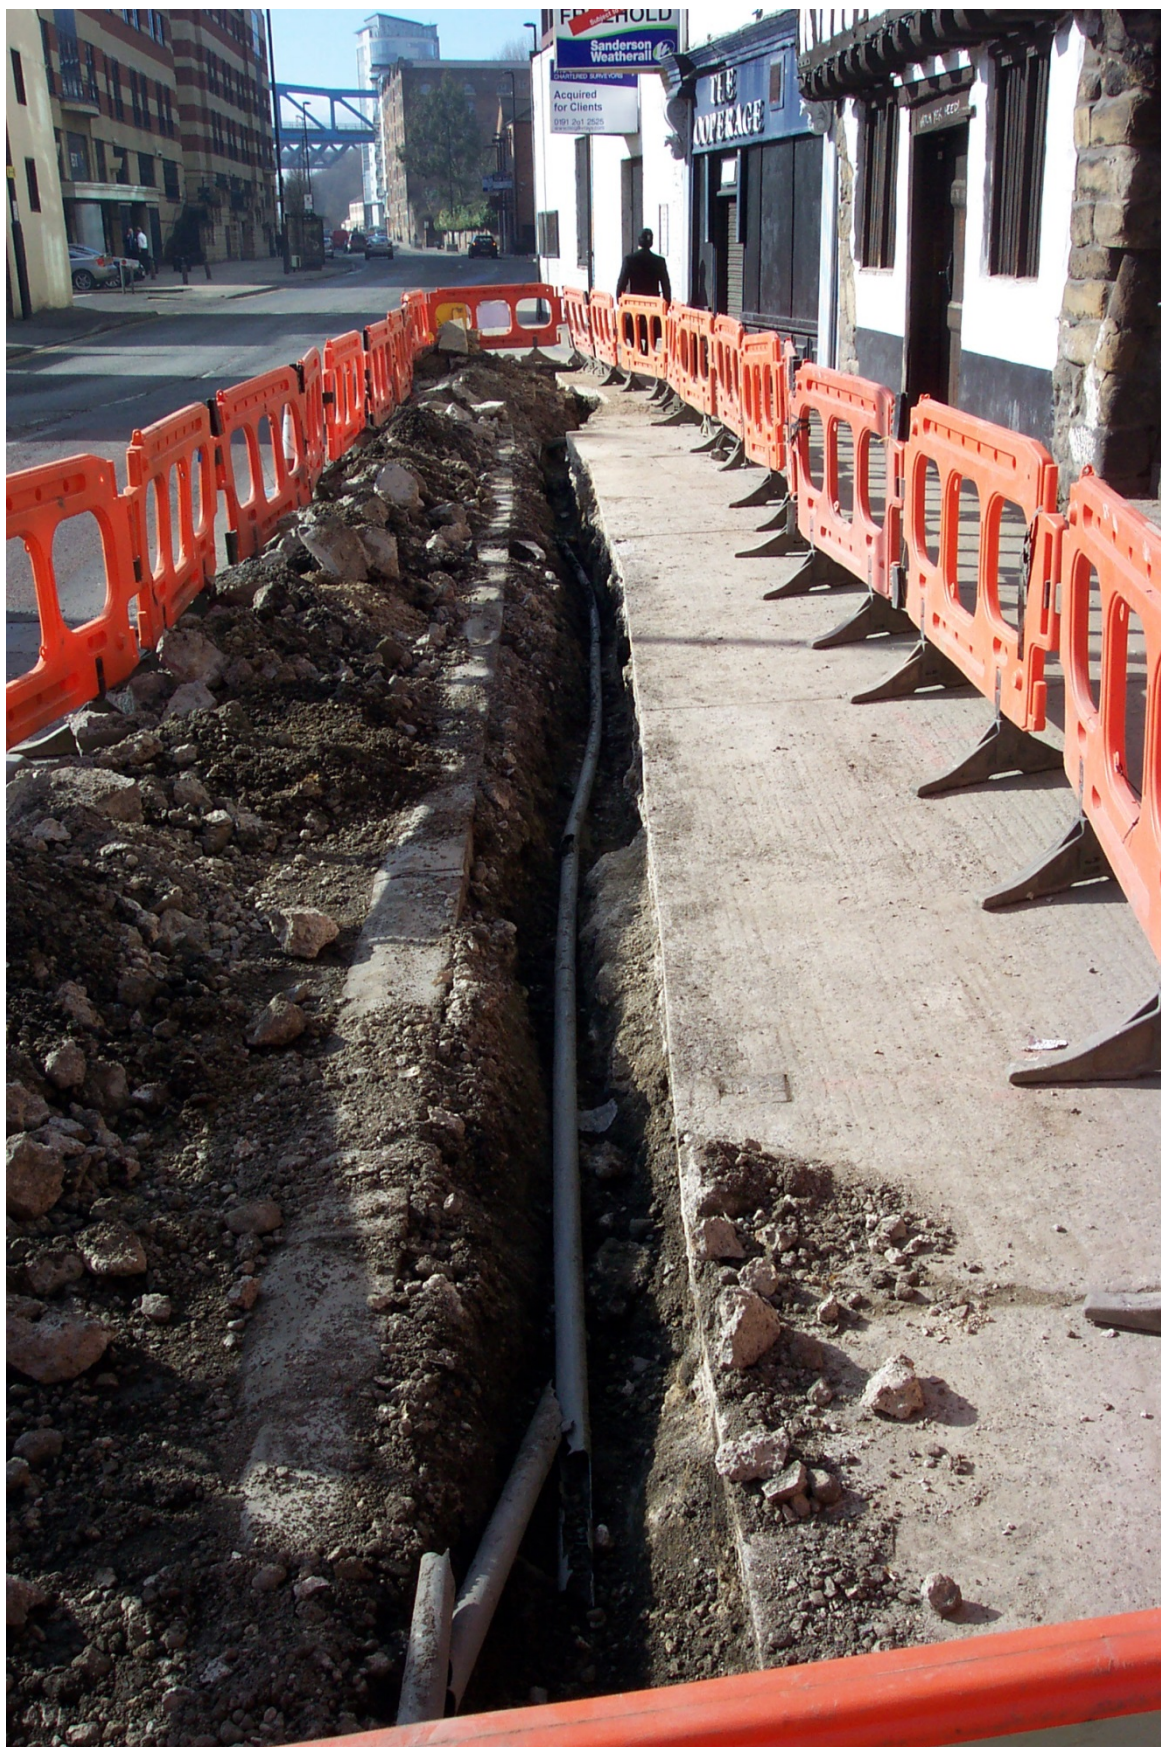
Plate 28 Trench extending westwards along the street frontage showing exposed cable(012).

Two 1.5cm diameter plastic cables were also noted in this area. (011) appeared to run to a lamppost and (012) possibly ran from this lamppost onwards to the west. The remainder of the western part of the trench followed this cable and lay entirely within the backfill of its trench (or within numerous other electric service cuts seen further to the west – *plate 28*).

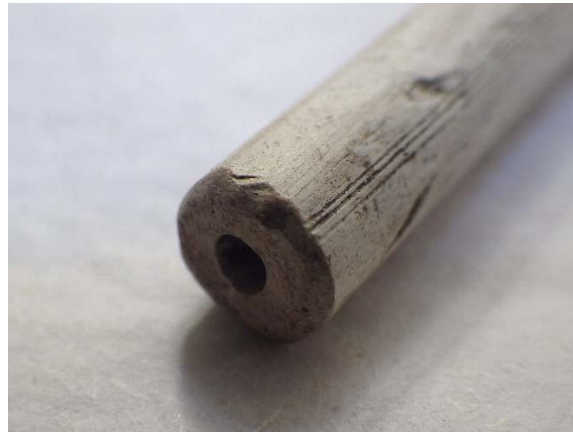
Plate 29 SF002, Stem recut into a new mouthpiece

Even though the assemblage is of small size, it contained a few objects of interest. A stem was cut (SF002) and slightly polished to be use as a new mouth piece (see *Plate 29*). The polishing of the break was done in order to avoid harm and cuts, thus indicating that the object was reused and not simply discarded. A decorated bowl (SF078) presents a bucolic scene, with a ripe ear of wheat on the spine (see *Plate 30*), and on one panel, what can be identified as a figure hoeing or ploughing a field, while the other shows a figure *en passant* with both arms raised standing in a ploughed field, probably conducting an agricultural activity (see *Plate 31*). The bowl shows signs of substantial use, the décor is worn and the chamber is heavily soot stained. A similar scene seems to be depicted on another bowl (SF002), with a folded standard or banner or a hay rig on the spine, and two panel with figures *en passant* engaged in uncertain activities in ploughed fields (see *Plate 32*).

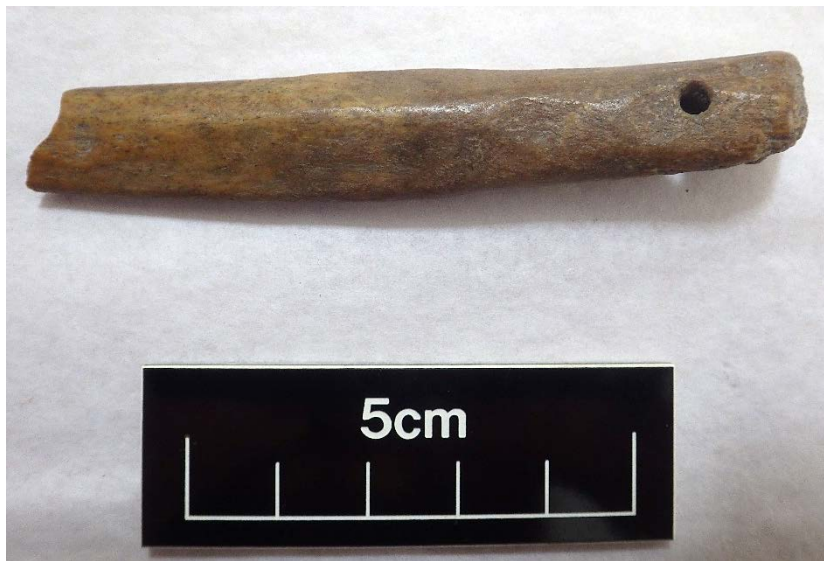
Plate 33 SF025, Worked bone awl

One worked bone object was uncovered, one awl with the tip broken off. The awl (SF025) was found in one of the deposits, (068), of the 13th century reclamation of the waterfront, and henceforth is at least medieval in date (*Plate 33*). The tool is 87mm long (the tip is missing), 14.3mm wide and 9.5mm thick.

The artefact displays the patina and smoothness of heavy use. One side is the external cortical bone, while the other presents trabeculae, the osseous inner tissue. This tool was crafted from a large ungulate long bone, most likely a cattle metapodium. A 3.2mm diameter hole was bored through near one end (*Plate 34*), the other side is tapered to a point that has been broken off (*Plate 35*).

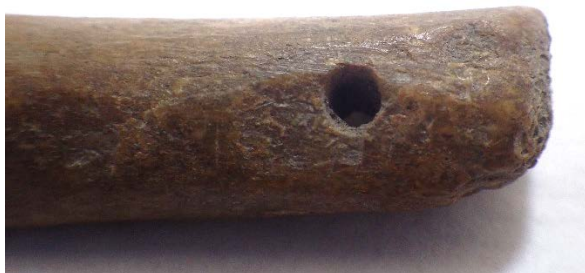
Plate 34 SF025, Worked bone awl, bore hole detail

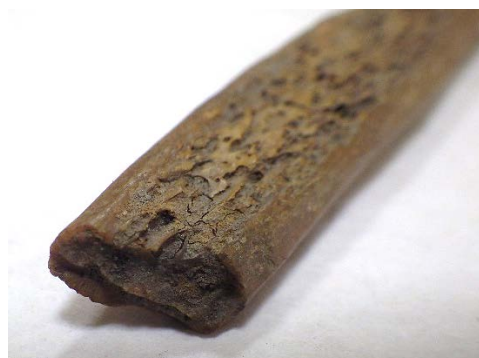
Plate 35 SF025, Worked bone awl, broken off point

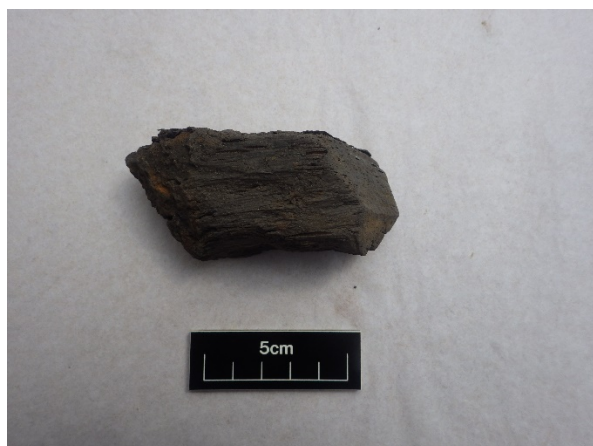
Plate 38 SF049, Stake

Four wood fragments displayed obvious tool marks. Two sharpened stakes, SF49 from (084) (*plate 38*) and SF58 (084) (*plate 39*), were most likely driven into the bank to hold the reclamation material of the river bank. Both are summarily sharpened, SF49 was sharpened by four cuts and SF58 was sharpened by two cuts.

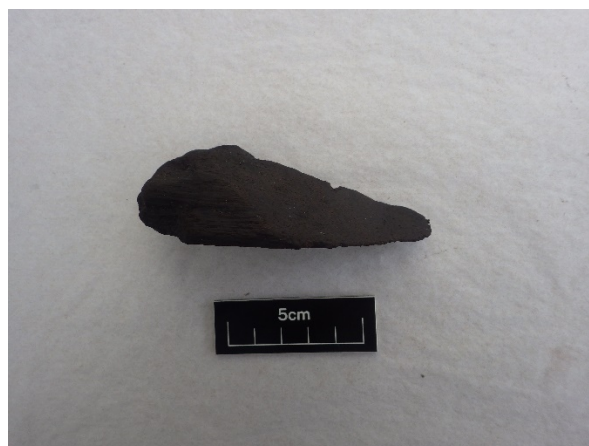
Plate 39 SF058, Stake

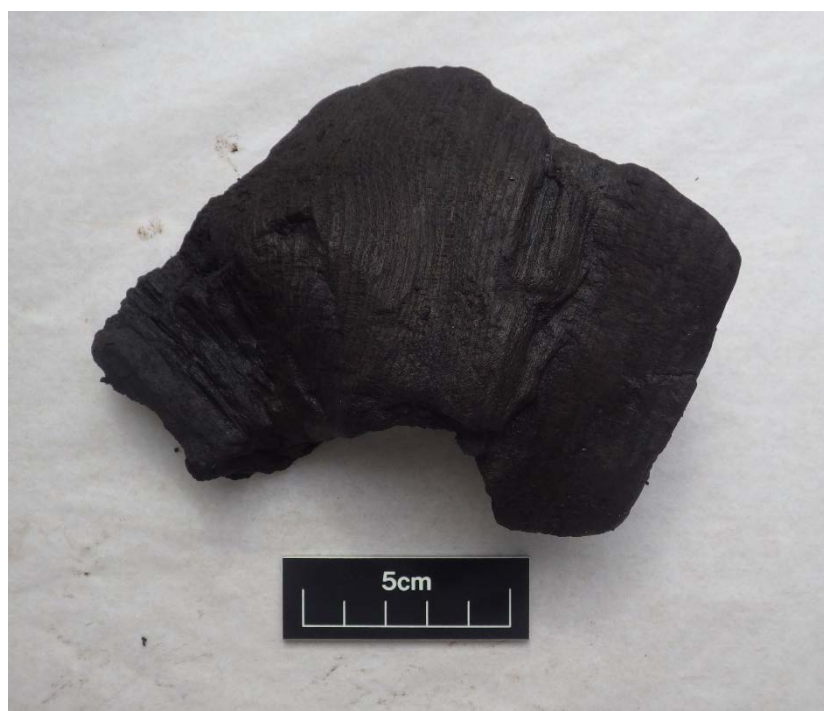
Plate 40 SF051, Unknown object

SF51 (see *Plate 40*) appears to have been worked, though its use and purpose is, however, unclear. It could be the roughly sharpened end of a timber, but it is also possible that this is the remains of the node on a naturally worn trunk, the node being more resilient and durable.

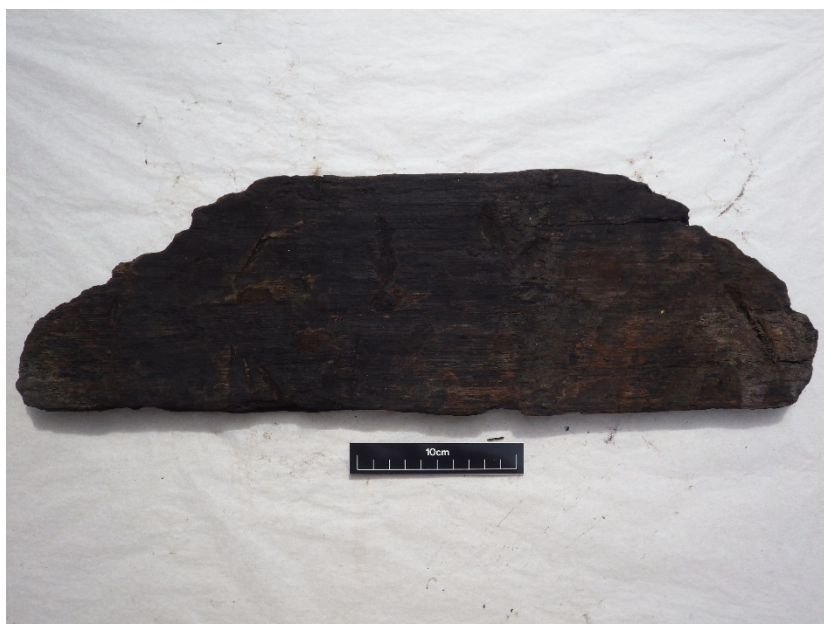
Plate 41 SF053, Barrel head

Lastly, a carved and worked plank, SF53, was found within the 13th century infill (see *plate 41*). This appears to be part of a barrel lid, one side being tapered into a croze bevel to be fitted into a croze groove, while the other side is groove to be fitted with another head plank. Dendrochronological dating was undertaken of this fragment, along with a large oak beam (SF70) recovered from context (087). The results of this are presented in Section 16 and *Appendix 2I*.

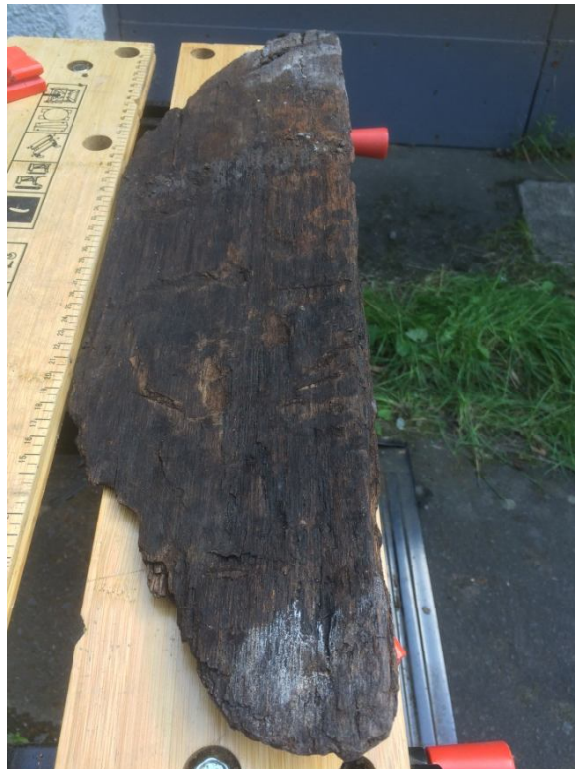
Illus 1 Oak board TCN53, probably part of a barrel head, from Context 068
