Eskside House Dalkeith, Midlothian

Historic Building Recording: July 2019

Job number 2392.00

by Philip Karsgaard

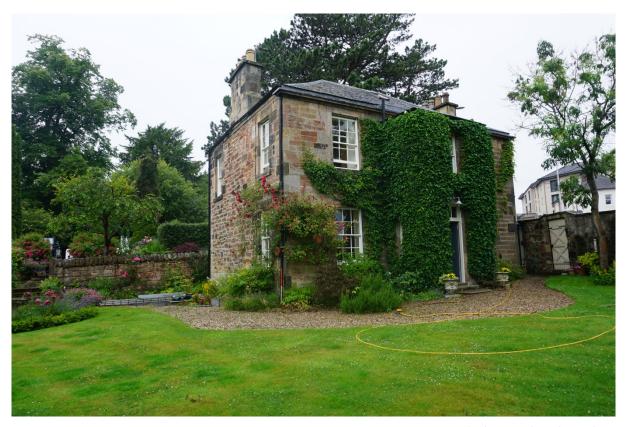
Eskside House from the southeast

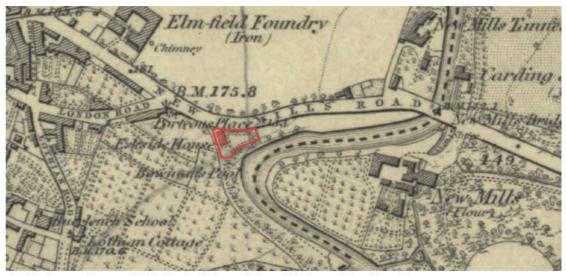
A. Ordnance Survey 1852 Six-inch 1st edition. Edinburgshire Sheet 7.

Eskside House is depicted on the first edition Ordnance Survey (OS) map from 1852, with its formal garden and its loop of garden path in place (*Figure 2A*). The listing states that the house was built sometime between 1835 and 1852. The second edition of 1892 (*Figure 2B*) shows the building to have been extended to the roadside by this time, with the outbuildings added to the north and west elevations of the House. Also by this time, the line of the road to the west of the house has been altered, and the large formal gates of the Newbattle Abbey West Lodge installed. The 1892 footprint of Eskside House remains unchanged for the succeeding editions (*Figure 2C* and *Figure 3*), except that a small outbuilding against the northern boundary wall, east of the house, disappears from the 1905 and later maps and appears to have been demolished. This small structure was close to the location of the existing door through the boundary wall to the street. The additions are included in the listing as an outbuilding to the west elevation and a piended roof addition to the north (roadside) elevation, although no dates are given for the additions.

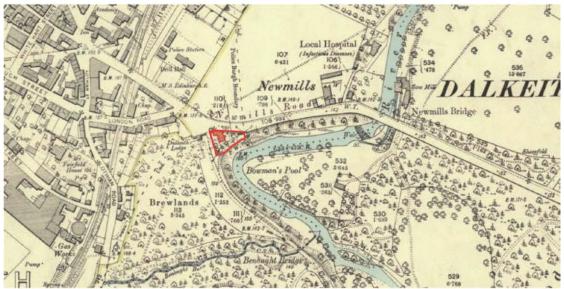
B. Ordnance Survey 1892 25-inch 2nd edition. Edinburgshire VIII.7 (Dalkeith, Newbattle).

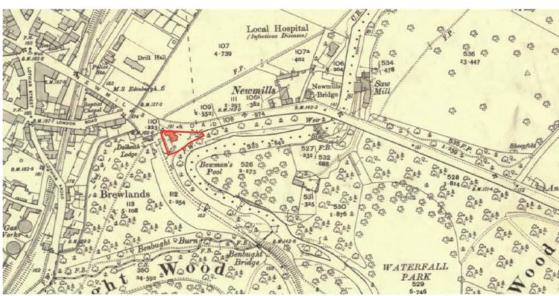
C. Ordnance Survey 1905 25-inch. Edinburgshire VIII.7 (Dalkeith, Newbattle).

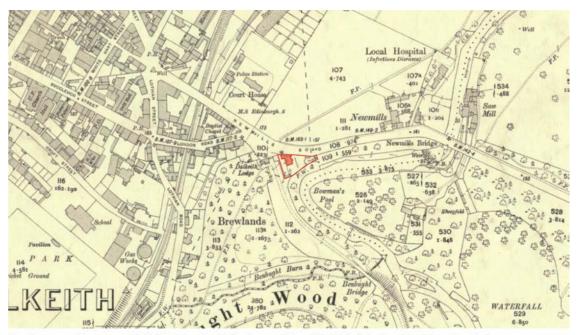
Figure 3 Ordnance Survey map with site outlined in red. NLS with AA additions.

Ordnance Survey 1912 25-inch. Edinburgshire VIII.7 (Dalkeith, Newbattle).

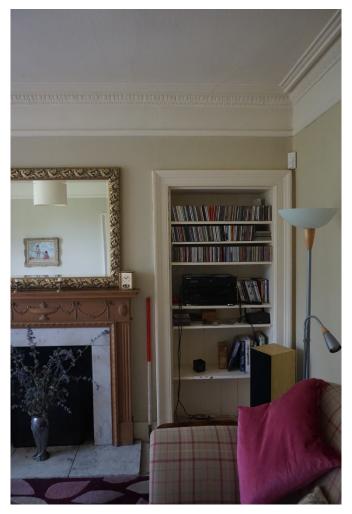
Only the south wall, to be partially dismantled for the construction of the proposed extension, was recorded internally (photos 01-04; *Figure 4*). The interior elevation includes a wall press to the west of the central fireplace, and a crown-moulding of egg-and-dart motif (*Plate 1*)

Plate 1 South wall interior elevation, W side with press and cornice

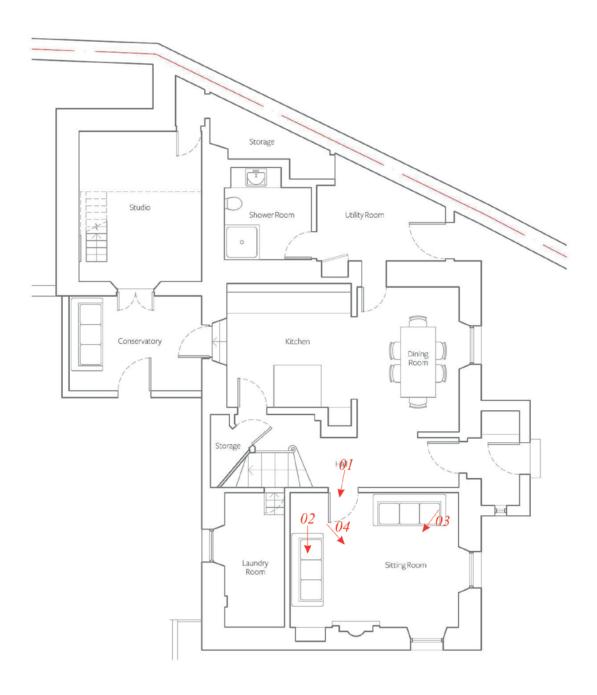
Figure 4 Photo location plan: internal recording

Photolocation Plan: Ground Floor Interior

Photo location plans of all images taken are given in *Figure 4* (interiors) and *Figure 5* (exterior and setting shots). Thumbnail images of these are provided in *Appendix A*.

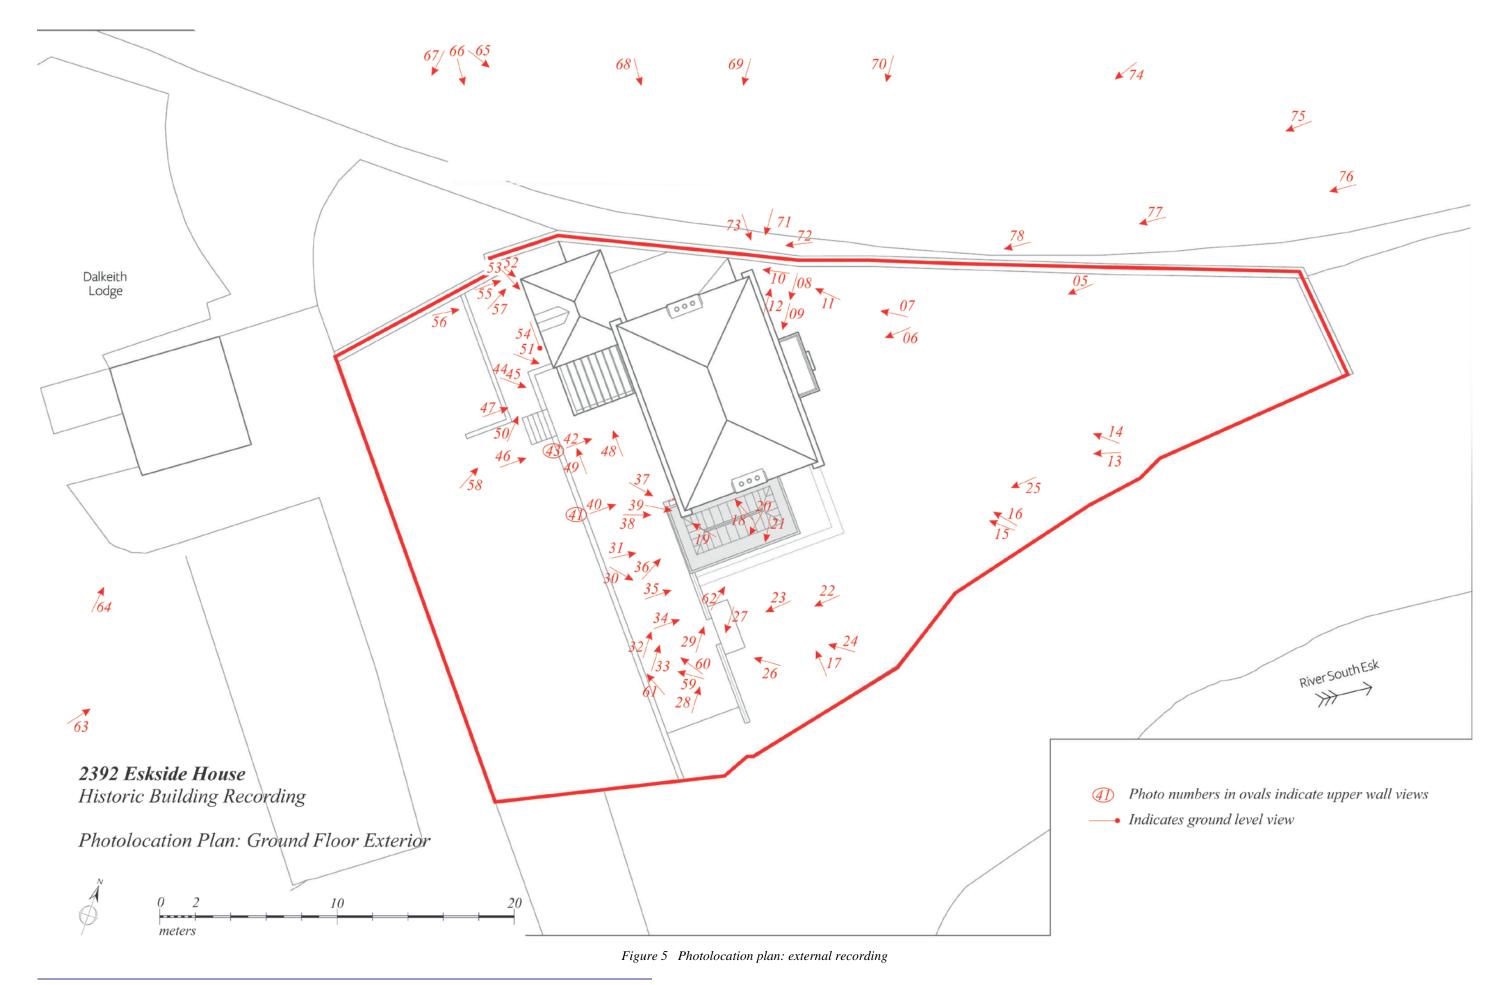
A full survey of the external elevations was undertaken (see Figure 5 for photo locations).
