The Law School, Old College Quadrangle

Watching Brief and Excavation: April 2016 to March 2017

Job number AA.2132

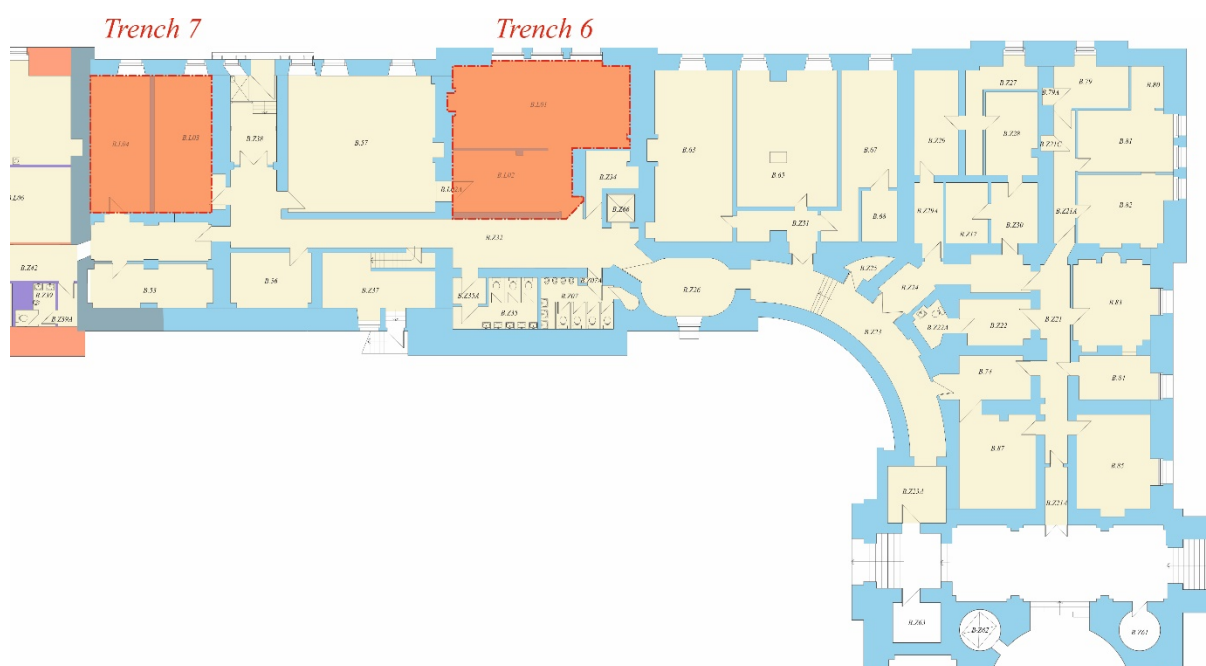
Figure 3 Basement floor plan of north and north-eastern part of Old College Quadrangle, showing trench locations

Monitoring was also conducted in rooms B.L03 and B.L04 (hereafter Trench 7, see *Figure 3*), where the floor level was being reduced in advance of service insertion and reforming. The deposits and features in Trench 7 were recorded archaeologically.

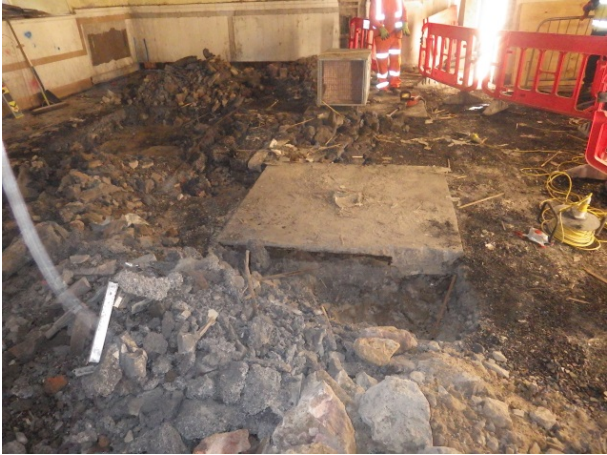
Plate 1 Trench 6 area pre-excitation with concrete surface broken out

Trench 6 was located in the northern part of the Old College building, towards the eastern edge (Figure 3). The existing wooden parquet flooring {600} and underlying concrete slab {602} were removed by the principal contractor under archaeological supervision. An engineers' test pit had also been excavated by the contractor against the north face of the room's southern wall; this test pit was cleaned, squared up and the section recorded archaeologically, and thereafter the area, measuring 8.20m E-W by 7.20m N-S, was excavated by Addyman Archaeology staff, with support by the contractor's labour in the removal of upper loose deposits (*Plate 1*).

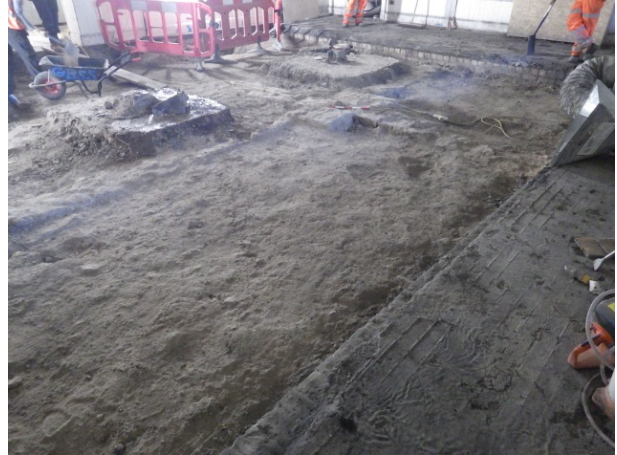
Plate 2 Trench 6 area after removal of concrete showing sleeper walls

Immediately under the concrete slab a series of sleeper walls {604} were revealed (*Plate 2*), two constructed east-west across the room and a third aligned north-south; the areas between the walls were subdivided into 6A, 6B, 6C, 6D and 6E for ease of recording during the excavation (*Figure 4*). The sleeper walls were constructed from rubble bonded in lime mortar, with rough coursing and stepped foundations and were reached at c.0.30m below floor level (hereafter BFL), just below the level of the existing concrete slab. There was also a central buttress/plinth at the junction of the N-S and northern E-W walls, perhaps added for extra support. The sleeper walls were associated with a foundation trench [605], filled with mixed clay and rubble (606); from this fill was collected a ceramic stirrer (SF016) and a glass vial neck (SF018), both possible chemical apparatus, though clearly residual in this context. The sleeper walls are believed to date from the first phase of the Playfair completion of the Quadrangle in 1817-23 (Fraser 1989: 187ff). A mixed rubble and clay infill deposit, (607), was present under the concrete slab across the entirety of the trench in between the sleeper walls, varying from c.0.75m to 1.10m in thickness. From this deposit came a number of finds, including iron objects; a possible copper alloy token or coin (SF025); ceramics of both the 19th/20th century and earlier reduced redwares with lead-glaze traces, and, more interestingly, probable crucible fragments (SF023, SF027, SF049, SF050); and glass including a possible test-tube fragment (SF029).

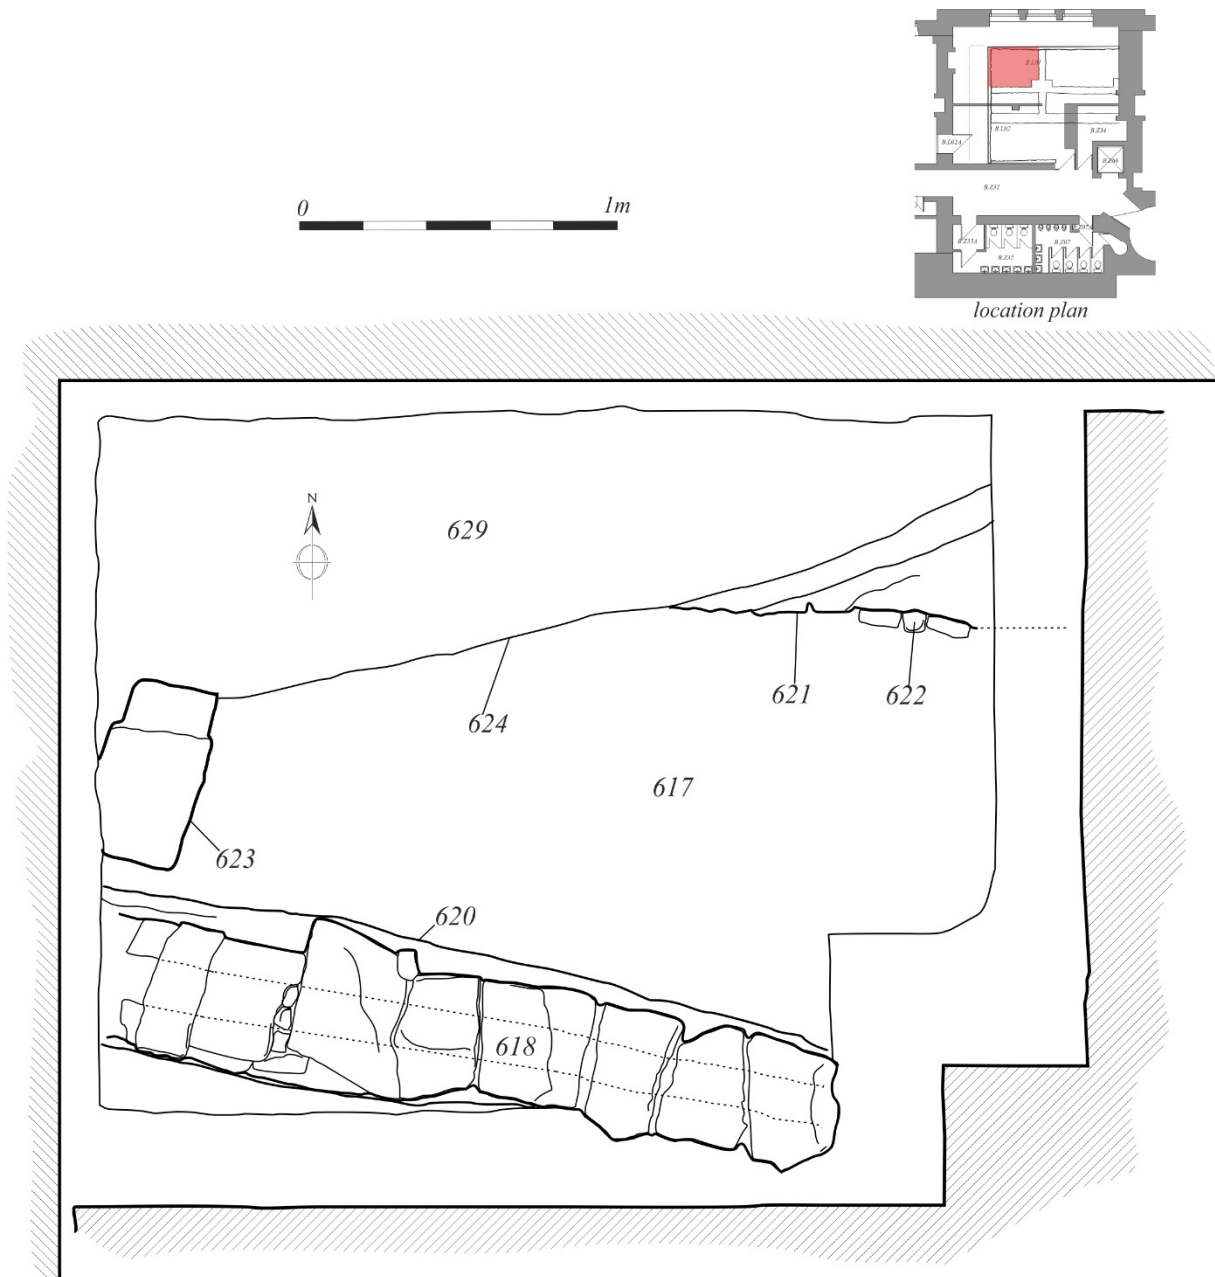
Figure 5 Plan of Area 6A showing Drain {618}

Also cutting (614) was an east-west curvilinear cut (curving to the northeast at its east end) at the north part of Area 6A. This cut, [624], was deep (c. 1.30m), had near-vertical sides and contained a loose fill, (629), consisting primarily of rubble and mortar inclusions, and was sealed by building debris (609). The original function of this cut is uncertain, but it is thought to possibly represent an extended foundation trench or a demolition dump. Also cutting deposit (617) was a stone-built linear drain, {618}, which was oriented east-west across the southern part of Area 6A (Figure 5). A very shallow east-west aligned linear cut [621] was also noted in the north eastern part of 6A, which contained [622], a linear arrangement of three small stones, thought to be the remains of either a channel or a heavily truncated wall foundation for the chemistry extension building of c.1812, the surviving stones being packing round robbed large foundation stones and the “cut” likely representing the wall sinking into the clay.

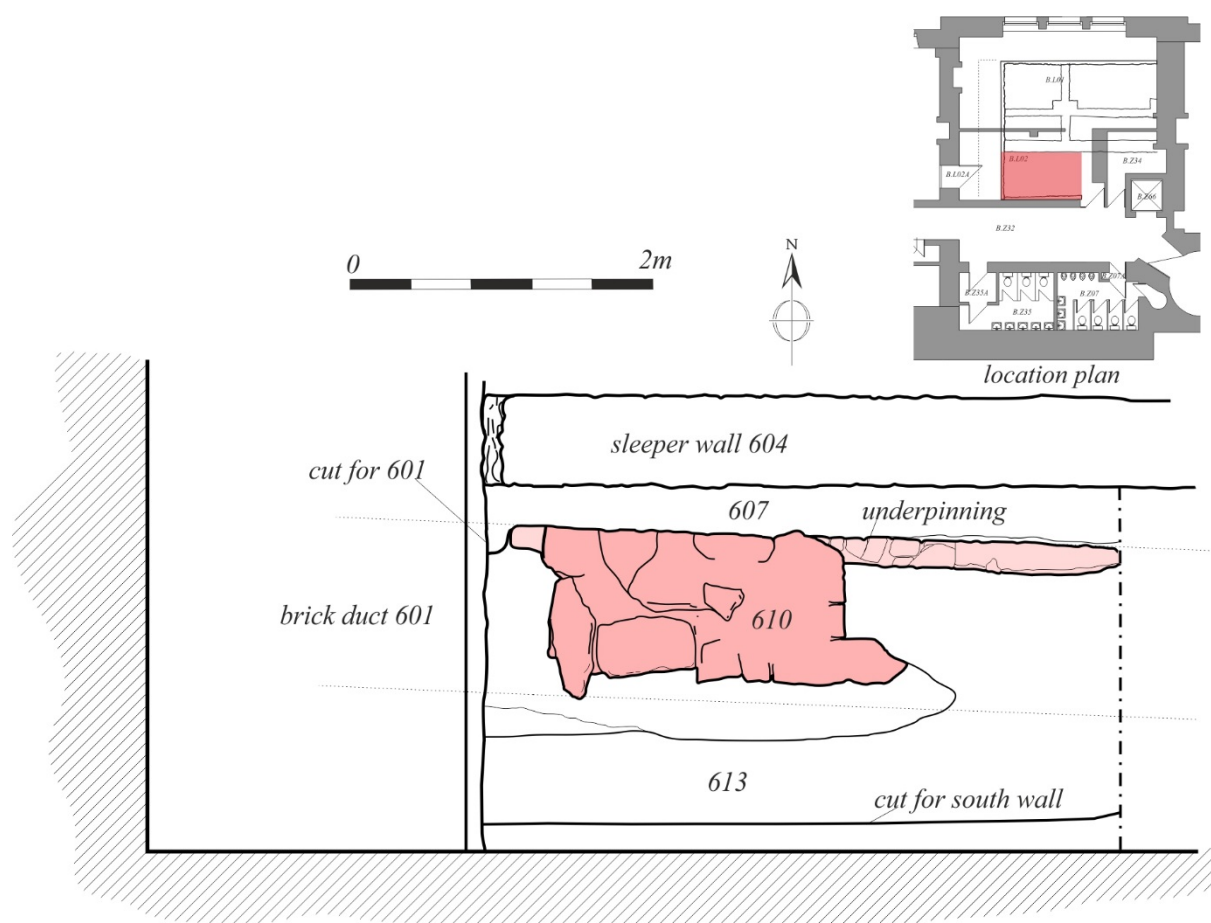
Figure 6 Trench 6 Area E, wall 610

As in the other parts of the trench, deposit (607) underlay the concrete slab. This overlay (612), a thin loose constructional deposit which sealed an E-W orientated lime bonded mortar wall foundation, Wall {610}, 0.95m wide, badly preserved over a length of c. 1.75m, which was situated in the western part of Area 6E (Figure 6). This is thought to relate to the chemistry building constructed in 1781, truncated by the subsequent reworking of the later buildings.

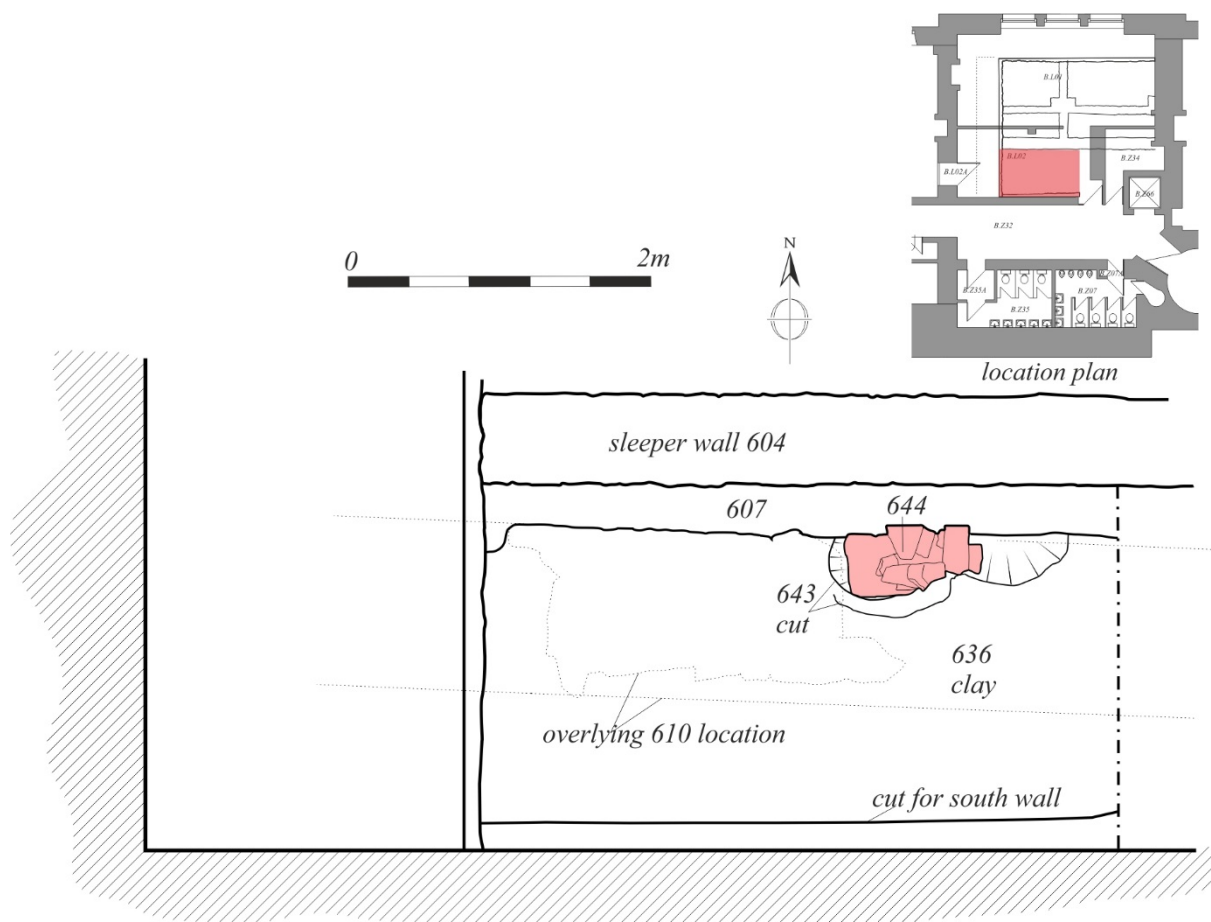
Figure 7 Trench 6, Area E, clay bonded masonry 644

Several features were noted cut into deposit (648). A partial clay bonded wall, {644} was revealed towards the northern part of Area 6E (Figure 7). The extant remains measured 0.92m x 0.49m, with a maximum thickness of 0.44m, and were constructed of rubble bonded with silty clay and based on a large flat foundation slab. Wall {644} was also cut in to the natural clay (649), sitting in a straight-sided foundation trench cut. The date of this wall is uncertain, but it is likely to be significantly earlier than the 1791 building as it was sealed by deposit (613), which underlay the 1791 wall foundation [610].

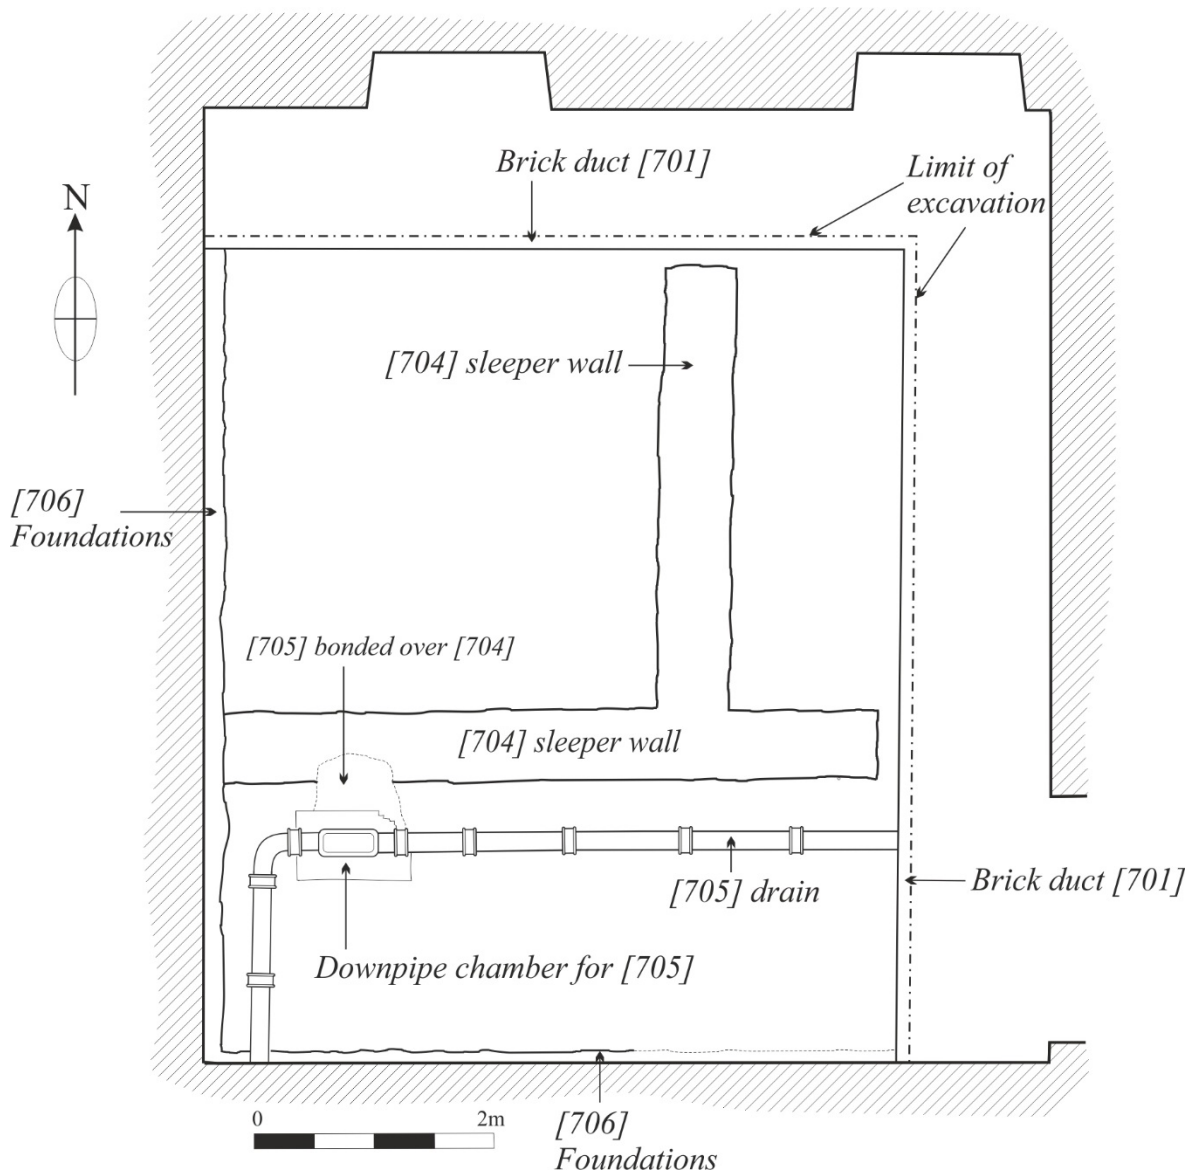
Figure 8 Plan of Trench 7

As in Trench 6, sleeper walls {704} were exposed by the excavation works. In this room they consisted of a north-south wall and an east-west wall forming a T-shape in plan (Figure 8), and the top of these walls were reached at 0.28m to 0.38m BFL. Brick-built ducting walls {701} were also revealed and formed the north and east sides of the excavated area. These were exposed to a maximum of 5 courses deep, as formation level in this room was 560mm BFL, and appear to have a near identical construction to {601} in Trench 6. These cement-bonded brick ducts cut the sleeper walls {704} and are related to 20th century works.

An E-W segmented salt glaze ceramic drain (0.16m diameter, collared) was also recorded running across the southern part of the room, parallel to the east-west portion of the sleeper wall, with a return to the south at its western end. An inspection chamber was noted at the drain return just east of the western bend.

On the southern and western sides of the excavation the foundations {706} of the south and west walls of Room BL.04/05 were also revealed. These were stepped, formed of rubble and lime mortar bonding and were exposed to a maximum height of 0.50m.

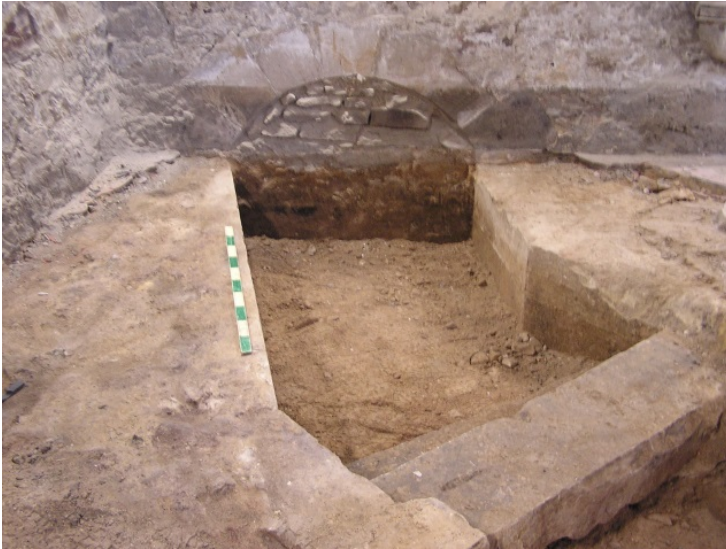
wall of the building. The archway was situated in the far corner of the north wall at a height of 0.45m above the level of the stairwell and was made of blond sandstone. It comprised three voussoirs either side of a keystone with fine tooling evident on the voussoir stones. It had been infilled with well-coursed angular sandstone blocks and loose mortar (*Plate 5*).

Plate 5 B.Z46 with steps to blocked arch

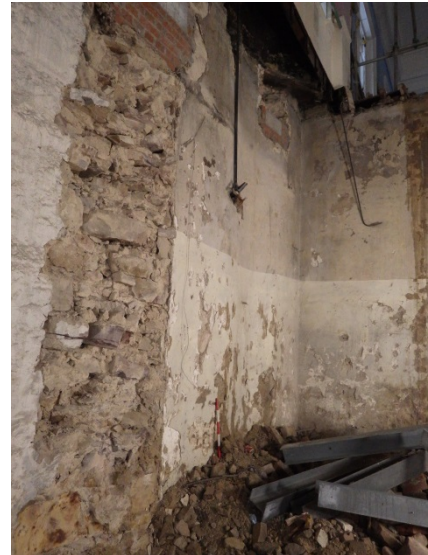
Room B.Z47 occupied the opposite, NE corner; beyond the remains of the demolished oblique partition wall, the curved wall section of a relict round narrow stair case was observed (*Plate 6, Plate 7*). This round stair appears on the building plan of 1895, and further elements of its structure were apparent in its upper masonry at the level of the ground floor above, further evidence in the floor structure on the floors above shows the stair formerly continued to the upper floors.

Plate 6 B.Z47 Demolished party wall in foreground with curving relict stair well at scale

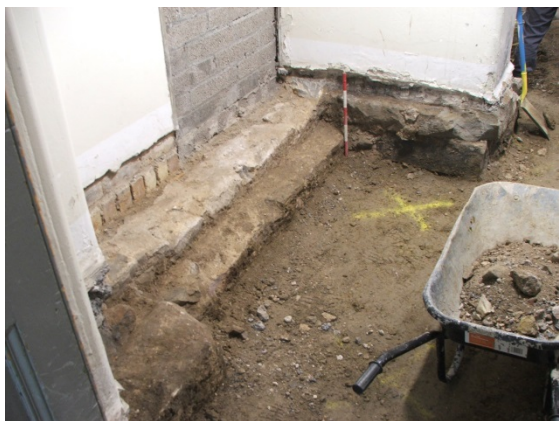
These rooms were also subjected to ground level reduction and breaking-out of the existing concrete floor, which revealed the stepped-out foundation courses of the standing building's walls, projecting 0.70m out from their wall foot (Plate 8). Also exposed in the ground reductions were substantial brick and concrete foundations, probably associated with the four sets of 4-fold end-threaded bolts set in the room corners clearly to support and hold some large machinery. This feature was heavily truncated by the imposition (and removal) of the existing concrete floor and by the many cut services required for the toilet installations existing prior to demolitions (Plate 9).

Plate 8 B.Z39-42 stone foundation courses of standing building revealed in ground reduction

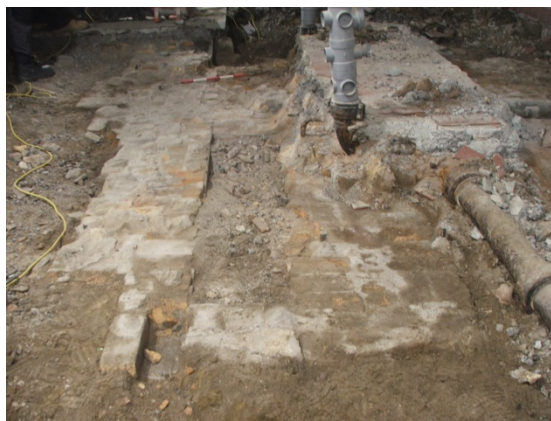
Plate 9 B.Z39-42 brick and concrete foundations

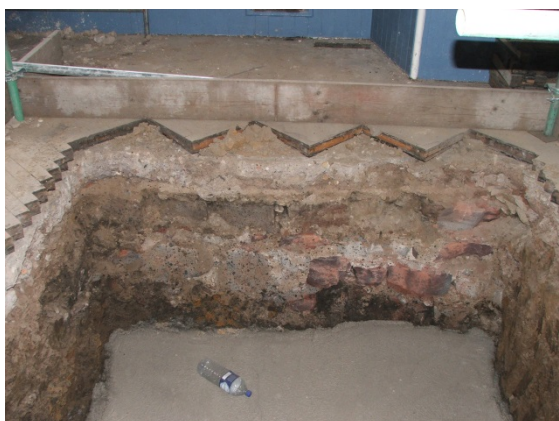
Both sets of masonry are likely to be related to the building which stood north of Hamilton House, of mid-16th century date with earlier elements associated with the buildings of the collegiate Kirk o'Field. The new BL05 walling may be either an internal cross-wall of the building north of Hamilton House, or possibly the south face of the northern end wall of that building.

Plate 10 Room B.L05/06 test pit N-facing section showing truncated early masonry

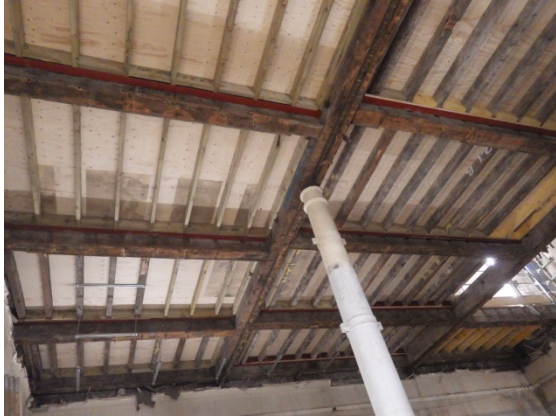
Plate 12 Room B.L05 with ceiling stripped showing floor structure

Monitoring in B.L05 also recorded features associated with the Old College building itself. Stripping of the ceiling revealed the floor structure of G.175 above. Two main north-south aligned beams were each supported by the room columns forming three panels of lesser joists between, with six squared

timber joists set east-west supporting the later floor boards and trimmers in each panel (Plate 12, Plate 13). The east west joists were set staggered in each panel to allow bolting of the joists into the main beams

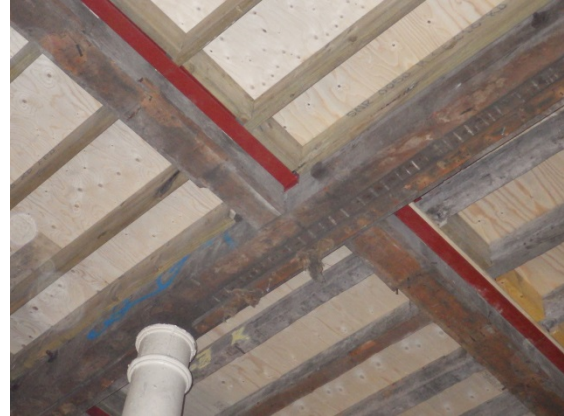
Plate 13 BL05 detail of floor structure above shows bolting visible for the east west beams

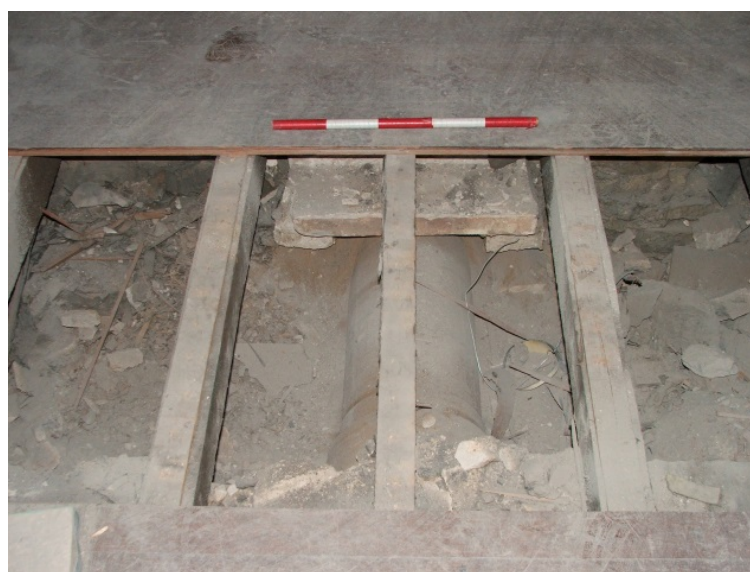
These vents, vaulted chambers and pipes are a part of the sub-floor central heating hypocaust system, visible on a plan of 1 November 1819 (Figure 11), designed by Playfair for what was to be the 'Lower Museum.' The large pipes were to conduct hot air from stoves at the south-east of the system through a central north-south main pipe with east-west offtakes, and up to the 'Upper Museum' on the floor above (see also Fraser 1989: 199ff with figs 7.6, 7.12). This plan also shows the position of the vaulting walls: two rows of six chambers on either side of the main north-south pipe, with apertures in the both north-south and east-west cross walls. By 1895, Room G.151 had been changed to a Laboratory and is marked as such on the 1895 survey plans, shown fitted with water tanks – used to hold aquaria for marine biology specimens (Fraser 1989: 285) – as well as demonstration benches. The later internal reorganisation of Old College changed the room again to the more formal Senate Room, with the laboratory fittings removed and walls surfaces and crown mouldings repainted.

Plate 15 G.151 detail of floor structure with cast iron pipes below

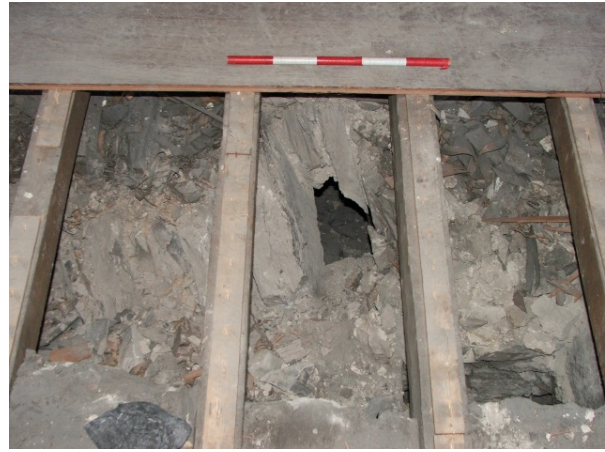
Plate 17 G.151 view of sub-floor vaulting showing small area of collapse allowing access for a camera

Below these pipes, exposed along the length of the opened-up area, was the north-south aligned sleeper-wall associated with the room's flooring. Close inspection revealed that this sleeper wall overlay an earlier wall on the same alignment, and, associated with this wall, a series of masonry vaults (Plate 17), the apparent remains of six vaulted chambers. On the east face of the early walling, six square-in-plan stone-built flues or vents were noted (Plate 16). The area below the vaults was visible where some vaulting had collapsed and was seen to be largely infilled with loose, rubble-rich deposits which obscured the lower masonry walls. However, one external aperture in this masonry could be identified, an opening to the west, towards West College Street, with *in situ* bars across the opening. Inspection of the external west elevation, however, did not reveal any apparent associated aperture, blocked or otherwise, in the existing masonry suggesting reskinning of the elevation or more likely a neat blocking up of the opening to match the surrounding masonry.

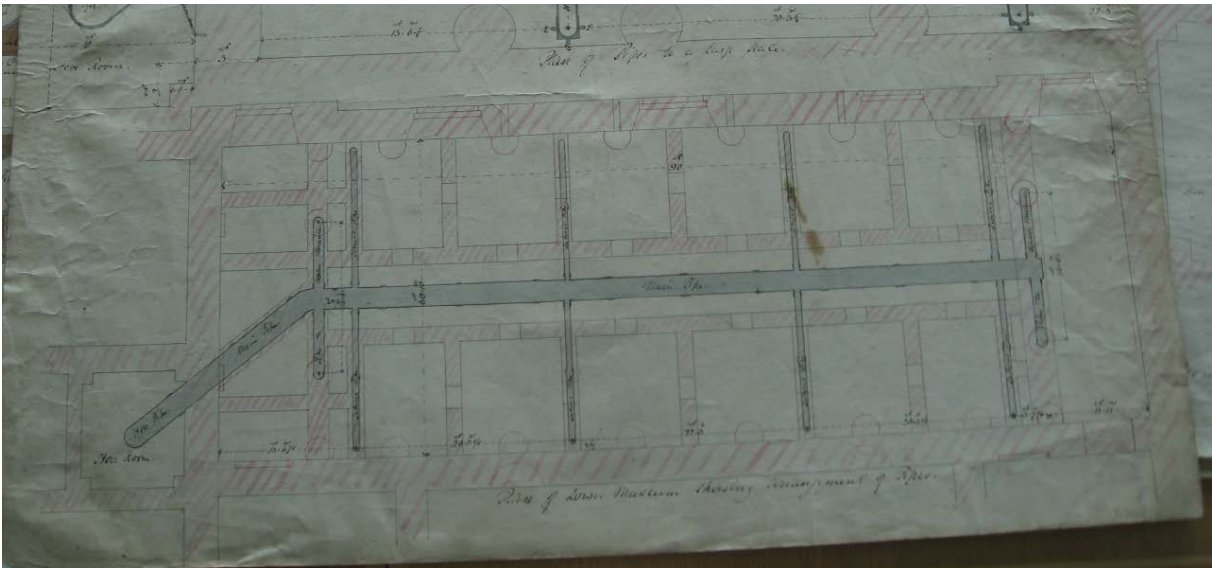
Figure 11 Room G.151: Historic 'Plan of Lower Museum Showing Arrangement of Pipes,' 1 November 1819. North to right of page. Courtesy LDN Architects/UofE.

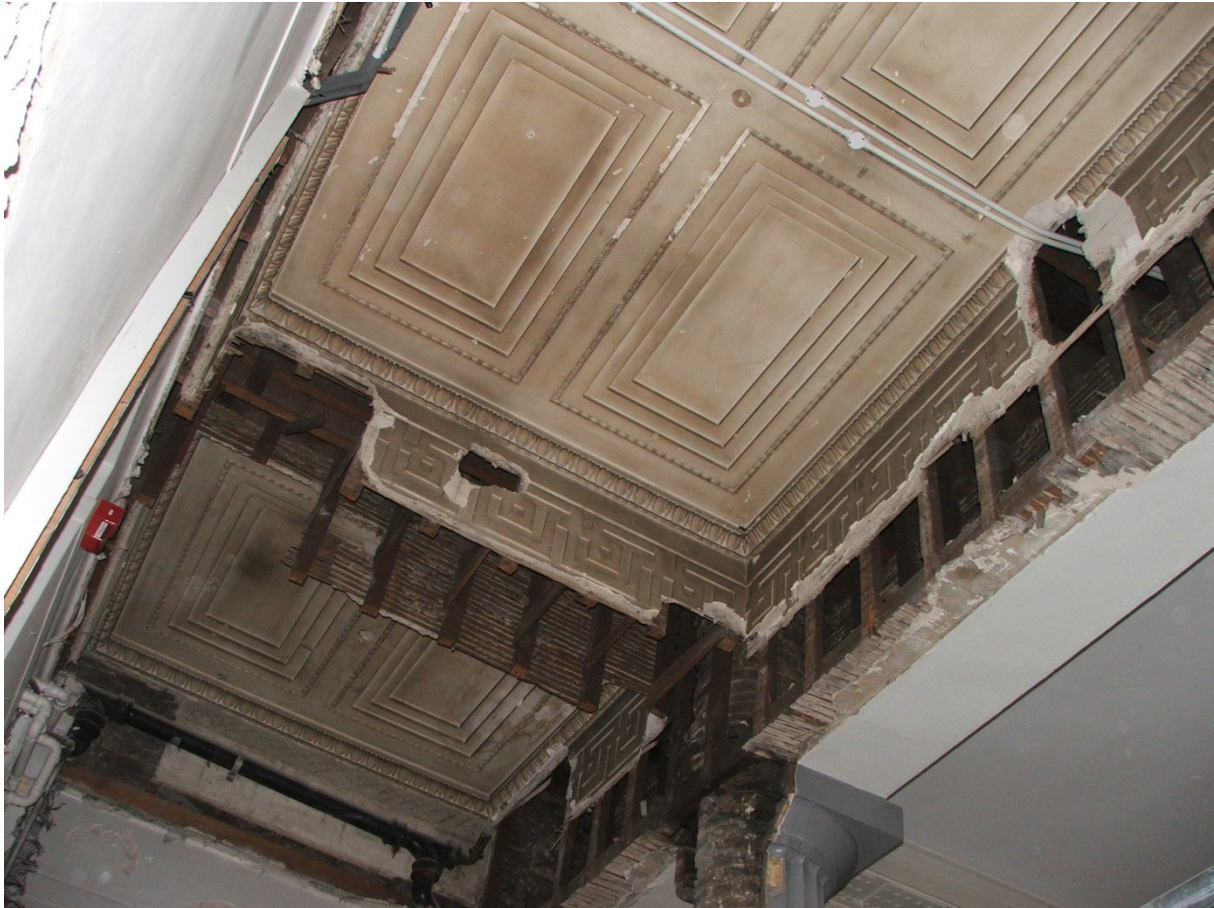
Room G.Z27 lies directly south of G.151. Here the removal of the modern low suspended ceiling revealed the historic ceiling structure. This structure was in three parts, with two removed former partition walls preserved in the lathe and plaster structure; the partitions had been on the line of the existing engaged columns of Room G.151. Each of the three smaller spaces created by these partition walls was demarcated with intact ceiling plaster divided into nested panels with egg-and-dart crown moulding and a Greek key-pattern frieze below (*Plate 18*).

Plate 18 G.Z27 general view of ceiling structure with relict partitions showing egg-and-dart and Greek key crown mouldings

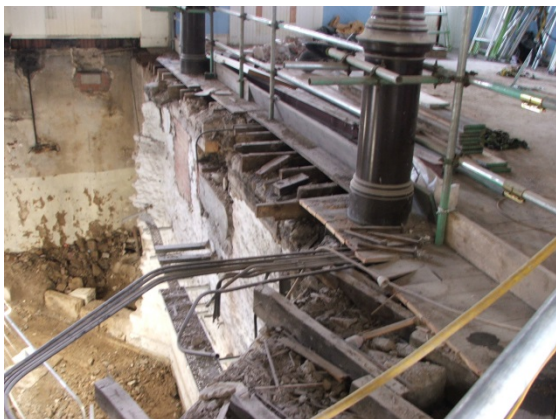
Plate 19 Room G.160/159 floor structure

Major internal alterations were made to this suite of rooms in the north-west corner of the building. This included the removal of the historic floor structure across this range of rooms, with a remnant of this floor structure preserved in Room G.159 (Plate 19). In Room G.159, a new opening was made in the east wall, cut through the historic fabric and lathe and plaster wall surface treatment, with new steel lintels inserted and the opening jambs made good with breeze-block (Plate 20). Immediately to the north of the new opening, a partial, cut-back and brick-blocked fireplace was revealed below the wall surface treatment.

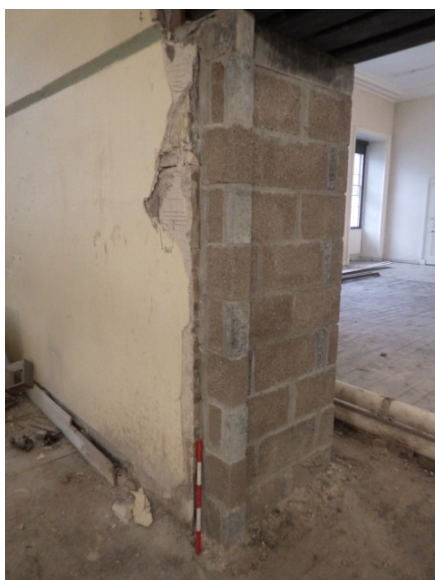
Plate 21 Room G.171/175 fireplace jamb cut by new door opening

Room G.175, marked as the ‘Celtic and Civil Law’ lecture room in 1895, is situated above BL05. A new opening was cut through its west wall, forming a new access in to Room G.171. This new opening was cut through the fine-grained grey jamb of the former fireplace in this wall. The thick plaster wall treatment had not been widely stripped from this area so that the further fireplace structure was not revealed (*Plate 21*).

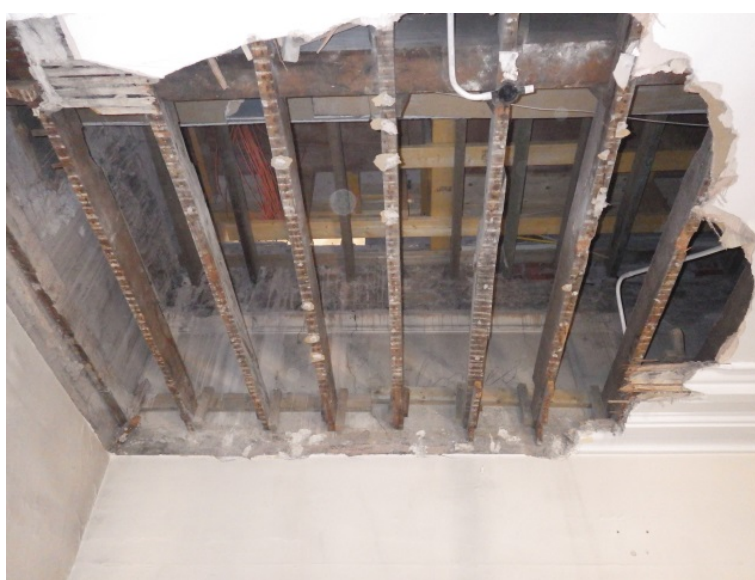
Later stripping revealed the ceiling structure in this room. The removal of the present ceiling, itself furnished with a moulded cornice, revealed a further cornice line approximately 1m above the current ceiling (*Plate 22*). A cream wall plaster extended up to this cornice line, and the bare rubble stone walls were exposed above it. The present, lower ceiling was associated with large boxed steel beams, designed to strengthen the floor above. An earlier attempt to strengthen the overlying floor was noted in the form of a substantial timber truss structure, also associated with the lower ceiling but inserted prior to the steel beam.

Plate 22 G.175 showing earlier, higher cornice line above existing ceiling

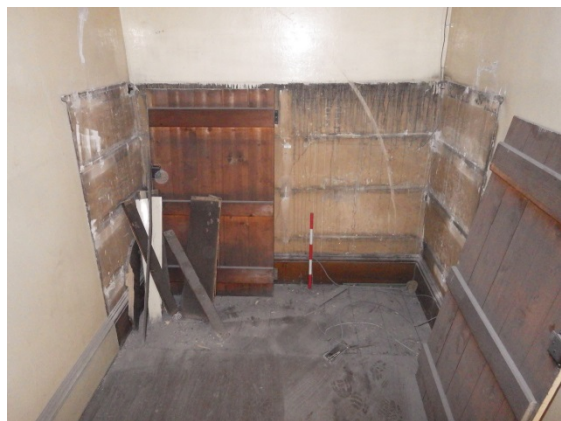
In this small room, marked as a 'Store' on the 1895 survey, the removal of shelving exposed the earlier decorative scheme of dark ochre plaster over lathes (*Plate 23*). Immediately to its west, the professorial 'Retiring Room' was furnished with a slightly more elaborate scheme of a darker red wall panel below a black painted dado line with cream plaster above (*Plate 24*).

Plate 23 Room G.Z33 with original decorative scheme behind removed shelving

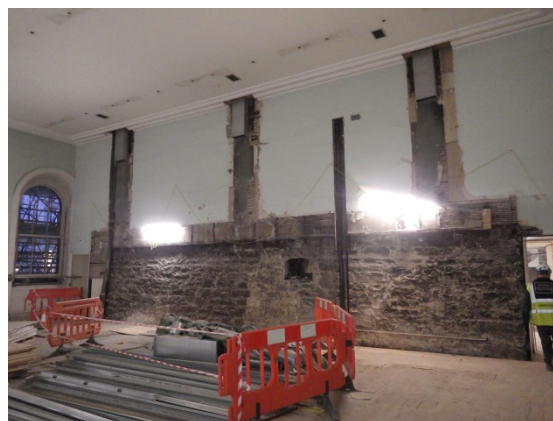
Plate 26 G.183 west wall with earlier dark green painted plaster and exposed rubble wall

In this lecture room (*Plate 25*), centrally placed on the north flank of the building, the partial stripping of the west wall revealed the rubble stone wall construction in a 2.30m strip above the current floor level. Above this, partial removal of the modern lath and plaster wall treatment and the removal of the three boxed vents revealed the earlier wall surface treatment of dark green paint over lath and plaster (*Plate 26*). Although the rectangular engaged ventilation shafts had been altered in the 20th century, they appear as a ventilation feature on the 1895 survey plans.

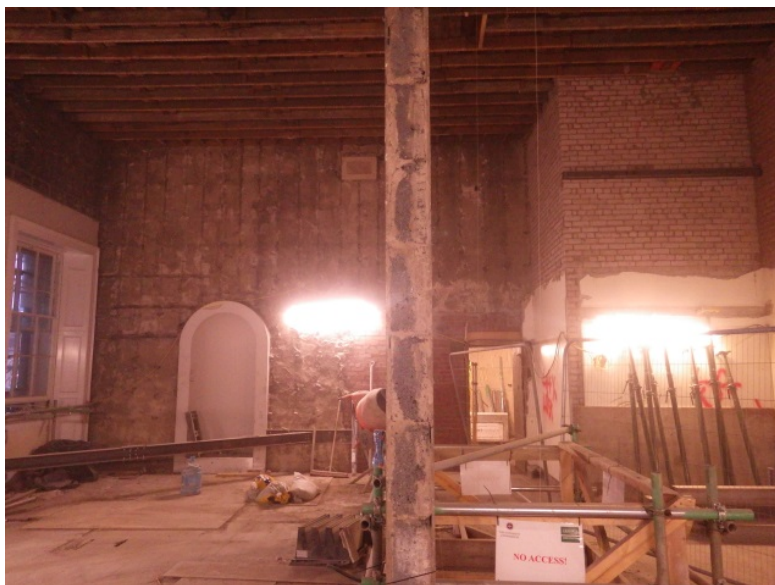
Plate 27 Rooms G.186-188 east wall with stove alcove and later brick partition walls

These rooms were modern subdivisions of a former larger lecture room, marked as the ‘Greek Classroom’ on the 1895 survey plans. The most recent use of these rooms included the Law School reception desk. Stripping out works in the northern half of this complex revealed the round-headed stove alcove in the masonry of the east wall, as well as the alterations to the door openings south of the alcove and the more modern brick partition walls, in this case around the lift shaft of room G.Z36 (*Plate 27*). Removal of the modern ceiling also revealed the historic floor structure of Room 1.288 above which is discussed further below; incorporated into the timber floor structure were the wooden box-vents associated with the early heating system (*Plate 28*).

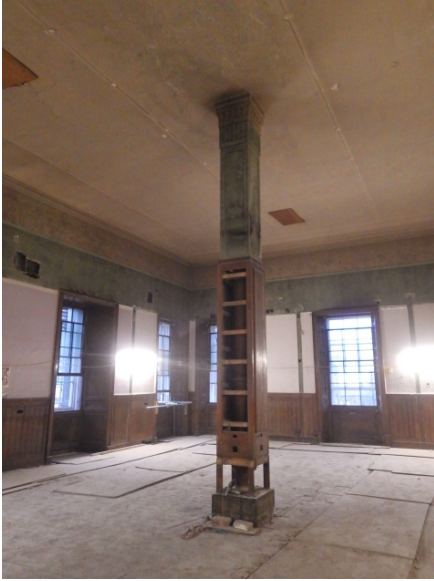
Plate 29 Room G.194, partitions removed, with column and early decorative scheme above modern ceiling line

This suite of rooms was a sub-divided large lecture room in the north-east corner of the college building (and therefore part of the Adam plan that was built before the Playfair infilling). The removal of the modern partitions, and the associated lowered modern ceiling, revealed some features of the original room layout (*Plate 29*). An earlier decorative scheme was apparent above the line of the modern suspended ceiling, with green paint extending to a moulded picture rail with cream paint above, rising to the guilloche crown moulding (*Plate 30*). Two circular iron columns were boxed in timber, creating rectangular columns with palmette capitals.

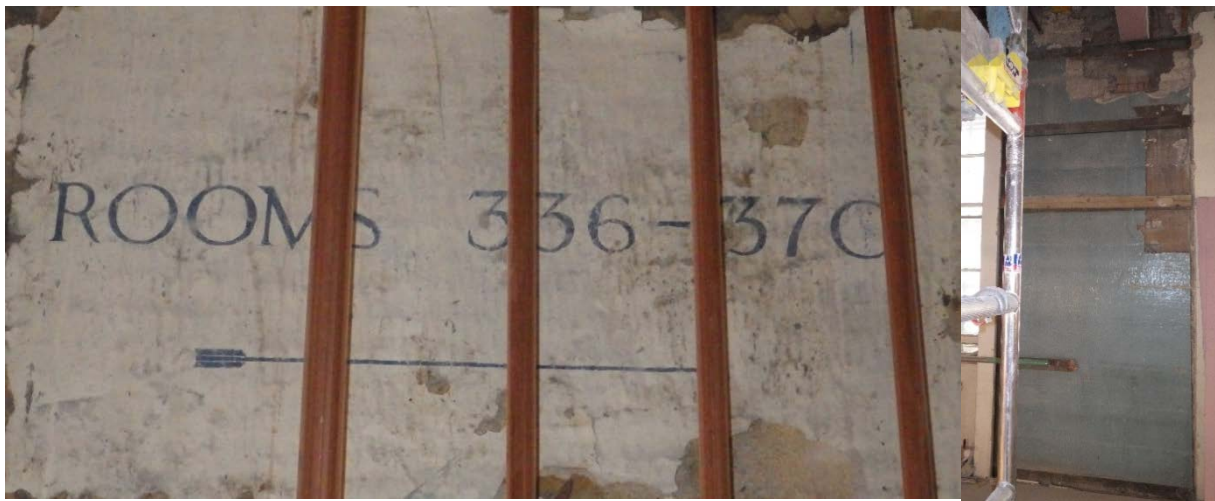
Plate 31 Room 1.278 painted room numbers on stairwell

The east end of 1.278 formerly contained a stair, visible on the 1895 building plan and as an outline in the painted decoration on the walls (Plate 32). Noted as part of the lost stairwell were some painted directions with an arrow pointing up the stairs to 'Rooms 336-370' (Plate 31).

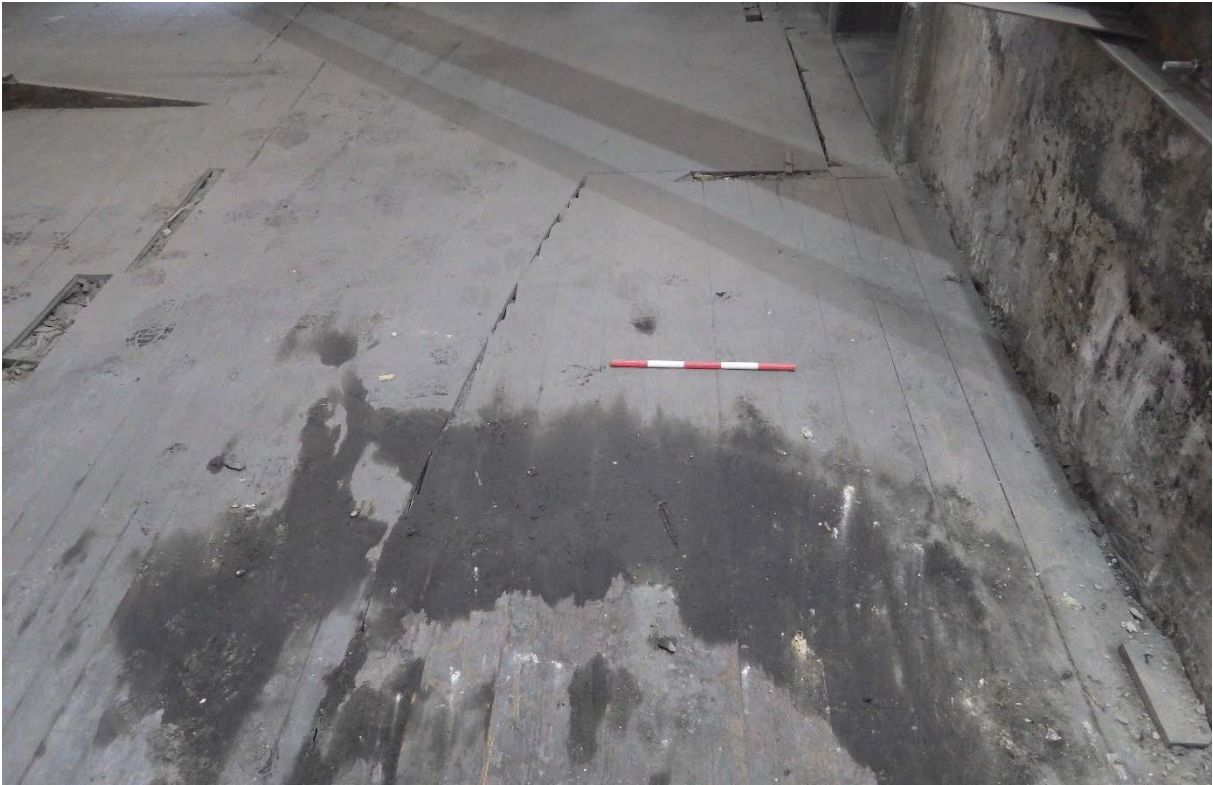
The metal part of the truss projected up from the floorboards into the room. This room was in 1895 referred to as the 'Logic and Metaphysics classroom' and was shown with curved and tiered lecture room seating rising up to the west and a curved lecture podium to the east (Plate 33). The outline of both the seating and the podium could be made out on the floor, with the floorboards beneath these of wider (about 6 inch) boards and the exposed boards between replaced with narrower boarding. It appears that the boarding beneath the seating and podium was left *in situ* and the worn exposed boarding between these cut away and replaced while the lecture room was intact. Alternatively, this may have been an original design with wider boarding used beneath the installed podium and seating but with narrower more attractive boarding used in the exposed and visible area of the floor.

Plate 33 Room 1.288 early floorboards shows curved outline of lecture podium mid frame and rough line of lecture room seating to left (lifted boards) and narrower boards in the passage between.

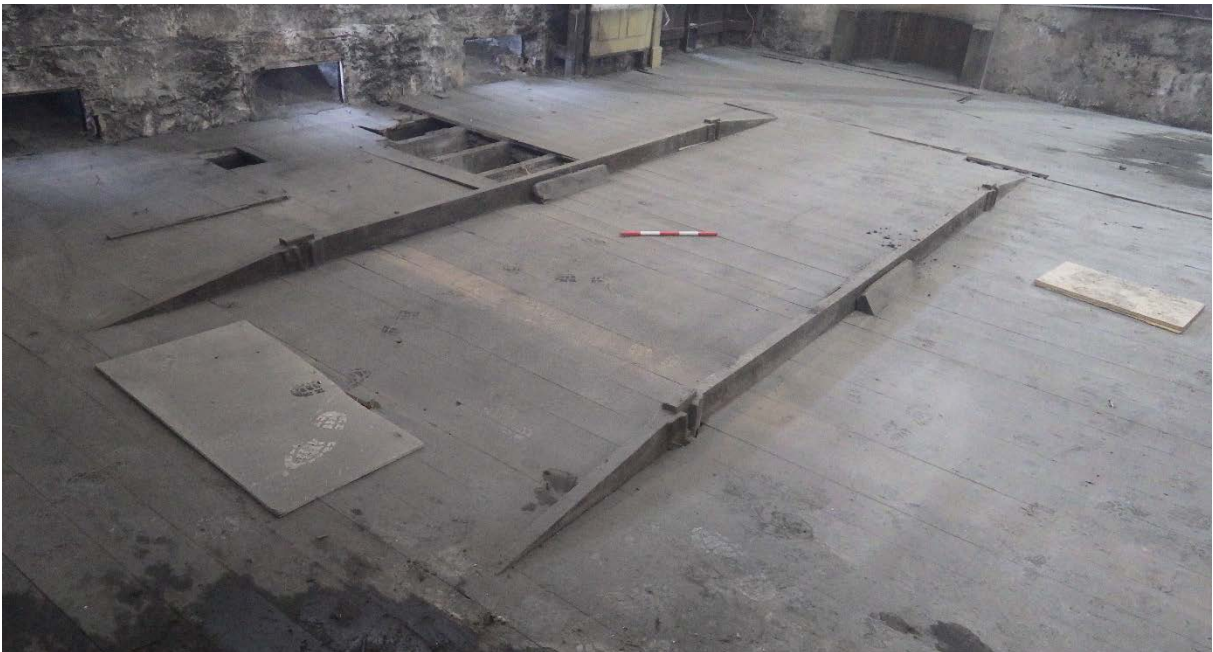
The metal part of the floor trusses visible above the floor would have originally been hidden beneath the seating but following the removal of the lecture seating a secondary raised floor was built over them (Plate 34).

Plate 34 Room 1.288 floor truss rising above original floor

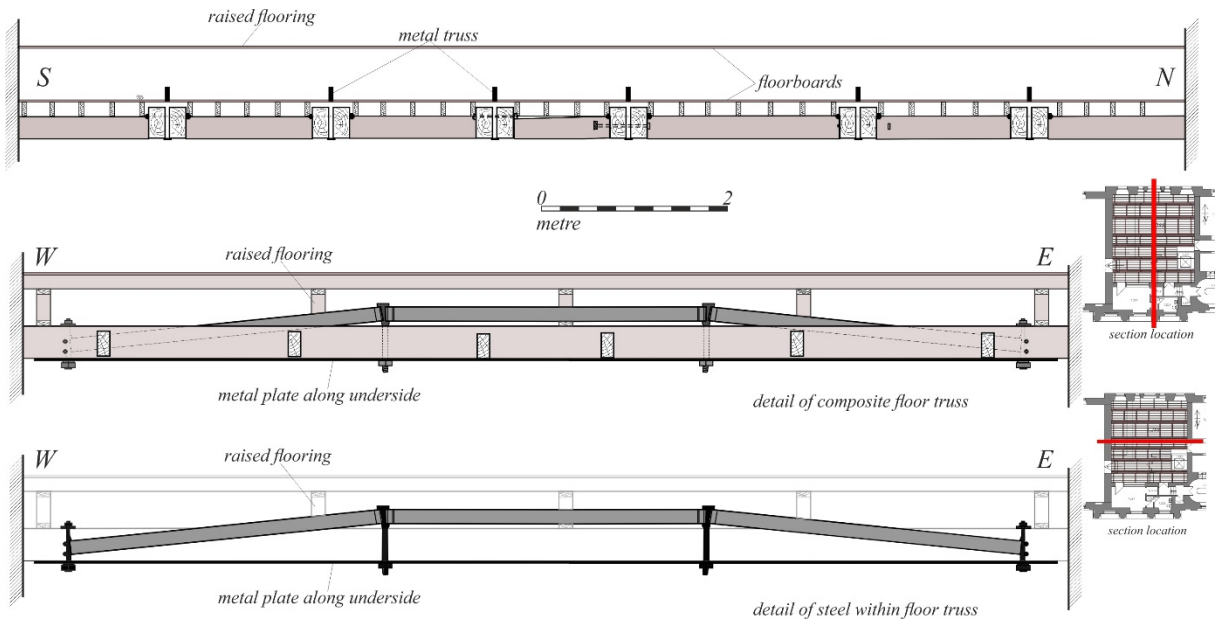
Figure 13 Room 1.288 survey sections through floor structure showing construction

The floor trusses were formed from composite timber and metal (Figure 13), with a multi-part jointed and bolted-together metal truss sitting within and sandwiched between timber beams. Samples of the truss were kept by the University.

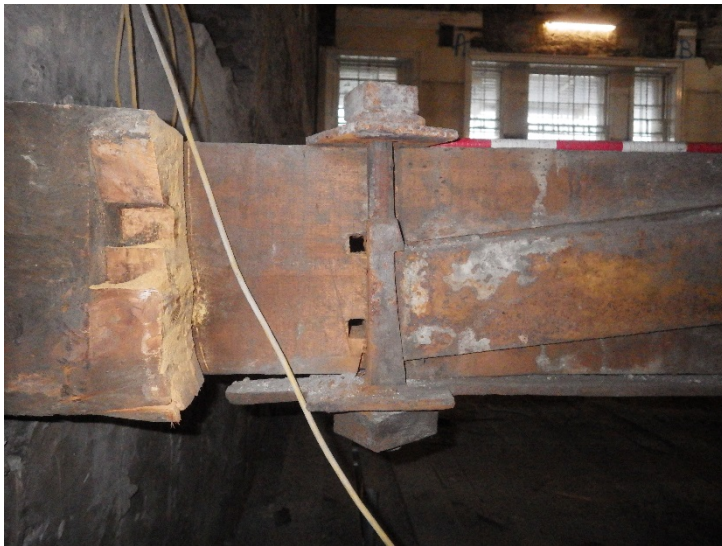
Plate 35 Room 1.288 detail of metal truss end exposed

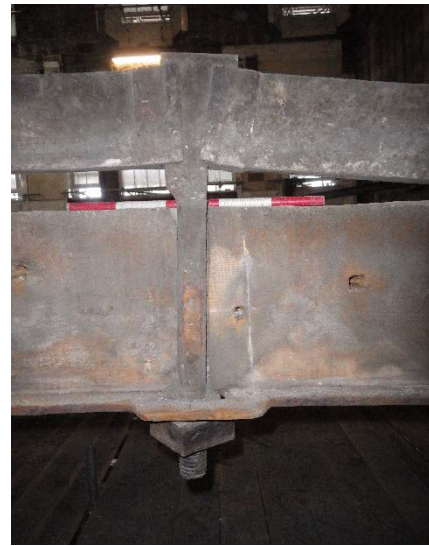
Plate 36 Room 1.288 detail of metal truss joint exposed

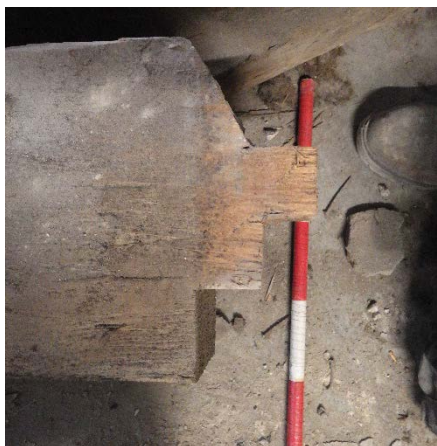
Plate 37 Room 1.288 lesser joist detail of sloped haunch tenon joint

The floor was made up from six east-west aligned composite trusses unevenly set across the room. Between these ran 6-7 north-south aligned lesser joists. These lesser joists were jointed into the main truss with a slope-haunched tenon and further held with a bolt (Plate 37). The bolt ran through the main truss into the end of the lesser joist and was tightened by a nut within the joist; the hole for the nut was blocked over with timber concealing the nut. A number of the main joist timbers showed race marks (Plate 38); these were likely relic from timber yards rather than related to construction.

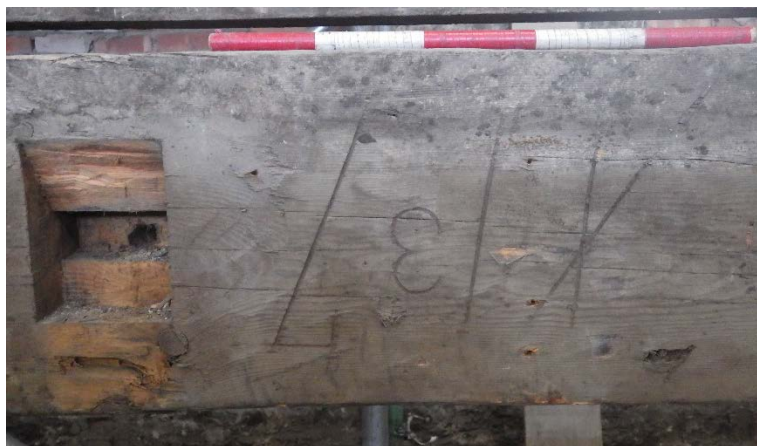
Plate 38 Room 1.288 main truss shows lesser joist mortise with bolt hole and race marks
