The Law School, Old College Quadrangle

Watching Brief and Excavation: April 2016 to March 2017

Job number AA.2132

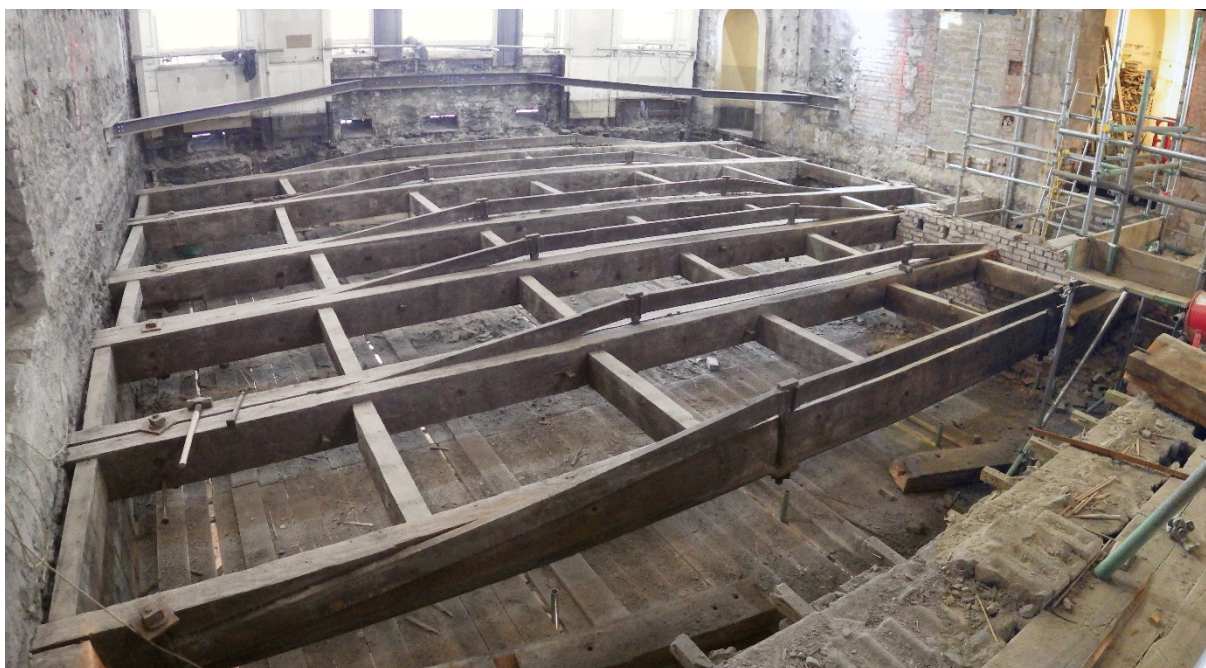
Upon the lesser joists, timber floor joists were laid oriented east to west; floor boarding was laid on top of these.

Plate 39 room 1.288 floor structure once floor joists and boarding removed

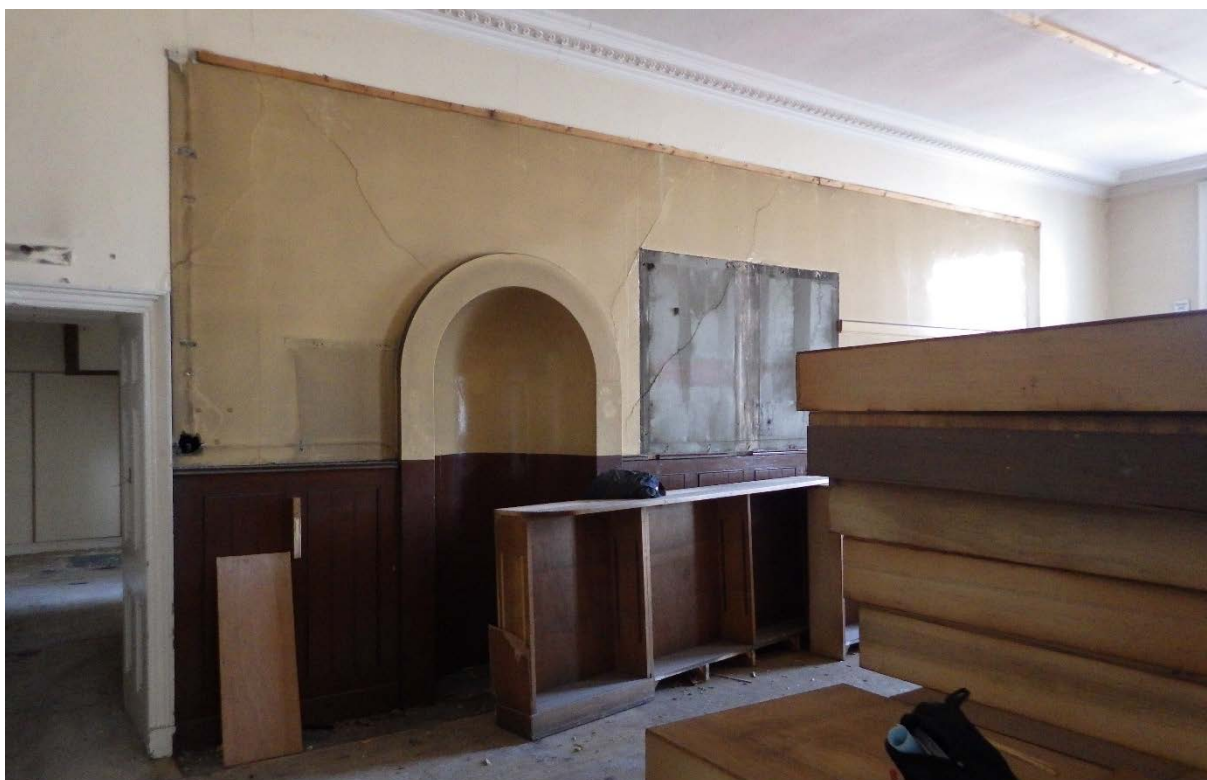
Plate 40 Room 1.292 western elevation shows earlier paint scheme and stove recess

This room was marked as the lecture room of ‘Education and Political Economy’ on the 1895 plan, with tiered seating rising up to the east and a large podium to the west with a stove in a recess. Stripping of modern shelving exposed the elevations revealing the stove recess and earlier colour schemes of a reddish brown on the timber dado lining and a cream above with an earlier blue grey paint exposed beneath (Plate 40). Stripping of the plaster ceiling exposed a large void up to the flooring above. Within this was an earlier higher ceiling line (Plate 41). The doors were also widened, exposing rubble masonry in the walling.

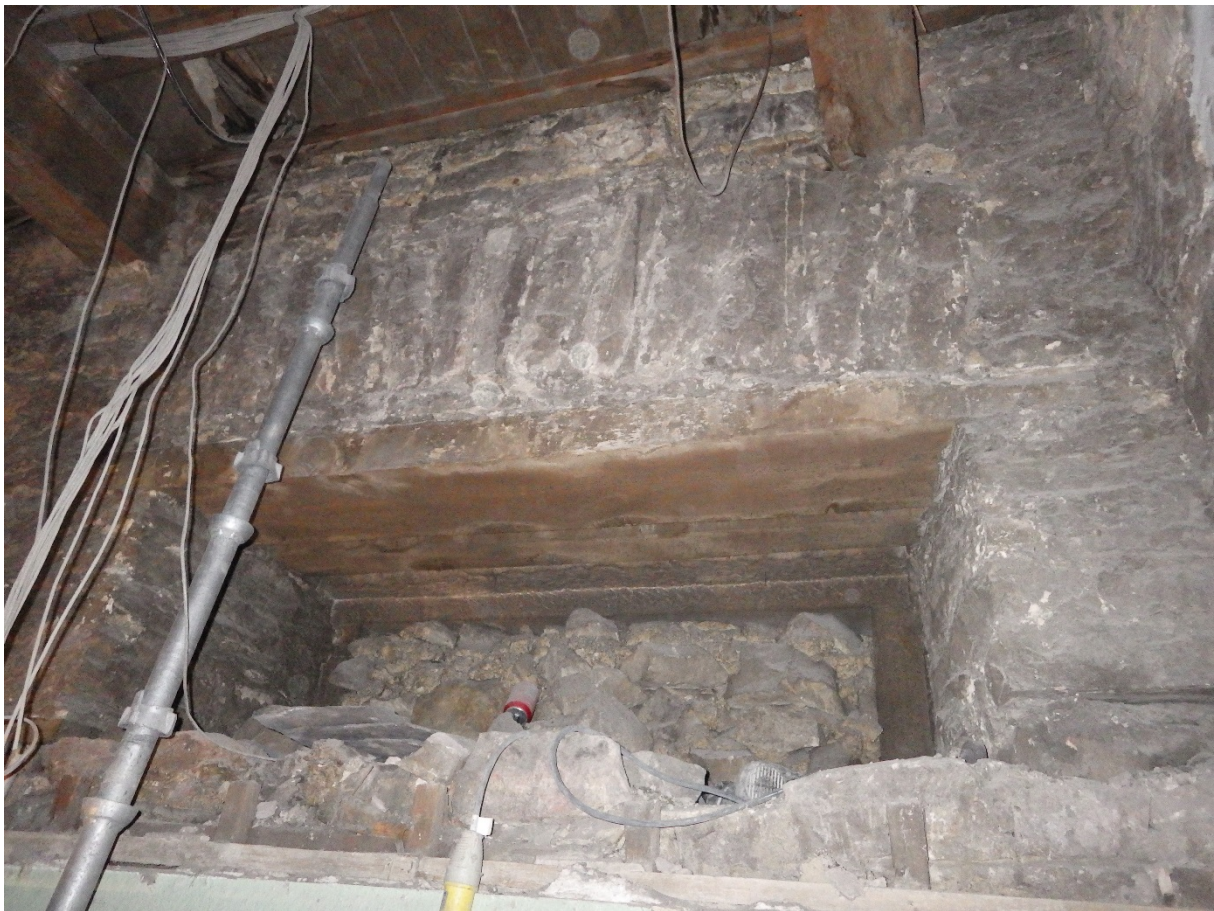
Plate 42 Room 1.Z28A blocked up windows visible above the low ceiling

The open part of the window showing the external surround was also blocked at the exterior face. No windows are shown here on the 1895 plans and a stair (room 1.Z28) is built against the exterior suggesting these are an early relic set of windows built before the stairs were constructed during the lengthy construction process

The roof structure was also exposed in this room, with four main beams aligned north-south and joists laid simply on top.

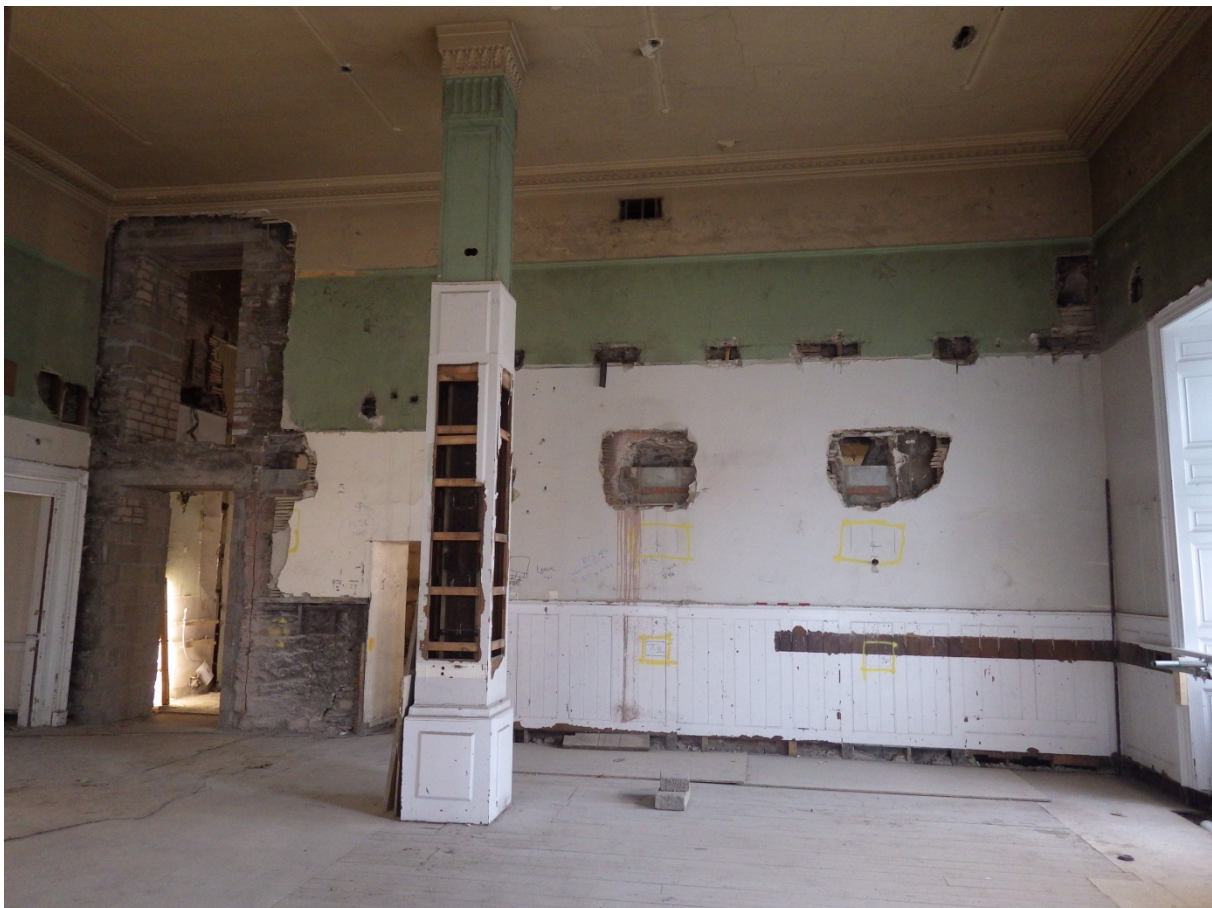
Centrally placed in Room 1.296 on the line of the former wall with Room 1.294, and centrally in Room 1.294, were a pair of round iron columns boxed behind square timber panelling with moulded capitals. The column sat on neatly-squared sandstone block foundation with horizontal tooling (*Plate 43*).

Evidence for a blocked fireplace was noted on the west wall of Room 1.294, offset towards the northern end of the room. A panel of brick blocking and an inserted panel of the timber wall-panelling indicate the location of this former fireplace, with a possible recess or press to its north in the same wall (*Plate 43*).

Plate 43 Room 1.294/6, general view with boxed column and west wall; blocked fireplace behind panelling at centre

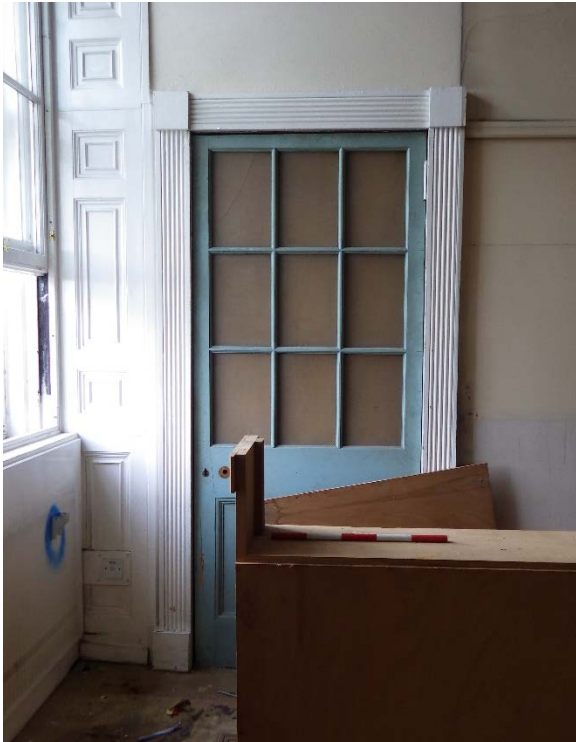
Plate 45 Room 1.298, southern wall showing exposed eastern relic door, leading to the “retiring room”

The eastern door (*Plate 45*) was half-glazed and painted blue; this was locked from the north and formerly opened into a ‘Retiring Room’. The western door (*Plate 46*) was six panelled and painted light green and fitted with a rim lock on the north side. This door opened into a timber lined passage through the wall lined with varnished vertical boarding with a plain skirting. The passage was blocked with cement blocks on the other side; the position of the rim lock on the north face of the door suggests the door was opened and locked from the southern room which historically was a small room coming off a stairwell.

From these doors we can surmise the circulation routes during use: the main access for students appears to have been from the south-west stair and the eastern door was used by lecturers to access a private room which itself was also accessed from the stairs.

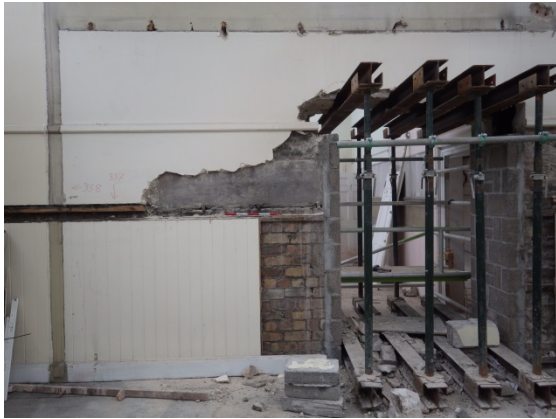
Plate 47 Room 2.Z21 east wall fireplace lintel in situ

Within this suite of rooms, the modern partition walls dividing it into four spaces had been removed, revealing the single room space marked as a ‘Natural Philosophy Laboratory’ on the 1895 plans. The opening up of the east wall of this original room for a new doorway had truncated and partially exposed a former fireplace, blocked with cement-bonded bricks. Later clearance of the rubble associated with the opening up revealed a stone-built flue, 0.30m x 0.30m square, associated with a fireplace below (Plate 48). The partially surviving north jamb of this fireplace was composed of rough rubble stone; its south jamb had been lost in the opening up. The location of the fireplace, with stepped-out jambs, is shown on the 1895 plan. The lintel of the fireplace was composed of a single fine-grained stone (Plate 47), and was notable for preserving traces of graffiti, both inscribed and painted. The reconstructed lintel and inscriptions are shown in Figure 15. Given the dates of 1722 inscribed on the stone, this lintel appears to have been reused from elsewhere, presumably from former University buildings demolished during the construction of Old College.

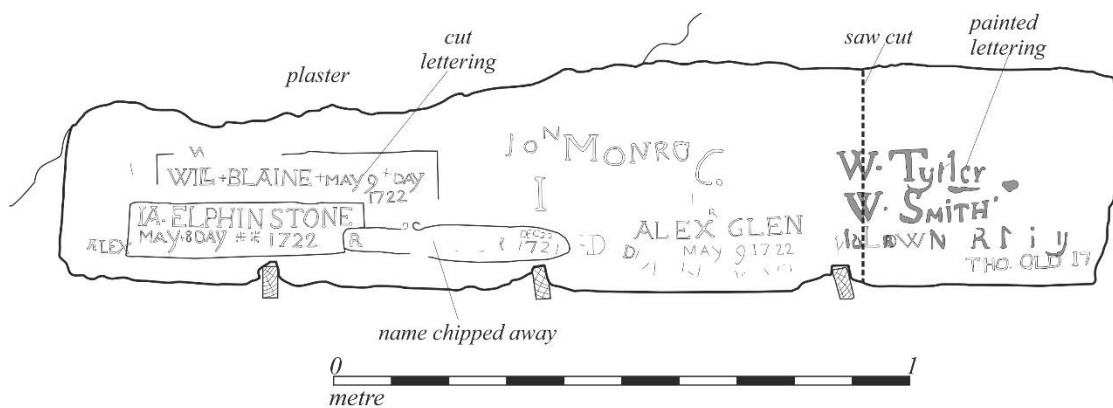
Figure 15 Inscribed fireplace lintel. Top, transcription. Bottom, composite photograph

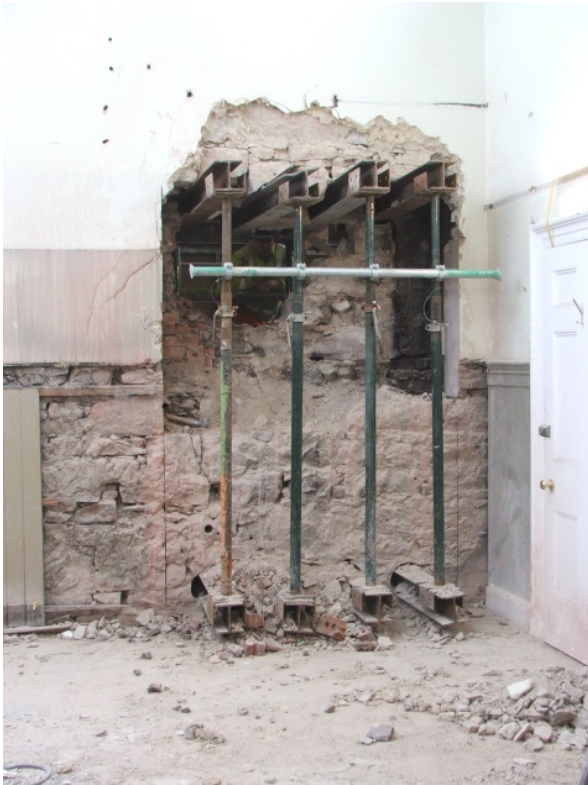
A further new doorway opening in the east wall of Room 2.340 partially exposed a chimney flue, very similar to that exposed in Room 2.Z21, within the historic fabric. The stone-built flue was 0.30m x 0.30m square, and its interior faces heavily sooted and heat-affected (Plate 49, Plate 50)

Plate 49 Room 2.340 east wall new door opening with flue exposed at right

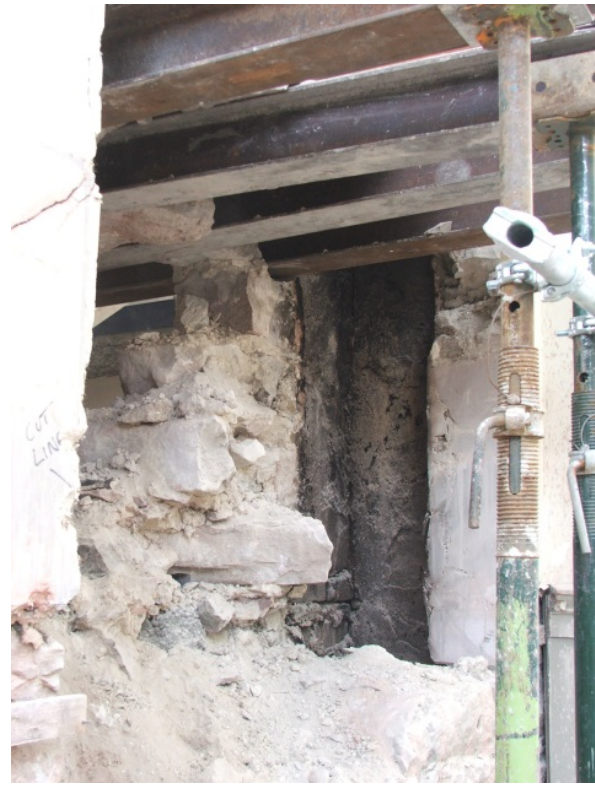
Plate 50 Room 2.340 detail of sooted and heat-affected flue

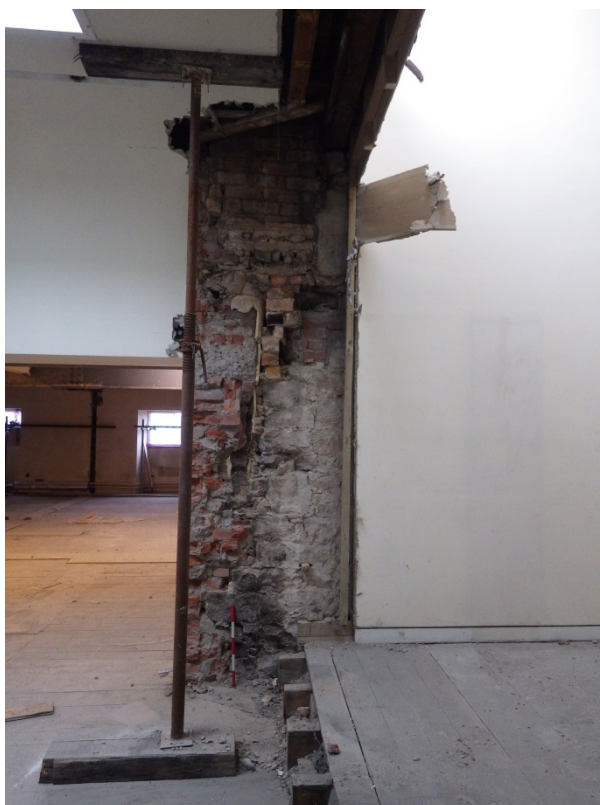
As with the rooms to the west, Room 2.343 was previously part of a larger space, which was marked as a 'Natural Philosophy Laboratory' on the 1895 plans. Demolition of the later partition walls and historic fabric for a new doorway in the east wall exposed a cross-section through the historic fabric. This revealed the rubble-stone construction of the wall, with a corner fireplace (blocked with 20th century cemented brick) and its associated ceramic pipe flue and brick chimney rising above it (*Plate 51*). The 1895 survey plans show both a fireplace with advanced jambs on the west face of this wall, and a niche for a stove setting on the east face of the wall (Room 2.347), off-set to the north. The chimney flues may be associated with either or both of these installations.

Plate 51 Room 2.344, blocked fireplace and ceramic pipe flue above

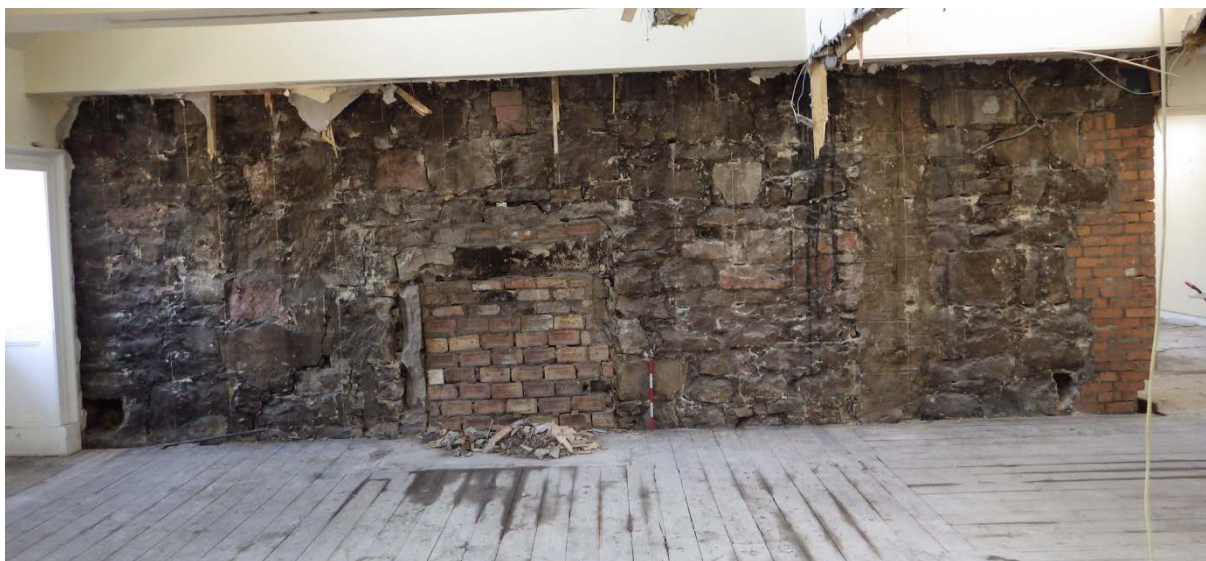
The modern partition walls and wall treatments had been removed at the time of building recording in these rooms which therefore appeared as a single space. A small part of the north wall of Rooms 2.357-8 had been stripped of its wall treatment, revealing the typical roughly squared reddish and grey sandstone makeup and in this case, a substantial timber beam preserved at the top of the wall head. The east wall of Room 2.358 and 2.359 was exposed (Plate 52), showing that the south end of the wall had been truncated northwards with the ends of the wall made up in brick. Slightly off-set to the north of the centre of the wall was a reduced and brick-blocked fireplace. The 'NIDDRIE'-stamped bricks were bonded in cement mortar. The relict fireplace they blocked was furnished with squared slabs of fine-grained grey stone, contrasting with the coarser rubble stone of the surrounding wall construction. The northern jamb survived as a cut-back stub which had been truncated back to the wall line; its companion jamb on the south had been removed almost completely and the void filled with brick. The single squared stone lintel survived, with some later brick repairs around it. A brick repair above the fireplace may be the traces of an aperture for a stove-pipe, as was the case in the rooms further east and was better preserved there (see below).

To the south of the blocked fireplace, a vertical line of render marks the position of an east-west cross-wall, c 0.60m wide, demolished before the installation of the 20th century partition walls. That this is a likely cross-wall is indicated by the alignment of the floorboards, which run east-west on the north side of the line of the cross-wall and change to north-south on the south side of the cross-wall. This change in alignment also indicates that the floorboards to the north are associated with the earlier room layout and the southern post-date the removal of the cross-wall, as they respect the demolished wall lines. The former alignment of this cross-wall may be seen on the 1895 survey plan, extending across Room 2.359, just south of the more modern partition walls. That the 1895 plan does *not* show this wall continuing across Room 2.360, despite the material evidence of the wall extending at least partially into that room, indicates that the cross-wall probably predates 1895 and was altered during the late 19th century internal modifications, to be finally demolished in the 20th century, probably during the 1970s major internal re-arrangements of Old College.

Plate 52 Rooms 2.358-9 east wall with blocked fireplace and brown rendered cut-back cross-wall to right.

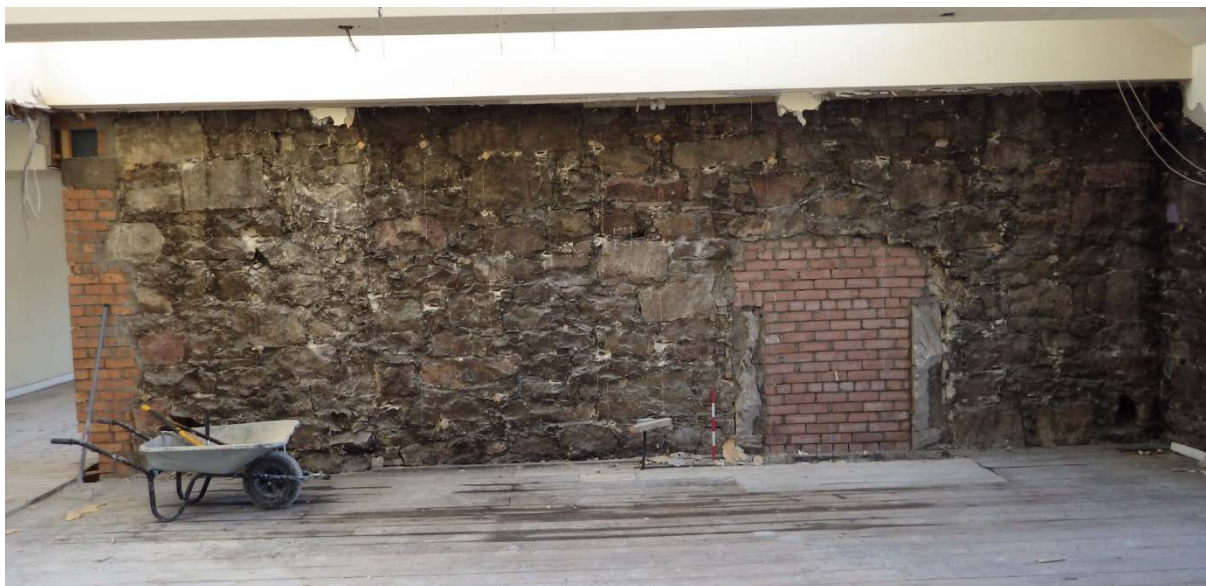
The west wall of the room (*Plate 53*) was noted to be composed of roughly squared rubble, with a relic fireplace offset towards the northern end of the wall. This fireplace had been blocked in cement-bonded brick. The flanking large rubble jambs had been roughly cut back to be flush with wall line, and the large lintel stone had been removed, so that the brick blocking filling the fireplace was notably T-shaped. The rectangular panel of inserted floorboards in front of the fireplace no doubt represents a removed hearth emplacement.

To the south of the blocked fireplace, a further feature was noted preserved in the masonry. A linear scar in the masonry and a change in the character of the stones' facing indicate that a masonry feature has been cut back in this area to flush with the wall-line. The most likely interpretation for this is a former cross-wall, aligned east-west that has been demolished and trimmed back to the wall face. This cross-wall is more apparent on the west face of this wall, in Room 2.359, as discussed above. Examination of the 1895 plan reveals a slight kink and a thickening of the wall in Room 2.360 at this point. This may indicate slightly careless wall-building, or, more likely perhaps, that the cross-wall pre-dates the 1895 changes made to the Old College building and this east-west cross-wall originally continued into Room 2.360. The flooring in this room is also therefore a later addition, as the boards cross the line of the cross-wall, unlike those of the Room 2.359 to the west, as noted above.

Plate 53 Room 2.360 west wall with blocked fireplace and cut-back cross-wall to right of wheelbarrow

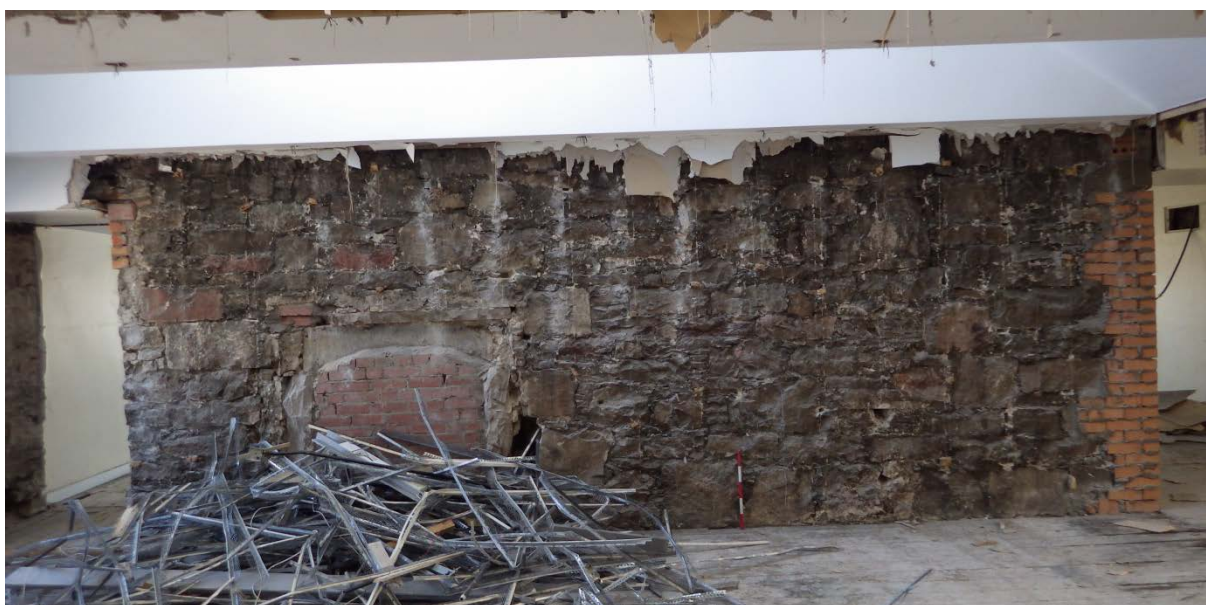
This room is marked as a ‘Retiring Room’ on the 1895 plan. The east wall had been stripped back to its original wall face showing the usual roughly squared rubble stone wall construction. The wall contained a fireplace, blocked with cement-bonded brick, off-set to the north end of the wall. The jambs of the fireplace had been trimmed back to be flush with the wall line, and were composed of large single upright slabs, in slight contrast to the fireplaces recorded on lower floors which tended to show rubble jambs. The large lintel stone, also in distinction to those others observed, had its underside carved into a curve close to a four-centred arch, and was further capped with a thin stone slab. The carved arch form may have been a later amendment to the fireplace to accommodate a stove or other alterations; in any case, this fireplace appears structurally slightly more formal and elaborate than others noted, perhaps due to the room’s function as a professorial retiring room.

Plate 54 Room 2.361 east wall historic fabric with brick-blocked fireplace

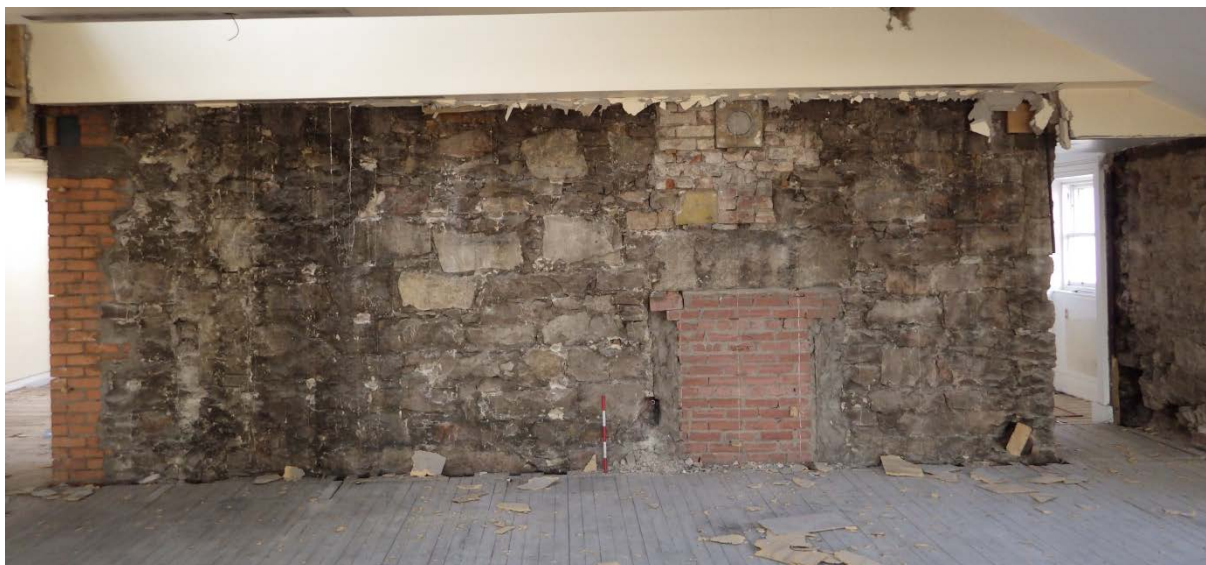
These rooms consist of the sub-divided former 'Geological Laboratory' of the 1895 survey plan; the north-south 20th century partition walls had been removed at the time of building recording. The west wall of Room 2.363 had also been stripped back to its historic fabric (*Plate 55*). The southern extent of this wall had been truncated by about 1.5m and the wall-end made good with brick. Off-set to the north of the centre of the wall, a fireplace or stove emplacement was noted, blocked in cement-bonded brick and with its projecting jambs cut back to flush with the wall line and the remaining voids infilled with cement. The single large roughly-squared stone lintel was still in place, with patches of the chimney brickwork visible, as was the round apertured stone slab to accommodate the stove pipe above.

Plate 55 Room 2.363 west wall historic fabric with blocked fire/stove and stovepipe fixture above

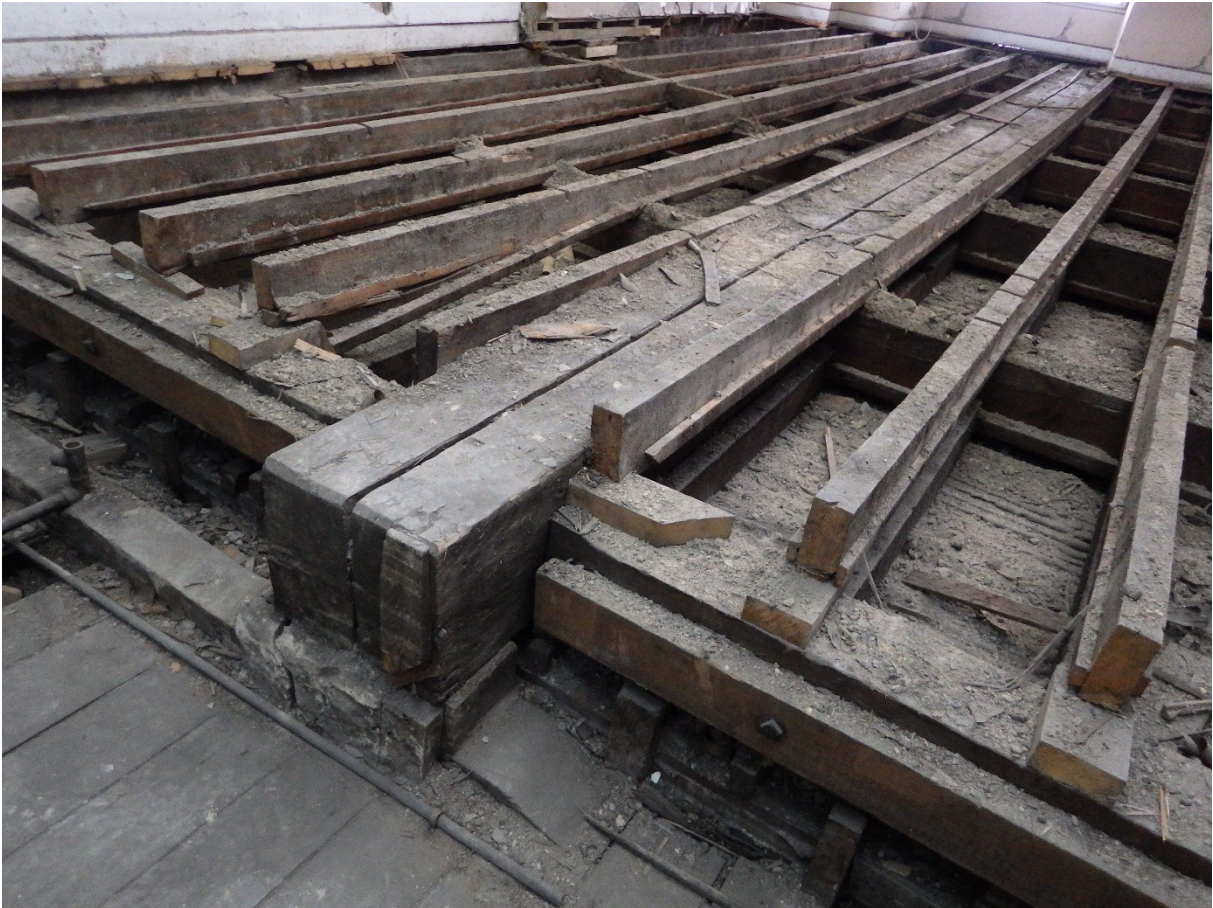
Plate 56 Room 2.365-8 floor structure shows main composite beam supporting floor structure and plaster ceiling below, note vertical lath and plaster of room below along edge of floor

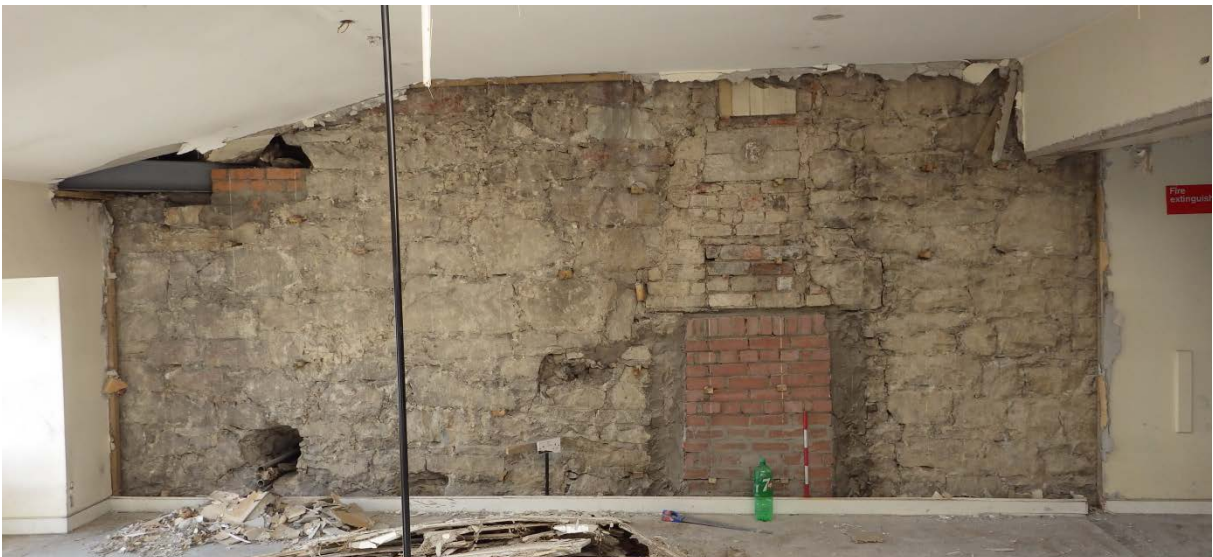
Plate 57 Room 2.368 south wall with historic fabric exposed including blocked fireplace with chimney and stove-pipe aperture above

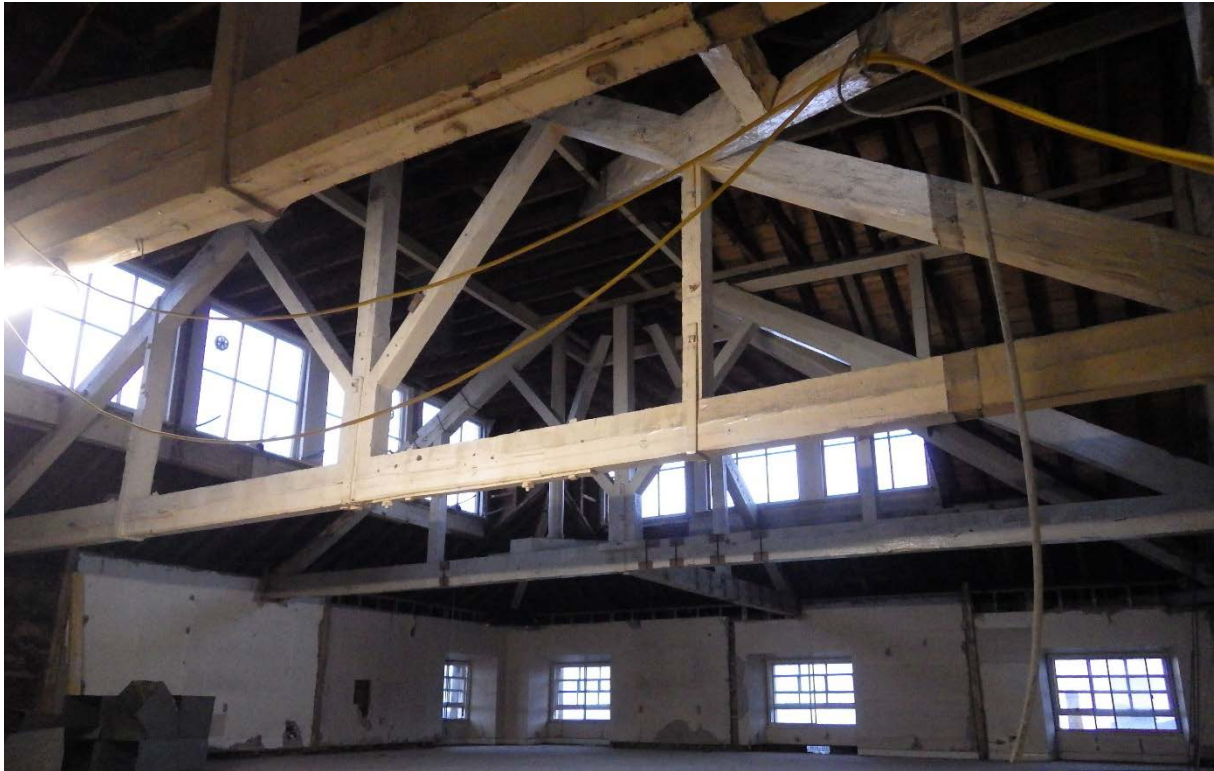
As part of the internal strip-out, the roof structure was largely exposed (*Plate 58*). It was formed from large king post trusses, many of which were painted white indicating they were formerly exposed within the space; latterly they had been lost behind lower inserted ceilings.

Plate 58 roof structure 2.357-2.368

The trusses were of king post design with additional vertical struts either side; the span of the tie beam was too wide for a single beam so two beams were joined together to form the tie. The joints were scarfed and held horizontally with straps tightened with gibbs and cotters. Further support for the jointing was provided by the vertical struts positioned above the joints and supporting the tie joint with stirrup strapping fixed with gibbs and cotters on both the tie and principal rafter (*Plate 59*). The joints were also bolted horizontally and vertically.

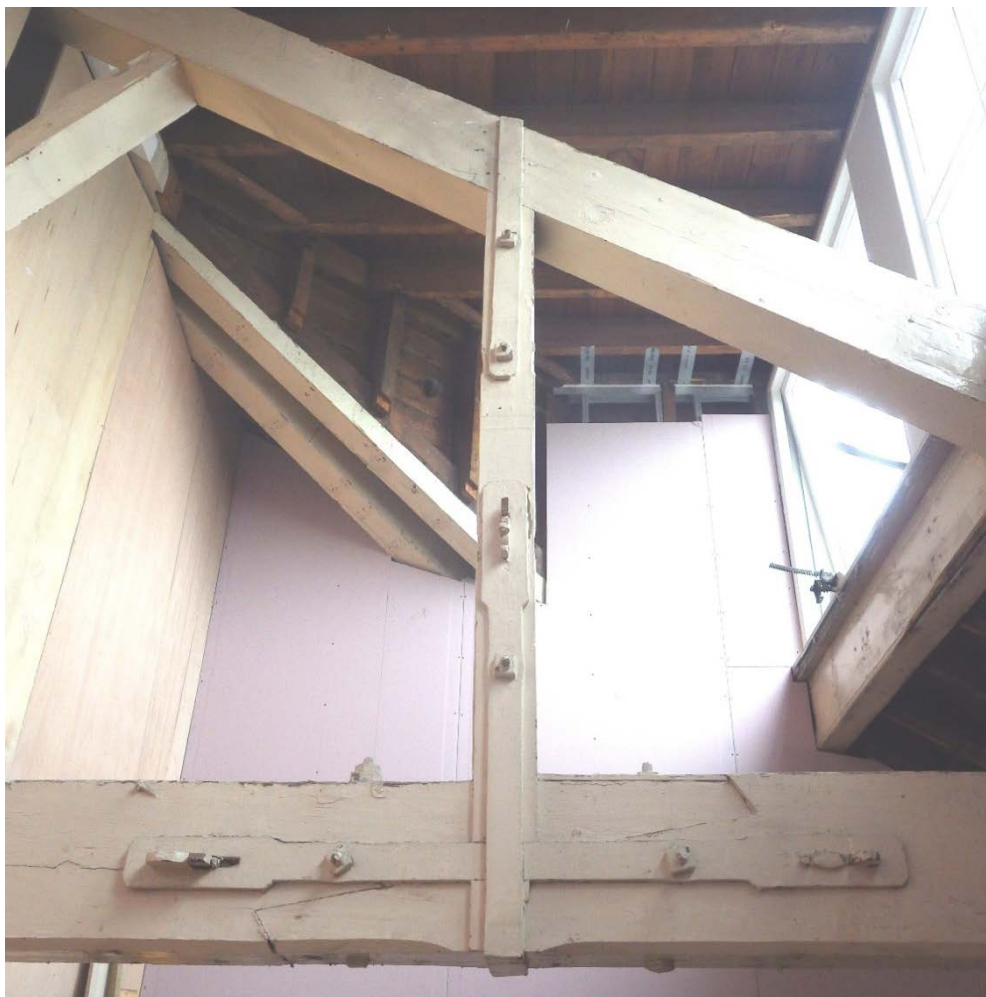
Plate 59 Roof structure 2.357-2.368 showing tie beam jointing with supporting strapping held with gibbs and cotters

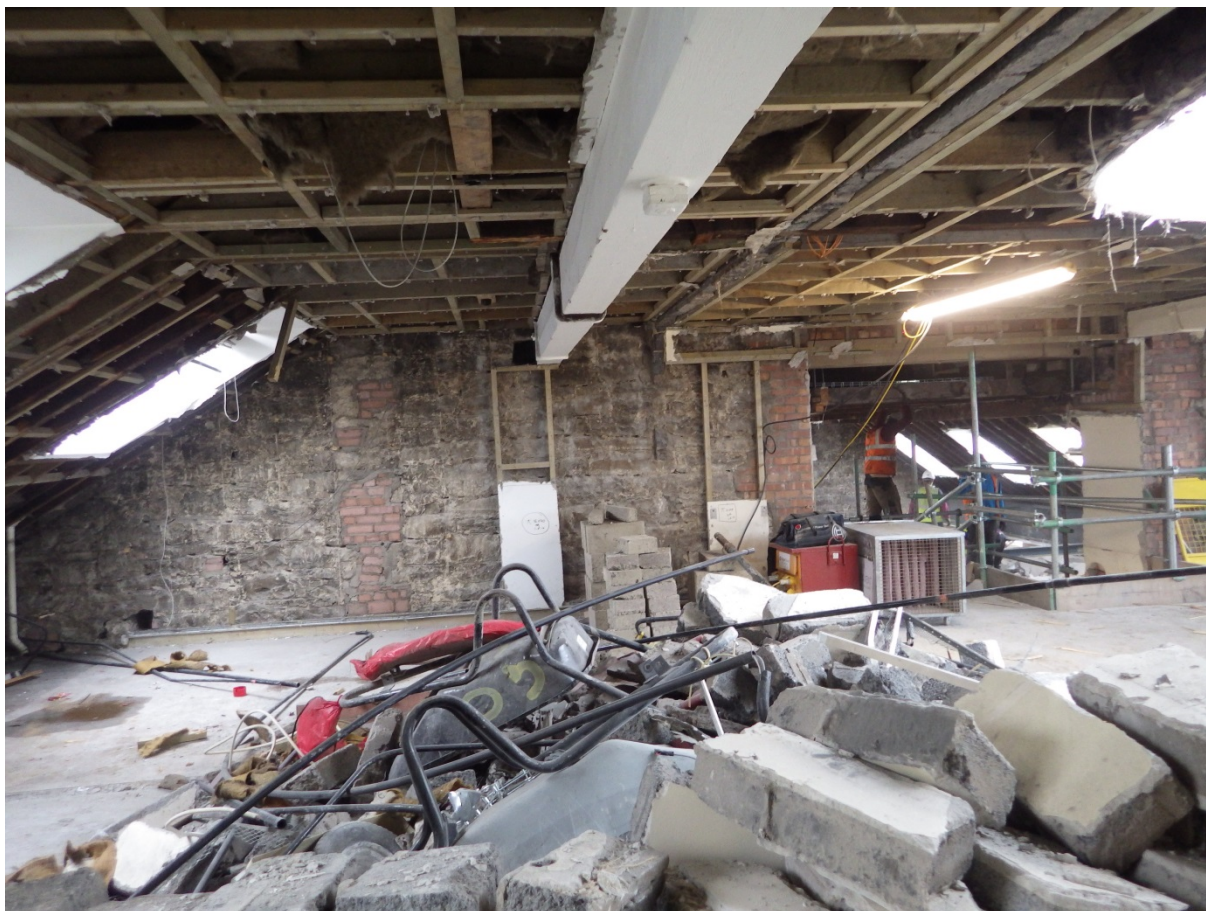
These rooms in the central section of the northern flank of the building were stripped of their internal partitions and the roof and wall fabric exposed (*Plate 60*). Door openings in the west and east wall were widened. The west wall of Rooms 3.413/414 show the remnants of both thin partition walls and a brick-infilled, clawed-back cross-wall, the latter at the junction of the flat and pitched roof sections. Two large major double roof beams with iron straps and bolts, tied in to the wall masonry and supporting the roof structure, extended across the suite of rooms to the north and south of the main doorways.

Plate 60 Room 3.413/4 west wall with historic fabric and rood structure exposed

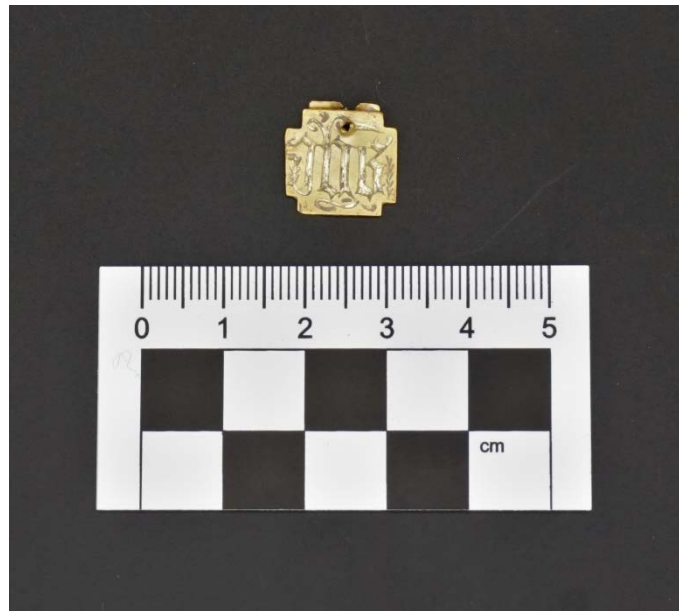
The ferrous and non-ferrous metal assemblage also includes a range of copper objects, some possible coins or tokens, as well as lace chapes and pins, common on medieval and post-medieval sites. Most of the ferrous metal items are nails or spikes. Most notable perhaps is the single gold item, a rectangular gold plaque with fixing holes, inscribed with the Christogram IHS (*Plate 61*), derived from lower deposits in Trench 6 and conceivably related to the medieval use of the site and the Kirk O' Field church, in use until the 16th century.

Plate 61 SF213, gold fixture, inscribed IHS.
