Woolsington Hall

Woolsington, Tyne and Wear

Watching Brief on Temporary Drainage: 27th January – 3rd February 2020

Cameron Hall Developments

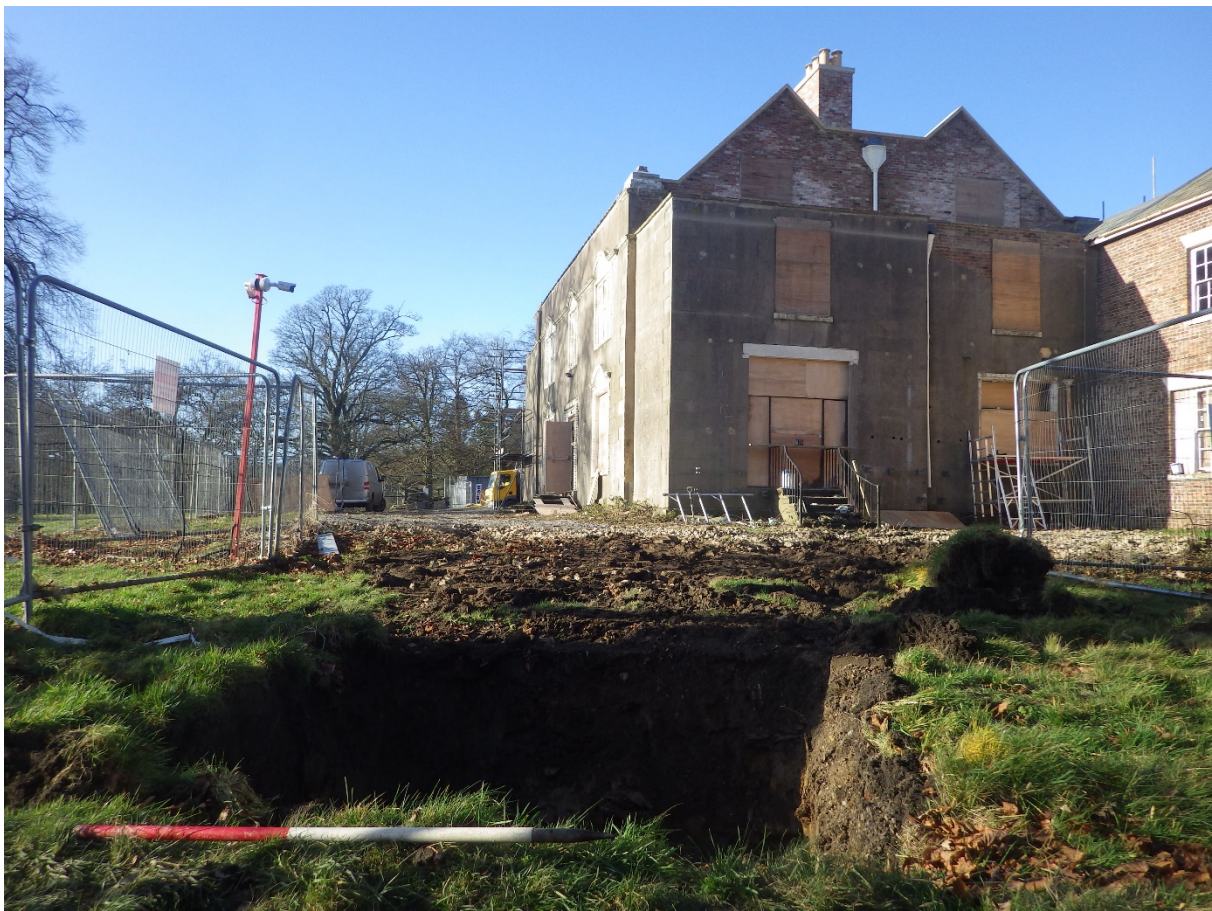
Excavating Trench 1, to the South East of the Hall

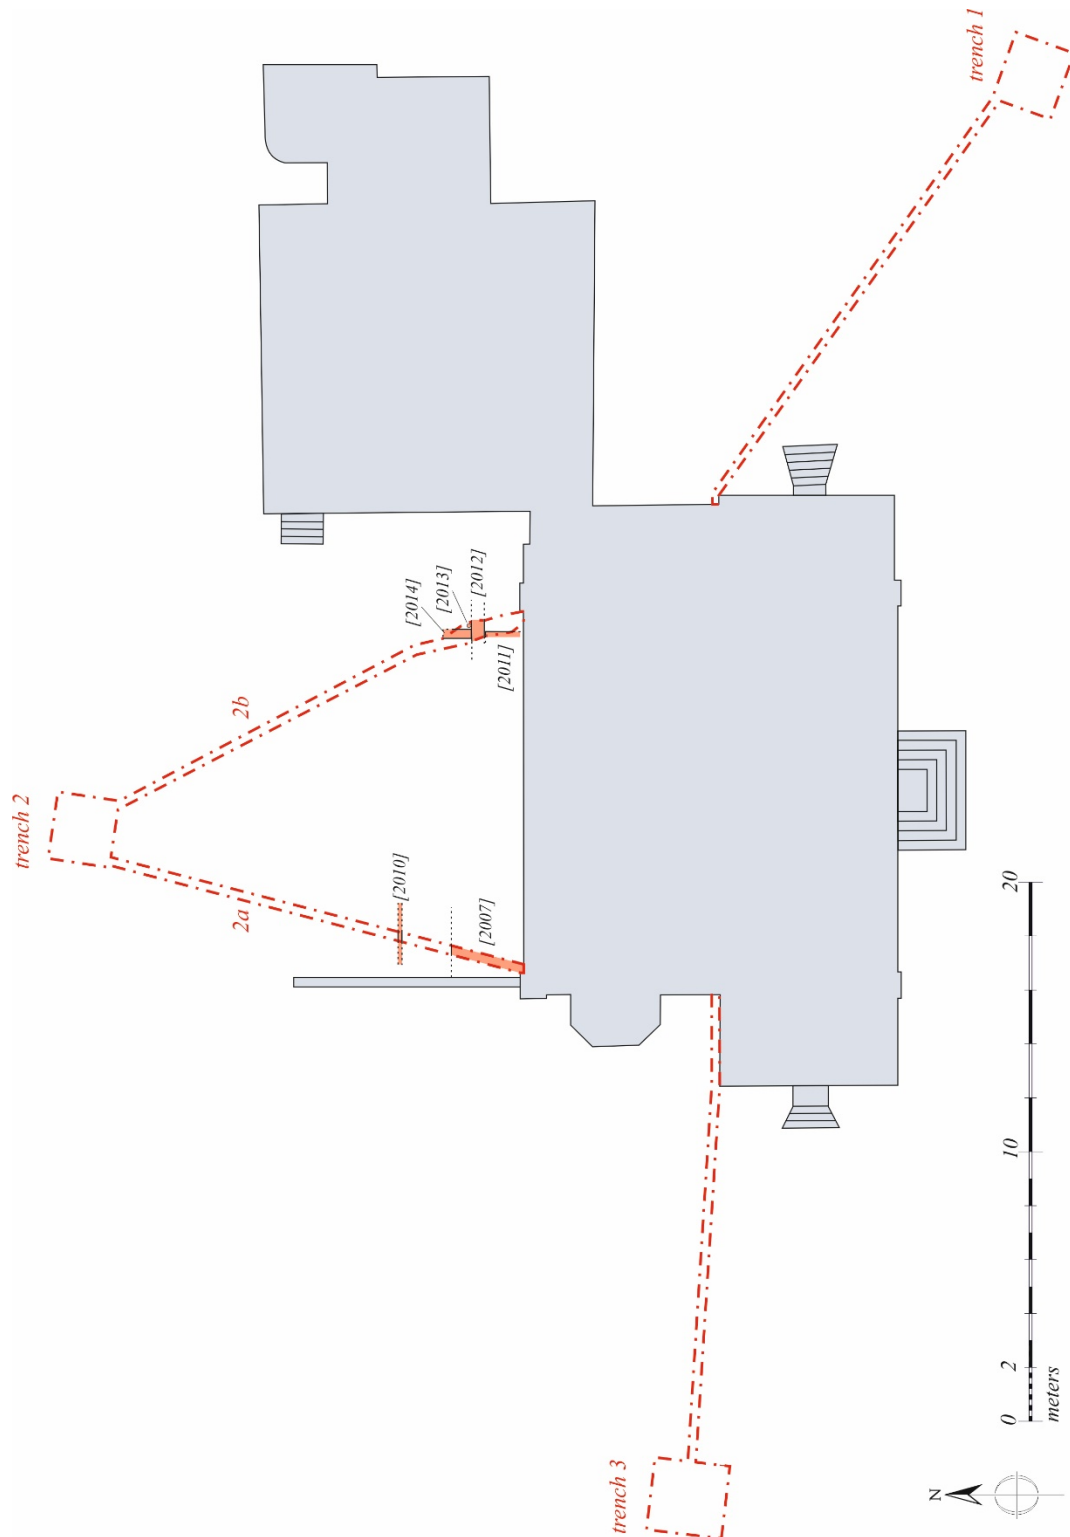
Figure 2 Site plan

The excavations were conducted in three areas: to the north, the west and the south-east of the Hall (*figure 2*). The ground breaking works were undertaken in order to install temporary French drains and sumps to soak away the water from the downpipes of the recently rebuilt roof. The drains consisted of one shallow 0.3m – 0.5m deep trench (two in the north) leading to a large deep pit backfilled with stones to serve as a sump.

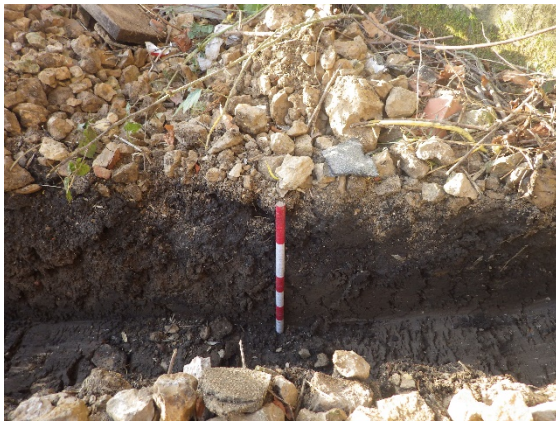
Plate 1 Trench 1, West end, North facing section

The trench was excavated through an overlying stone horizon 2003 (0.15m thick) which had previously been laid by the contractors around the Hall during the works. The stone 2003 overlay dark brown – black topsoil 2004 (0.2m thick); this was over greyish brown – light brown gravelly clay 2001 with occasional CBM and sandstone fragments and char/coal nodules, interpreted as a construction horizon 2001 (*plate 1*). Between 8m and 15m from the north-west end, the trench was excavated through very disturbed surface slurry. The east end and the sump of Trench 1 was excavated through 0.3m of loamy topsoil 2000 and 0.3m of construction horizon 2001, which sealed the natural clay 2002 (*plate 2*).

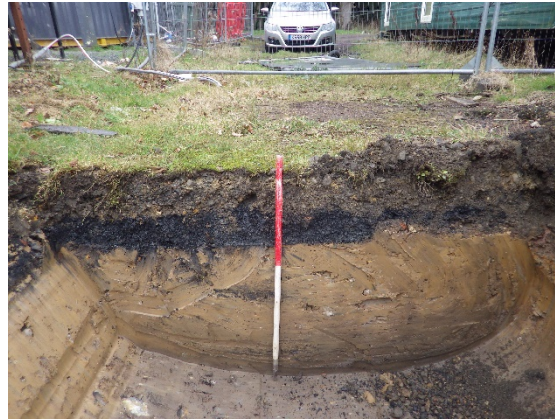
Plate 3 Trench 2, Sump, South facing section

Excavation of the sump revealed 0.25m of topsoil 2005, which overlay a 0.15m cinder horizon 2006; the cinder 2006 sealed the natural clay 2002 (*plate 3*).

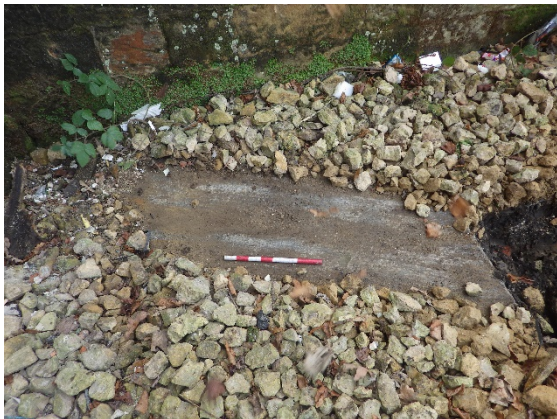
Plate 4 Trench 2a, Concrete 2007

The southern end of Trench 2a was overlain with stone horizon 2003. Against the north elevation of the Hall, this stone 2003 covered a concrete pad 2007 (*plate 4*). The extent of the concrete 2007 east to west was not exposed but the pad was 2.7m wide and 0.2m thick. To the north of the concrete 2007, excavation proceeded through stone 2003 and construction horizon 2008, similar to construction horizon 2001 in Trench 1. The top of a salt glazed ceramic pipe drain was encountered 4.5m from the north elevation of the Hall. This drain 2010 runs east to west and was 0.15m in diameter, with no visible cut within construction horizon 2008 (*plate 5*). At 6.5m from the south end excavation revealed a heavily disturbed build-up 2009, created during the downtakings and emergency works. The last section of the trench, closest to the sump was excavated through topsoil 2005 and cinder 2006.

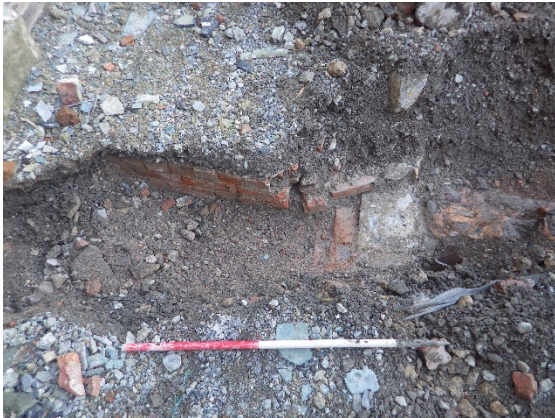
Plate 6 Trench 2, East, Wall 2011

A number of features were encountered at the southern end of Trench 2b, which had been previously exposed during the excavations and recording of the Hall and were backfilled only recently when the later extension to the Hall was demolished (*figure 3*). A brick wall 2011 bonded with pale brown mortar extended north-south at the southern end of the trench; three courses of stretchers were exposed (*plate 6*). This was a crosswall of the later extension to the Hall. Parallel to the western extent of the wall 2011 was a flagstone and brick foundation 2012, made of brick bonded with grey mortar and a single course of flagstone, which measured 0.5m wide. This was originally the north wall of the Hall extension. To the north of the foundations 2012 a 0.15m diameter ceramic downpipe 2013 was recorded, originally this would have been the corner between the north extension and the 20th century stairs, of which the surviving east wall was revealed as brick and concrete wall 2014. Wall 2014 was

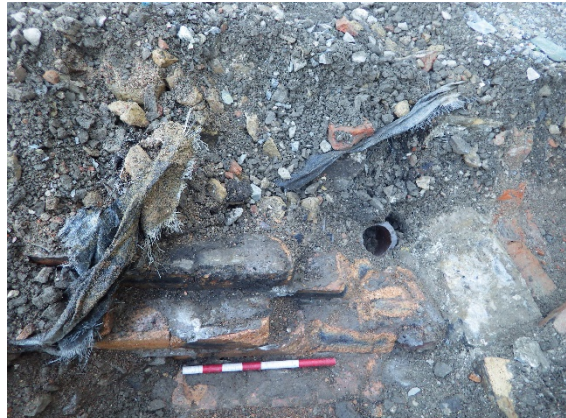
Plate 7 Trench 2, East, Foundations 2012, Downpipe 2013 and Wall 2014

exposed to a depth of three courses (*plate 7*); its east-west return was completely dismantled in 2019, along with all above ground masonry of the extension.

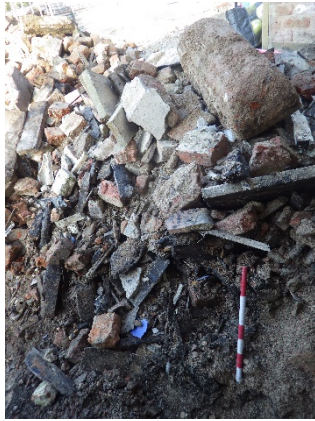
Plate 8 Trench 3, Demolition 2016

Initial excavation of the trench was undertaken through loose demolition rubble 2016, which had built up against the west elevation of the Hall and was made up of bricks, burnt debris and rubbish (*plate 8*). Excavation stopped when the pre-fire ground level was reached. The demolition rubble 2016 extended for 4.39m from the eastern end of the trench; subsequent excavation was within stone 2003 and topsoil 2017 (similar to topsoil 2004 and 2005). The sump excavation was undertaken through

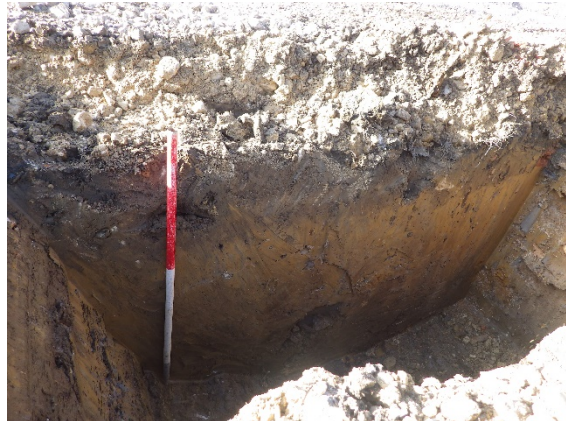
Plate 9 Trench 3, Sump, East facing section

stone 2003 (0.3m thick) and topsoil 2017 (0.4m thick), which overlay natural clay 2002 (plate 9). As the sump was excavated through the main access road, both stone 2003 and topsoil 2017 were quite compacted here. It is possible that the topsoil 2017 in Trench 3 is a combination of the topsoil and a construction horizon, similar to that found in Trenches 1 and 2, which has been disturbed by the works and the vehicular traffic above. No archaeological features were noted within Trench 3.
