Orwell Farm

Kinross, Perth and Kinross

Historic Building Recording: June 2020

Orwell Farm Limited

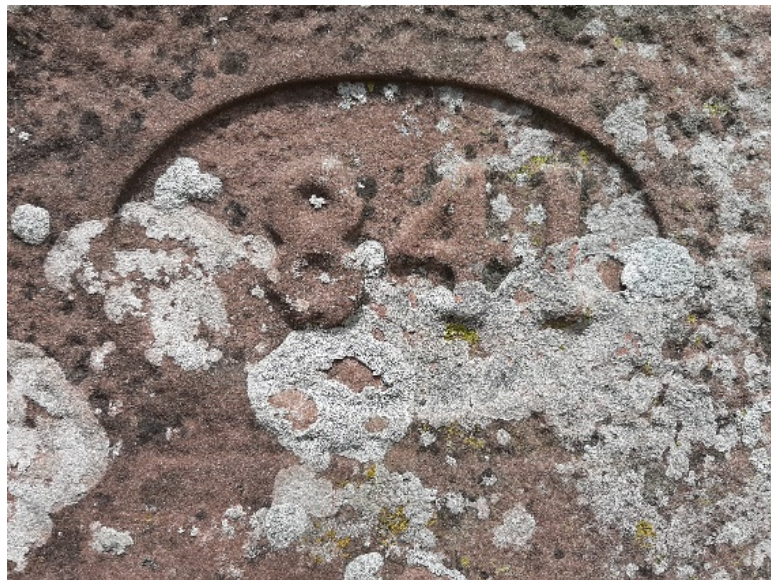
The combined range appears to have been of a single overall conception and integrated design typical of an improvement farming enterprise of the mid-19th century. There exists a date stone of 1841 upon a loft level window lintel towards the west end of the south side of the southern range, *Plate 1*. It is probable that the construction of the entire range dates to about this period in spite of the fact that there is some variation in sandstone employed.

Plate 1 Date stone on southern range

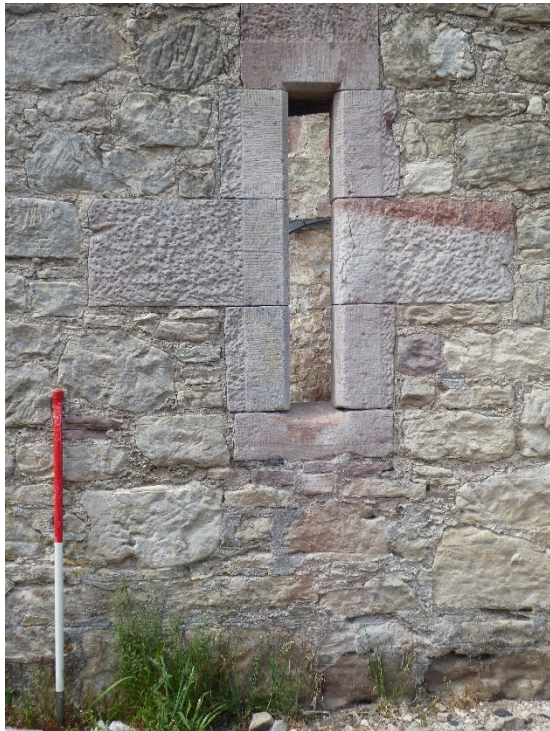
Overall the two ranges are of sandstone rubble construction with dressings that are crisply detailed with raised margins and narrow chamfers that are dove-tooled and tails that are broached. In most areas of the complex a sandstone of medium pink hue was employed for both the rubble walling and the dressings. However the northwards-facing openings in the south range, comprising four broad arched openings in the centre part of the range and ground floor entrances to the west up to the re-entrant are all of pale yellow stone. The loft openings within the western part of the south range's north wall start as constructions of the yellow stone, however these then employ the pink sandstone further east, within work of the same build. Also the rubblework of the south end of the east wall of the west range also employs pale yellow stone for the rubble walling at ground floor level.

Plate 2 Tooling detail, vent opening on east wall of west range

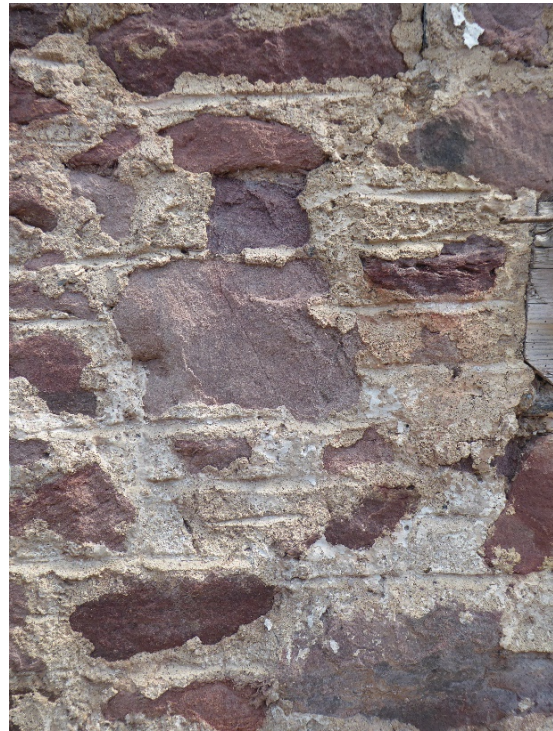
In some areas external pointing detail survived, this generally flushed and horizontally struck; however it is not clear whether this particular detail extended to all areas.

Plate 3 Pointing detail, W wall of machine house

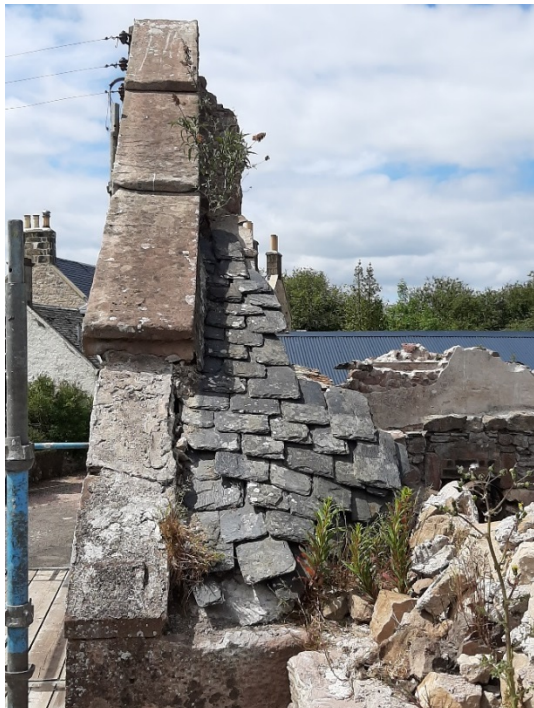
It was possible to determine details of the roof structure from the remaining evidence. The roof was of sawn pine construction throughout and slated on to sarking with slightly iridescent dark grey slates of west highland character, these evidently laid to slightly diminishing courses, *Plate 4* and *Plate 5*. Coping details survive to the gable to the east and that at the south end of the west range; in each case these are formed of long flat stones detailed with interlocking overlaps *Plate 6*.

Plate 4 Surviving slates in place

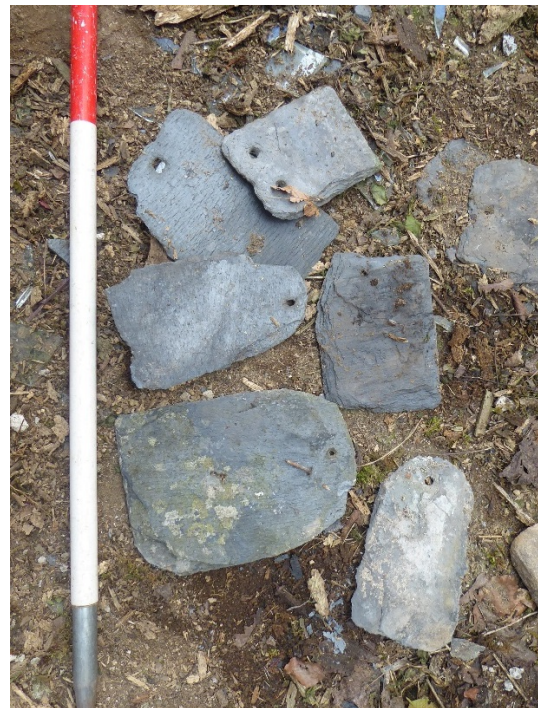
Plate 5 Detail of fallen slates

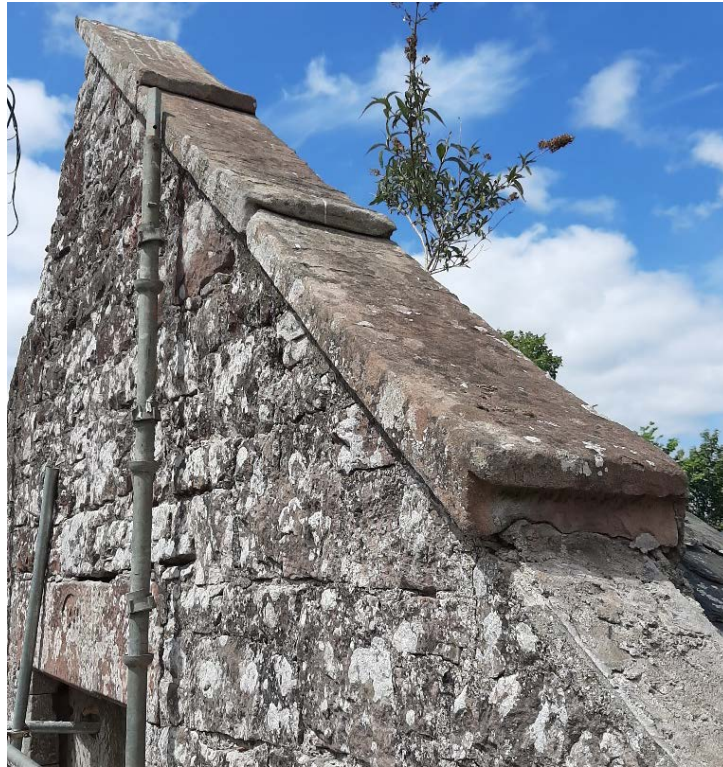
Plate 6 Detail of coping

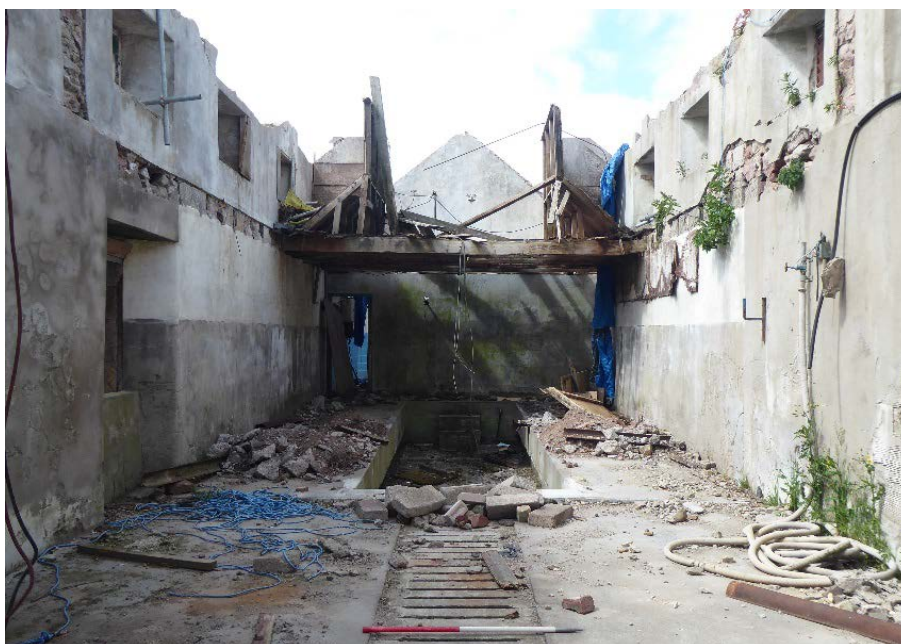
Internally the south range had seen extensive modern remodelling; all pre-existing interior arrangements were removed, the walls were cement plastered and tiled in places and concrete flooring installed. The building had been converted to form a dairy and a milking pit installed at the east end *Plate 7*. The original floor structure that ran the length of the compartment is largely removed, except to the west. The chamber is now of notable length though formerly sub-divided by a masonry cross-wall. This wall together with other masonry internal walls are shown on the Second Edition Ordnance Survey Figure 3.

Plate 7 Interior of dairy showing milking pit

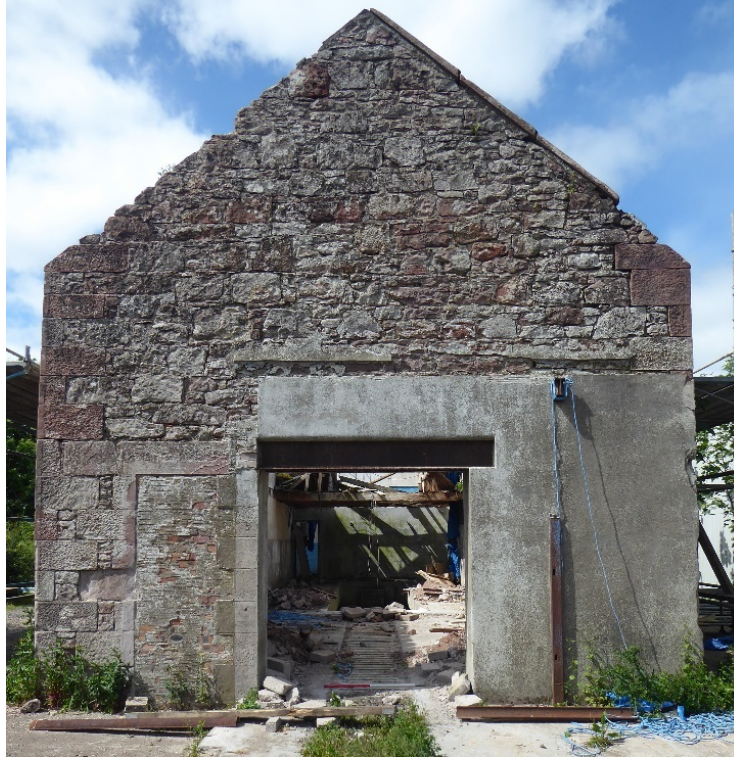
The chamber to the east of this wall seems likely to have been a stable, this entered by an entrance at the south end of the east gable wall, *Plate 8*, and lit by two windows in the south wall – the position of the entrance and windows suggest the stalls were located against the north wall. At the east end of the north wall there is evidence for a recess that seems to have had secondary infill, this possibly relating to a manger arrangement and possibly indicating a feed chute from the floor above.

Plate 8 East gable showing former entrance to stable to left

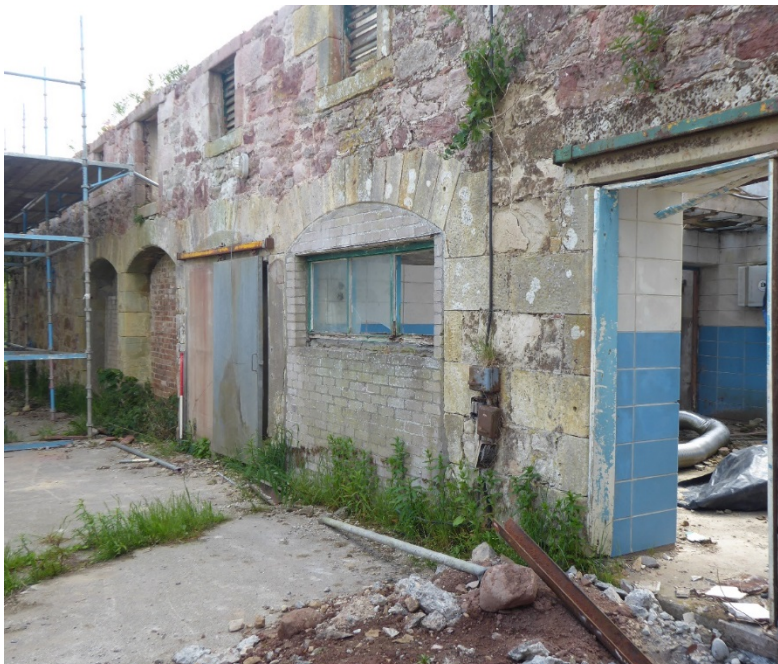
The western part of the existing eastern chamber had evidently functioned as a 3-bay three cart shed, this on the basis of three corresponding broad arched openings in the north wall (each now with secondary infill of brick) *Plate 9* and *Plate 10*.

Plate 9 North elevation of cart shed

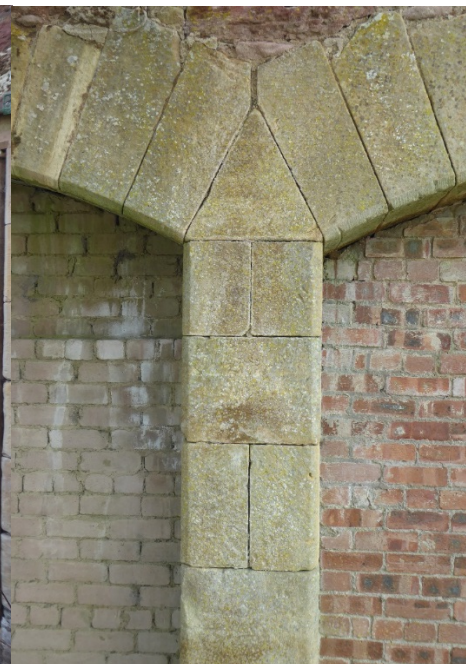
Plate 10 Detail of cart entrance

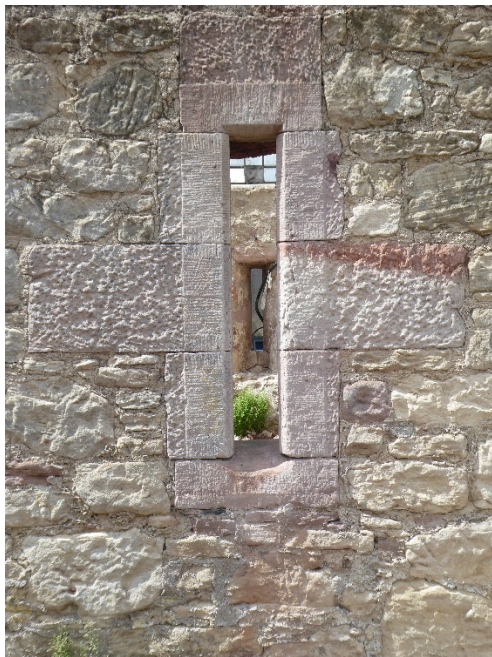
The area occupying the corner between the south and the west range is a single overall space. Other than the evidence for and part survival of the first floor floor structure the former internal arrangements of this area have largely been removed. The space has been part sub-divided in the later 20th century with brick partitions and a chamber thereby cordoned off to the south-west. The northern part of this area – corresponding to the southern end of the west range – features substantial opposed entrances that evidently provided through-access, perhaps a cross-passage possibly defined by timber partitions. The remaining space on the north side of this access only features narrow vent openings, one each to the east and west, thus presumably indicating a store, *Plate 11*. To the south of the through-access there seems to have been an area dedicated to milling infrastructure. In the upper west wall some of the machinery mechanism remains in the form of an axle running through the wall with a cast-iron wheel to either side to accommodate belt-drives *Plate 12*.

Plate 11 Narrow vent opening

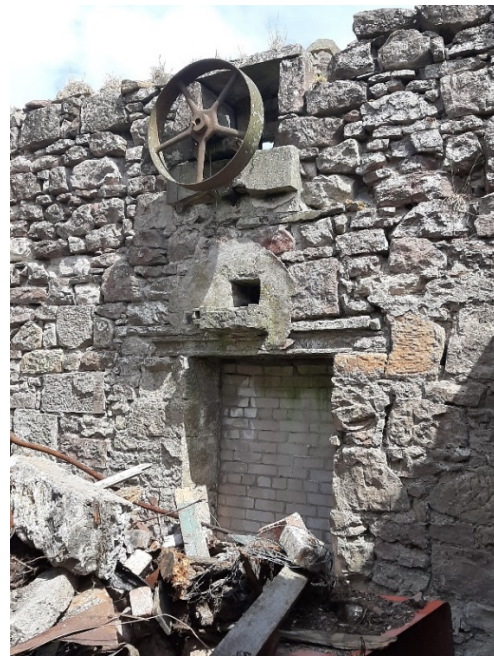
Plate 12 Axle and wheel from threshing machinery, west side

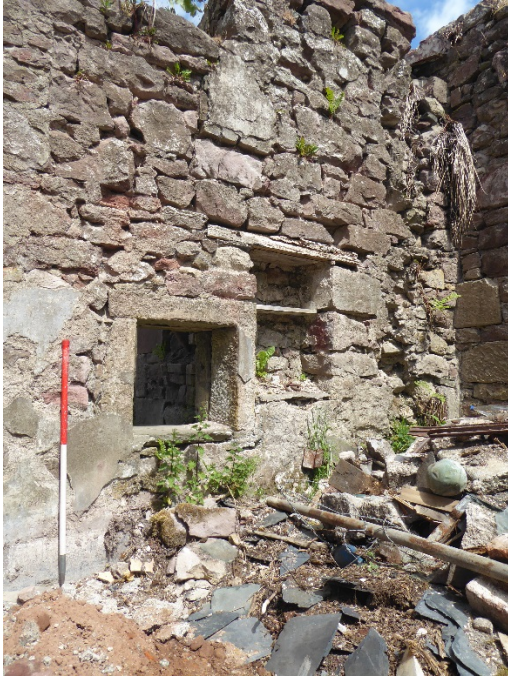
The machine house and associated chimney were located in a separate building abutting the west gable of the south range. This chamber which seems to have been open to the roof structure rather than floored had evidently contained the mechanical apparatus to drive the milling machinery within the main range to the east; the above-mentioned belt-drive mechanism remains in the upper east wall, located above a former entrance through. Though the lower parts are presently mostly rubbish-choked, the walls of this interior feature a central timber-framed opening to the west wall (subsequently blocked), a narrow hatch opening to the north and a wall recess in its east side *Plate 13*.

Plate 13 Wall recess in machine house

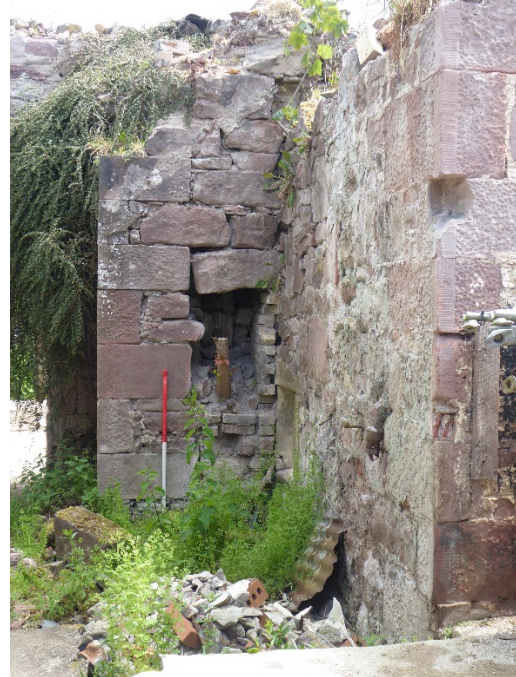
Plate 14 Stoke hole in base of chimney, looking east

Against the exterior north wall of this structure had been a lean-to, possibly open or timber-walled and, at the east angle with the main steading range, a chimney arrangement only the masonry lower stage of which now remains. The latter preserves a stoke-hole or ash-pit access on its west side (*Plate 14*) that was accessible from within the lean-to; the interior of the flue was in part lined with pale refractory bricks. The chimney would have been built from brick and would have been a highly visible feature of the steading and the surrounding landscape.

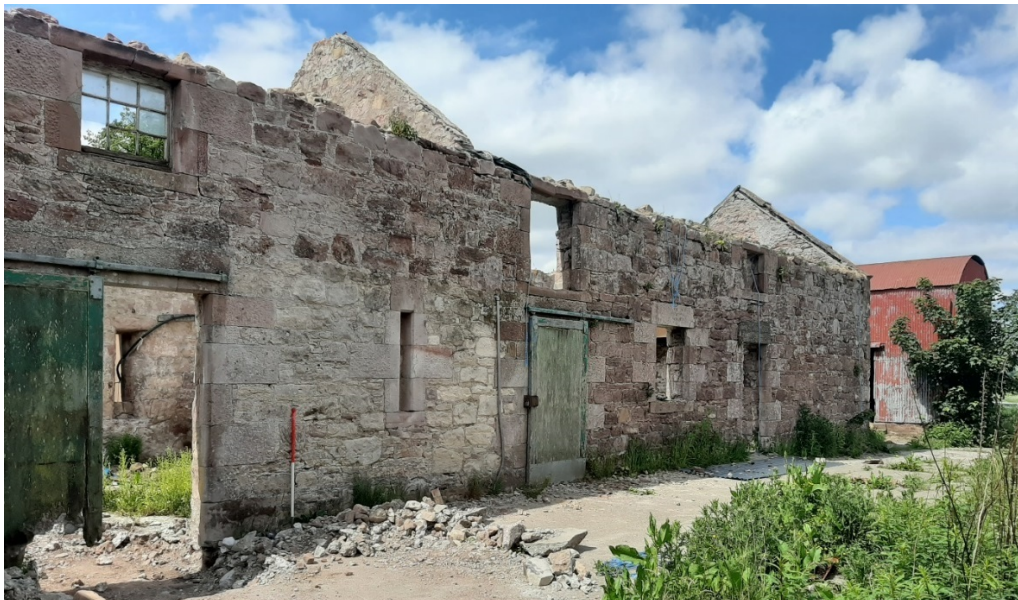
Plate 15 East exterior elevation of west range; byre to right

The northern part of the west range now comprises a single chamber. Joist sockets and upper windows demonstrate this area to have been fully floored above, *Plate 15*. The existing concrete flooring is of 20th century date, as are the remains of byre subdivisions surviving as silhouettes in the west wall, *Plate 16*; the southernmost still exists as do paired ceramic troughs to either side, *Plate 17*.

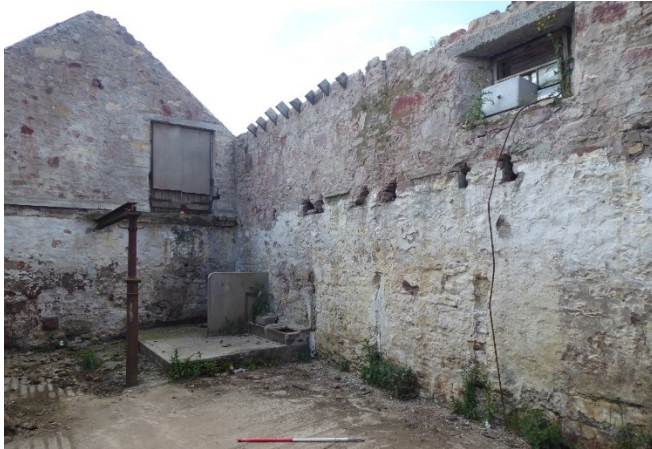
Plate 16 Interior of Byre looking south west

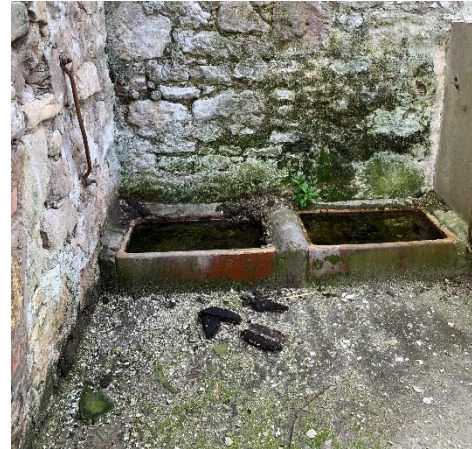
Plate 17 Stone troughs within stall

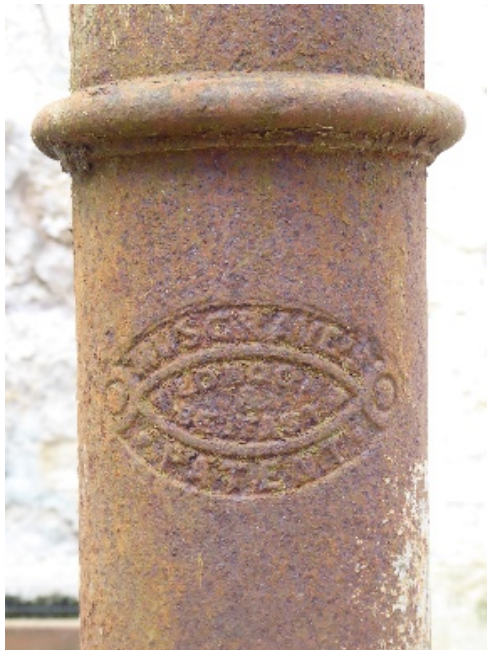
There also survives a single cast iron post, the southernmost of a series of posts on the centre-line of the chamber; this rises to a longitudinal steel joist that in turn supported the floor structure above, *Plate 18* and *Plate 19*. The west side of the post features a vertical slot-seating for the timberwork of an original byre sub-division.

Plate 18 Cast iron pier detail

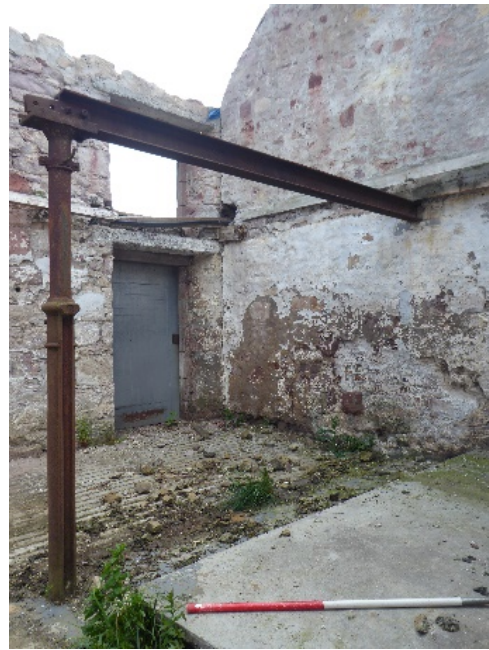
Plate 19 Pier and cast iron beam

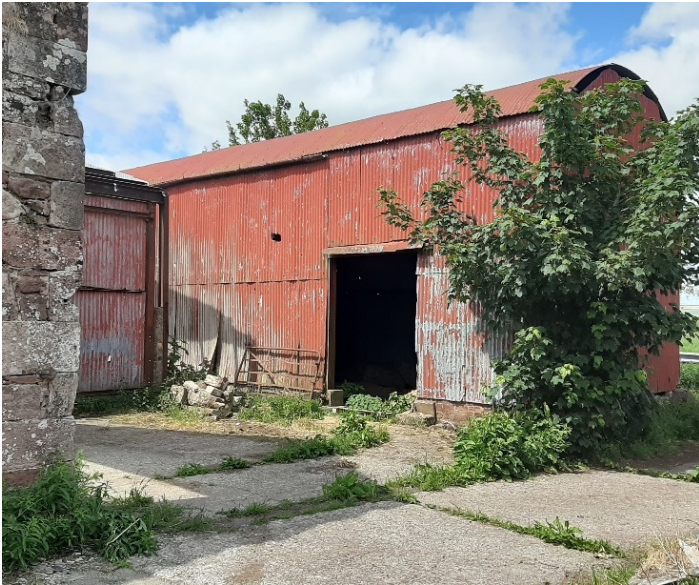
Other than the farmhouse itself and associated walls there is little else remaining that relates to the mid-19th century complex. Sheds were erected in the mid-later 20th century to the north-east, within the former steading court to the north and against the west side of the west range. To the north-west exists a somewhat earlier red-painted Dutch barn that remains in good condition but falls out-with the scope of the present survey, *Plate 20* and *Plate 21*.

Plate 20 Exterior of Dutch Barn

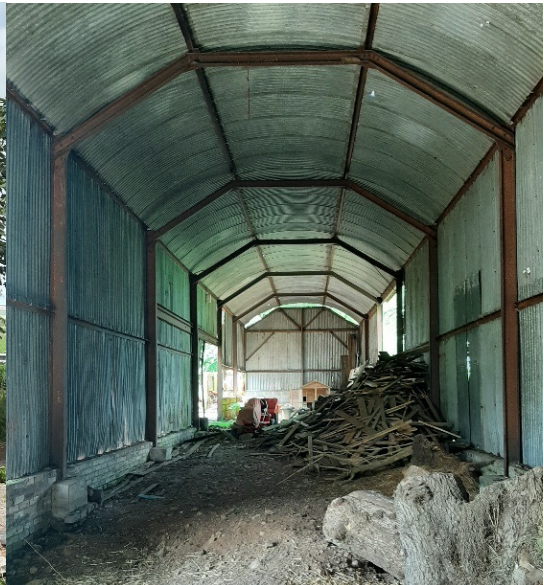
Plate 21 Interior of Dutch Barn
