Newcastle Area Command Headquarters, Forth Banks *Newcastle-upon-Tyne*

Building Recording: December 2009 - January 2010

Building Recording (December 2009 - January 2010)

(project AA. 1847)

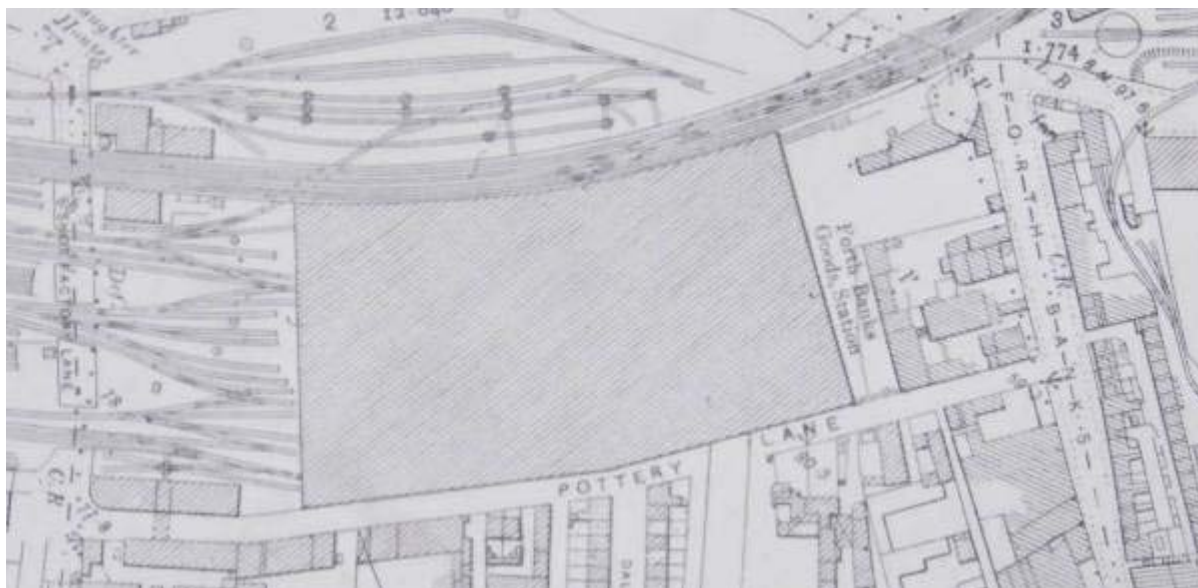
Figure 9: 2nd edition OS map of 1898, sheet 18. The former Forth Banks Goods station can be seen rebuilt and enlarged to the west of Central station.

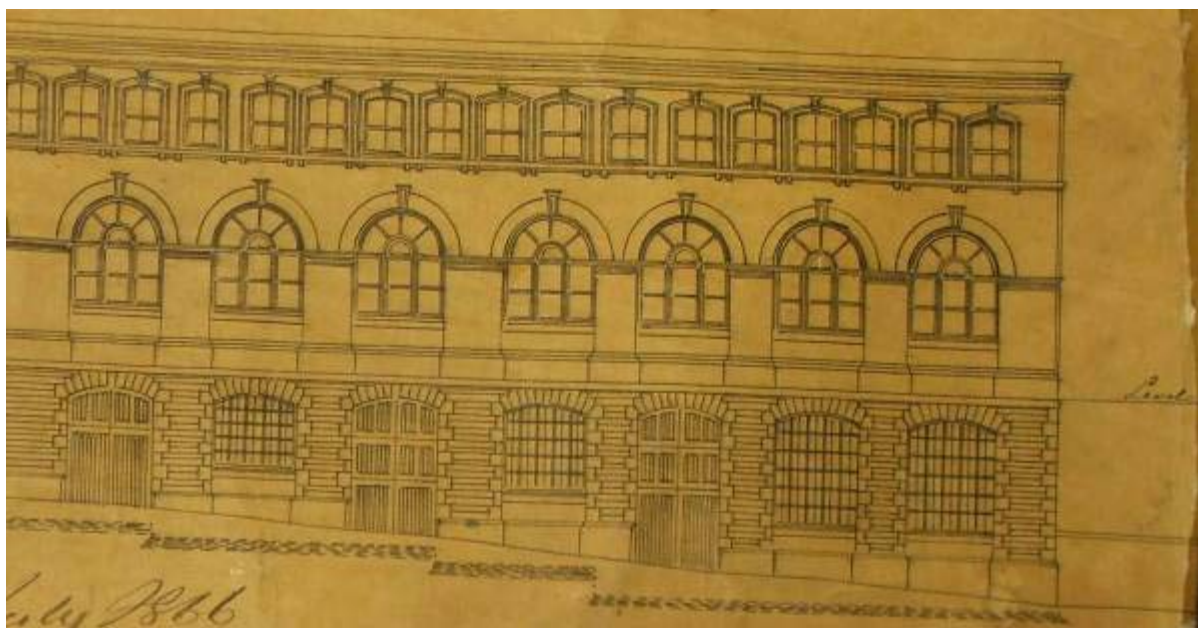
Figure 10: 1866 architect drawings of the southern façade of the Forth Banks Goods Station. This is the eastern end, which falls within the site boundary; the 1905 King Edward viaduct now truncates the doorway at the left hand side of the picture.

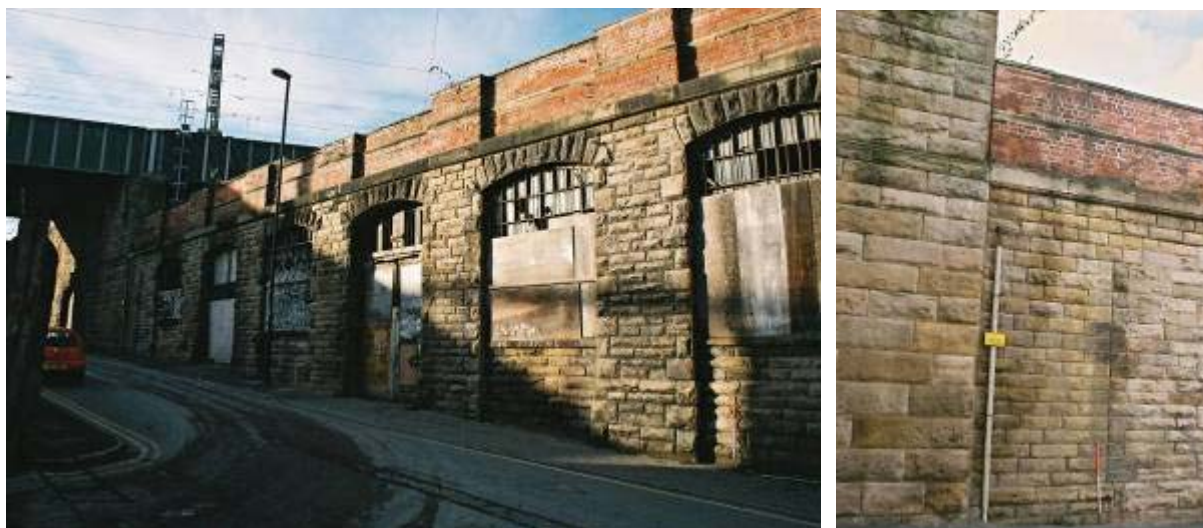
The arched openings form a combination of windows and doorways. The lower sections of the windows are infilled with coursed sandstone faced in the same fashion as the principal construction. The original metal grating in the windows is still largely in place, although it is generally covered over by later boarding. However, the large two leaf doors have all been removed and replaced.

*Plate 1: Southern façade, eastern end, of Forth Banks Goods Station
Plate 2: Southern façade of Forth Banks Goods Station, showing blocked doorway where the façade is truncated by the 1905 King Edward Viaduct*

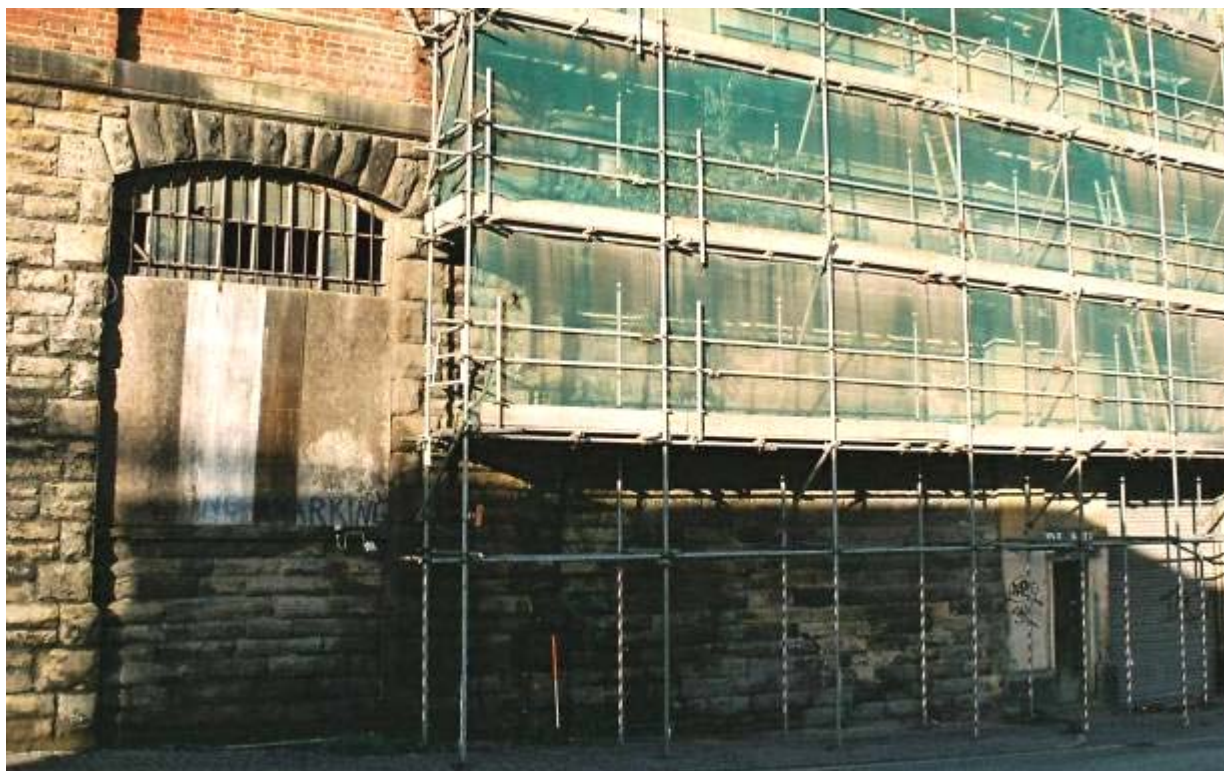
The 1907 Goods Warehouse was constructed at the eastern end of the Goods Station. However, on the lowest floor these two buildings appear not to have abutted each other; there is a gap between the two buildings which on the S elevation has been filled with sandstone of a similar construction style to the Goods Station. Behind this wall is the void formed when the 1907 Warehouse was constructed. The upper floors of the warehouse extend over the void and would have abutted the upper floors of the Goods Station, which have since been demolished.

Plate 3: Sandstone infill between Goods Station and Goods Warehouse, lower floor facing onto Pottery Lane

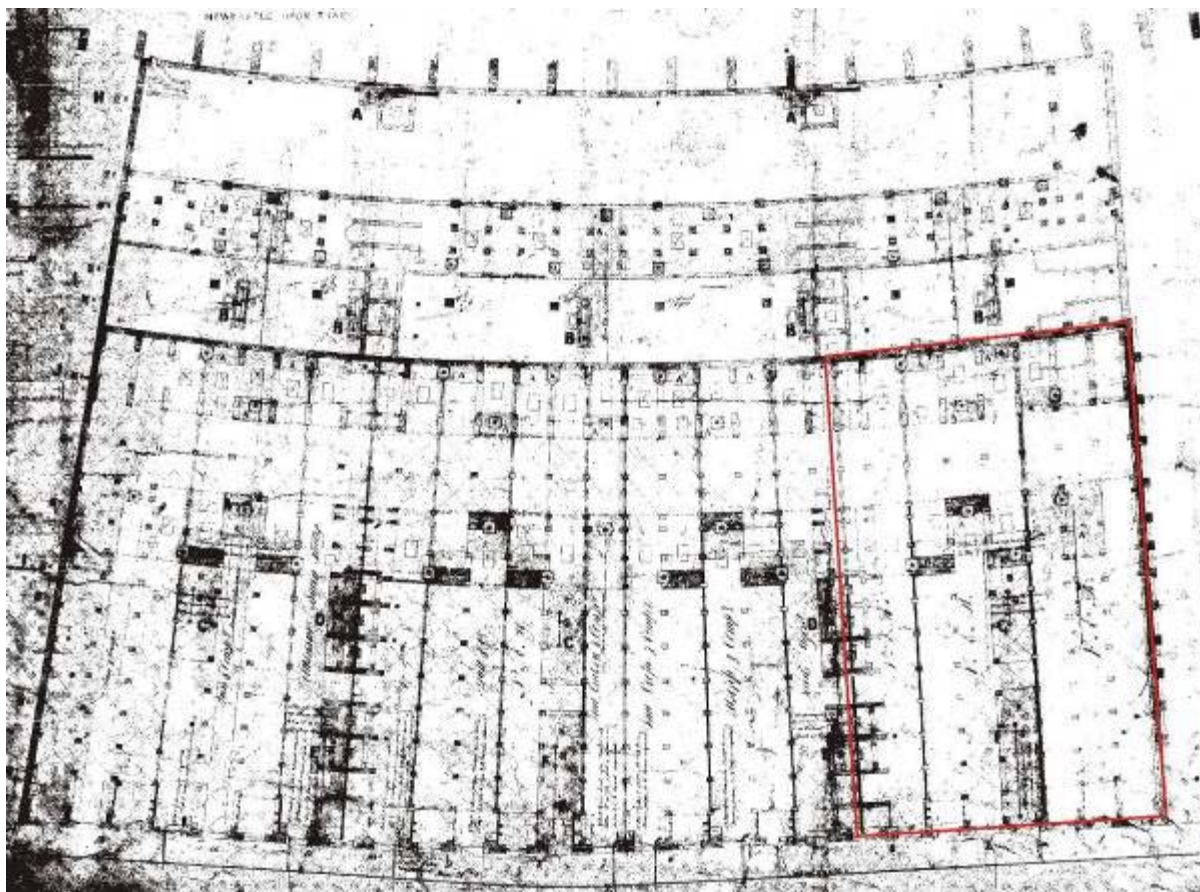
Figure 11: 1866 building control plan of the goods station undercroft with extent of current survey outlined in red, NER ref 130

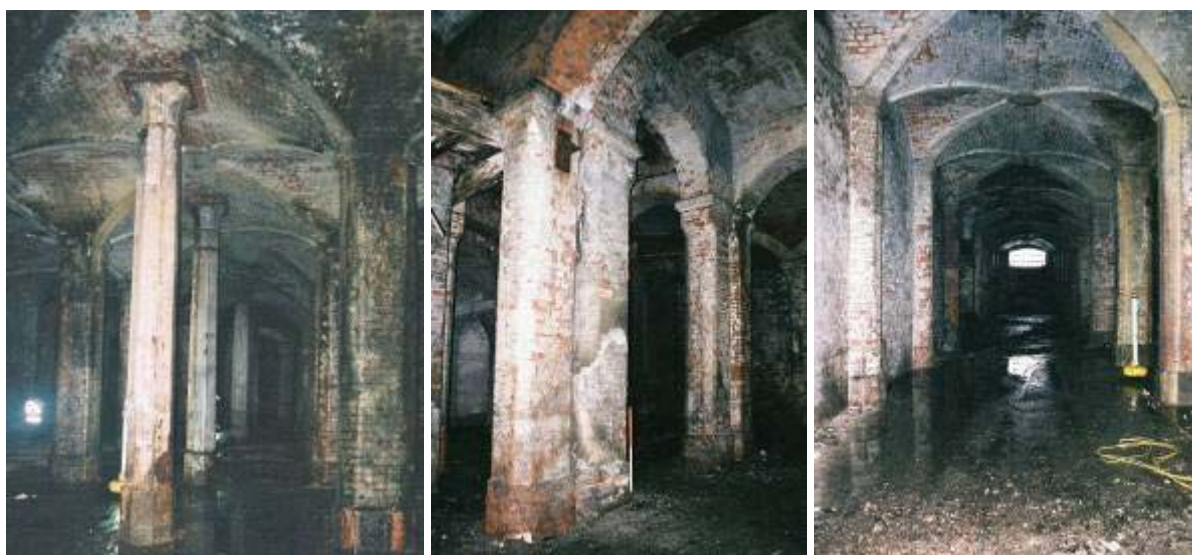
In the centre of the second ‘aisle’ from the E side of the building (aisle 2), extending N-S, is a row of octagonal metal columns supporting the vaulted ceiling (see plate 4). These are original to the construction of the building, as they can be seen on the original construction plans (see figure 11). These columns extended up through the undercroft ceiling to the floor above, where the office accommodation was located (see figure 12); the ceiling structure presumably needed extra support in this location.

Plate 4: View of octagonal iron columns and brick piers in the Goods Station undercroft (looking N)

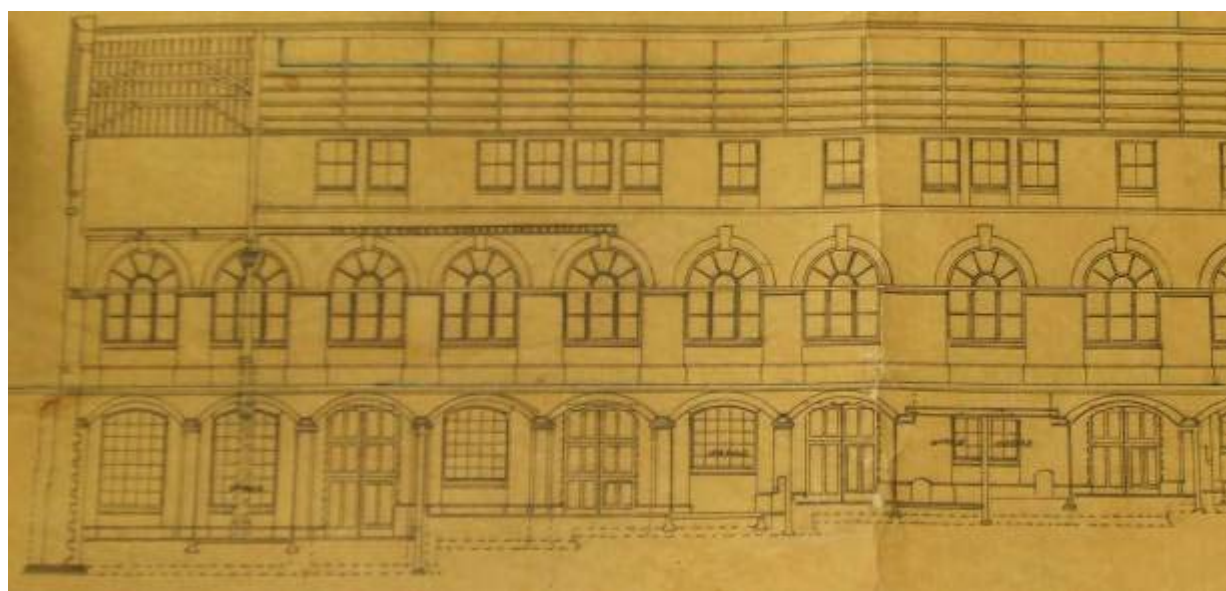
Figure 12: Internal section south facing through building, 1866, showing office space and iron columns extending to upper floors

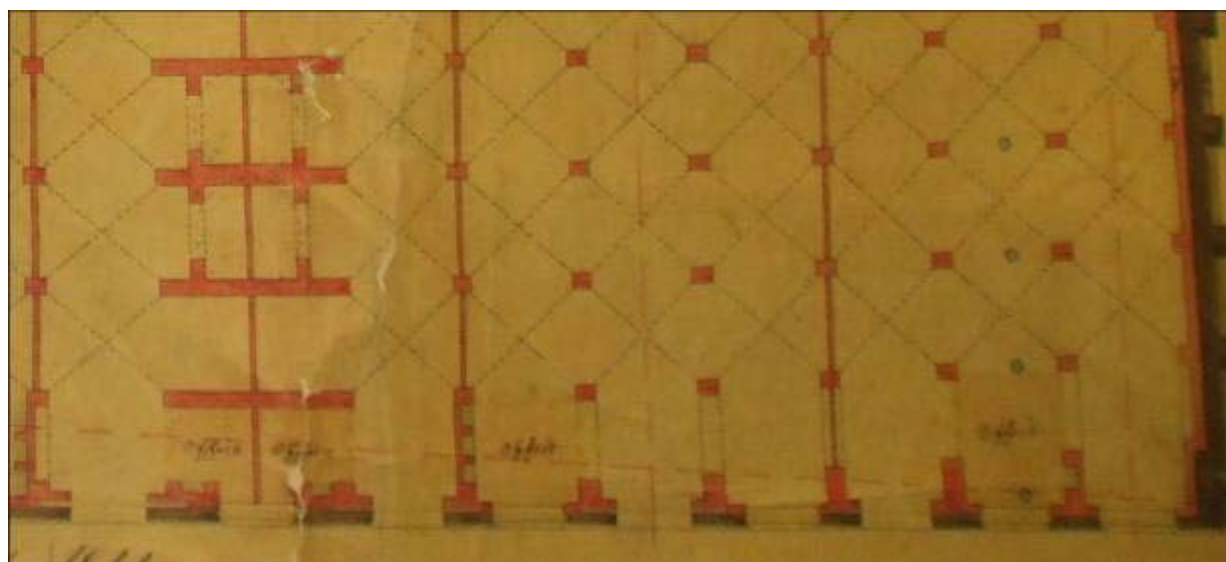
Figure 13: 1866 architects plan of the Goods Station undercroft, showing office accommodation along the southern elevation.

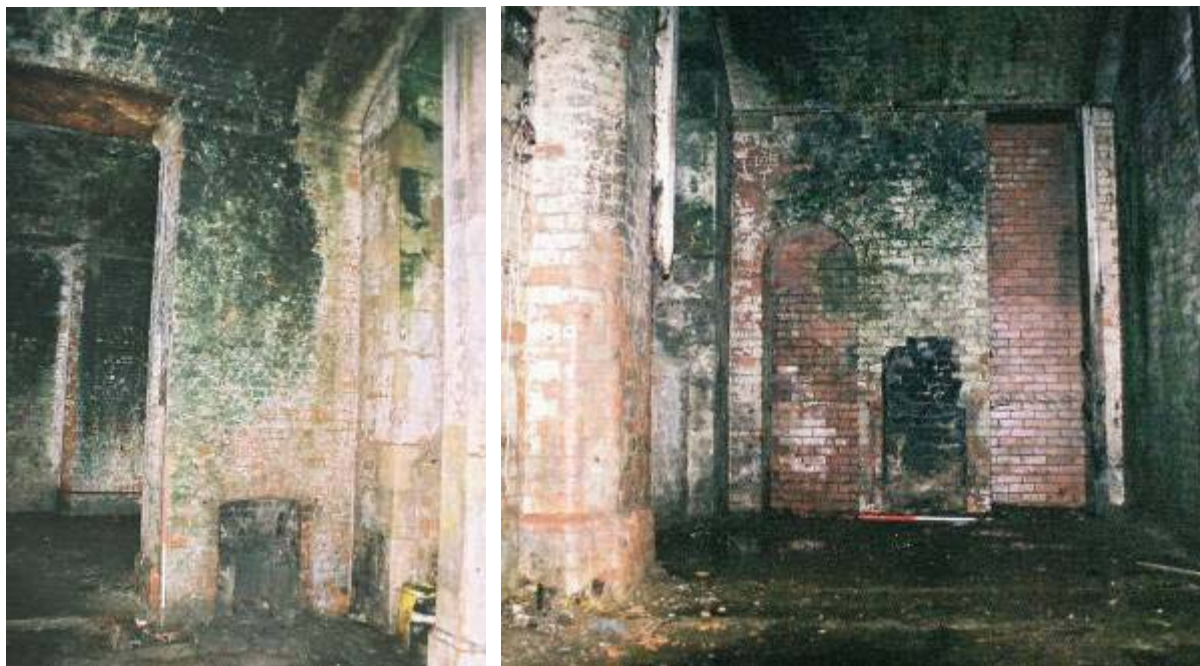
the eastern side of the building (aisle 2) have been removed but the fireplace in the short brick wall extending outwards from the south elevation is still present (plate 7). The office area located in the sixth aisle from the east (aisle 6) has also had the partitions removed (the brick wall forming the northern partition is a later addition). The western elevation of the office retains the fireplace, which is flanked by two alcoves (plate 8). The southernmost of these is arched whilst the northern extends the full height of the room. The rear of the alcoves are formed from brick which appears to be of a later date than construction; the original plans show these to be alcoves rather than openings so it may be the case that the alcoves were opened up sometime after the original construction, then latterly blocked in again.

Plate 7: Fireplace in former office area, in 'aisle 2' of the Goods Station undercroft

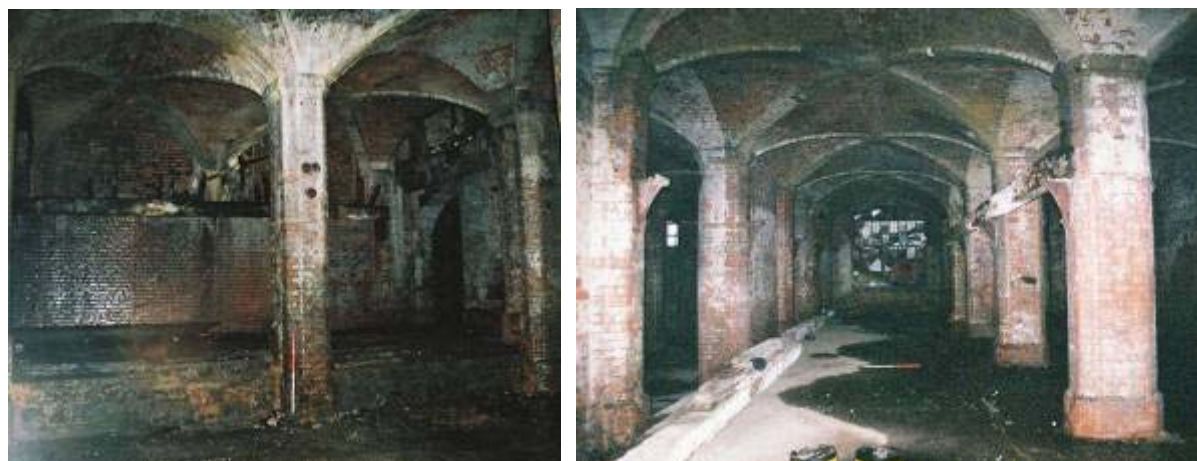
Plate 9: raised area to the west of 'aisle 4' in the Goods Station undercroft, looking west

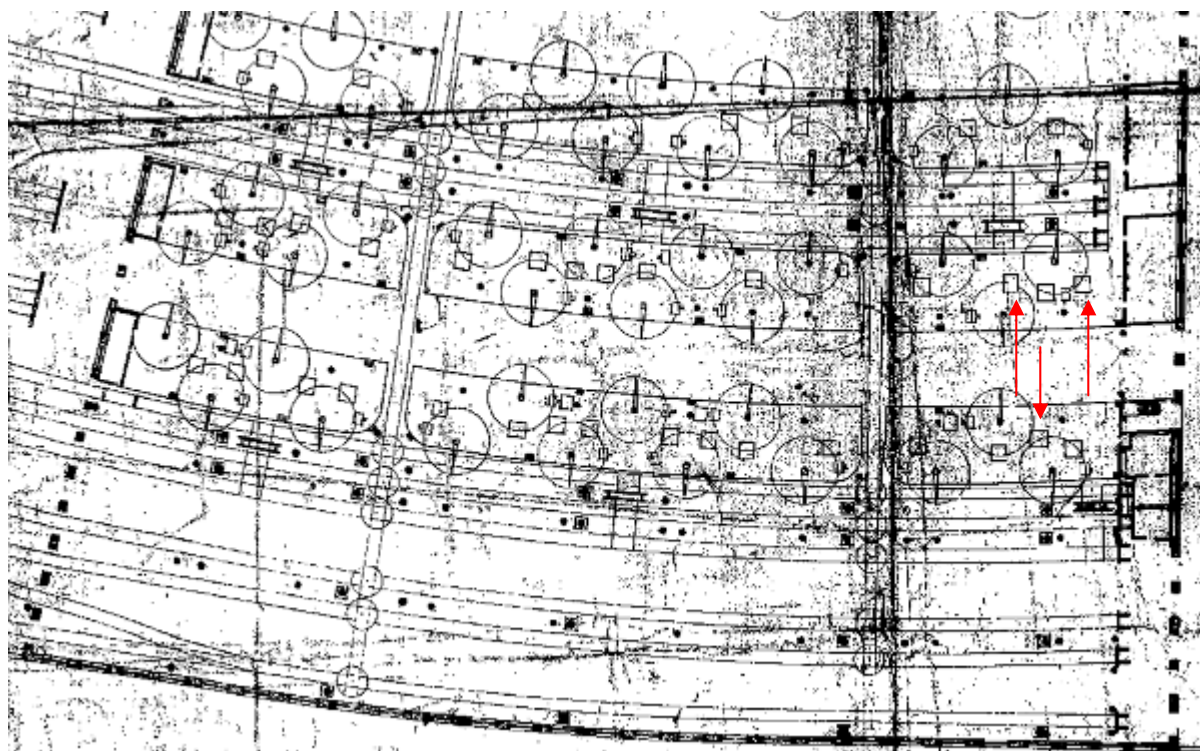
The hatches visible in the ceiling of the vaults are those which were associated with the southern platform of the northern line and the northern platform of the southern line (see figure 14). The ceiling construction of the bays running beneath the platforms are of high barrel vaulted construction, rather than a fan vault construction, presumably to provide more structural support as the cranes were located directly above this. The brick piers are also grouped into pairs in these areas, again, presumably to provide more support (plate 5).

Figure 14: 1866 NER ground floor plan of Goods Station, showing hatches in platforms either side of the train tracks, providing access to the undercroft

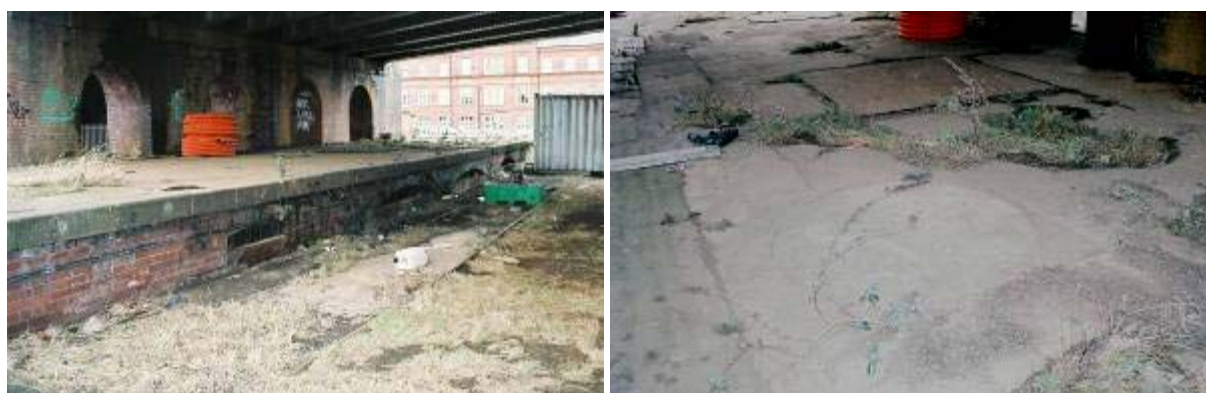
Plate 11: View of remains of platform and rail tracks in the car park area, located above the Goods Station undercroft; these would have originally run through the Goods Station.

Plate 12: detail of covered over hatches and footings for cranes on the Goods Station platform in the current car park area

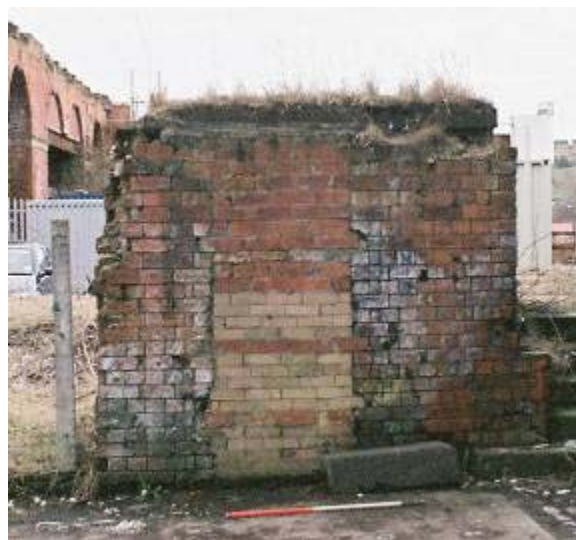
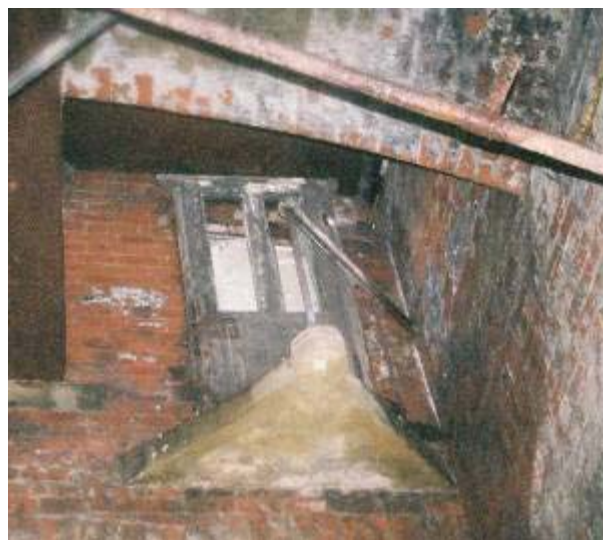
Plate 13: Brick structure in car park area, formerly providing access to the viewing platform in the station undercroft below (bay 9, aisle 2)

Plate 14: viewing platform, located beneath southern platform (bay 9, aisle 2), looking north

There are two viewing platforms within the vaults area under consideration; these are located at ceiling height, leading from the floor above (ground floor). These are located to the rear of the area, beneath the southernmost of the main platforms which run over the vaults (bay 9). These platforms are accessed from the floor above (ground floor) – the platform above bay 9, aisle 2 is accessed from the platform above, in the current car park. The door to this platform is currently located in a brick structure with concrete aperture margins, which appears to be contemporary with the station, although it has been altered (see plate 13). This doorway gives access to the viewing platform, which appears to have formerly had a metal spiral staircase leading down to the ground floor of the vaults (the stair has been removed by the concrete footing for the stair is still in place – see plate 14). This stair was apparently still in place into the mid 20th century, as it was used to provide access to the vaults during First and Second World Wars, for use as an air raid shelter (*pers. comm.*).

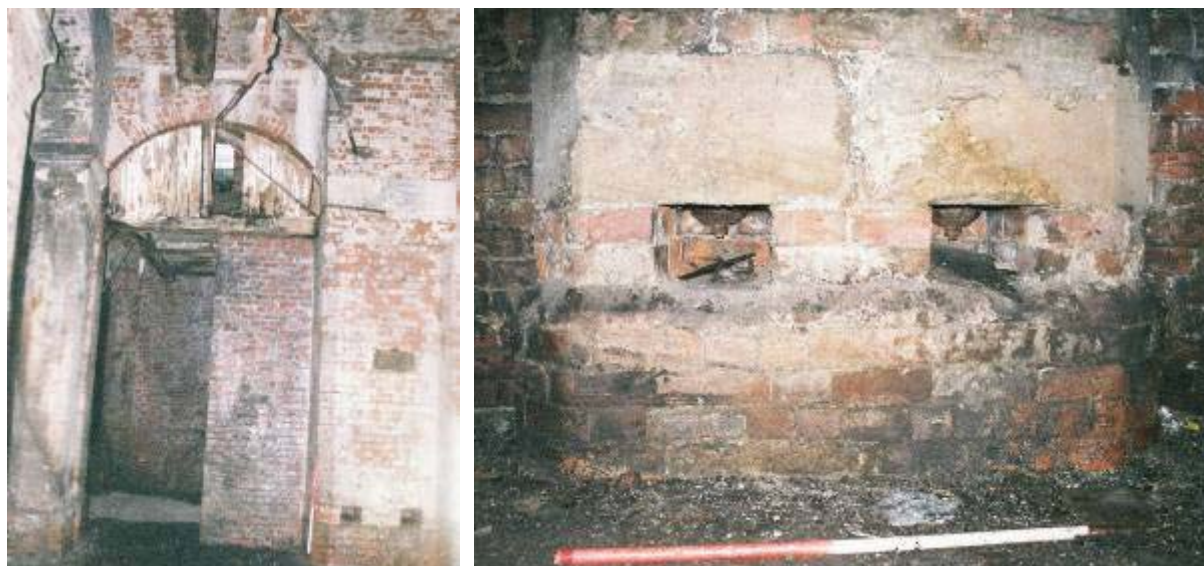
Plate 15: Gas pipe with fitting for gas lamp, extending around the ceiling of the Goods Station undercroft
Plate 16: Detail of brick pier, with fittings at base, for controlling the lighting system?

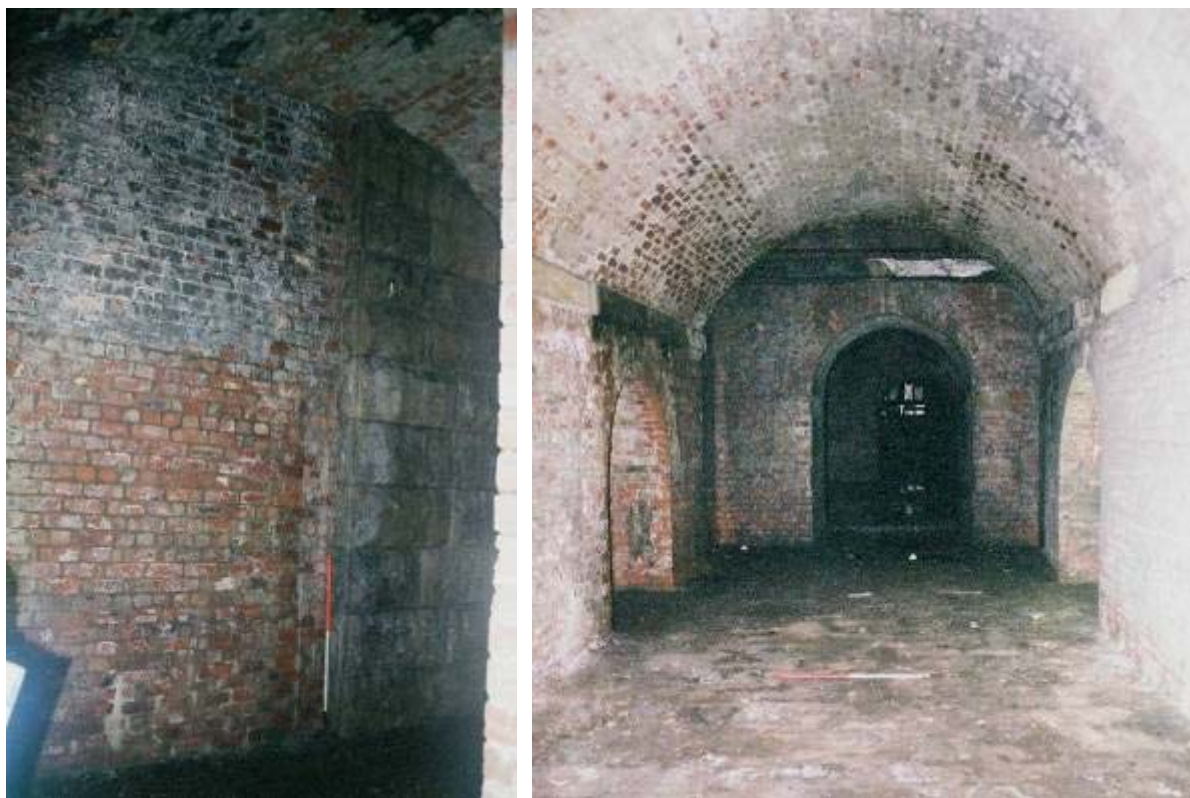
The barrel vaulted chambers are long low brick built chambers running N-S (plate 18). The barrel vaulted chambers which run beneath the southern platform (bay 9) were originally interconnected by low arches in their side (E and W) walls (although some of these have been latterly infilled). The secondary barrel vaulted chambers in the more southerly area of the vaults were originally accessible from the original undercroft area, but were not in themselves interconnected, the dividing wall between them being of solid construction.

*Plate 17: brick infilled arched opening, where the 1905 viaduct truncates southern façade
Plate 18: secondary barrel vaulted chamber – substructure of 1905 viaduct*

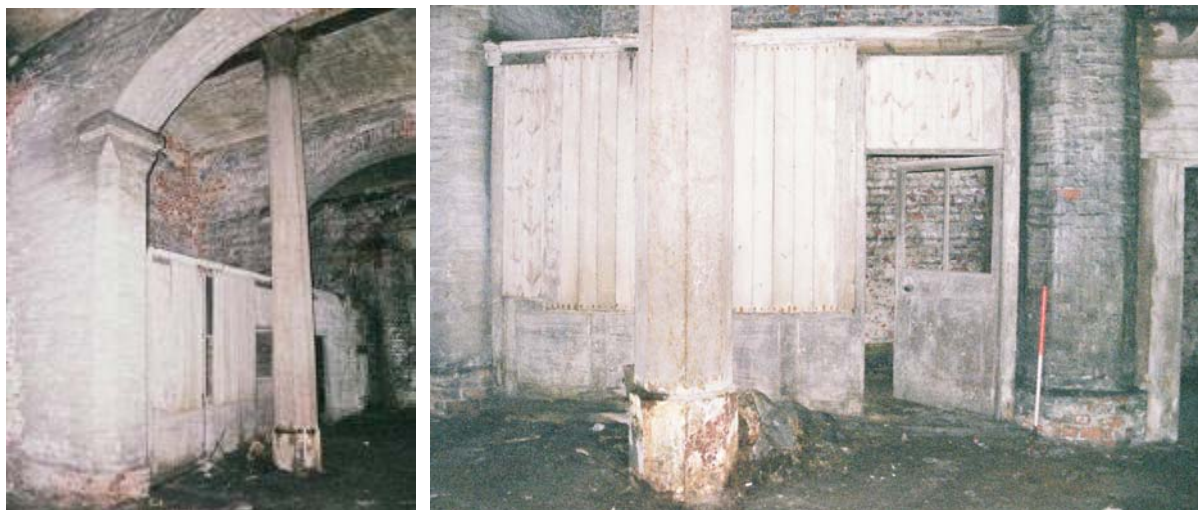
Plate 19: Partitions at northern end of aisle 2 and 3, view looking NE

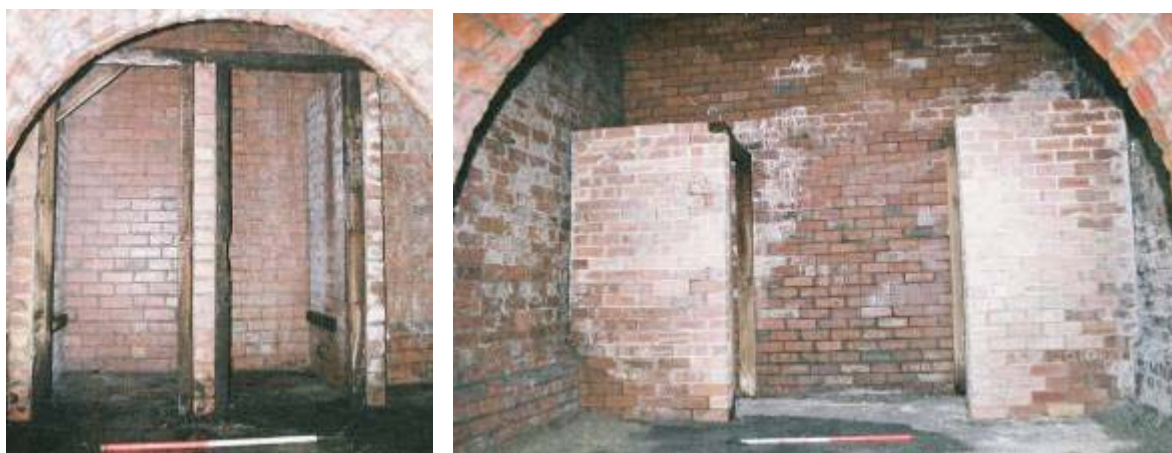
Also associated with this phase was the creation of a number of cubicles in the area of groined vaulting at the western-most side of the area under consideration (aisle 8), accessed from the 1905 barrel vaulted areas at the southern end of the undercroft. These brick built cubicles have wooden framing and were thus likely covered by wooden doors. There also appears to have been low wooden benches fitted on the interior (plate 21 and 22).

Plate 21: Secondary brick cubicles in aisle 8, bay 3

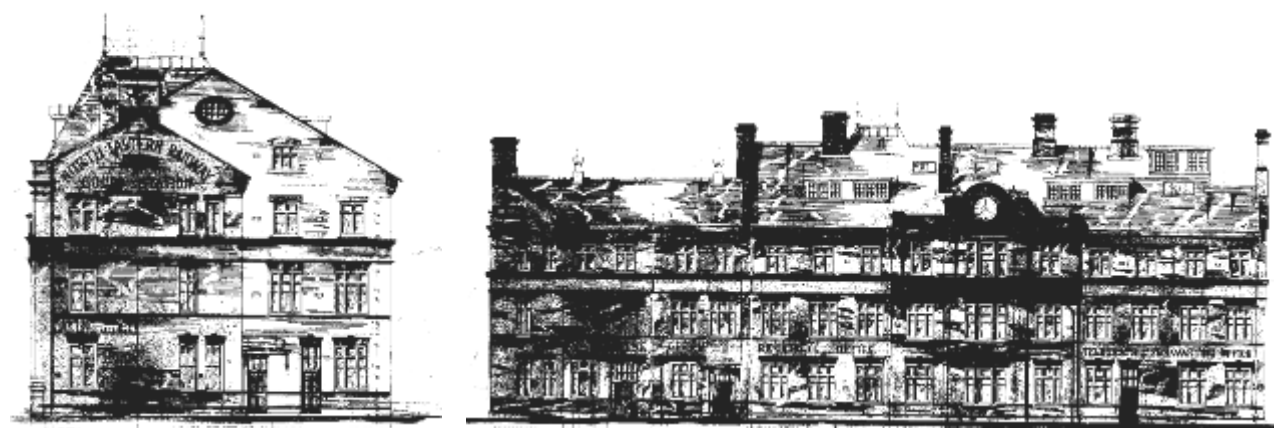
Figure 16: NER 1904 drawing ref 257, N elevation of Kings House, showing North Eastern Railway sign
Figure 17: NER 1904 drawing ref 258, W elevation of Kings House, showing Receiving Office and Telegraph Office sign

The original 1904 elevation drawings show numerous ‘North Eastern Railway’ signs attached to the exterior of the building, primarily on the E and N elevations (figure 16). In addition, they show a ‘Telegraph Forwarding Office’ sign (W elevation S end) and a ‘Receiving Office’ sign (W elevation N end – figure 17). It is unclear if these signs were ever installed but a slight discolouration on the brickwork on the N elevation may point to the location of a former sign, suggesting that the other signs may also have been installed.

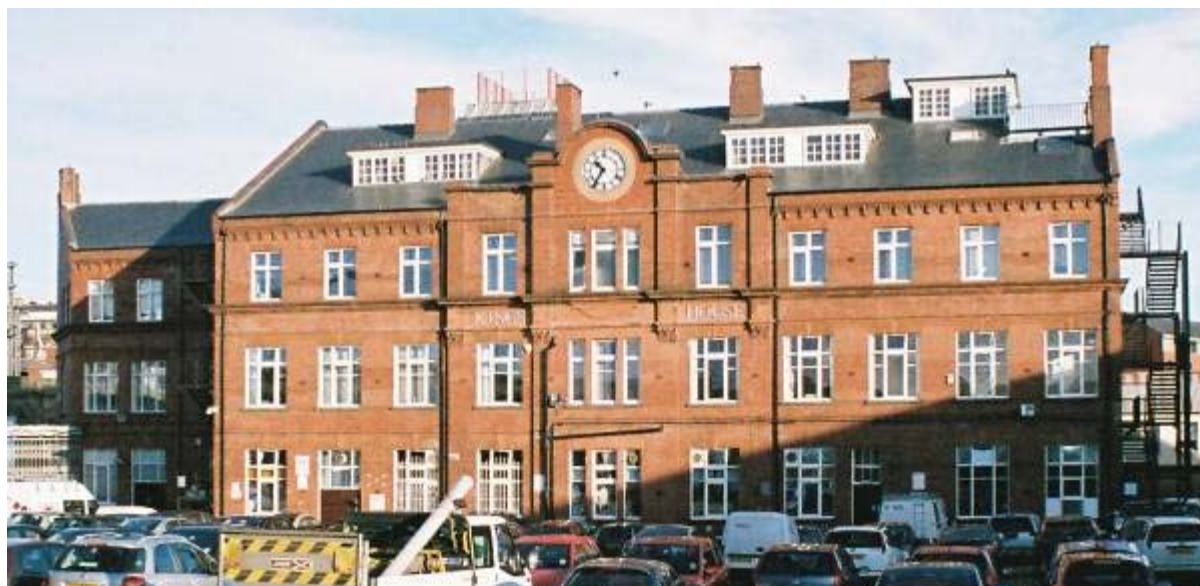
Plate 23: W elevation of Kings House

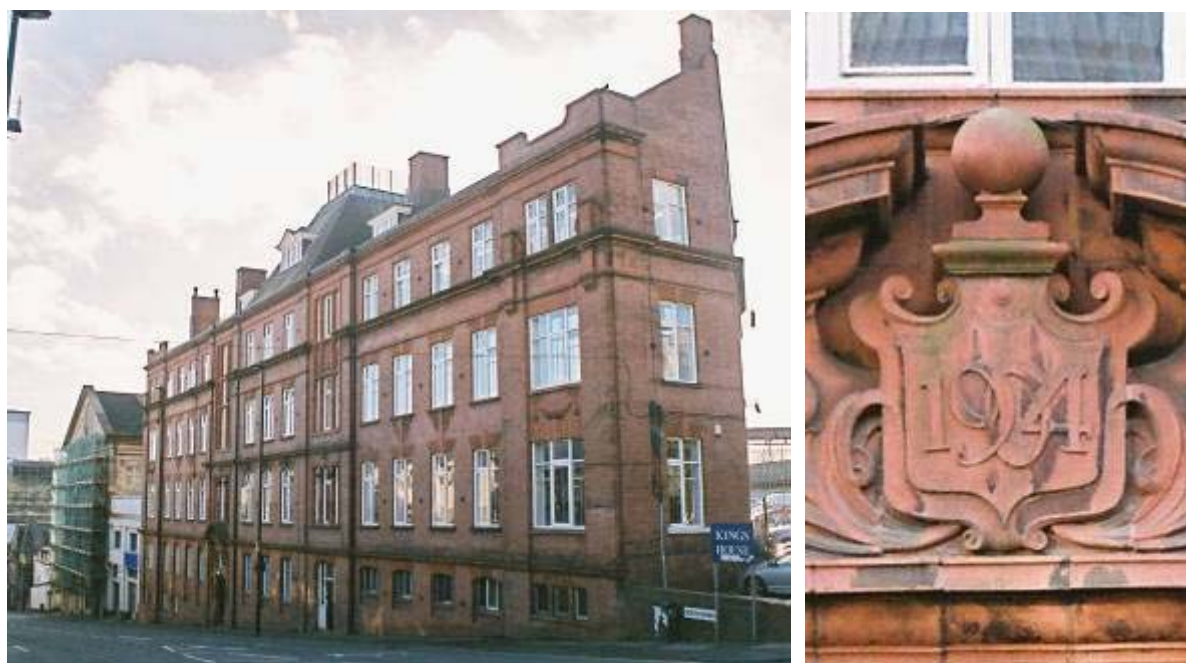
The E elevation facing onto Forth Banks (plate 24) is of a similar construction style to the W elevation but there is an extra storey and additional half storey (only at the S end of the building) visible on this elevation, as a result of the sloping ground. The design of this elevation includes the N jamb, unlike the W elevation as the N jamb is set back from it. Including the N jamb, this elevation is of fifteen bays in length. To either side of the central three bays is a doorway which provides access to the lower ground floor on the interior of the building. The southernmost of these doorways has an arch above it which includes a date stone of '1904' (plate 25). The central three bays are flanked by shallow pilasters and the bays to either side contain larger three light windows with stone mullions. The southernmost of these bays lights the internal stairwell, accounting for the large windows which cross the floor levels (first and second) on the interior. In the northern of these bays, this section is at a floor level and is thus infilled with a moulded panel.

Plate 24: E elevation of Kings House, view looking down Forth Banks
Plate 25: Detail of 1904 date stone above southern doorway

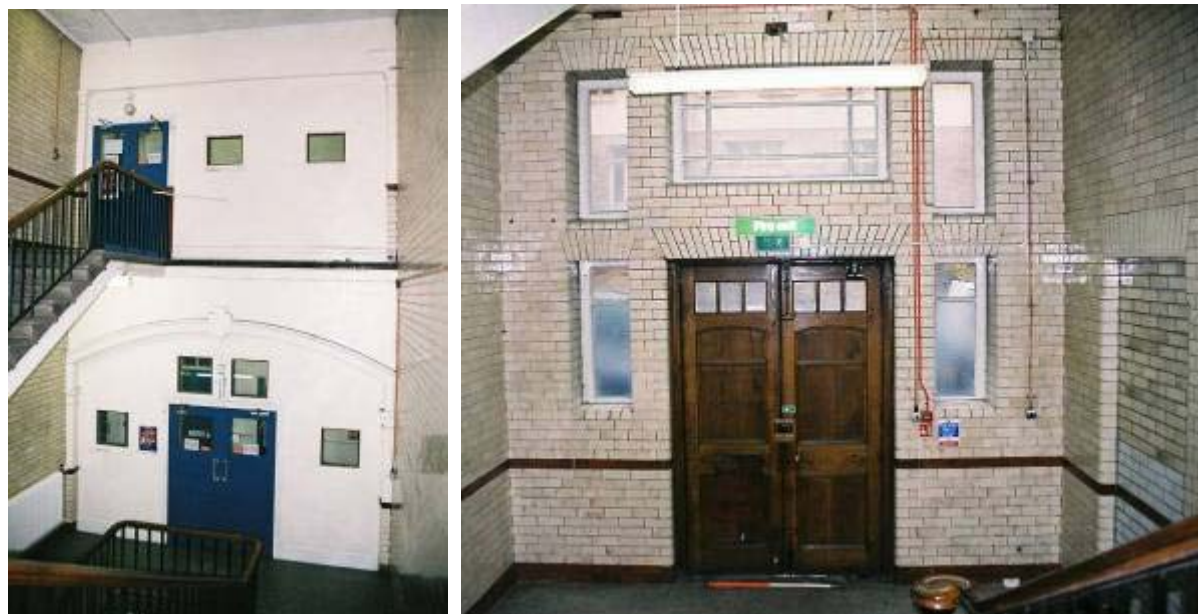
Plate 26: W elevation in principal stairwell, to second and third floors

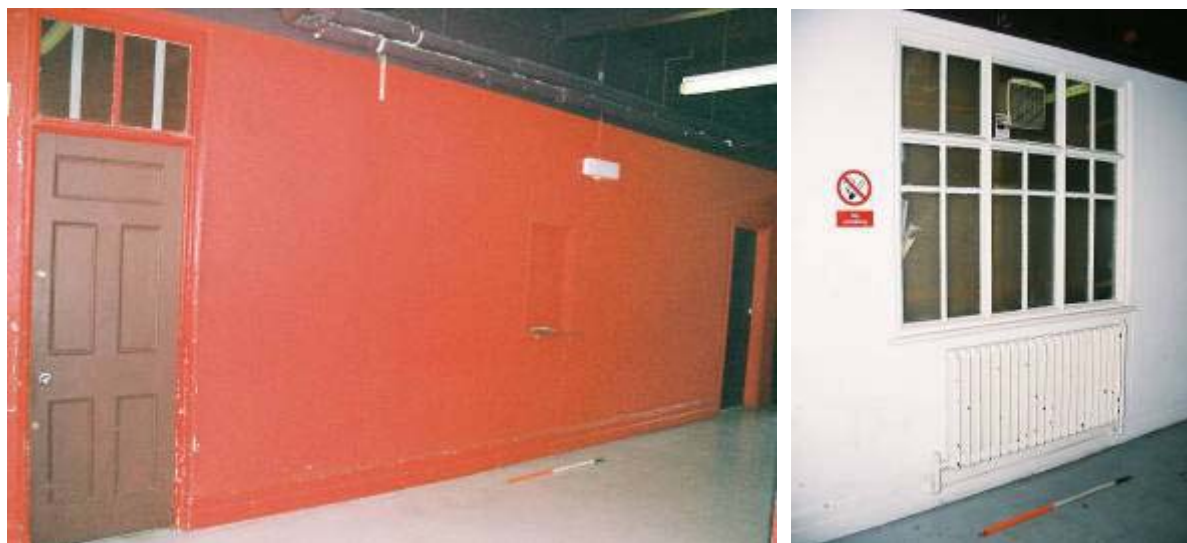
Plate 28: lower ground floor corridor 2, doorway to library, with blocked librarians hatch in the centre of the image, with later insertion doorway to room 13 towards the right of the image

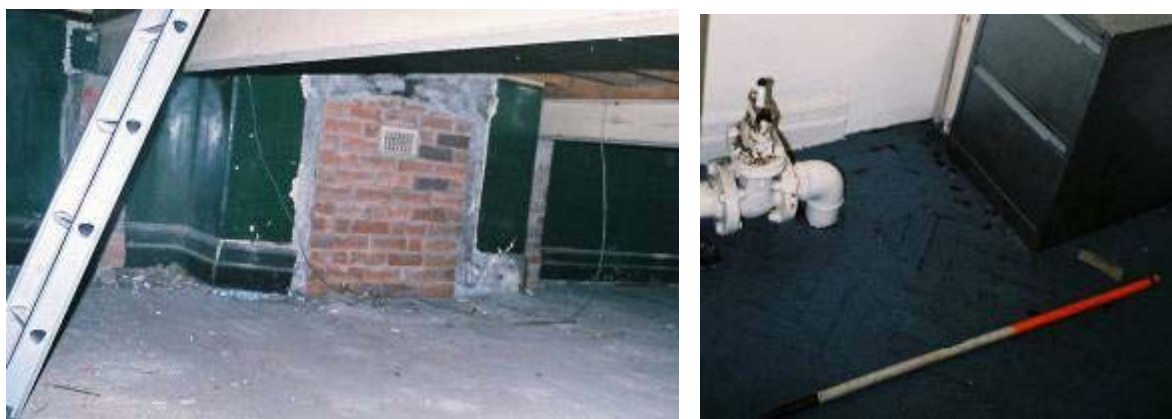
Plate 30: Bricked - in fireplace in Engineers waiting room (basement room B5/lower ground floor room 5)

Plate 31: cut in skirting show location of former cupboard/store in Muniment room, base of stairs 3

This document store room was originally a large open space with stairs leading up to the ground floor along the N elevation. It originally had two doorways providing access, one in the centre of the E elevation, within stairwell 2 which provides access to the basement, and one at the W end of the N wall, beneath the stairs. Both of these have been blocked in but their outlines are still visible. Stairwell 3, which leads up to the ground floor, appears to have originally been part of the main room. However, a stairwell area separate to the main room has been created by the insertion of a partition to the S of the stairs. A doorway leads from the main corridor on this floor into the lobby area at the base of the stairs, with an additional door to the S leading into the main room. The main room has also been modified by the insertion of later partitions, creating a sound proof booth against the S elevation which contains the original chimney breast. It appears that there may have originally been a small storage unit, possibly for important or confidential documents, in the NE corner of the room. This is evident on the 1904 drawings and the termination of the skirting on the N wall in this location also gives an indication of its extent (plate 31). The parquet flooring of herring-bone design in the lobby area at the base of the stairs is possibly the original flooring. The lower section of the stairs appears to be secondary (the stairs appear to have been accessed from the W side, rather than the E as at present). This alteration in layout likely occurred when the stairwell partition was installed.

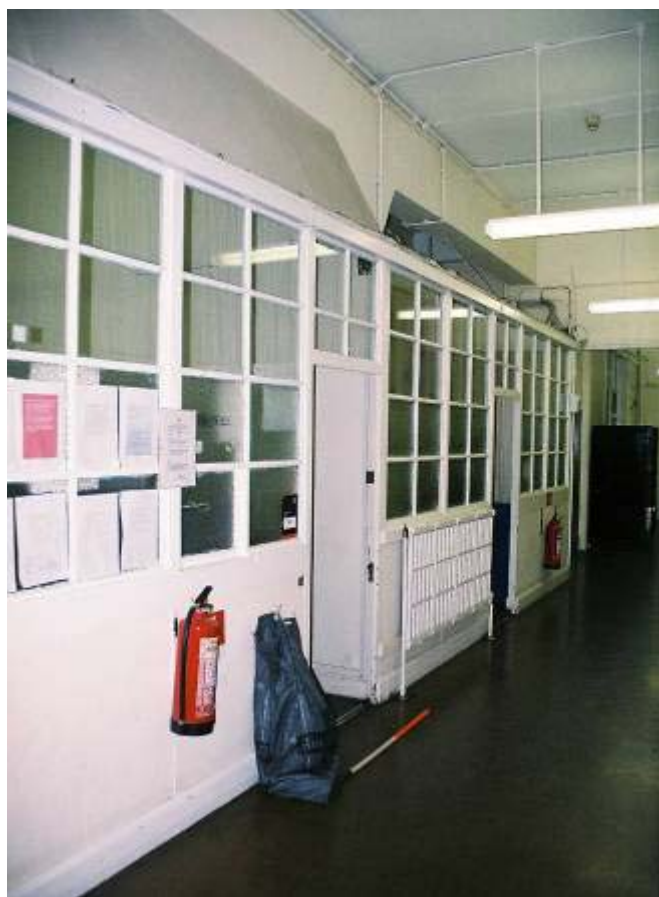
The counter in the NW corner of the room has been removed and half glazed partitions installed along the W wall. *Rooms 1 and 1A* currently house the building supervisors offices and the enquiries office; these rooms are separated by a modern partition (post-1989) which contains a window to the S of the doorway. The enquiries window is located at the N end of the half glazed partitions separating the room from the corridor.

Plate 32: secondary half glazed partitions forming W wall of former Enquiries Office, view from NW corner of corridor 2

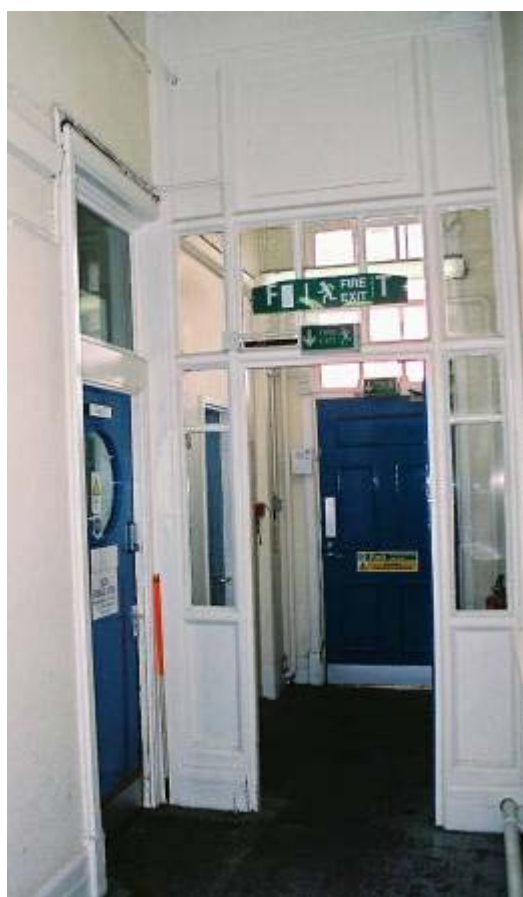
Plate 33: S end of corridor 1, showing lobby partition and moulding which surrounded former window to room 2

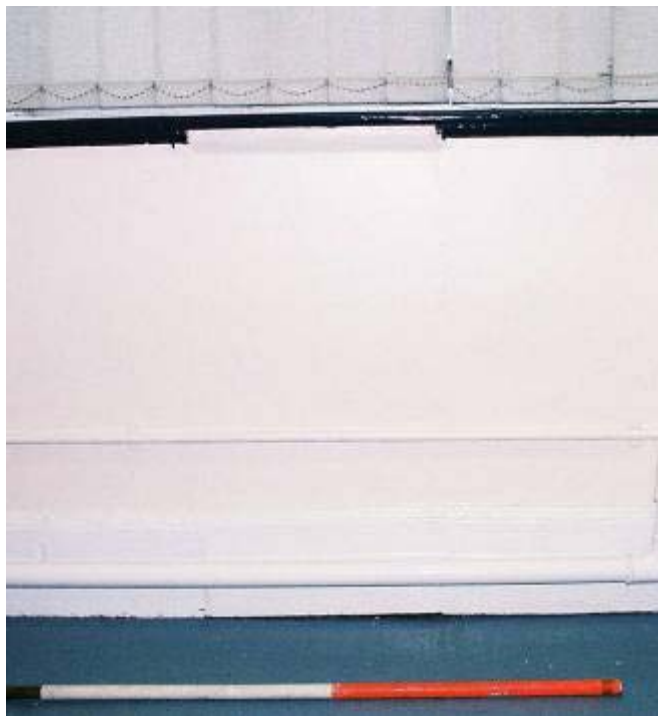
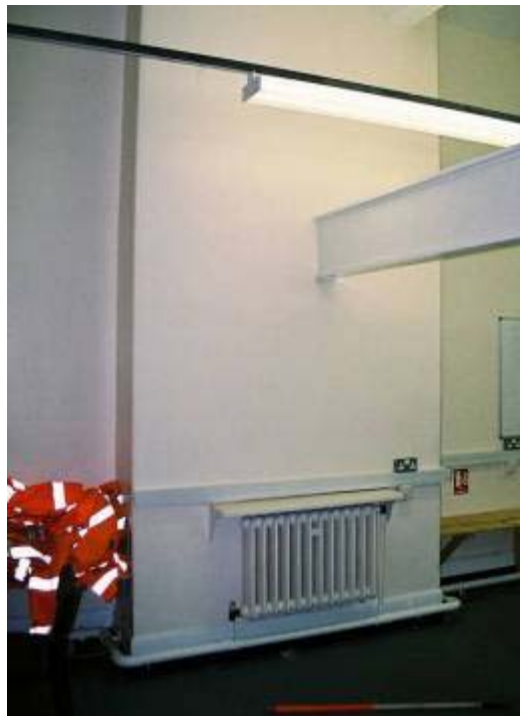
Plate 34: wall scar and cut in window sill and skirting, showing former counter location for Receiving Office, now in room 7

Plate 35: chimney breast in former Receiving Office, now in room 6A

The fireplace in the S elevation has been blocked off but the chimney breast is still visible.

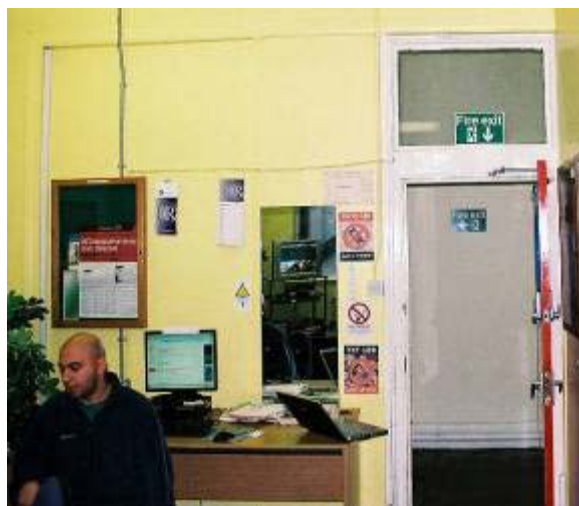
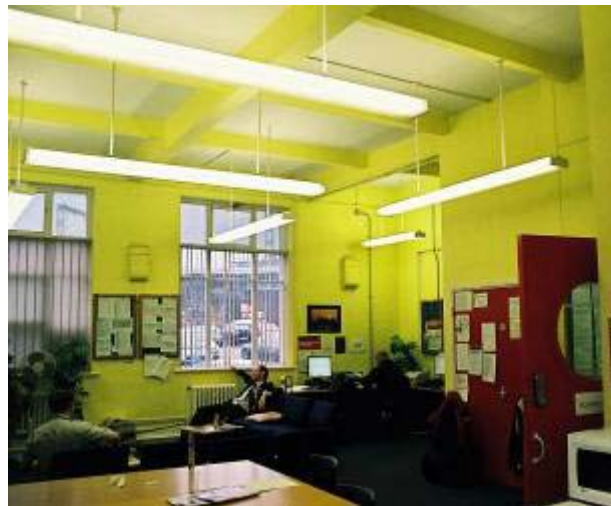
Plate 36: infilled counter window for Correspondence Staff office, in N elevation of room 2

Plate 37: General view of room 2, from SE corner, looking NW

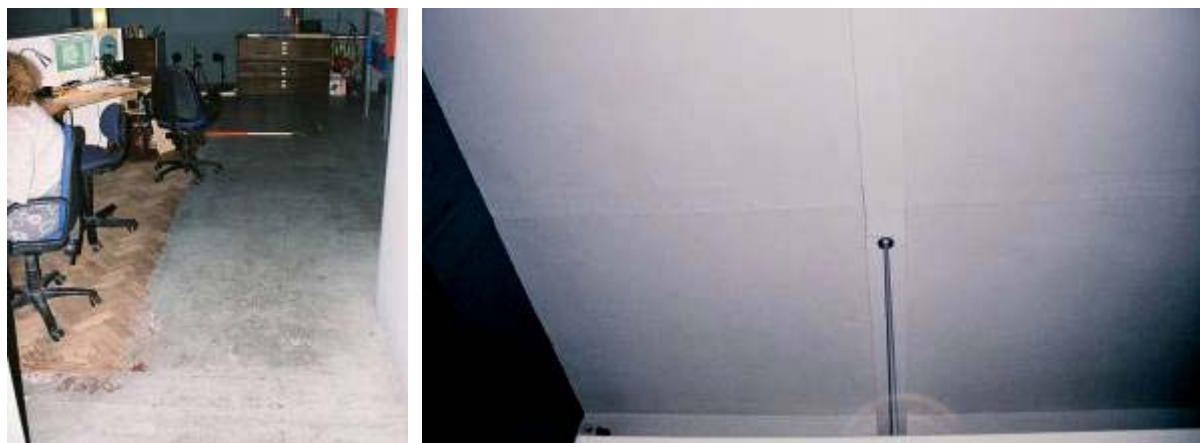
Plate 38: E-W orientated floor scar, indication former counter location in room 3 (separating the Carter's lobby from the Foreman's area)
