Newcastle Area Command Headquarters, Forth Banks *Newcastle-upon-Tyne*

Building Recording: December 2009 - January 2010

Building Recording (December 2009 - January 2010)

(project AA. 1847)

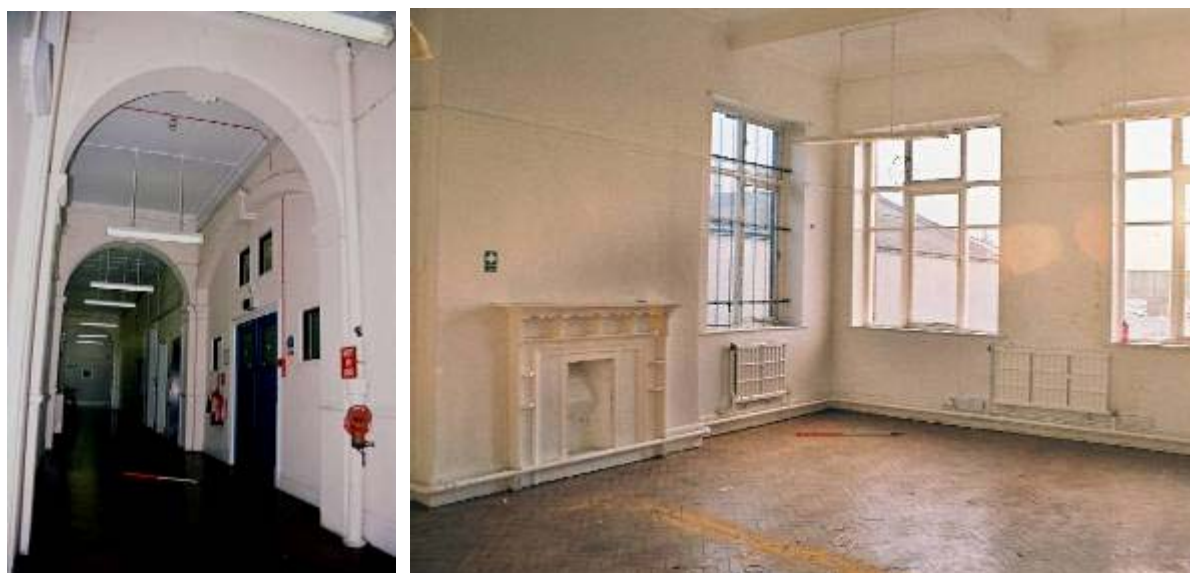
*Plate 40: Detail of arches in corridor at entrance from stairwell, view looking N
Plate 41: Room 2, first floor, view looking SW, with original fireplace in S wall*

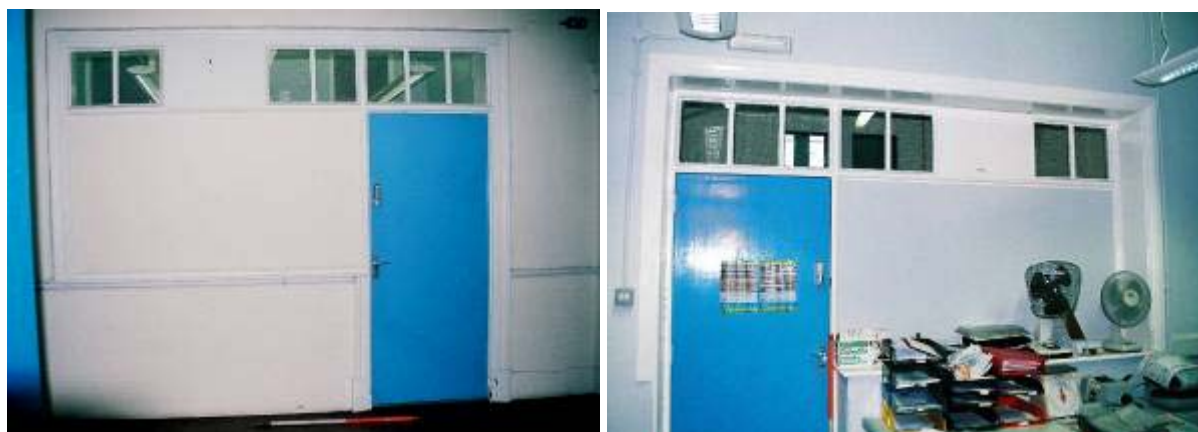
Plate 42: blocked Messenger office window, view looking from corridor into room 5, first floor

Plate 43: blocked Messenger office window, view looking from room 5 to corridor, first floor

Located opposite the central stairwell, which was open to the corridor. There was originally a window in the corridor elevation, with a counter beneath it in the room interior. This window presumably had an enquiry window within it (plates 42 and 43). The doorway to the immediate N of the counter is in its original location but the door itself has been replaced and the window blocked over. However, the moulded surrounds of the window are still in place and it can be seen where the counter cut across beneath the window. There were originally two telephone cubicles in the current kitchen area leading off from the N side of room 5.

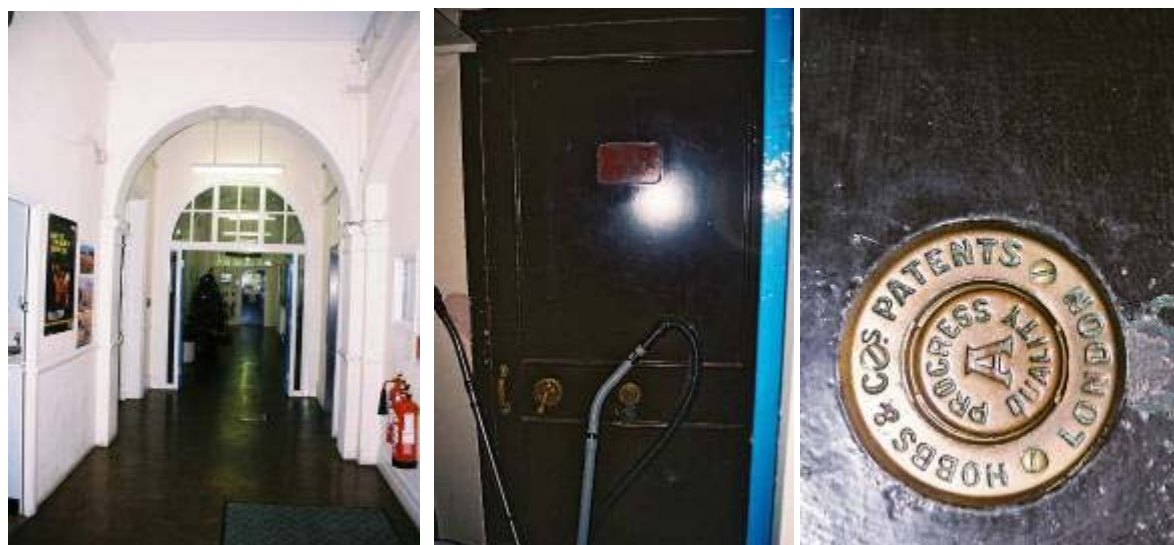
Plate 44: General view down corridor on second floor, looking N

Plate 45: walk in safe in room 5, second floor, now accessed through cleaners cupboard

According to the 1904 plans, arranged along the W wall (to the S of the doorway) were three separate areas. From S to N these contained the lift (not accessible from this room), the safe and lavatory (both accessible from this room). The 1904 plans state that the safe had an iron door and frame. If the plans are correct the doorways to the safe and lavatory have been blocked and a doorway inserted in the N wall of the lavatory, which has been modified to serve as a cleaner's cupboard (plates 45 and 46). The walk in safe is still in its original location, but if the construction plans were followed the door has been moved from its original location in the E wall, to the N wall.

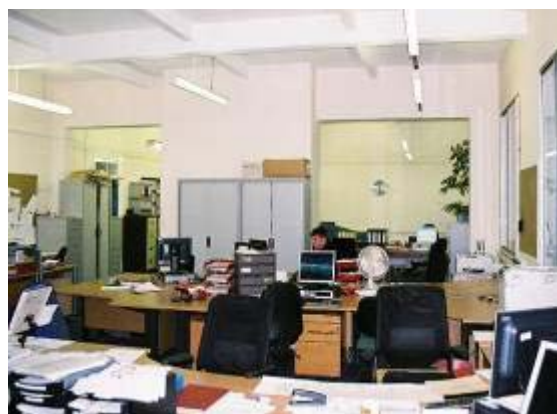
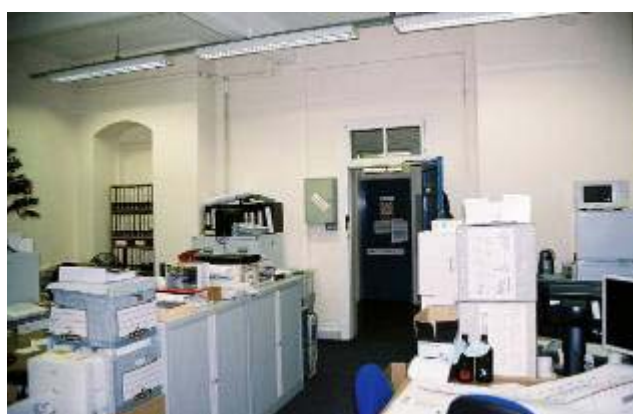
Plate 47: second floor room 1, later insertion openings to E and W of chimney breast

Plate 48: E elevation of room 2 second floor, with archway originally forming entrance to lavatories, now an alcove

Some time after this the original truncated walls were removed and replaced with a single dividing wall, at the S side of the chimney breast in the E wall, which was originally located centrally in the contractors room, thus creating the current two offices (*rooms 2 and 3*). The archway which formed the access to the lavatory from the corridor has been partially blocked and now forms an alcove in the E wall of *room 2* plate 48).

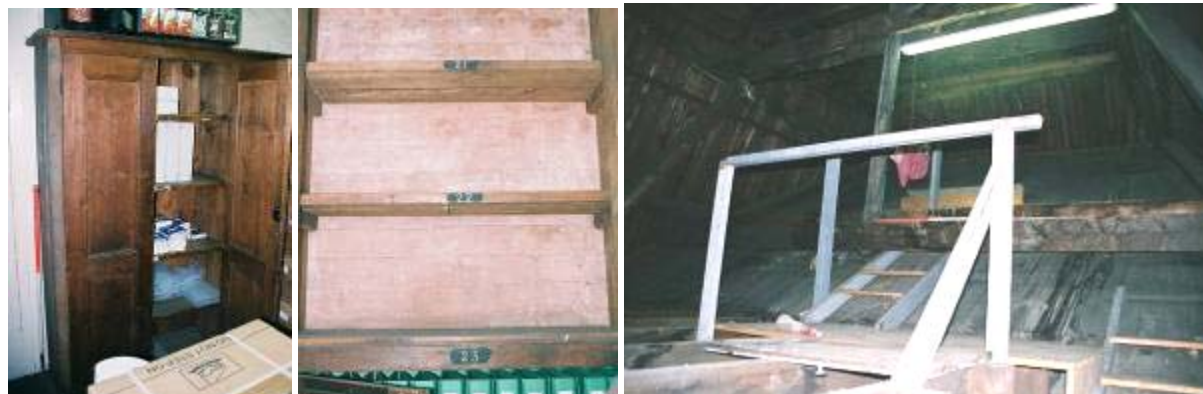
Plate 52: cupboards in room 13.1

Plate 53: detail of shelve numbering in room 13.1

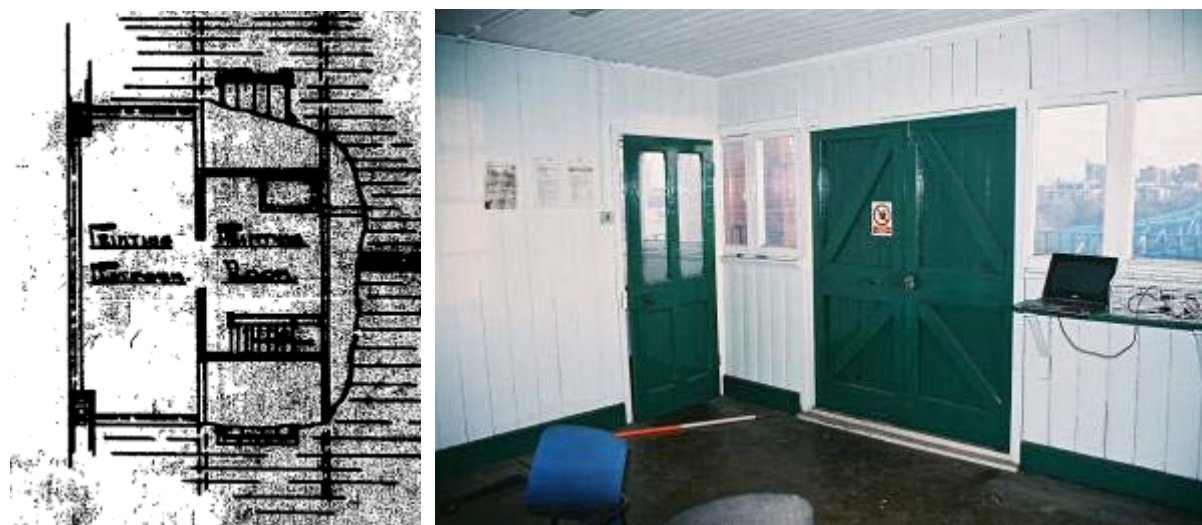
Figure 23: 1904 plan of fourth floor Kings House

Plate 55: fourth floor, room 1, view looking SE

This was originally divided into two rooms, one forming the printing room and the second containing the printing presses (figure 23). The printing room has a row of windows running along the S elevation and a set of double doors leading out to a viewing platform on the roof (plate 55). The room does not retain any original machinery.

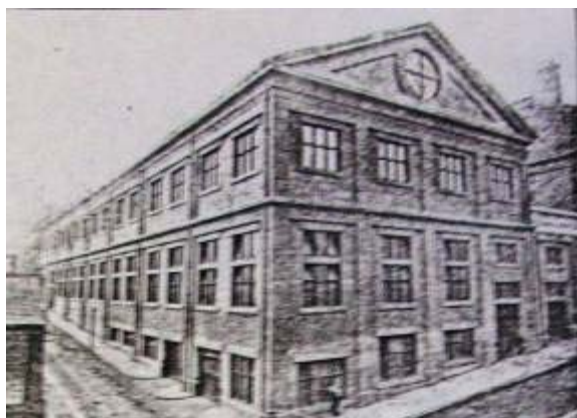
Figure 24: Early 20th century image of the Goods Warehouse and Link Building, view at the junction of Forth banks and Pottery Lane^{vii}

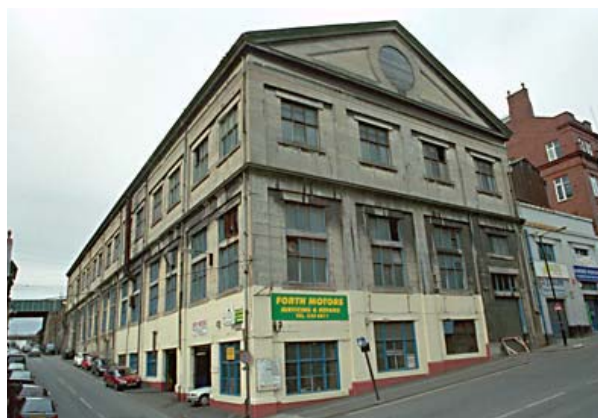
Figure 25: later 20th century image of the Goods Warehouse and Link Building, view at the junction of Forth banks and Pottery Lane^{viii}

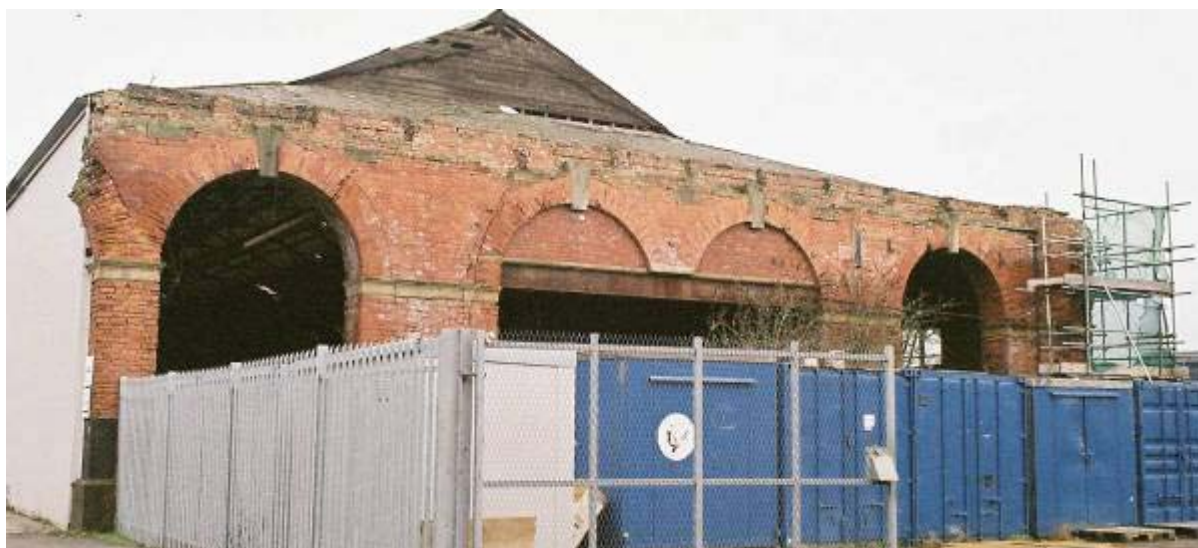
Plate 56: W elevation of Goods Warehouse, showing truncated arches of demolished Goods Station and modified central arches

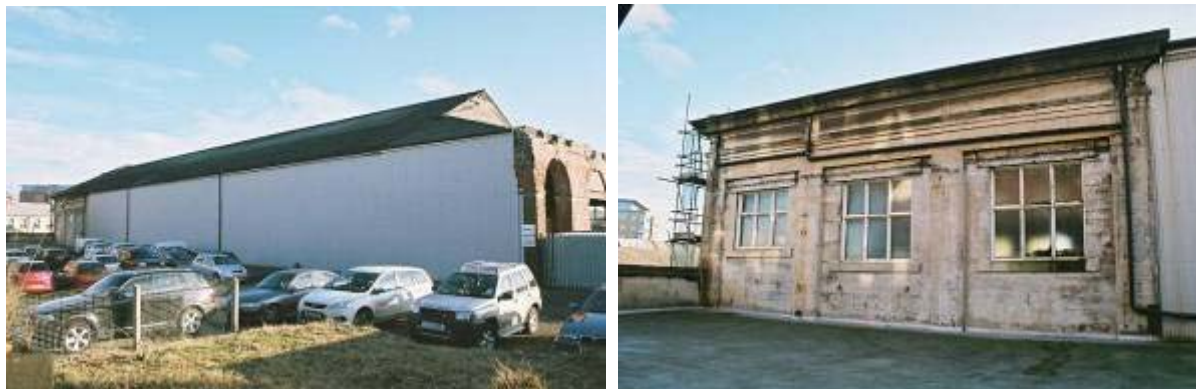
*Plate 57: N elevation of Goods Warehouse, general view looking SE, showing later covering
Plate 58: N elevation of Goods Warehouse, original masonry at E end*

The N elevation appears to have been largely open, with the exception of the E end, where there is a three bay elevation of similar construction style to the principal elevation. The remainder of this elevation would have been open but it is now covered with corrugated iron (plates 57 and 58). There were latterly temporary sheds built against this later sheeting (visible on the 1940 OS map), but these have since been demolished.

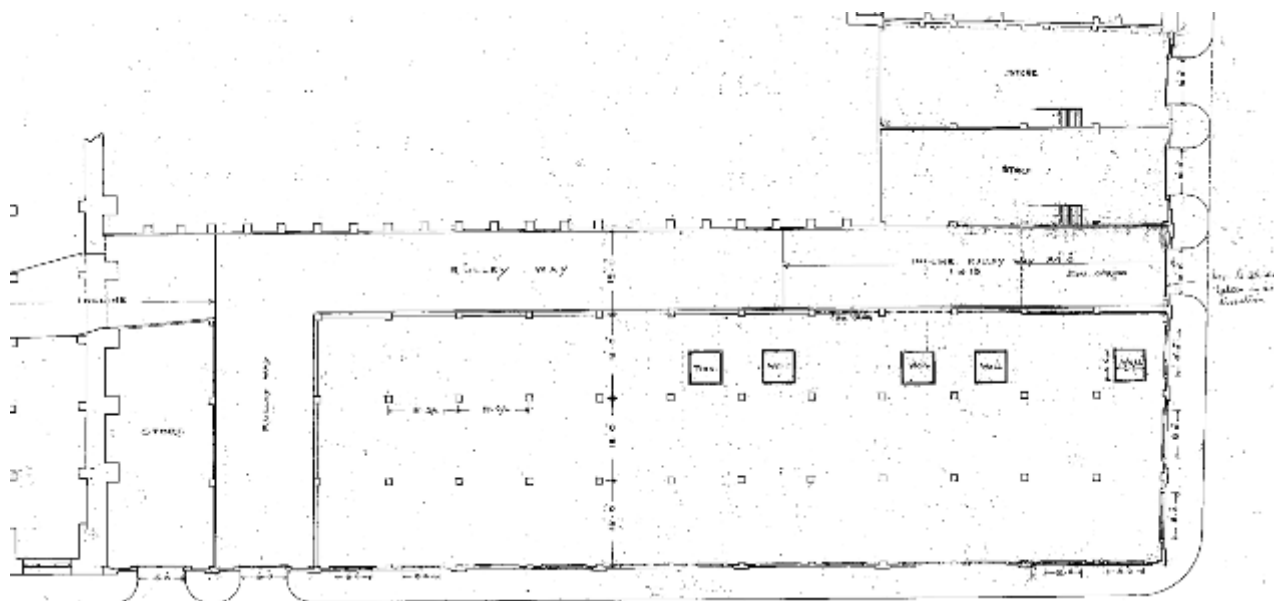
Figure 26: Forth Banks Warehouse ground floor, showing 'rulleway',
NER 1907 drawing, ref 66

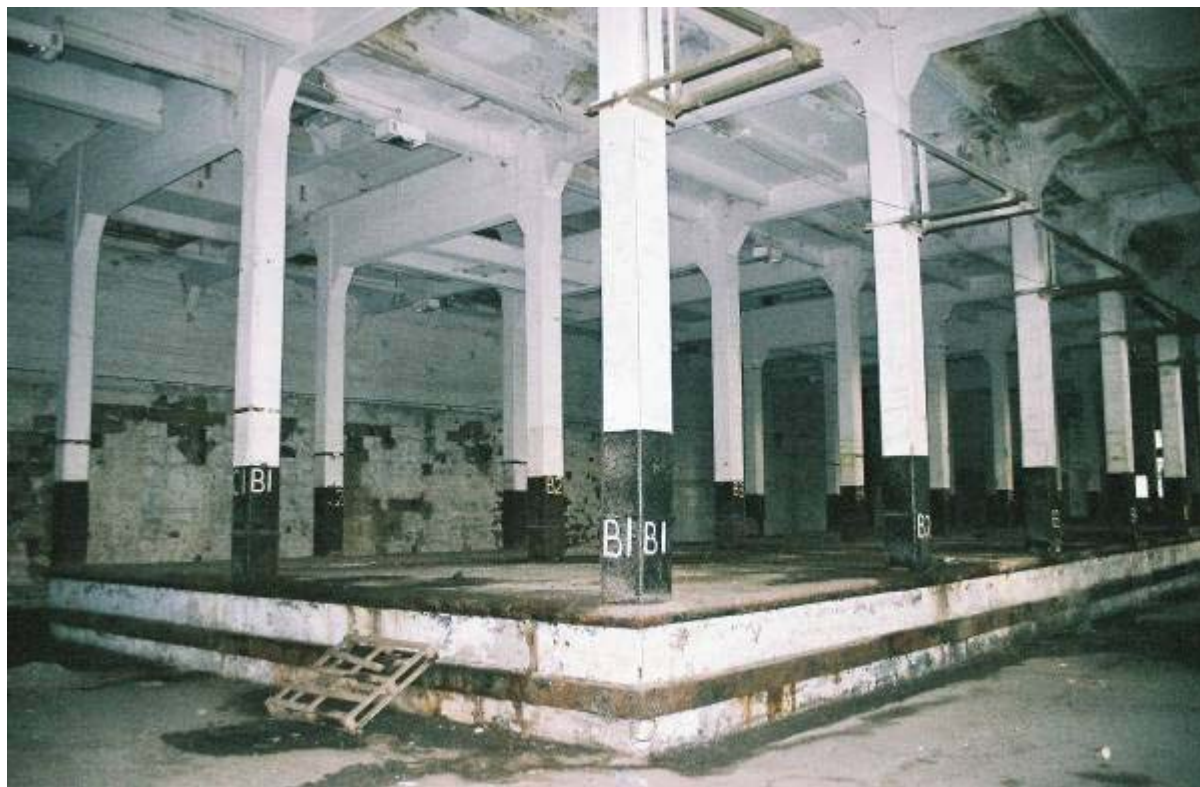
Plate 59: Goods Warehouse, ground floor platform with numbering system, also showing brackets and pulleys at the top of the piers

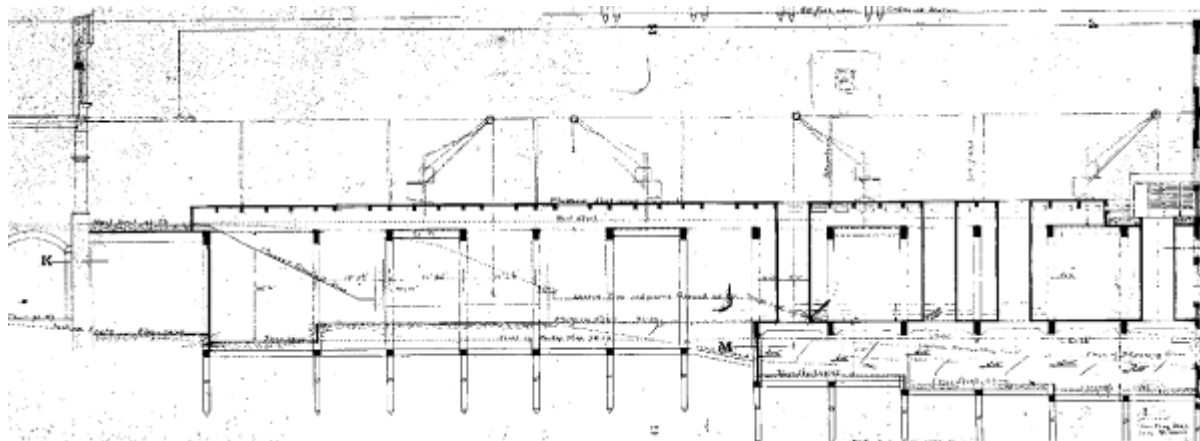
Figure 27: Longitudinal section through the warehouse building, showing cranes on the platform on the upper floor lowering goods down through the hatches to platform on the lower floor, NER 1907, drawing no. 16

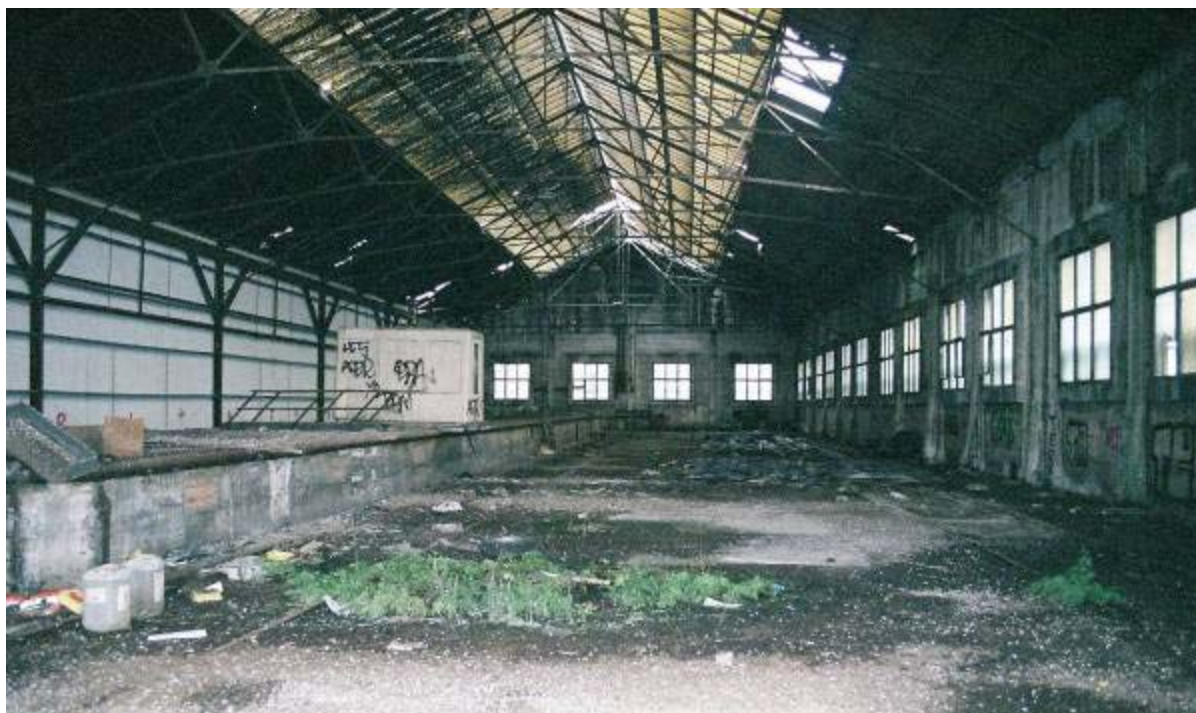
Plate 62: general view of upper floor of warehouse, looking E

fourteen bays in length and in the S elevation there is a six light window in each bay. The N elevation is largely formed from secondary corrugated iron; only the three easternmost bays are of solid construction, each with a six light window. The floor of the upper floor is primarily formed from wooden setts of the same style as the floor below. This has secondary concrete patching in some places, particularly where the floor has bowed due to water ingress. The roof structure is carried on a steel frame; the supporting piers are visible on the N elevation, as this was originally open, but on the S elevation the roof trusses project into the concrete walling. The roof has glazed strips which run from the apex to approximately half way down the roof (plate 62).

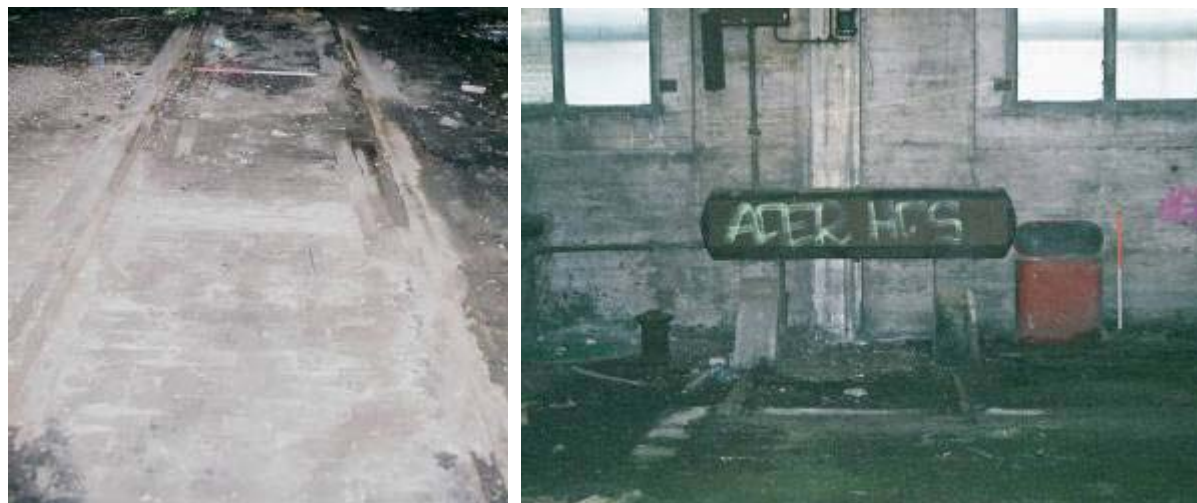
*Plate 63: detail of track with wooden runners, in upper floor of warehouse, southern track
Plate 64: detail of buffer at W end of N track in upper floor of warehouse*

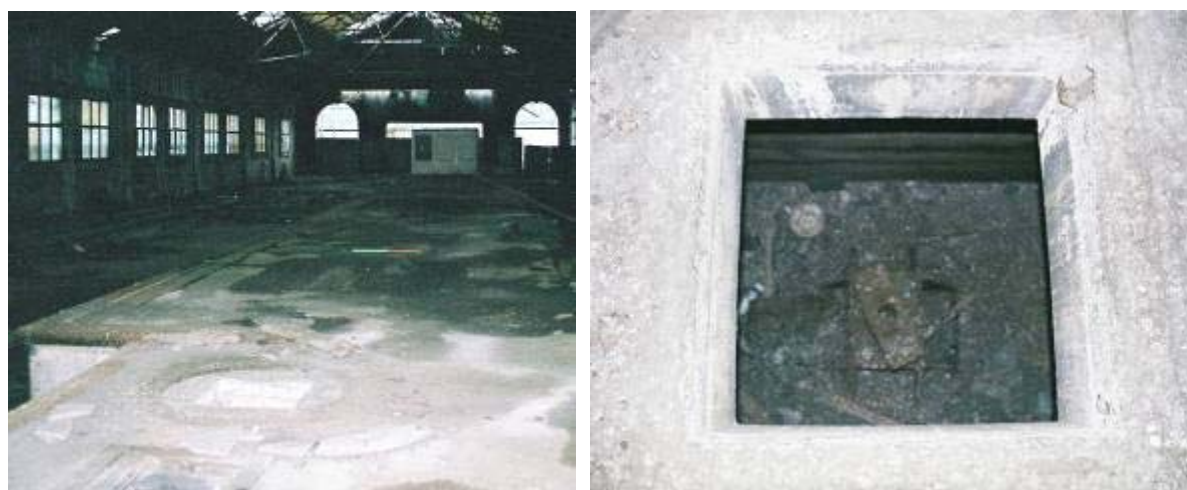
*Plate 65: View looking W along the platform; the circular crane bases and boarded over hatches are visible
Plate 66: View down open crane base, with footing for crane shaft at the bottom*

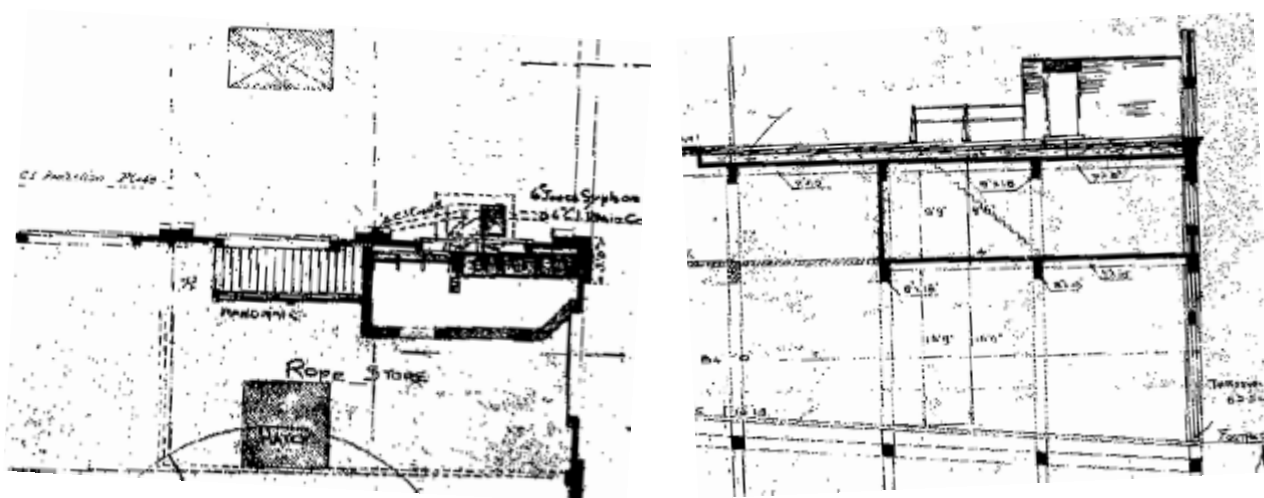
Figure 28: detail of 1907 plan of the warehouse upper floor, showing stairs from the Linking Building and structure at NE corner, NER ref 271

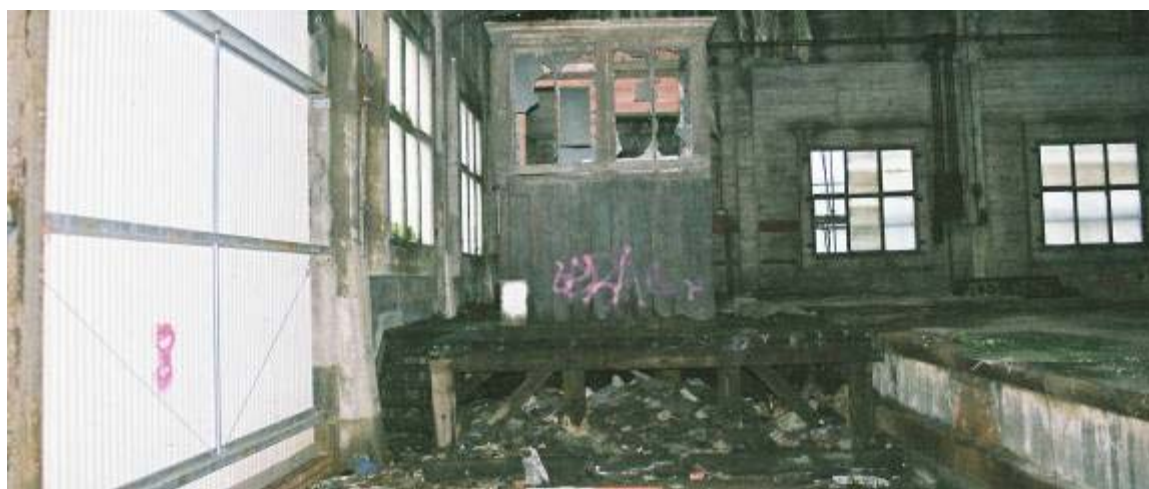
The wooden platform extends to three bays in length, sitting directly to the S of the solidly constructed part of the N elevation of the upper floor. It is accessed via a small flight of steps which lead up from the W, directly beside the n elevation of the warehouse. A small wooden booth sits at the W end of the wooden platform (plate 67). This has a doorway in the E elevation and windows extending around all sides in the upper half of the walls. Within the booth, on the N elevation, is a small wooden 'desk' with lids covering two compartments. The windows are broken and the door has been removed.

Plate 67: Secondary wooden platform and booth at NE corner of warehouse, upper floor, looking E

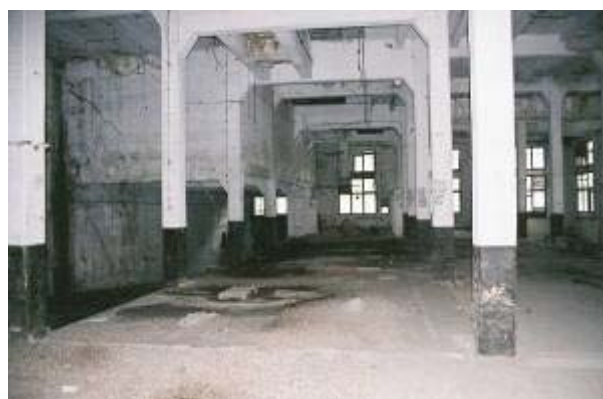
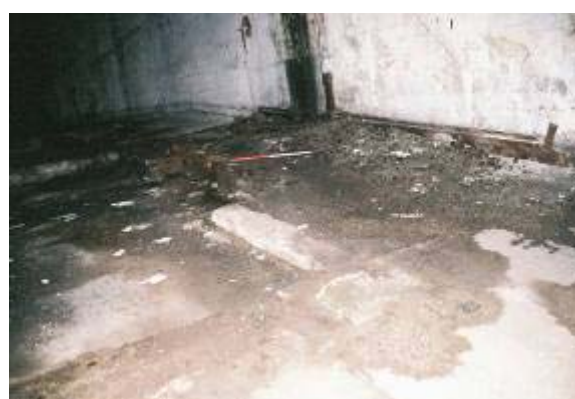
Plate 69: E end of platform in ground floor of Warehouse, showing former location of 1955 'dressing hall'
Plate 70: Remains of brick walls relating to 1955 abattoir structures at E end of N rulleway

The major alteration relating to this phase was the creation of a large partitioned area on the N half of the central platform at the E end, extending into the rulleway to the N (see figure 31). This was the major processing area for the abattoir, with the hogs entering through the doorway in the E elevation and through the various stages of the processing system. The 'dressing hall', located on the central platform was formed from brick walls with glazed upper sections. These have been largely removed but the outline is still visible and parts of the walls are still upstanding towards the E end of the platform (see plate 69). There is less evidence of the structures created in the N rulleway, but the foundations of the brick dwarf walls and steps along the N wall are still visible, as are those against the S wall (plate 70). A paint scar is also visible extending along the ceiling in N rulleway, marking the width of the structures running along the S wall. At the SW corner of the central platform a 'bacon room' was created by the partitioning off of the first two bays – no traces of this remain. A flue extending from above the dressing hall on the central platform also appears to relate to this phase. The building control plans depict this as extending out through the window in the fifth bay in the S elevation, but instead it was extended through the third.

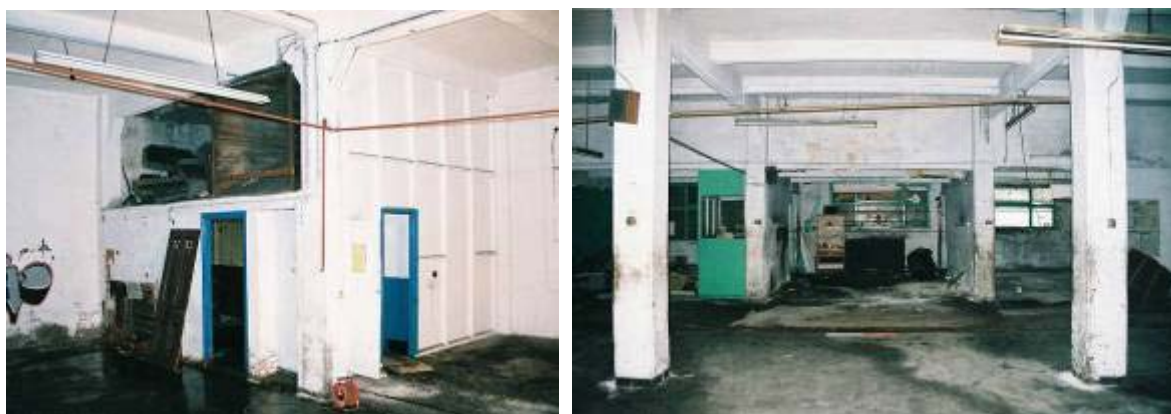
Two partitions have been installed along the S and W sides of the bay in the NE corner of the lower ground floor, within which are two distinct, unconnected areas (plate 71). One area is entered via the door in the S elevation and the other via the door in the W elevation. Each area contains small rooms and a toilet cubicle.

A number of additional partitions have been installed between the along the S elevation in Area 2, creating small workshop areas. In the third bay from the E a small partially glazed booth has been installed (plate 72). The use of this part of the building as general workshops continued until relatively recently.

Plate 71: Secondary partitions in the NE corner of the lower ground floor of the warehouse
Plate 72: Secondary partitions along the S elevation of the lower ground floor of the warehouse

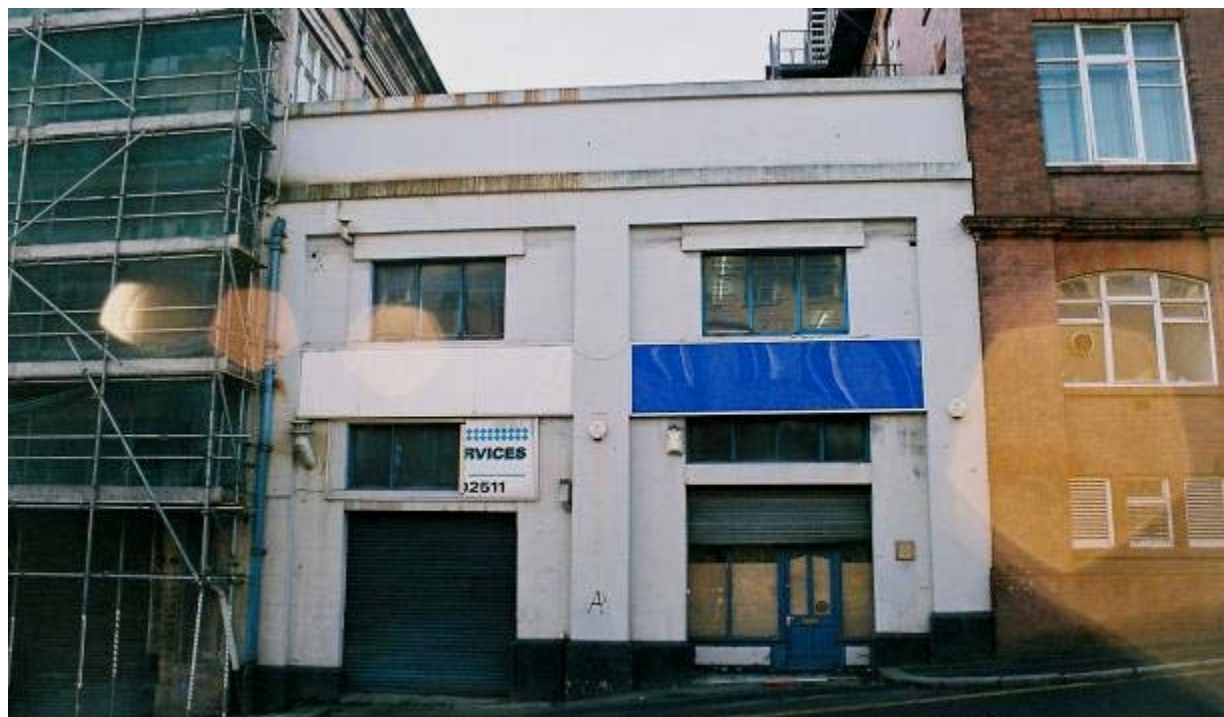
The façade has seen some alterations since its original construction – the original doors have been replaced with a single leaf door with glazing either side (N doorway) and roller shutters (both

Plate 73: E elevation of Link Building

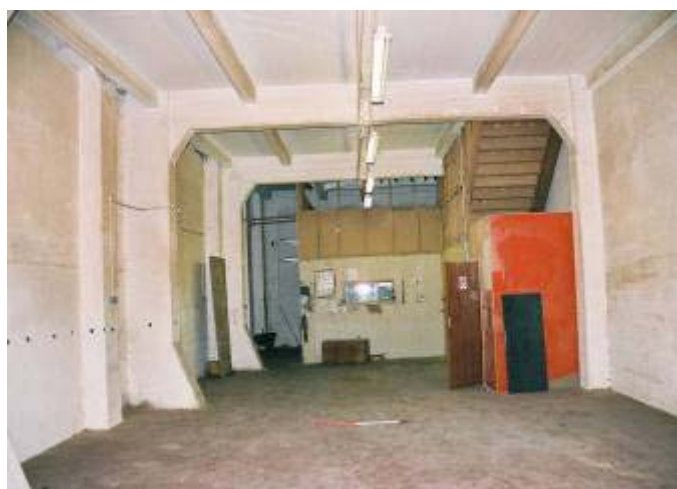
The appearance of the ground floor of the Link Building is very similar to the ground floor and lower ground floor of the warehouse, with large iron piers joined by overhead beams with angular brackets. The ground floor appears to have originally been composed of two large rooms, each of one bay width running the full length of the building; the rooms were separated by a dividing wall running down the centre of the ground floor from E-W (see plate 74). Each room is accessed via one of the doorways in the E elevation and the two rooms each appear to have been originally independent (there is currently a doorway at each end of the central wall but these appear to be later insertions). Both rooms are depicted as ‘stores’ on the 1907 drawings and are therefore of a very functional design, with little detailing or embellishment. The floor level of the N room is slightly higher than that of the S room.

Plate 74: General view of Link Building ground floor, N room (*room 2*), view looking E

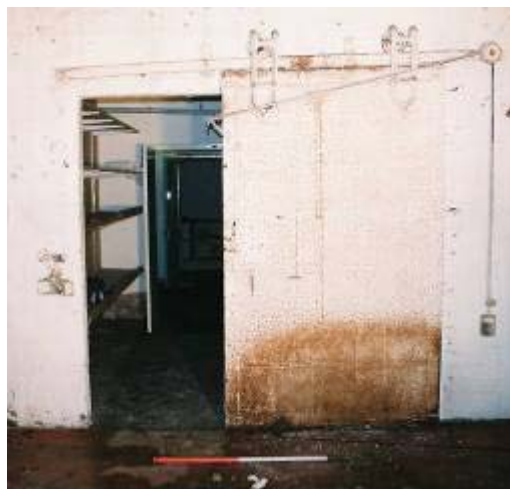
The upper floor of the Link Building is one bay wider (to the S) than the floor below. This is due to the fact that the southern room at this level (*room 10*) slots into the side of the warehouse building, sitting above the E end of the N rully way on the ground floor. This room is separated from that to the N by a wall with a connecting doorway in the third bay from the S end. This doorway is covered by a solid sliding metal door which still retains the original pulley system for opening and closing it on the rear (S) side (see plate 75). Unlike the other rooms on this floor, this room has not been lined out and it is therefore possible to see its original appearance, which is very similar to the rooms on the lower floor. The 1907 plans depict this room as the 'rope store' and its plain appearance reflects its original function.

Plate 75: Link Building upper floor, metal door with pulley separating room 9 and 10

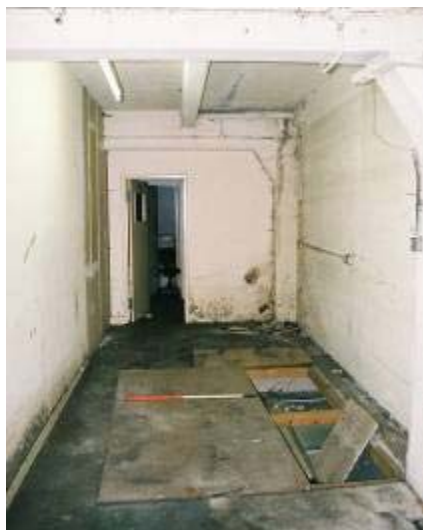
A flight of stairs originally extended up the N wall of this room. However, the opening in the ceiling, in the second bay from the E end of the building has been boarded over and the stairs have been removed; only the last few steps close to the ceiling remain. These steps provided access to the upper floor of the warehouse, accessing the floor at the point now covered by the wooden platform and booth. To the immediate N of the stairs is a hatch, which would have also provided access to the upper floor of the warehouse. This room is depicted as a rope store on the 1907 drawings.

Plate 76: Link Building first floor, room 9, boarded over hole in floor indicating former location of stairs leading up from the ground floor

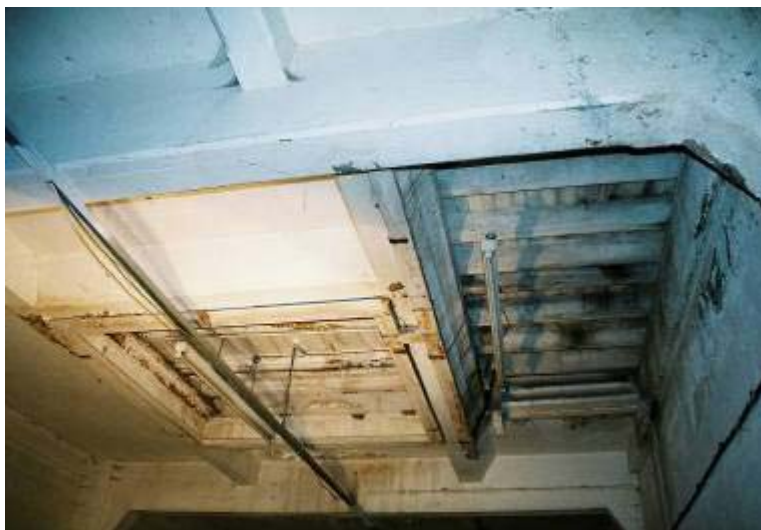
The opening in the E elevation has been boarded over but this room would have originally been lit by a window in the warehouse frontage. There is a doorway at the E end of the S elevation of this room. This doorway provided access a stair (now removed) which led down to the ground floor of the warehouse.

In *room 10* the NW corner of the room has been partitioned off (*room 13*) and shelving installed along the S wall of the southernmost bay. The stairs which originally led up from the E end of this room to the upper floor of the warehouse have been removed (see plate 77).

Plate 77: Link Building first floor, room 10, cut of stairs and hatch originally providing access to the upper floor of the warehouse building
