**LAND AT VAN DIEMAN'S LAND, WOBURN ROAD,  
KEMPSTON RURAL, BEDFORDSHIRE**

**ARCHAEOLOGICAL FIELD EVALUATION**

Document: 2004/39  
Project: VDL987

Produced for:  
Old Road Securities plc.

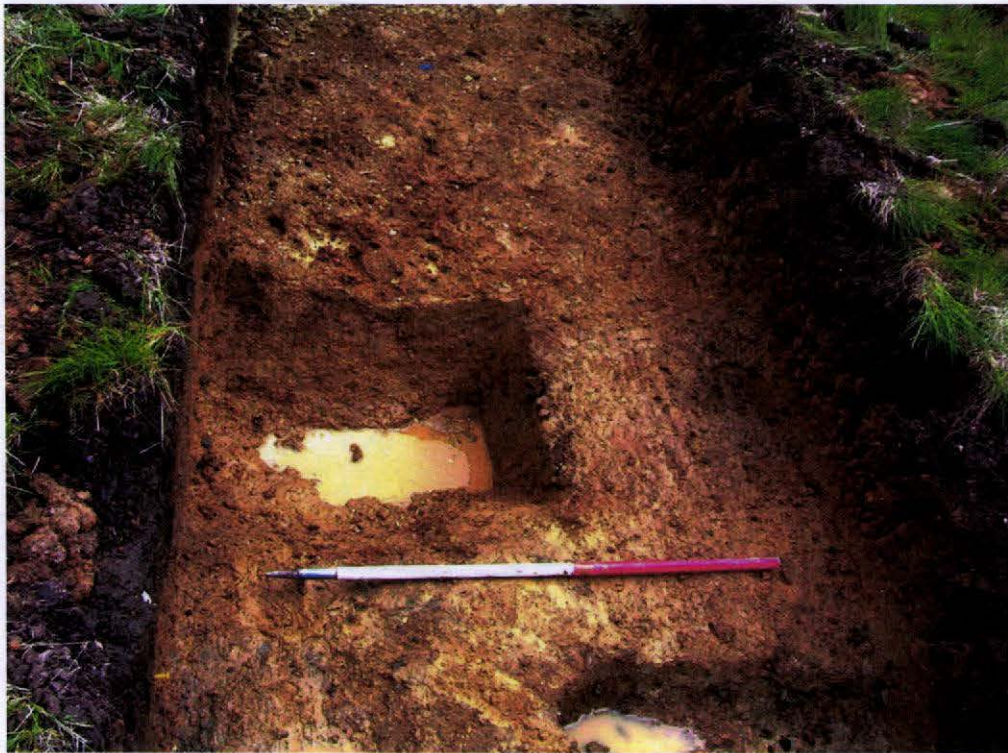
A single, narrow, irregular, linear feature [308] (plate 1), running ENE – WSW, was recorded c.26m from the southern end of the trench. Its U-shaped profile contained a slightly clayey silt fill, which produced no artefactual material. [308] is too far to the south to be the continuation of the linear feature, identified in the previous evaluation to the north of the current study area. The absence of this

**Plate 1:** Ditch [308], Trench 3

feature in Trench 3 probably reflects the difficulties inherent in projecting the alignment of linear features from observations made in relatively narrow trial trenches.

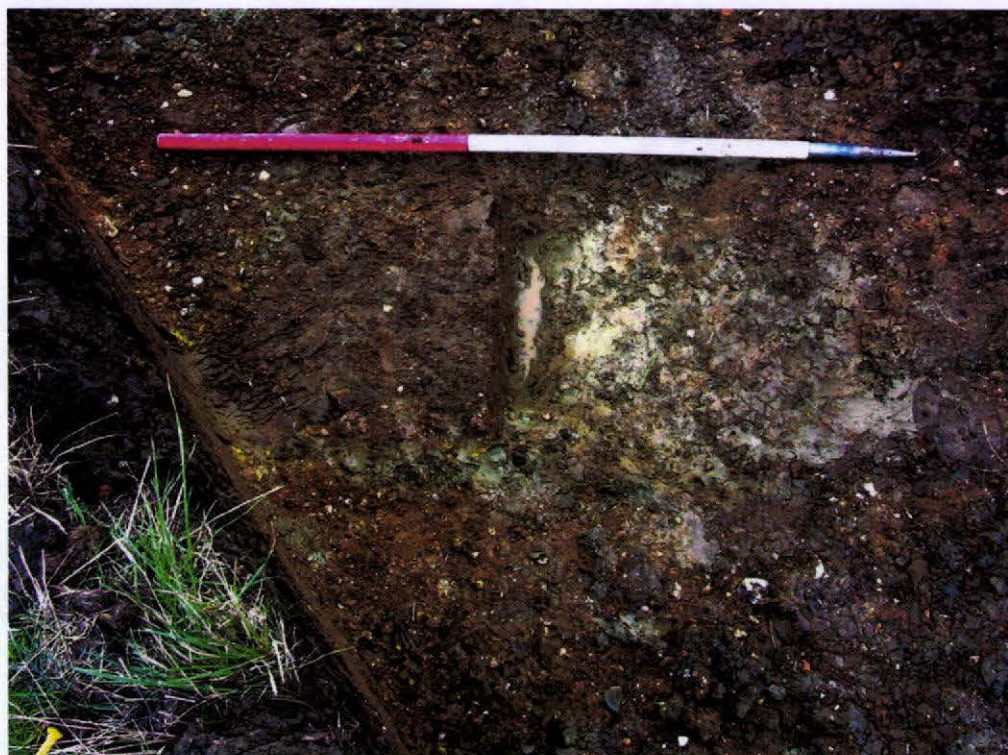
Three relatively small, shallow, irregular pits [306], [314] and [316] (plates 2, 3 and 4) were also investigated. All contained a similar grey brown silty clay fill, devoid of any artefactual material. It is unclear whether or not these features should be considered of archaeological or natural origin.

**Plate 2:** Pit [306], Trench 3

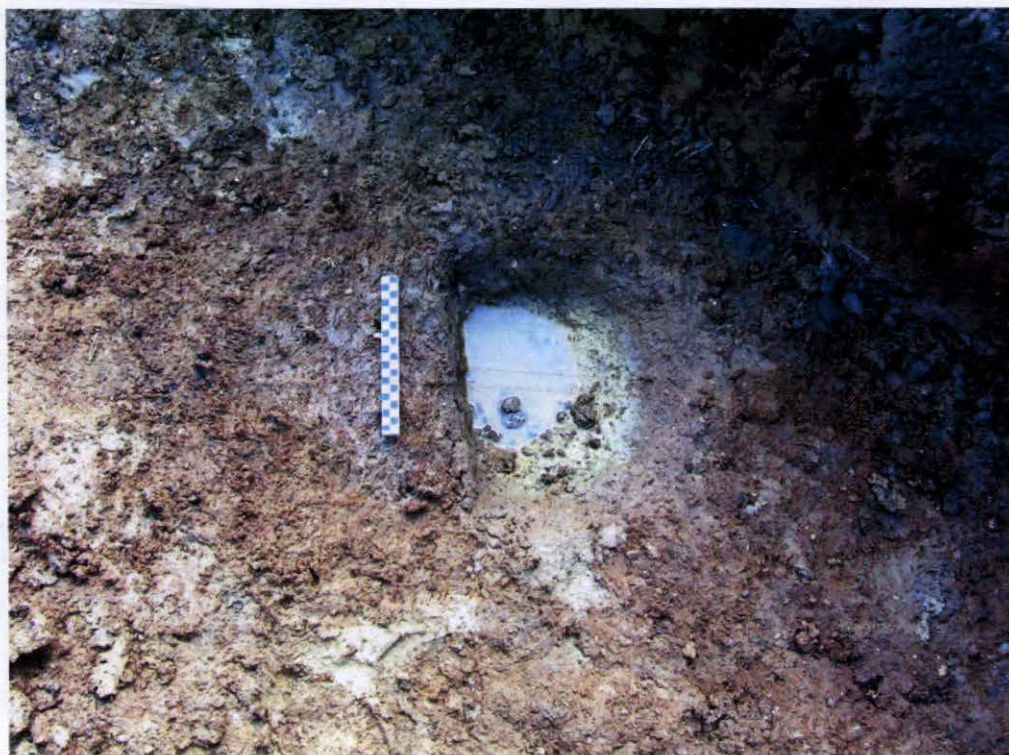
**Plate 3: Pit [314], Trench 3**

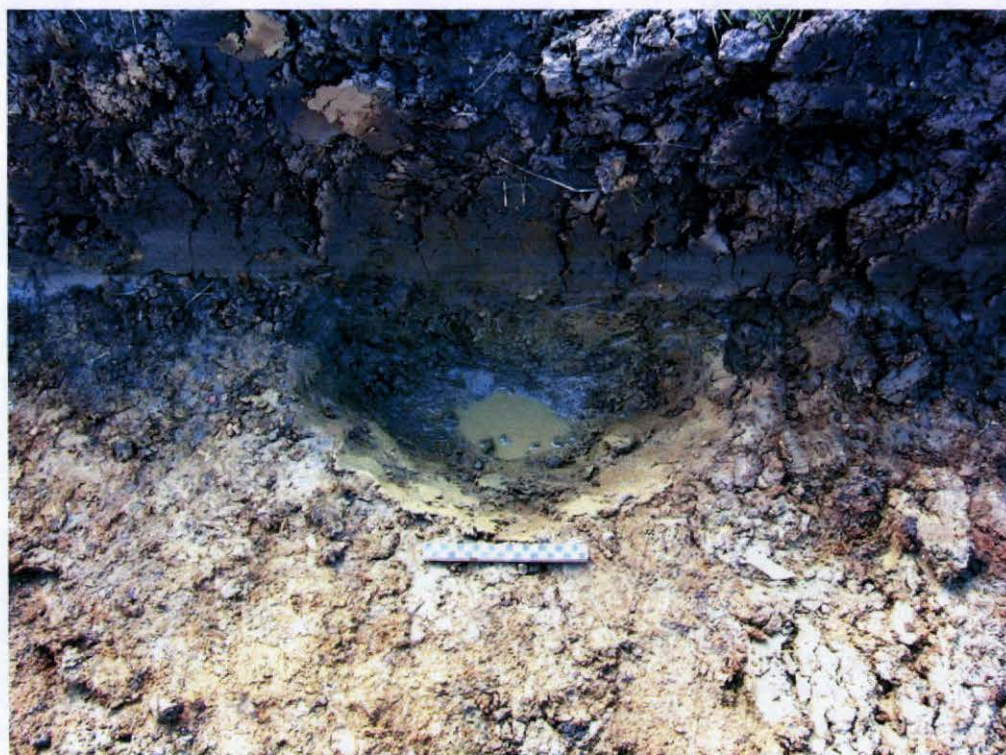
**Plate 4: Pit [316], Trench 3**

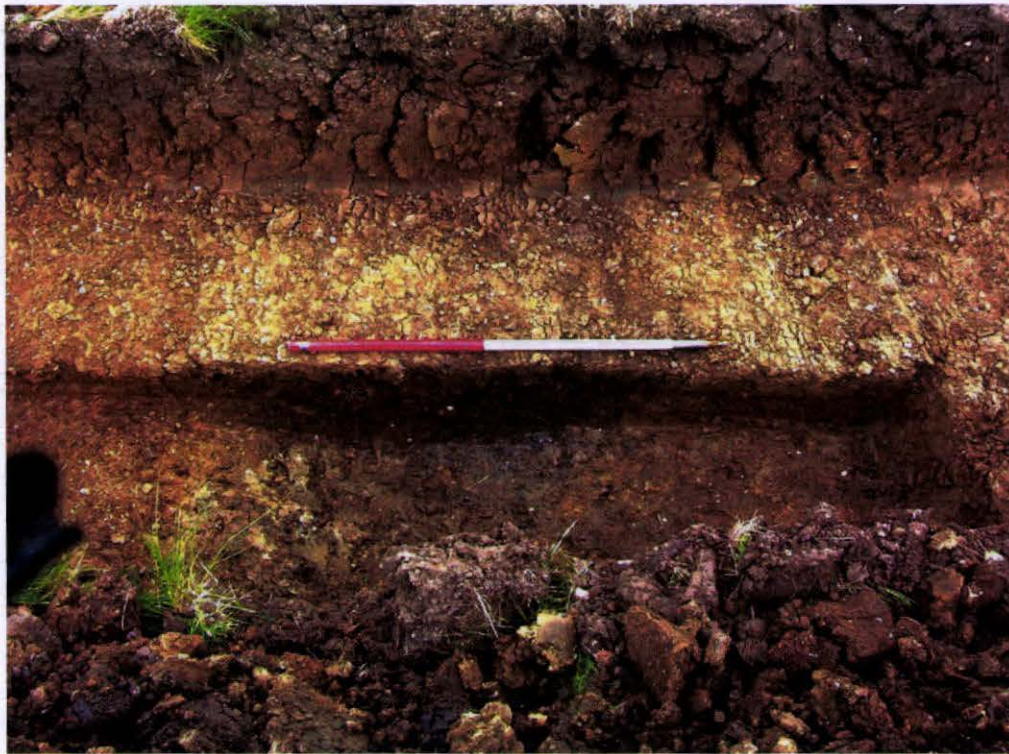
Two moderately sized linear features [505] (plate 5) and [507] were recorded. Both were aligned NW-SE with irregular, concave profiles. The fill of [505] was clay, whereas the fill of [507] was a clay silt mix. Neither ditch contained any artefactual material.

**Plate 5: Ditch [505], Trench 5**

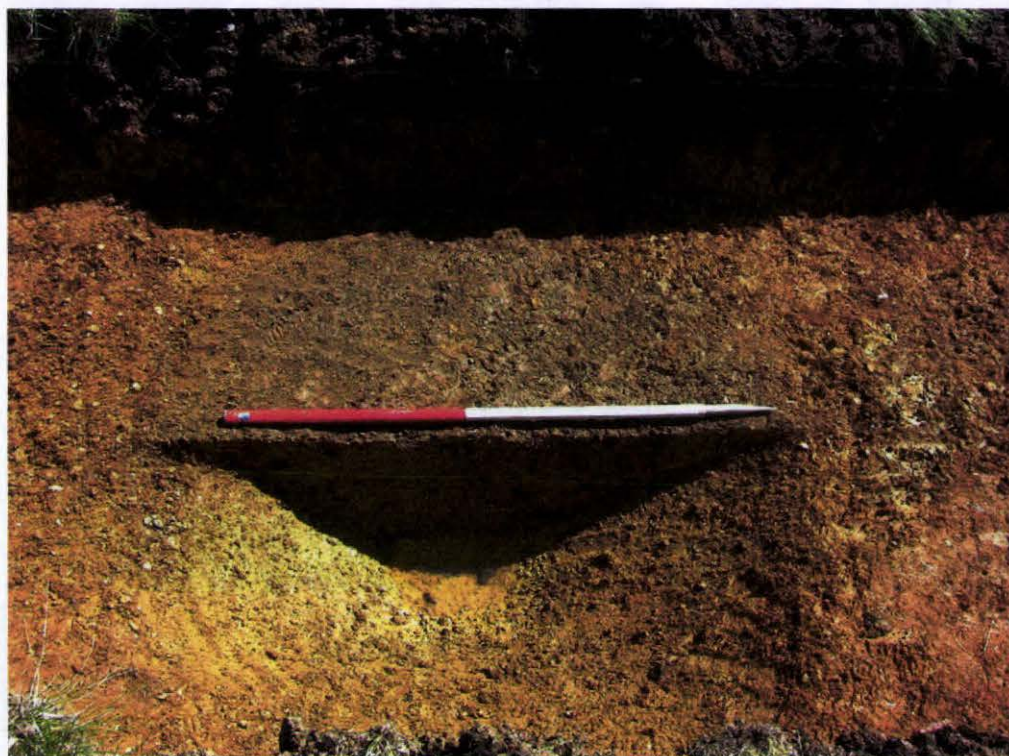
A single archaeological feature [606] (plate 6), c.12m from the southern end of the trench, was sealed by the lower subsoil (603). It comprised a large circular pit, 1.42m in diameter and 0.42m deep, with an open, concave profile. It did not contain any artefactual material. Its atypical, friable brown fill (607) was suggestive of a high organic content. However, off-site processing and analysis of a soil sample failed to produce evidence for any ecofactual material.

**Plate 6: Pit [606], Trench 6**

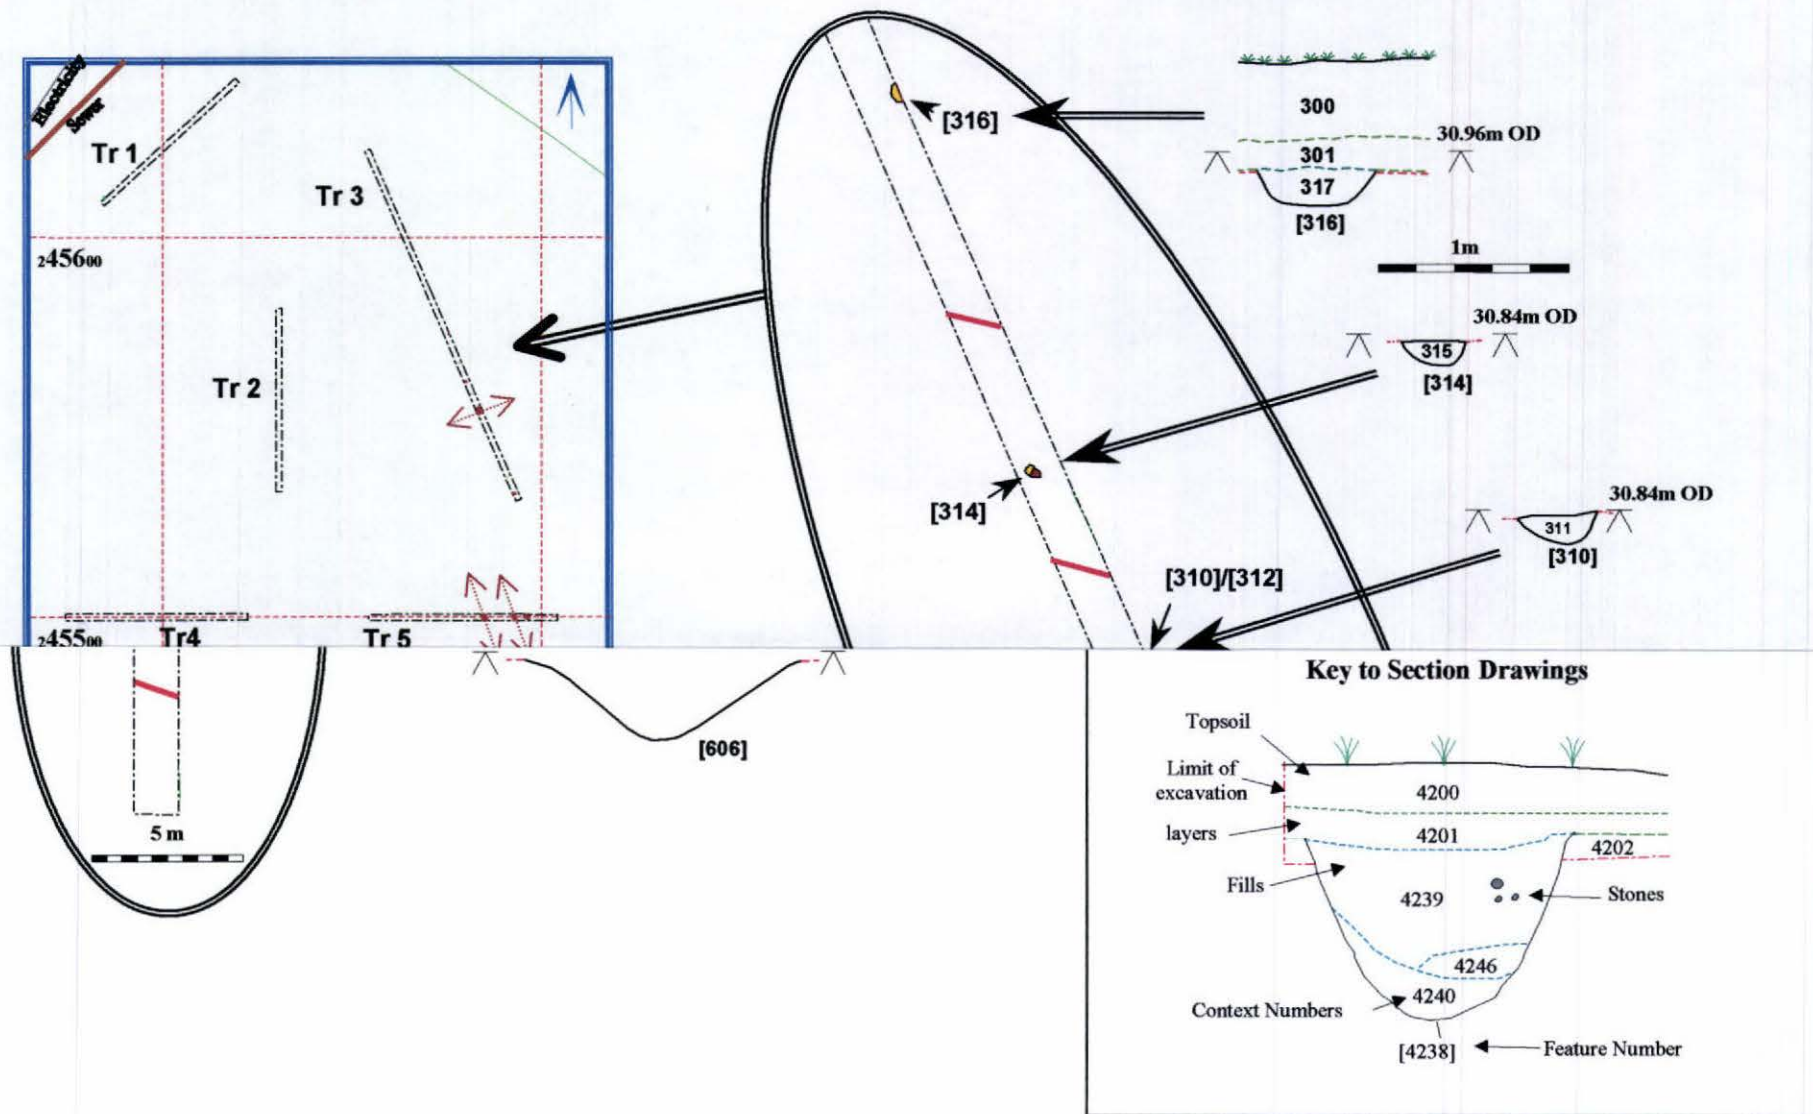
Within the study area it is interesting to note that ditches [505] and [507] in Trench 5 appear to run perpendicular to the line of ditch [308] in Trench 3 (Figure 2). The deposits within ditches [308] and [507] are relatively similar (Appendix 1), suggesting that these features may be related and possibly contemporary. At the very least, the fact that they contained similar material suggests they may have been backfilled at the same time. Field boundaries are known to sub-divide plots of arable land, using exactly this pattern. It is, therefore, possible that these features are the remnants of a field system. Such an interpretation would be consistent with their location on the periphery of the core settlement area at Marsh Leys Farm, which would undoubtedly have been surrounded by just such field systems.

**Figure 2: All features plan**
