The Bartlow Hills in context: a Roman funerary landscape

**H. Eckardt, T. Astin & S. Hay,
with A. Clarke, L. Cramp & D. Thorney**

August 2005

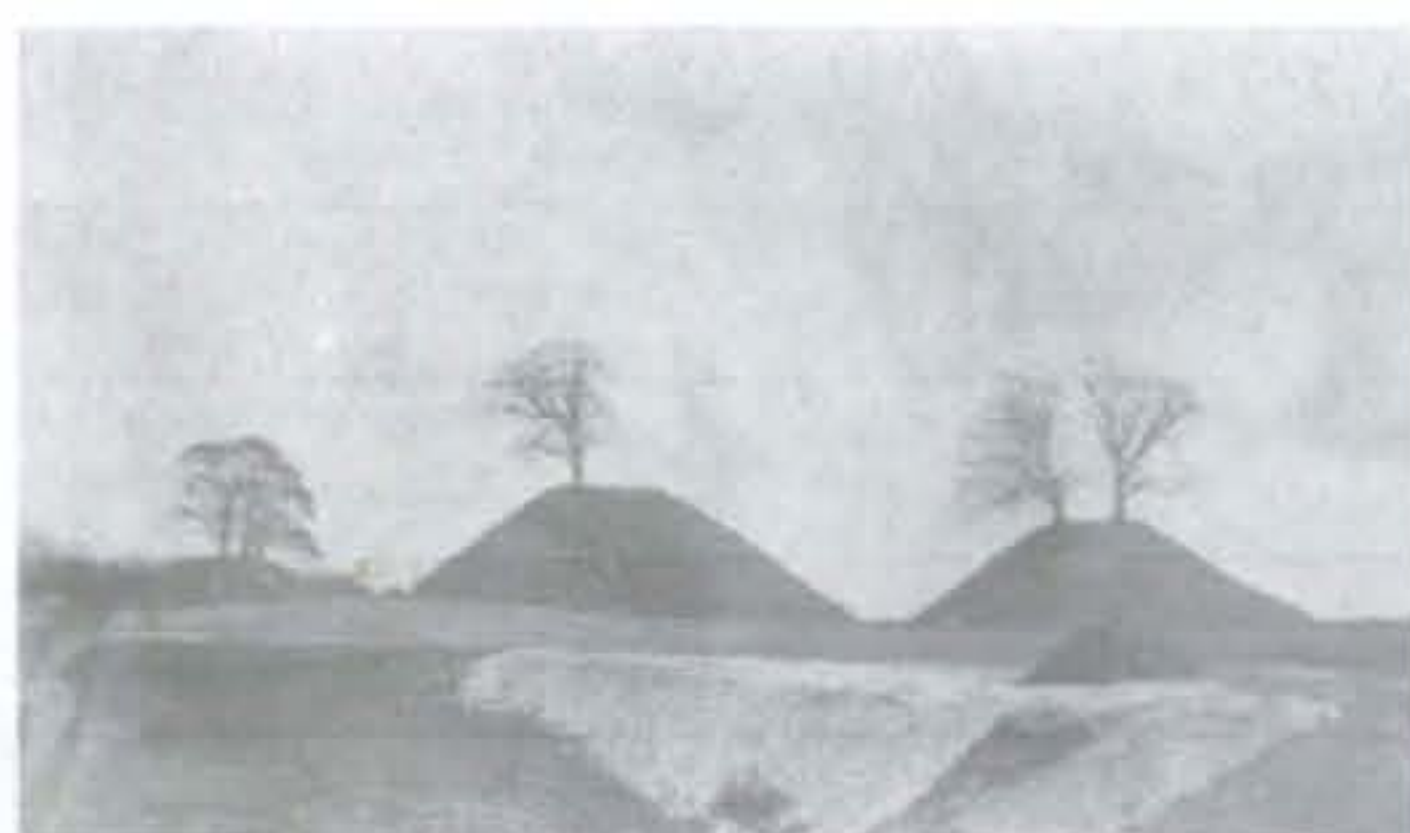
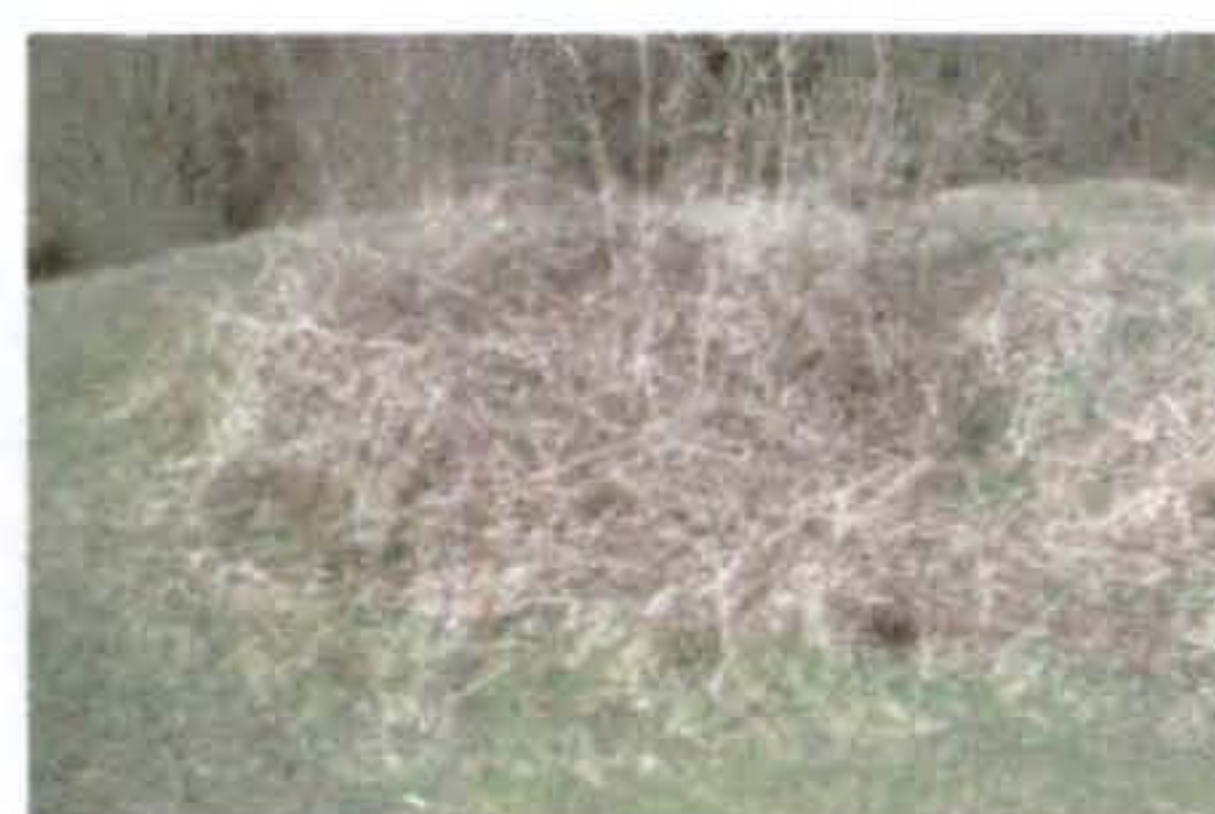
Fig. 9 a: View of the Bartlow Hills in 1904, with prominent trees on top (Camb. Coll. Y Bartl.K4) and (b) view of depression on top of Barrow IV.

In his explorations, Gage appears to have excavated the larger mounds by either digging horizontal tunnels (e.g. Barrow IV) or digging down from the top (e.g. Barrow VI). There is also some later archaeological activity which is largely unrecorded such as Brocklebank's 12ft deep section cut through Barrow VII after a hollow appeared at its top (VCH Essex 1963, 43). All the large mounds have significant depressions at the top and these may have been created by the removal of large trees that were growing on top of the three southern large mounds in the 19th and early 20th century (fig. 9 a & b; cf. figs. 3 & 4).

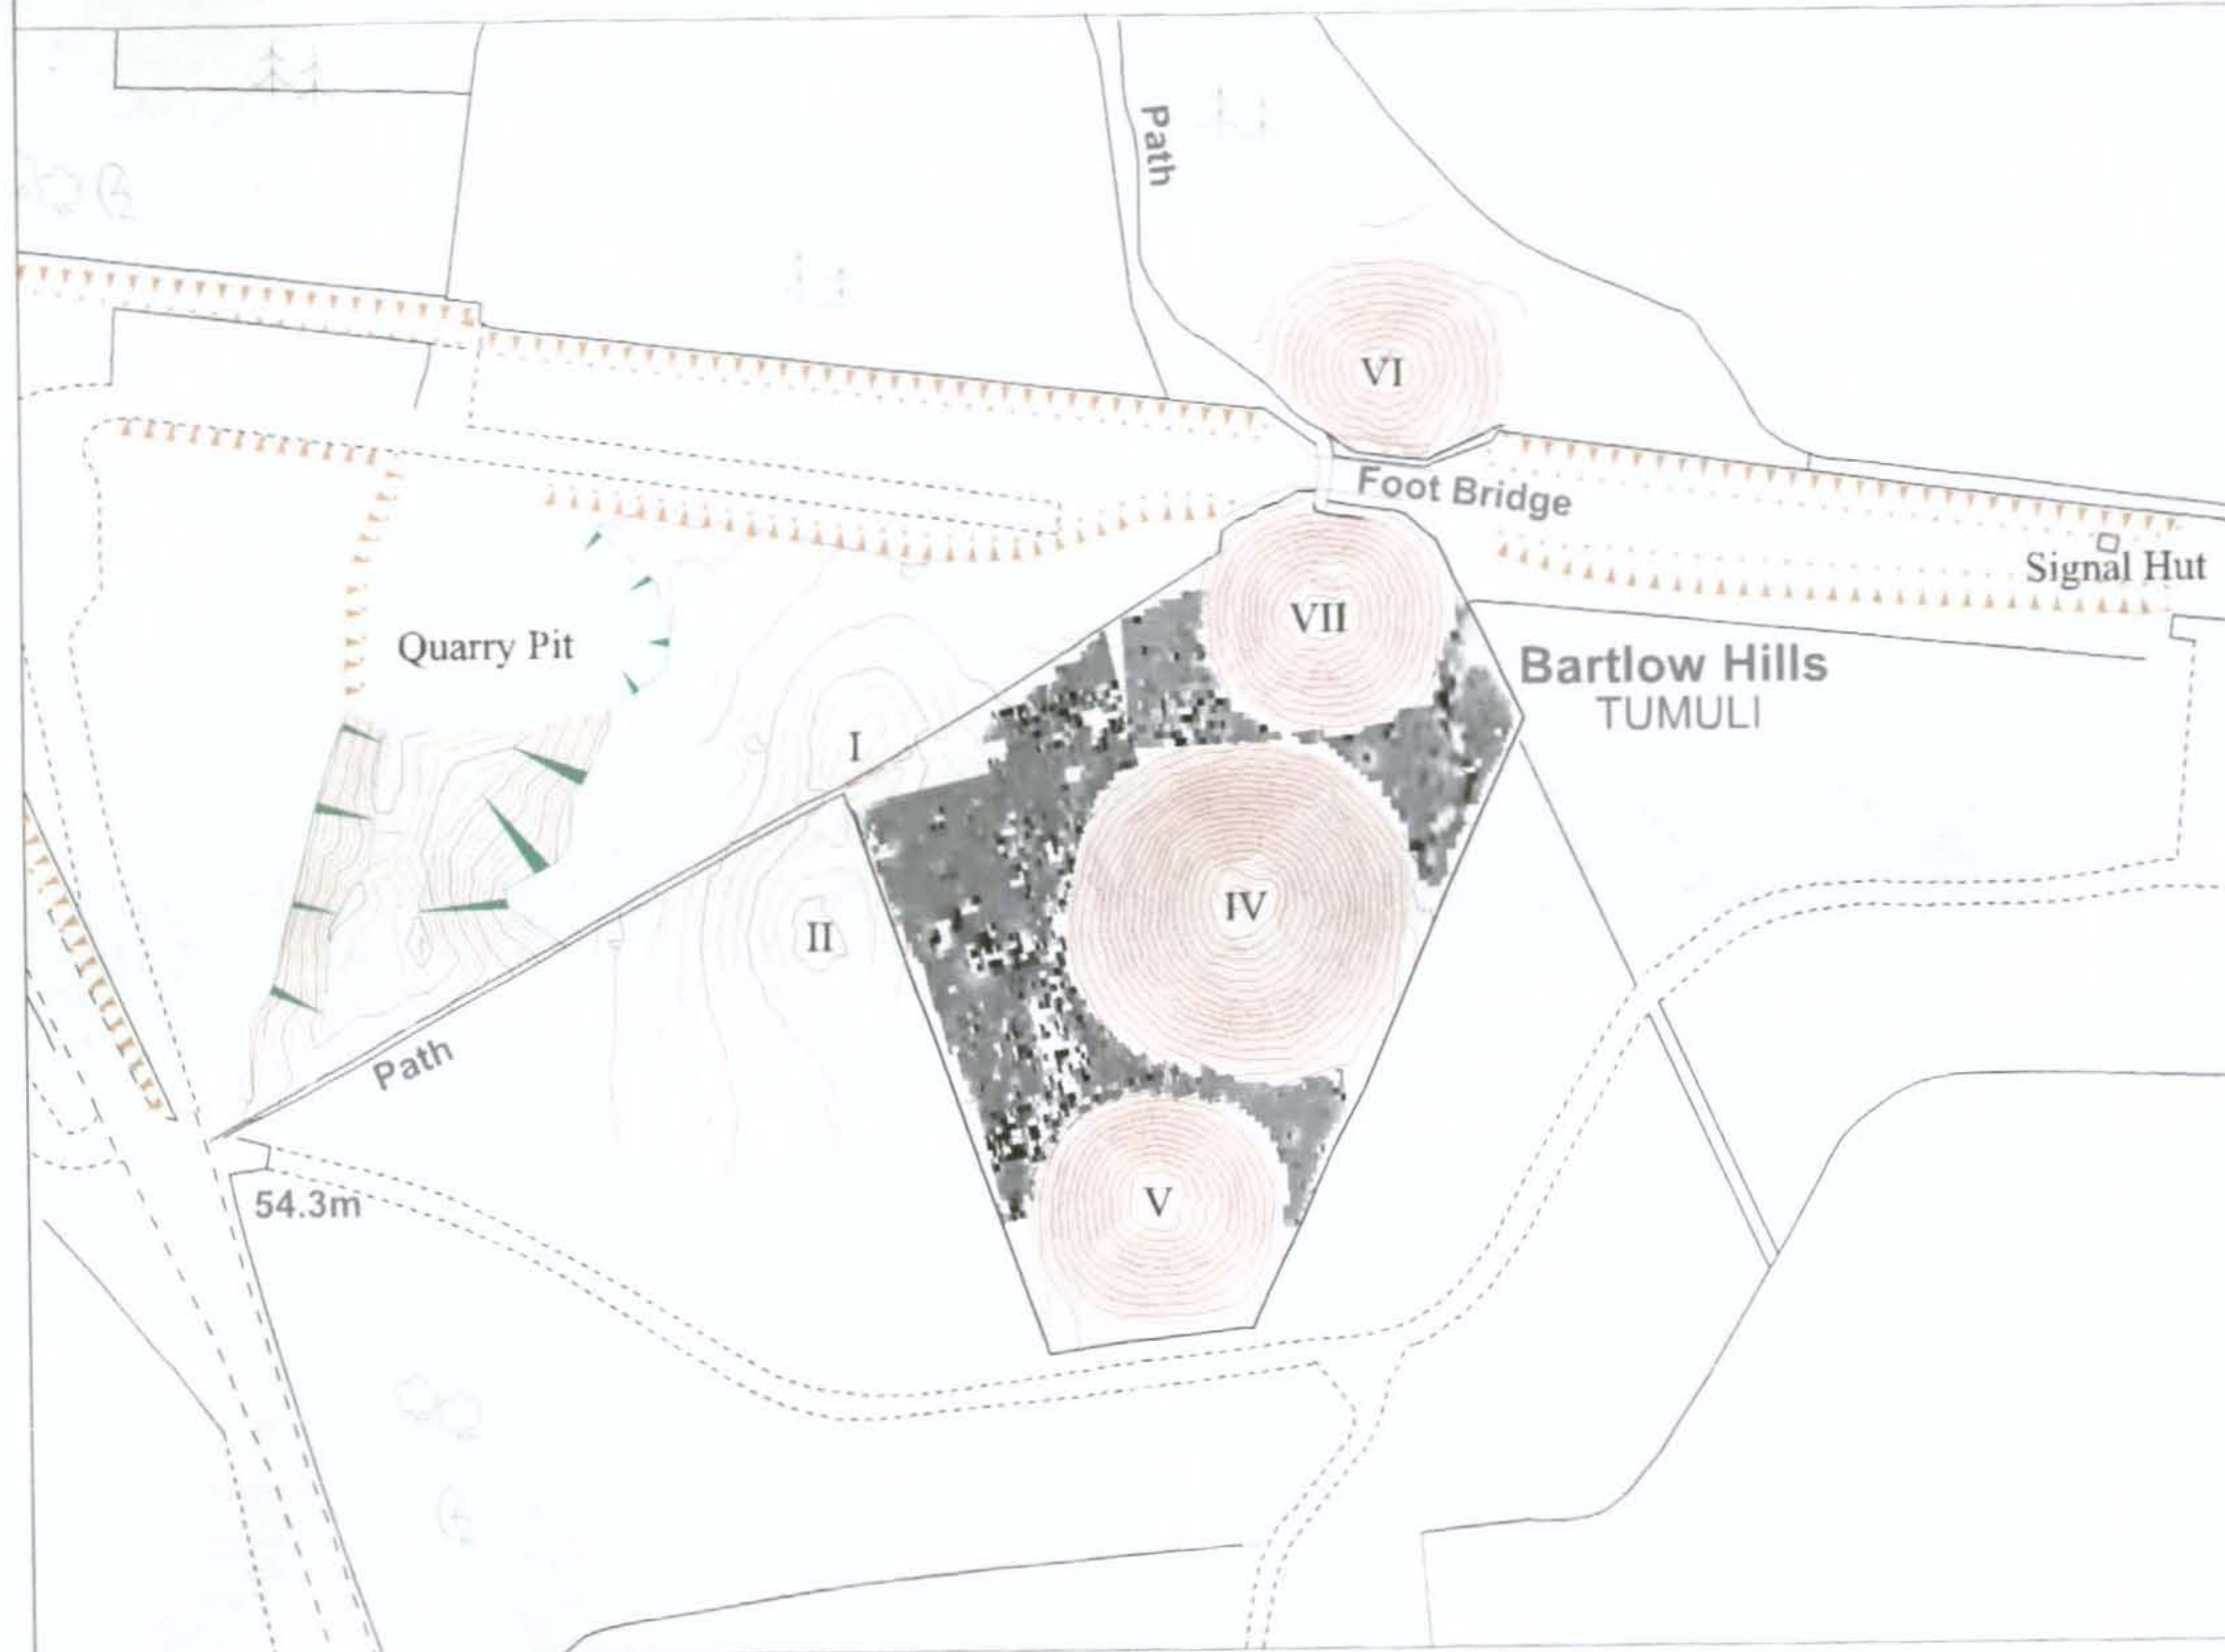
Greyscale image of the
magnetometer survey results.
Measurements taken at 0.5 x 1m

Dominating the magnetometer survey results (fig. 13) are curvilinear positive anomalies (m1 & m2); these features probably trace the lines of earlier footpaths and fences. By contrast, the possibly rectangular anomalies m3, m4 and m5 may represent archaeological features.

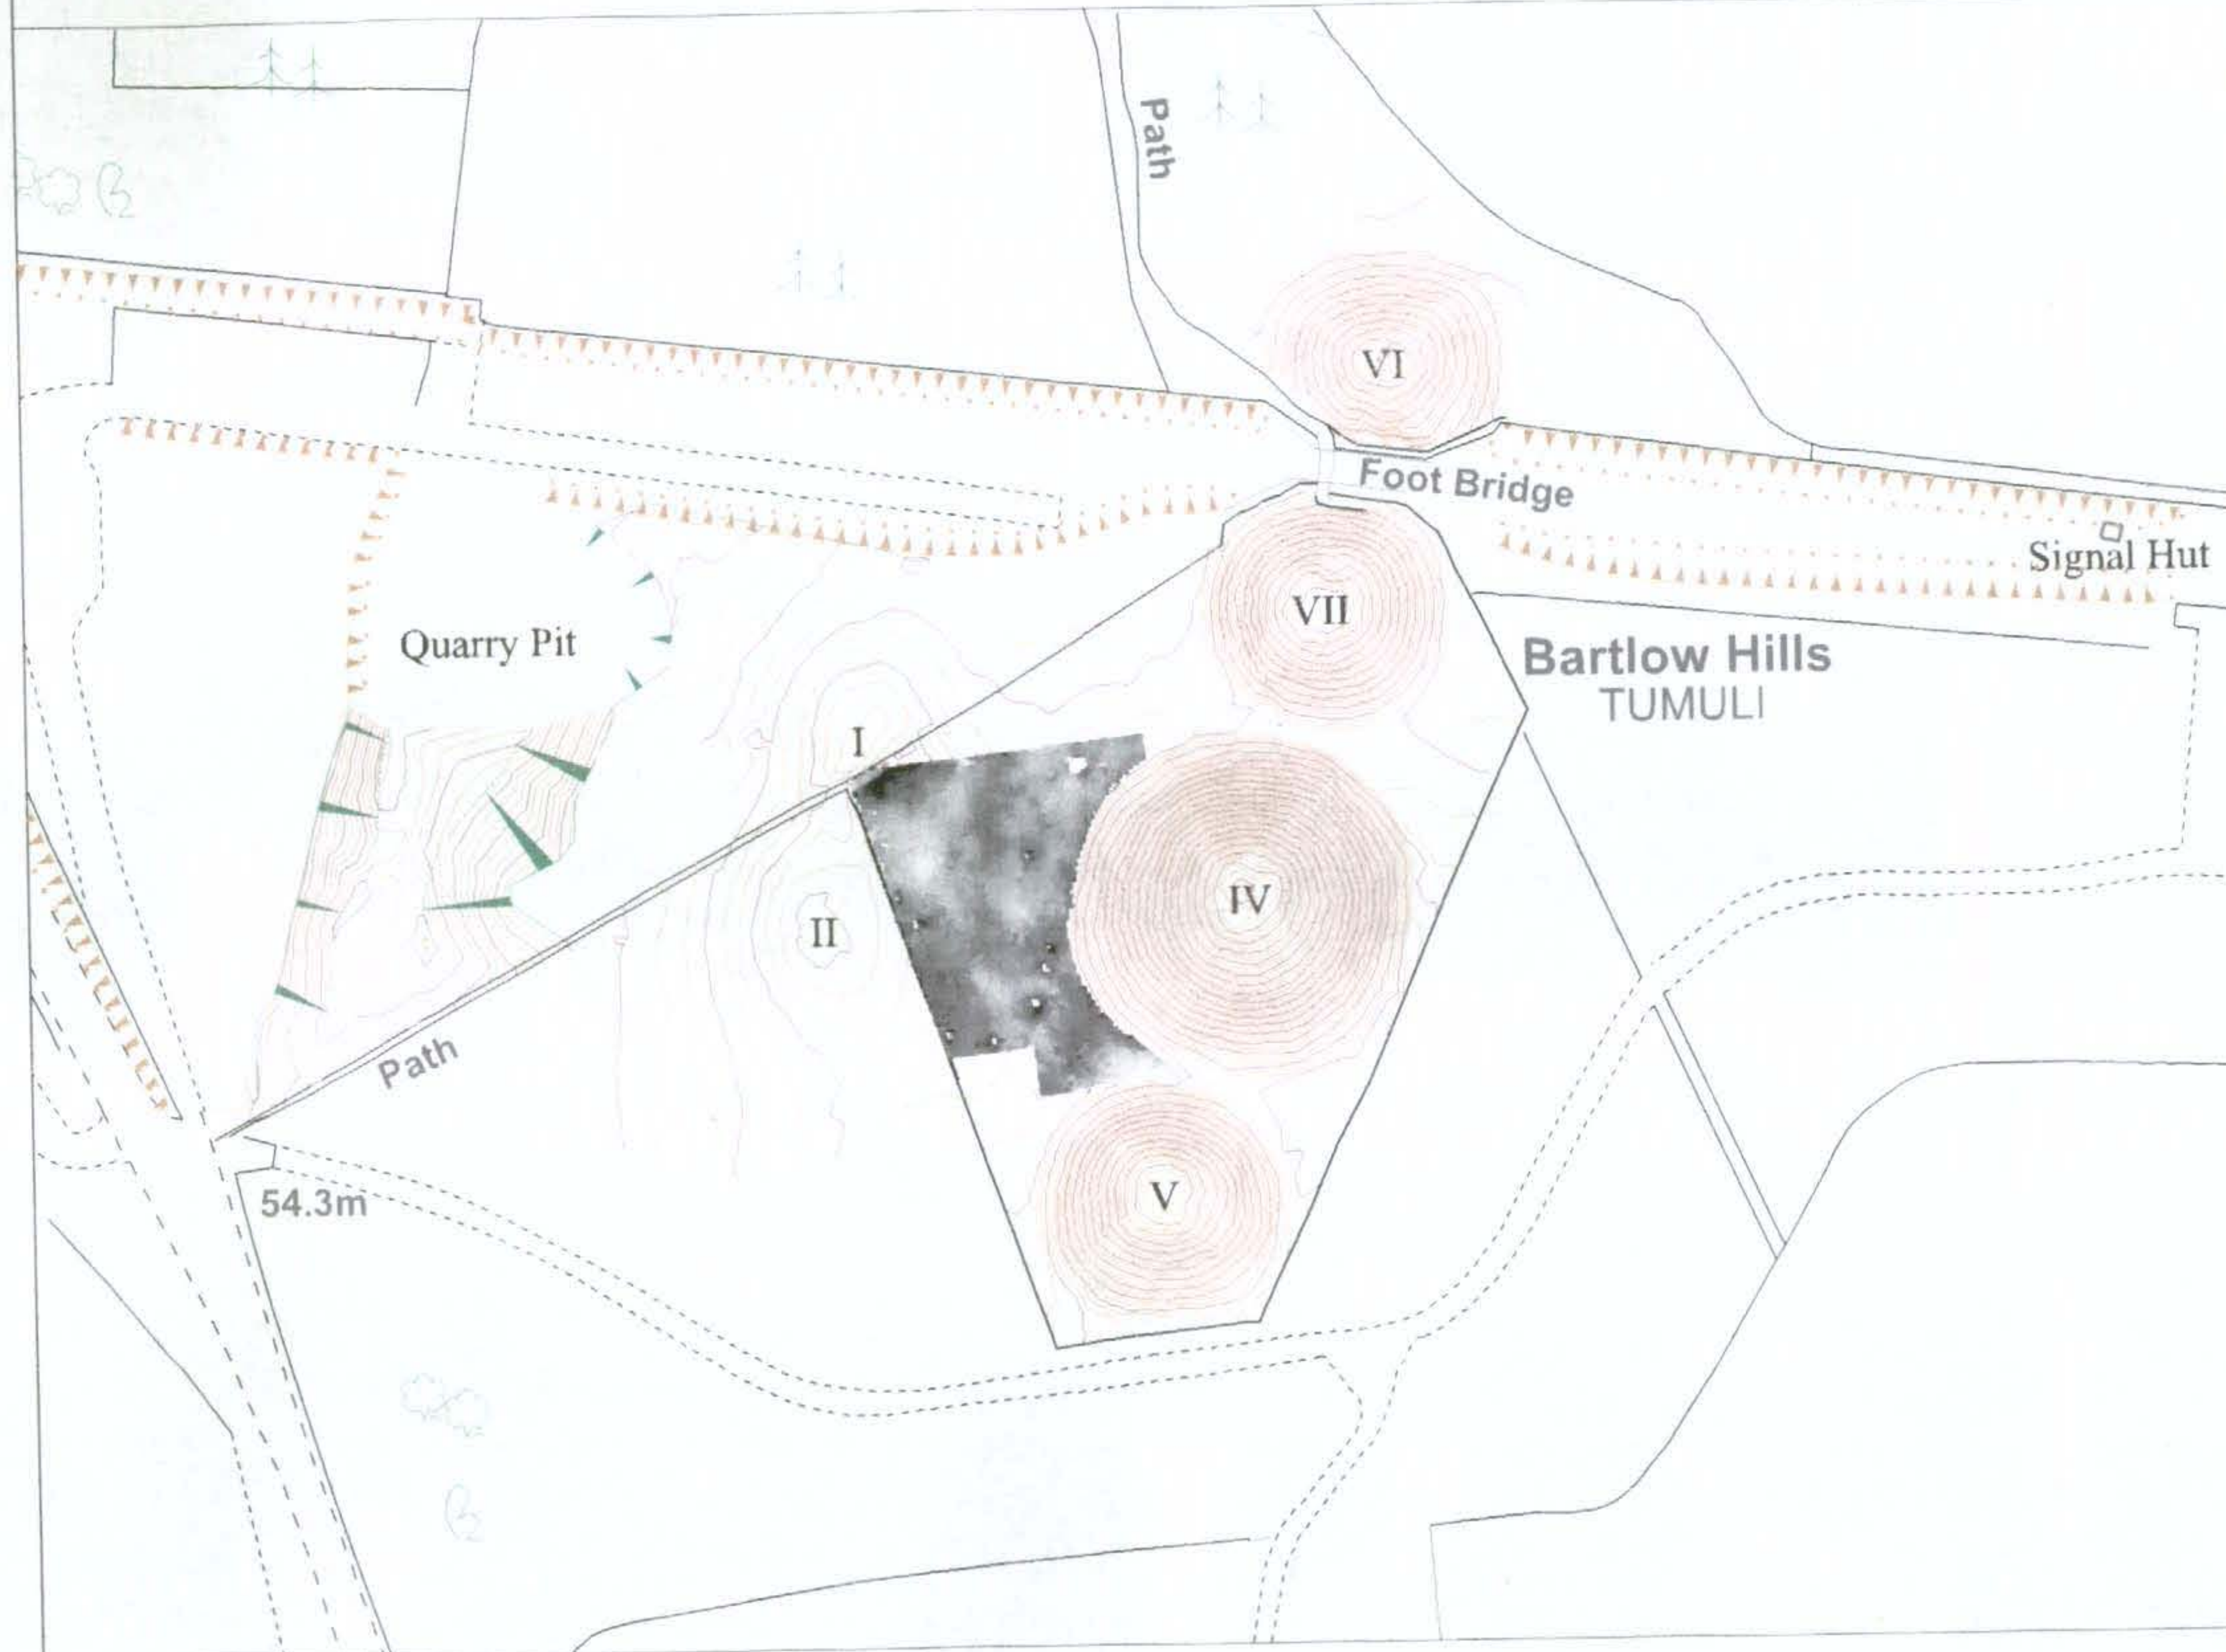
Greyscale image of the
resistivity survey results.
Measurements taken at 0.5 x 0.5m

The resistivity survey was targeted on the most promising areas identified by the magnetometer survey (fig. 15 a-b; fig. 16).

The Resistivity survey reiterated the results of the magnetometer survey; again the anomalies are not well defined and modern disturbance has been identified (r1).

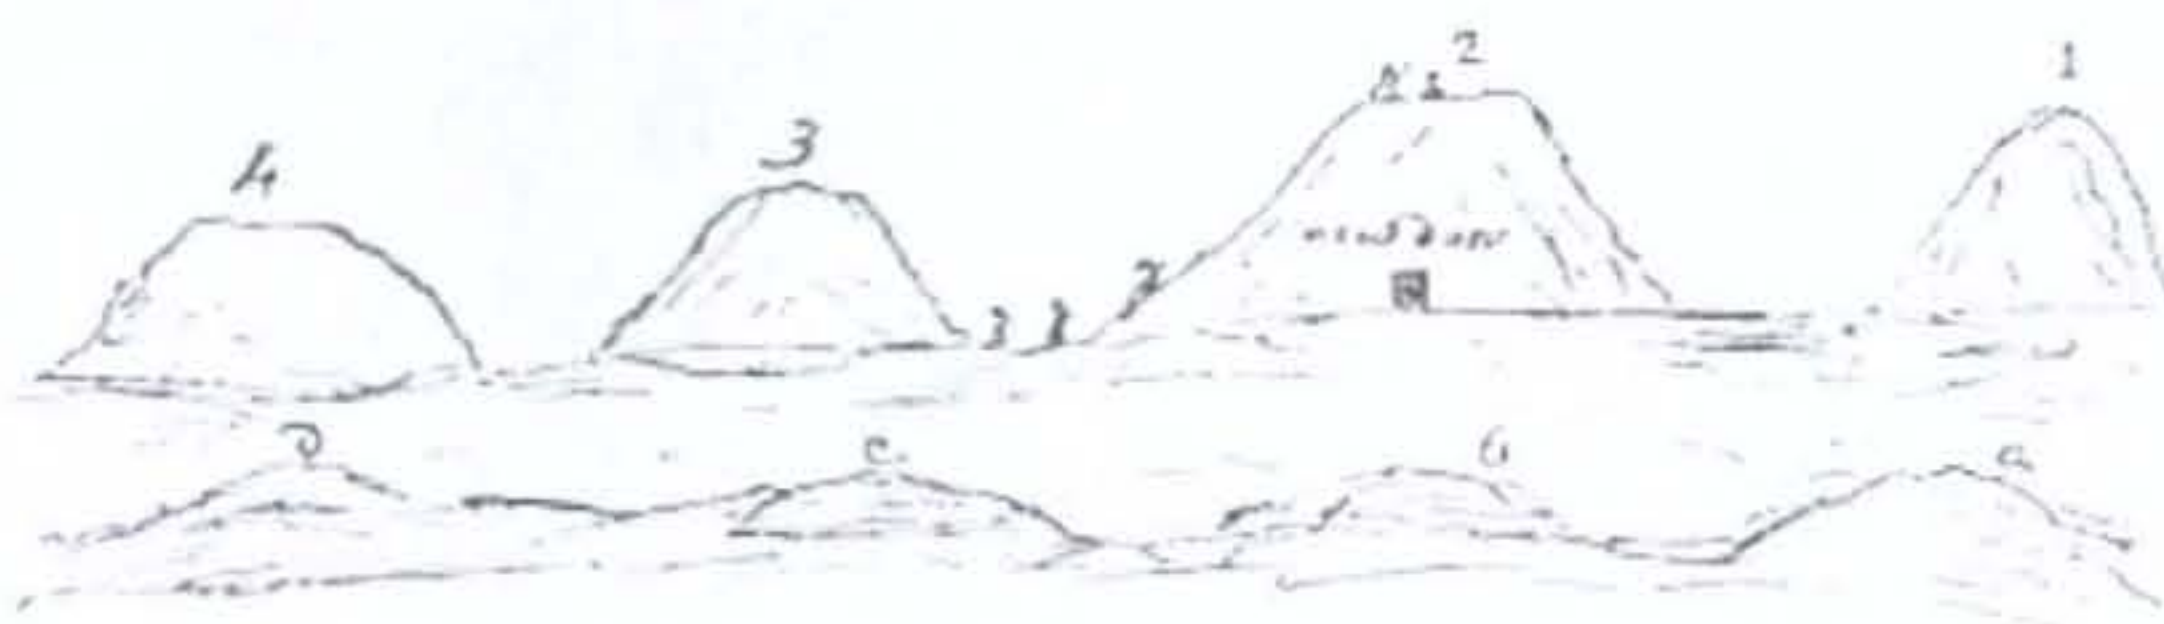
Fig. 23: Sketch by The Rev. A. Sedgwick (who was present at the opening of Barrow IV) of the tunnel door. After: Clark & McKenny Hughes 1890, p. 11).

While some shoring appears to have been necessary near the entrance, none was used for the bulk of the tunnel as the mound was found to be of “the firmest consistency” and made up of horizontal layers of earth and chalk, varying in depth from a few inches to a foot or more (Gage 1836, 301). The labourers hit onto a cavity on the tenth day of excavation but the tunnel was locked until the next day, when the landowner and a group of local dignitaries arrived to witness the discovery. Perhaps the most famous of these visitors was the Reverend Adam Sedgwick who sent a letter with an account of his visit to his nephew in April 1840 (Clark & McKenny Hughes 1890, 9-13). Sedgwick (*ibid.*, 11) suggests that he “cannot draw half so well as a pig’s foot, which can make its own likeness in mud and clay” but nevertheless includes a sketch drawing which clearly shows the presence of the door at the base of the largest barrow (fig. 23).

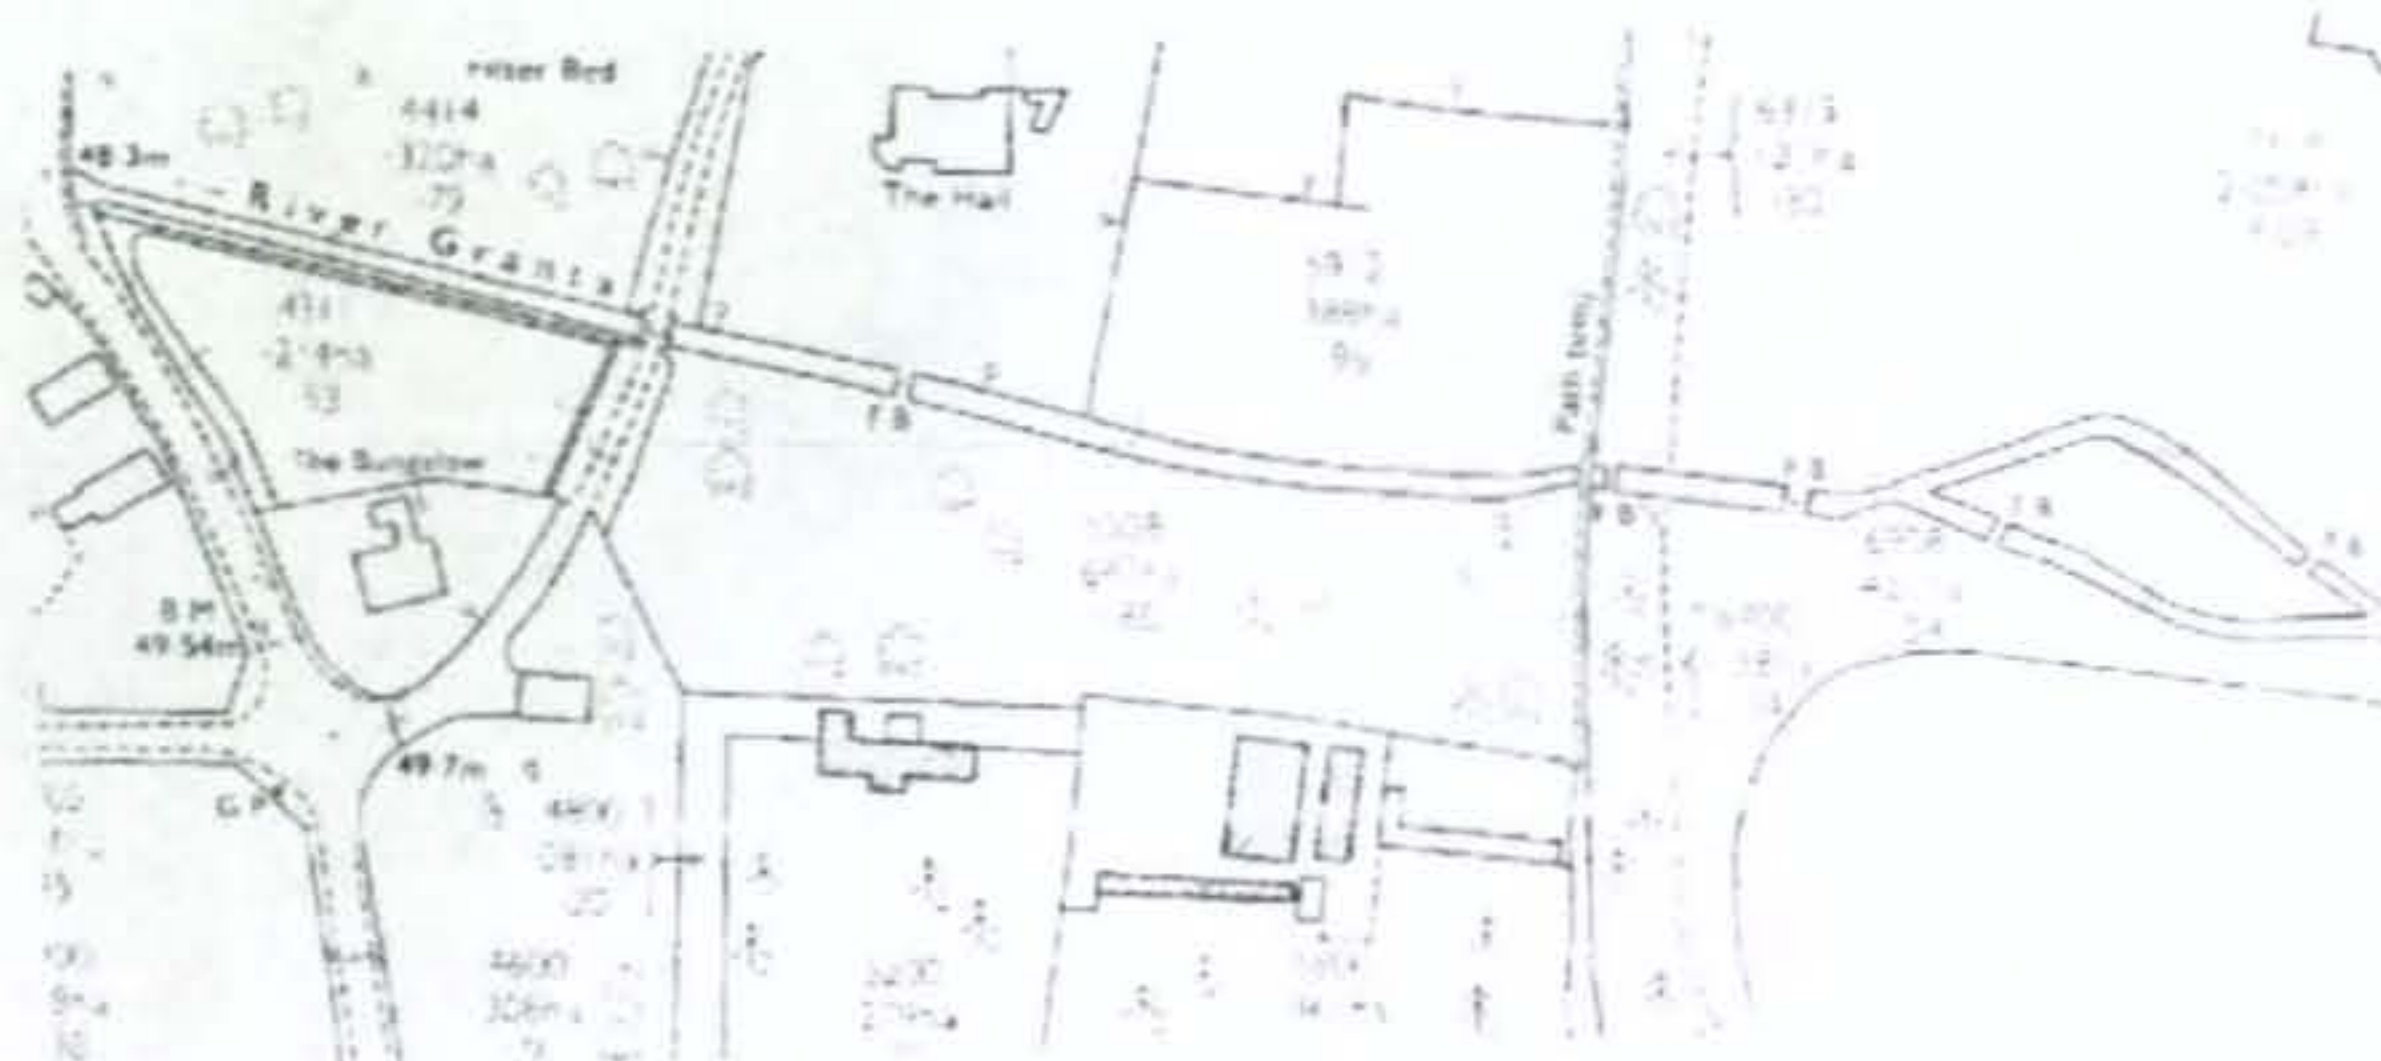
Fig. 29: The linear earthwork to the west of the Bartlow Hills: it is visible on the O.S. map of 1877 but by 1903 a gravel pit had been excavated over its western end; by 1978 a new road and bungalow were constructed.

By 1903, a large gravel pit has been cut immediately adjacent to the road. The northern end of this pit must have destroyed part of the earthwork, and it is here that the 5ft deep V-shaped ditch cut into the chalk was observed (VCH Essex 1963, 39, see above). Goddard (1899, 353) records that workers also found Roman pottery, bones and a millstone (now in Cambridge Museum) in the quarry pit.

Today, a small part of the earthwork is still visible in a lightly wooded area to the east of the Bungalow and just to the north of the walled gardens. It can be observed running for about 4 m on an east-west alignment. Where it meets the 'new' road running to the east of the Bungalow, there is a substantial mound but this is extremely unlikely to represent Gage's low barrow. Rather, it appears that that barrow and the most western part of the earthwork were completely destroyed by the quarry pit and the subsequent construction of the new road and the bungalow. The low mound at the side facing the new road may well be disturbance caused by the construction of a short access path, the boiler room once servicing the greenhouses in the walled gardens or its conversion into a garage (cf. fig. 29c).
