**NEW EXTENSION, 49 BLANDFORD ROAD,
HAMWORTHY, POOLE**
Archaeological Observations and Recording

Report No. 53169.1

December 2004

Archaeological Observations and Recording, Sept 2004

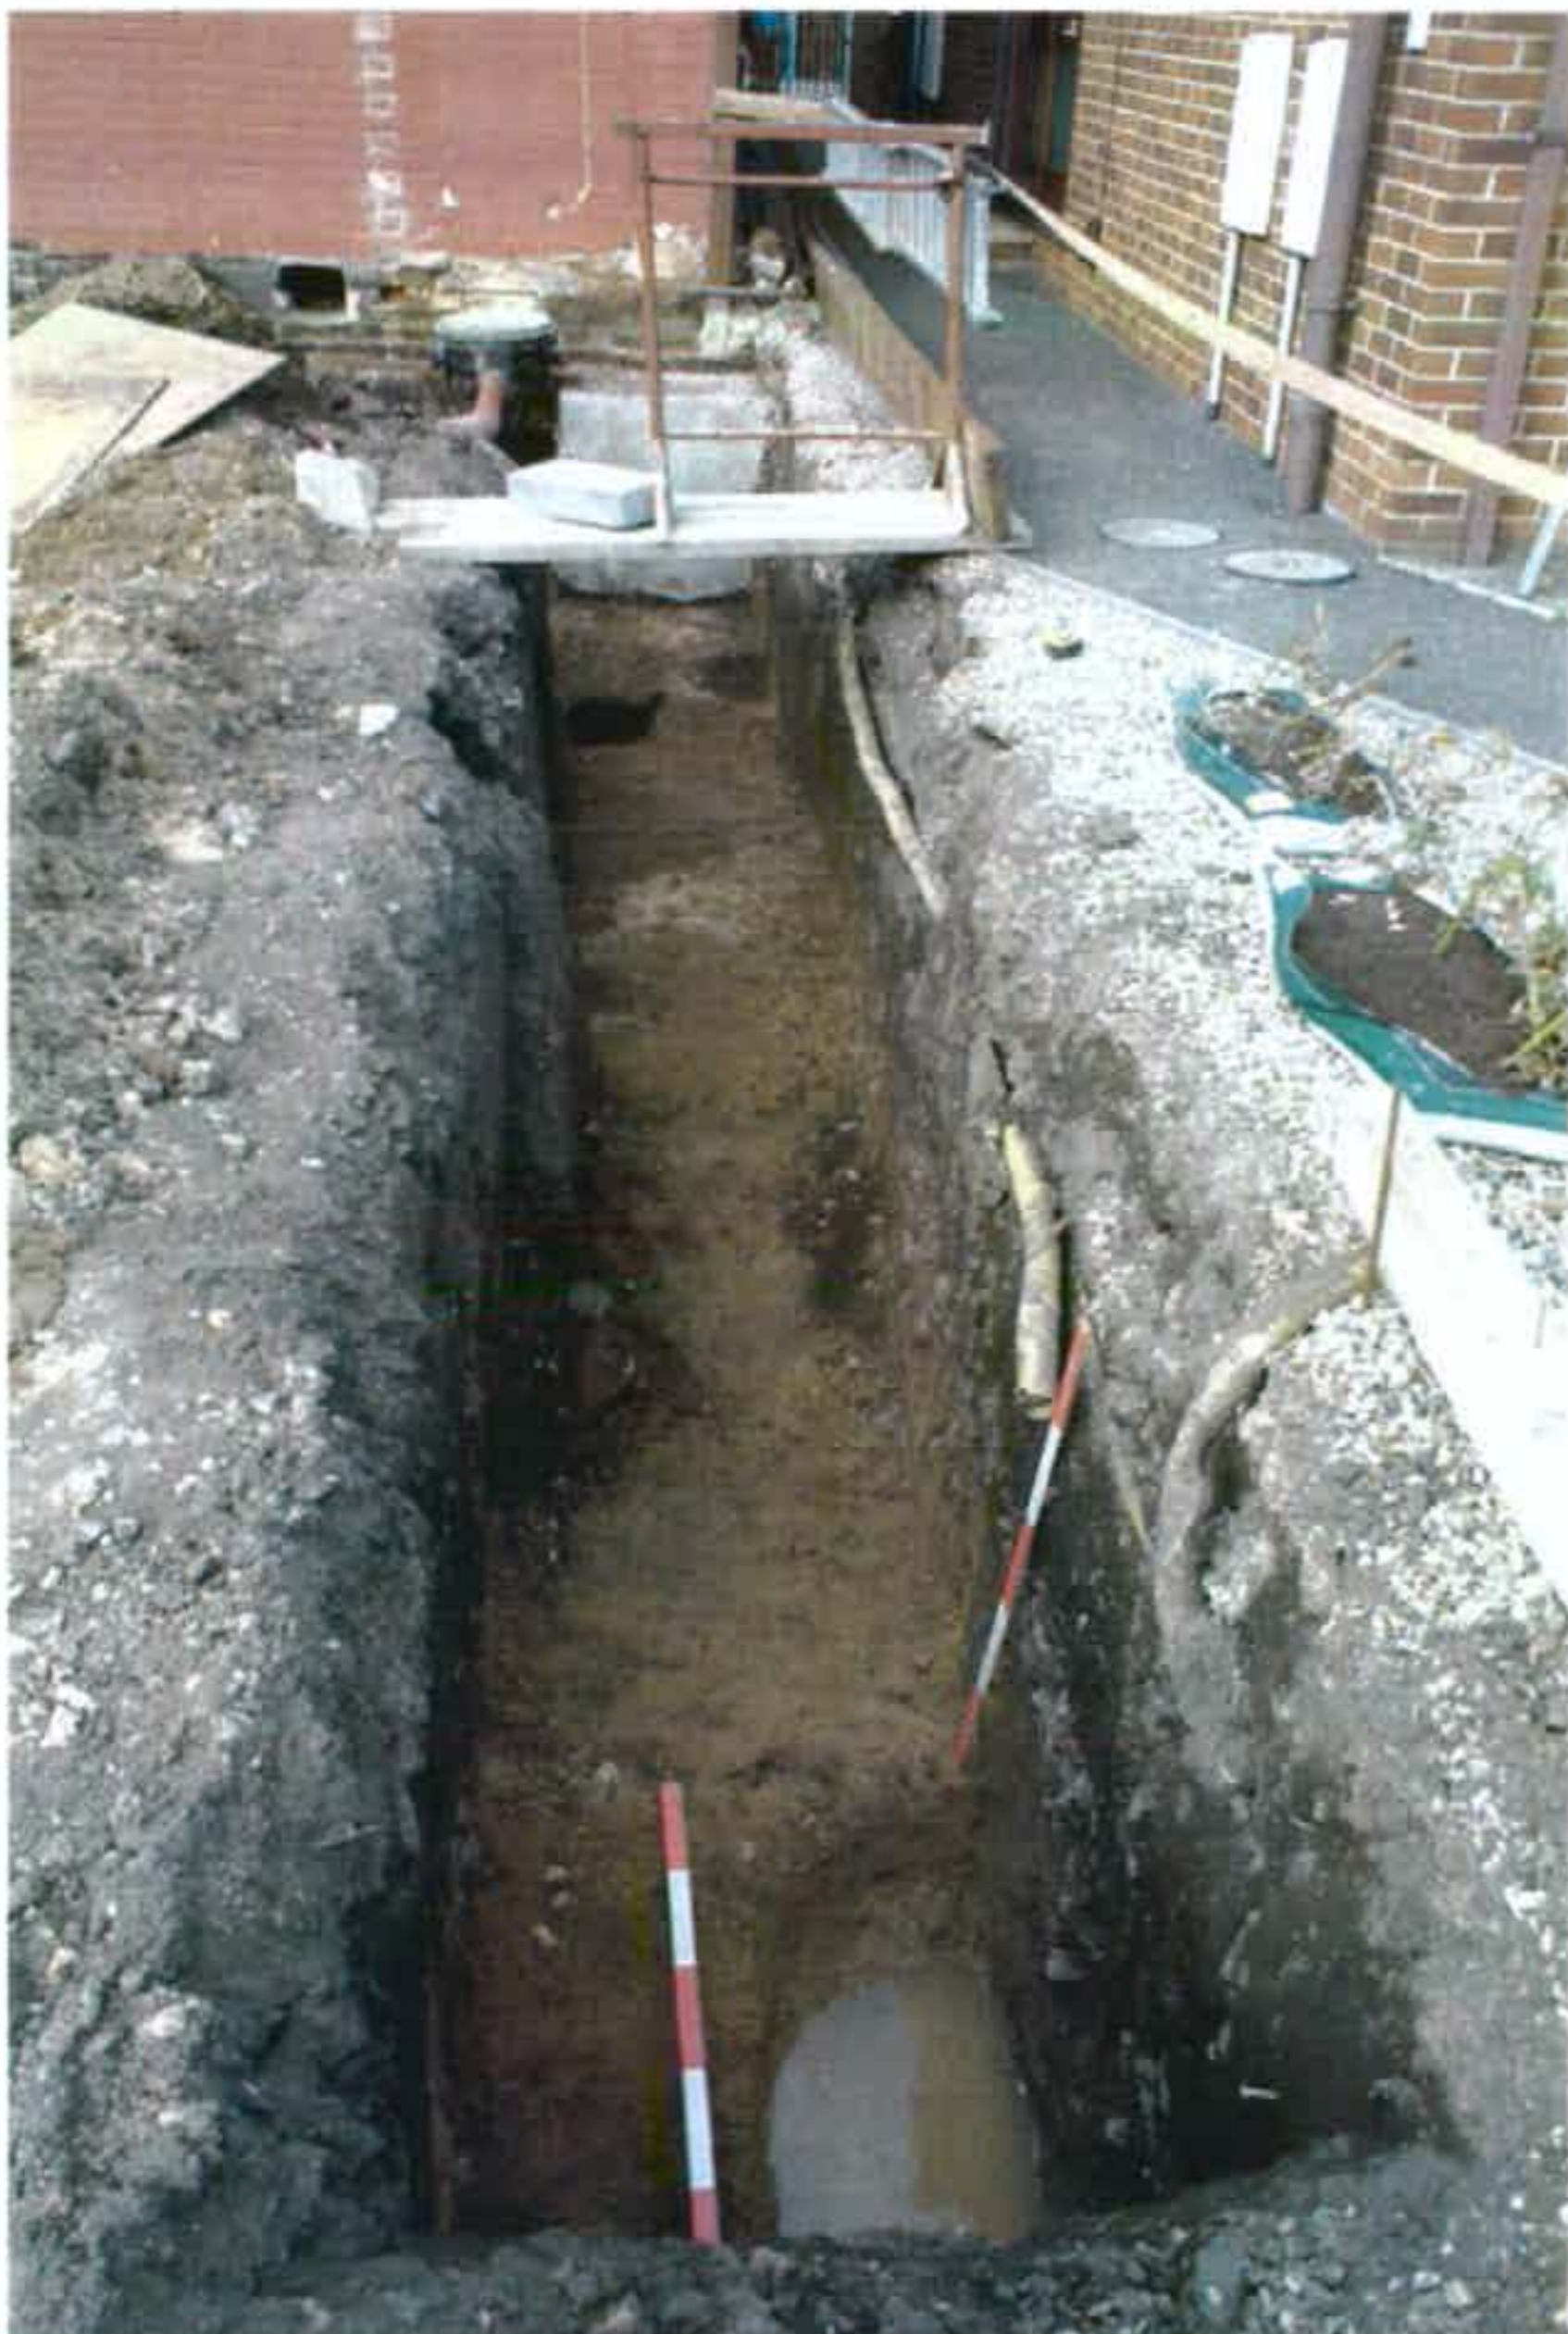
Plate 2: View along east footings trench with Pit 111 in foreground and Ditch 107 in background.

A single pit (111) was found in the southeast corner of the site (Figure 2, Plates 2 & 4). It was only partly within the footings trench, so its full size and shape were not exposed. It appeared to be subrectangular in shape with steeply sloping sides and a flat base and measured 1.2 m by over 0.5 m across and 0.8 m deep. It cut through soil layer 105 into the natural sand below (Figure 3). The upper part of the pit was removed by machine, but the lower 0.3 m was excavated by hand, though this was hampered by the rapid ingress of ground water.

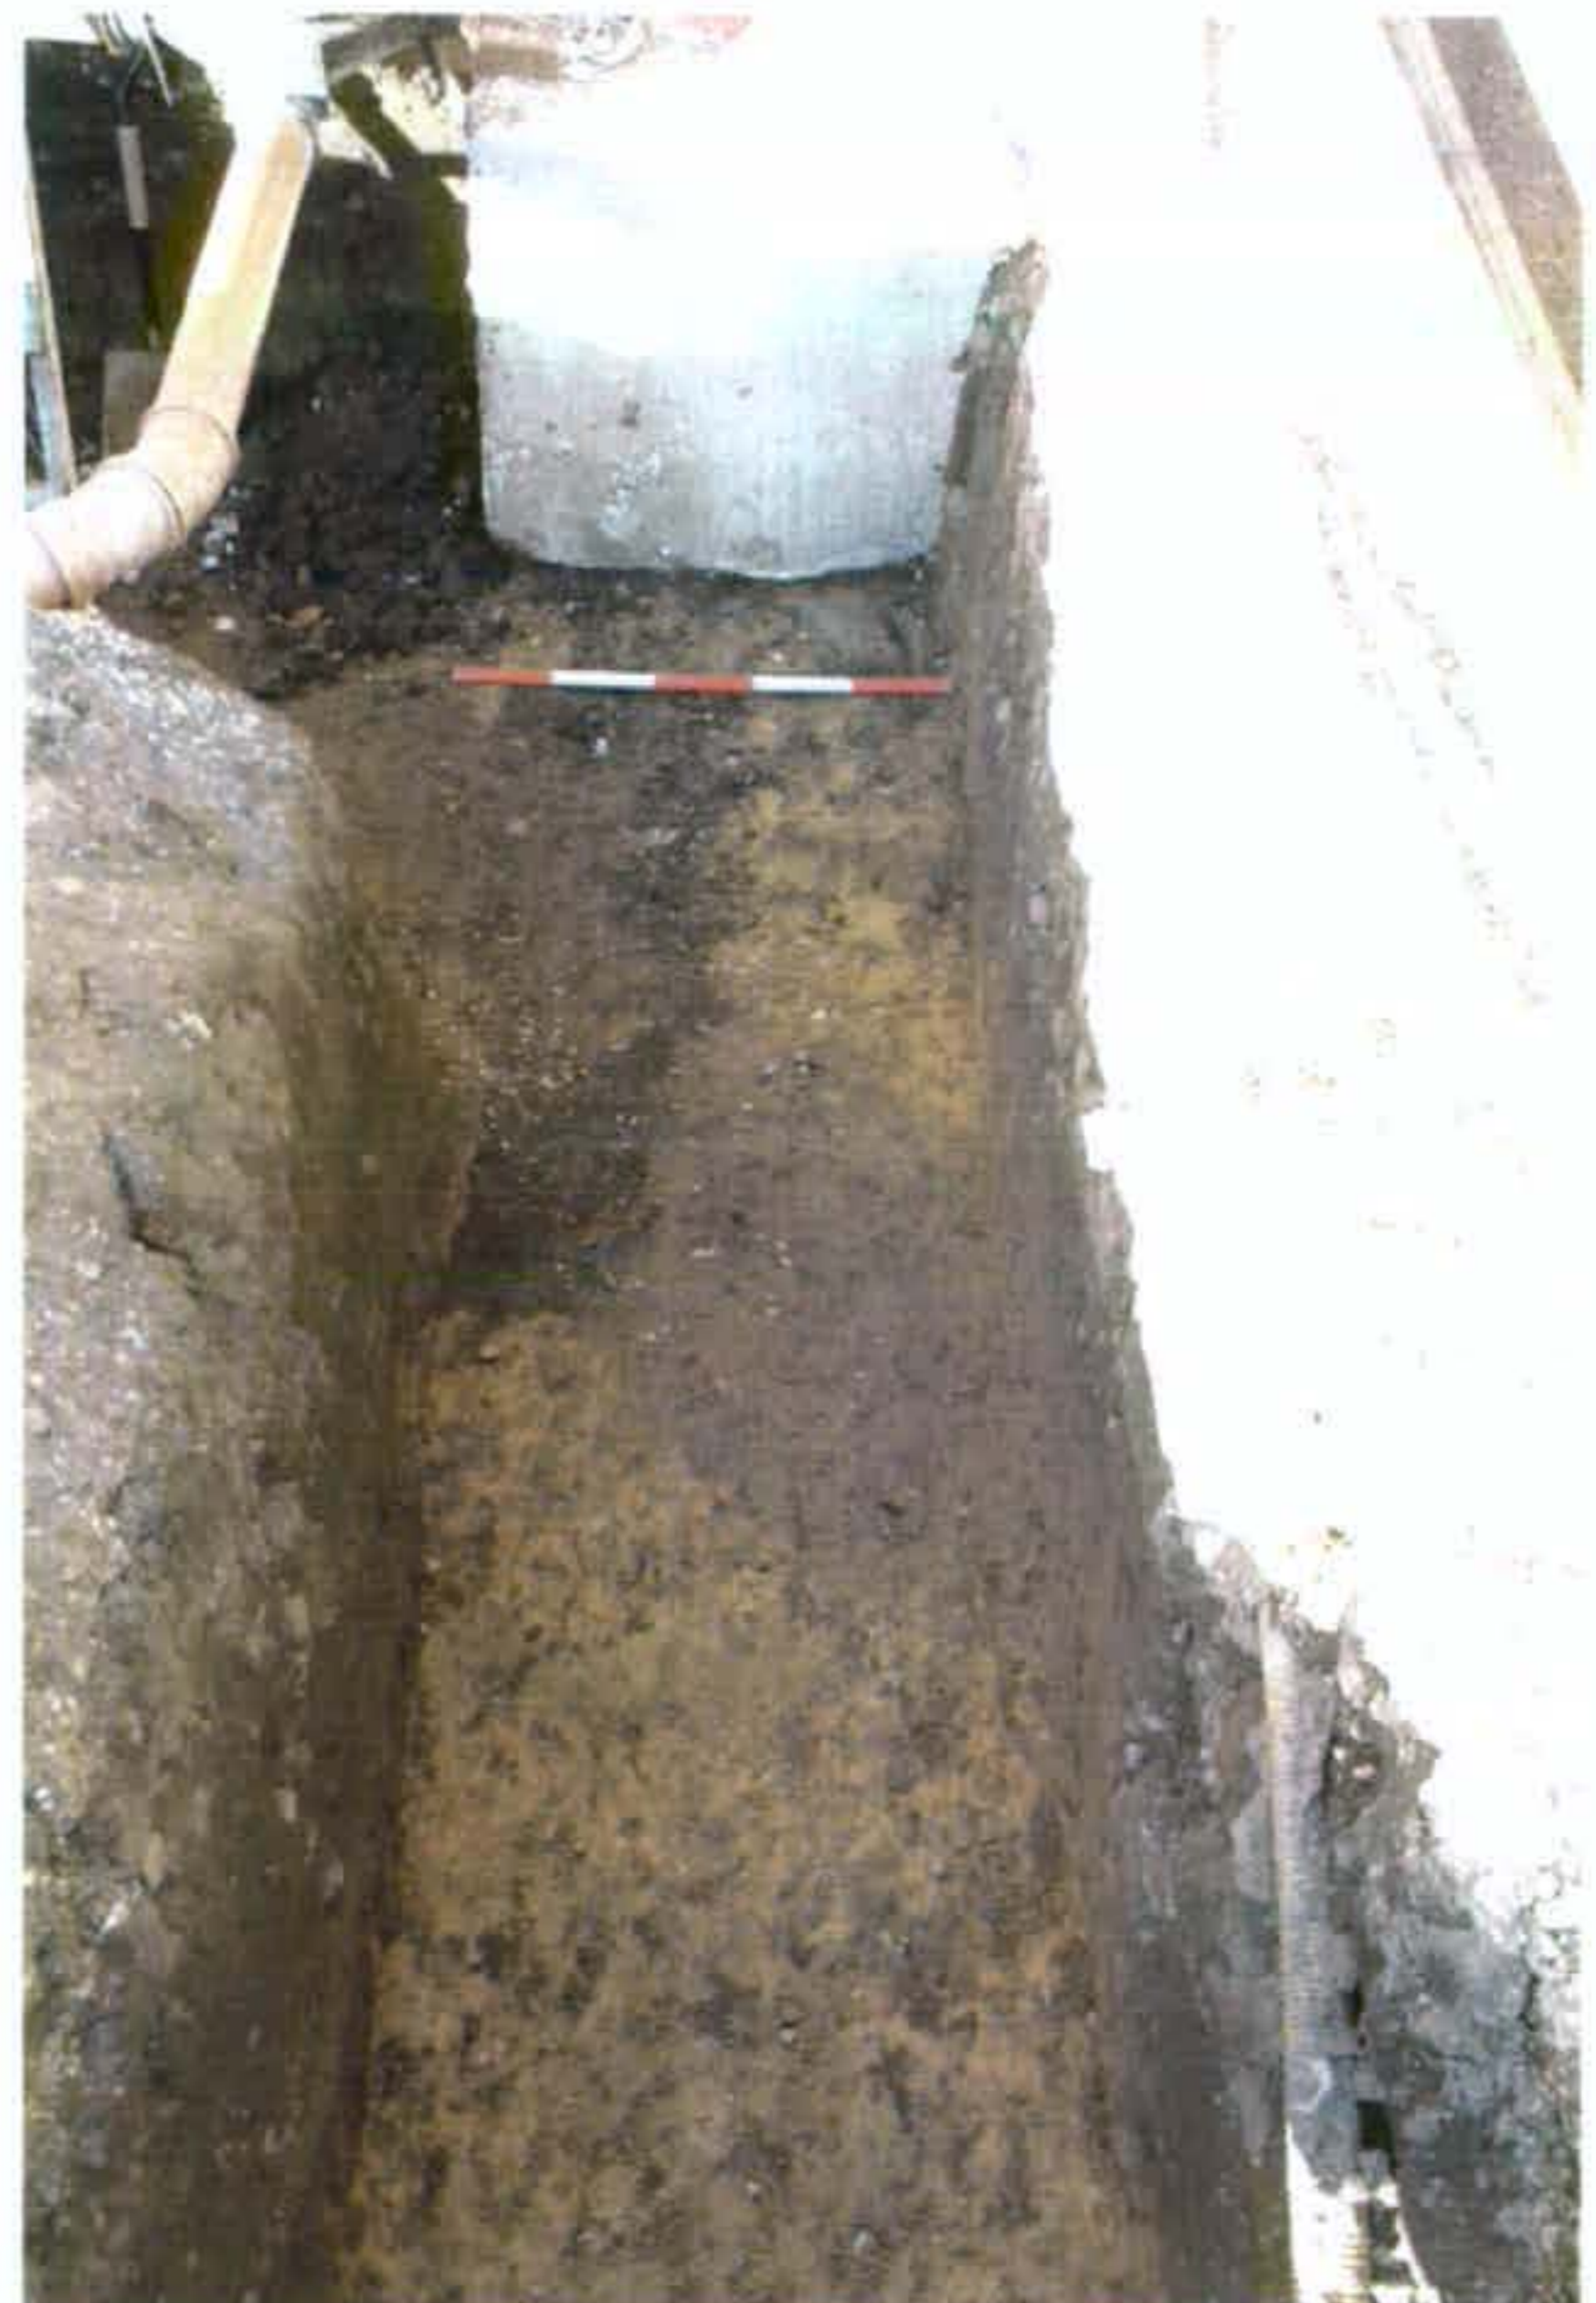
Plate 3: Ditch 107, looking north.

In the northeast corner of the site, the remains of a ditch (107) oriented roughly NNW–SSE was exposed cutting into the natural sands (Figure 2, Plate 3). This ditch may have also cut through the buried soil layer 105, but the similarity between the fill of this ditch layer 105 meant that this was not determined with certainty. It had shallow concave sides in the upper part and more steeply sloping sides towards the base. It measured about 1.5 m wide and 0.6 m deep. It was filled with yellowish-brown clayey sand (108) with occasional flint nodules and flint gravel and sparse charcoal flecks. A small quantity of 1st century AD pottery and briquetage was recovered from this ditch.

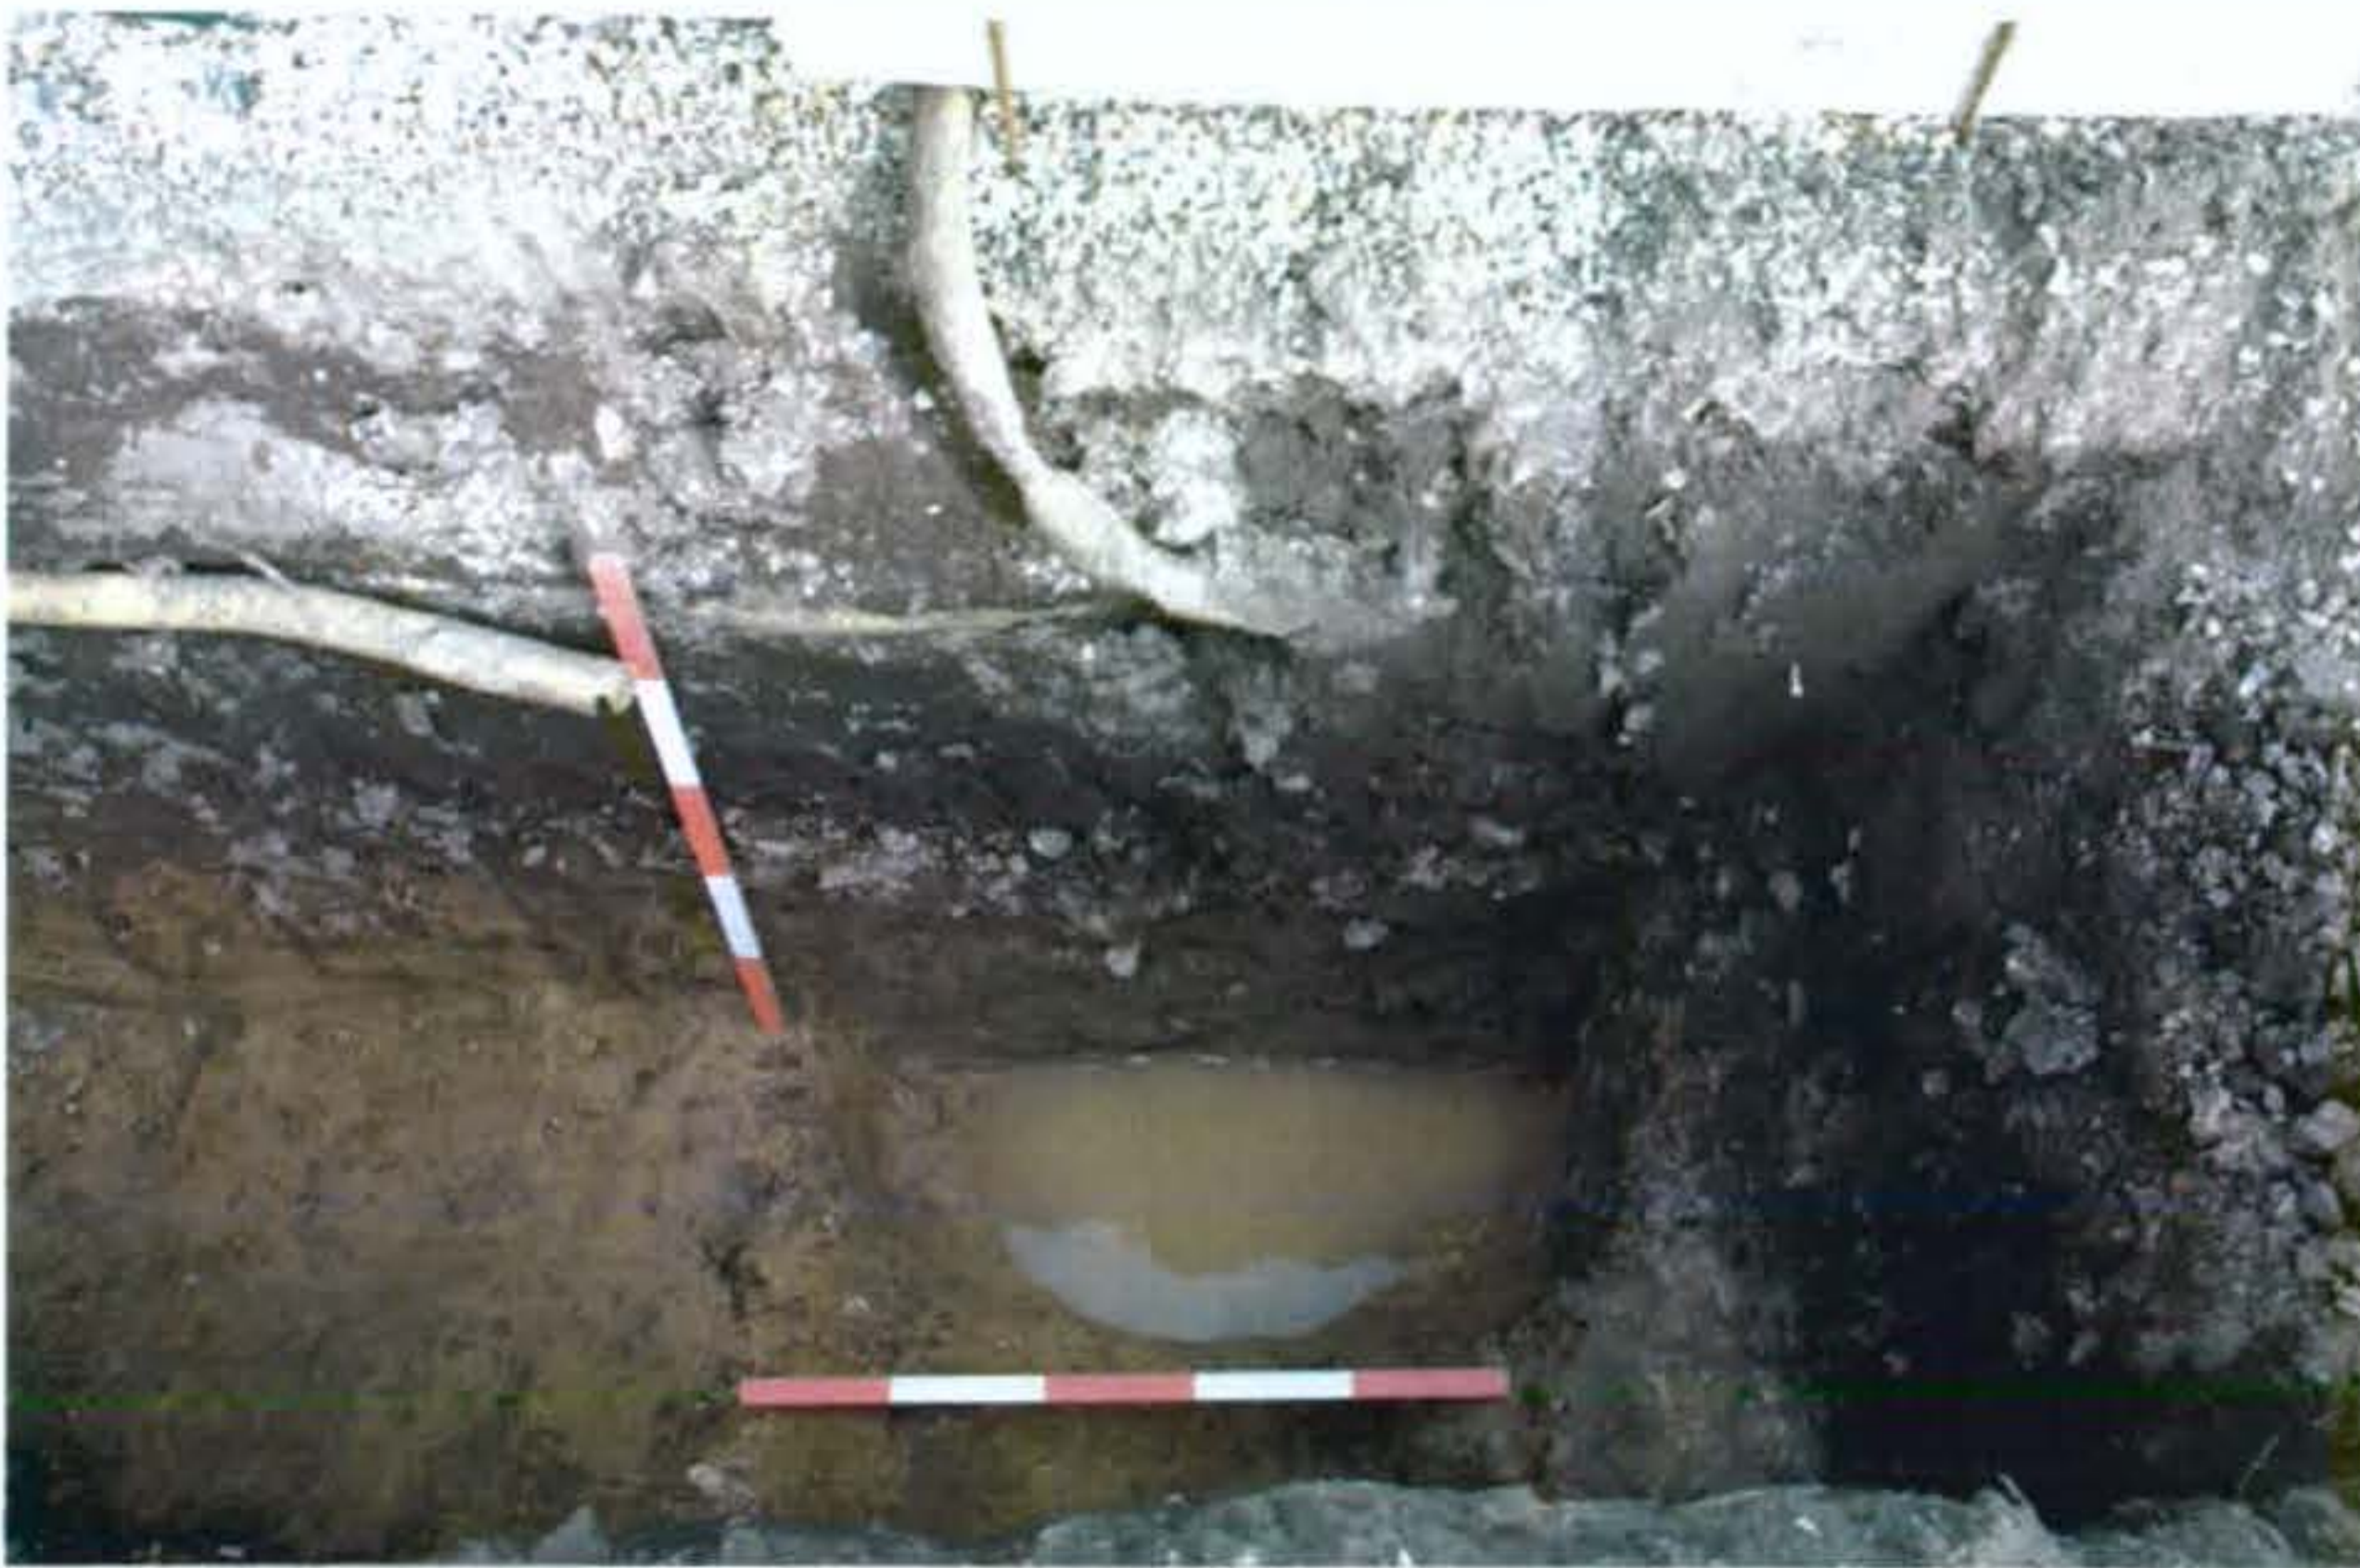
Plate 4: Pit 111 after excavation.

The pit was filled with light brownish-grey clayey sand (110) with moderate charcoal flecks and occasional flint gravel and a 0.2 m thick layer of compact brownish-grey sandy clay with frequent flint gravels (109) above. A small quantity of 1st Century pottery and briquetage was recovered from the lower part of the pit (Table 1). A fragment of limestone and a large lump of baked clay, similar to the clay from the salt boiling hearths found about 150 m to the southwest on the Shapwick Road site (Bellamy and Pearce 2001), were also found in this pit.

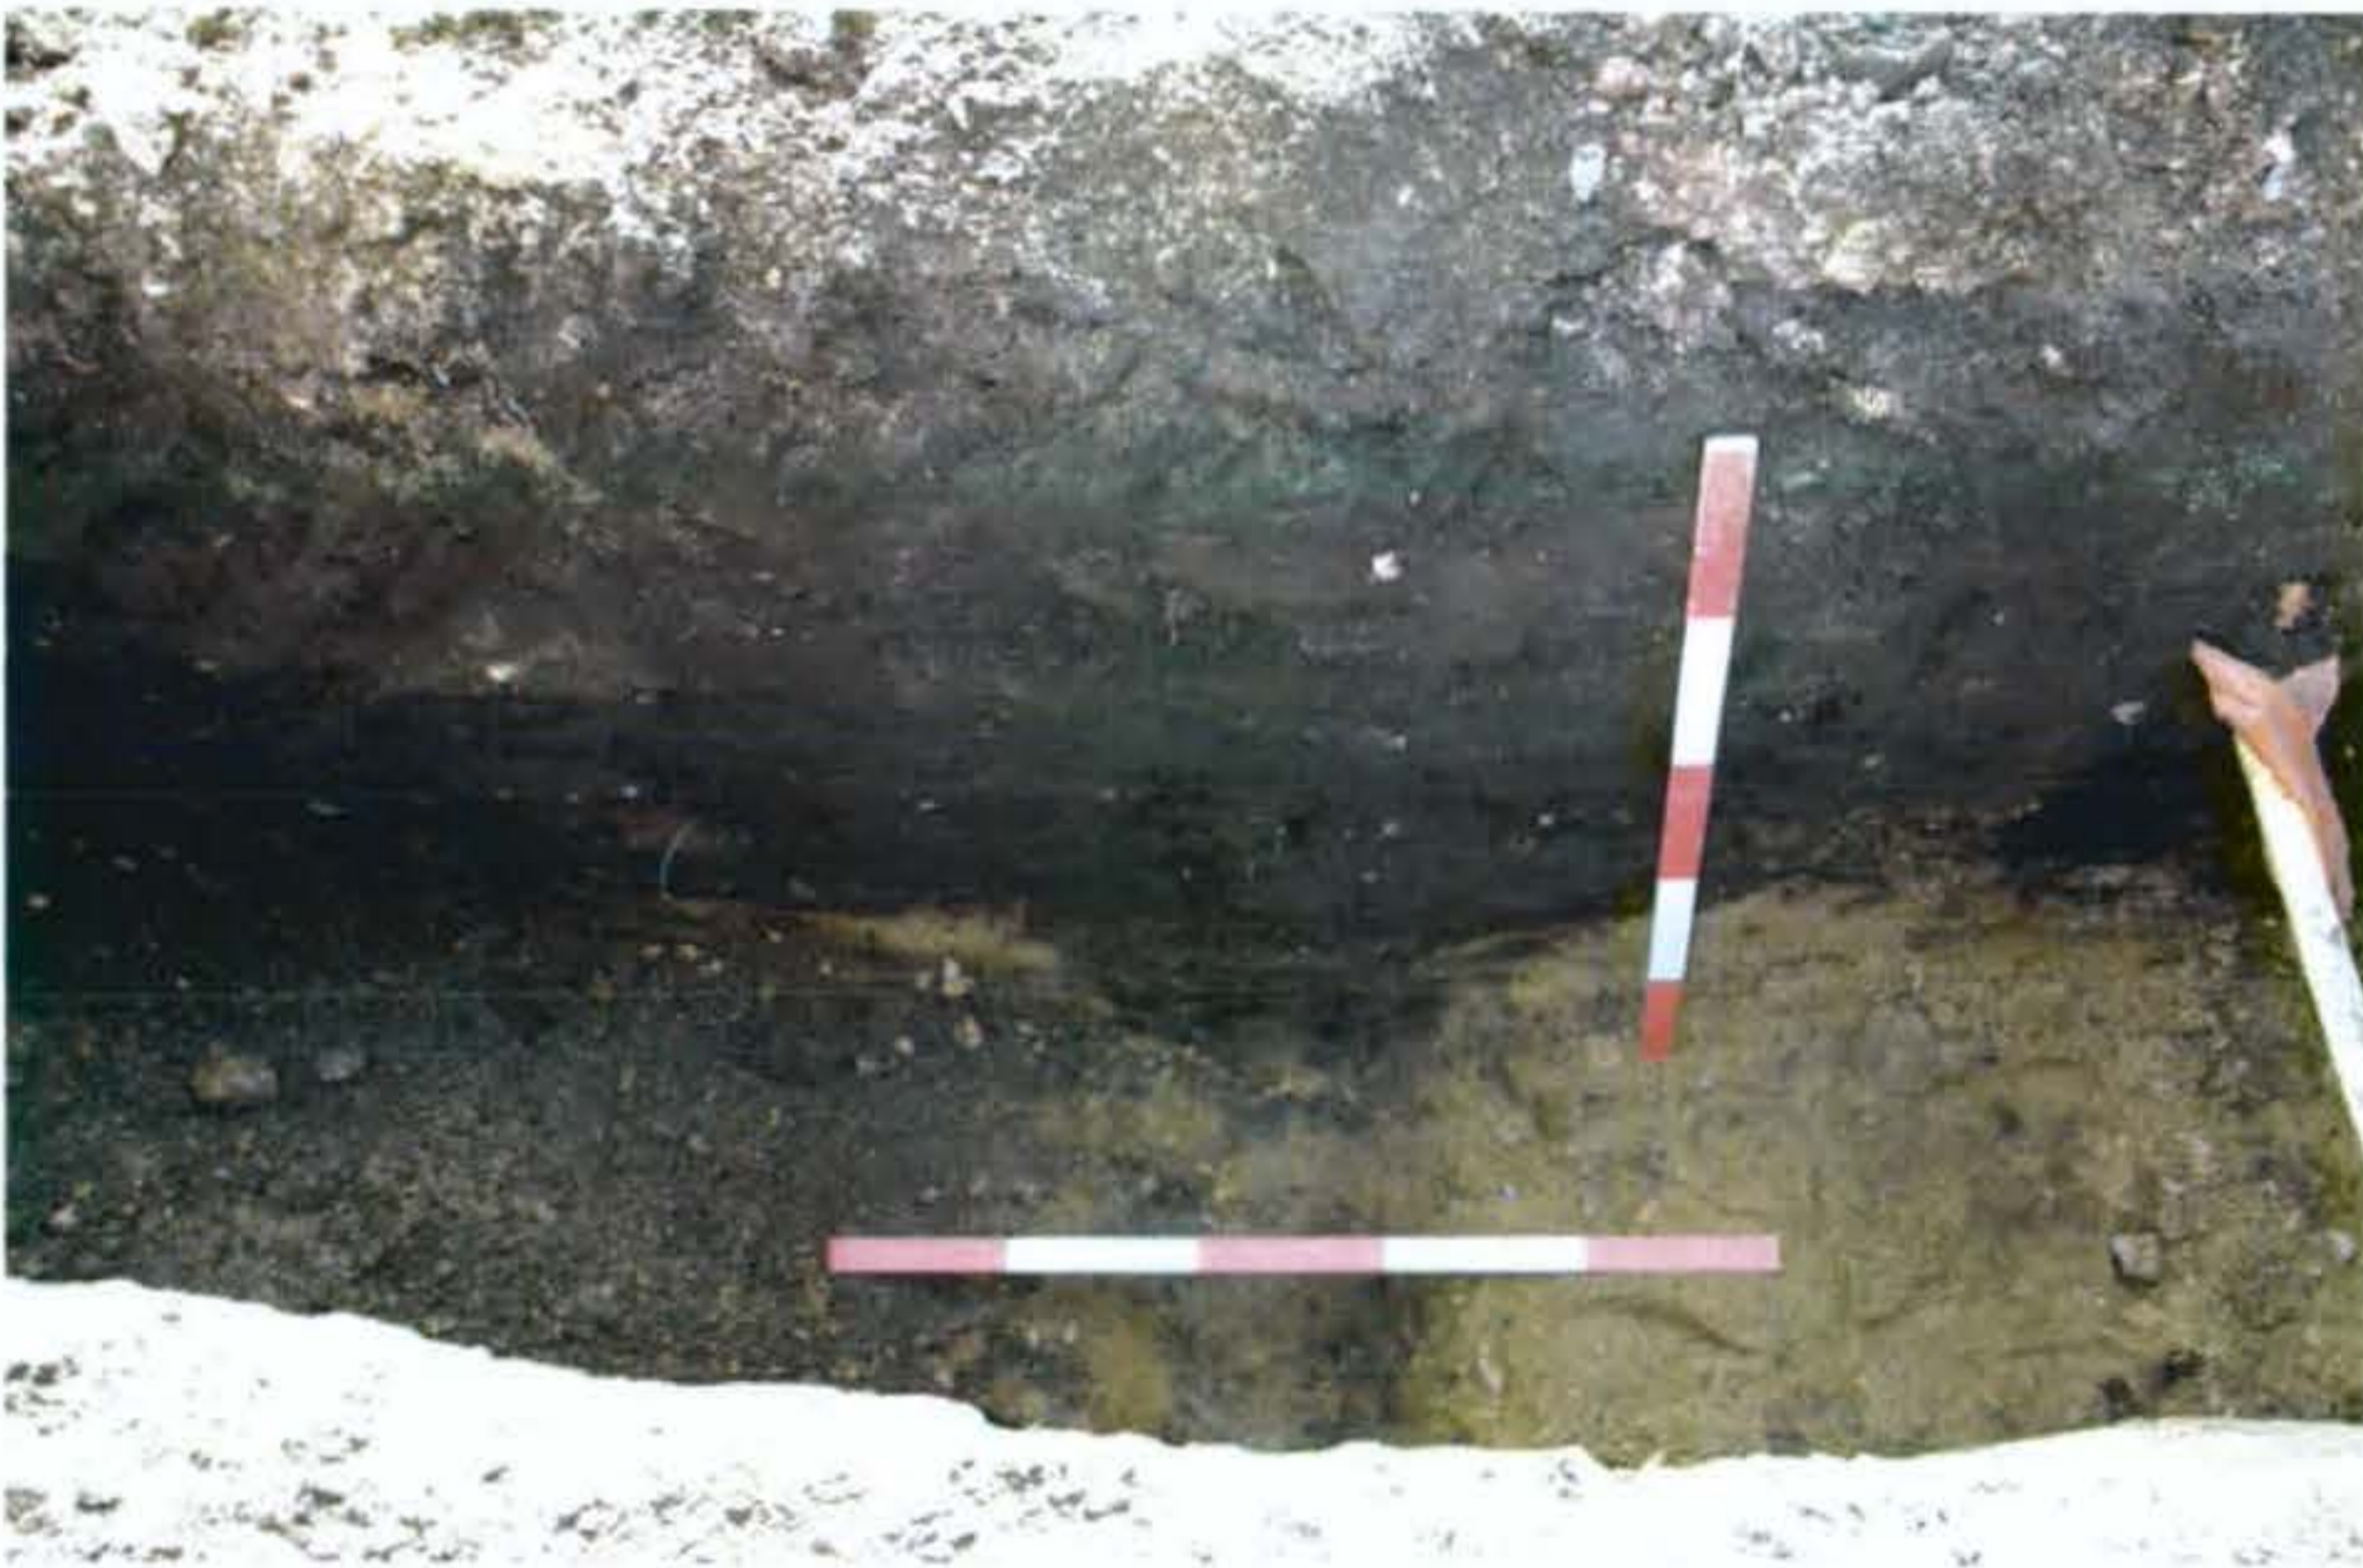
Plate 5: Ditch 121, looking south.

Another small ditch (121), oriented NNE–SSW, was exposed in the southern footings trench (Figure 2, Plate 5). This ditch was similar to ditch 119, about 0.9 m wide and 0.55 m deep, with steeply sloping sides and flat bottom (Figure 3). It is unclear whether it cut through soil 105 or was

sealed by it. It was filled with yellowish-brown clayey sand (120) with moderate flint gravel nodules and sparse charcoal flecks. It contained a single Roman coarseware sherd and a very small quantity of briquetage (Table 1).
