MELTON WASTEWATER TREATMENT WORKS EAST YORKSHIRE

ARCHAEOLOGICAL POST-EXCAVATION ASSESSMENT

NAA 04/61

June 2004

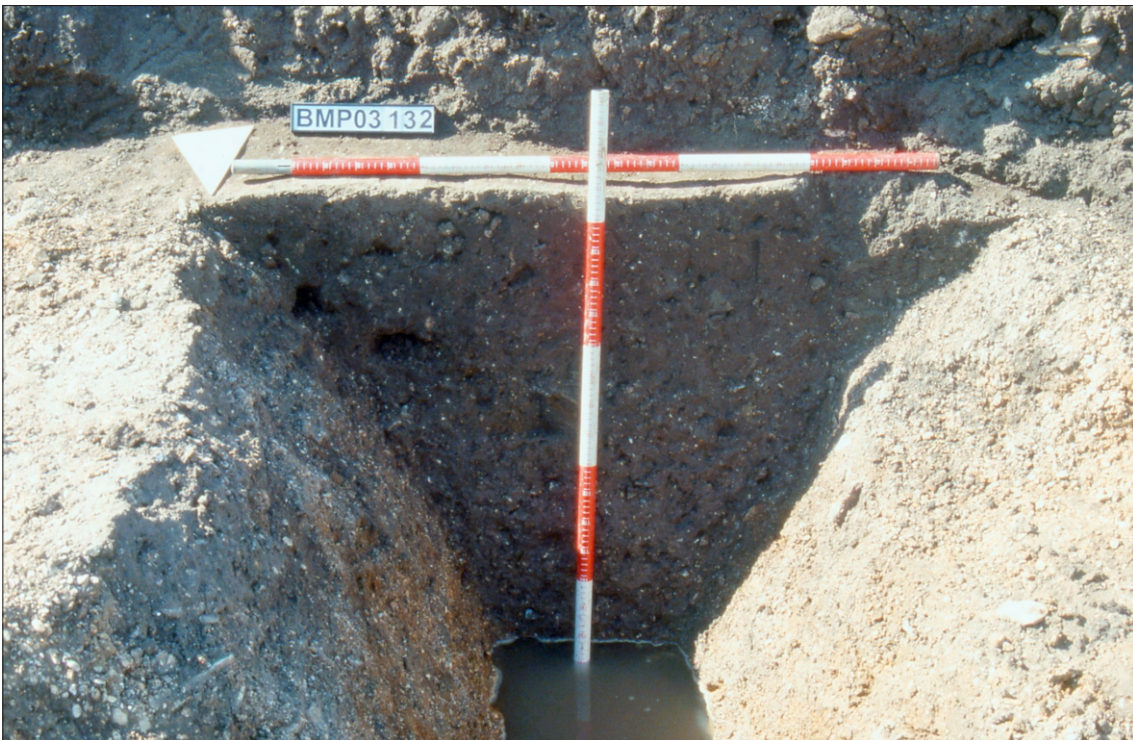
Plate 2: Low Common Lane. North-facing section of ditch 132. Scale intervals at 20cm

- 4.16 A truncated ditch terminal (132) was located within the southern half of the excavated area. Another ditch (052) was found to cross the trench and this cut earlier features (092 and 098). A series of features (197) beneath the later road (193), and a gully (26) cut by later ditches, may belong to this phase.

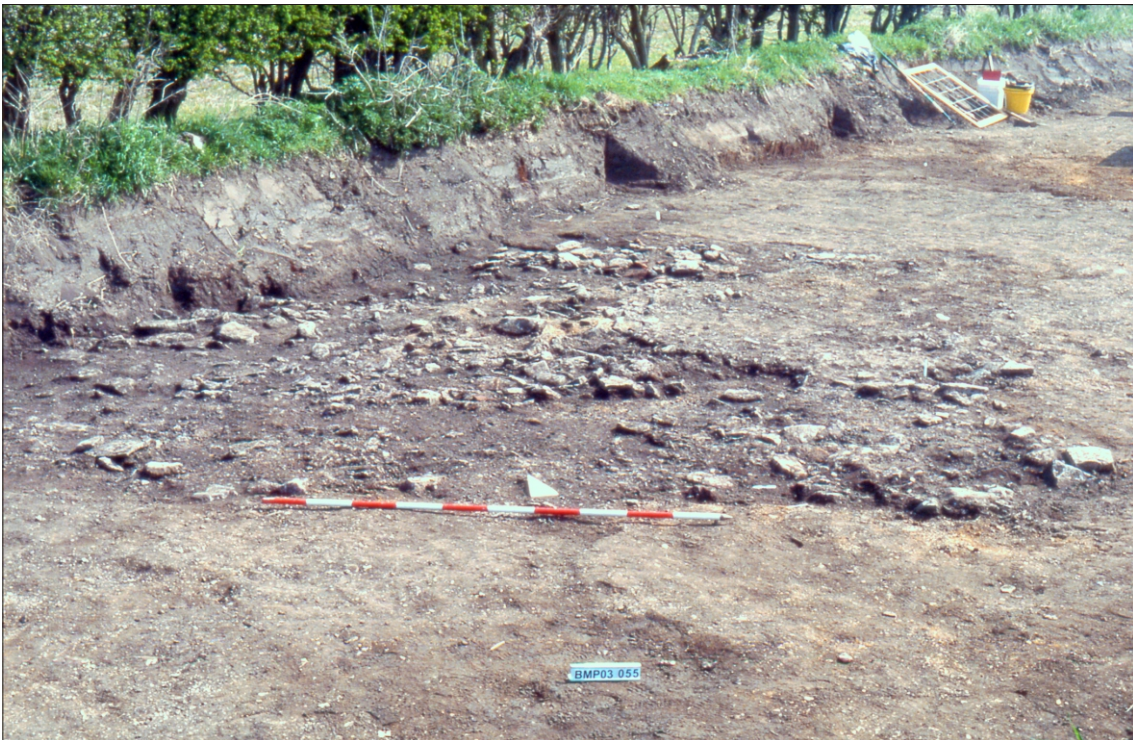
*Plate 3: Low Common Lane. General view of road surface 55 from the south-west.
Scale intervals at 20cm*

- 4.31 As it survived, the road was up to 3.6m wide and formed from a number of discrete patches of foundation material of rubble (55) comprising angular stones (0.01m to 0.15m diameter) and larger blocks (up to 0.2m by 0.3 m), some of which incorporated broken roofing tile (54), with occasional areas of compacted metalling formed from subangular stones (0.05 to 0.15m diameter) in a mid brown sandy silt matrix (56).

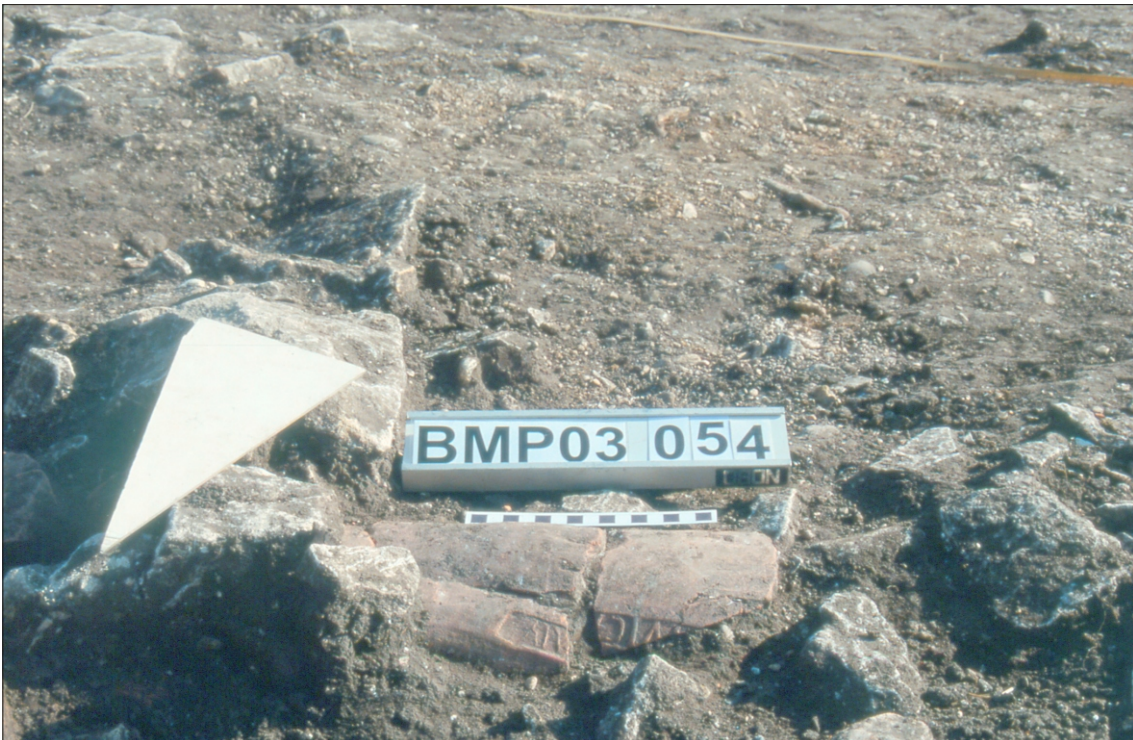
*Plate 4: Low Common Lane. View of the stamped imbrex of the VI Legion in situ.
Scale intervals at 1cm*

No ansate: a sideways 'V' pattern found on some legionary stamps (Brodrigg 1997, 120), was evident on the 'complete' end, indicating the use of a plain rectangular stamp with the dimensions of: length: >84mm and width: 18mm. The surface is slightly abraded though the letters; in relief, are clearly delineated. Although incomplete, the tile had a length >291mm. Legionary stamping was common practice in Britain during the 2nd and 3rd centuries AD (Brodrigg 1987, 118) and were not only used as a sign of authority but also as a preventative measure against the risk of theft from legionary stores (*ibid* 117).

The quantity of the material recovered does not substantiate the presence of a building within the immediate locale, although it may represent residual or re-used material from a structure within the vicinity. The interpretation of a civil settlement with the presence of a road surface 193 and a possible corn drying kiln 37 therefore suggests that the ceramic building material may have been used within the kilns' construction and for metalling and or repairs within the road surface. The material recovered from the stone and rubble layers/surfaces may have been incorporated within? hardstanding surfaces due to its re-useable and robust nature as evident by the presence of the legionary stamped *imbrex* recorded within a layer of stone and tile rubble 54.

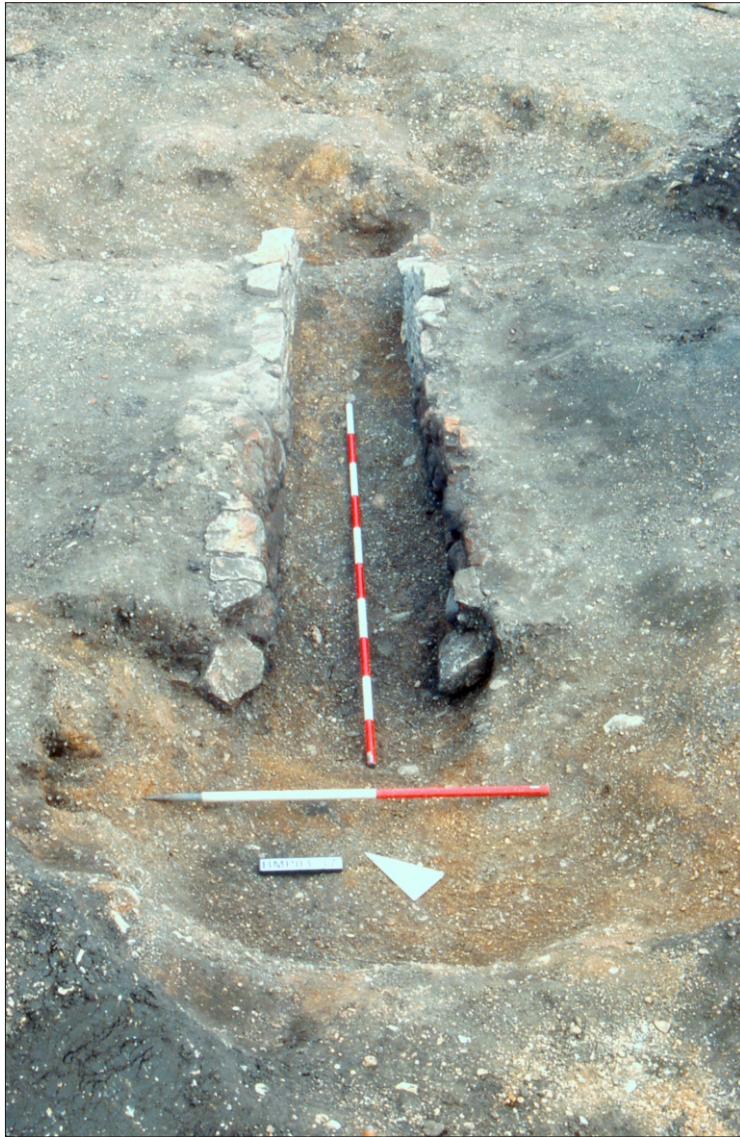
Plate 5: Low Common Lane. View of kiln 37 as excavated from the west. Scale intervals at 20cm and 50cm

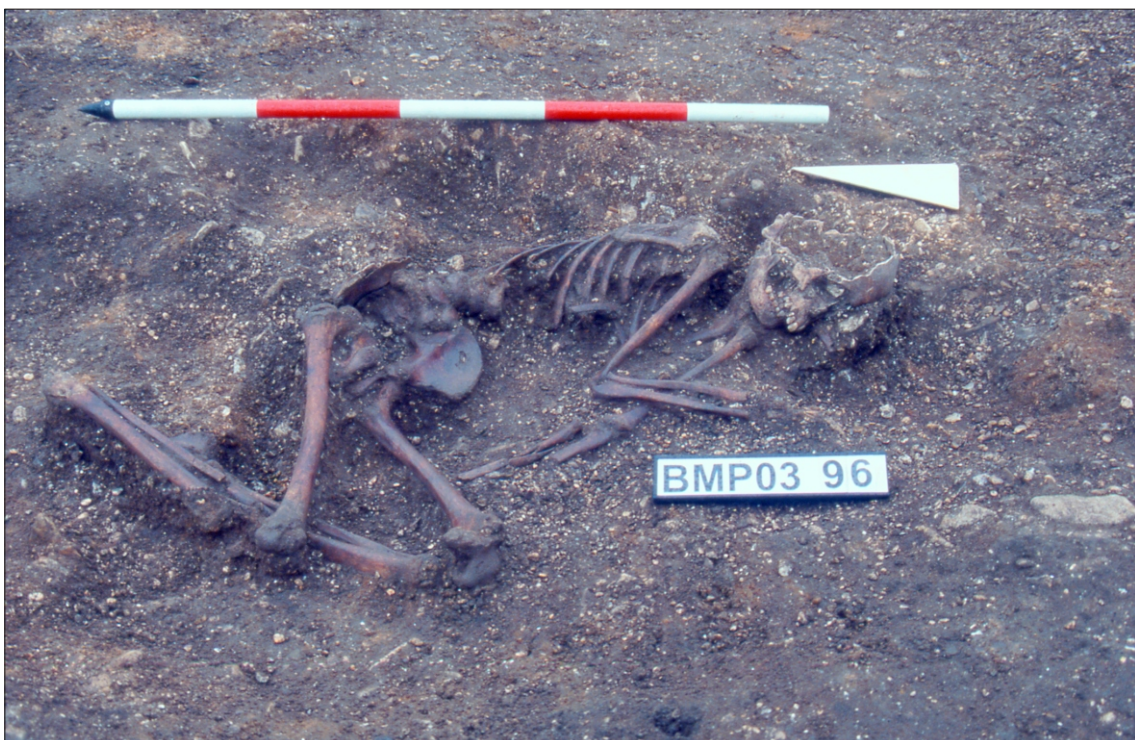
Plate 6: Low Common Lane. View of skeleton 96 from the west. Scale intervals at 20cm

- 6.31 A single flexed inhumation within an oval grave was situated immediately adjacent to the kiln at Low Common Lane. The skeleton was orientated north-east to south-west, and there were no accompanying grave goods.
- 6.32 The single skeleton (96) was non-adult, and was of good general preservation, over 75% complete, and moderately fragmented. The cranium was highly fragmented.
- 6.33 A small amount of disarticulated human bone was found in three additional contexts. These consisted of well-preserved infant bone fragments (149 and 159) except for those found in the kiln flue fill (39), which may be associated with skeleton 096.

- 6.34 Skeleton 96 should be subject to full basic analysis. Age, sex, pathologies, metric and non-metric data should be recorded where possible. Comparisons with contemporary inhumations may be drawn to demonstrate any unusual findings.
- 6.35 The disarticulated bone from additional contexts should be identified, and unusual pathologies or other abnormalities should be noted.
- 6.36 The skeletal remains should be retained in a suitable location subsequent to analysis, for future research purposes.
