An Archaeological Evaluation and Watching Brief: Windmill Hill to Hazards Green Transfer

Project No. 3177 Report No. 2008007 Oasis No. archaeol6-48273

September 2008

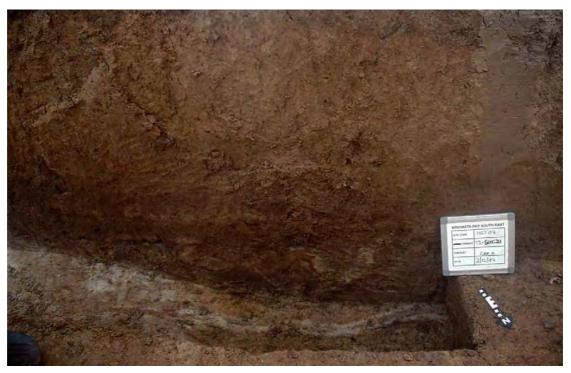
Fig. 15: Trench 2, [011], [013], [015], looking south

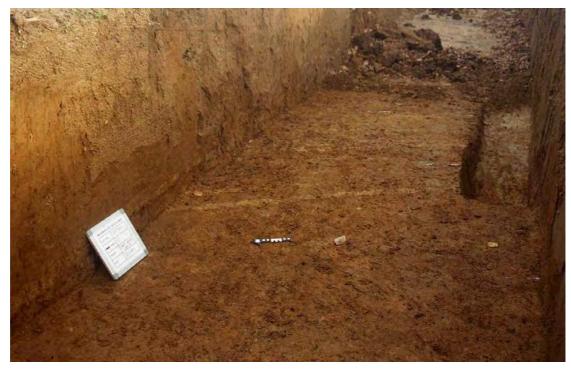
Fig. 16: Trench 2, [017], [009], [011], [013], [015], looking east

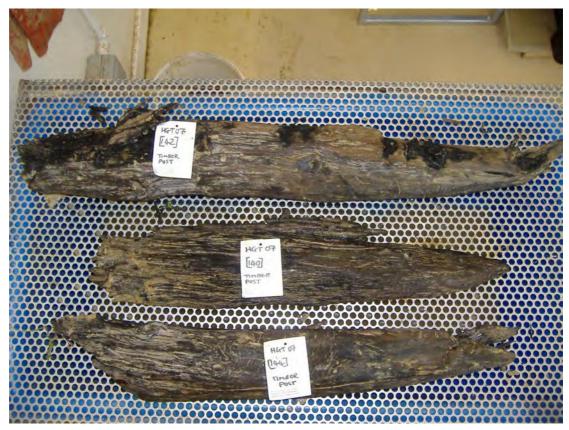
5.5.1 Three truncated oak (Quercus sp.) posts were collected from contexts [140], [142], and [144]. Each of these waterlogged timbers retains their tips, although the tip of the post from [142] is broken. They display clear evidence for being worked into their current forms and some chisel marks and notches are preserved on the surfaces. These marks are at right-angles to the lengths of the posts. The posts were made of slow grown mature oak which is not generally considered suitable for dating due to its longevity. Some sapwood is present, however, on the largest post from context [142] and this would be suitable for radiocarbon dating and would provide a date for the felling of the tree. Interestingly, these posts were located on the same alignment as some timber posts (MES3329) found to the north (figure 9), 'lying horizontally in association with a whole Romano-British pot, a glass bottle and sherds of Samian ware and pieces of Roman floor tile' (Young 2007; 4.5.4), by a farmer excavating a ditch. It is thought that the discovery of these timbers could indicate a potential Roman jetty and so it is worth considering the possibility that posts [140], [142] and [144] may also be related to a possible jetty/landing stage.

Fig. 18: Timbers [140], [142] and [144]

- 7.2.4 The post-hole series in Area H is of interest as their situation along the edge of this possible marine inlet could suggest a possible jetty. It is worth bearing in mind that other timber posts (MES3329) were found by a farmer when excavating a ditch, north of the pipe trench (along the same route of the marine inlet) within a probable Roman settlement area (Young 2007; 4.5.4). These have been interpreted as a possible jetty or landing stage (Young 2007; 4.5.5).
