**SURVEY AND ARCHAEOLOGICAL EXCAVATION**

**KINGS WESTON ROMAN VILLA,  
LAWRENCE WESTON, BRISTOL.**

**City Valuers Department, Bristol City Council**

**Bristol and Region  
Archaeological Services**

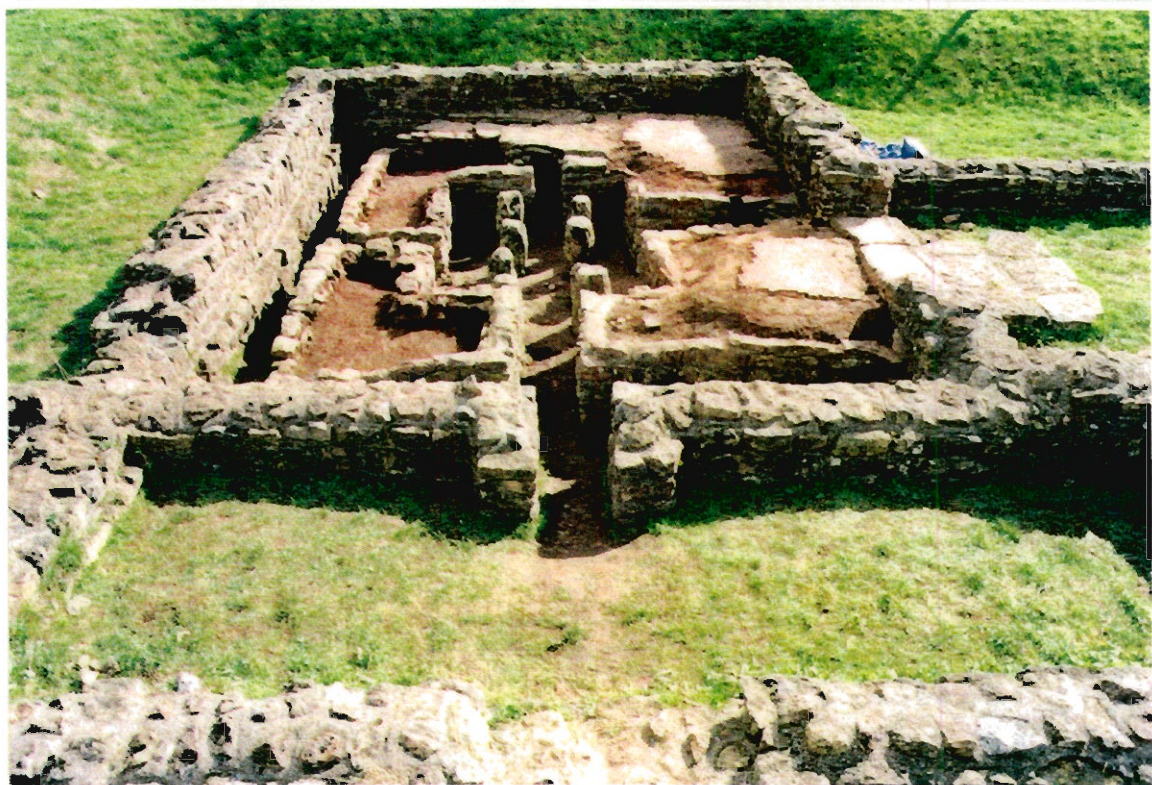
Cover Room XI after excavation

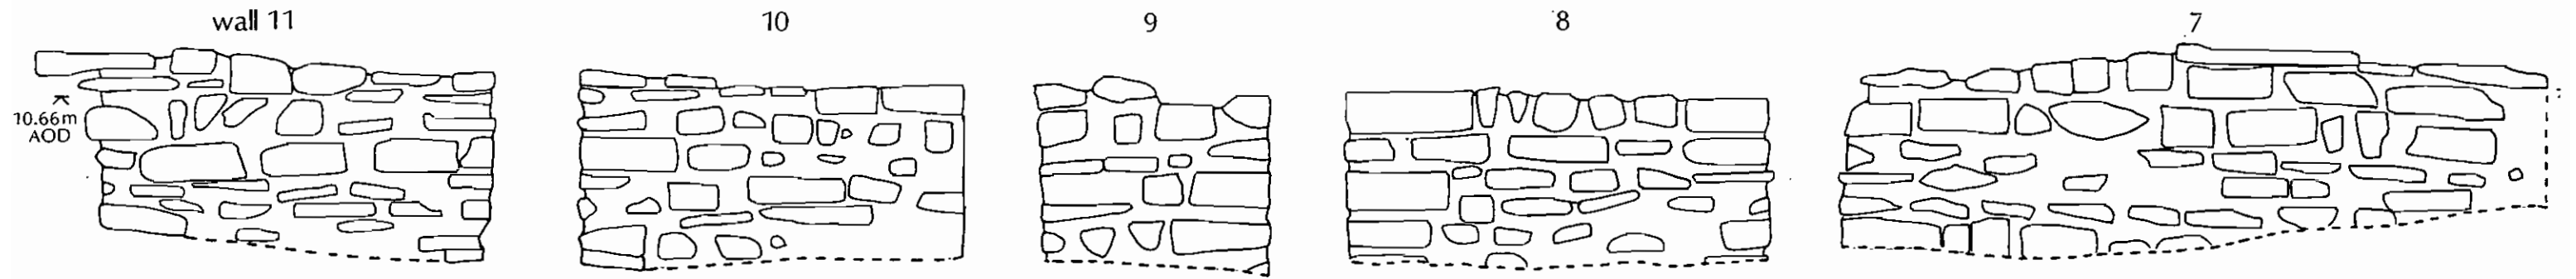
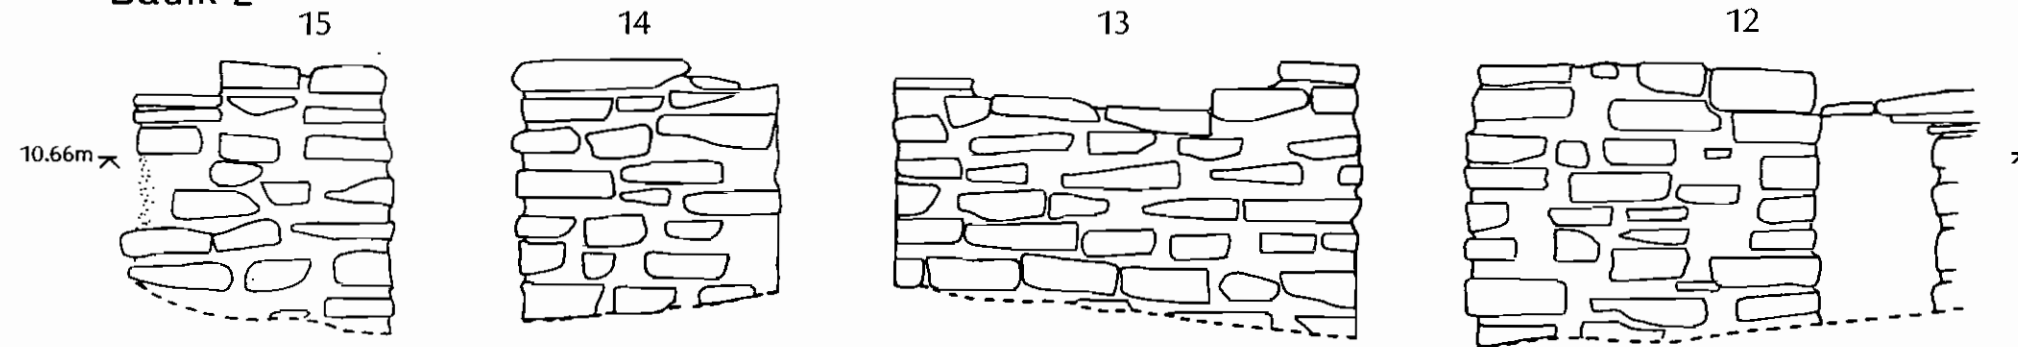
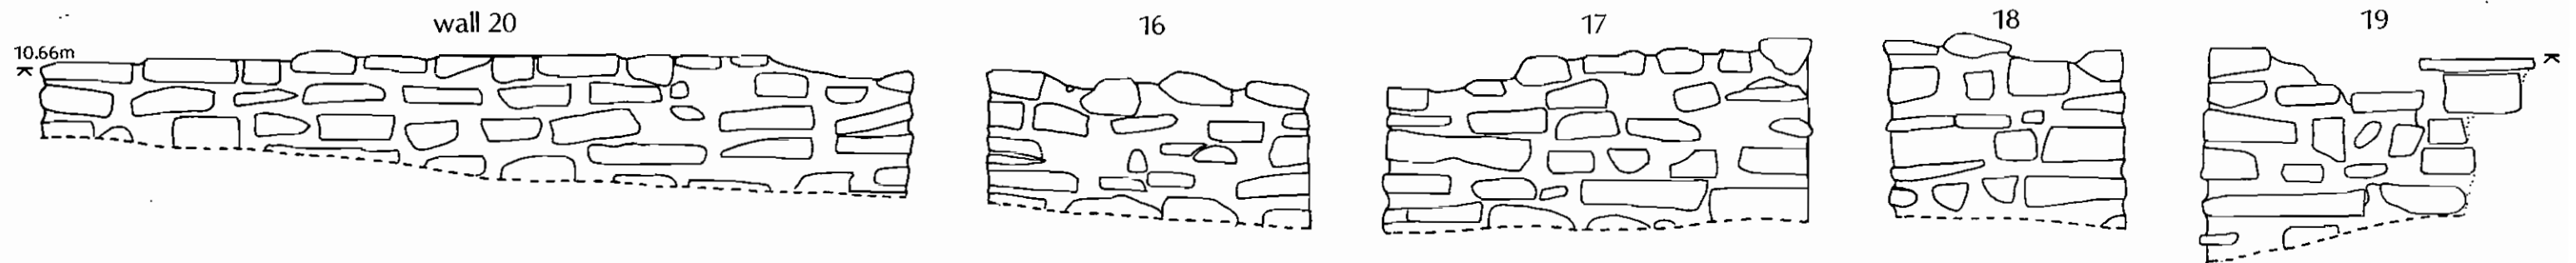
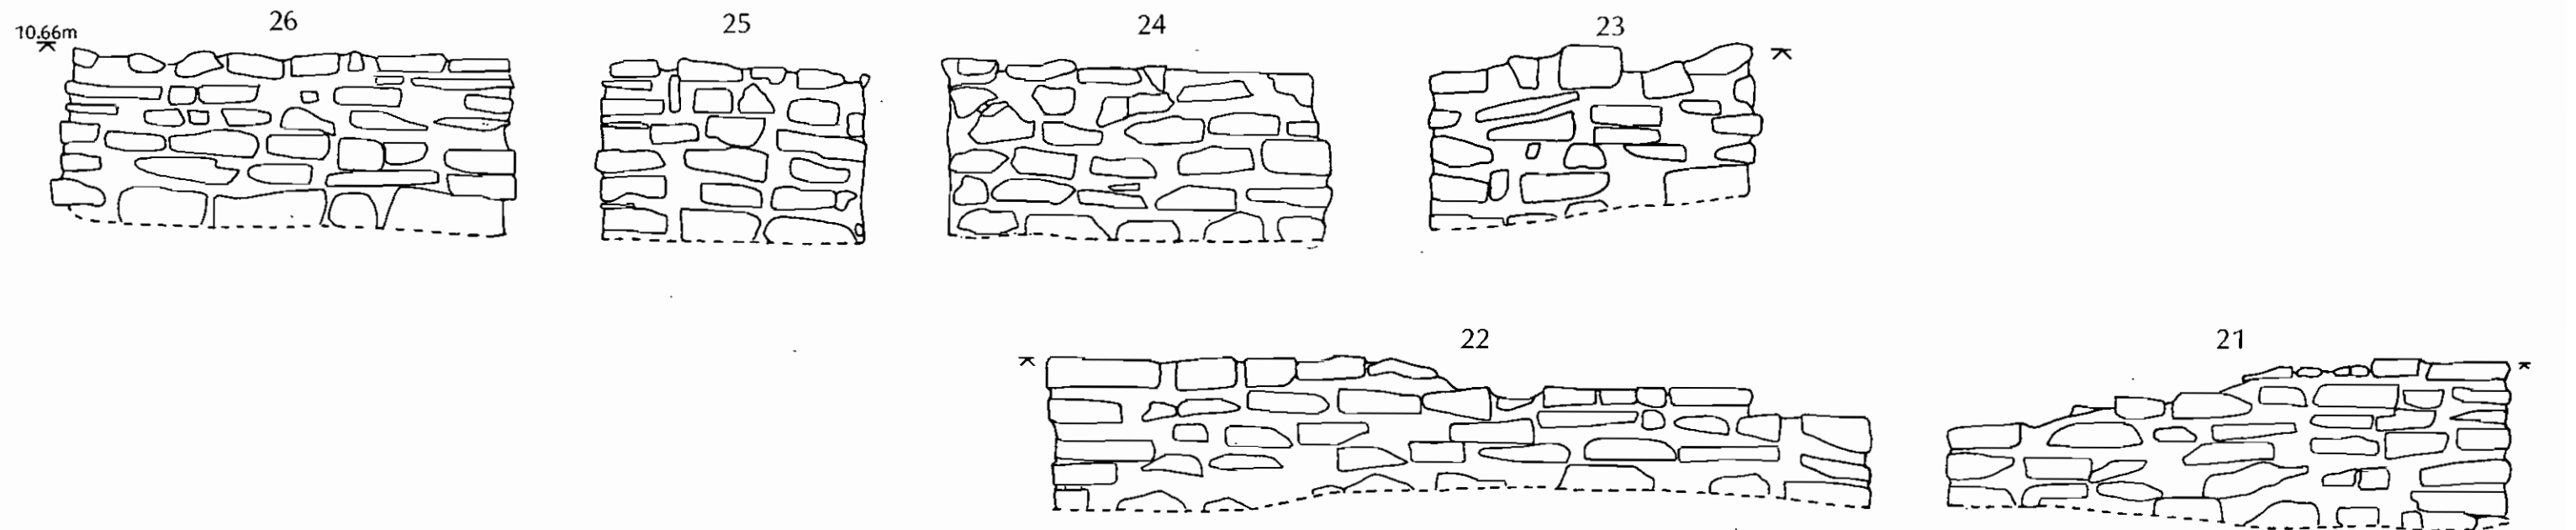
Fig.4 Elevations of walls lining flues

- 4.10 Examination of the flue walls showed that they are in very poor condition. The walls were faced with yellow sandstone rubble re-pointed with a modern grey cement mortar when the consolidation work was undertaken sometime after 1948. This cement has

become loose and in a number of instances has become detached from the wall. Much of the stone is badly eroded and several faces exhibit large cracks.

- 4.11 The internal construction of the walls was more random suggesting that rubble had simply been packed behind the external faces. The external faces were originally bonded in mortar, but no mortar survived. However, as Boon (1950) recorded the original mortars as being brown in colour, it is possible that the mortar has become indiscernible from the soils revetted by the walls.
- 4.12 The test pit against the west range clearly shows that the earth bank to the south is made ground and that archaeology does not survive there.

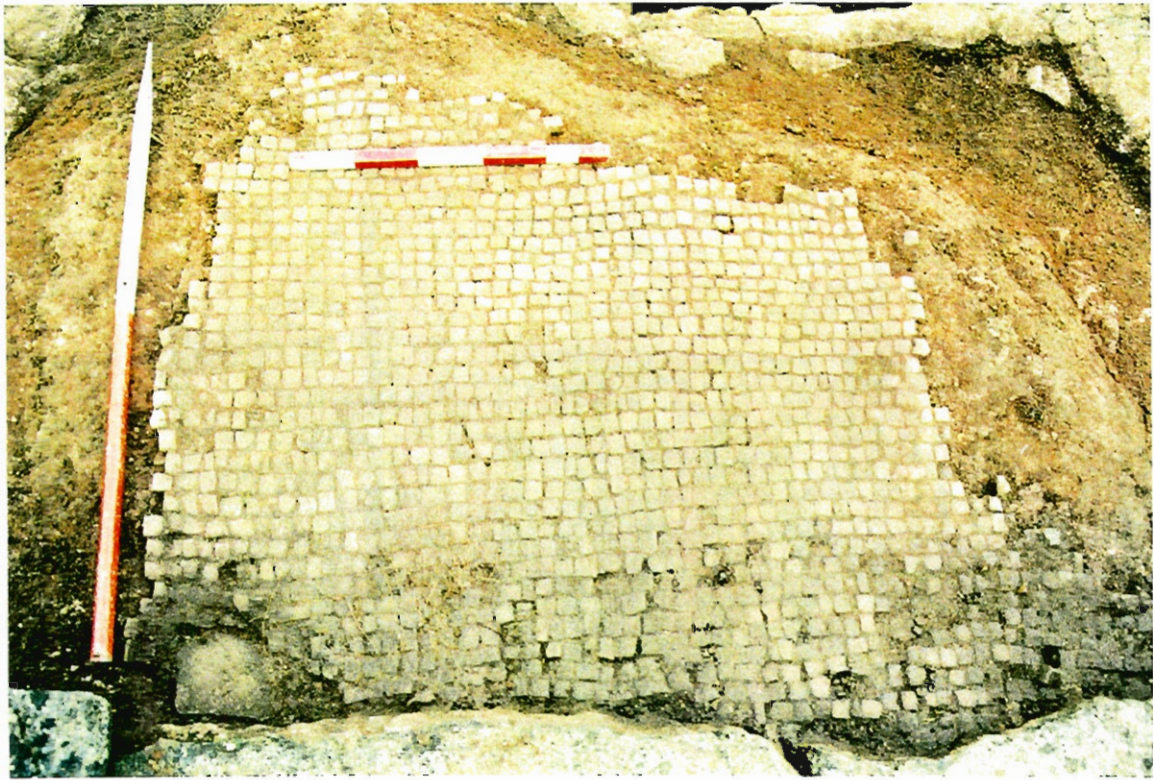
Plate 3 Tessellated pavement from Baulk B1

- 4.3 The B1 floor was much reduced in area with a considerable part of the pavement and its underlying make-up having been lost into the base of the hypocaust, mainly as the result of water and frost damage. Many tesserae were loose and detached from their mortar base and the area had suffered considerable damage from weeds.

- 4.6 After discussion with Mr A.Davison of English Heritage and Mr G.Reeder of the City Valuers it was agreed that the remains of the tessellated floor above Baulks B1 and B2 would be retained in-situ and a strategy devised to ensure its future protection. It was further agreed that Baulks B3 and B4 should be fully excavated to permit examination of the internal faces of the flue revetment walls and, if possible, to record the sequence of construction of the second period floor.

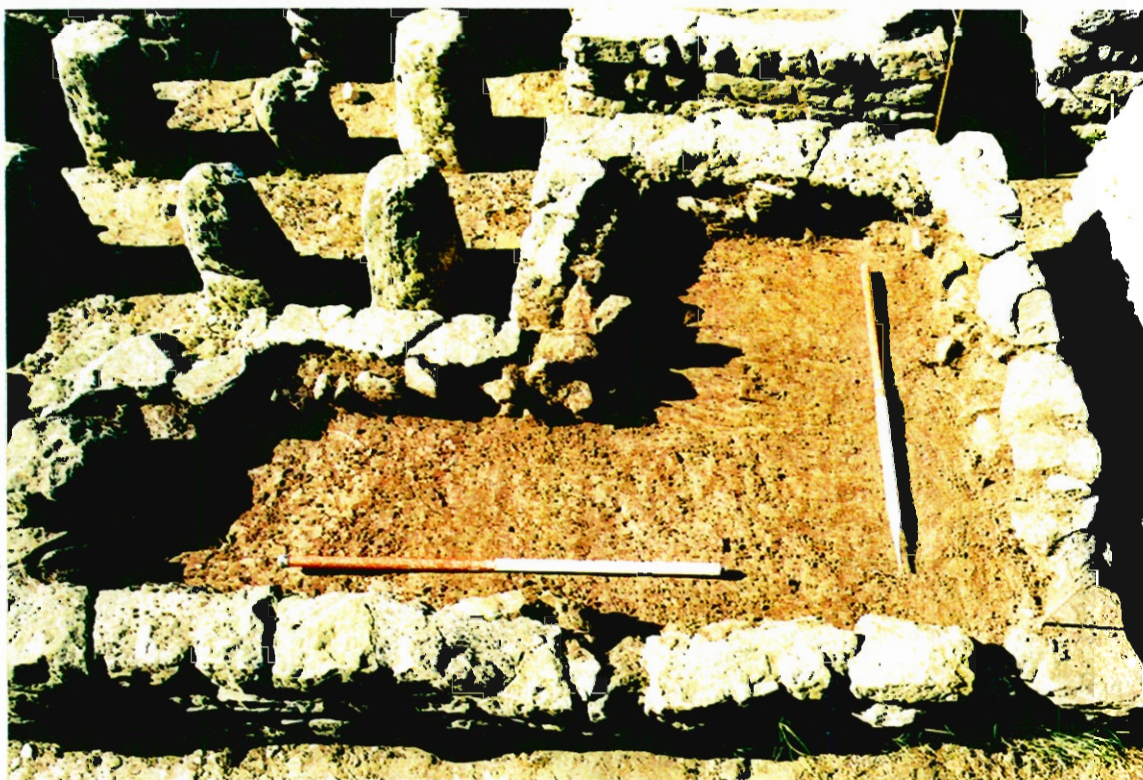
Plate 5 Baulk B4 after excavation

- 3.9 In the northeast corner of Room XI, Baulk B4 was devoid of any evidence for the tessellated floor. Covering B4, except at its southern end, was a 200mm deep deposit of yellow-brown sandy soil (44), which contained finds including loose tesserae (Pennant Sandstone), five sherds of late Romano-British pottery and a single flint flake.

- 3.10 At the southern end of B4 a lens of yellow-brown sandy clay, flecked with charcoal (45) contained part of the rim of a wide mouthed jar or urn. It was made of a soft, rather corky, fabric containing quartz, ceramic, other opaques, and rare vegetable matter. The vessel is decorated with simple thumb-nail indentations. The sherds have not yet been positively identified but may possibly originate in the Sub-Roman or Dark Age period.

- 3.11 Beneath layers (44) and (45) there was a pink to red-brown clay that became more sandy to the north (46). This appeared to be the natural subsoil (**Plate 5**).
