An Archaeological Desk-Based Assessment of land at
Lullingstone Roman Villa, Eynsford, Kent

- a) Site centred NGR 553035, 165053
and
b) Site centred NGR 553003, 165082

July 2007

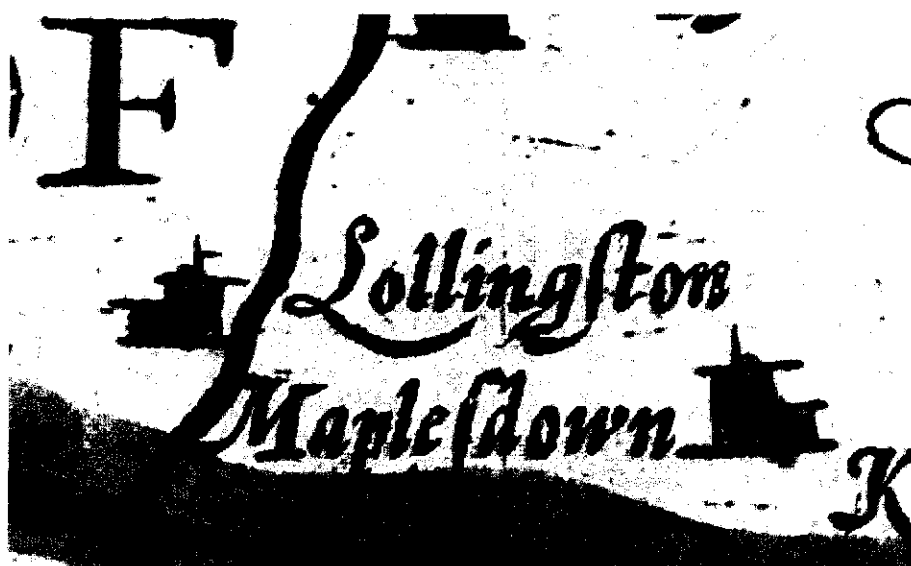
Figure 3
Detail from Christopher Saxton's county map, 1575
(Centre for Kentish Studies)

- 7.1 No maps depicting the villa site from before 1575 have been located as part of this assessment. The oldest map, a county map by Christopher Saxton in 1575, uses a standard depiction of a church to locate Lullingstone (*Lollingston*) as a single settlement on the west bank of the River Darent. Philip Symonson's map of 1596 and Samuel Parker's map of 1719 which follows it again use a depiction of a single church to locate Lullingstone (*Lollyngston* on Symonson's map).

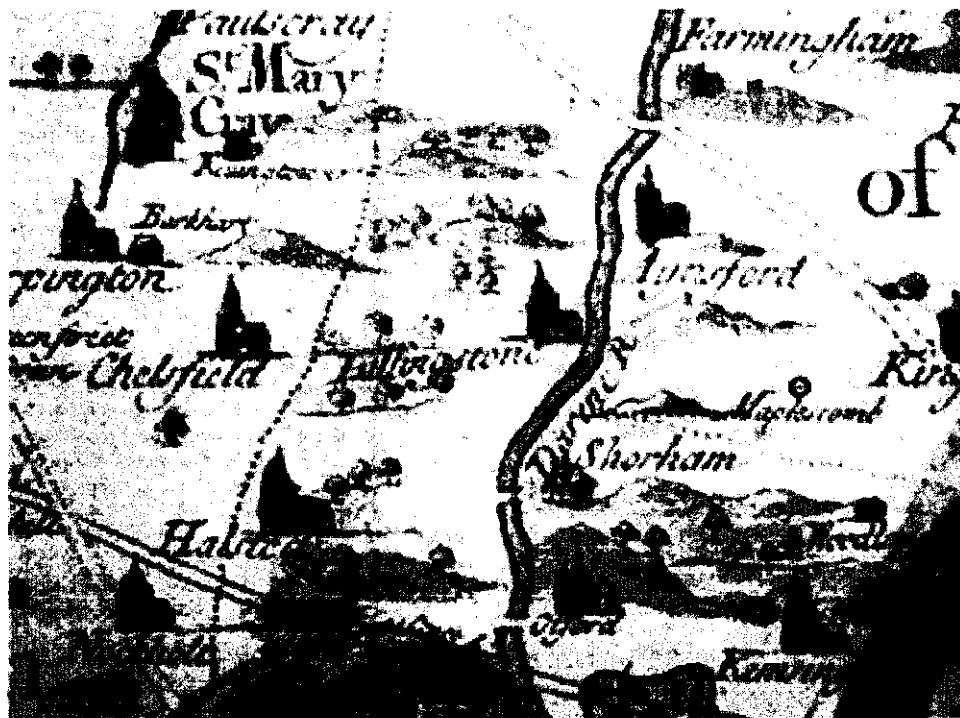
Figure 5
Detail from Samuel Parker's county map, 1719
(Centre for Kentish Studies)

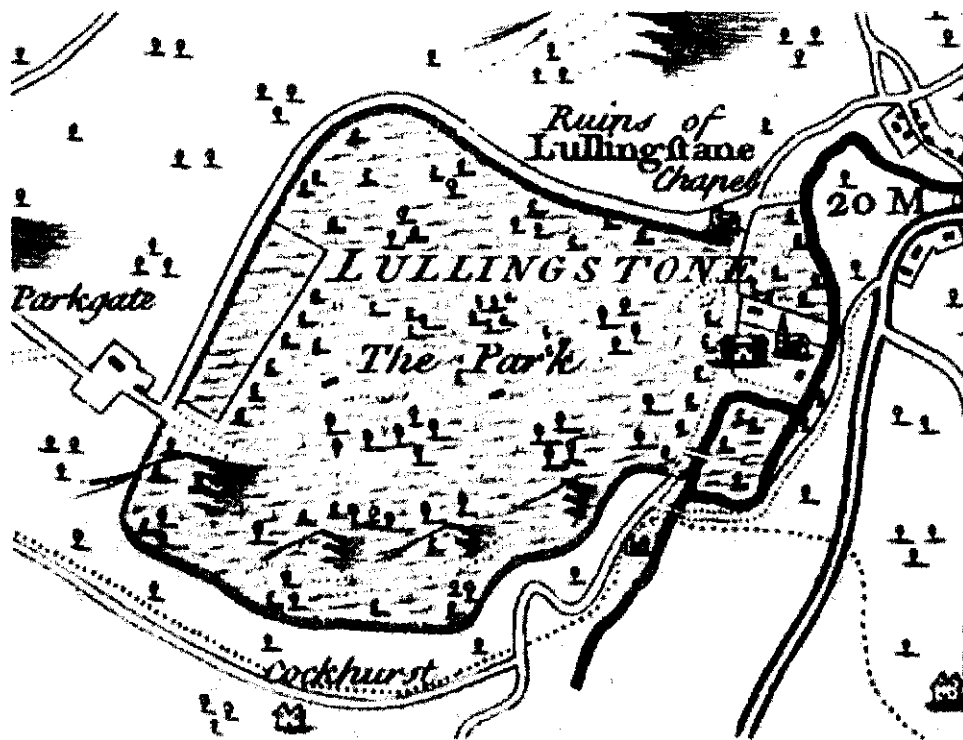
Figure 6
Hasted map for Lullingstone, 1778
(Centre for Kentish Studies)

- 7.2 Hasted's map of 1778 is the first to depict Lullingstone with greater topographical detail. Lullingstone parish church and Lullingstone Castle are shown within the deer park. Immediately beyond the park's pale, just outside its northeast corner, the ruins of Lullingstane church can be seen. This is the earliest cartographic reference to the formerly separate parish.. The road from Eynsford to Lullingstone can be seen running parallel to the river, as it does today, with Lullingstane church on its west side. The ground between the ruins of the church and the river is depicted in exactly the same way as the rest of Lullingstone Park, as open ground with some trees. No buildings are depicted.

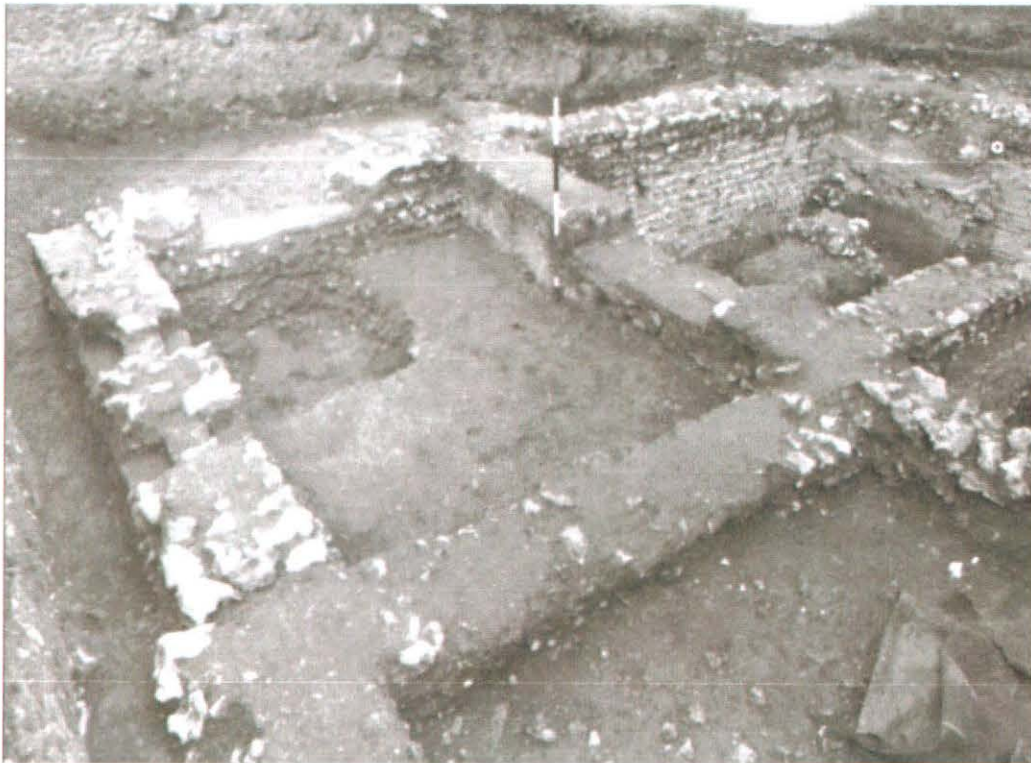
Figure 15

Views of room 11 looking north towards appraisal area B

Top: photograph from Meates, G. W., *The Lullingstone Roman Villa, Volume I – the Site*, Kent Archaeological Society 1979 (p.192 plate xi, a.)

Bottom: photograph showing present arrangements

- 9.3.2 Although appraisal area B is located outside the exposed remains of the villa, it is close to buried remains extending under the entrance lobby/shop area. This sub-surface evidence was excavated by Meates, who identified it as forming part of the primary phase of the villa built in c. AD 100 and integral to an external entrance to the deep room or cellar. The same material has been interpreted more recently as belonging to the north range of rooms constructed in the second half of the 2nd century and subsequently demolished in c. AD 275 (Neal, 25 – plan; Fulford, 25 – plan; see figure 15).

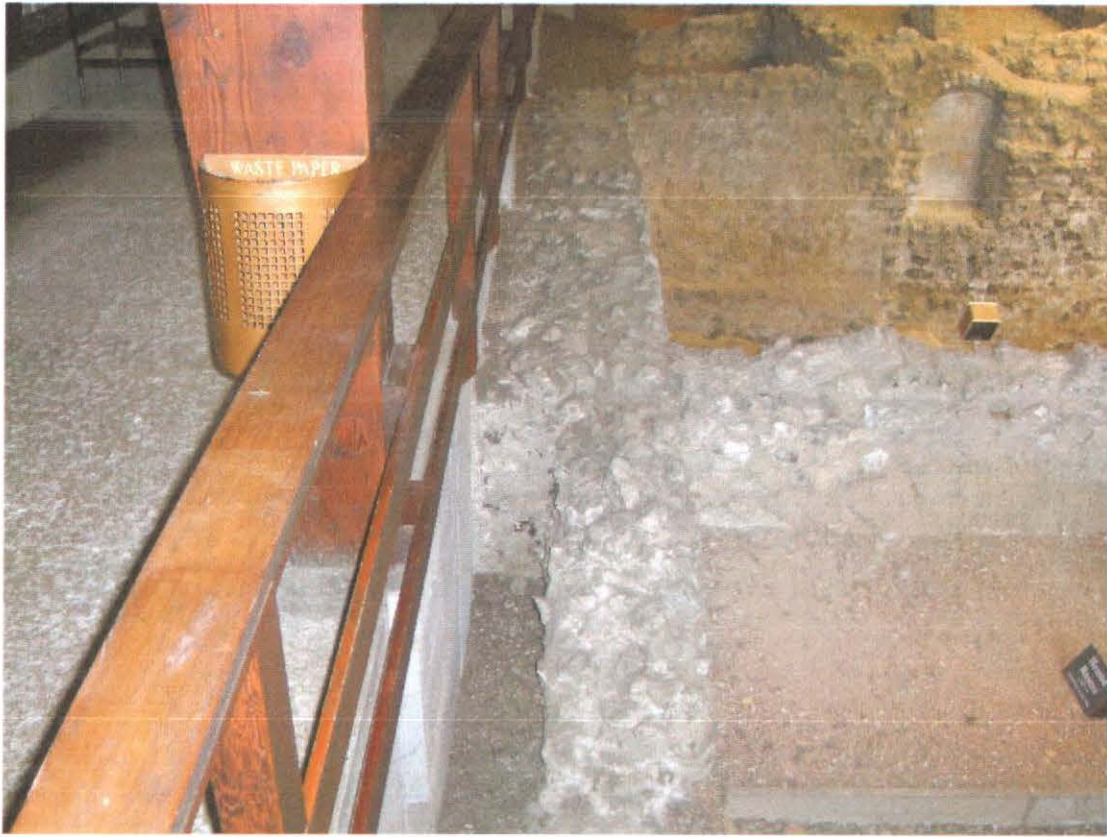
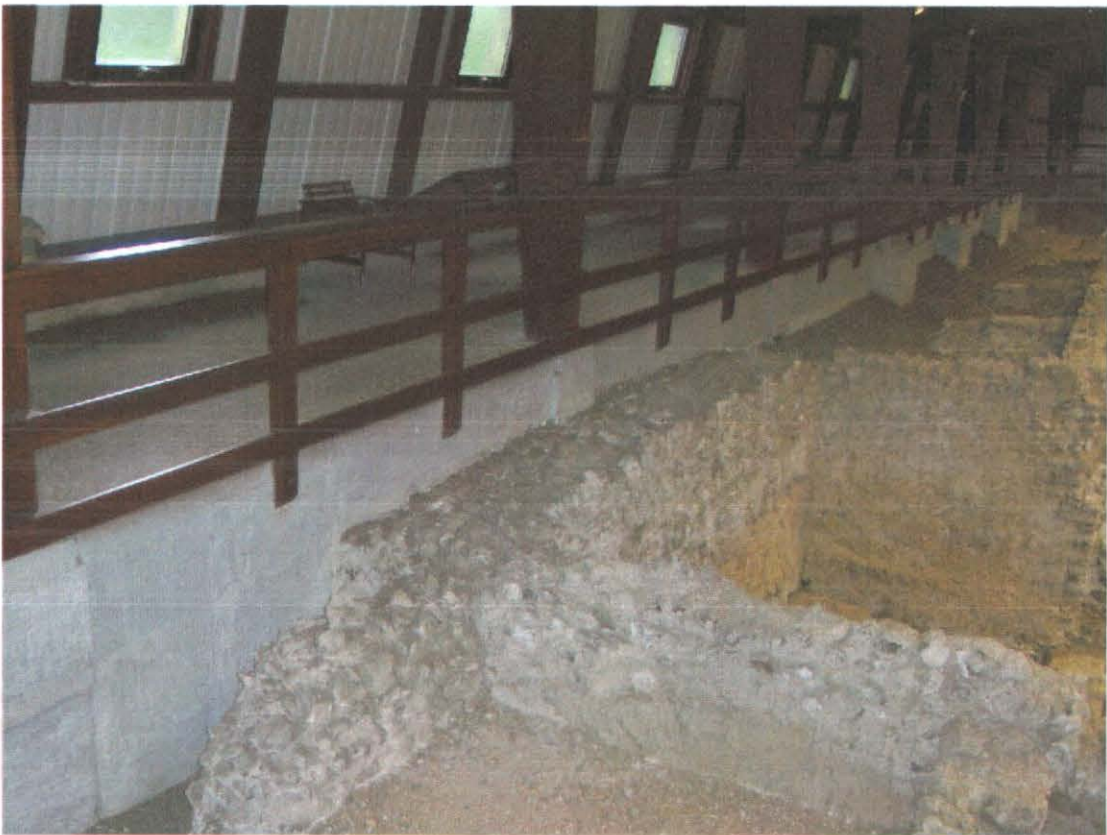
Figure 14
Interface between exposed remains of villa and concrete walkway (adjacent to appraisal area A)
