**GAS MAINS REPLACEMENT, ALDBOROUGH,  
NORTH YORKSHIRE**

**WATCHING BRIEF REPORT**

**REPORT NUMBER 2013/08**

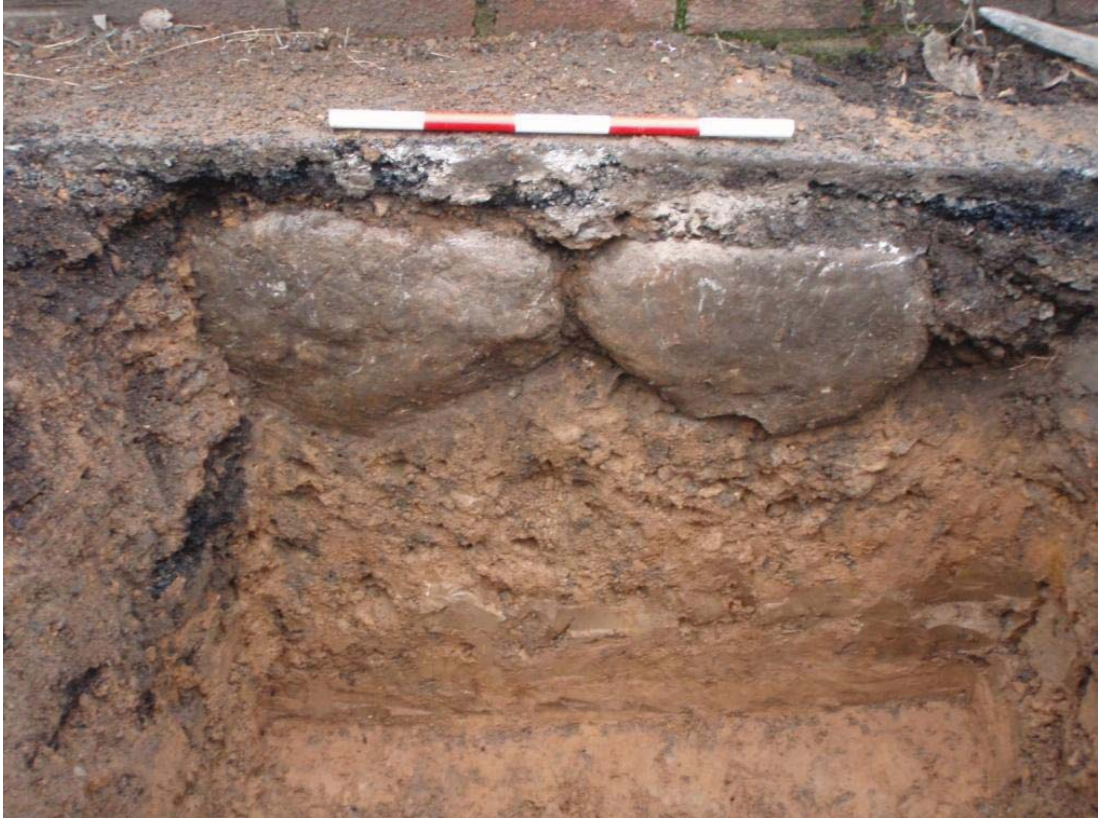
*Plate 1 Former kerbing formed of large water-worn cobbles in Trench 9. Looking W*

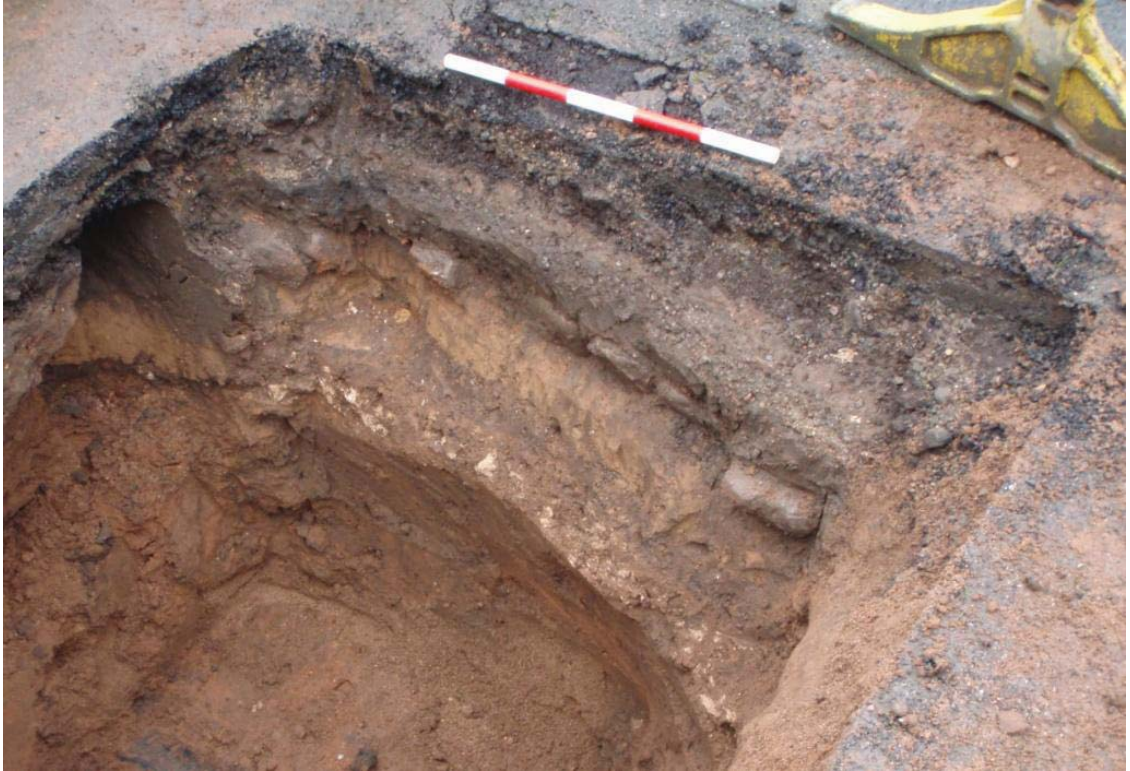
In the case of Trench 25 (Plate 2) this kerbing was directly associated with a metallised surface formed of a layer of cobbles set within a sandy bedding. This metallising appears to be a precursor of the modern road surface of Back Street. A thin silty deposit above the metallising appears to represent an accumulation over this surface. An earlier metallised surface of small pieces of stone within a silty matrix was evident below this, itself sealed by what is probably an accumulation deposit. The dating of this earlier surface is not clear cut and it could conceivably relate to the medieval period. Additional areas of cobbles, which were not seen to be directly related to kerbing were seen in Trenches 27, 28 and 66. The former two trenches were located on the eastern side of the grassed Square and suggest that the northern part of Back Street was wider than it is now whilst the same argument applies to Front Street in the area of Trench 66.

*Plate 2 Metalled surface of cobbles set on a bedding of sand in Trench 25. The position of the kerbing (removed) can be seen in the void to the upper left. The stoney layer below this represents an earlier surface, with accumulation above. Looking NE*

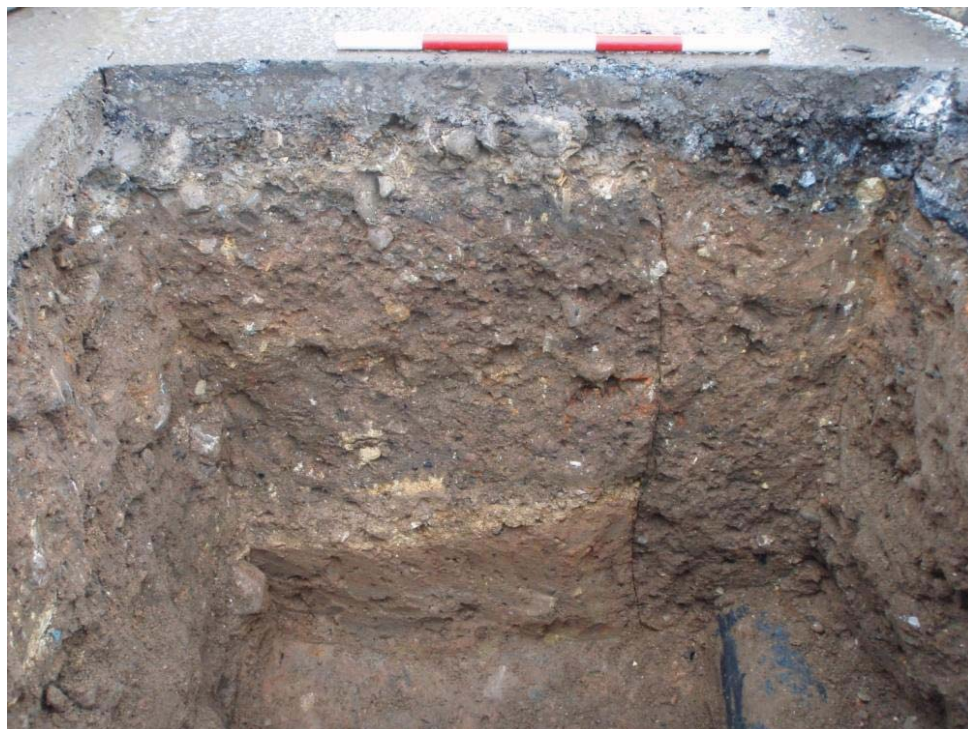
*Plate 3 Stony layer beneath modern road materials in Trench 48. This probably relates to a post-medieval metalled surface or its bedding. Looking E*

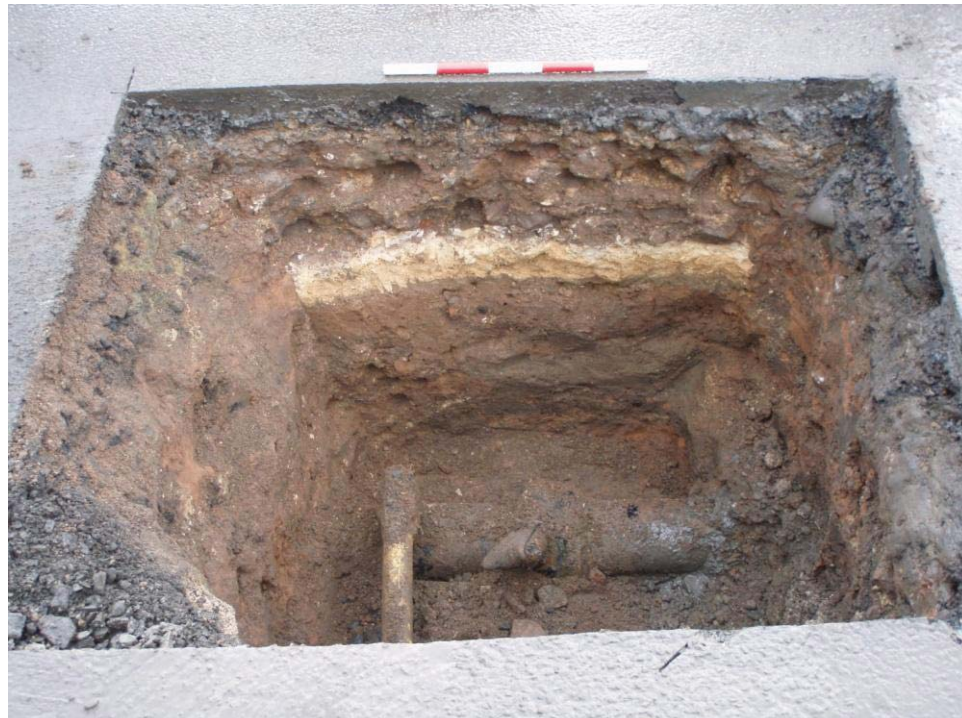
*Plate 4 Metalled surface, predominantly of cobbles, below modern road materials in Trench 50. The pale coloured layer of crushed stone immediately below may relate to a bedding/makeup. Looking S*

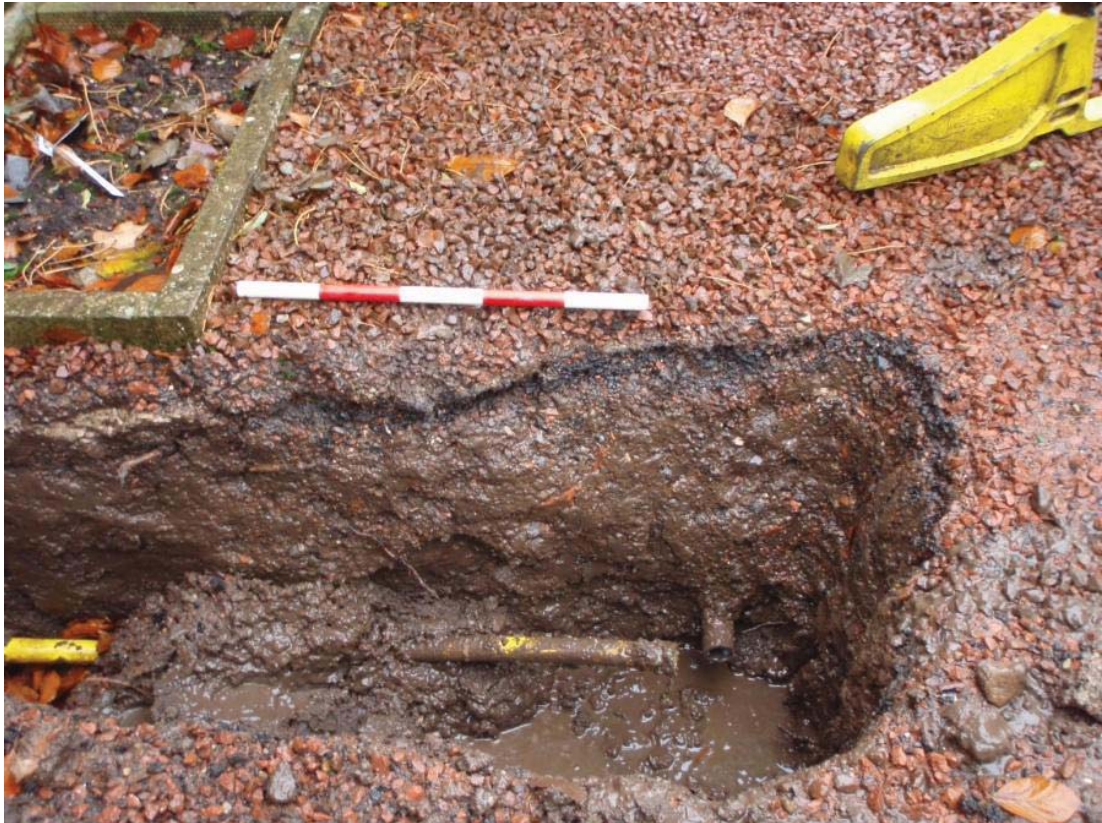
*Plate 5 Former garden soil beneath modern surfacing in Trench 47, looking S*

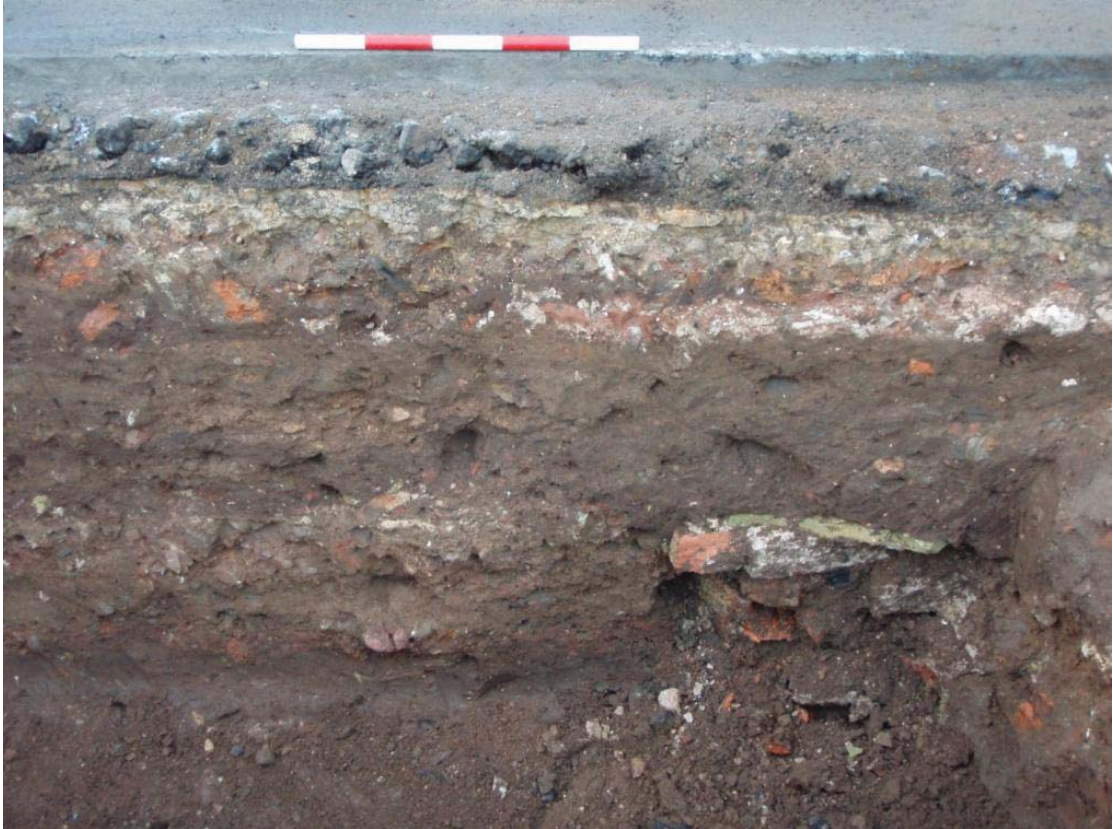
The remains of a Culvert extending across Boroughbridge Road were encountered in the north-western side of Trench 87 (Plate 6). Aligned south-south-west / north-north-east this feature occupied a construction trench that had been cut from a high level and was somewhat wider than the culvert itself. Backfilled with comparatively stone-free soils this cut had then been capped-off with aggregate to reinstate the roadway. The culvert was constructed of lime mortar bonded bricks capped off with thin slabs of pale yellow sandstone. The characteristics of the brick suggest that this culvert is of 18<sup>th</sup> or earlier 19<sup>th</sup> century date. Its alignment suggests it extends from an area somewhat to the west of Aldborough Manor down towards the lower ground to the north.

*Plate 6 Remains of culvert in Trench 87, looking SW.*

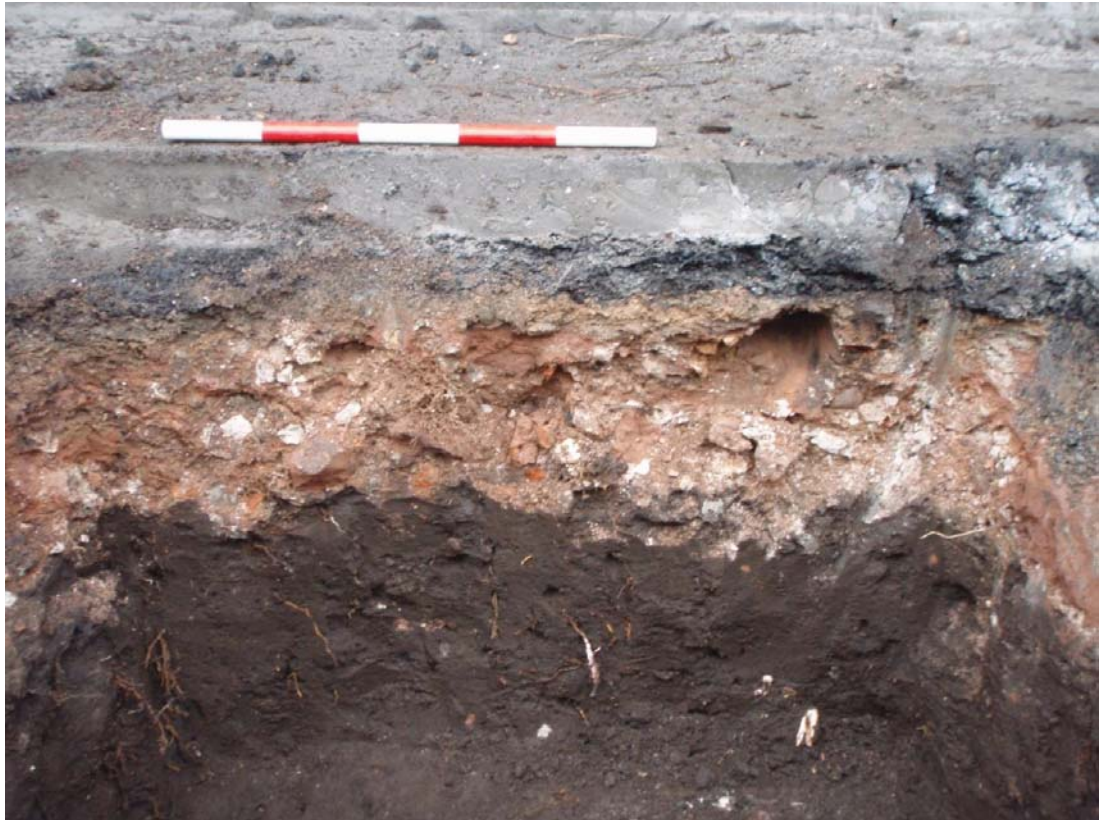
A series of post-medieval deposits were observed in Trenches 32, 33 and 34 in pavement areas immediately adjacent to the boundary wall of Aldborough Hall (Plate 7). In each of these trenches up to 0.30m of rubble, primarily comprised of fragments of ceramic building material, pebbles and fragments and flecks of lime mortar with a small amount of sand, was seen to be located under the existing footpath. The brickwork of the adjacent boundary wall suggests an 18<sup>th</sup> century, or slightly later date, for this feature. It is probable that this rubbly material relates to the levelling up and bedding for a pavement, though it is not clear whether it was for a pavement contemporary with the construction of the boundary wall, or later.

*Plate 7 Post-medieval deposits sandwiched between existing footpath and soils in Trench 33, looking N.*

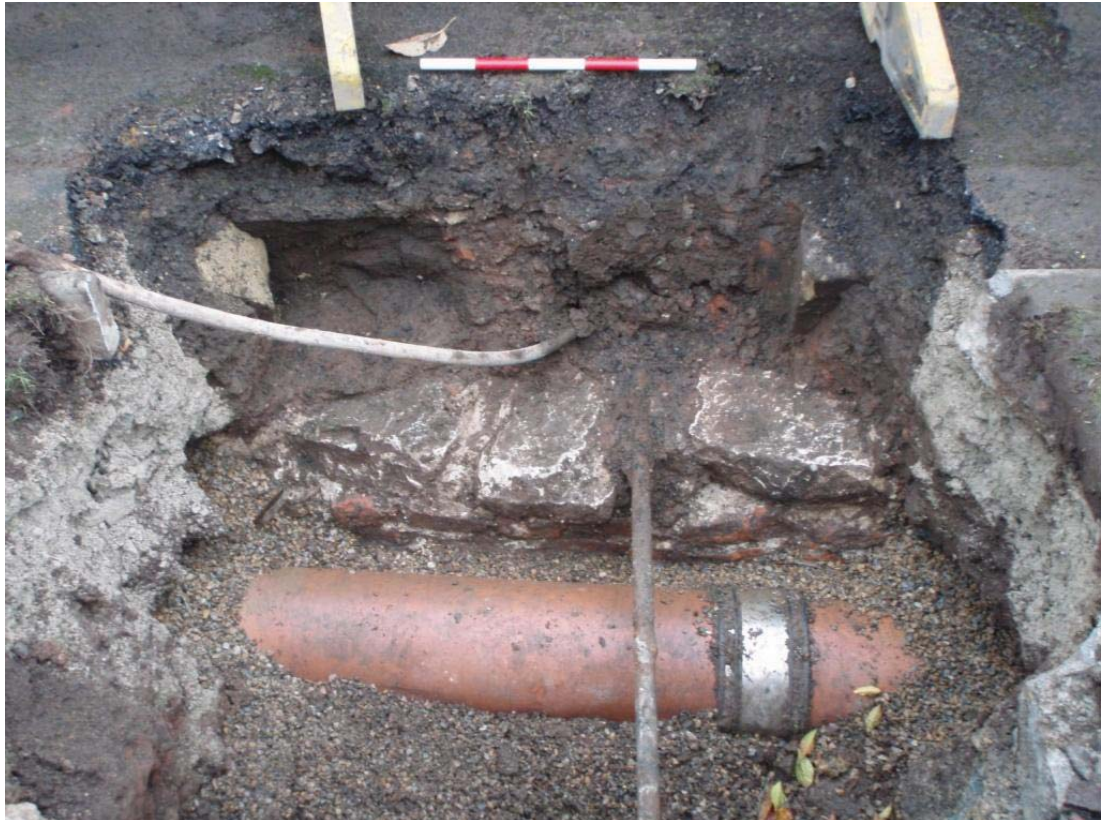
The only structural remains likely to be of post-medieval date relate to an arrangement within Trench 37, which also contained remains of later post-medieval kerbing (Plate 8). Although the remains were partly obscured by a variety of services a wall-like feature, aligned south-west / north-east i.e. parallel to the existing street alignment survived towards the south-eastern side of the trench, the uppermost parts being some 0.55m below existing pavement level. The lowest parts of this feature were two courses of thin bricks bonded with lime mortar. The bricks, which measured some 285mm in length by 60mm thick, appeared to extend to greater depth though it was not possible to excavate these further owing to the presence of adjacent services. The brickwork was surmounted by a single course of rough blocks of a creamy coloured limestone, again bonded with lime mortar, some of which measured in excess of 0.30m across by 0.20m thick. The overall width of the walling could not be determined due to its extending beyond the south-western limits of excavation. Whilst this feature appears to represent a wall quite what its specific function was is less certain, though its alignment does respect that of the adjacent roadway. It may be part of a boundary wall, alternatively, it could even form the sill wall for a timber-framed building. The lack of secure dating evidence for this feature does allow the possibility that it could relate to the latter part of the medieval period.

*Plate 8 Stone and brick structural remains in Trench 37, looking SW. Note that the stubs of later kerbing slabs can be seen towards the upper parts of the sections to the side of the trench (removed between these points).*

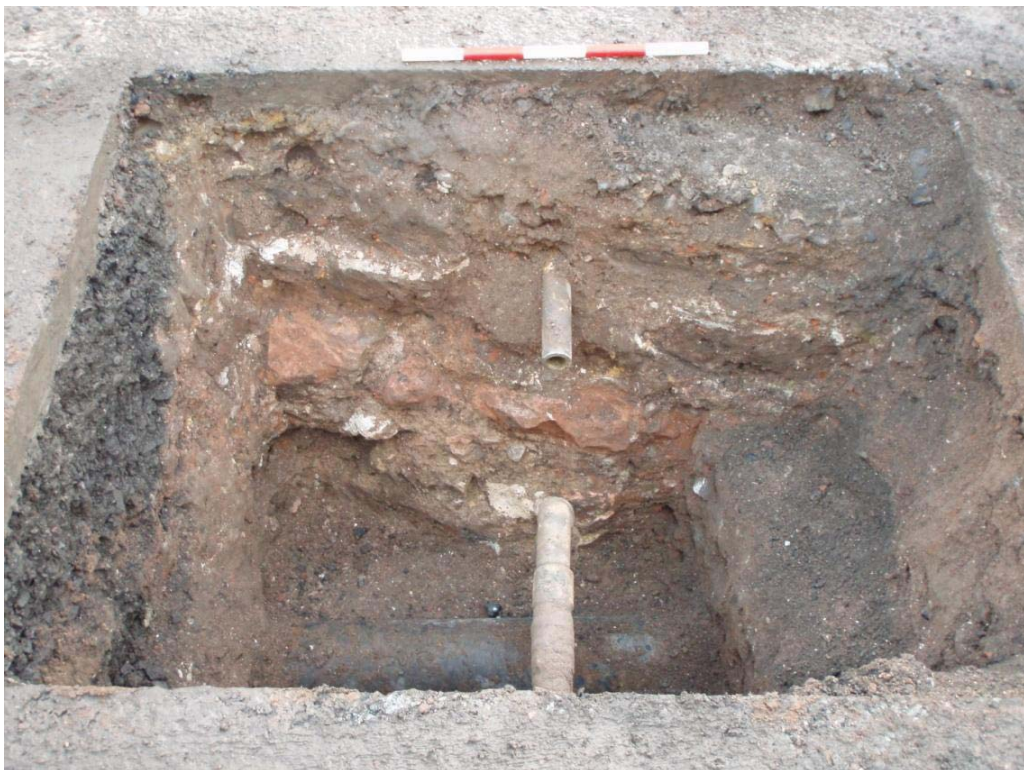
The walling within Trench 58, 586, was visible to its southern side and was comprised of a single course of rough blocks of red sandstone up to 0.32m across and 0.16m thick that were bonded with lime mortar (Plate 9). Although clearly at least partially truncated by the old gas main as well as by old narrow gas spurs, the alignment of the wall appears to be east-south-east / west-north-west. The stone blocks sat directly over a foundation comprised of approximately 60% lime mortar and 40% fragments of sandstone, 587, (largely the local red sandstone though a few pieces of creamy white sandstone were also present). This foundation material extended beyond the basal limits of the trench and was in excess of 0.30m thick. A thin silty deposit that probably accumulated immediately above the remnant stone blocks appears likely to relate to a post-Roman period.

*Plate 9 Mortared red sandstone blocks above a thick deposit of lime mortar and rubble in Trench 58, looking S. The sandy silt and mortar deposits directly above are likely to post-date the Roman period.*

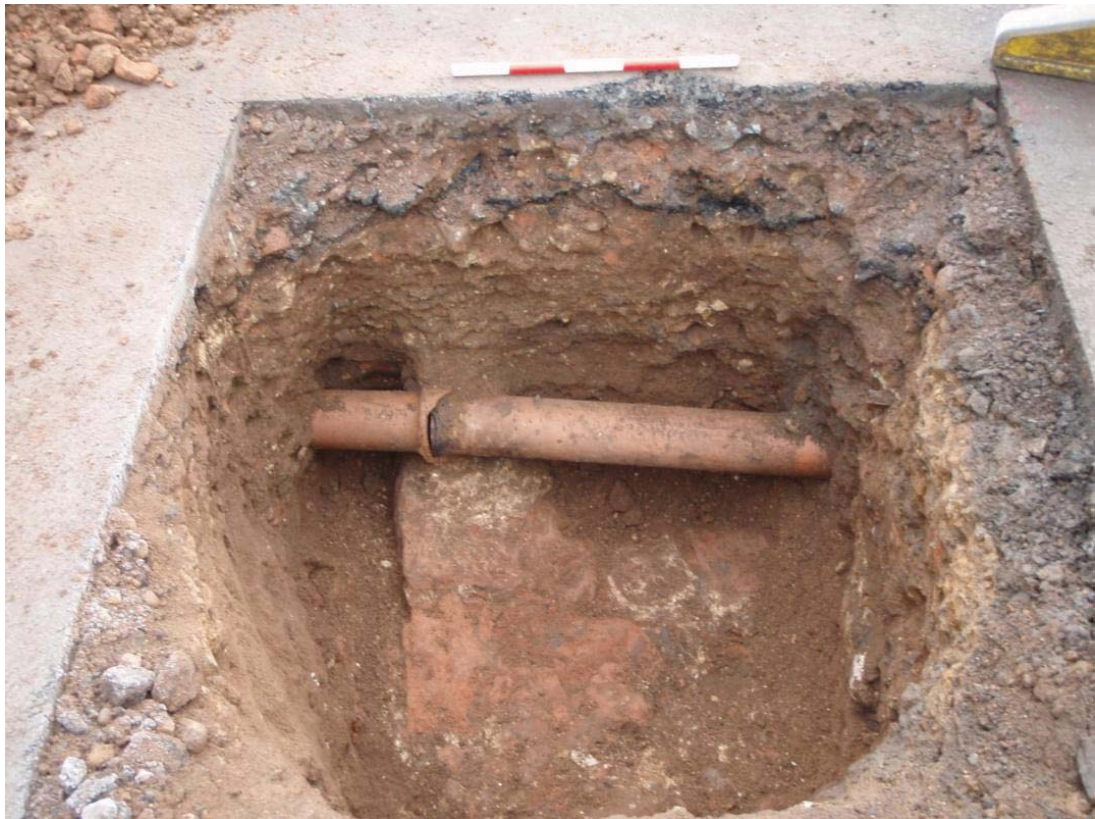
Within Trench 79 a single course of walling, 797, aligned west-north-west / east-south-east, was observed at the base of the trench at a depth of some 0.90m BGL (Plate 10). This was constructed of roughly squared blocks of red sandstone, up to 0.38m in size, bonded with lime mortar and extended beyond the basal limits of the trench. Clearly in excess of 0.73m wide, the northern face of the wall was fully exposed though its southern face lay beyond the base of the trench. The surviving upper surface of the wall undulated somewhat and this may

be the result of later robbing for stone. The deposit directly overlying the wall, 796 was comprised of angular fragments of sandstone and flecks of mortar with a slightly lesser proportion of greyish brown sandy silt up to 0.30m deep. The stoney characteristics of this deposit suggest it may derive from the robbing of wall 797. As such it is possible that this deposit may relate to a post-Roman, rather than Roman, period.

*Plate 10 Wall of mortared red sandstone within Trench 79, looking E*

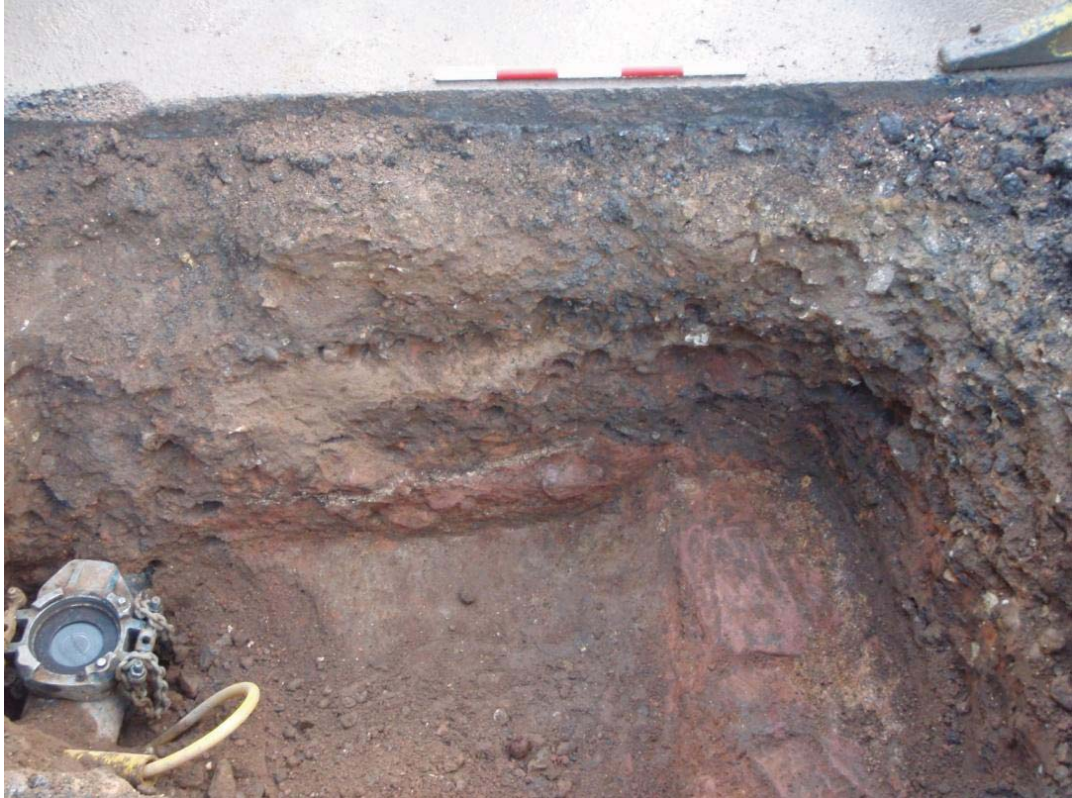
The northern part only of a single course of walling, 8191, aligned west-north-west / east-south-east, was found in Trench 81, the remainder extending beyond both the basal limits and southern baulk (Plate 11). The upper surviving parts this wall, which occurred at around 0.78m BGL, was again constructed of roughly squared blocks of red sandstone, up to 0.32m in size, and bonded with lime mortar. Trench 81 is located only around 15m to the north-west of Trench 79 and although the walling within both is similarly aligned the spatial relationship of the trenches suggests that they may form separate, rather than the same, walls. To the northern side of wall 8191 a deposit comprised overwhelmingly of fragments of red sandstone, 819, was present whilst sealing this was a thin stripe of mortar and plaster, 818. These deposits may relate to the collapse or demolition of this walling as may the deposit overlying the mortar, 817, a spread comprised predominantly of stone rubble.

*Plate 11 Wall of mortared red sandstone, 8191, within Trench 81, looking E. Note the stone rubble, 819, sealed by a thin stripe of mortar and plaster, 818, to the north of the wall which may relate to collapse or demolition. The deposit above the mortar stripe, 817, may also relate to this process.*

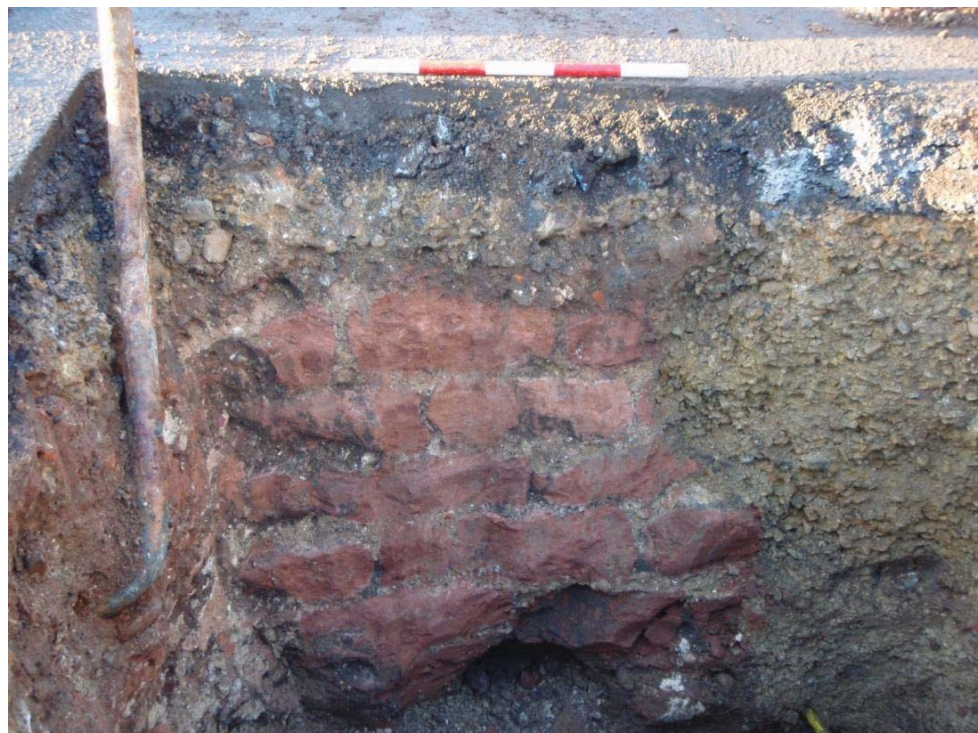
The adjacent trenches 85 and 86 both revealed stretches of walling, several courses tall, aligned north-north-east / west-south-west and at remarkably high levels. The uppermost course of that within Trench 85, 855, occurred within 0.30m of the existing road surface and continued for six courses to the base of the trench, beyond which it extended (Plate 12). The uppermost course within Trench 86, 865, was at a depth of some 0.54m of the present surface and continued for a depth of three courses with suggestions of a fourth extending beyond the basal limits of the trench (Plate 13). The stonework to each wall was of roughly squared blocks of red sandstone, fairly well coursed and bonded with lime mortar. The blocks to wall 855 were up to 0.34m long and 0.14m thick, those to wall 865 being up to 0.32m long by up to 0.15m thick. No surviving face to either wall was visible in the trenches as both walls had been truncated in the past by a combination of gas, water and unidentified services. The closeness of proximity of these similarly aligned walls (the trenches being approximately 1m apart) argues for some sort of relatedness between the two.

*Plate 12 Wall of mortared red sandstone, 855, in Trench 85, looking W. Truncated to three sides by modern services the orientation of the blocks indicates the alignment of the wall.*

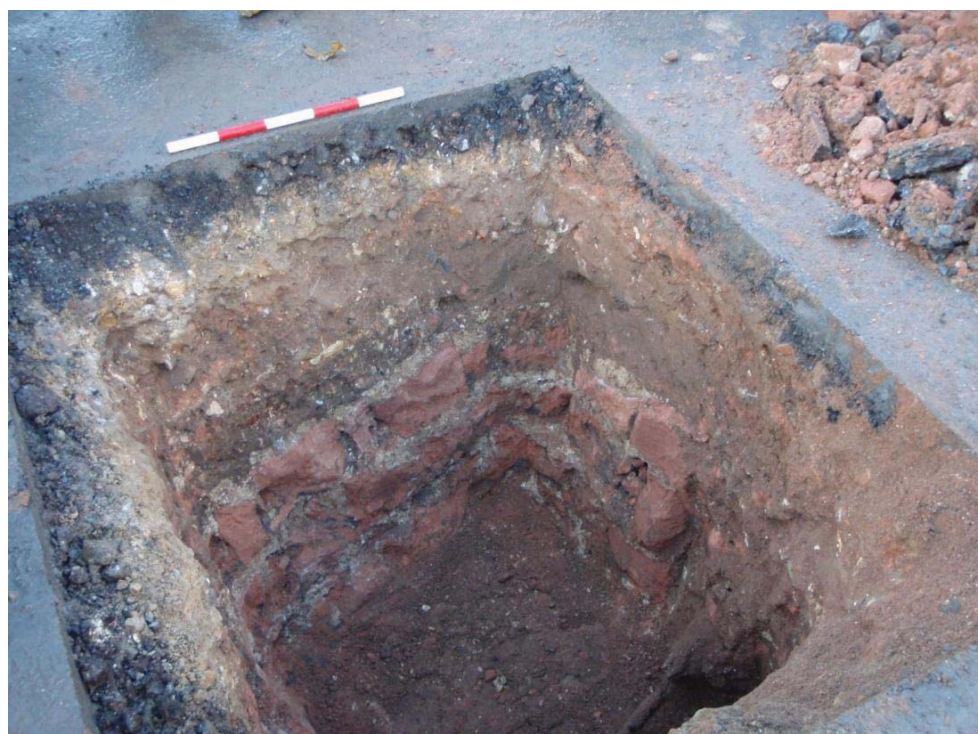
*Plate 13 Wall of mortared red sandstone, 865, in Trench 86, looking WNW. Although again heavily truncated the orientation of the blocks indicates the alignment of the wall.*

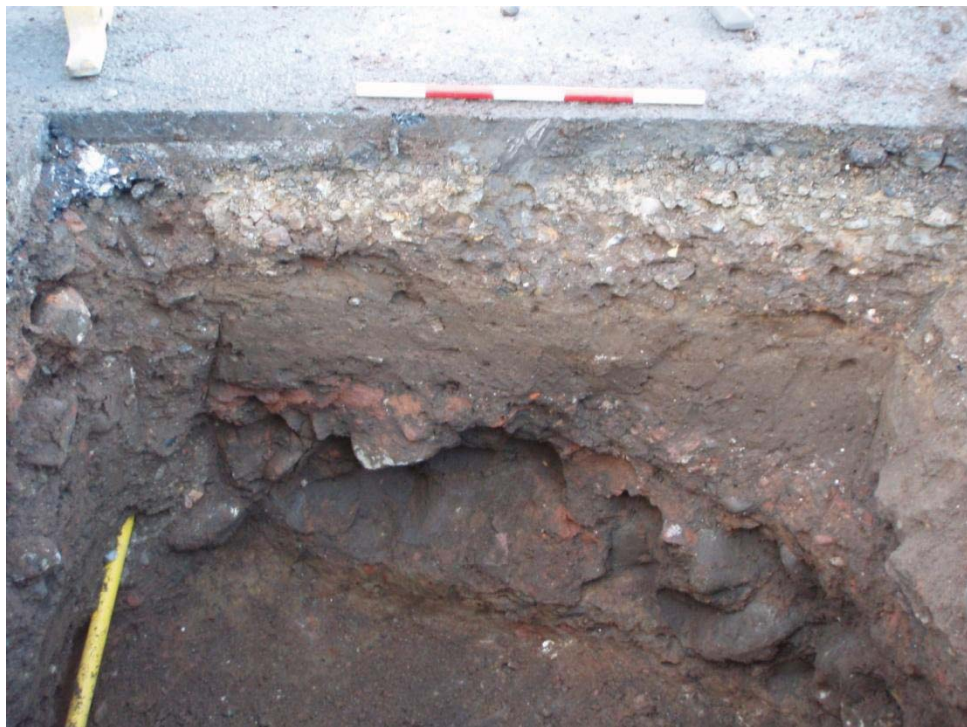
Within Trench 57 a dense mass, some 0.38m thick, of large rounded cobbles of a size up to 0.29m across, 579, was observed (Plate 14). This overlay a deposit of pale greenish yellow slightly clayey sand containing occasional flecks of charcoal and the odd fragment of red sandstone. Deposits 578 and 577, essentially fairly thin and very stoney layers containing varying quantities of greyish brown silt overlay the cobbles. These two layers may relate to robbing debris or levelling deposits.

The mass of cobbles 579 are likely to have formed foundation material, possibly for walling, or even for some sort of surface.

*Plate 14 Trench 57, looking S. Thick cobble layer can be clearly seen (though many of the cobbles at the section edge have fallen away) as can the stoney layers immediately above. The relatively stone free soil deposit above these produced some residual Roman material*

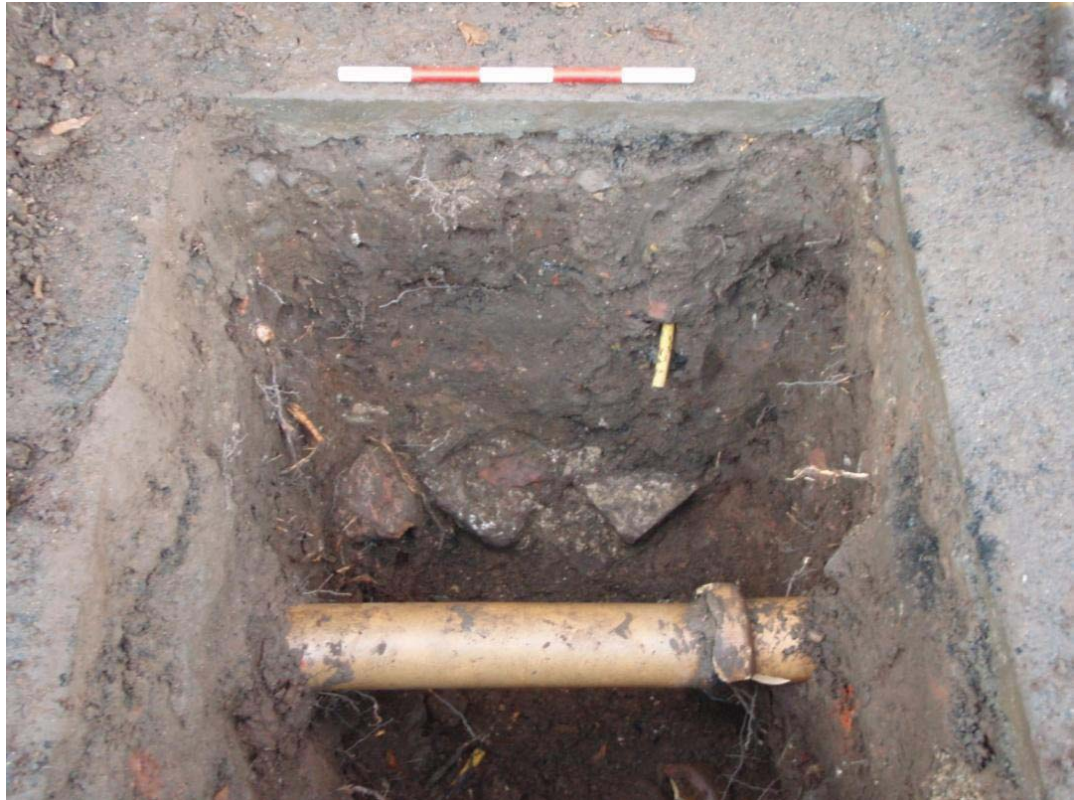
Trench 77 also contained a thick layer of large cobbles together with large fragments of red and white coloured sandstone, 777, close to its base (Plate 15). Lime mortar was also evident between some of these large stones. Interpretation of this deposit is not clear cut. The layer may represent a wall footing or even unwanted left over debris from the robbing of a wall. A pale coloured silty sand deposit, 776, immediately above 777 contained quantities of mortar and flecks of plaster and could conceivably relate to a wall robbing event.

*Plate 15 Layer of cobbles in Trench 77, looking S.*

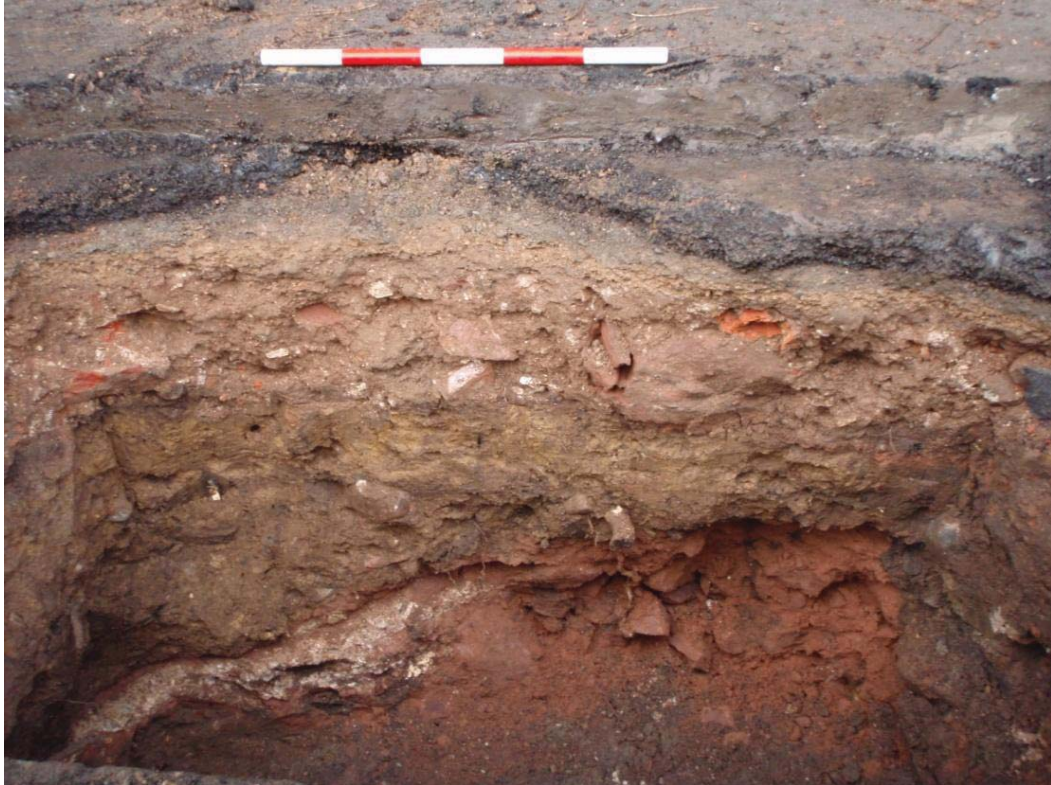
Within Trench 34 a dense mass of fragments of red sandstone, 348, were evident to the western part of the south facing elevation (Plate 16). Stratigraphically above this in the eastern part of the section successive deposits of mixed silts, 349, a layer of crushed mortar, 346 and further layers of pale coloured, stoney, silts, 346 and 345 were present. The stone deposit 348 is very likely to be derived from a wall. The particular interest in this instance is that the course of the eastern side of the town wall is said to be located at a point immediately to the east of Trench 34. It is tentatively suggested that 348 may represent the western tail end of deposits associated with either the collapse or robbing of this wall. It is possible that the layer of crushed mortar, 347, may be related to this episode whilst deposits 346 and 345 may post-date this.

*Plate 16 Trench 34, looking N. Dense deposit of stone fragments may relate to the demise of part of the eastern side of the town wall, as may the mortar deposit to the lower left. Deposits immediately above this would seem likely to relate to a post-Roman period.*

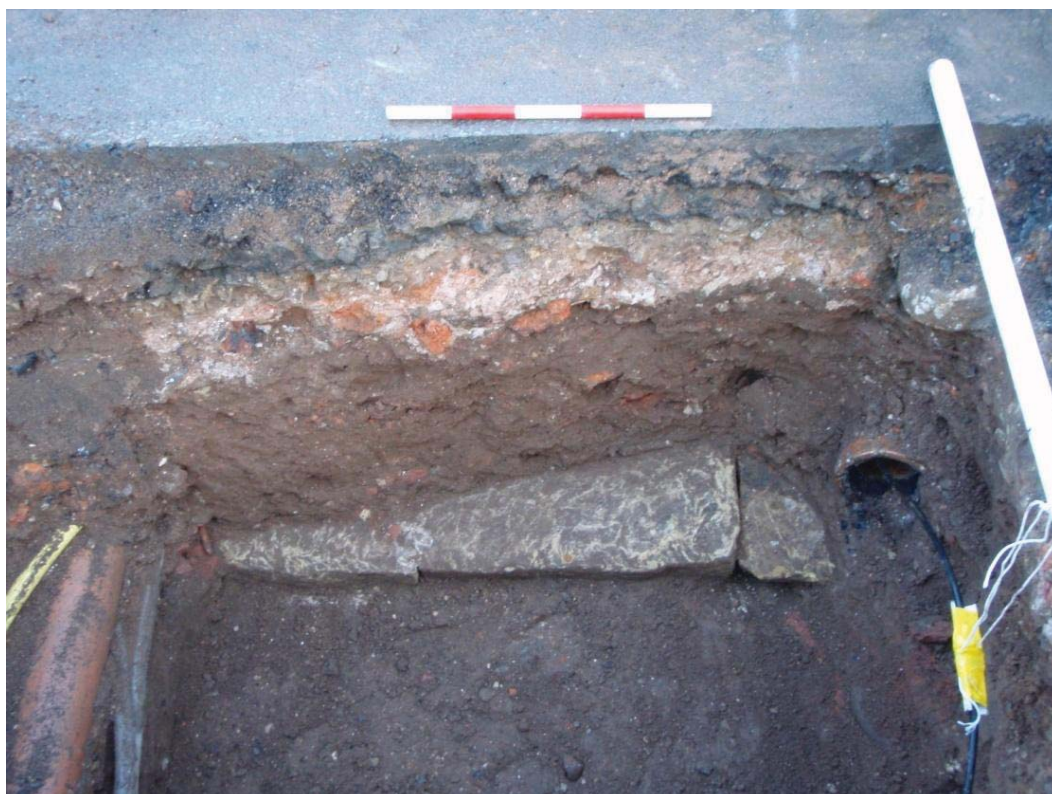
Toward the very basal parts of Trench 83, and at a depth of some 0.86m BGL what may be the remains of a drain aligned approximately north-west / south-east were revealed (Plates 17, 18). Only the southern part of this feature lay within the trench and these remains were comprised of three slab-like blocks of pale yellowish coloured fine grained sandstone. The pieces had all been roughly squared and the largest was some 0.66m in length. Each piece was bonded with lime mortar to the adjacent piece. A modern electric duct had cut into the top of this feature at the eastern side of the trench. Judicious exploratory probing indicated that the large central slab was only some 0.12m thick and no further stonework could be detected beneath. Such slab-like pieces of stone are perhaps unlikely to have formed part of a wall, particularly as no traces of mortar were present of the upper surfaces of the blocks. These observations may suggest that the slab like elements are actually capping stones sealing a stone-lined channel whose width is somewhat narrower than that of the capping stones themselves. Several drains of such form and of varying sizes are known from Roman contexts in York. Although the absence of dating evidence prevents the attribution of a conclusively Roman date for this feature, such must be considered a distinct likelihood.

Plate 17 Possible drain in Trench 83, looking N.

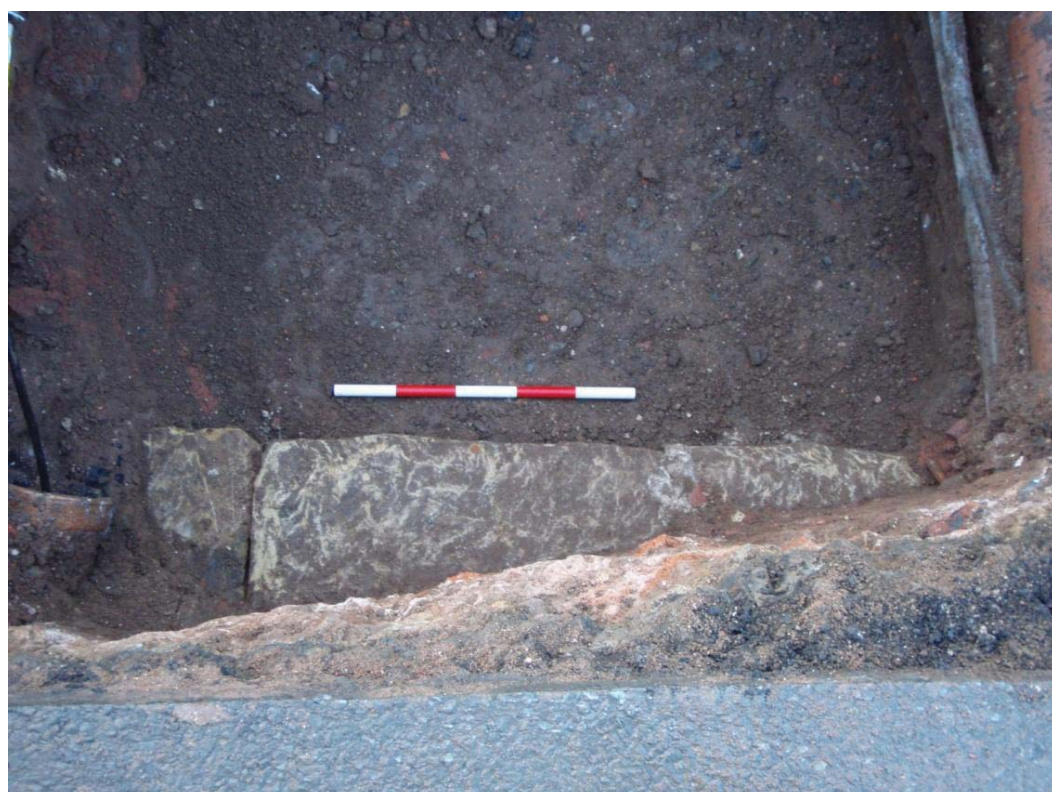
Plate 18 Looking down onto the possible drain in Trench 83.

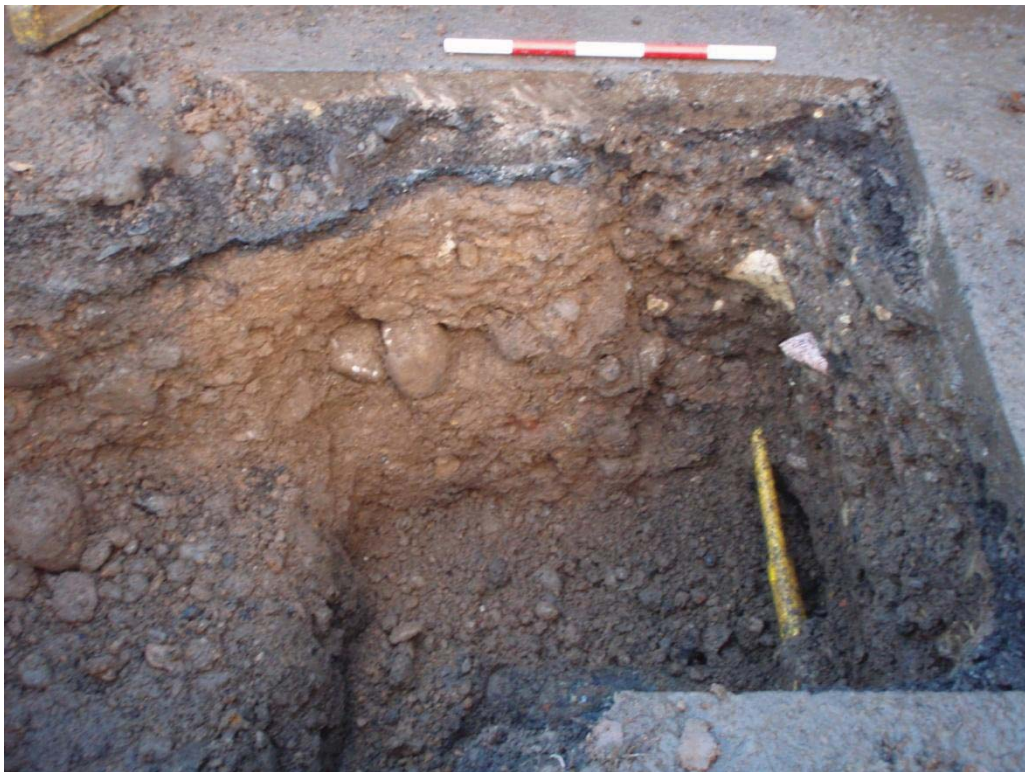
A very thick deposit of compacted clean gravel and cobbles was exposed in Trench 52, 524, (Plate 19). This material, which was cut at its eastern side by the trench of an old gas spur, extended from immediately below the tarmac of the footpath to beyond the basal limits of the trench. Suggestions of horizontal laminations were hinted at by lines of aggregate of common size. No finds or other dating material was recovered from this trench. Deposit 524 has the superficial appearance of a thick deposit of road makeup such as is occasionally found in Roman period deposits. Against this, it must be highlighted that the deposit was remarkably clean and, perhaps significantly, extended fully to the underside of the footpath tarmac. Whilst it is conceivable that this deposit may be of Roman date, one is minded to err on the side of caution and accept the possibility that it could be of modern date, perhaps relating to the backfill of a very large modern feature.

*Plate 19 Thick deposit of compacted gravel and cobbles in Trench 52, Looking N.*

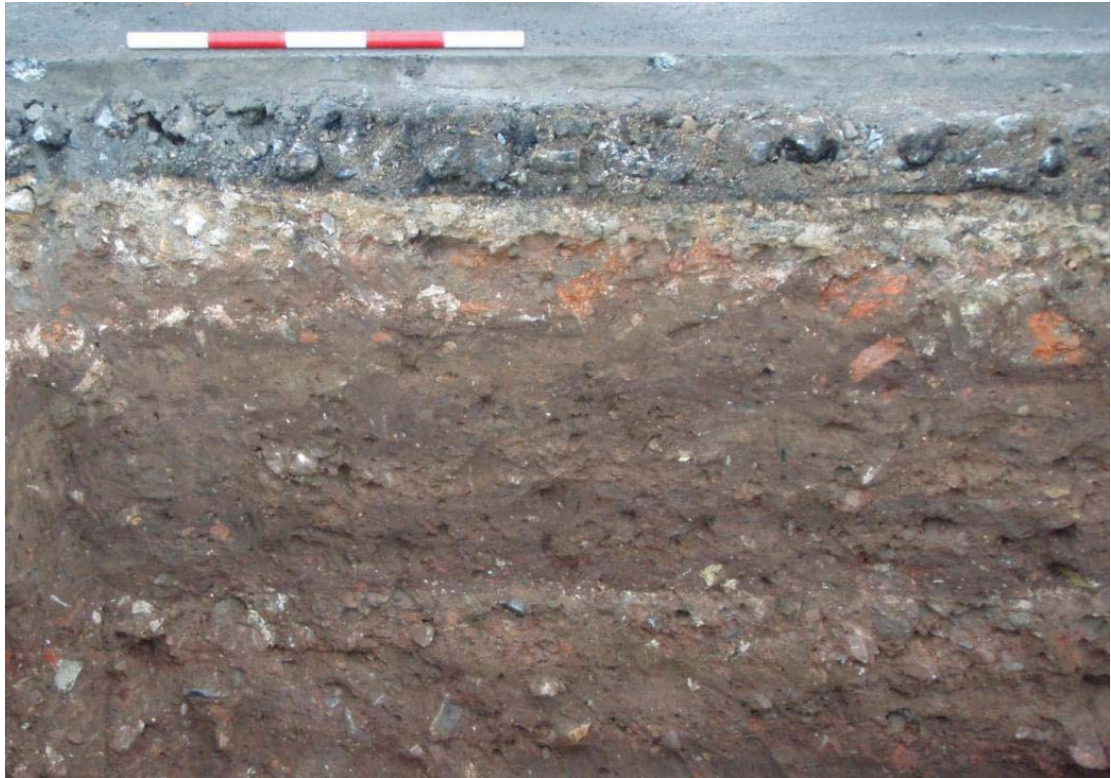
What may be road or surface metalling of the Roman period was present in Trenches 87 and 88 on the Boroughbridge Road. That in Trench 87 was comprised of a series of two horizontally lain stone rich layers, generally in the region of 0.10m thick and extending from a height of 0.79m BGL to the base of the trench at 1.05m BGL, 877, 879 (Plate 20). Interleaved between the two stoney bands was a deposit of yellowish brown sandy silt, 878. No dating evidence was recovered from these deposits.

*Plate 20 Two bands of probable metalling in the lower 0.25m of Trench 87, looking SW*

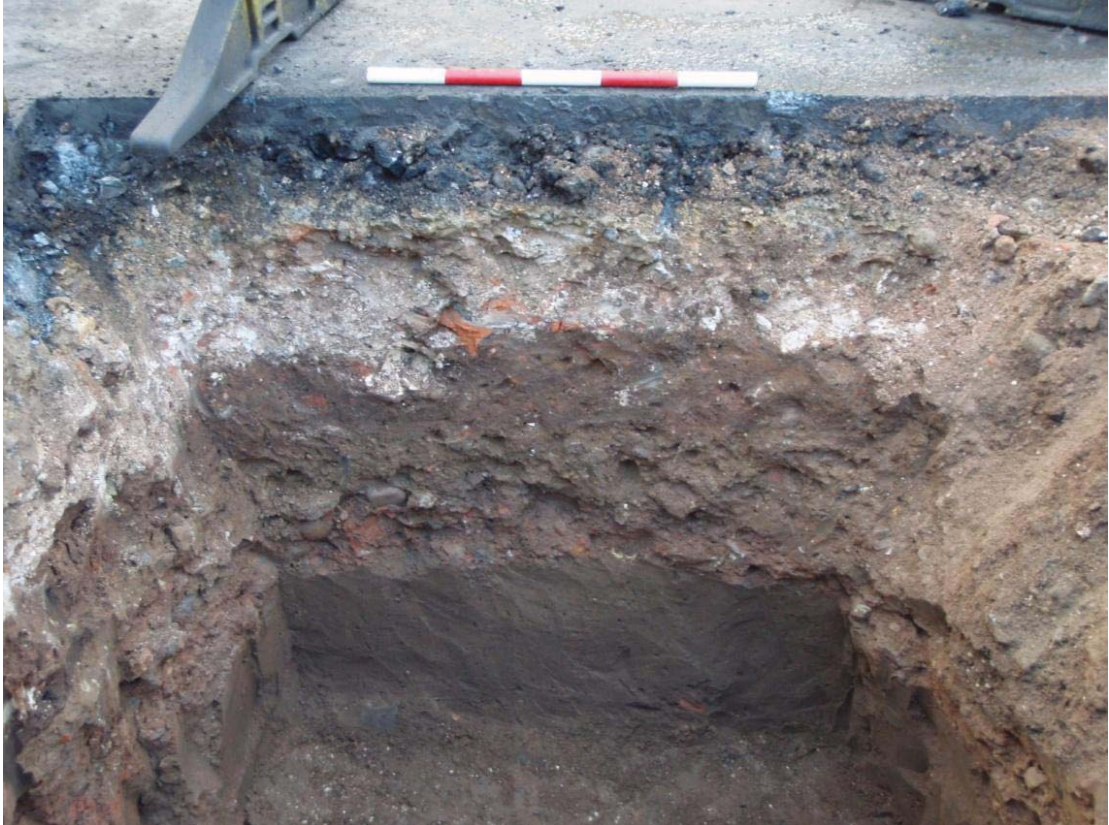
Within Trench 88, which lays immediately to the west of the defences of the western side of the Roman town, a somewhat denser layer of probable metalling, 884, was seen (Plate 21). The lower half of this was comprised of coarse gravel and fragments of red sandstone whilst the upper half was of gravel and occasional small cobbles. Interestingly, 884 directly overlay a clean, virtually stone free, soil of brown sandy silt of entirely 'non-urban' character, 885 (see 5.3.5 below). The characteristics of layer 884 suggest the likelihood that it formed metalling for a roadway or surface of some sort.

*Plate 21 Probable road metalling in Trench 88 immediately above clean soil, Looking SW.*
